Asbestos Refurbishment Survey Window Removal to Tower and Kingsway (Link Bridge)

**Space House
1 Kemble Street
London
WC2B 4AN**

Survey Date: 09 March 2020

Project Reference: P-366327

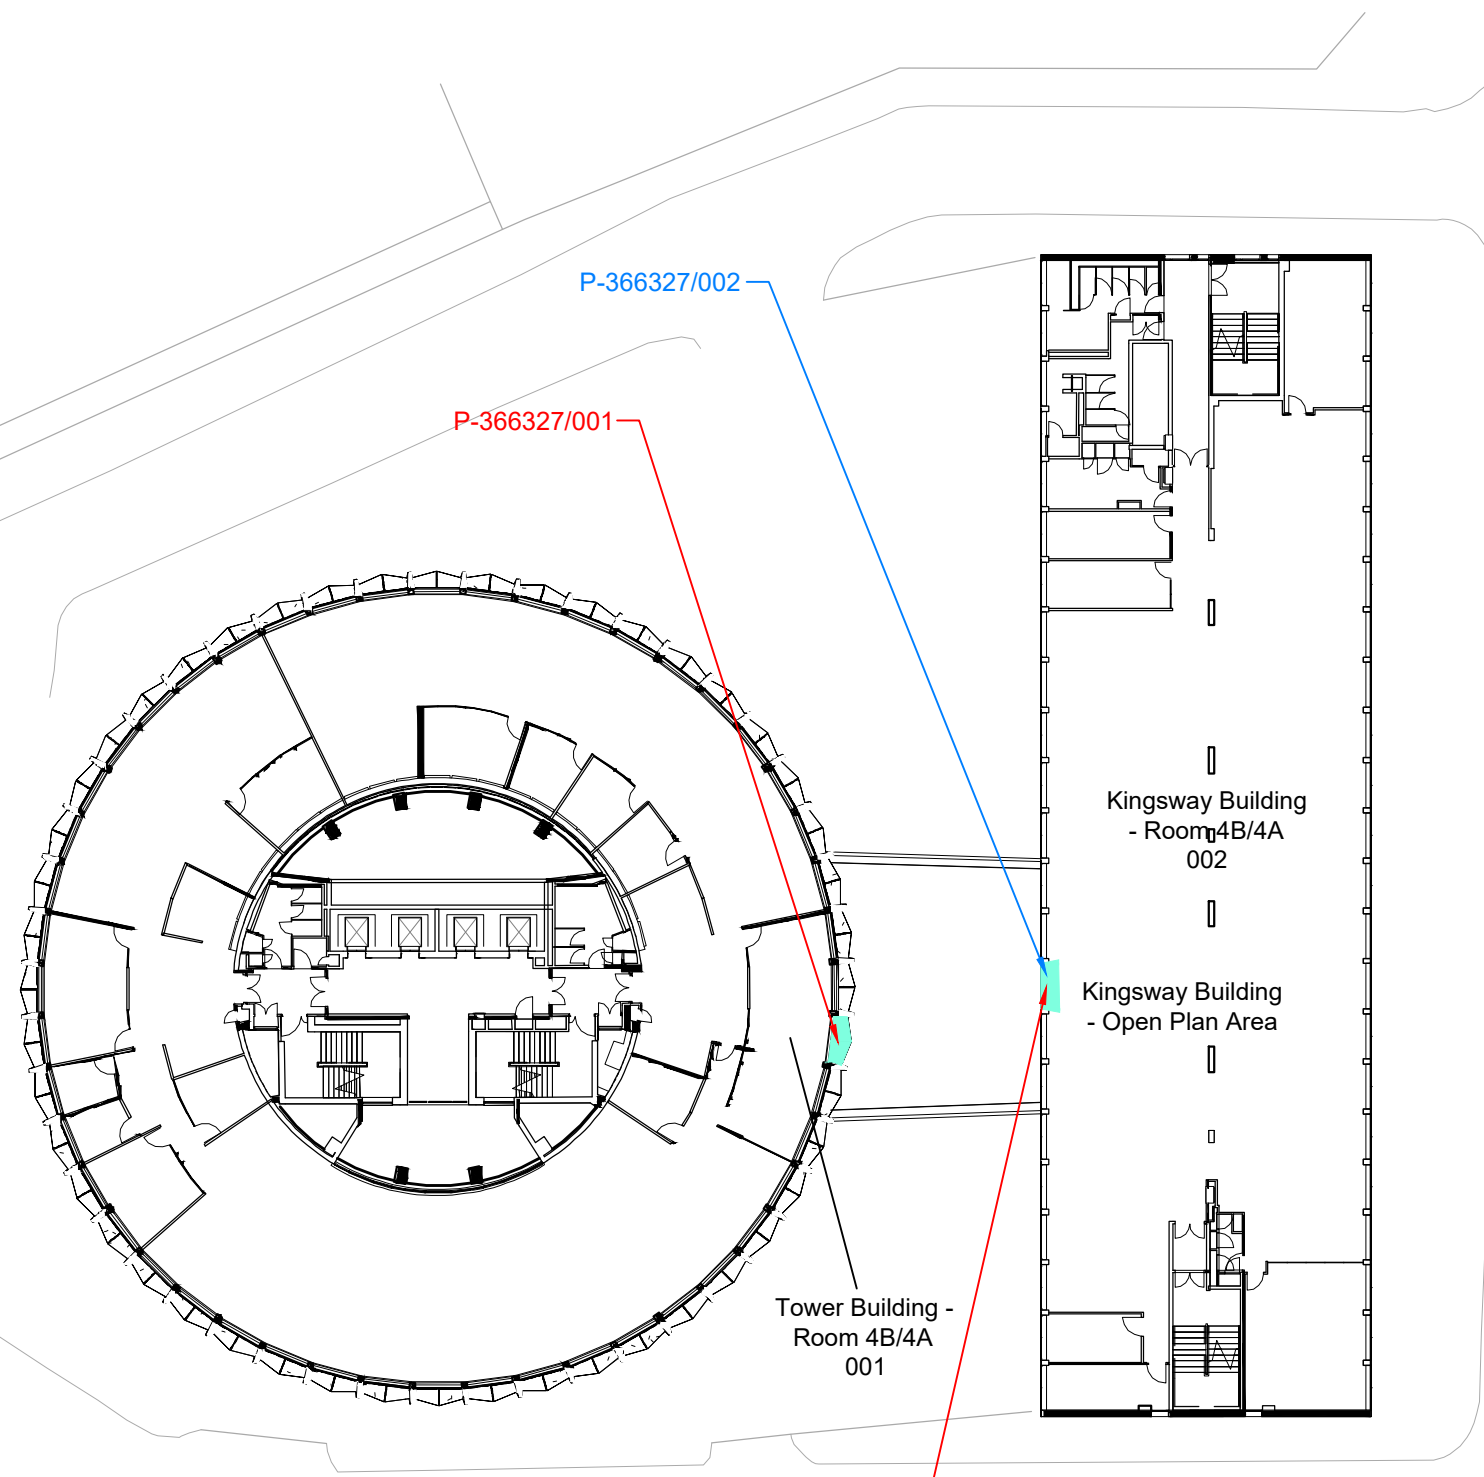
DRAWING 4th Floor	
SHEET: 01 of 01	
SITE NAME: Space House	
Site Address: Space House 1 Kemble Street London WC2B 4AN	Project: P-366327 Survey Date: 09/03/20 Surveyors: APU Drawn By: TTS-GA
Client: SLQR Trustee

FLOOR INTRUSION
