BASEMENT IMPACT ASSESSMENT ADDENDUM_2
20A FERNCROFT AVENUE
LONDON
NW3 7PH

JOB NO: P19-461

DATE: 9th April 2020 – Rev 0

BS 5837:2012 Tree Survey Arboricultural Impact Assessment

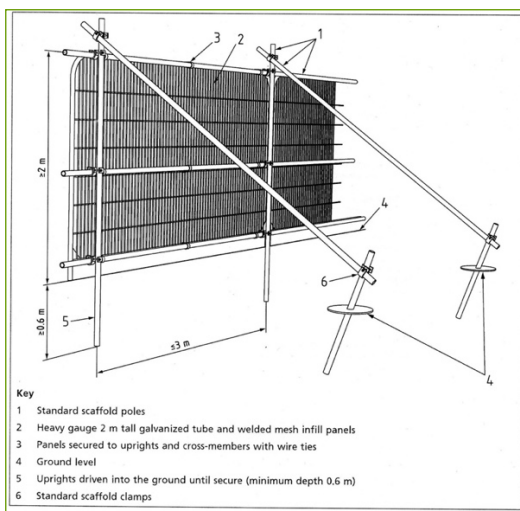
Fig 1 Shows the default specification of protective barriers (taken from BS 5837)

There is a default specification of barriers (Fig1) which is recommended and these are designed to be permanent barriers and positioned as per the TPP. In most instances this takes the form of welded ‘Heras’ panels, secured onto a scaffolding framework, which is then braced and secured into the ground. The panels should be difficult to move and should form permanent rigid structures. Should site conditions mean this default fencing is impossible to install, then an alternative fencing can be suggested by the retained arboriculturist, to be approved by the local planning authority.

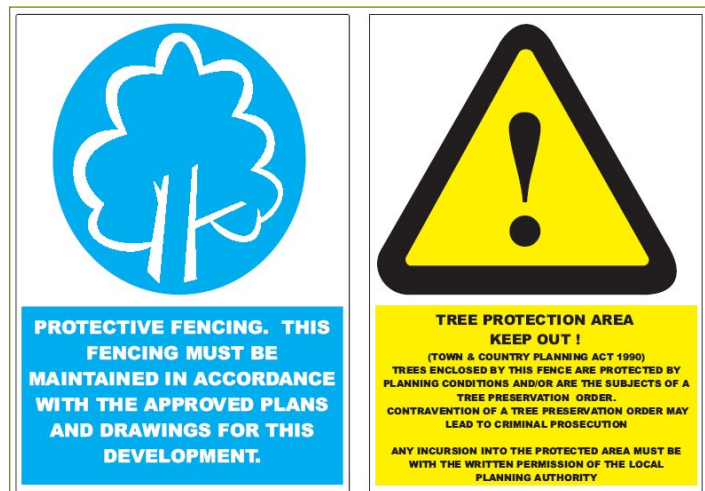
Fig 2 Shows examples of the all-weather signage to be attached to protective barriers.

The protective fencing should also be accompanied by clear all-weather signage fixed securely to the barriers, examples of which are shown in Fig 2.

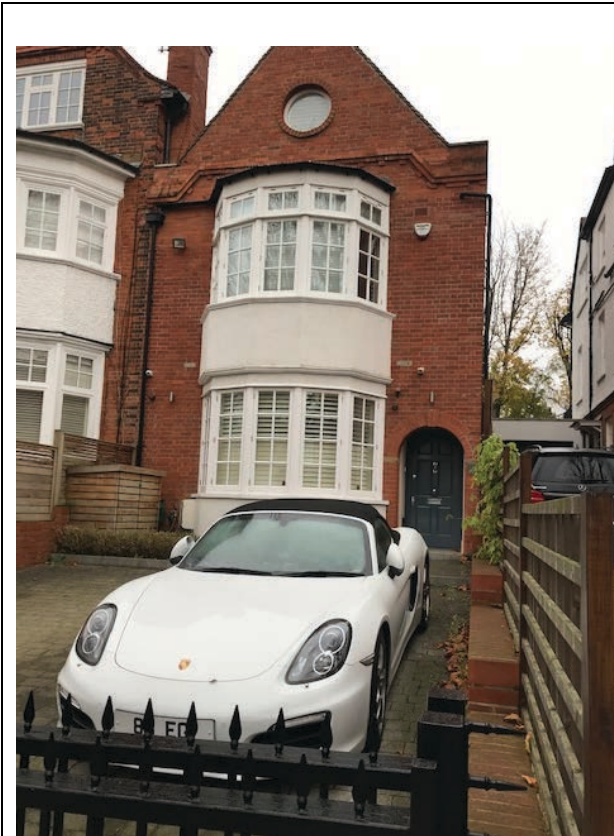
Front garden of 20 A Ferncroft Avenue

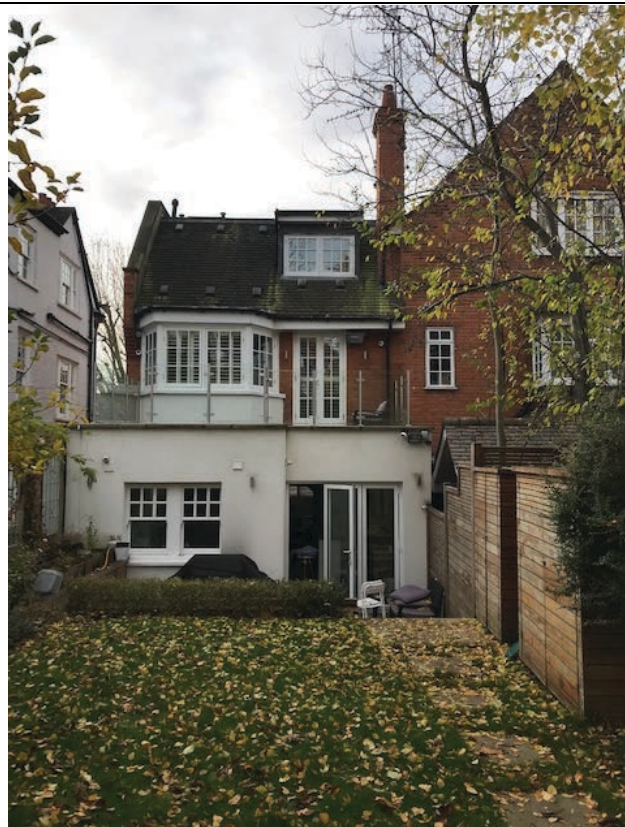
Rear views of existing extension of 20A Ferncroft Ave

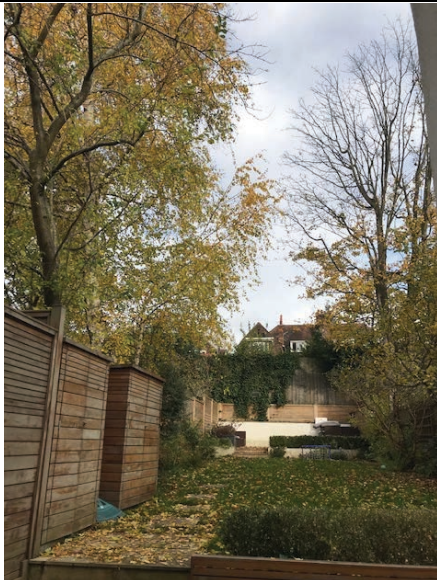
View from the house showing boundary trees

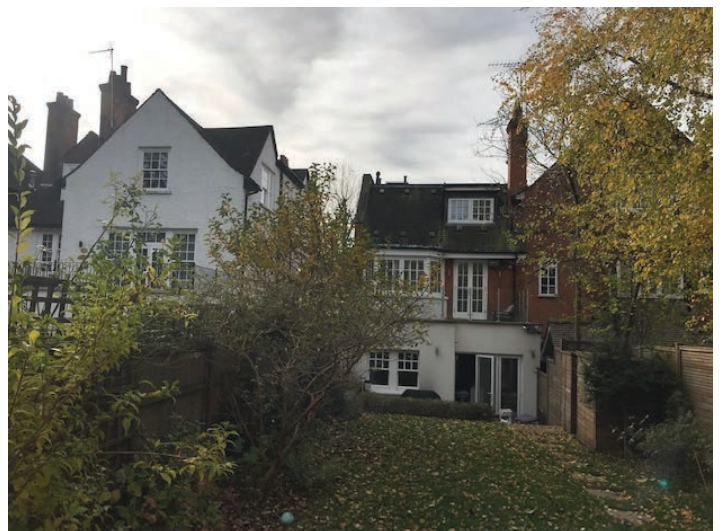
View from the rear of the garden showing boundary trees

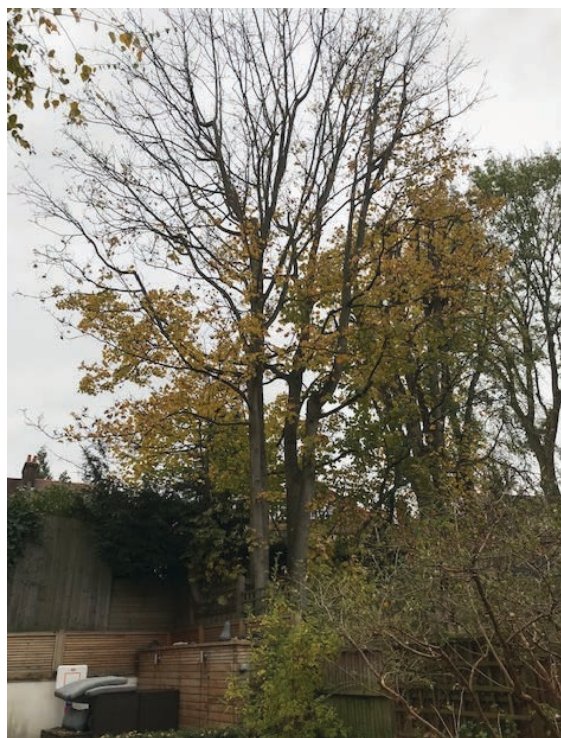
- 2.6 The other 3 trees will not be affected as demonstrated in the enclosed TCP (Appendix 3). It should be particularly noted that the neighbours Category 'B' multi-stem mature sycamore (T4) which has a canopy extending into the garden, is well away from the construction zone.

T4 Category B Sycamore at rear of garden

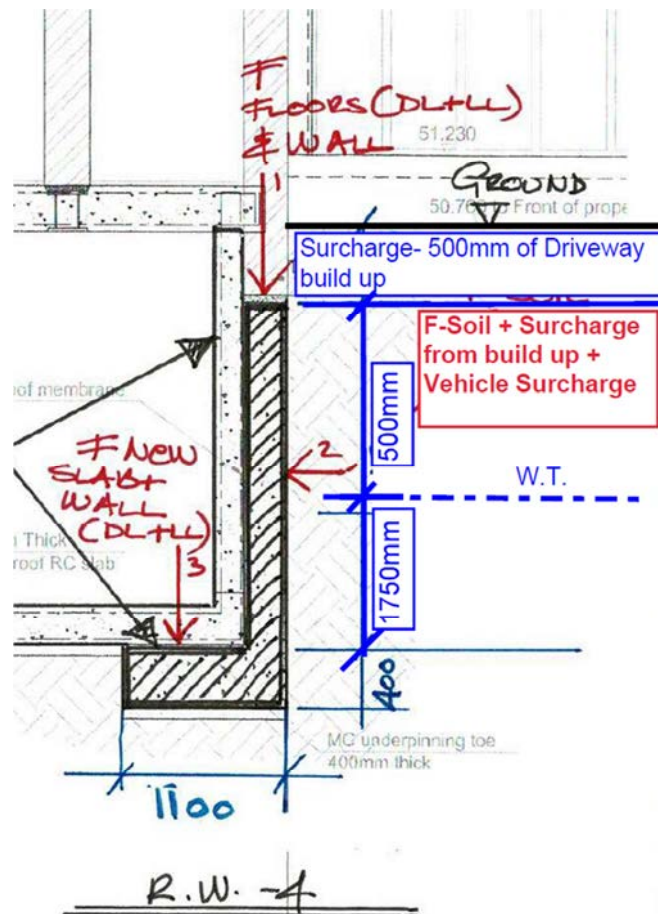
The top level of the drive way is 50.780m; the top of the concrete wall for the basement underpinning the existing walls is below the ground level. Therefore the effective height of the concrete wall from the top of the wall base is 2375mm circa, and the loading from the soil above is considered as an additional surcharge.

Image: extract of sketch showing loading applied to retaining walls revised March 2020.

As shown in the above sketch the all retaining the soil next to the garage is loaded with a surcharge equivalent to 500mm of retained soil.
