Ark Stained Glass & Leaded Lights Limited

Condition Report on Christ Apostolic Church (Formerly St John the Baptist) Kentish Town South Nave Windows

5th May 2020

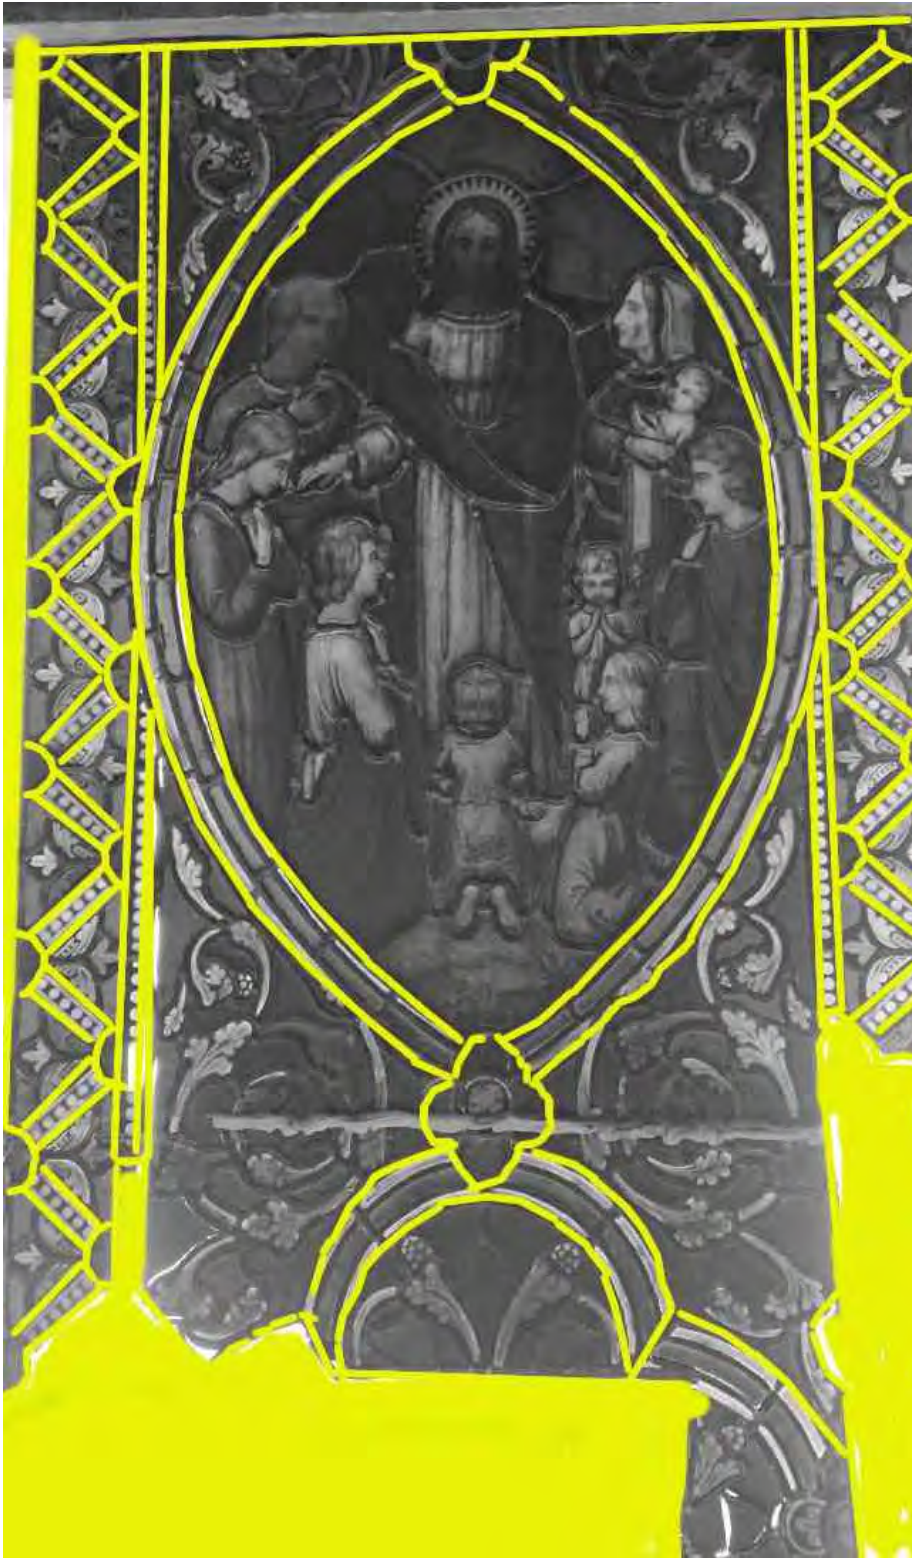
SN2 Middle Panel Sketch

- The middle panel is complete.
- There are a number of breaks and missing pieces of glass. Missing border glass.
- Breaks shown with red line; missing areas with red hatching.
- The main structural leadwork of the panels is very weak, while the areas within the roundels and blocks of decorative leadwork are in better condition.
- Bowed areas outlined in blue.
- The decorative border has split away from the central section.
- Lines of detachment shown in green.

- Some degree of releading is required: from partial dismantling and releading to a full relead.
- The extent of releading to be discussed below. Though the sketch shows the minimum amount.
- Cracked quarries of glass will be repaired. Methodology see appendix *Treatment of Cracks and Breaks*. We would recommend the order of preference to be; copper-foiling single breaks and only edge-bonding where the piece has multiple breaks. We would take this approach, as the edge-bonded items require back-plating, thereby increasing the weight of the panel.
- Clean glass.
