Appendix C – Asbestos Survey

REFURBISHMENT SURVEY FOR ASBESTOS-CONTAINING MATERIALS

CLIENT: 1923 Mortimer Investments Ltd

SITE: 40-50 Tottenham Street, London, W1T 4RN

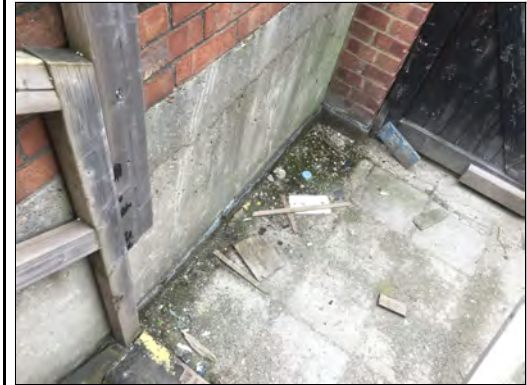
Building	Block	Floor/ room	External / External to rear of building		
Assessment no.	028	Accessibility	Occasionally likely to be disturbed		
Material Risk					
Identification	Identified	Condition	Good Condition		
Extent	<10lm	Asbestos Type	Chrysotile		
Location/ position	Bitumen membrane adjacent timber stairs				
Surface treatment	Completely Sealed				
Product type	Bitumen				
Material risk	Very low	Material risk score	2		
Action	Remove
