Site Investigation Report

Job Information	
Client	
Client ref	
Visit date	17/02/2020
Report date	17/02/2020

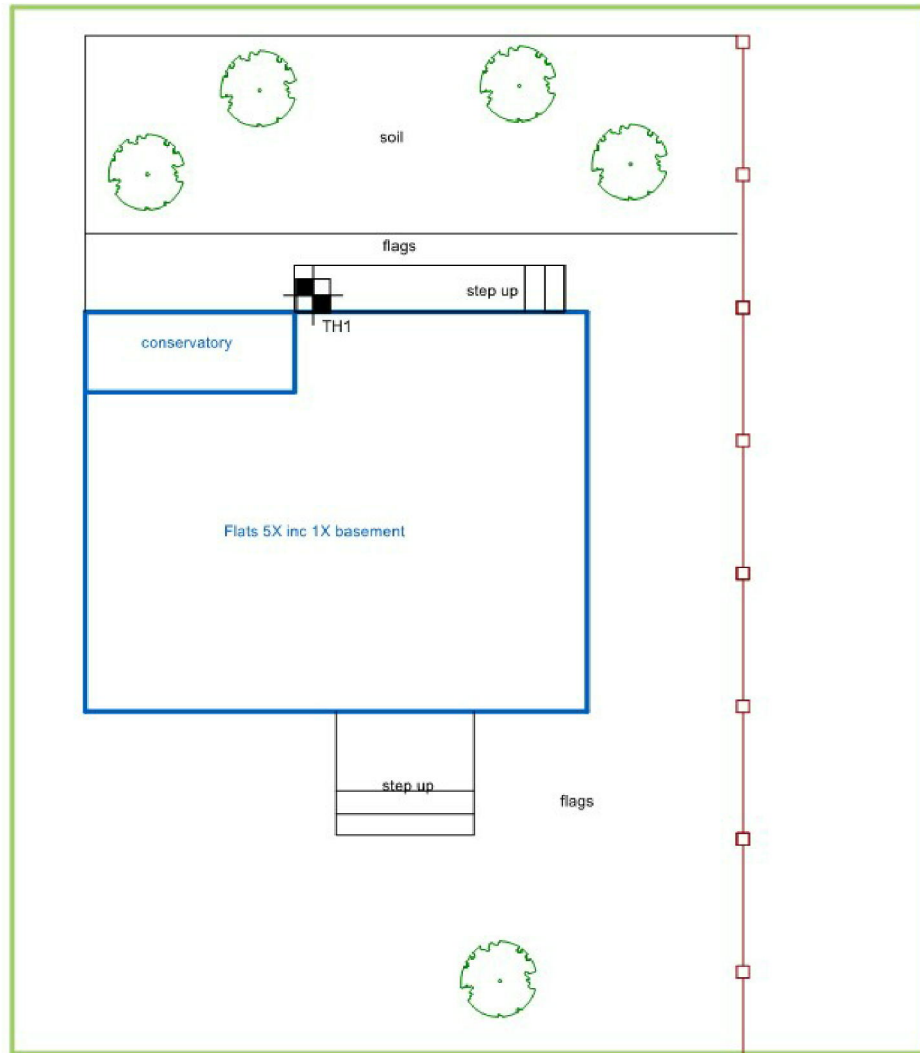
This drawing should be used for diagrammatic purposes only. Auger are not responsible or liable for any 3rd party works undertaken using the details outlined in this drawing.
Confirmation of the drainage configuration can only be confirmed by excavation or detailed technical survey.
