22 Froggnal Way - Curtilage Wall and Outbuilding

Structural Inspection Report

Job Number: 23261

Date	Version	Notes/Amendments/Issue Purpose
June, 2018	2	For Information

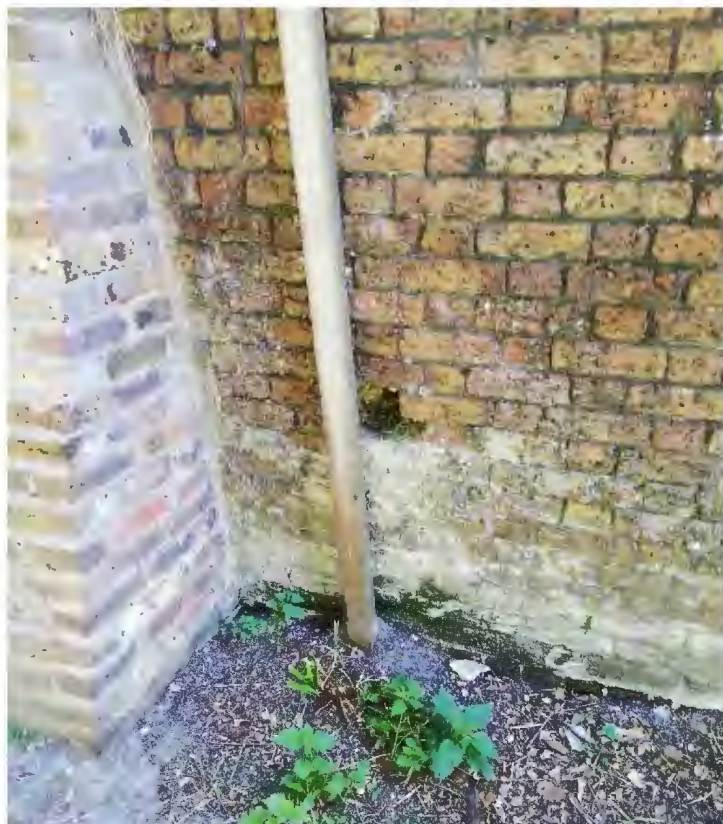
It should be noted that there is an level change between the two properties along this wall, with a retained height of approximately 860mm to the 20 Perrins Walk side the neighbouring property.

Measurements taken on site of the lean to the wall were measured at 48mm, 131mm and 144mm and correspond to the locations A, B & C in Elevation 2, above.

Finally, we have investigated the structural design of the 2.3m high freestanding wall with piers at a maximum of 5.0m centres as a standalone item. Location C on Elevation 2, where the wall spans 5.0m between piers is not satisfactory. The maximum allowable spacing of piers for the wall to be compliant with current codes is 4.6m. This is achieved at Locations A and B on Elevation 2, although as noted earlier, this section of wall fails once the retaining forces are taken into account in any event.

We would therefore recommend that Elevation 2 & 4 are either strengthened or taken down and rebuilt to modern codes of practice.
