174 Regents Park Road

*Rebuilding of the Closet Wing
~ Design + Access Statement ~*

May 2020

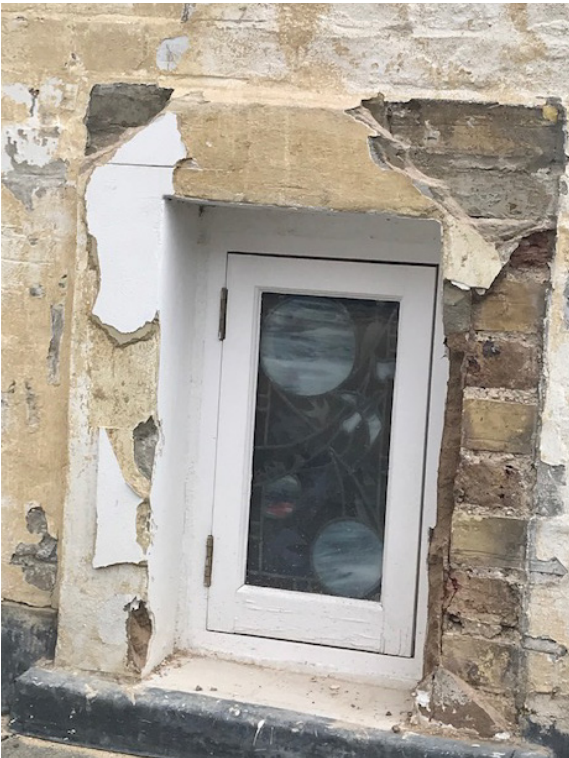
After removing the facing render the SW elevation is found to be a patchwork of different aged brick. Much of it is not original.

Figure 7 : View of the existing lower window

The proposal is to clad the structure in reclaimed stock brickwork to match the original character. The bond is to be Flemish to match the period.

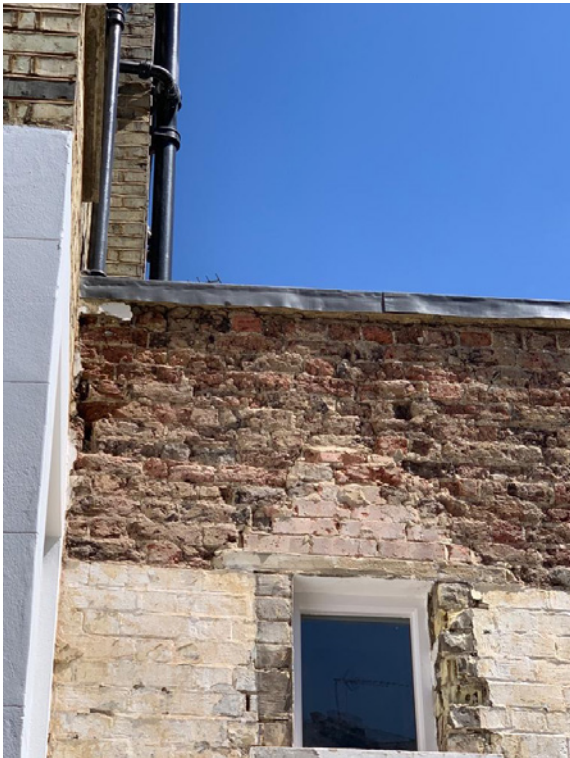
Figure 8 : View of the existing upper window

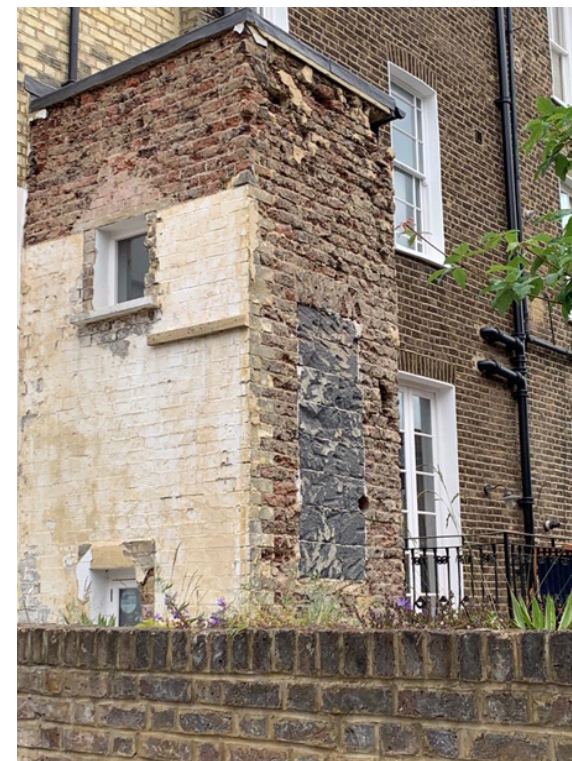
The SE elevation is found also to have very poor brickwork. The removal of the render additionally revealed a full height window opening that has been blocked up.

Figure 14 : Corner view of the closet wing from Berkley road

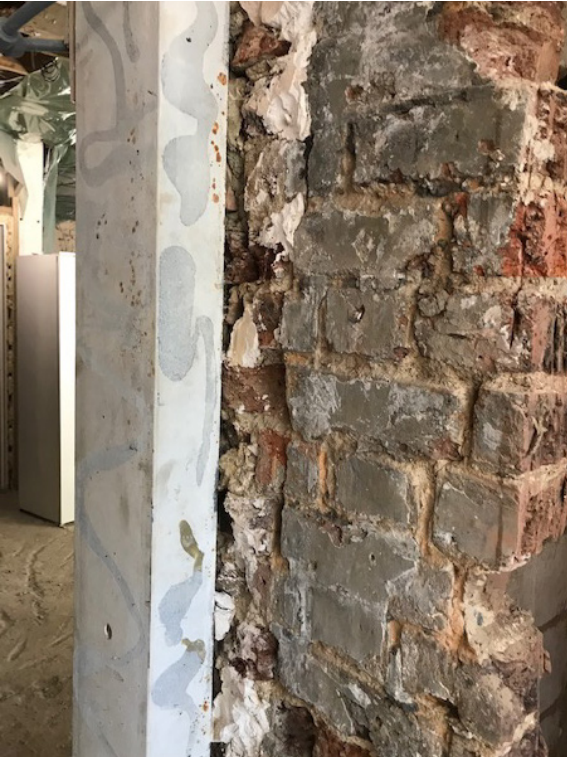
The internal site views show that the closet wing structure has been undermined by previous works carried out at the property in 2012 (2012 - ref. 2012/4284/P.)

Figure 25 : Steel and masonry

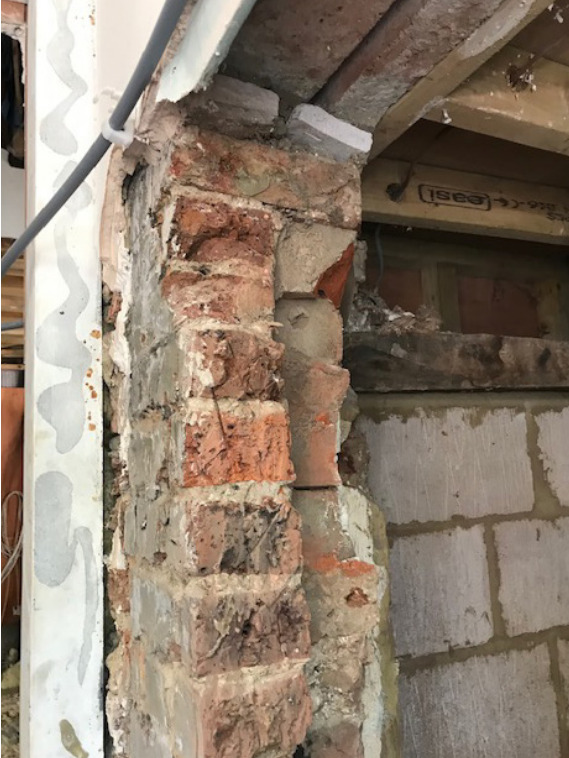
Figure 26 : Steel, original masonry and blockwork
