5 HAMPSTEAD HILL GARDENS

CLIENT: MR & MRS BEECROFT - 5 HAMPSTEAD HILL GARDENS
PROJECT: FRONT WALL AND RAILINGS RECONSTRUCTION
TITLE: EXISTING PLAN AND ELEVATION
DATE: FEB 2017 SCALE: 1:50 DWG NO: BD-01

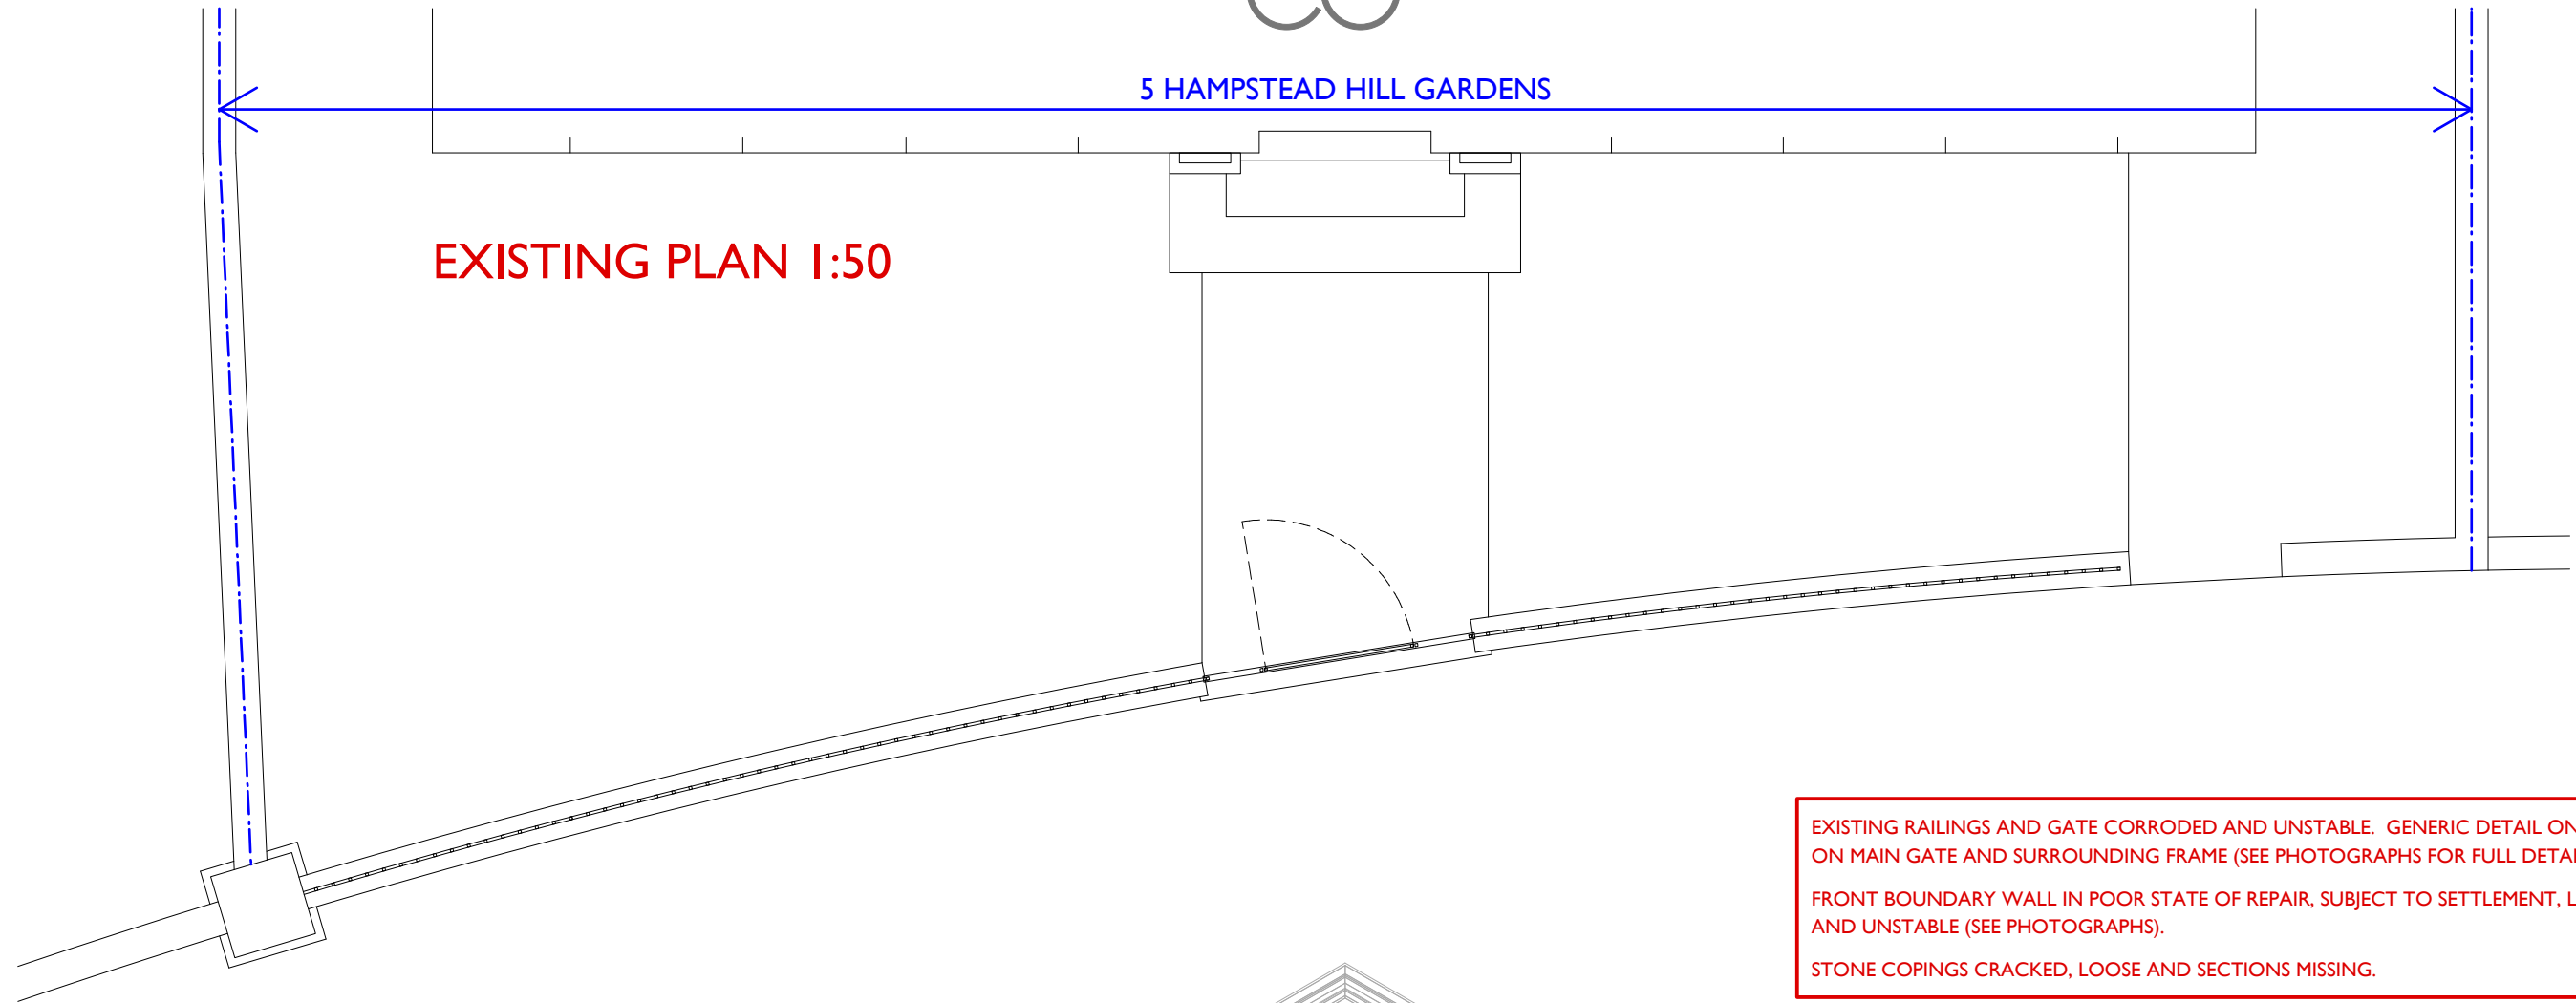
EXISTING PLAN 1:50

EXISTING RAILINGS AND GATE CORRODED AND UNSTABLE. GENERIC DETAIL ONLY SHOWN ON MAIN GATE AND SURROUNDING FRAME (SEE PHOTOGRAPHS FOR FULL DETAILS).
FRONT BOUNDARY WALL IN POOR STATE OF REPAIR, SUBJECT TO SETTLEMENT, LEANING AND UNSTABLE (SEE PHOTOGRAPHS).
STONE COPINGS CRACKED, LOOSE AND SECTIONS MISSING.
