# TAVENER

## **3 Elm Row, London NW3: - Window Survey 7<sup>th</sup> May 2020, Rev: C**

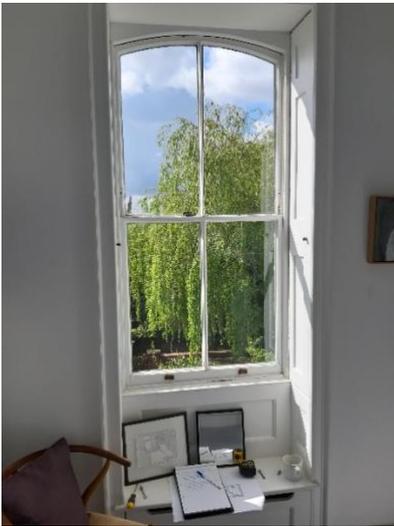
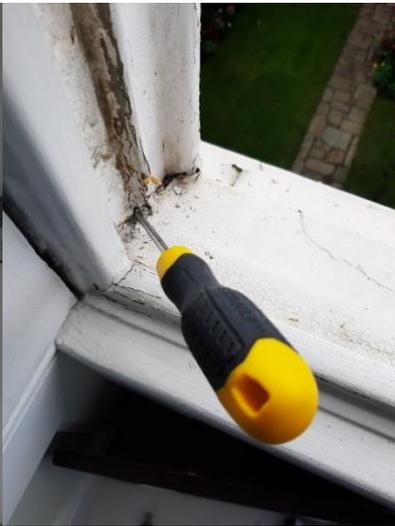
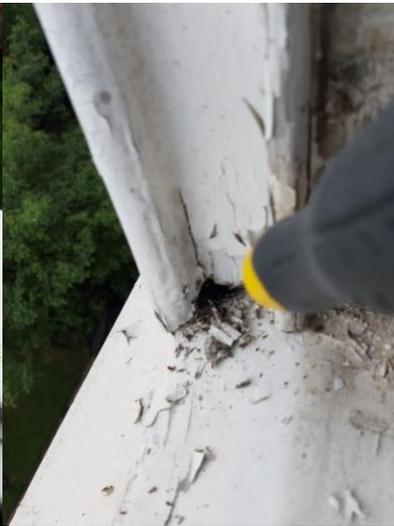
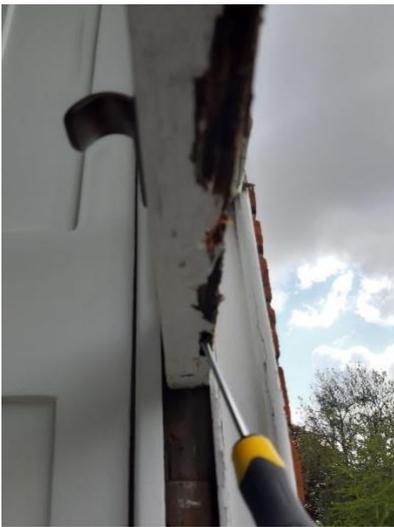
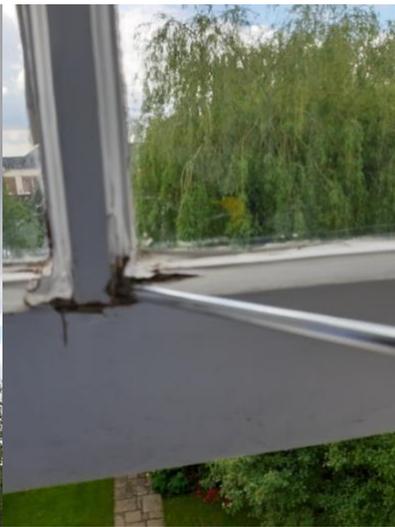
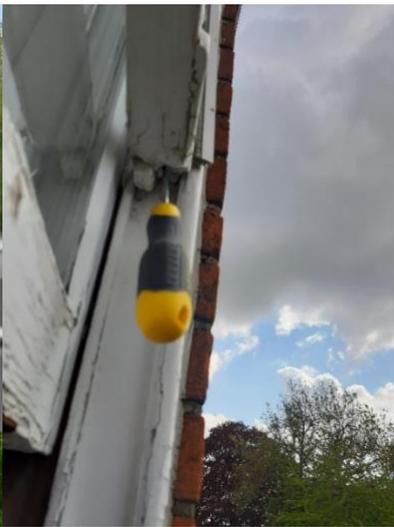
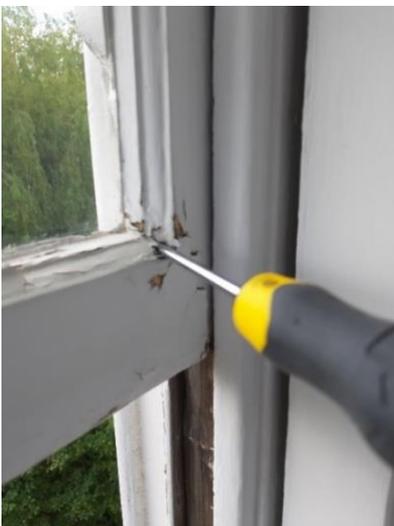
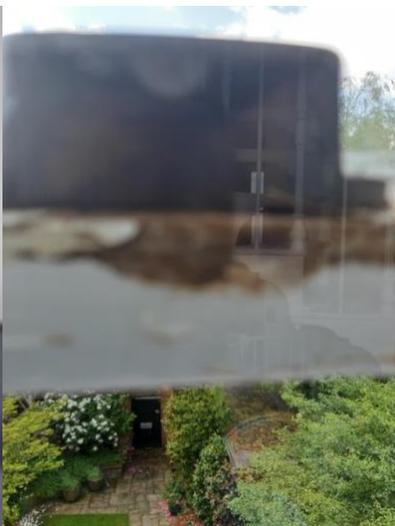
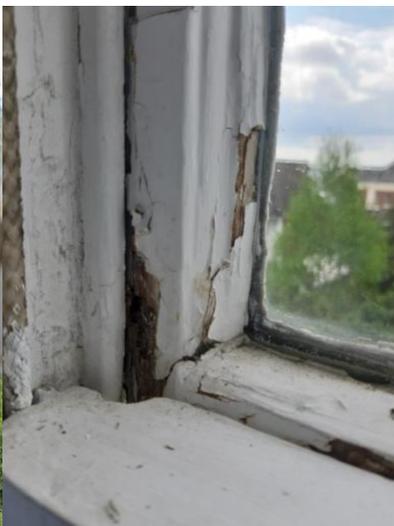
Decay at cill ends & pulley stiles. Top sash meeting rail & stile decayed, horn missing, rail dropped in centre, vertical bar loose. Top sash a hazard. Bottom sash bottom rail decay at bar & stile junction.

Recommendation: - Replace sashes & parting beads, carry out repairs to lower section of box. Splice in new sections of pulley stiles, outside linings, inside linings. Repair cill as necessary.

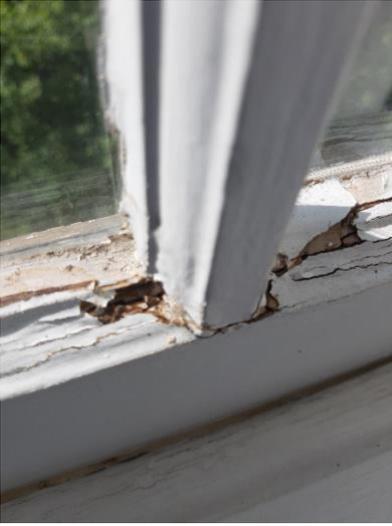
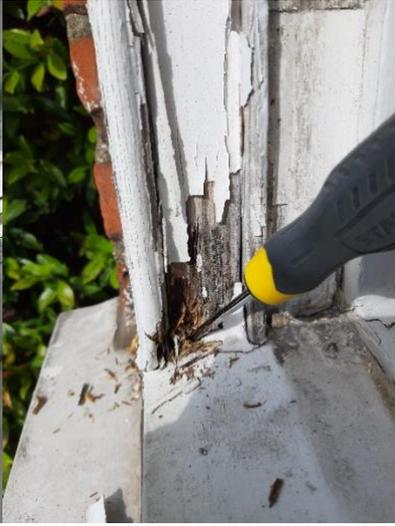
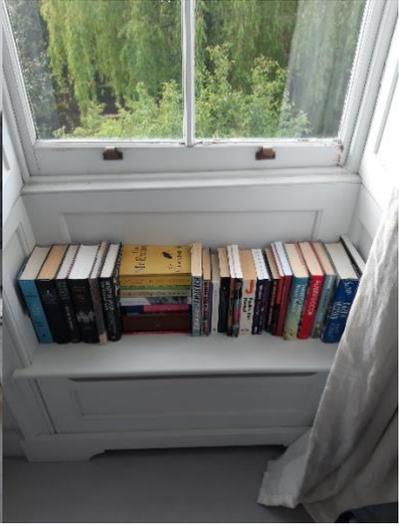
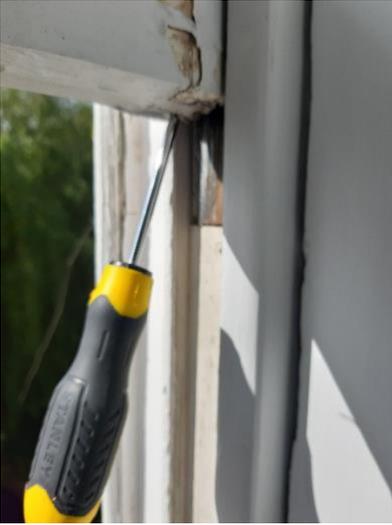
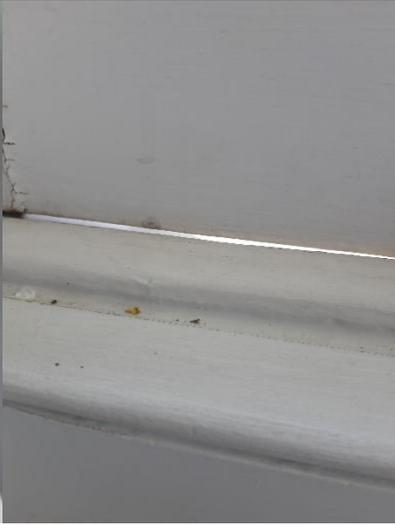
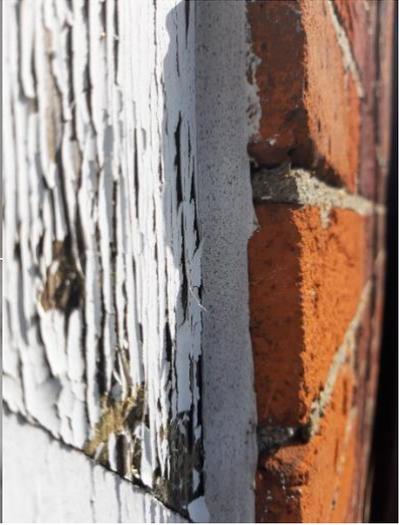
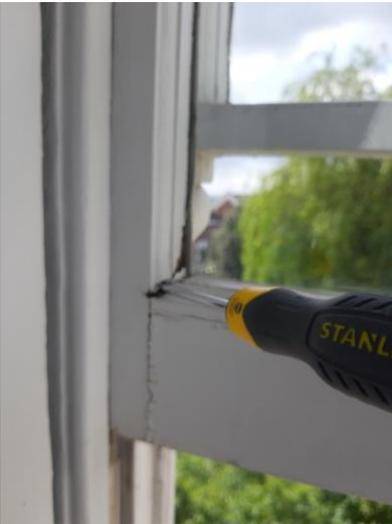
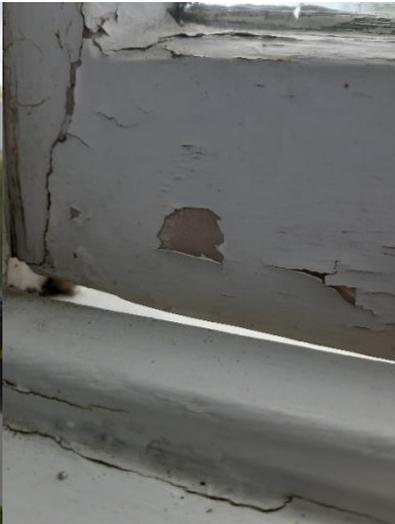
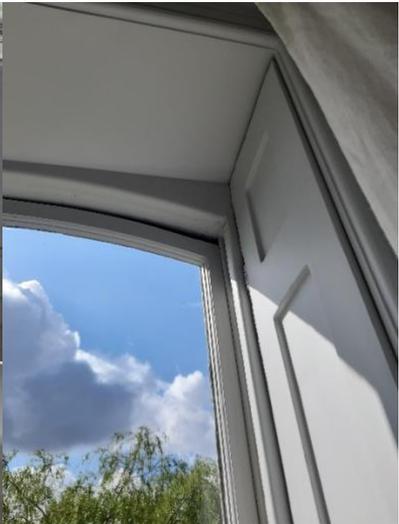
Pulley stiles & cill decay, outside lining decay above previous splice repair. Bottom sash bottom rail has decay at stiles and vertical bar, very poor fit at top and bottom, due to previous subsidence, can see through to the outside, top sash meeting rail showing some decay behind previously installed repair brackets. Meeting rails do not meet.

Recommendation: - Replace sashes & parting beads, carry out repairs to lower section of box. Splice in new sections of pulley stiles, outside linings, inside linings. Repair cill as necessary.

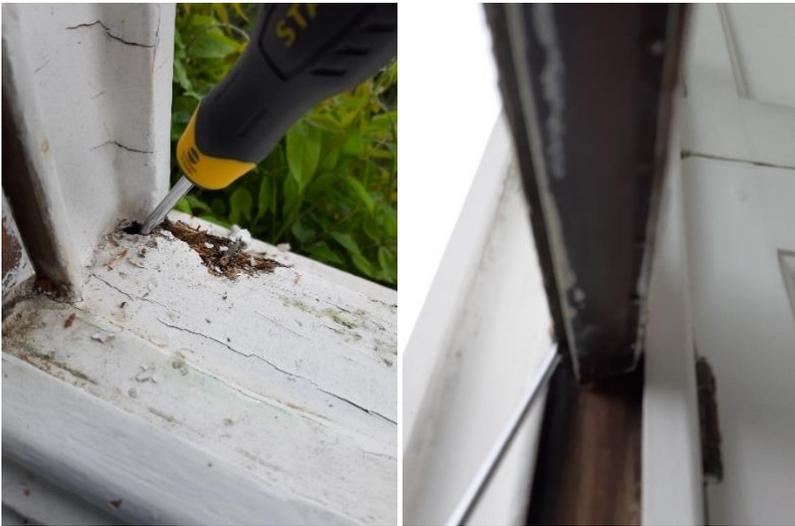
Left hand cill, pulley stile & outside lining decay.

Bottom sash bottom rail decayed, needs replacing.

Recommendation: - Replace sashes & parting beads, carry out repairs to lower section of box. Splice in new sections of pulley stiles, outside linings, inside linings. Repair cill as necessary.
