6. INVENTORY REPORT - PRINCIPAL TIMBER ELEMENTS DETAILS

6. DOME INVENTORY - PRINCIPAL TIMBER ELEMENTS DETAILS

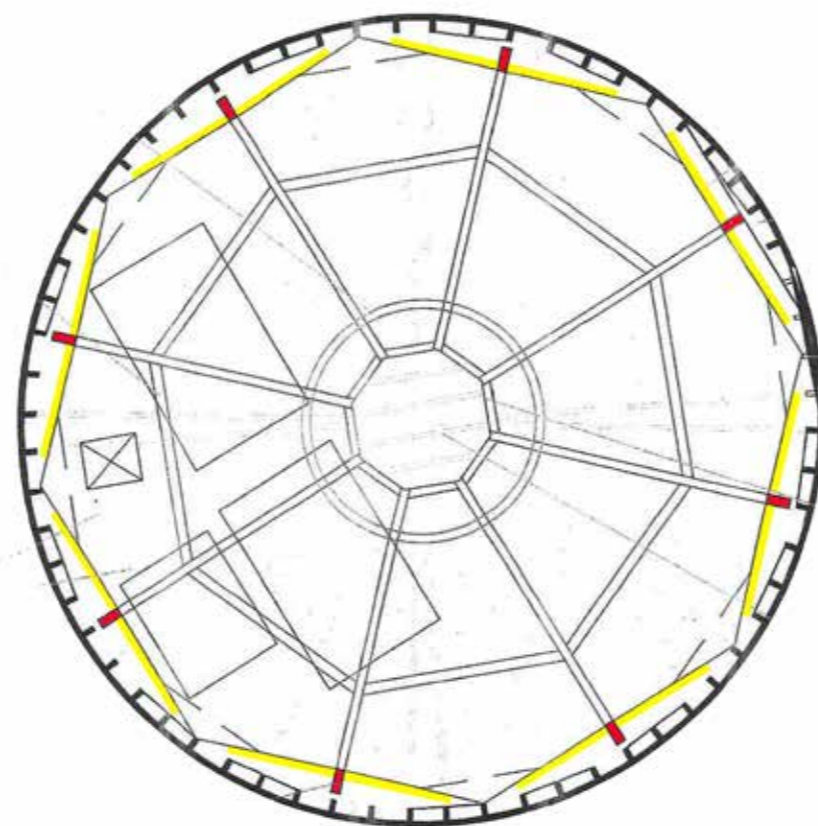
Most of the main support posts and supporting braces are charred, how-ever they were found in their original position.

Figure 41: Main support posts (A) & Supporting Braces (G) (2019) © H&R (SLHA edit)

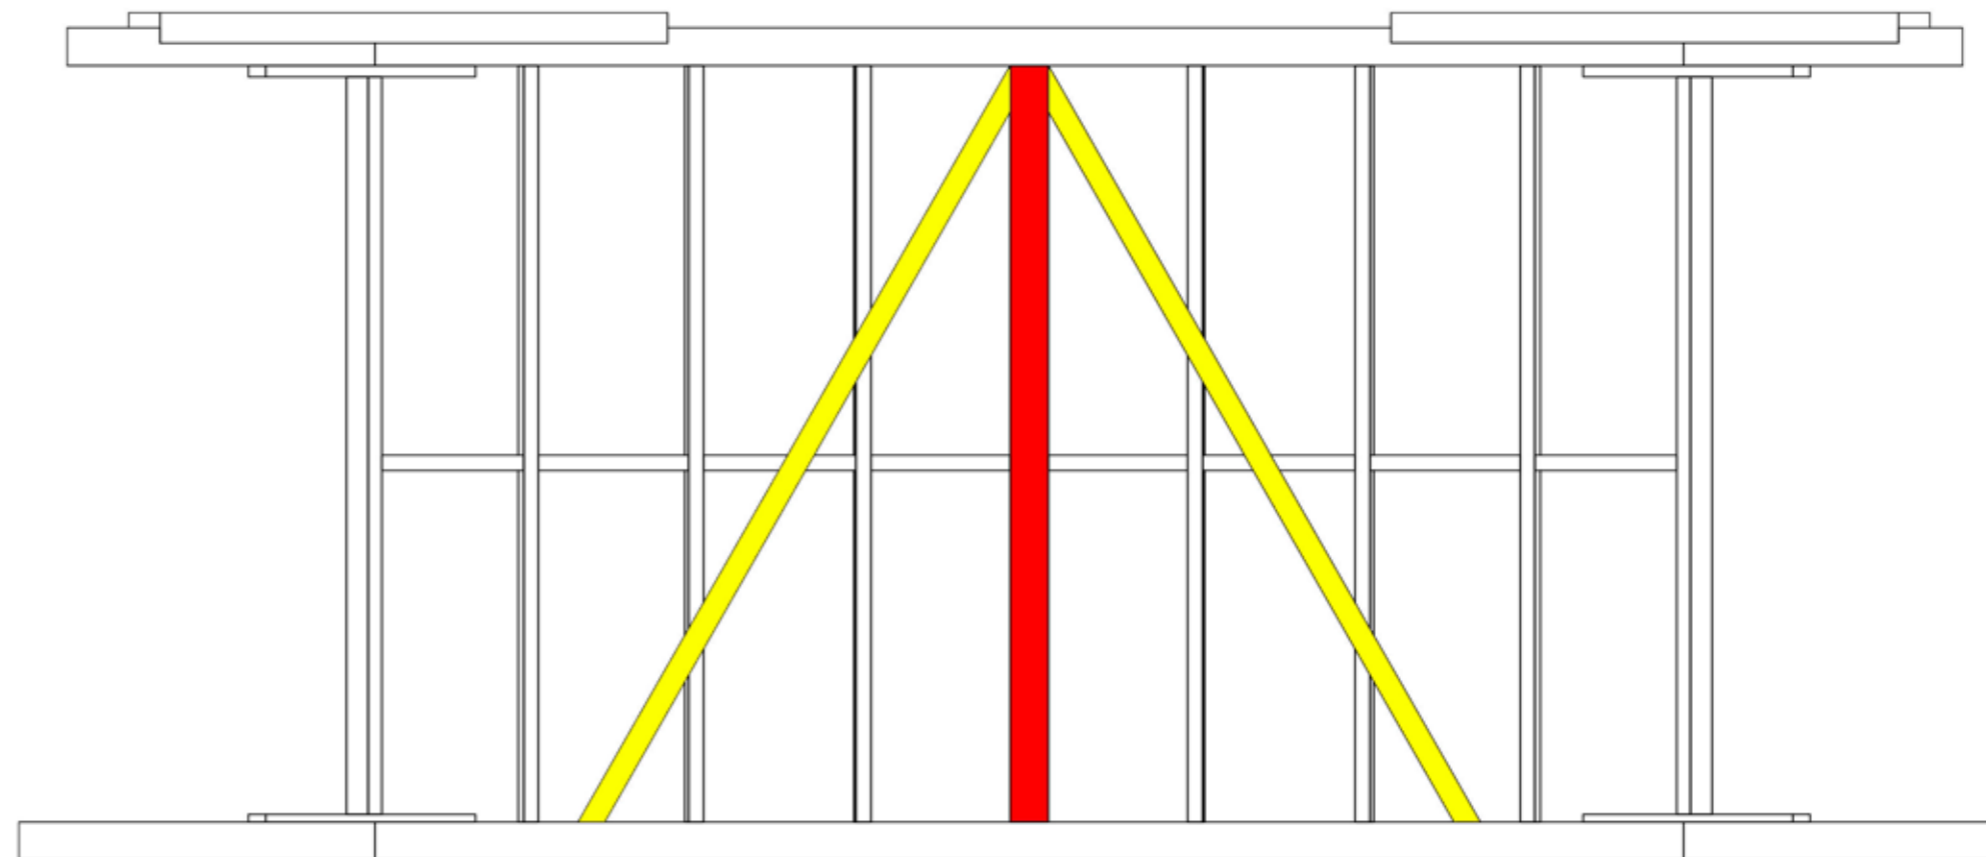
Figure 43: 1:20 post -fire measured survey - Main support posts (A) and supporting braces (G) highlighted in dome wall elevation (2020) © SLHA

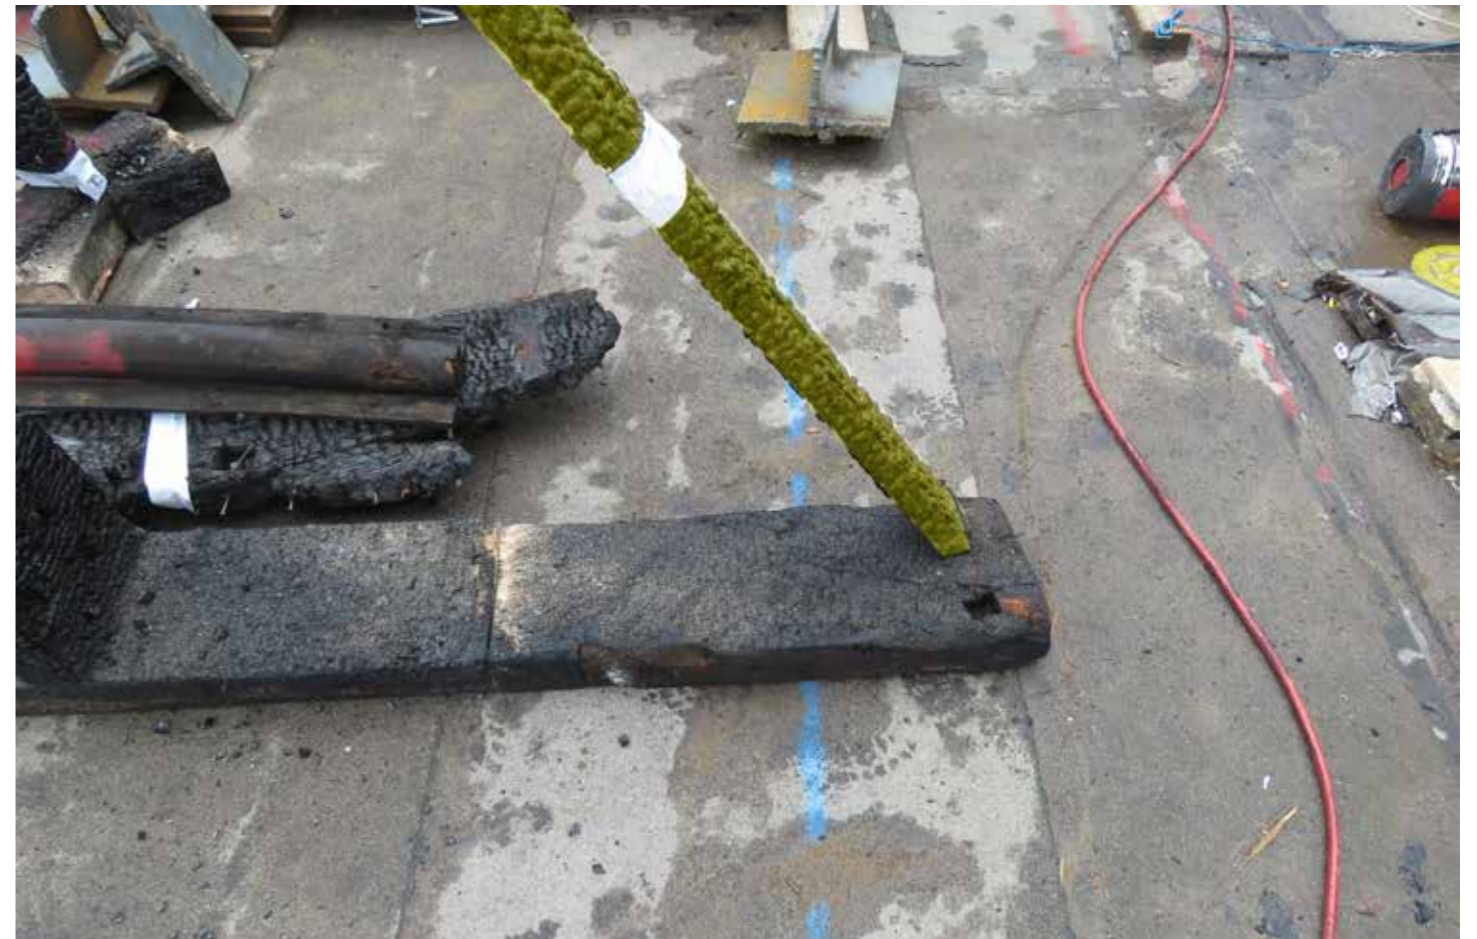
Figure 45: Sample #1 - Main support posts braces (G) on inner lower stud wall (D) (2020) © SLHA

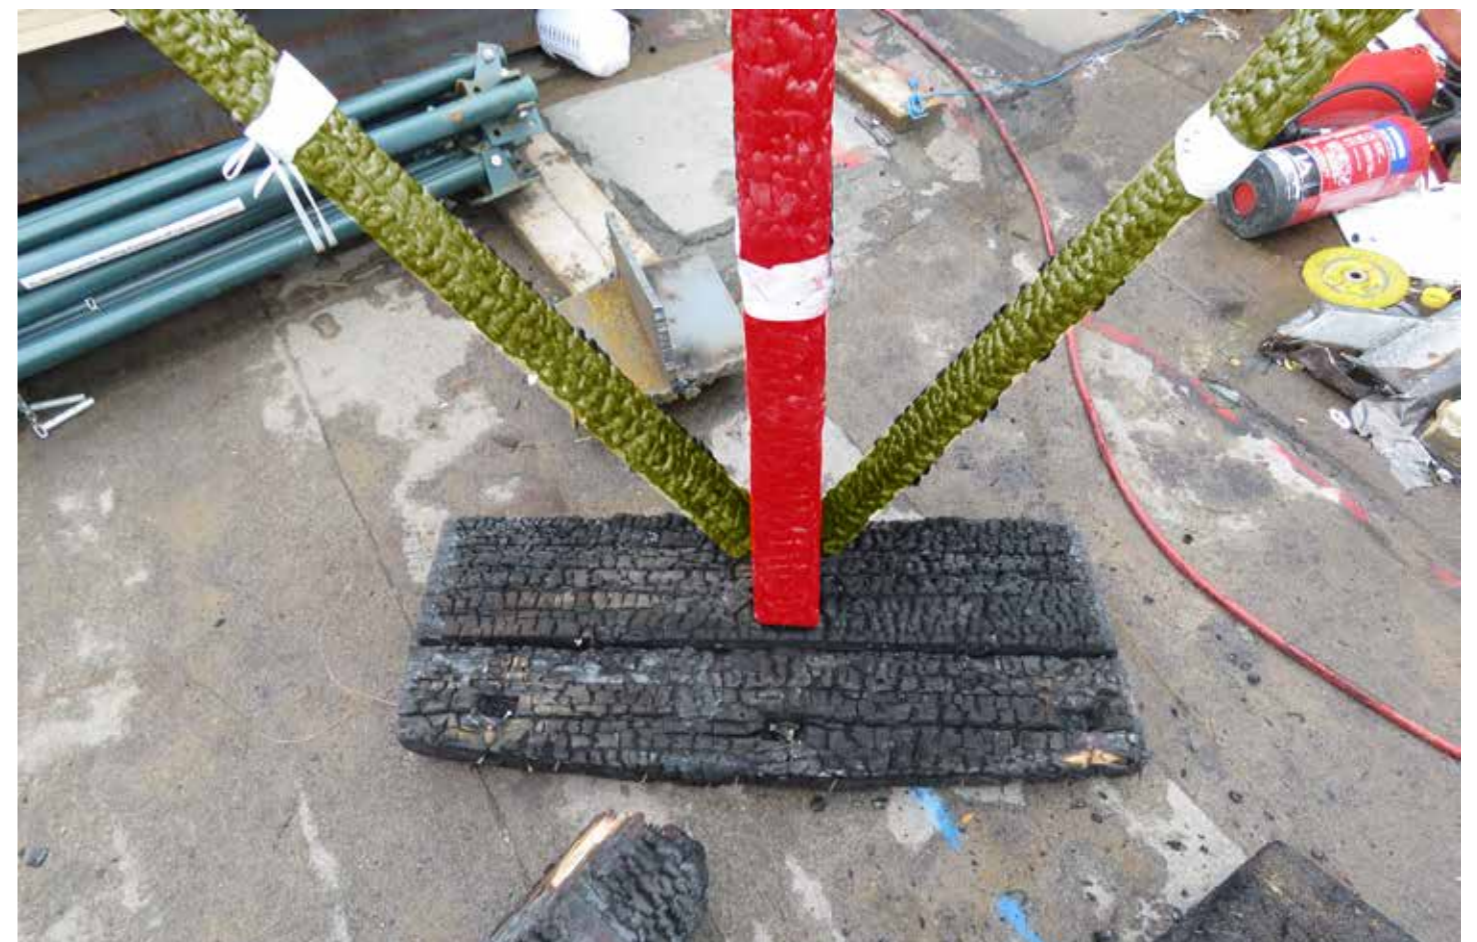
Figure 46: Sample #2 - Junction between main support post (A) with braces (G) and upper rafter plate (E) (2020) © SLHA

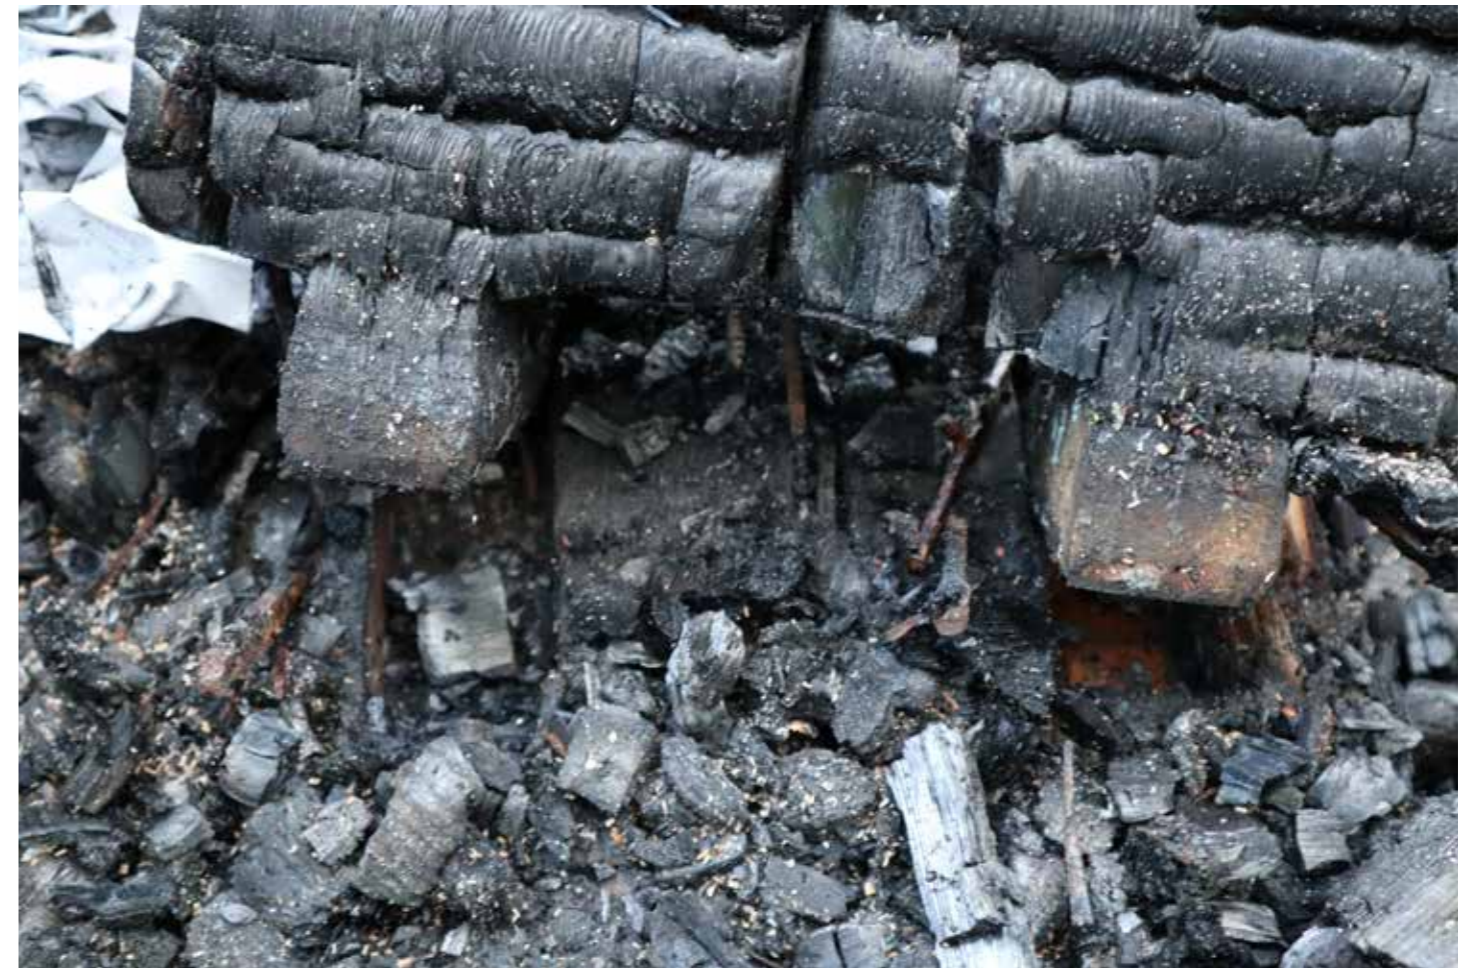
Figure 48: Mortise and tenon joints between main support posts (A) and lower stud wall plate (D) (2020) © SLHA

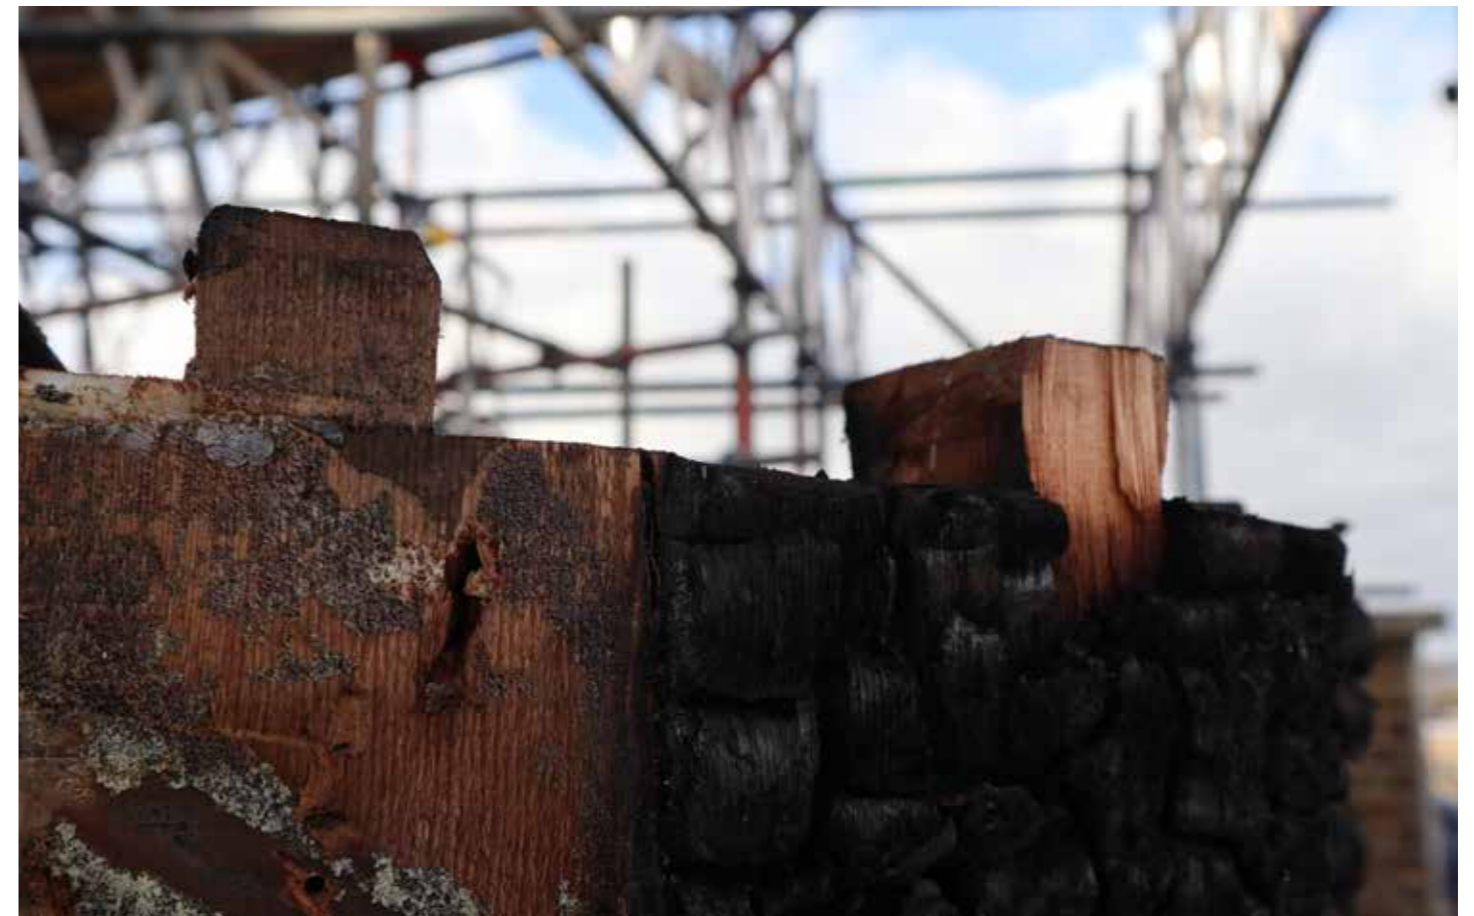
Figure 49: Sample #3 - Tenon joints at the top of main support posts (A) (2020) © SLHA

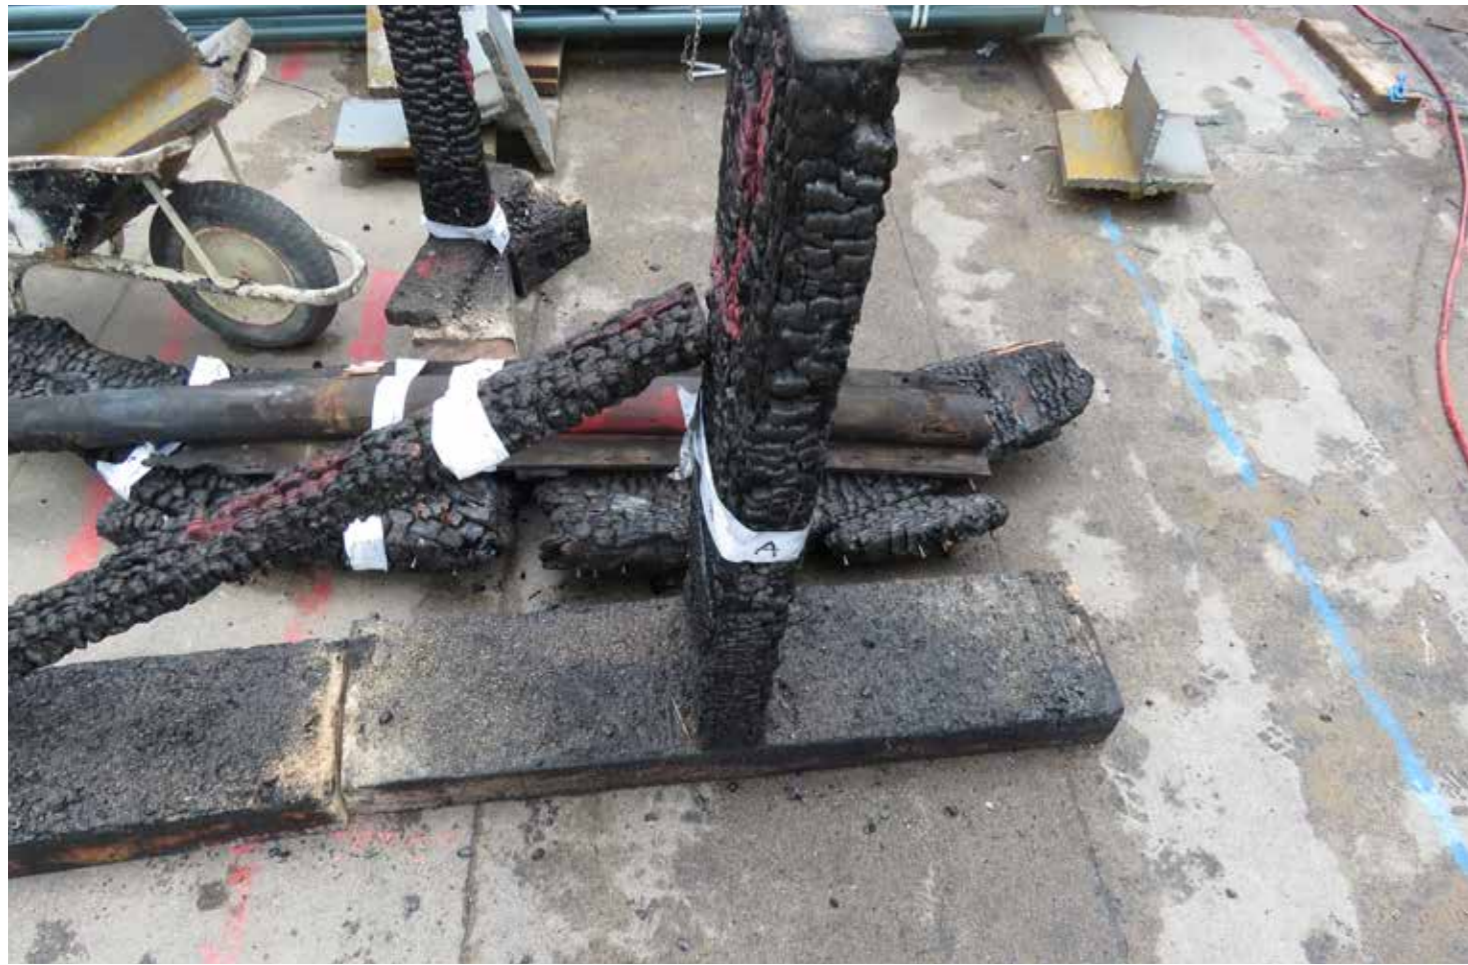
Figure 50: Sample #3 - Main support posts (A) and lower stud wall plate (D) (2020) © SLHA

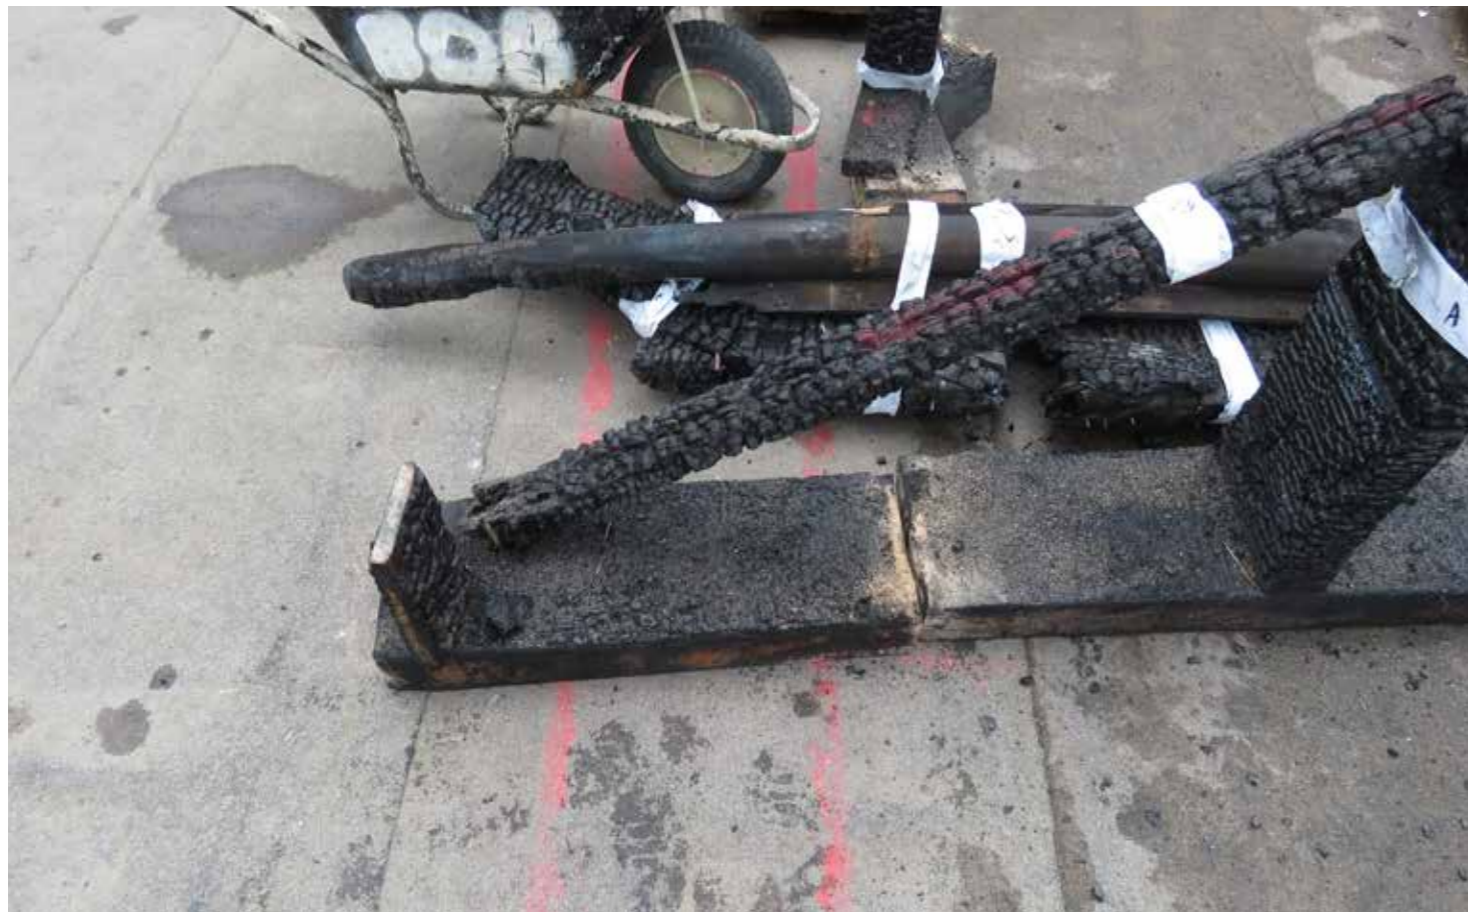
Figure 51: Sample #4- Junction between main support post (A) and braces (G) on inner lower stud wall plate (D1) (2020) © SLHA

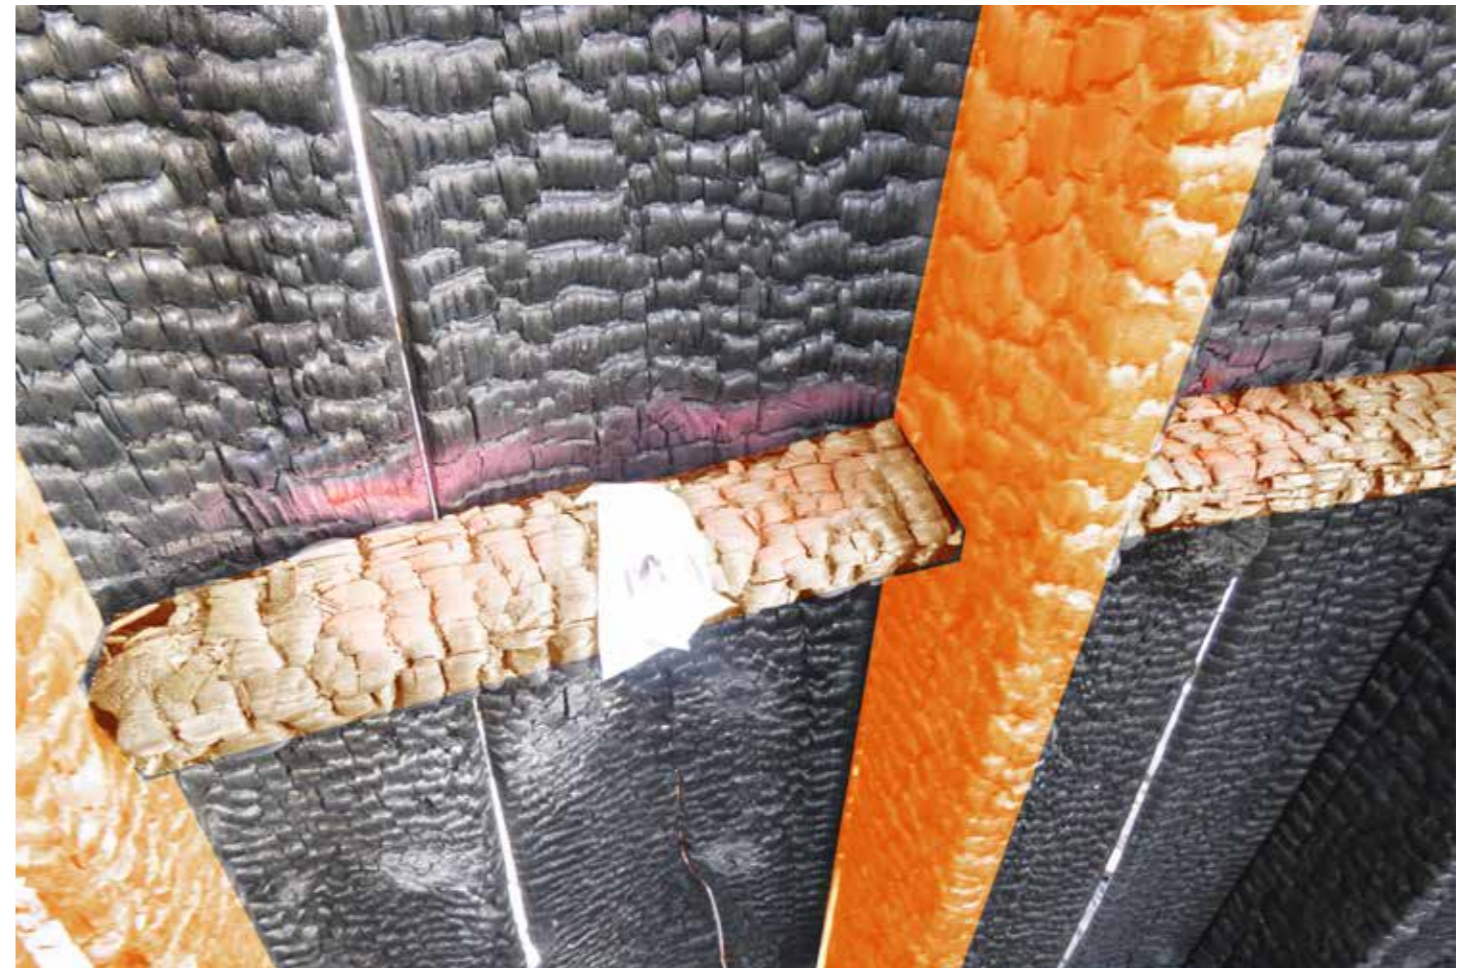
Most of the timbers are significantly charred due to fire damage, although most remained in position.

Figure 59: Wall studs and ties (B) in situ (2020) © SLHA

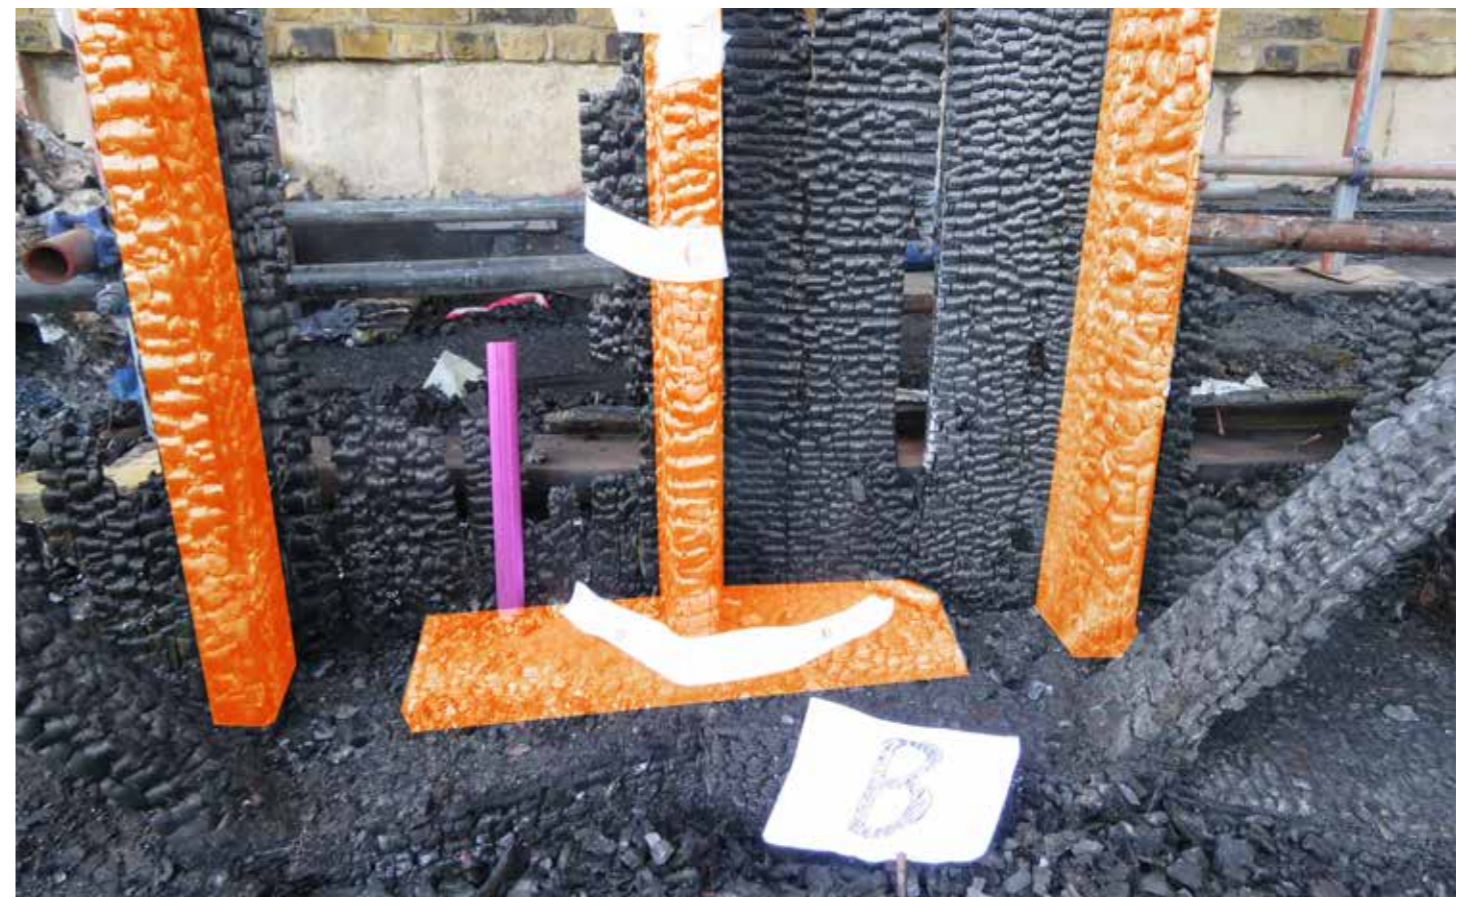
Figure 60: Wall studs (B) with bottom plate tie at junction between the corner of lower rafter plates (2020) © SLHA

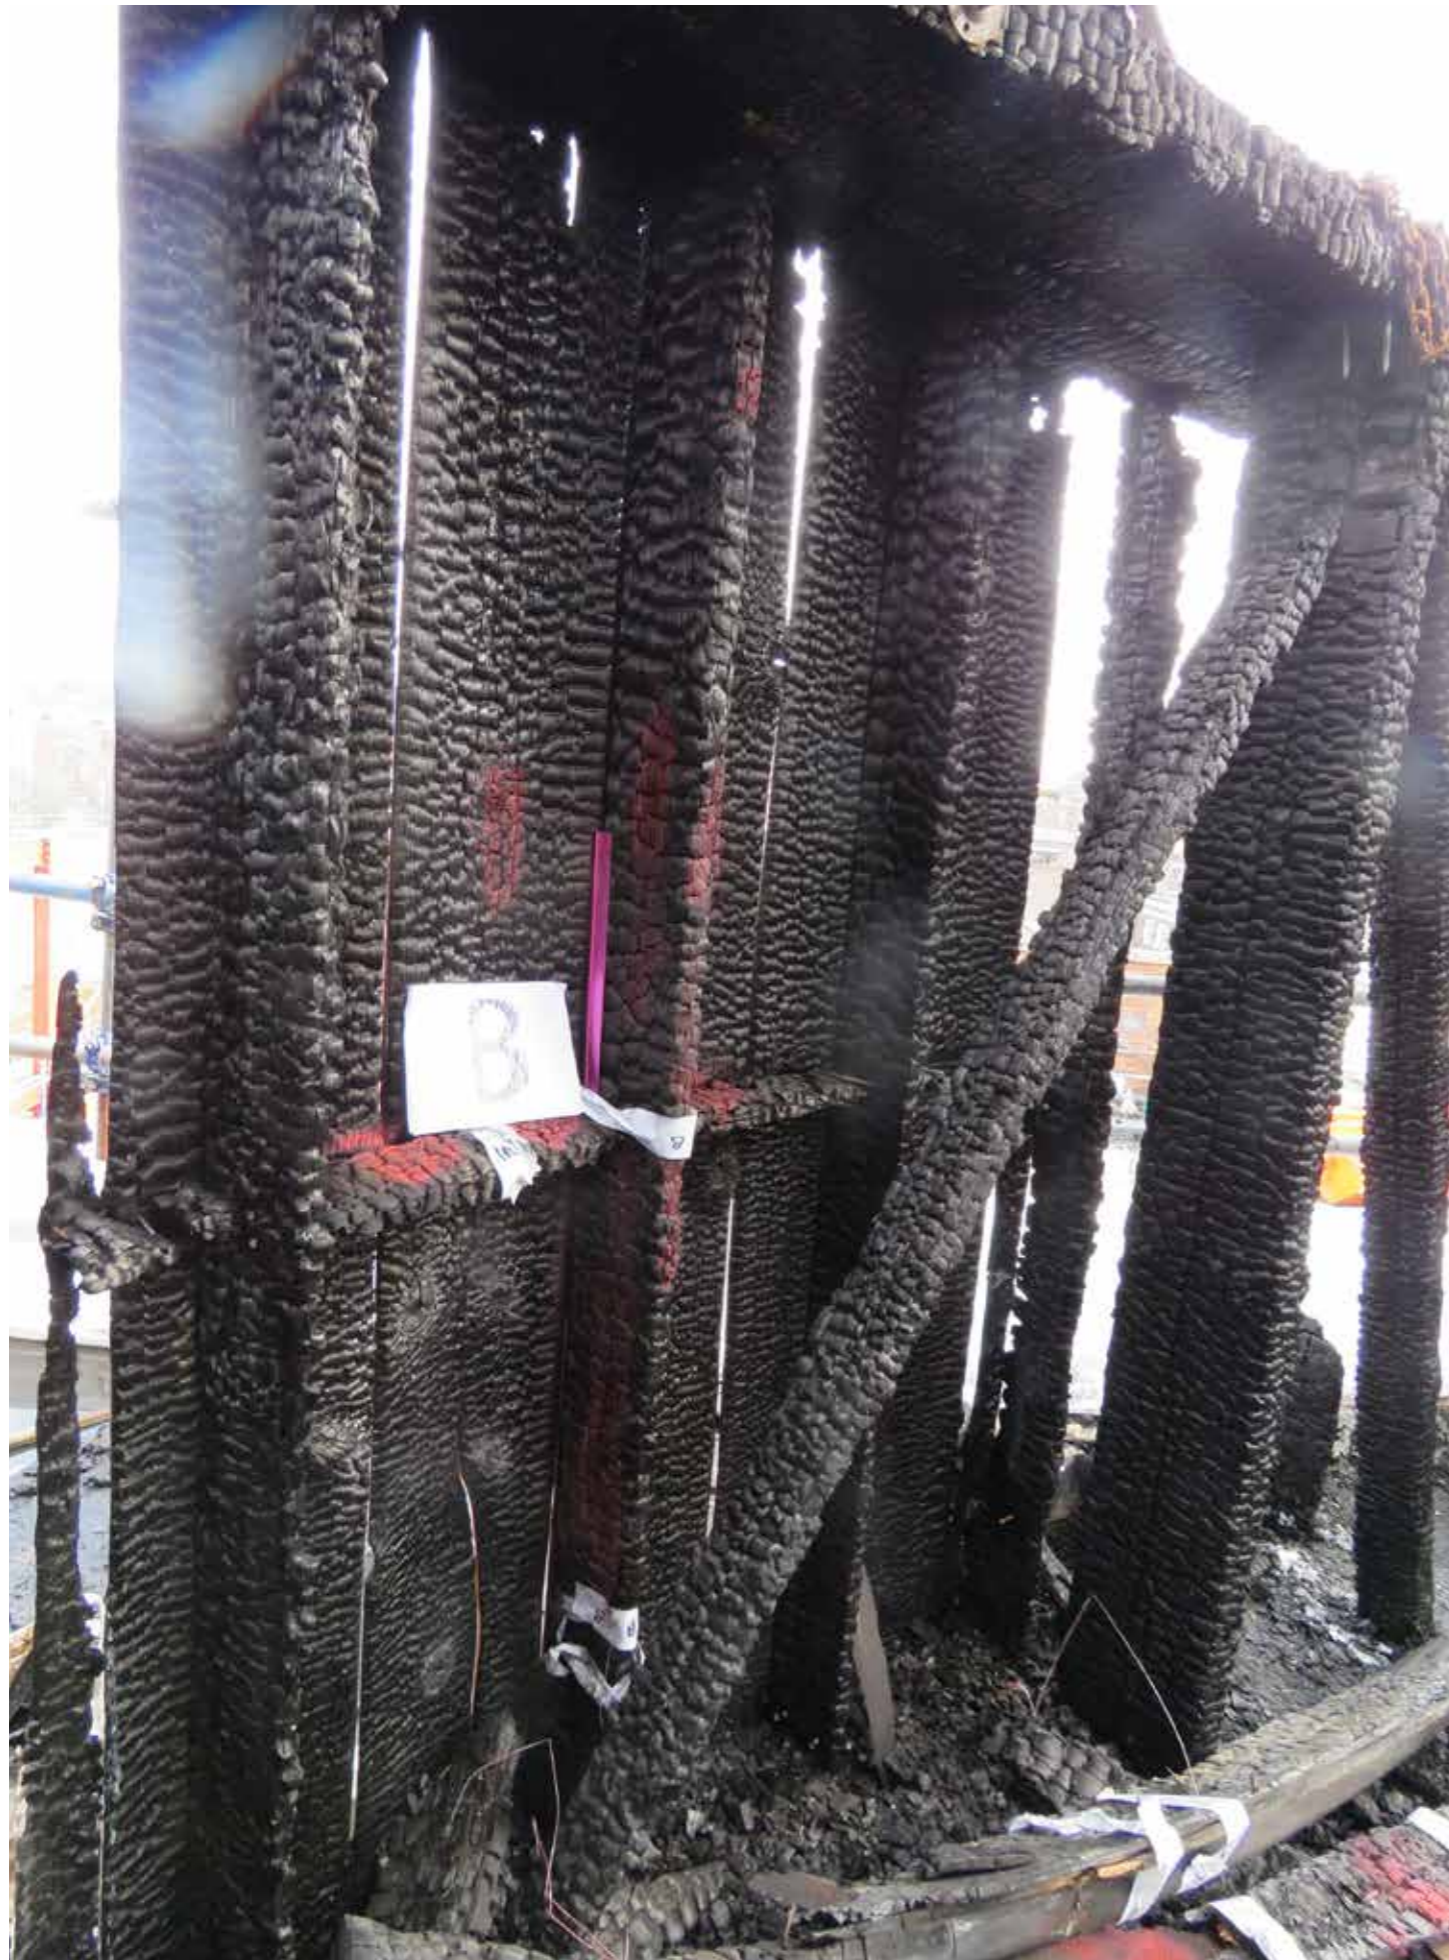
Figure 61: Wall studs and ties (B) in situ with wall boarding (H) and indication of proximity to main support posts (A) (2020) © SLHA

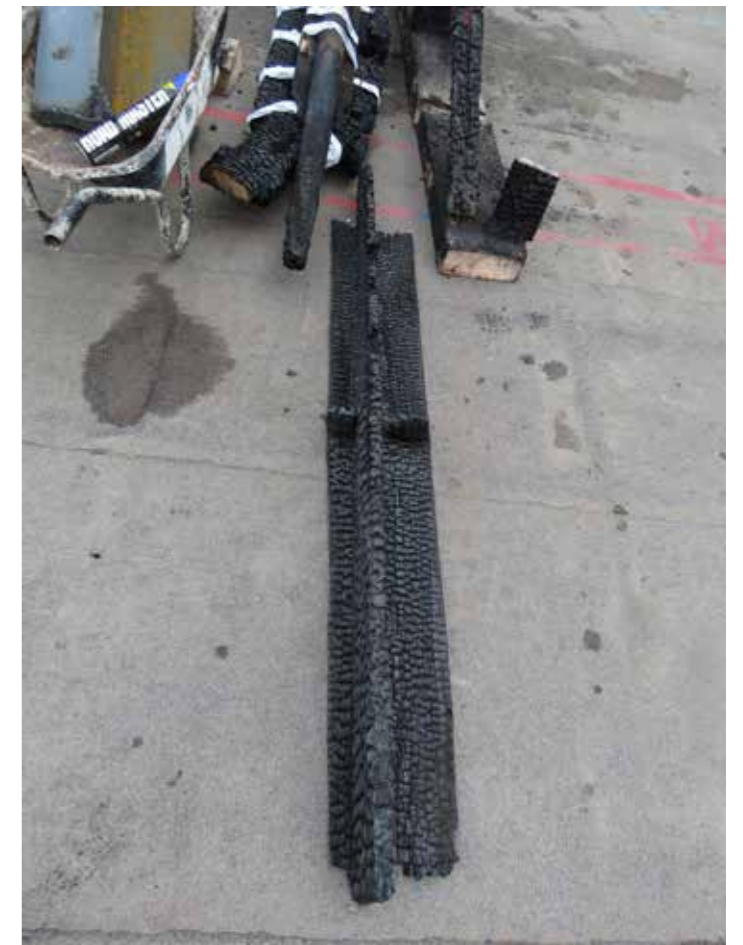
Figure 64: Sample #5 - Wall studs and ties (B) with wall boarding (H) (2020) © SLHA

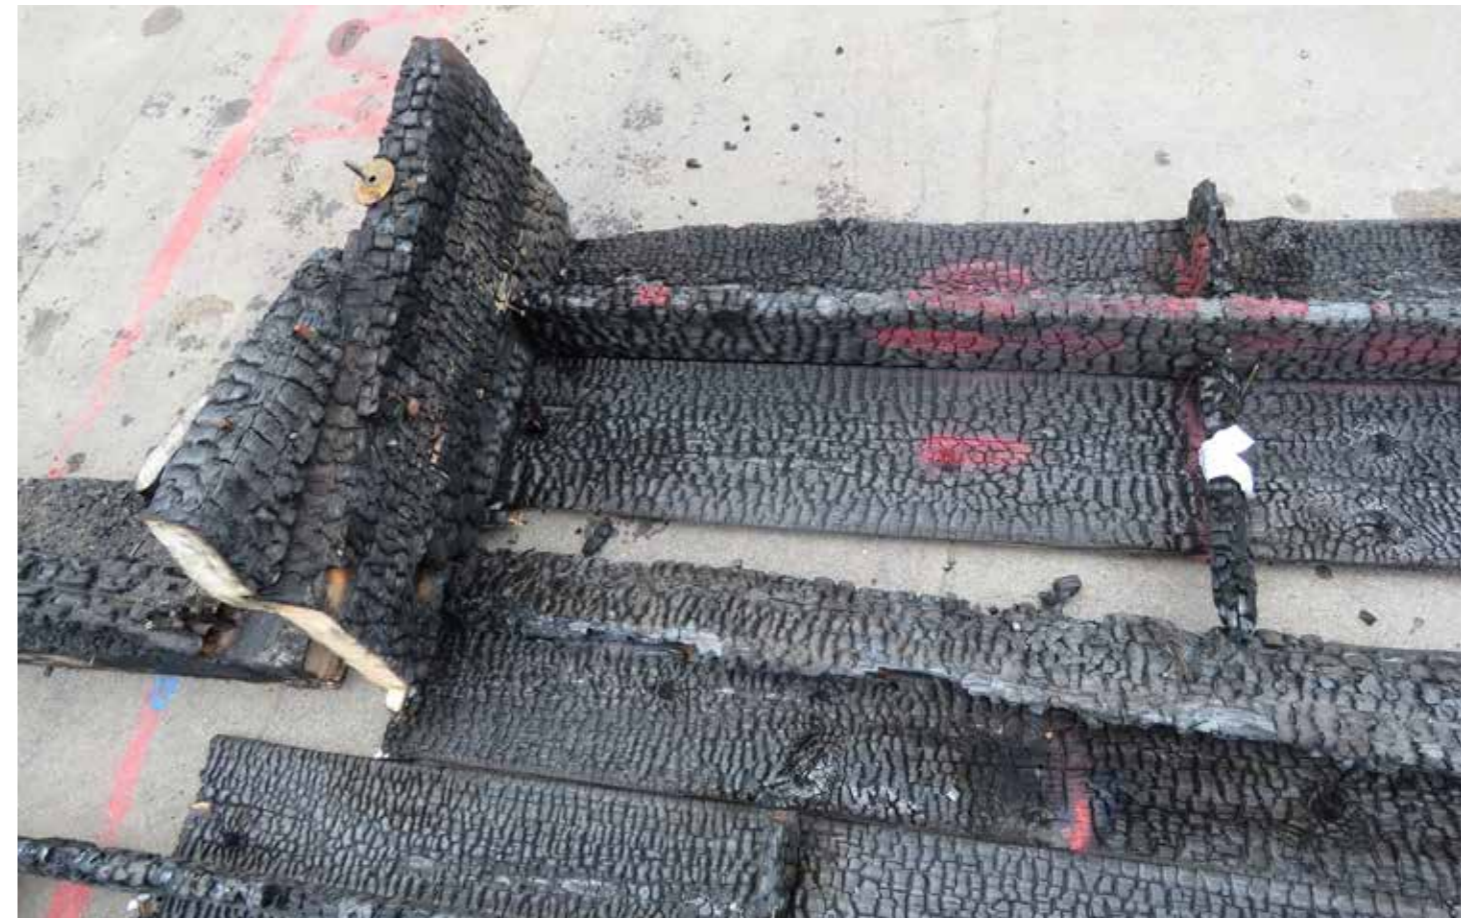
Figure 67: Sample #6 - Wall stud (B) with upper rafter plate (D), wall boarding (H) and horizontal rafter wall tie (M) (2020) © SLHA

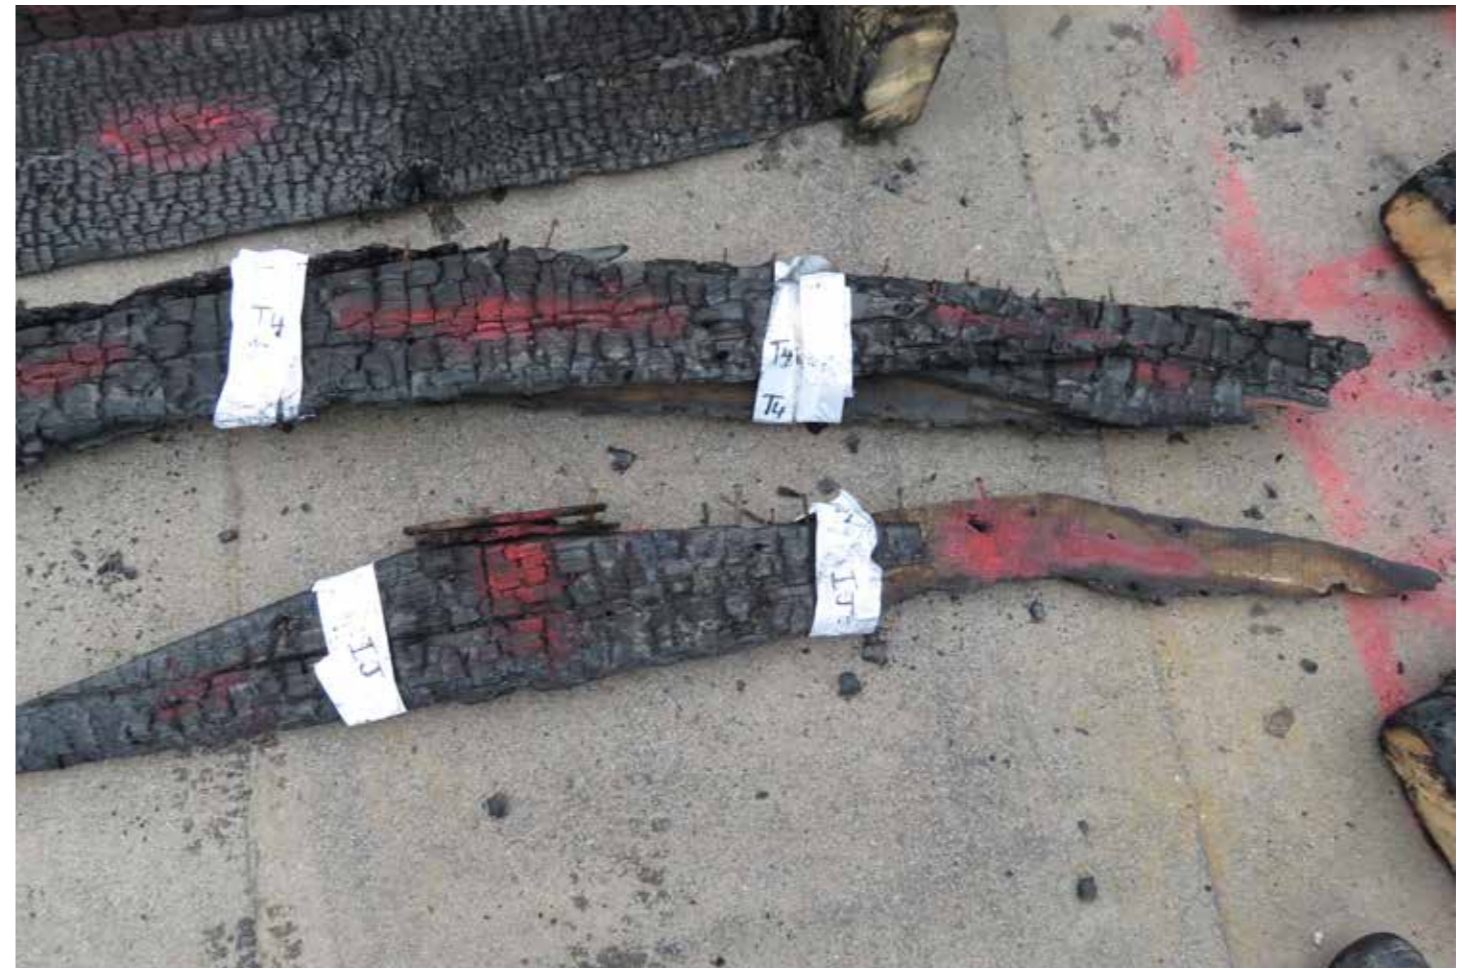
All the ribs have been heavily damaged by the fire and only fragmentary evidence was discovered in the debris.

Figure 73: Sample #8- 2-Part ribs (C) found within debris (2020) © SLHA

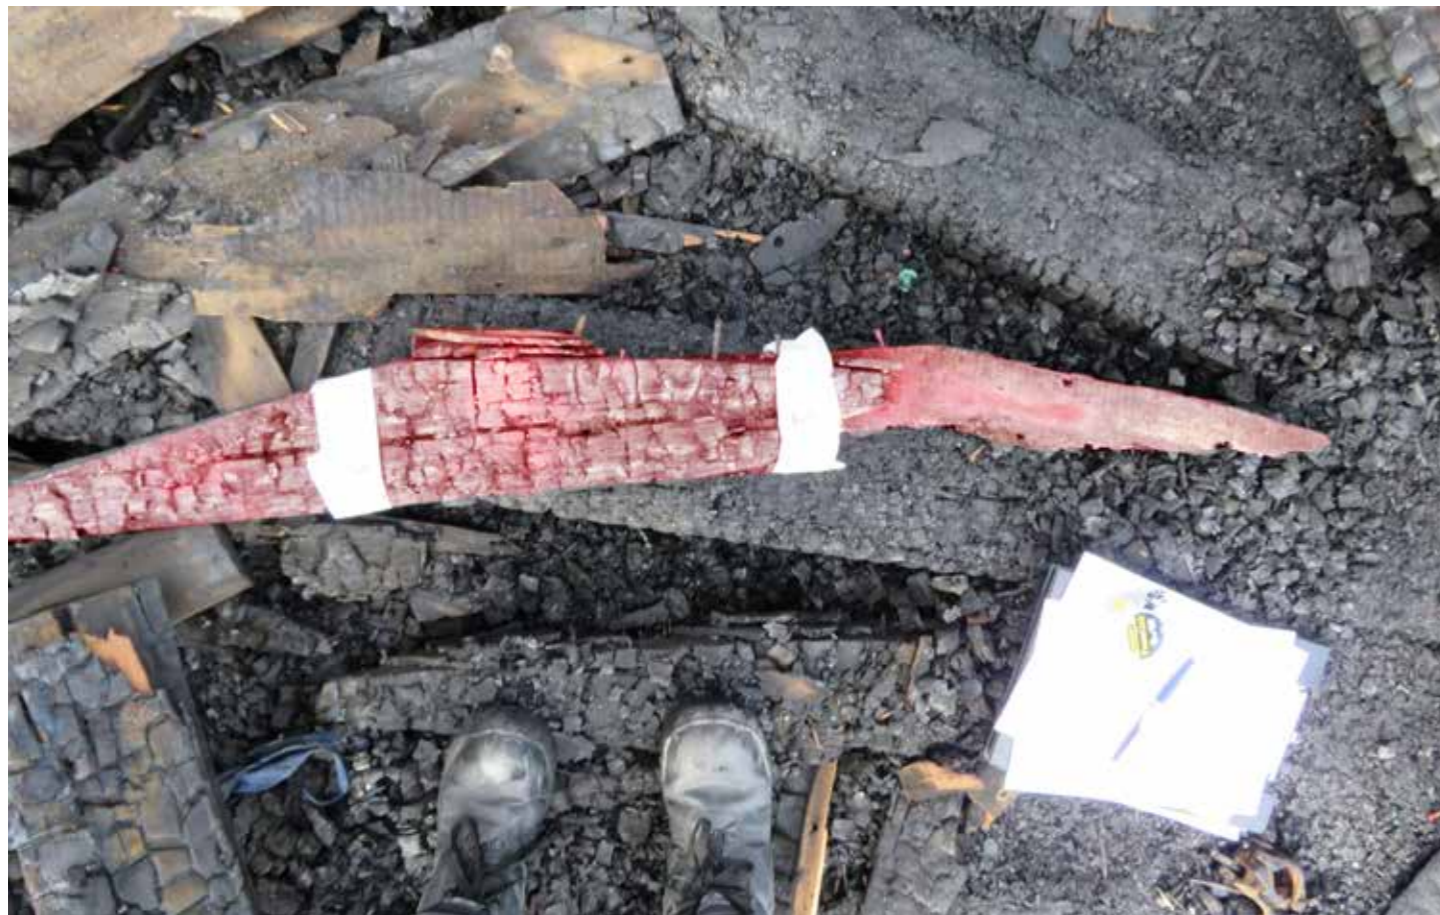
Figure 72: Sample #8 - 2-Part ribs (C) found within debris (2020) © SLHA

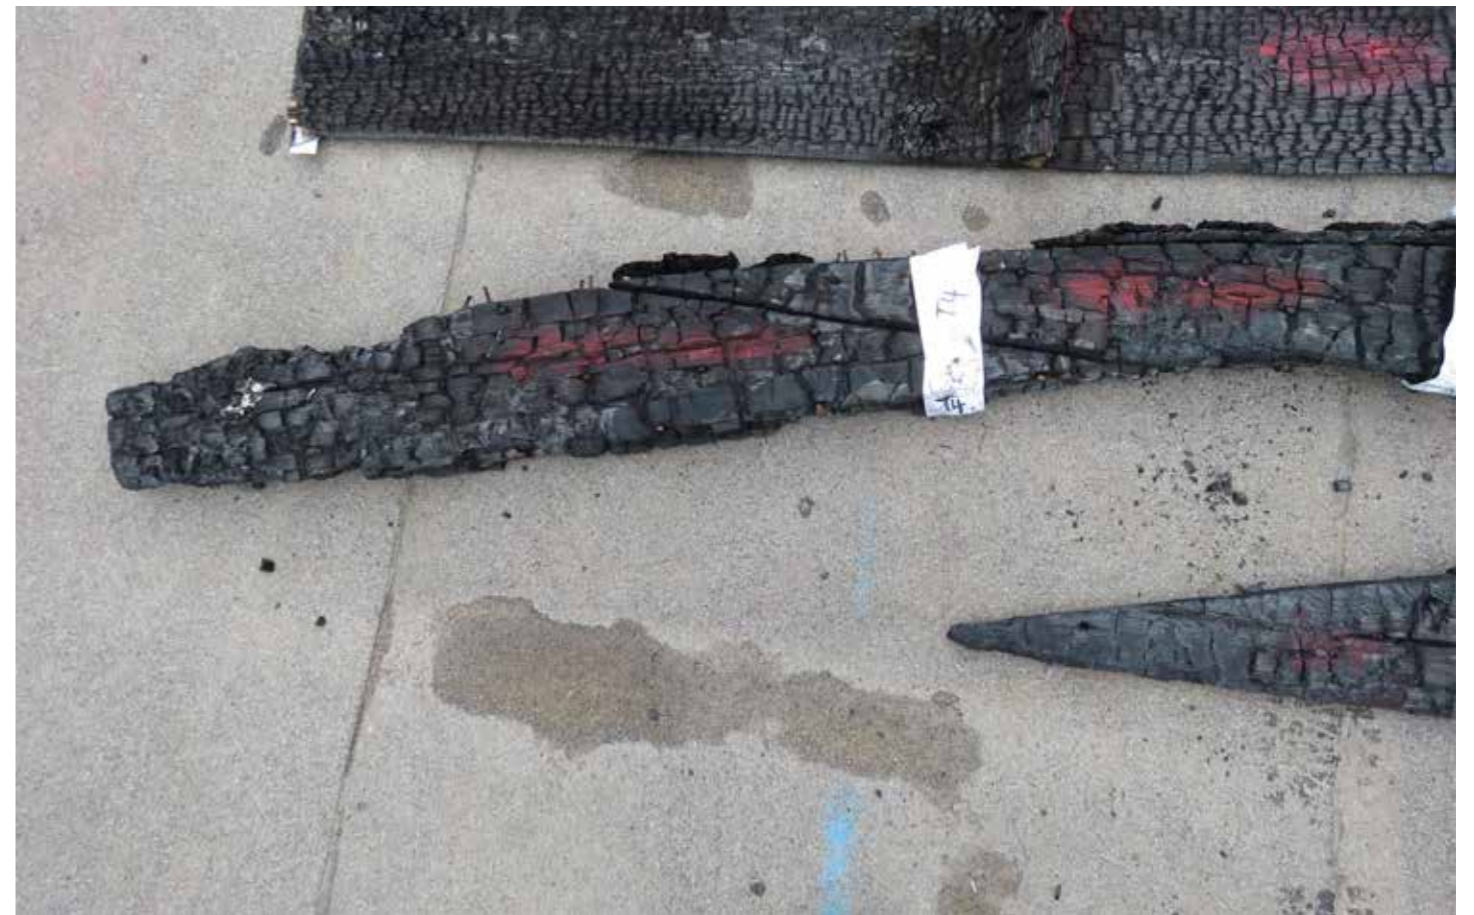
Figure 74: Sample #9- 2-Part ribs (C) found within debris (2020) © SLHA
