6. INVENTORY REPORT - PRINCIPAL TIMBER ELEMENTS DETAILS

6. DOME INVENTORY - PRINCIPAL TIMBER ELEMENTS DETAILS

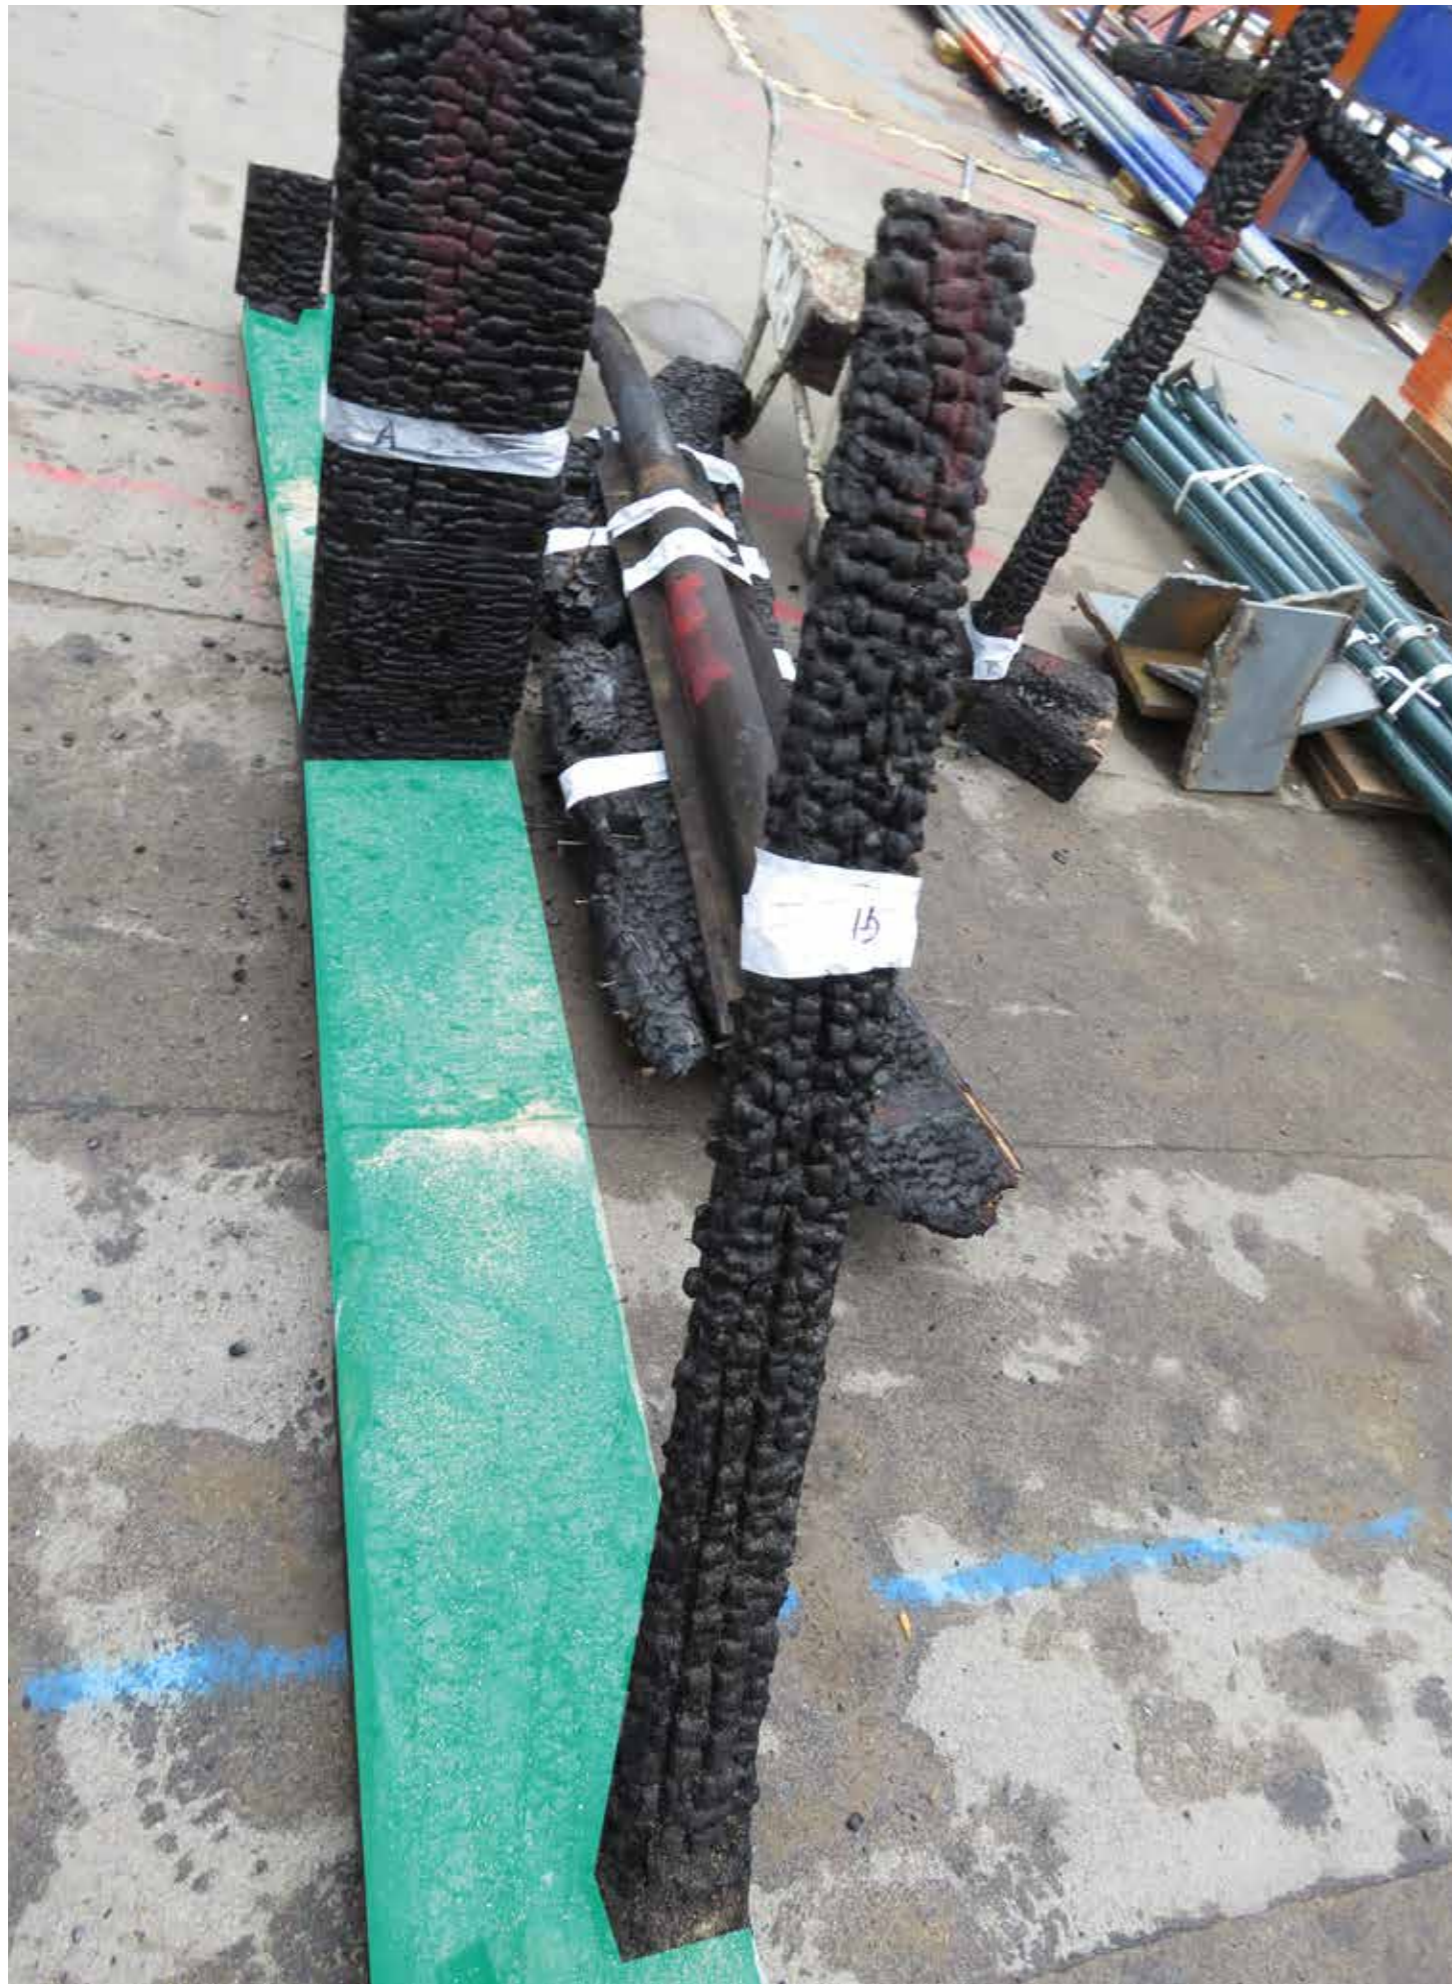
The lower stud wall plate timbers have suffered significant fire damage but have been found in situ.

Figure 79: Sample #10 - Inner lower stud wall plate (D1) (2020) © SLHA

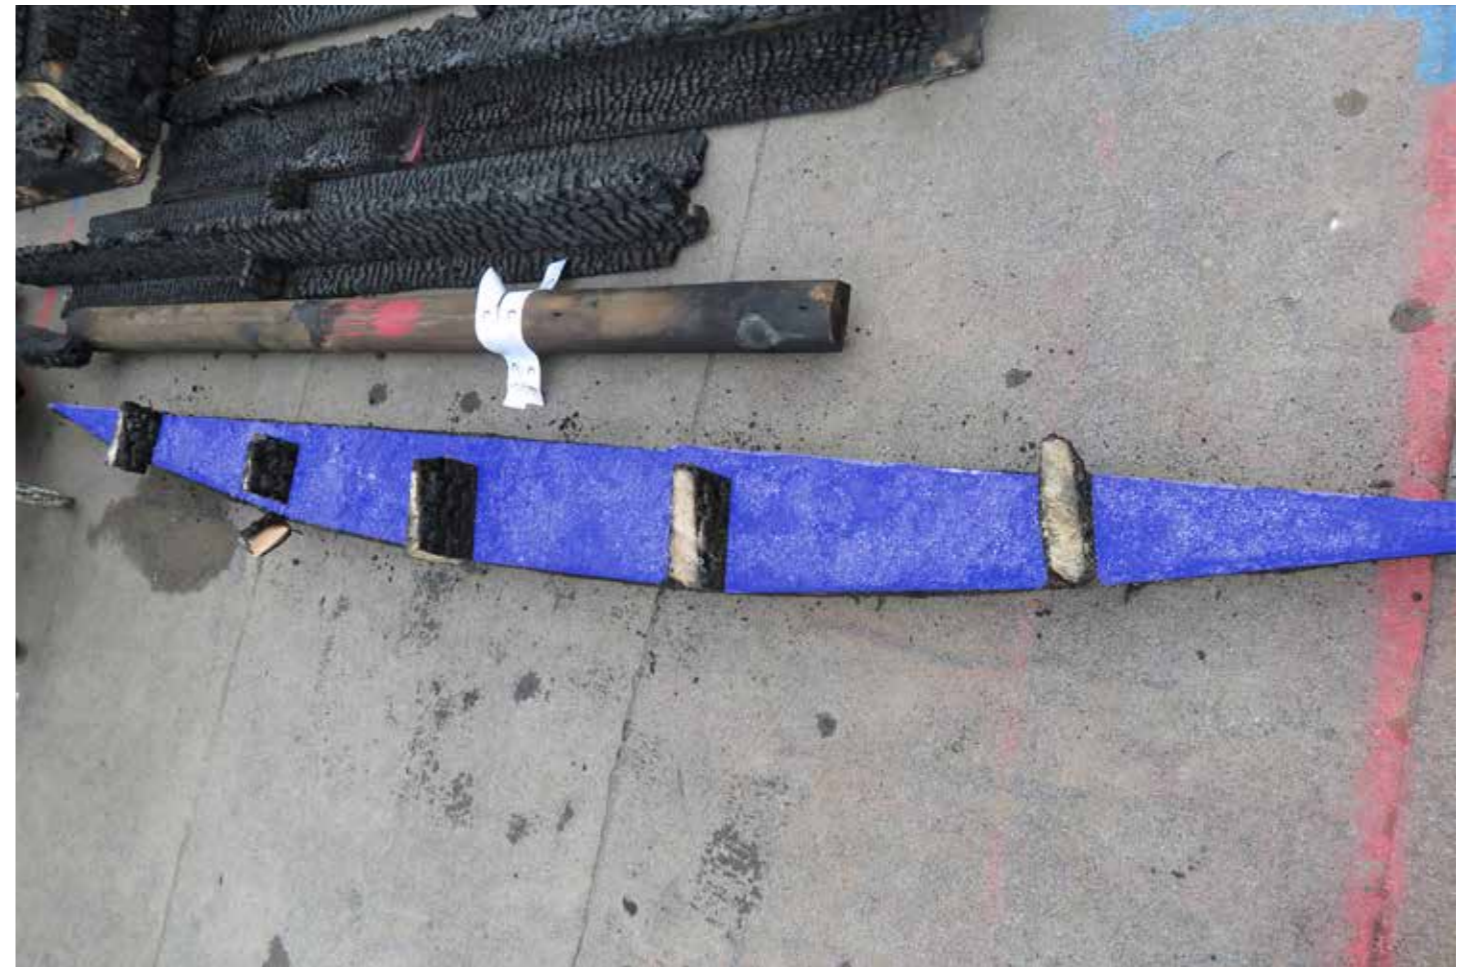
Figure 80: Sample #11- Outer lower stud wall plate (D2) (2020) © SLHA

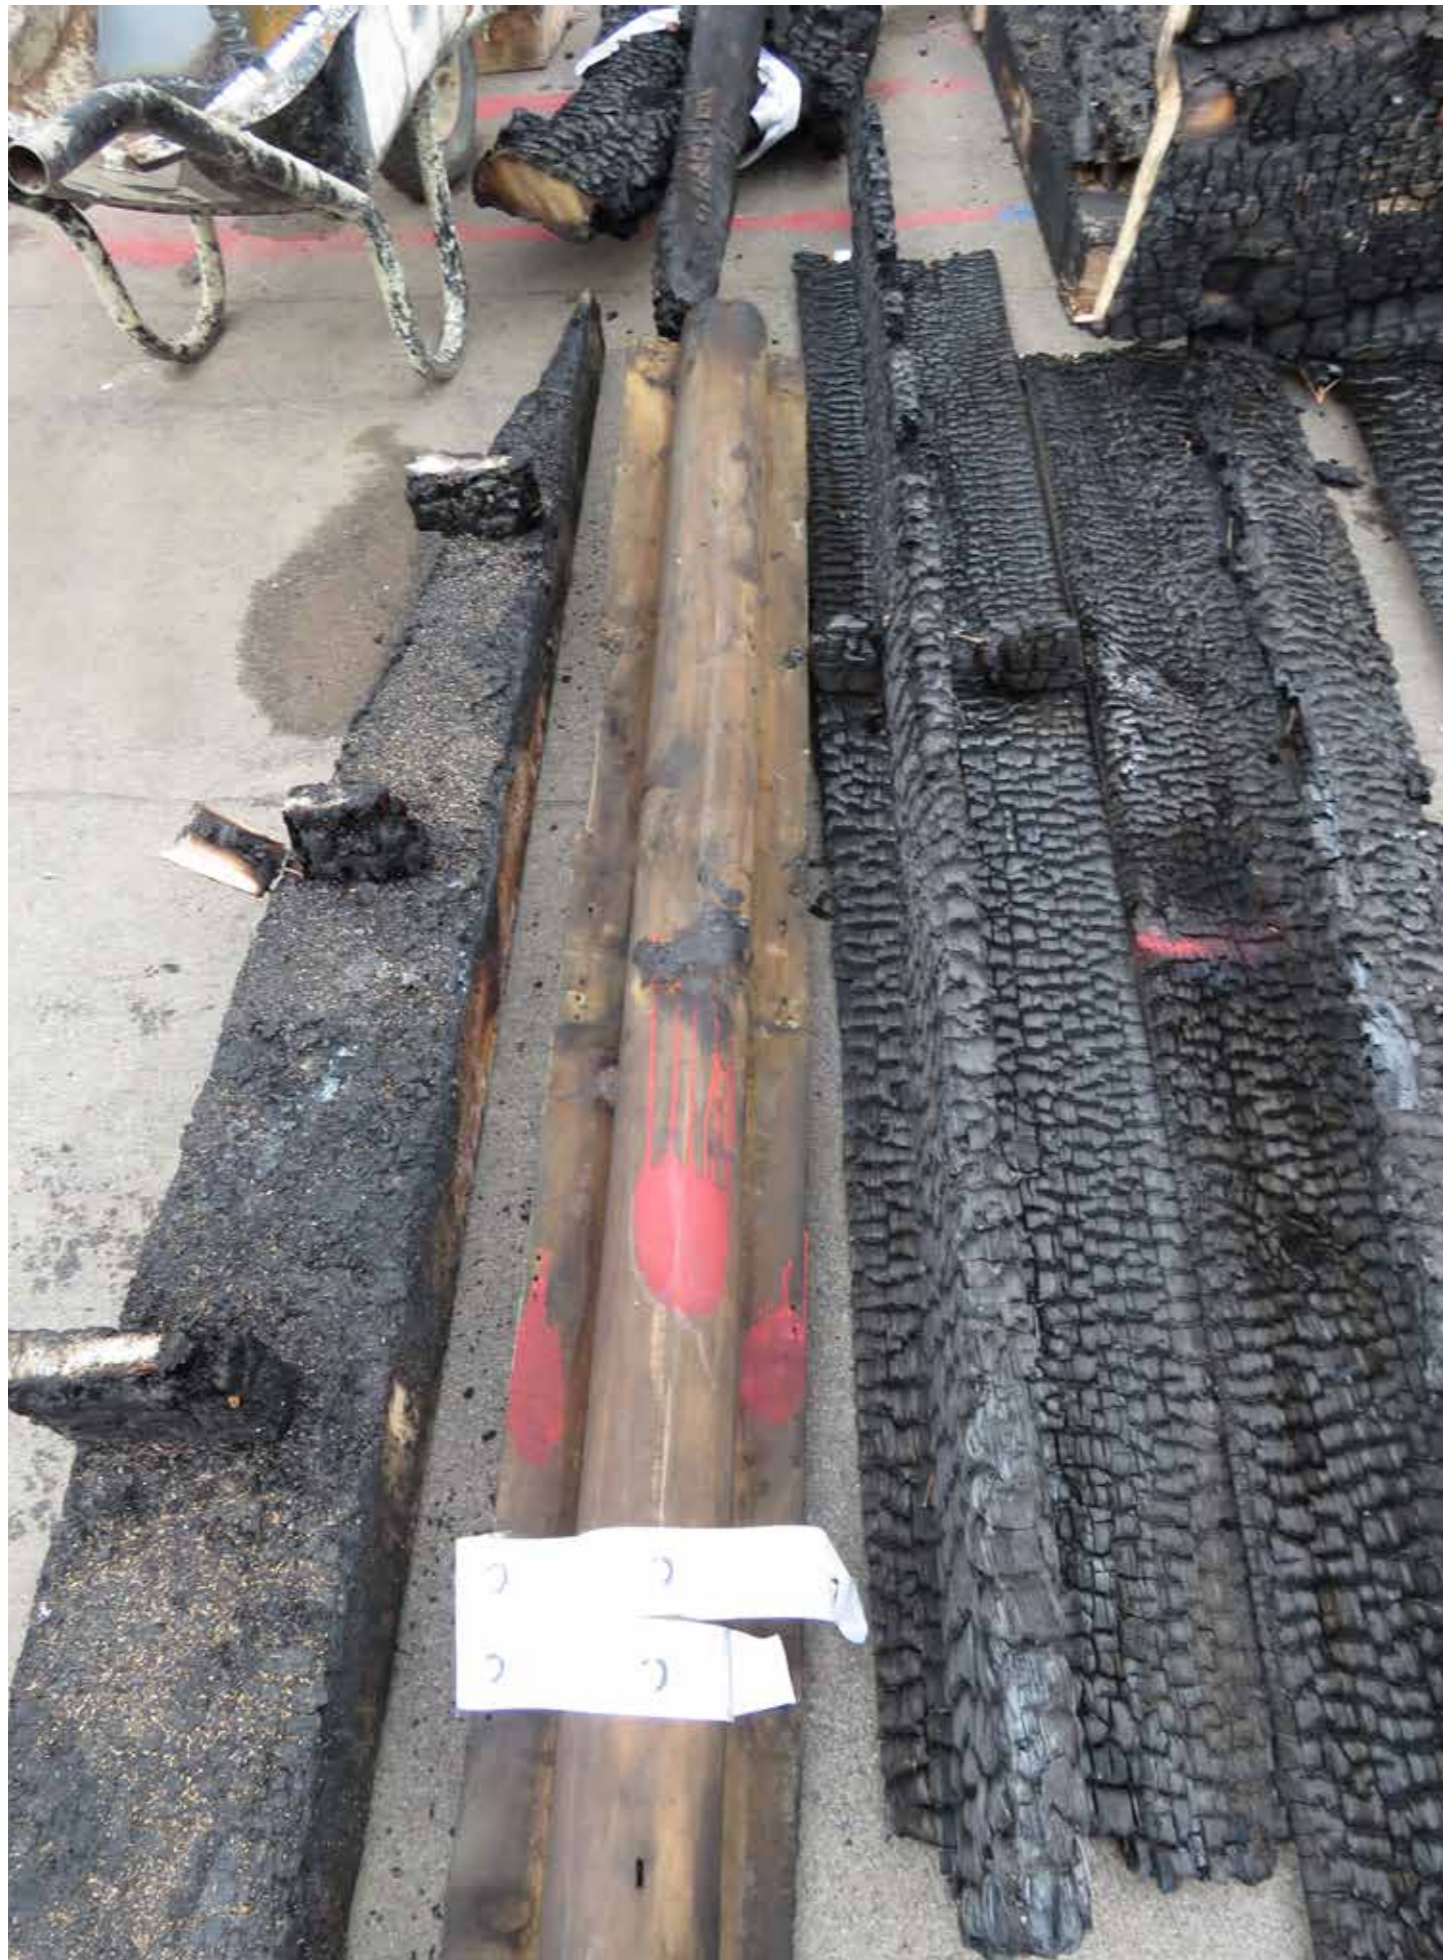
Figure 82: Sample #12 - Outer lower stud wall plate (D) with wall stud ends (B) (2020) © SLHA

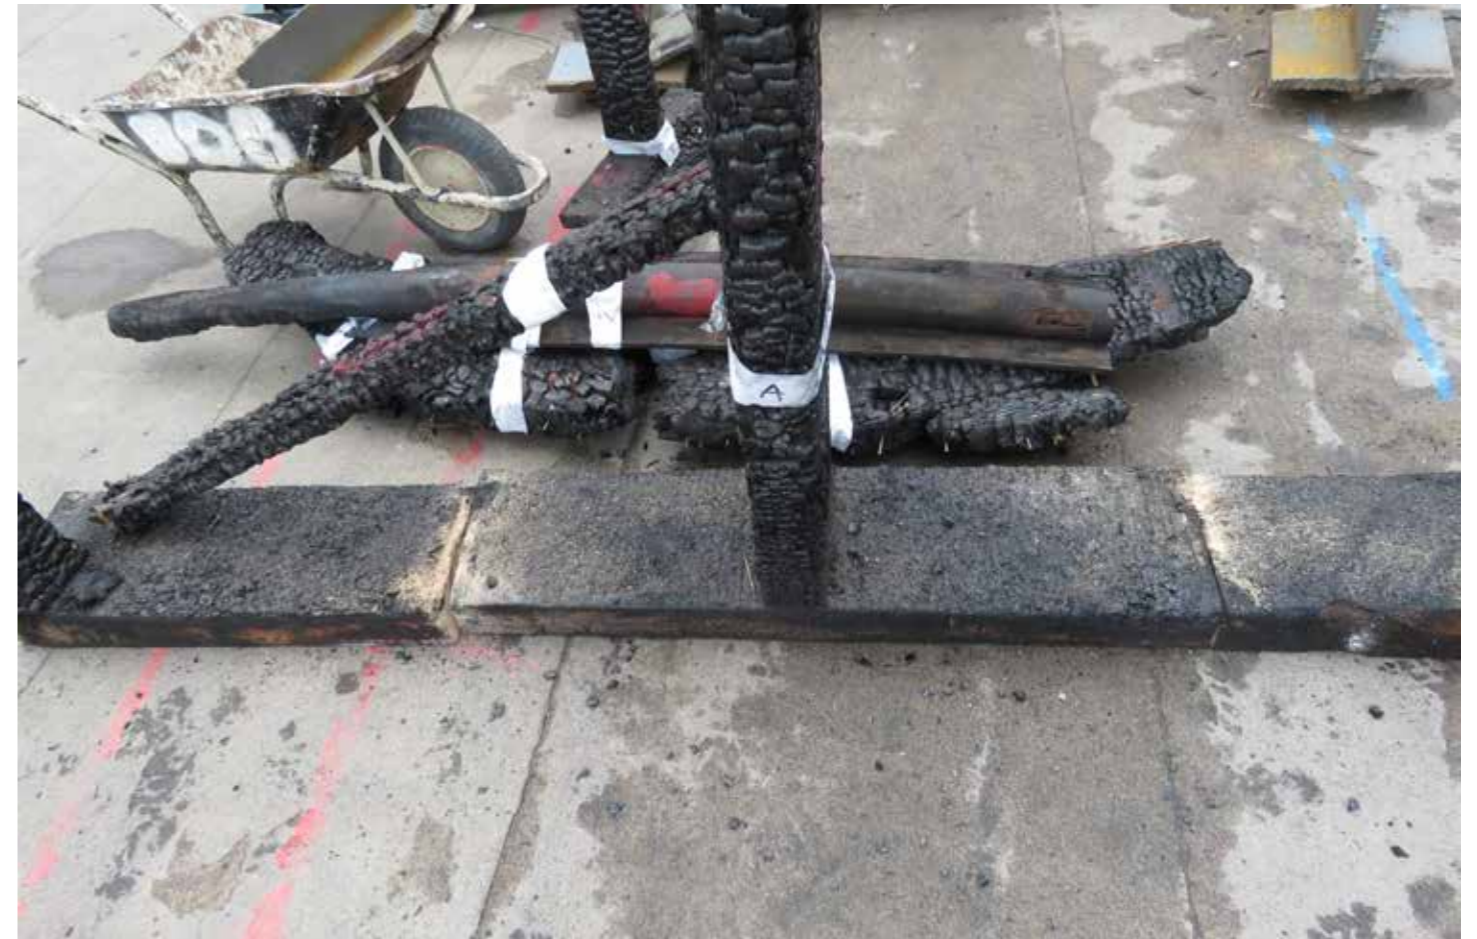
Figure 83: Sample #13 - Inner lower stud wall plate (D1) with main support post (A) and supporting braces (G). This elements was required to be divided into three separate parts (2020) © SLHA

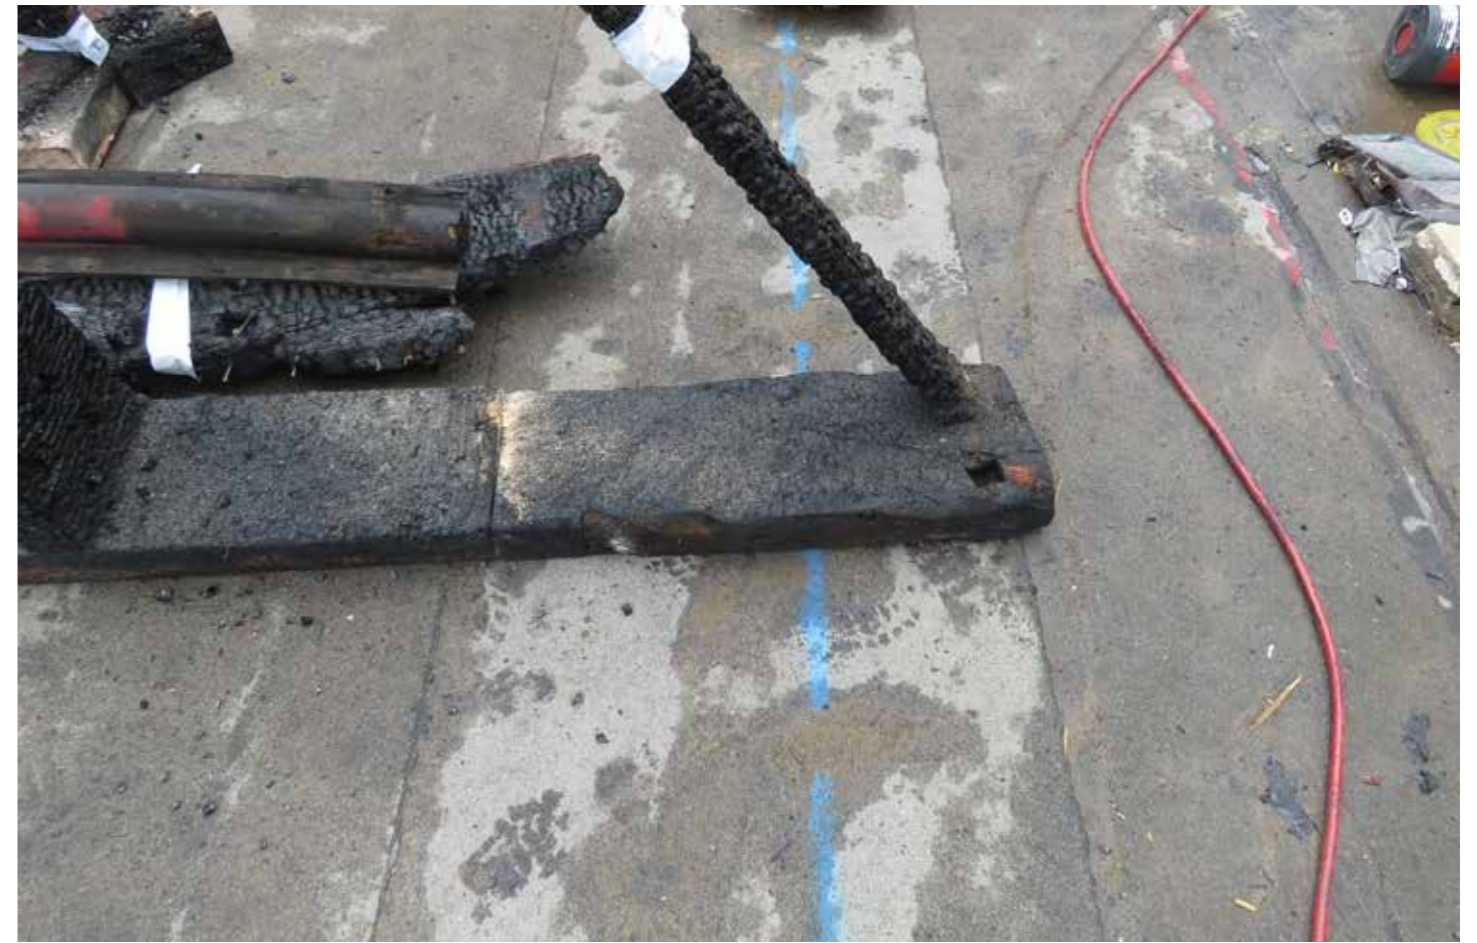
Figure 86: Sample #13 - End of inner lower stud wall plate (D1) with supporting braces (G) (2020) © SLHA

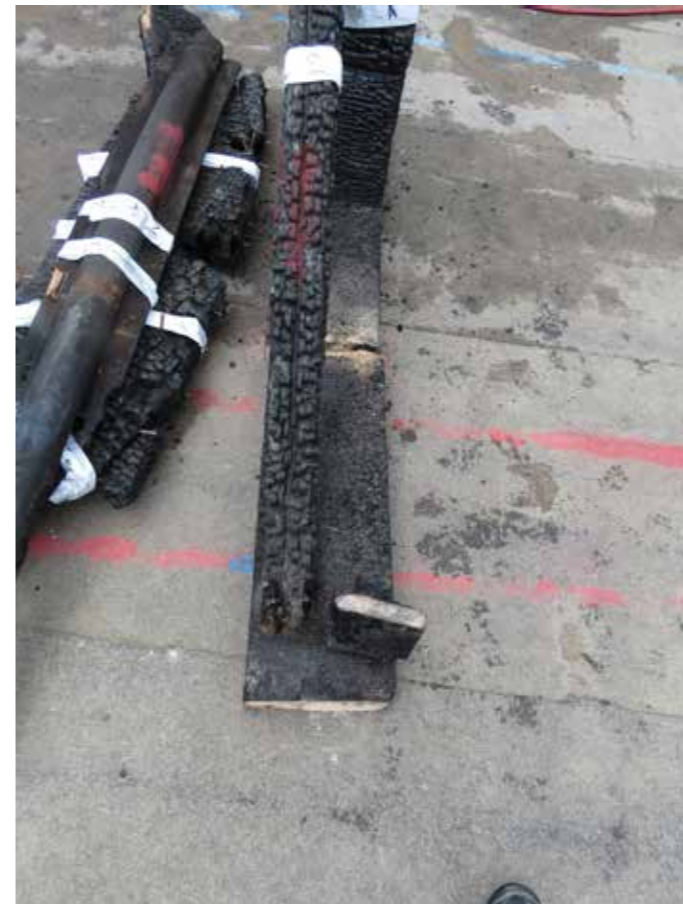
Figure 87: Sample #14 - End of inner lower stud wall plate (D1) with supporting braces (G) and overlapping wall stud (B) (2020) © SLHA

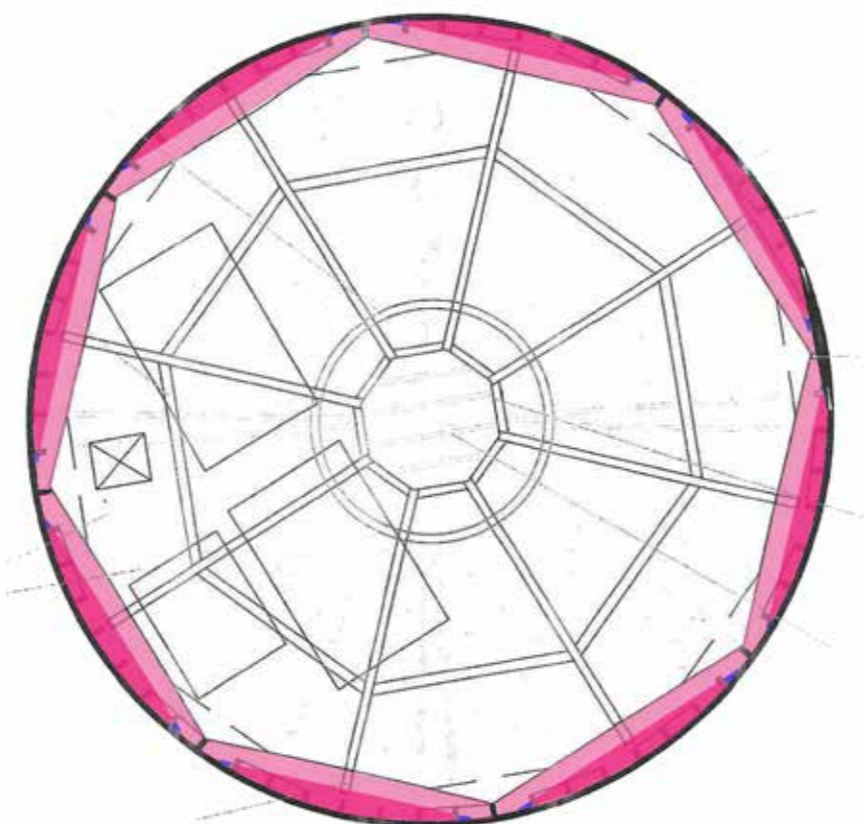
Figure 89: Upper rafter plates (E) in plan view (2019) © H&R (SLHA edit)

The upper rafter plate has been severely damaged in the fire, however aside from a small section on the southeast side, most of the plate was found in situ. All dome elements above this level had collapsed resulting in severe damage to some sections of the rafter plate.

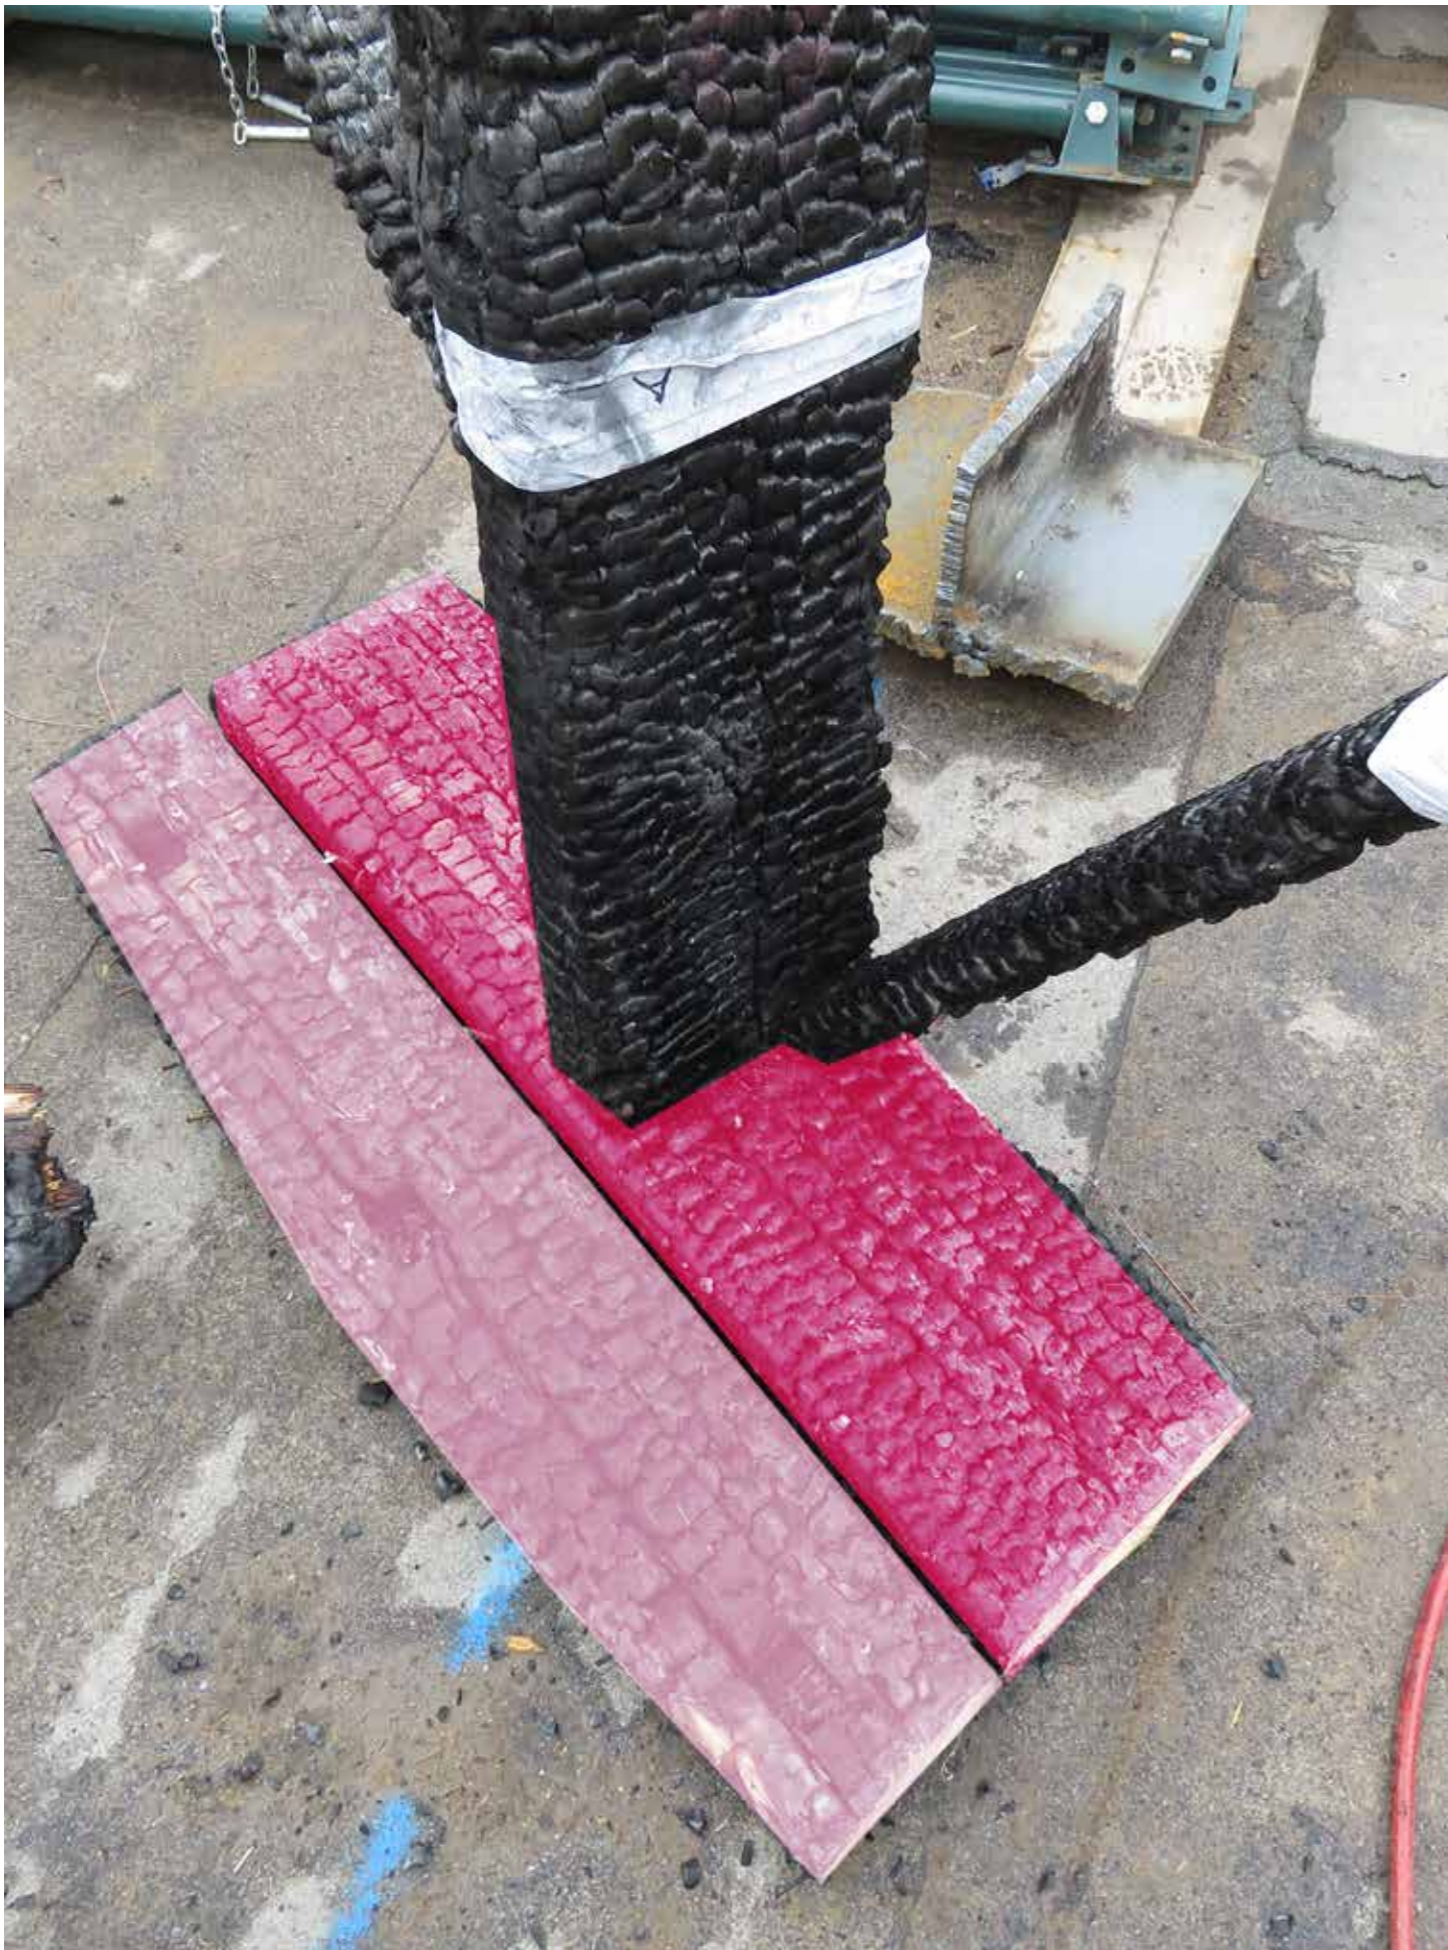
Figure 93 Sample #15 - Upper rafter plates (E) sample taken with the main support post (A) and supporting braces (G) (2020) © SLHA

A number of samples showing important connections and junctions of the rafter plate have been salvaged and catalogued.
