6. DOME INVENTORY - PRINCIPAL TIMBER ELEMENTS DETAILS

6.6 H - Wall boarding

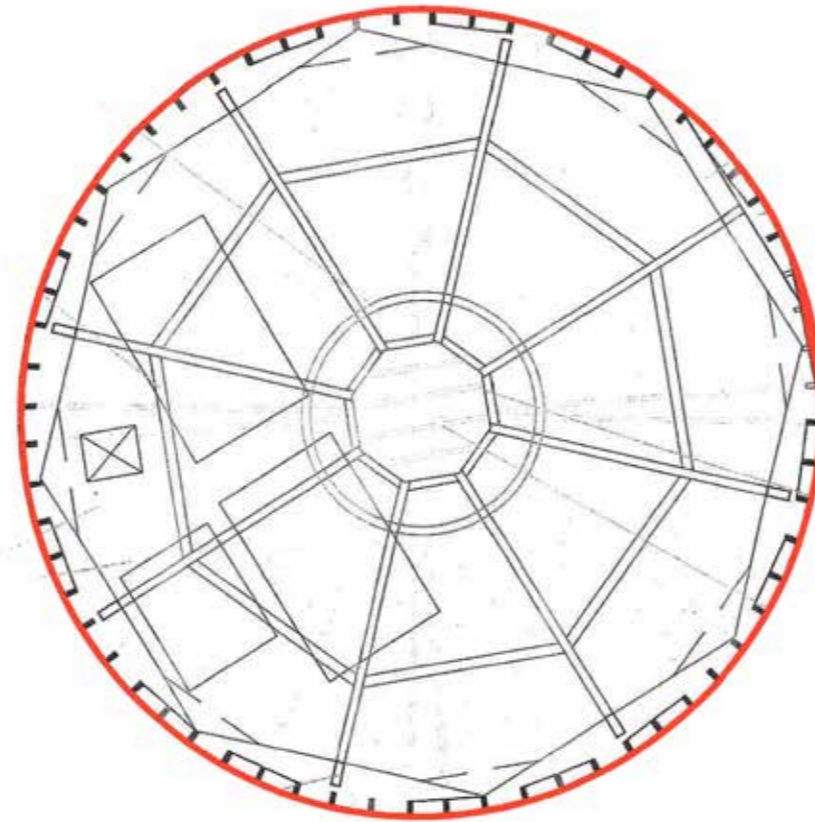
Figure 103: Wall boarding (H) in plan view (2019) © H&R (SLHA edit)

While a significant part of the wall boarding was completely destroyed by the fire, charred timber panels were preserved in situ on the west, north and north east sides.

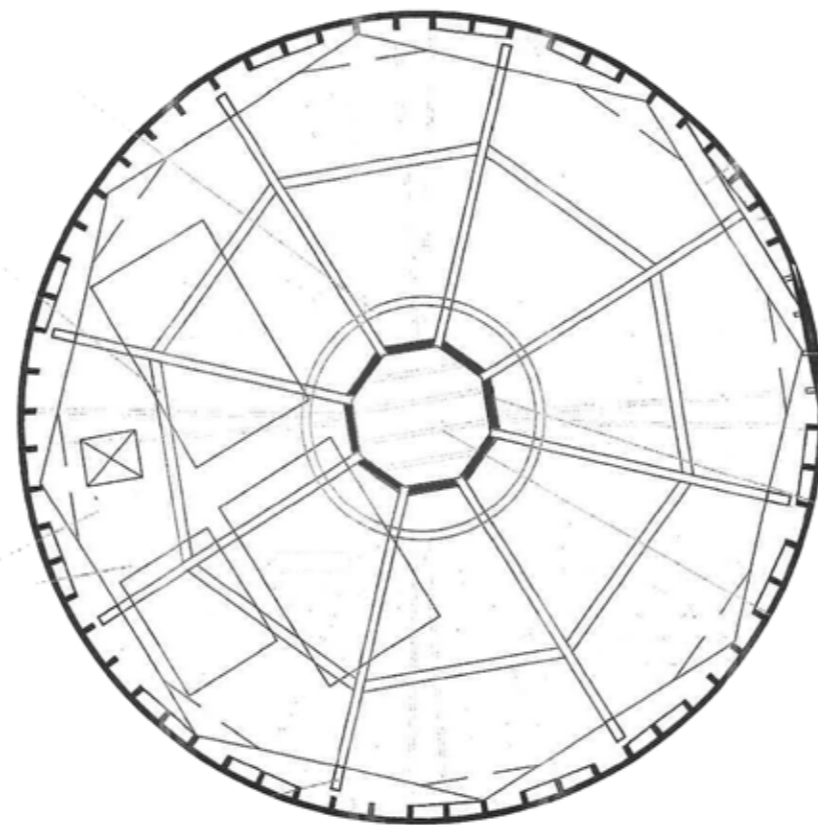
Figure 116: Inner apex ring beam (I) in plan view (2019) © H&R (SLHA edit)

The inner apex ring beam was completely destroyed by fire and only a small fragment was discovered in the debris.

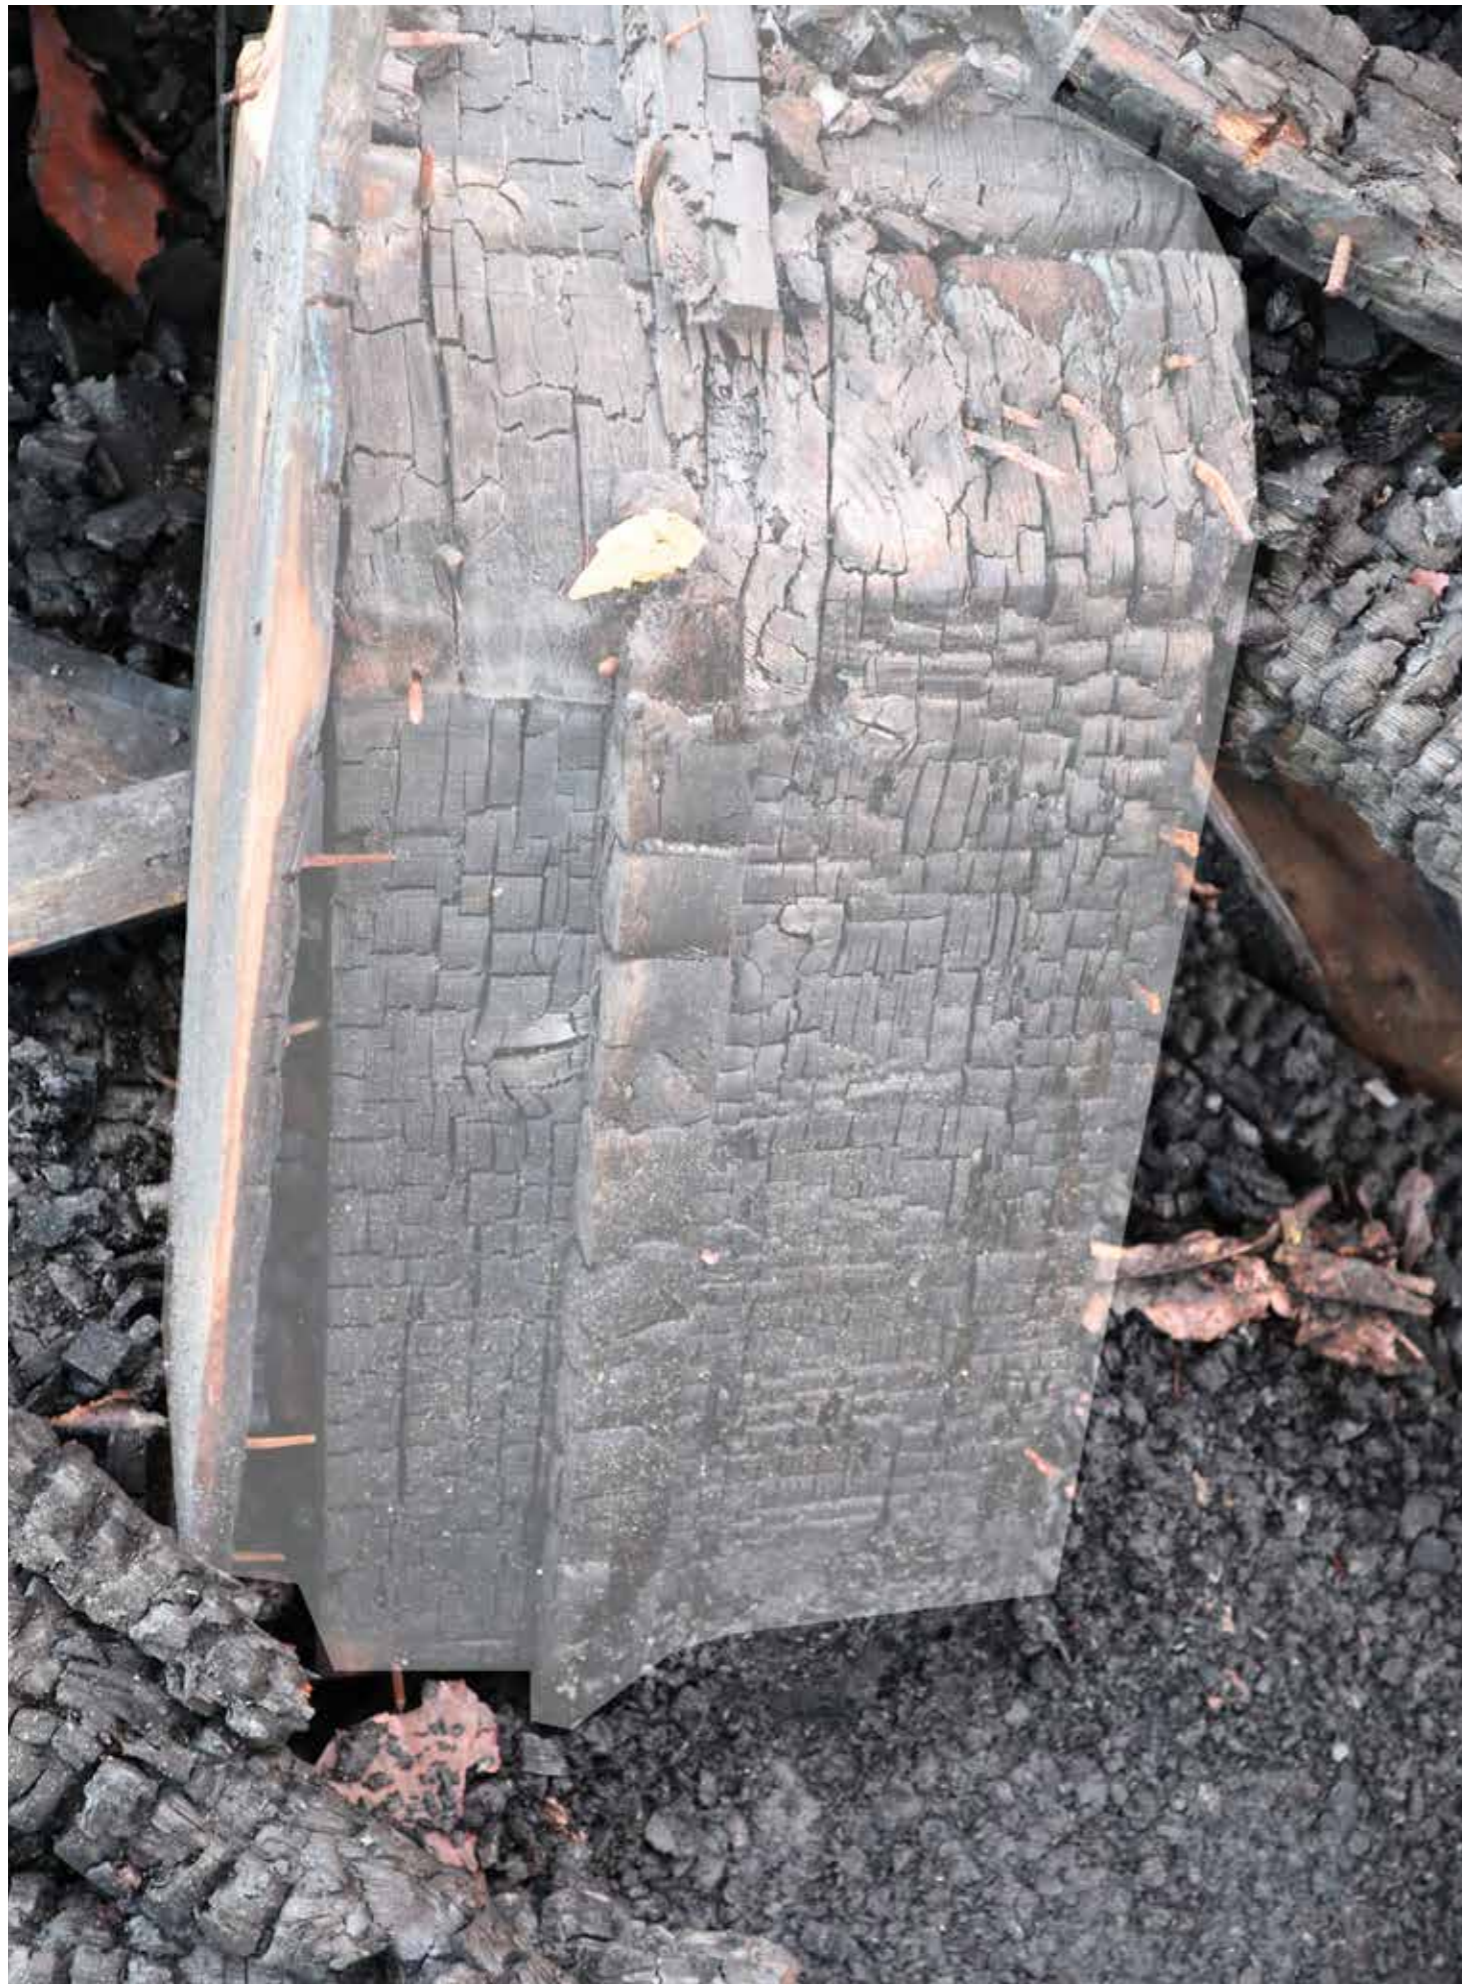
Figure 119: Sample #16 - Inner apex ring beam (I) in situ (2020) © SLHA

Only one section of the inner apex ring beam was identified within the debris and has been salvaged and catalogued.

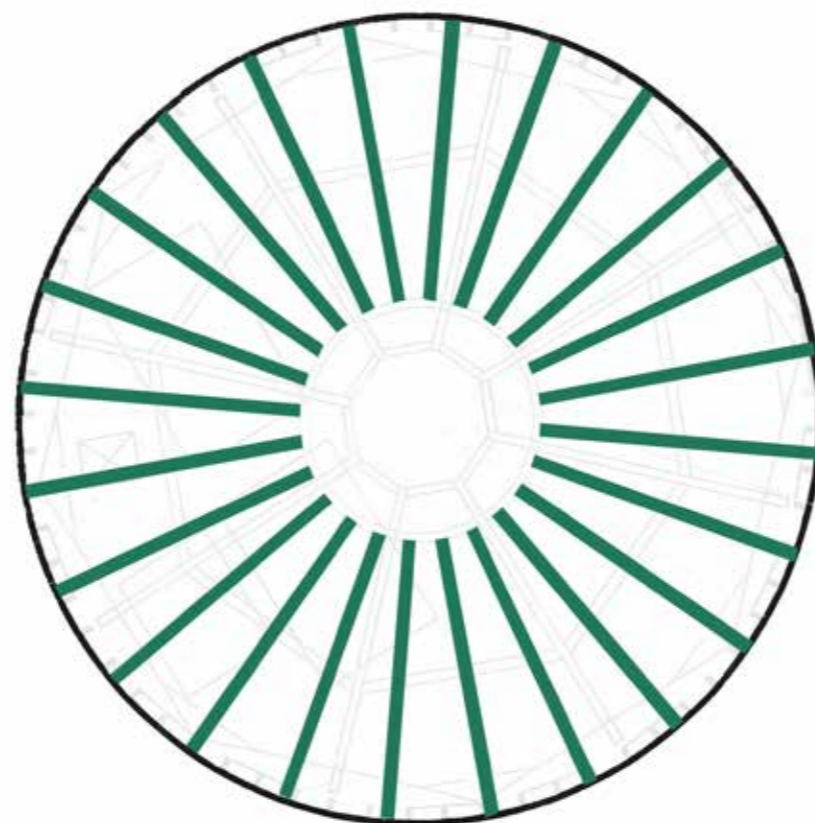
Figure 122: Timber roof rolls (L) in plan view (2019) © H&R (SLHA edit)

The roof rolls of the dome were significantly damaged by the fire and some were found within the debris.

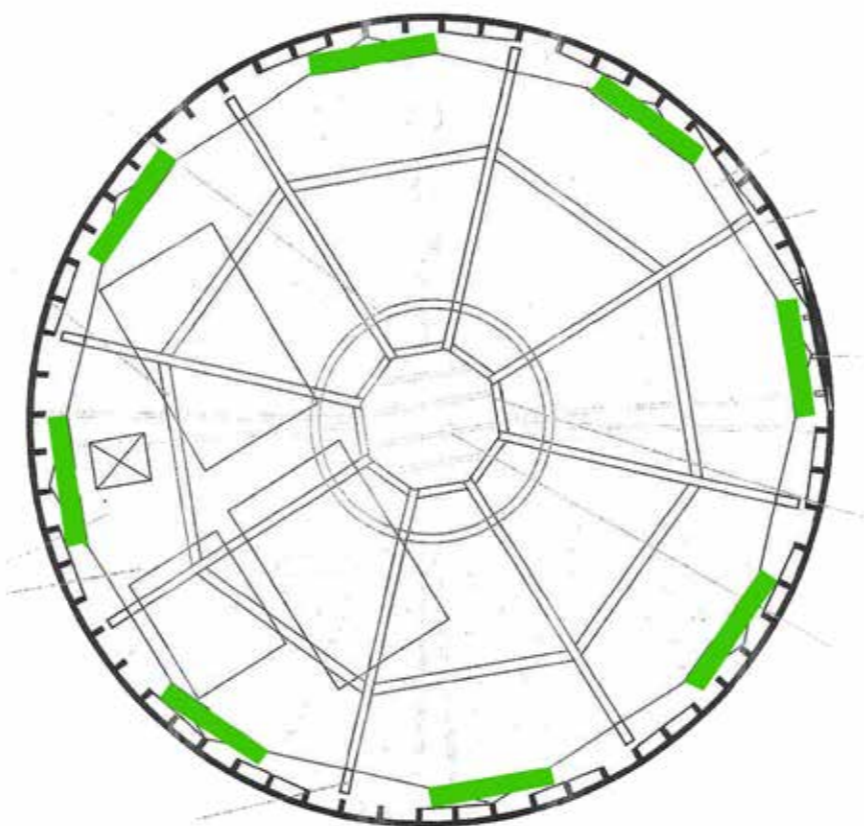
Figure 135: Horizontal rafter wall ties (M) in plan view (2019) © H&R (SLHA edit)

These elements have suffered similar damage as the upper rafter plate.

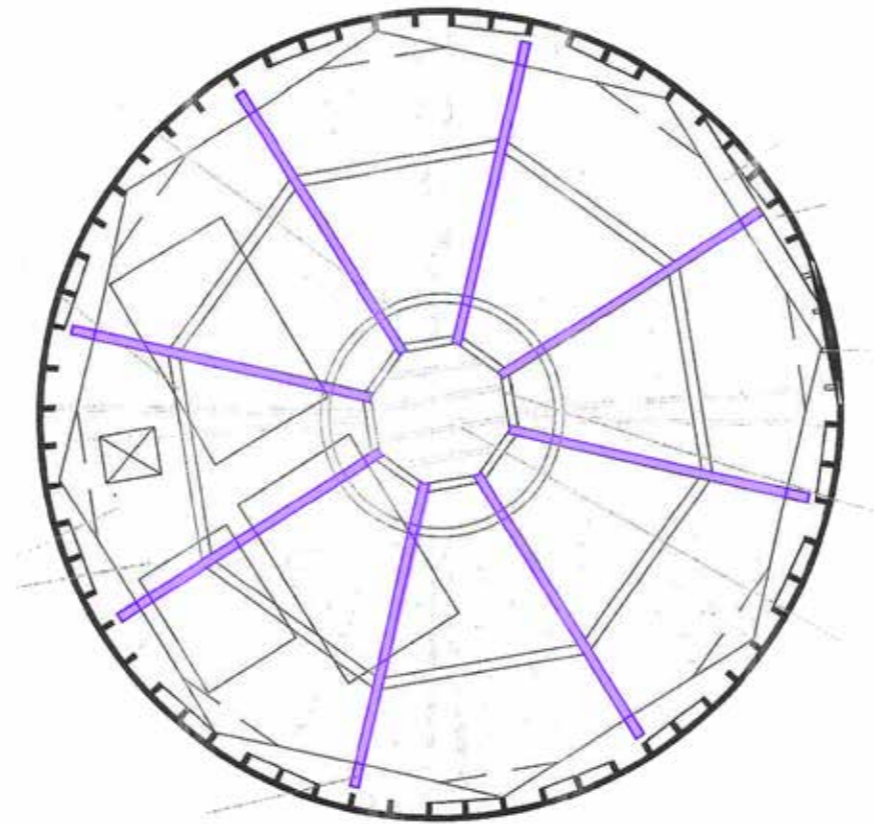
Figure 148: Trusses (T) in plan view (2019) © H&R (SLHA edit)

Though trusses did not disassemble during the fire, they collapsed and were discovered as whole elements.

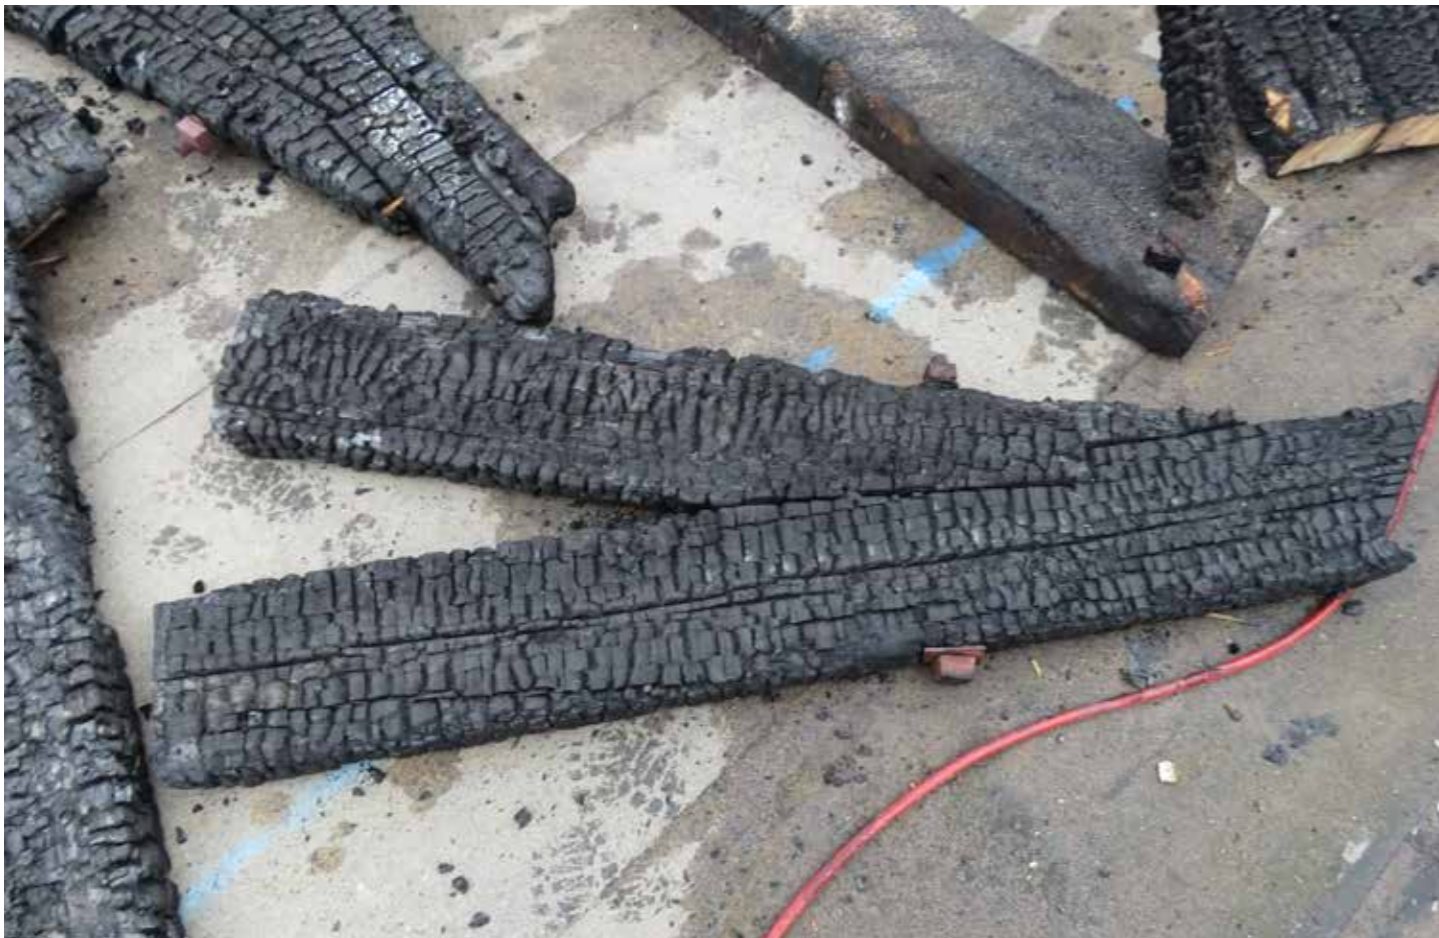
Figure 158: Sample #24 - Bolted metal brace (T4) connecting tie beam (T1) to principal rafters (T3) sample taken (2020) © SLHA

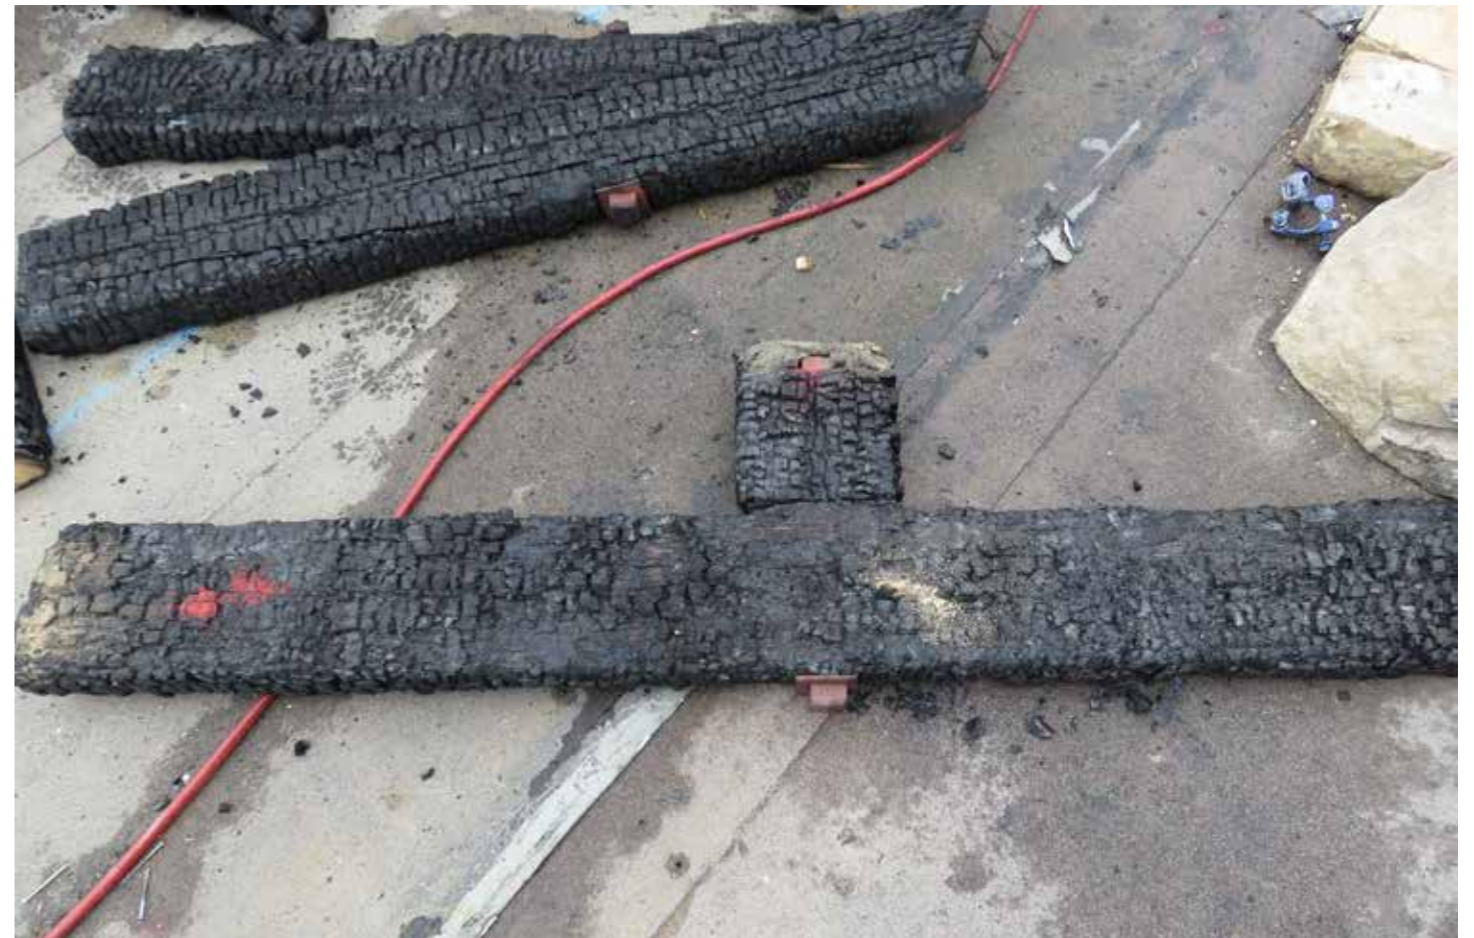
Figure 160: Sample #26 - Bolted metal brace (T4) connecting king post (T2) to tie beam (T1) in situ (2020) © SLHA
