2020/1523/P	98 Highgate West Hill N6 6NR	Amendments to proposed roof, dormer, side elevation window, side entrance and rear extension as granted by permission ref 2017/5939/P granted 18 December 2017 for erection of single storey lower ground floor rear extension, first floor rear part infill extension, rear and side dormer roof extensions; installation of four rooflights to the side roof slope; infill of first floor south side facing window and addition of first floor obscure glazed north side facing window	Thomas Sild
-------------	------------------------------------	--	-------------

Objection,

These comments update the earlier comments following the opening of the Non-Material Amendment Statement to public view on 11-Jun-20

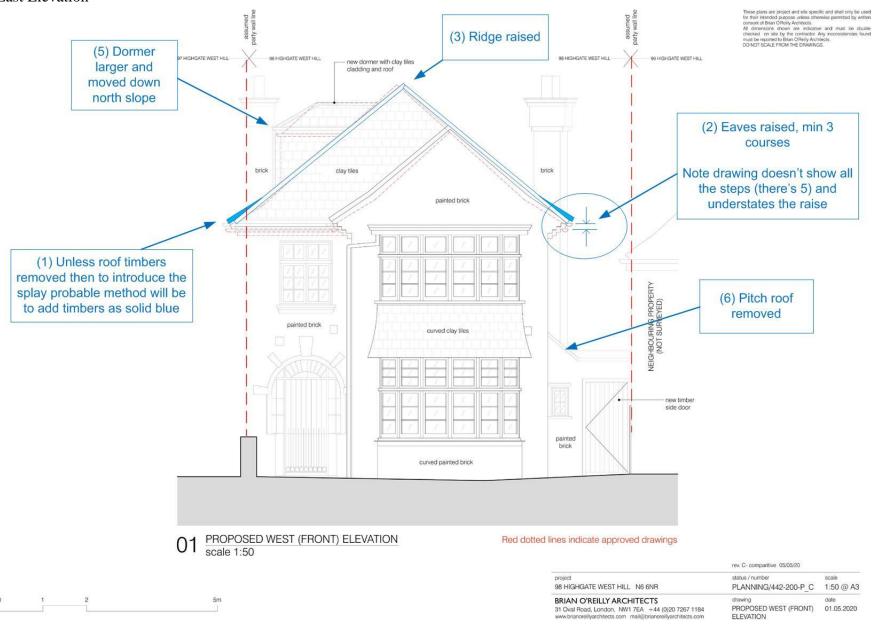
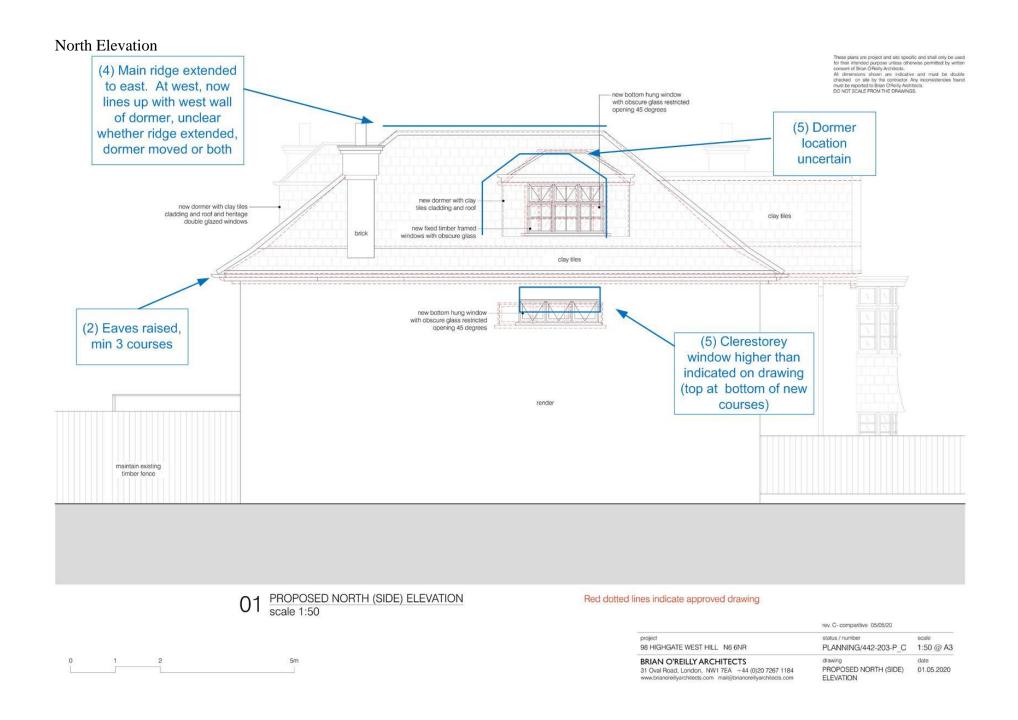
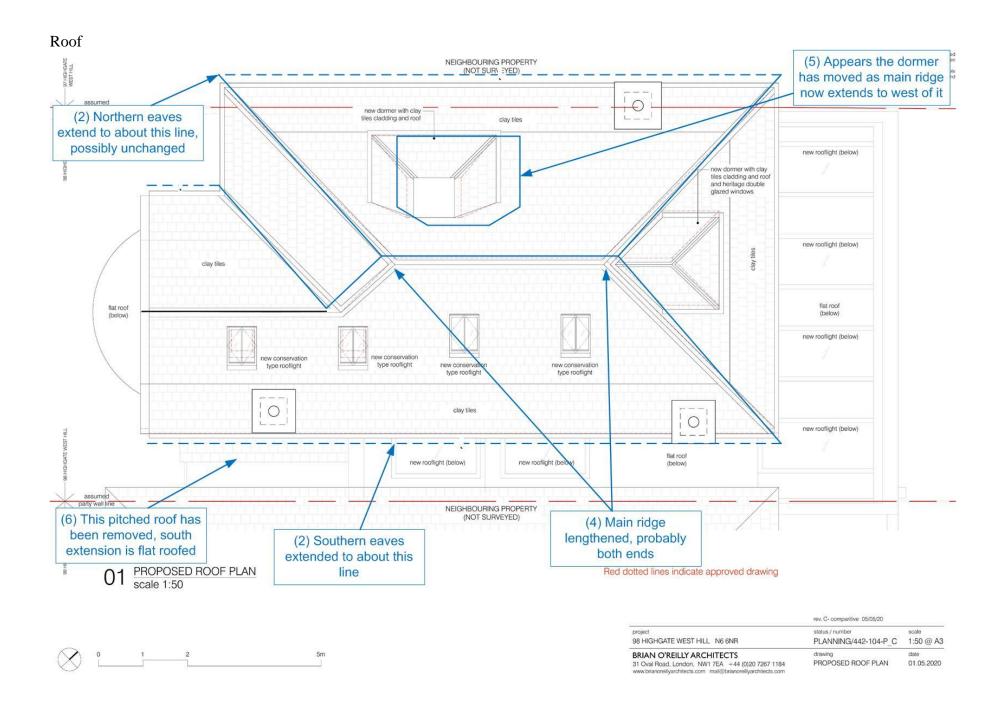
East Elevation

At the end of this document I have added to the Proposed drawings indications of where they differ from the approved drawings, not all the points above are accurately shown
