ARBORICULTURAL IMPACT ASSESSMENT REPORT

BS 5837:2012 'Trees in relation to design, demolition and construction. Recommendations'

Land surrounding Snowman and Casterbridge House,
Belsize Road, Camden, NW6 4DP

DATE: 19 May 2020

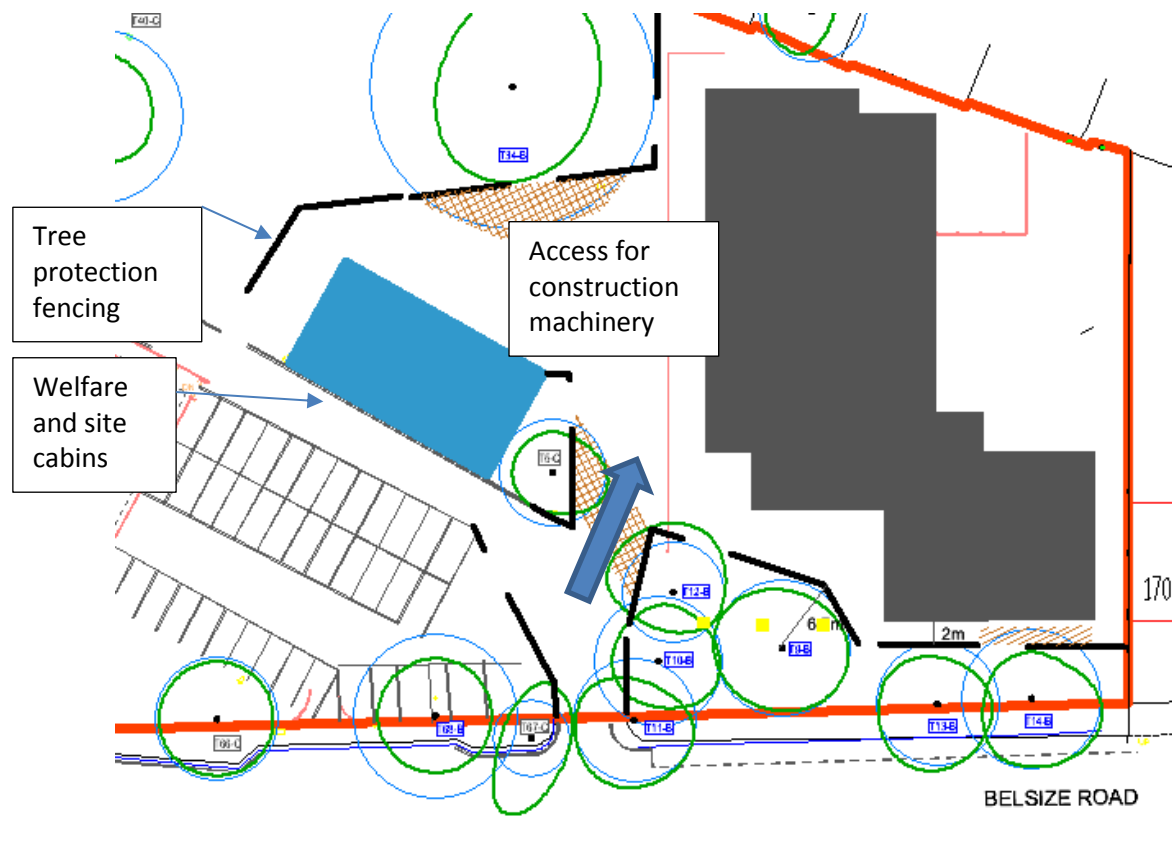
Plan 1 – extract from SHA 1032 TPP2. Do not scale. North

The proposed building is clear of the root protection areas. The crown spreads of the trees to be retained will provide a pleasant outlook, screen, pollution moderation and ecosystem services.

The trees to be retained will be protected during construction by a combination of tree protection fencing and ground protection to a specification at appendix 5 and at a location shown on the plan *SHA 1032 TPP2* for construction. The fencing has been set back slightly to enable a 2m clear scaffold zone near T13 and T14. The ground protection includes an area between T5 Norway maple and T12 sycamore, on the outer edges of their root protection areas to allow for the site compound and access for construction vehicles. Both trees will be crown lifted to achieve clearance. This is modest incursion into the root protection area, and levels allow for the raising of the surface without the need to excavate. A fence near T10 will be removed with care, as shown on the plan *SHA 1032 TPP1* as a yellow line. Details for this will be in the forthcoming method statement post planning.

The timber frame structure will be installed using screw piles (or similar to be agreed) following root investigation under arboricultural supervision along the desired lines of posts. The details of this will be established post planning by way of Arboricultural Method Statement. The view overleaf shows the location of the proposed structure relative to the nearest trees, T9, T10 and T12. It is likely that the narrower spaced vertical timbers will not need foundations, but be supported by the corner and the larger timbers and the horizontal support.
