33 Fitzroy Square
London, W1T 6EU

Design Statement -
Proposed Replacement of the
Front Elevation Medallions

London
10 July 2020

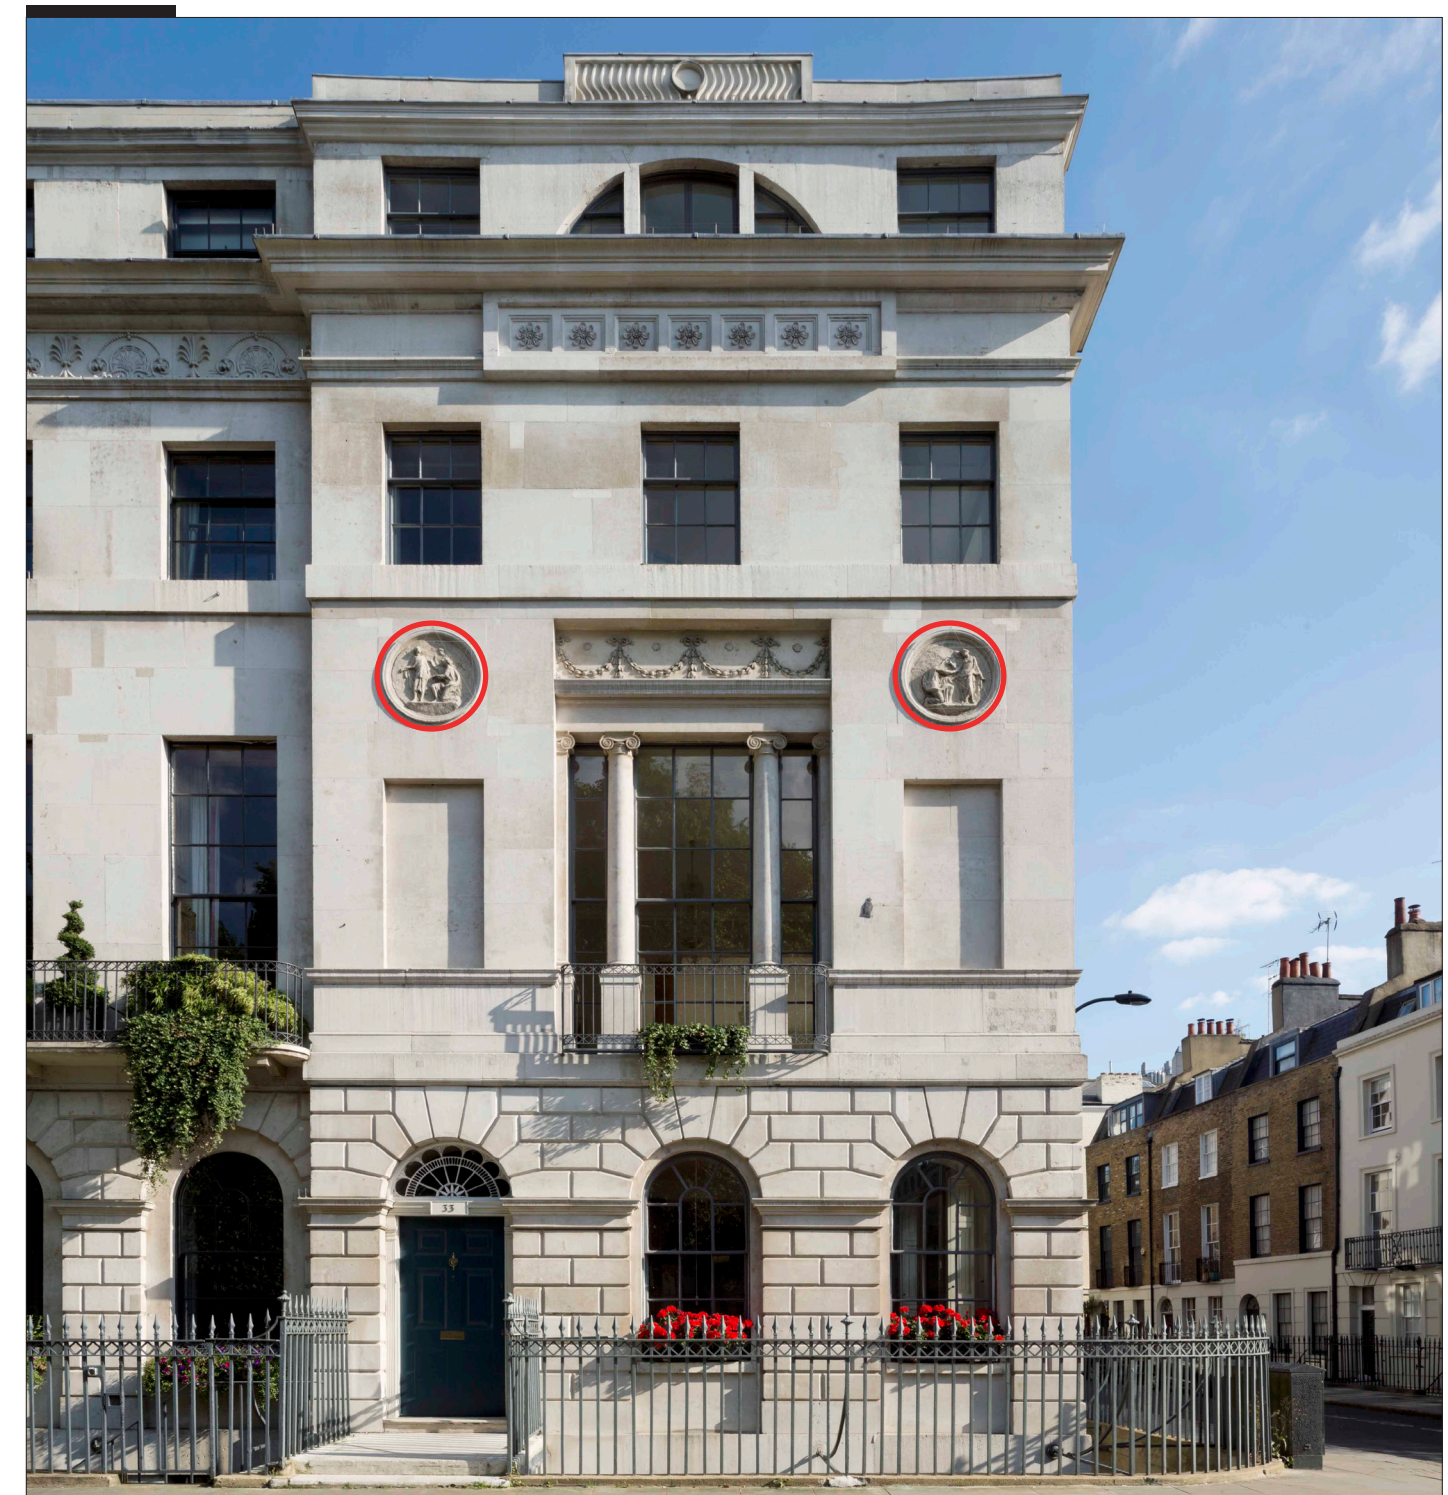
Existing Front Elevation - Existing Medallions highlighted

- Drawing showing exact location of medallions, to remain as existing - approx 850mm diameter.
- Classical scene set within a portland stone frame. Stone frames in a good state of repair & to remain as existing.

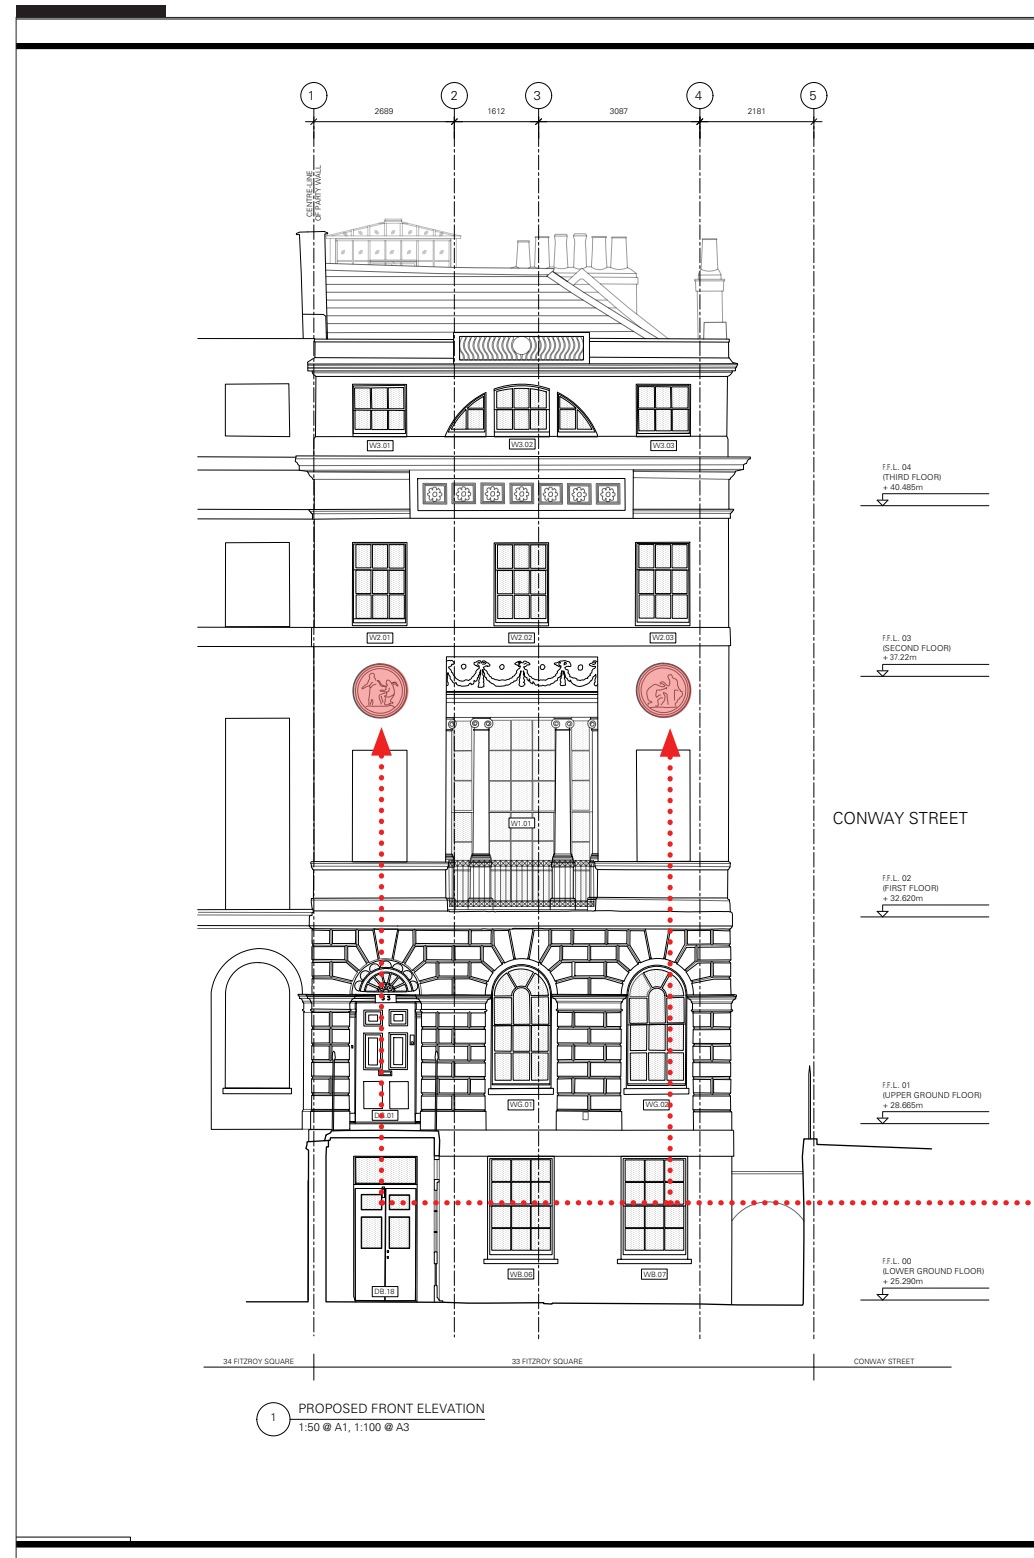
Images (2010/6848/L) - Left-hand side during & post paint removal

- Detailed in Application 2010/6848/L is evidence of the previous restoration works carried.
- Paint removed from the entire facade, to expose the early portland stone & assumed Liardet decorative medallions, depicting individual classical scene.
- Images illustrate more pronounced scenes, suggesting the exposure in the last 8-10years, since this report was produced, has had a detrimental effect on the material.
- Right Hand Medallion, suffered severe cracking & wires installed to prevent material falling.
- Two additional & individual scenes are found in the same location of the facade at No.40 Fitzroy Square (eastern end of the Southern block).

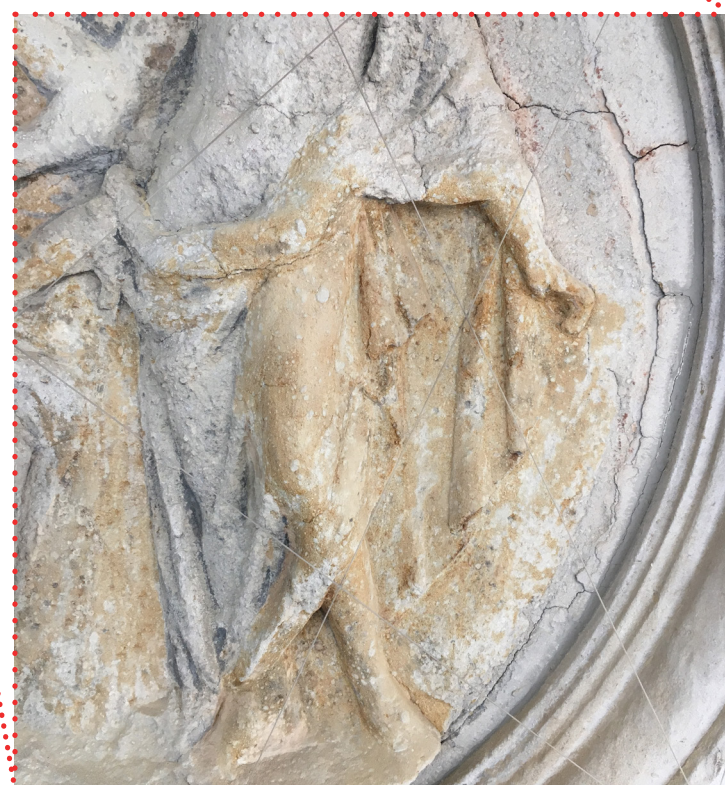
Existing Medallion - Right-hand Side

- 3 The material has very little mechanical strength is orange in colour with a textured paint finish ,
- 4 It is difficult to understand why this inferior material with a different colour would have been incorporated into a I façade of this magnitude and so we are of the opinion that these quite possibly are not the original works but poor quality replacements,

- Scene are not made of Coade Stone, either made of a natural or cement based lime stone.
- Basic testing of material suggested it's a lime based material.
- Material has very little mechanical strength, orange in colour.
- Opinion that these are not early works but poor quality replacements.

- 5 Because of their unstable nature we would suggest that the roundels will need to be removed from the façade to our studios to be either restored or replaced.

- 6 Clearly further investigation will need to be carried out in order to move matters on but It could be that this material is so friable that we may need to consider making replacements , I am always determined to maintain and conserve original work where at all possible but I should make you aware that replacement of the roundels may be our only option

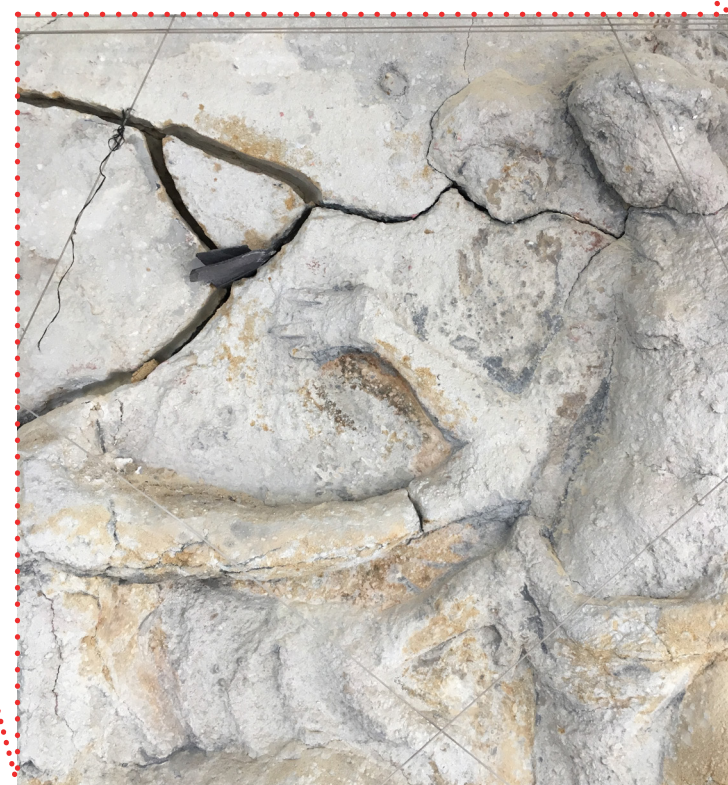
Existing Medallion - Right-hand Side

Specialist Investigation - Sympathetic removal of a loose area

- Area of stone removed was blown from surface & loose.
- Surface extremely degraded, friable & appeared to have suffered damage from paint removal - either by chemicals or sandblasting.

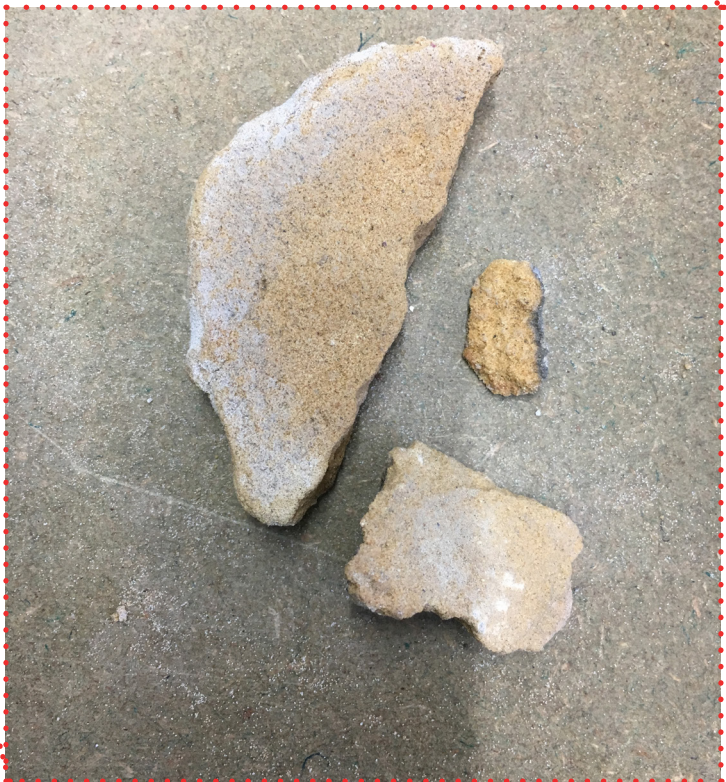
Existing Medallion - Right-hand Side

The samples were found to comprise organic binder, non-hydraulic lime and sand mixes.

The organic binder contents of the samples were found to be 6.5% and 5.0% by weight of sample. Without reference materials it is not possible to say whether the results represent the full organic binder content. Any decisions based upon the results should be taken with a degree of caution.

The lime contents were found to be 6.5% and 3.5% by weight of sample. Without petrographic confirmation of a lime binder it is possible that the acid soluble calcium contents are from limestone rather than a lime binder.

- Sandberg carried out an analysis of the mortar sample taken from the back of the removed loose section of the medallion.
- Sandberg were specifically asked to concluded if linseed was present in the sample - the blinding material used in Liardet - the anaylsis was inconclusive.
- Sandberg - "We did run FTIR to try an identify the organic material but the analysis was inconclusive and didn't point towards linseed oil nor any other sensible answer."

Sandberg Material Anaylsis - Inconclusive as being Liardet
