CONTRACT: Tottenham Street

CONTRACT NO. 6606

STRUCTURAL INSPECTION  
REPORT

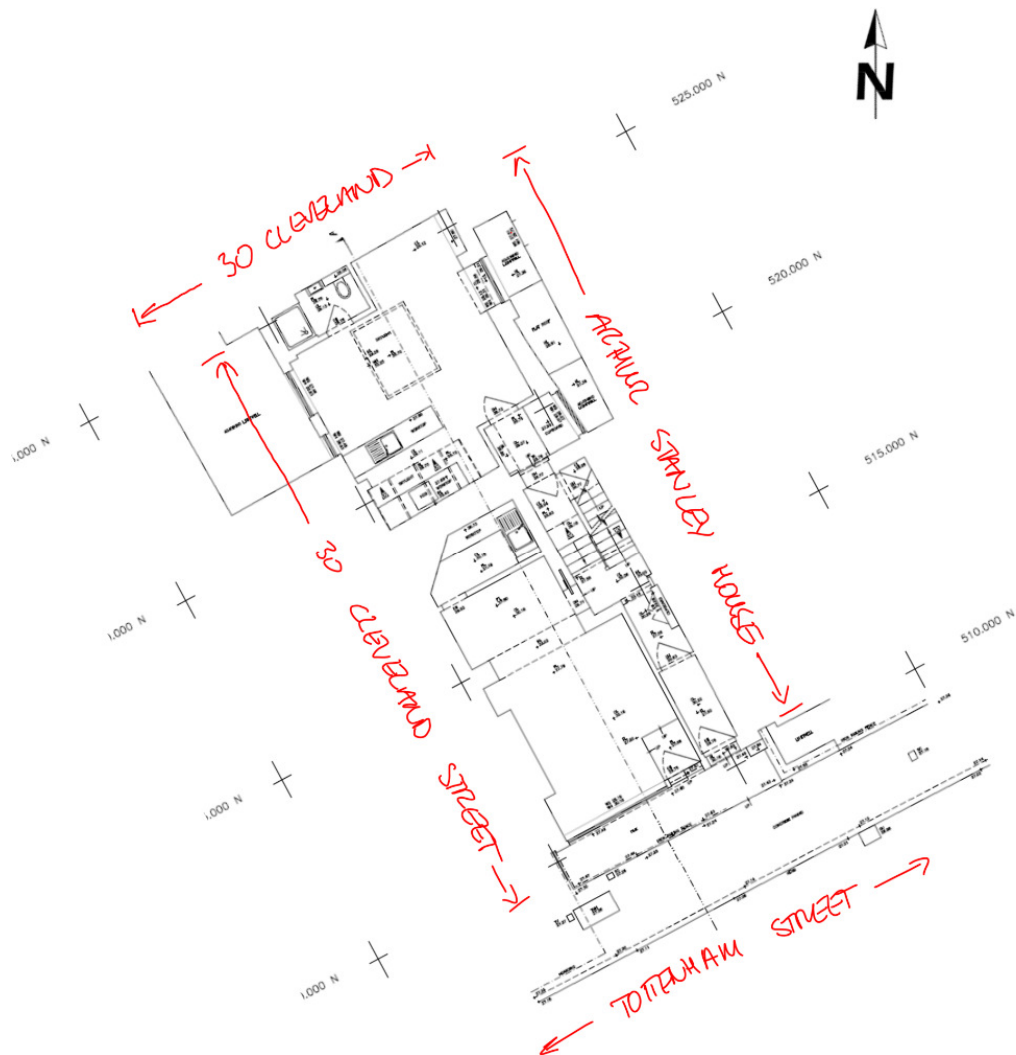
**Figure 1 Site plan and description of boundaries**

To the South-East of the site is the principle elevation with Tottenham Street. Existing vaults extend under the pavement to the kerb.
