4 Flitcroft Street Facade Alterations Discharge of Conditions - render removal rev B

Ian Chalk Architects

Consolidated Group March 2020 1.0 Introduction

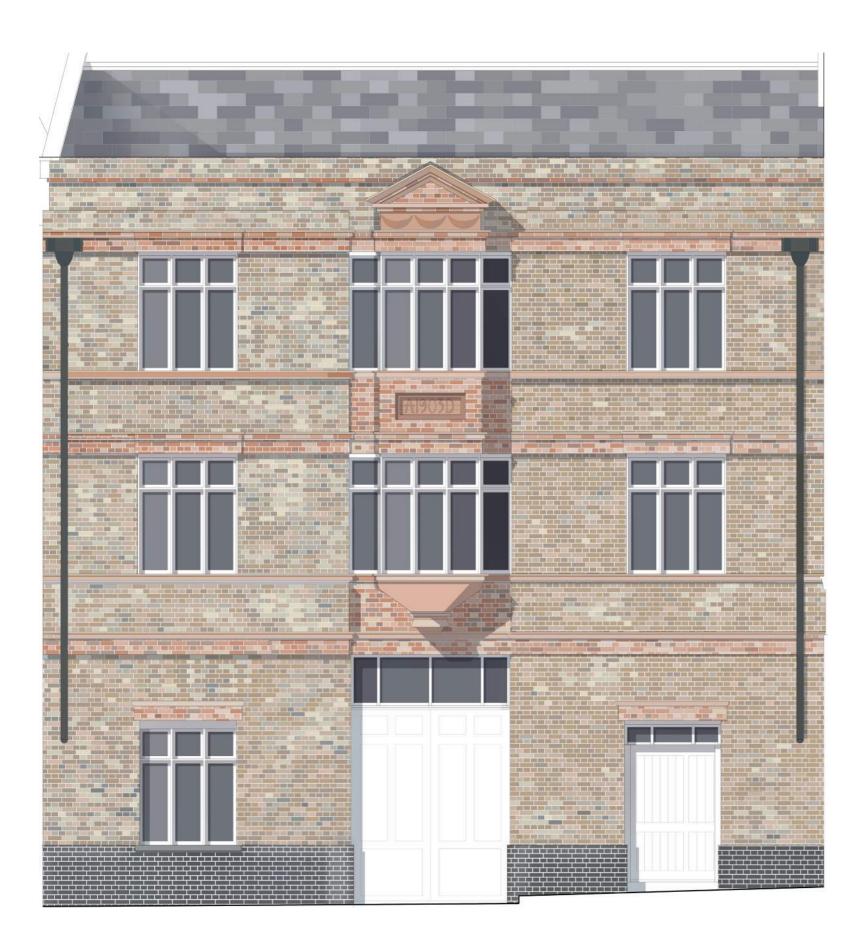
4 FLITCROFT ST. - 2017

The façade at upper level is finished in render applied over original brickwork. Horizontal bands of feature brickwork between windows, with a projecting central barlos of feature bickwork between windows, with a projecting central bay window with terracotta panelling. The ground floor façade has been significantly remodelled with two of the openings having been enlarged with painted metal glazing and prominent steel roller shutters. The lower facade is in stucco render with deep horizontal banding.

Symmetry of facade disrupted by ground floor alterations.

Facade has been rendered over the original brickwork with expressed brick banding retained.

Lintols to ground floor have mostly been lost.

Deep banded render to base of building.

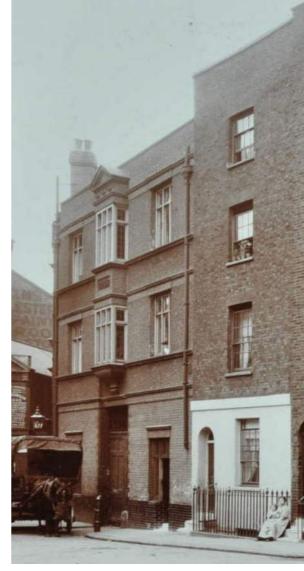
4 FLITCROFT ST. - 1908 SHORTLY AFTER CONSTRUC-TION IN 1903 The building was originally built in 1903 as a commercial building in the Queen Anne style, with warehousing on the ground floor and offices on the floors above. The principal elevation to Flitcroft Street is on three storeys with a mansard roof with dormer windows added later, above.

The photograph and mock-up to the left show the facade in its original condition which was largely a brick frontage with expressed band of decorative brickwork in red rubber and a glazed brick base. This reading of the facade has been lost with the later introduction of render to the main body of the brickwork.

Symmetrical facade, windows arranged in a grid.

Brick facade with expressed brick banding.

Expressed brick lintols to ground floor openings.

Dark glazed brick base.

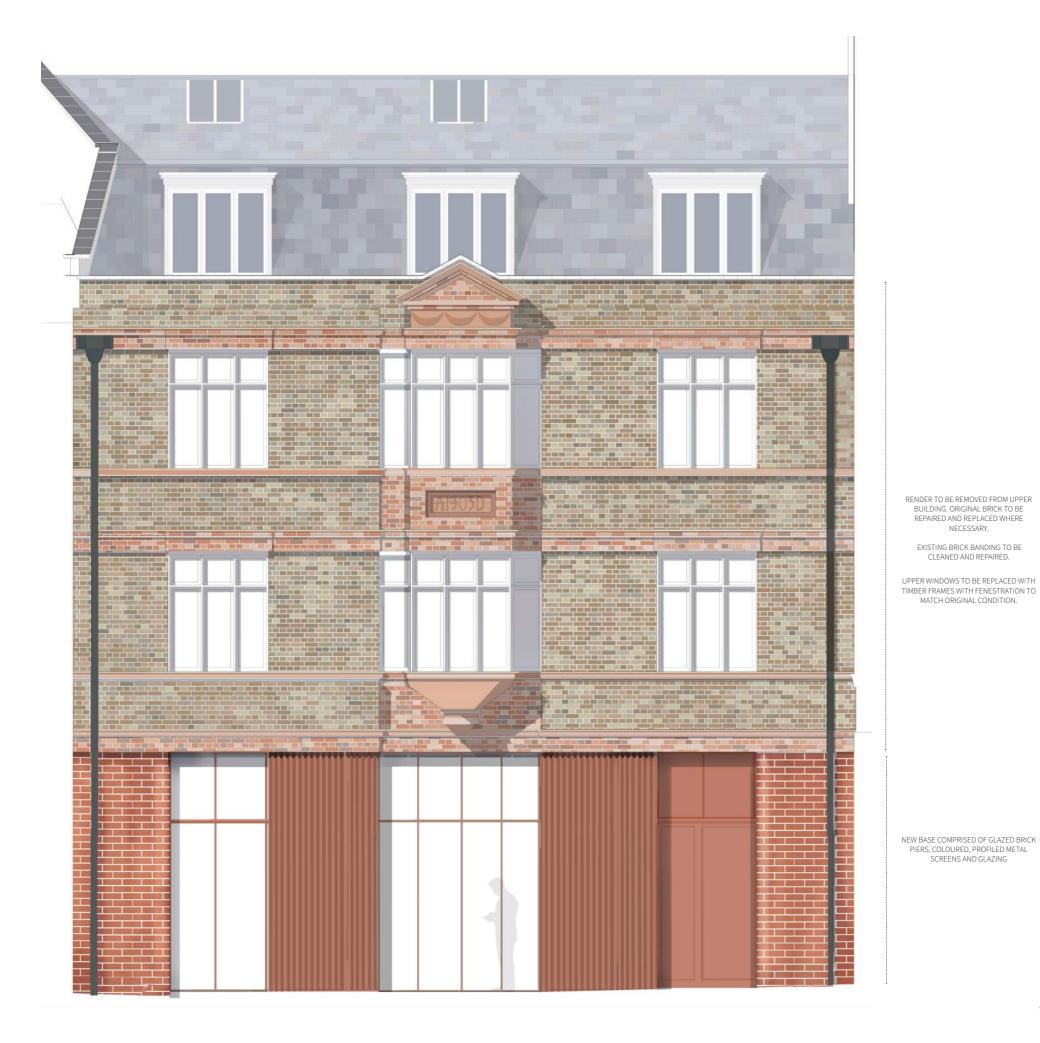
EXISTING BRICK BANDING TO BE CLEANED AND REPAIRED.

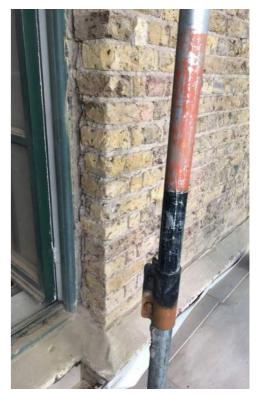
4 Flitcroft Street - front facade showing render removed to First and Second Floors existing stock brick revealed beneath - bricks have been carefully cleaned and repaired by hand creating a soft consistent appearance.
