**64 Lincolns Inn Fields, London**

## Structural Assessment Report

**Ref:** 190861/K Clark

**Date:** 10 Jul 2020

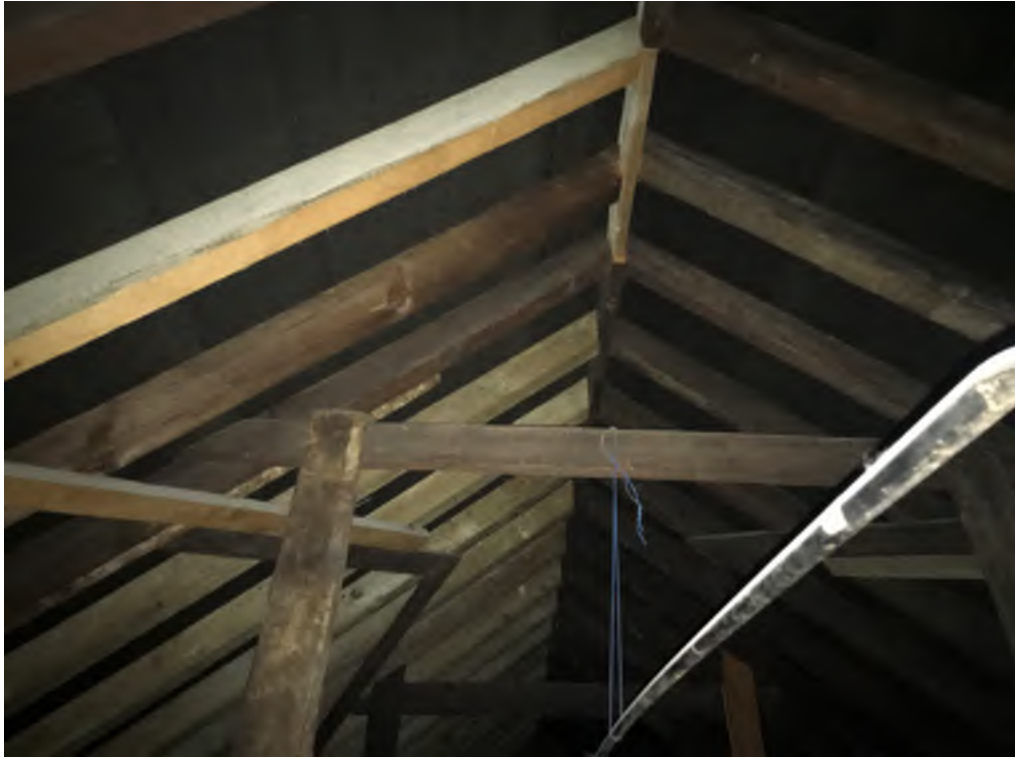
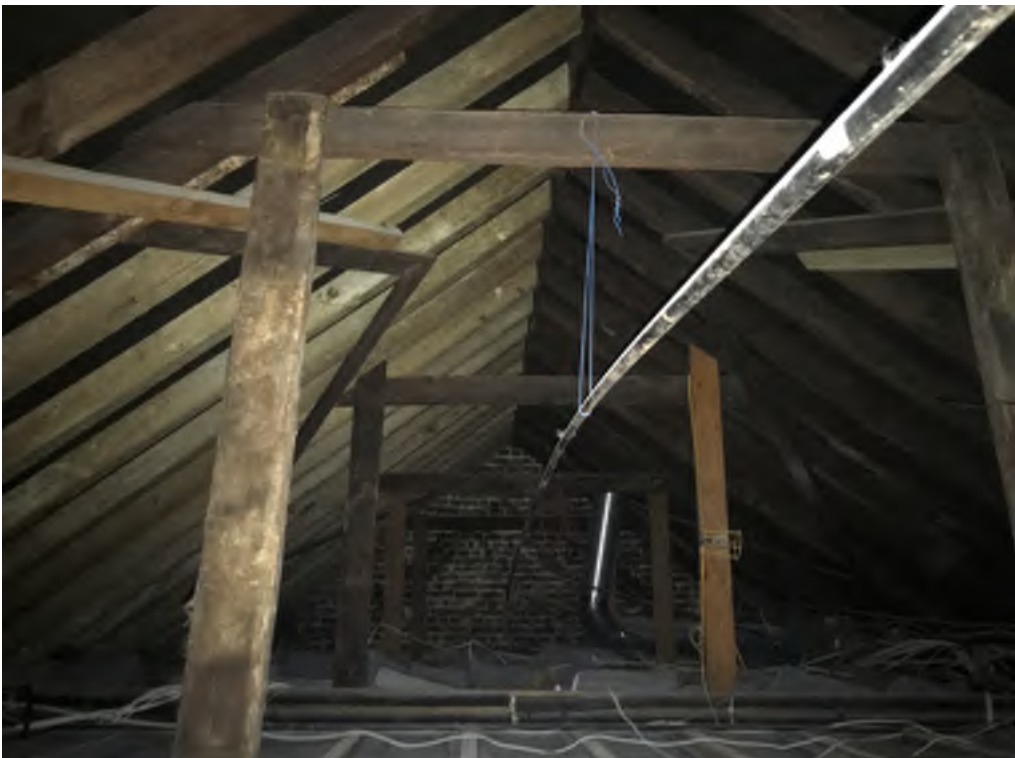
- 5.2.10 The rafters of Roof 1 meet at a ridge beam, and the large primary beams at ceiling level are supplemented by hangers and straining beams forming rudimentary queen post trusses (photographs 7 & 8). Approximately two thirds of the roof structure dates from the C19<sup>th</sup>, the remainder at the south end of the front pitch comprising C20<sup>th</sup> rafters presumably installed during the 1970s when other alterations were undertaken (see 5.2.10 below). The ceiling structure is formed entirely from C20<sup>th</sup> joists supported on the primary beams which are mostly C19<sup>th</sup> in origin, and the ceiling itself has been subjected to previous alterations resulting in the replacement of all original lath and lime/sand plasterwork with a modern C20<sup>th</sup> suspended ceiling on a proprietary framing system.

**Photograph 7:** Roof 1 view south

**Photograph 8:** Roof 1 view south

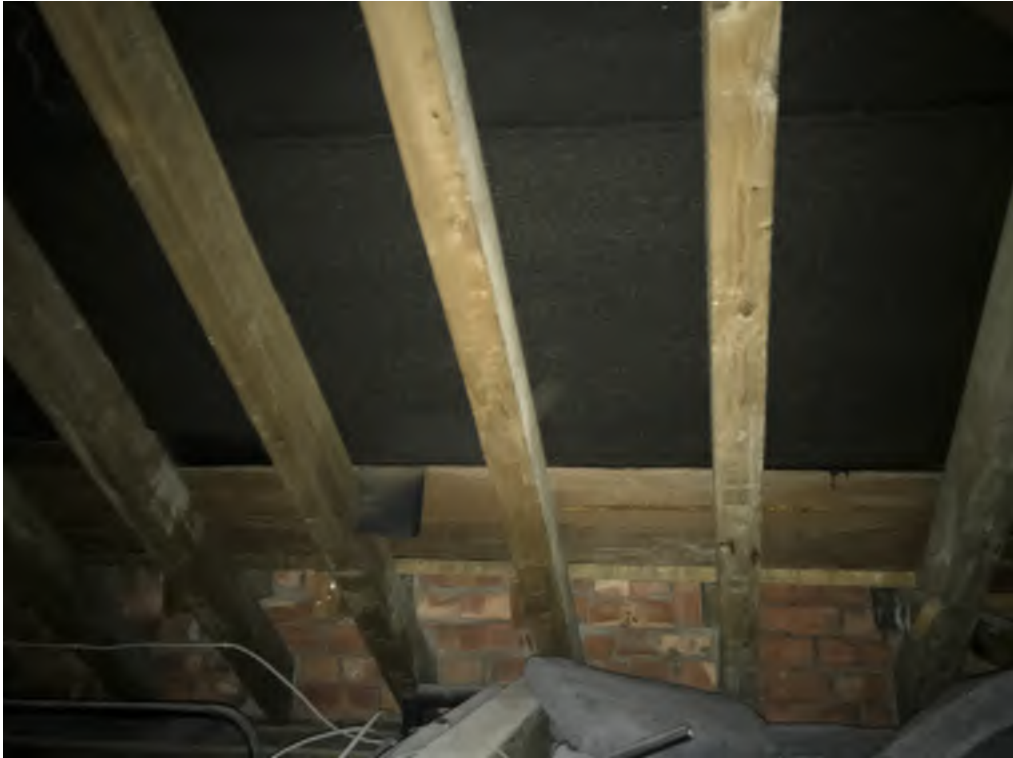
- 5.2.11 The southern half of the parapet to the front elevation has been partially rebuilt in modern brickwork, corresponding to the modern rafters at the front roof pitch (photograph 9). These interventions may relate to the position of a chimney stack and breast in this area which were removed during the 1970s roof alterations.

**Photograph 9:** Roof 1 view east

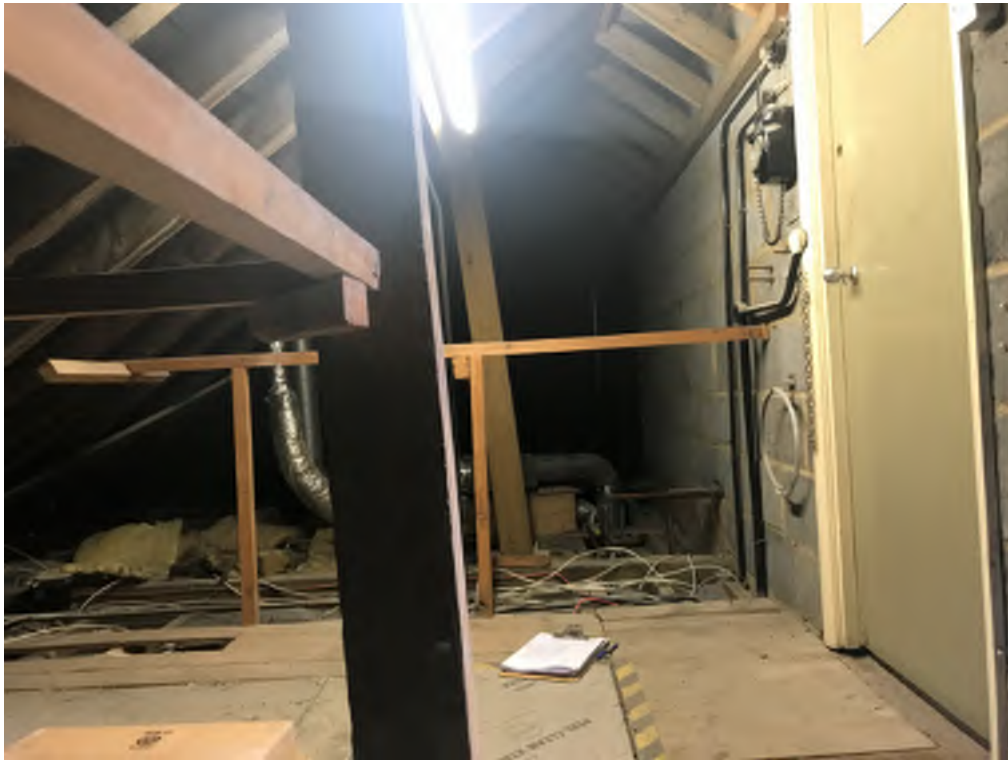
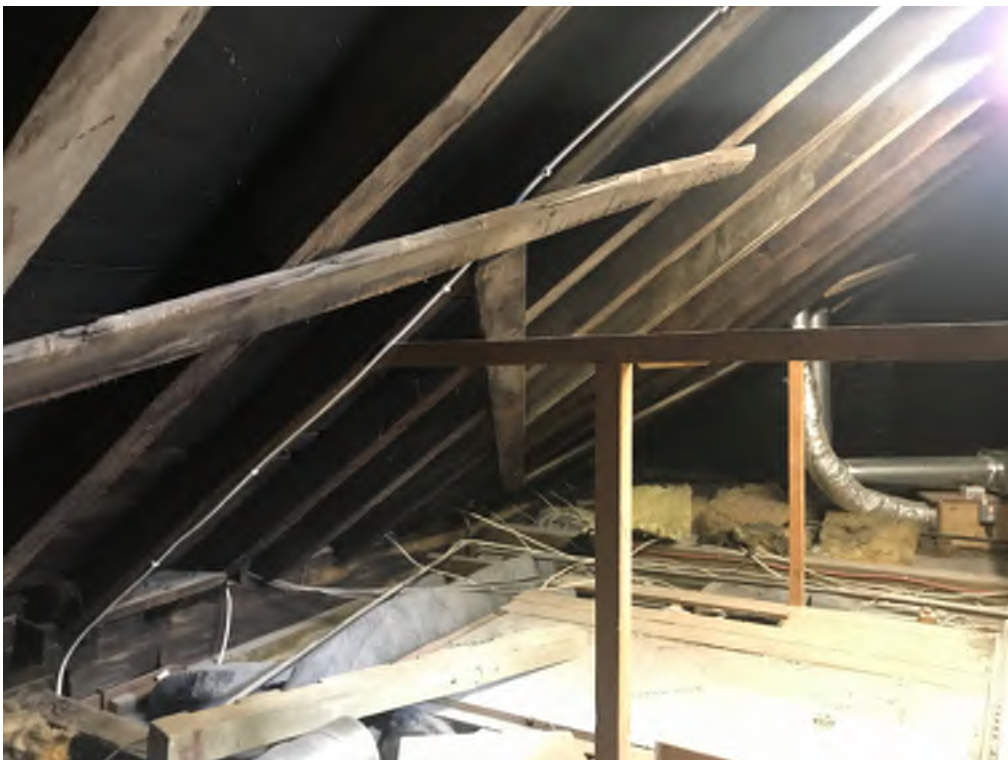
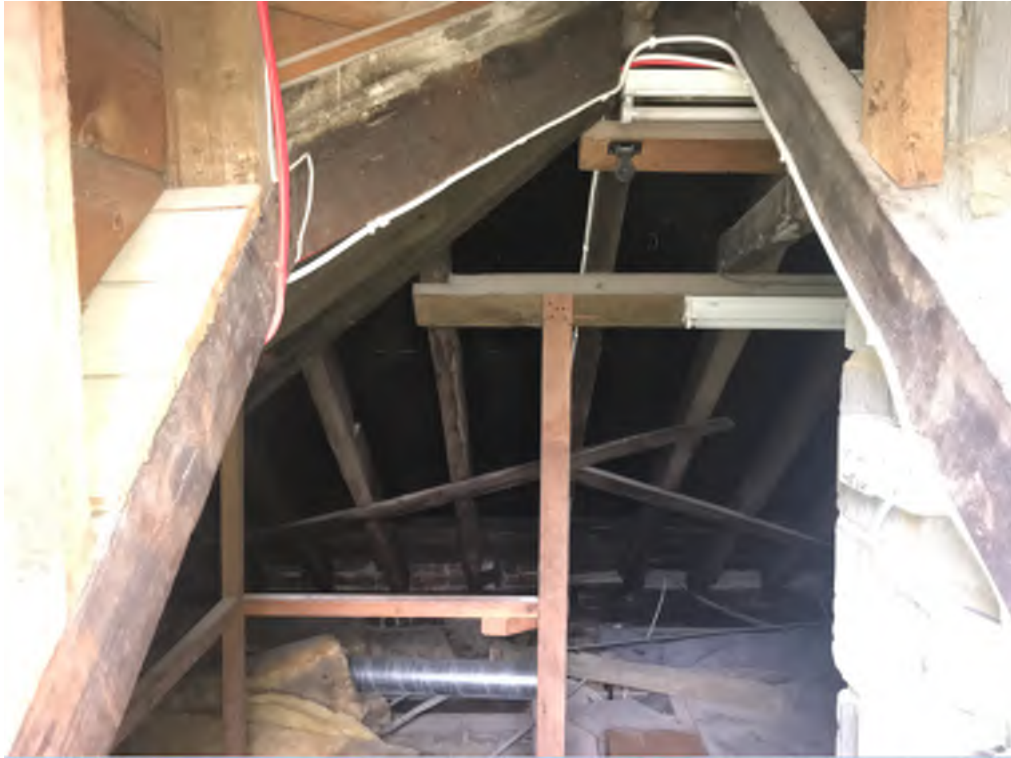
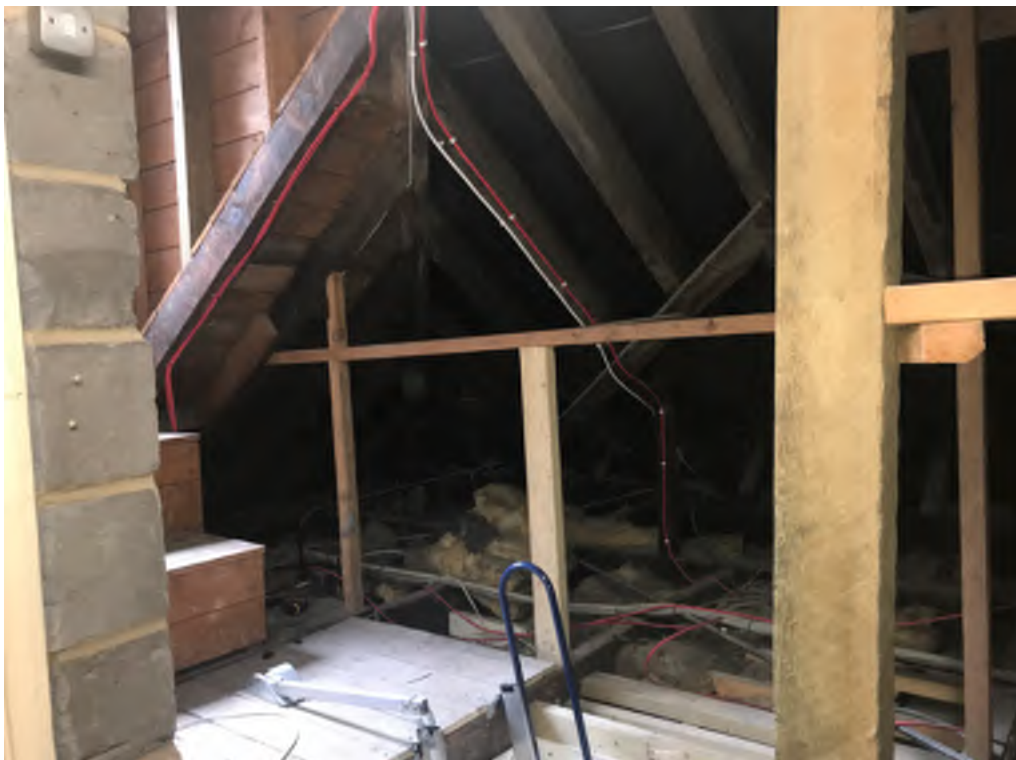
- 5.2.14 Most of the structure in Roof 3 dates from the C19<sup>th</sup> with the remainder comprising late C20<sup>th</sup> additions including the ceiling joists supported on C19<sup>th</sup> primary beams (photographs 13 to 16). However the larger primary beams located longitudinally beneath the valleys and which support the feet of common rafters in Roofs 3, 4 and 5 are of Oak and are of an earlier date, possibly late C18<sup>th</sup>. Some of these beams are provided with wrought iron straps at their interconnections to tie the beams together to prevent disengagement of their joints due to natural shrinkage and the lateral thrust applied at the rafter feet, thereby improving overall restraint and robustness. Such straps may have been installed in these locations by a diligent builder to strengthen and integrate reused older timbers or as a remedial measure to consolidate dislocated mortice and tenon joints.

**Photograph 13:** Roof 3 view north

**Photograph 14:** Roof 3 view north west

**Photograph 15:** Roof 3 view west

**Photograph 16:** Roof 3 view south east

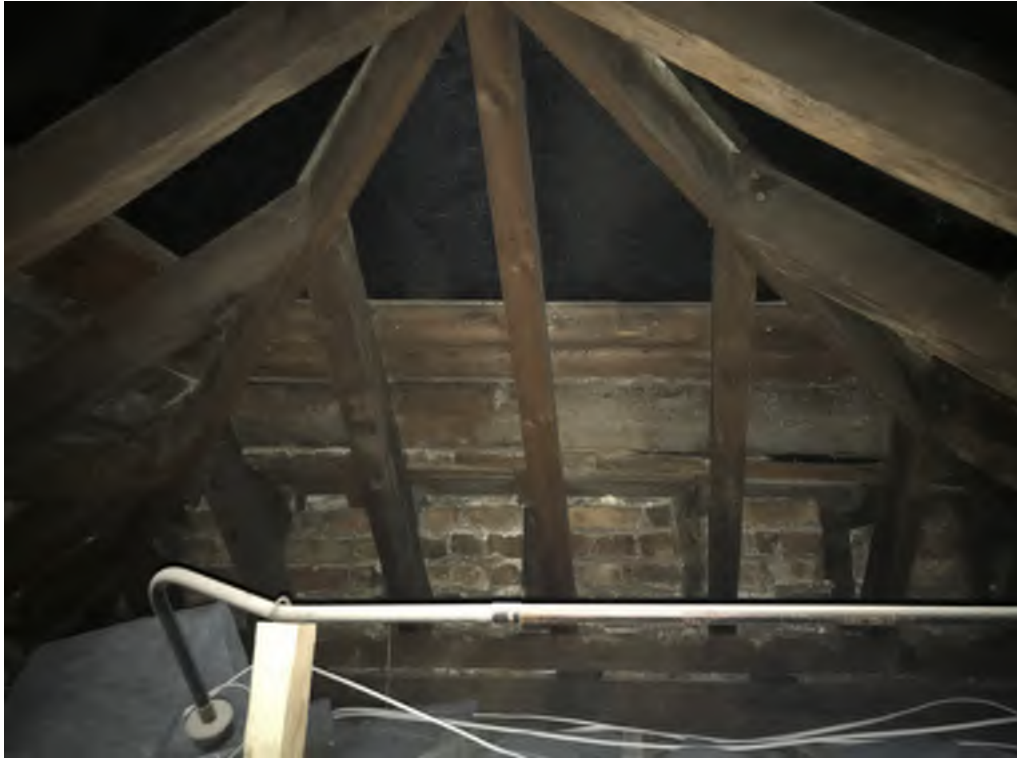
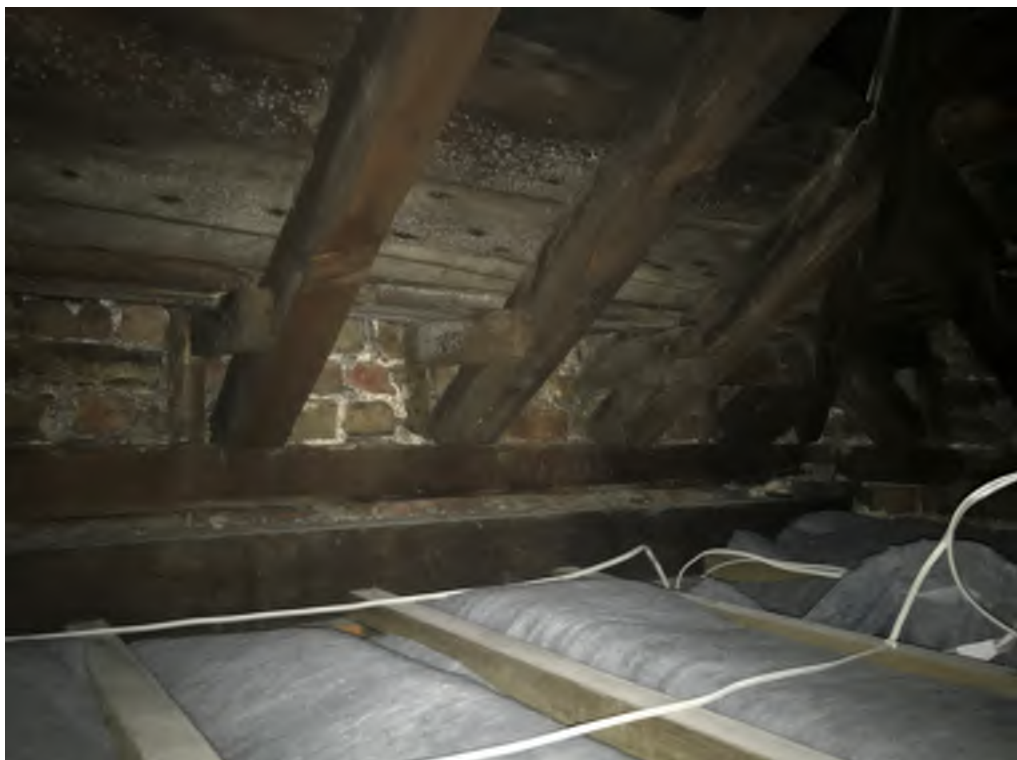
- 5.2.22 The construction of Roof 5 is similar to Roof 4, comprising C19<sup>th</sup> rafters and C20<sup>th</sup> ceiling joists supported on C19<sup>th</sup> primary beams (photographs 23 & 24). The ceiling below Roof 5 has been subjected to previous alterations resulting in the replacement of all of the original lath and lime/sand plasterwork with a modern C20<sup>th</sup> suspended ceiling on a proprietary framing system.

**Photograph 23:** Roof 5 view north

**Photograph 24:** Roof 5 view west
