42 Bedford Square

*Proposed External Cleaning to
13 Bedford Avenue
August 2020*

Rev A 18th August 2020, Introduction updated

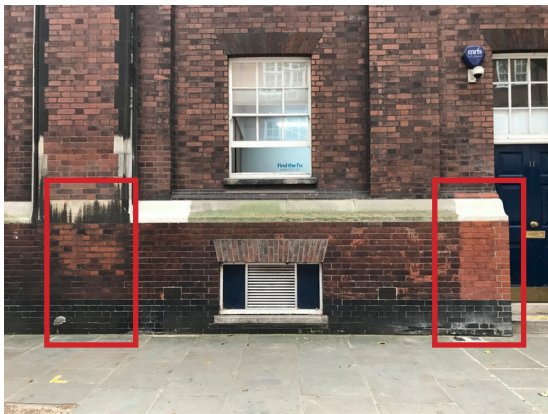
**11 Bedford Avenue
Sample Areas**

Two cleaning options were proposed in order to determine the most appropriate cleaning method. Cleaning trials were carried out on the neighbouring property, 11 Bedford Avenue. Completed trials used the TORC/ JOS and DOFF cleaning methods are shown in the adjacent images.

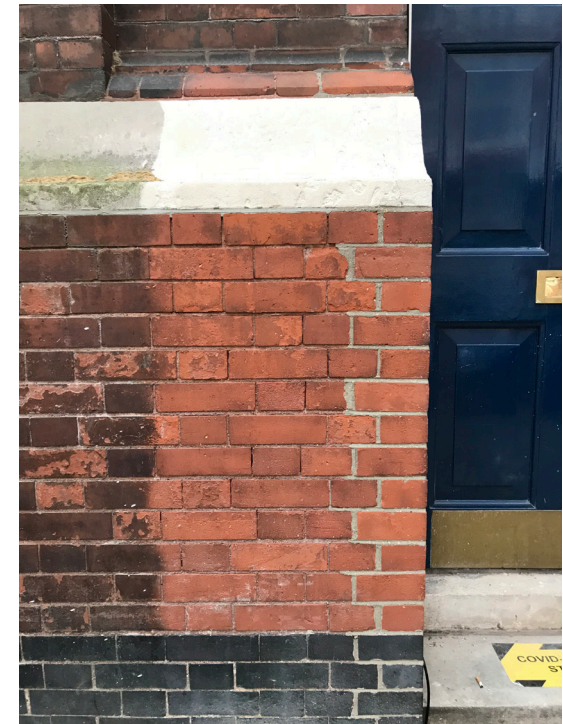
**Wet Abrasion Cleaning System:
TORC/ JOS**

The results indicate that the wet air-abrasion TORC/JOS cleaning sample is the most appropriate. Therefore this method is proposed. Nozzles and pressures to be as sample clean. Heavily soiled areas to be reviewed after initial clean to agree if further cleaning is required.

Prior to cleaning, loosely adhered deposits and growths to be removed using suitable corrosion resistant brushes with copper bristles, and scrapers/ spatulas that do not abrade or gouge the surface.
