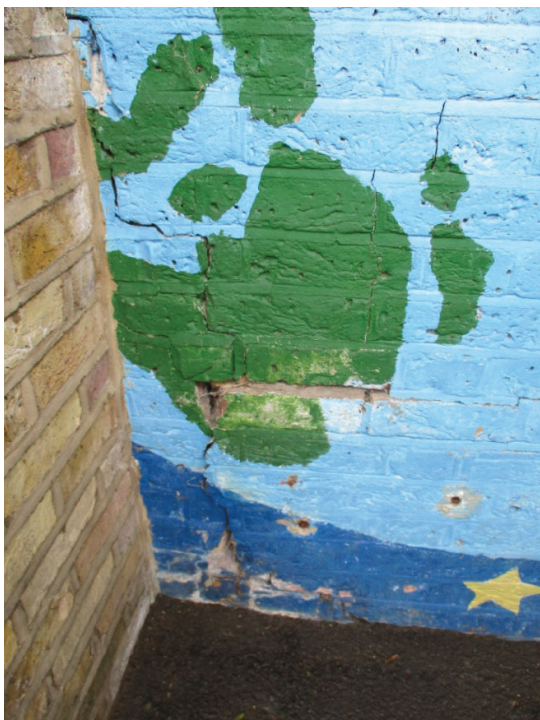
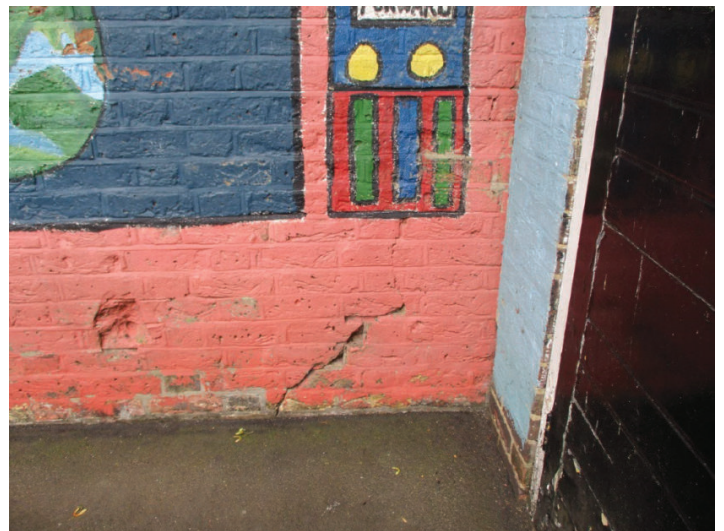
8.0 The wall has had remedial work in the past with signs of repointing, but has continued to move over time and has cracked in places. An elevation sketch of the wall is shown below:
