# Arboricultural Appraisal Report

Impact Assessment & Method Statement to Inform Development

39 Maresfield Gardens  
London  
NW3 5SG

CLIENT:	Schneider Designers
MWA REF:	DEV200814-558
MWA CONSULTANT:	Mark Bisley <small>BSc Hons</small>
REPORT DATE:	04-09-2020

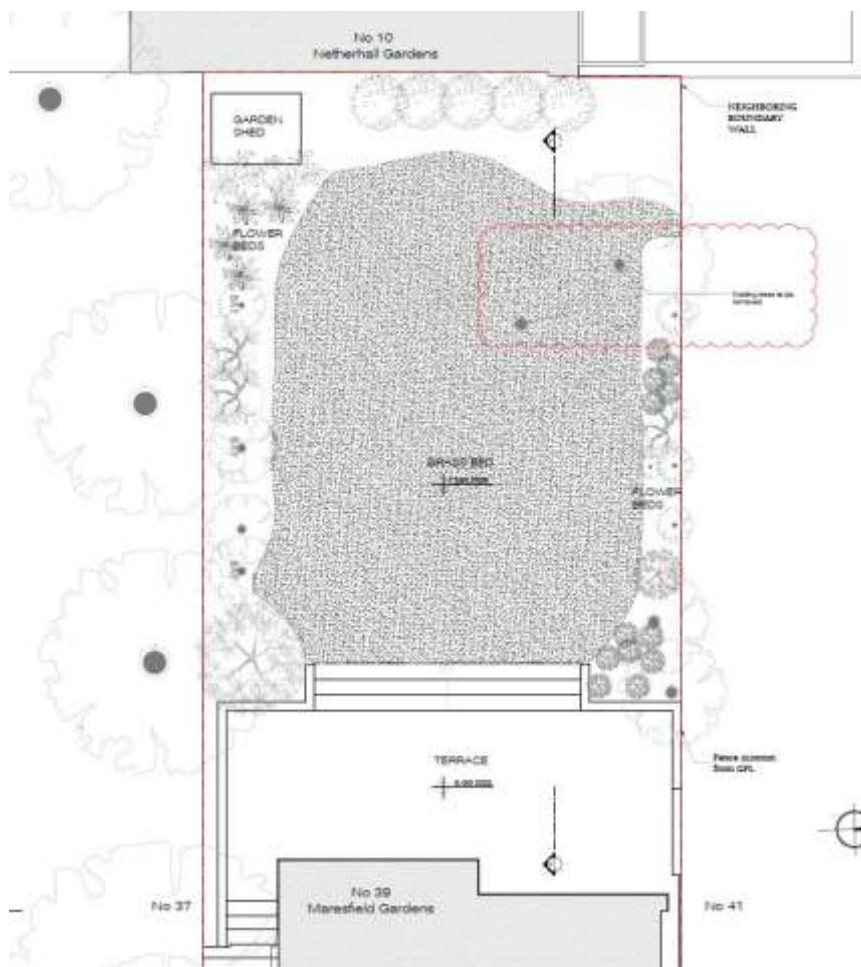
**Figure 1: Existing Situation**

- 6.1 The site is located to the north of Maresfield Road in a largely residential area. The site is approximately level and adjacent land generally matches the onsite topography.
- 6.2 The front garden has been paved and is used for car parking.
- 6.3 The rear garden includes a lower section of hard landscaping adjacent to the dwelling to allow access from the lower ground floor flat. Steps allow access to the rest of the rear garden.
- 6.4 A single wooden shed is currently present to the rear left of the garden.

- 6.5 A single tree is present in the front garden and has been lifted to clear parking below and pollarded in the past.

- 
- 6.6 The rear garden contains few trees with most being relatively small and therefore primarily visible for only short distances. A false acacia is present which does exceed 10m in height, but this tree has old fire damage on the stem to a height of 2m, has been crown reduced in the past and has been cut back to the boundary by the neighbour so is not likely to gain significant additional size under existing management.

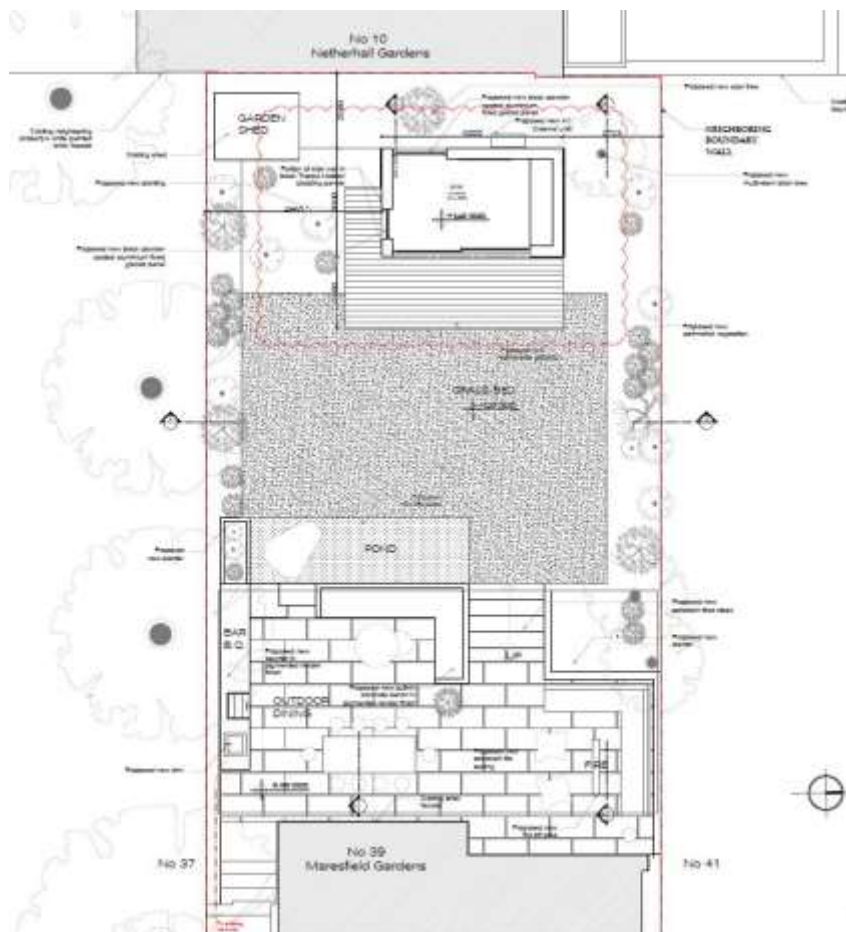
**Figure 2: Proposed Situation**

- 7.1 The proposed development will entail the construction of a new outbuilding in the rear garden and revisions to existing hard and soft landscaping.
