Window Survey Report

26a Rosslyn Hill, London, NW3 1PD

On behalf of Ridge & Partners LLP

Stride Treglown job no.	152565
Prepared by	Stephen James
Checked by	Chris Kemp
Date	15.04.19
Revision	A

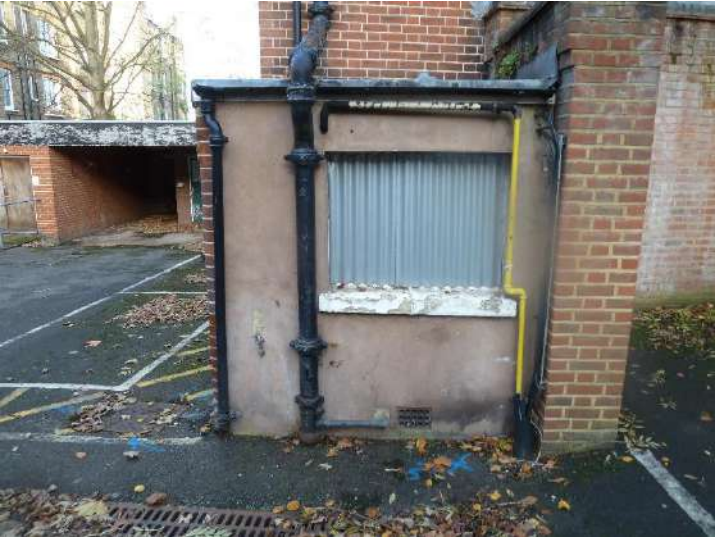
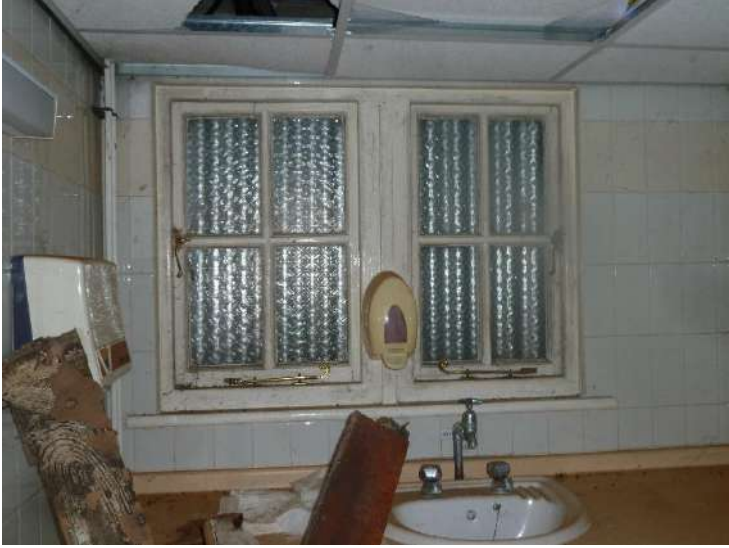
W140 (a)	W140 (b)

Ref.	Location	Description	Condition	Recommended Remedial Works	Photo Ref.
		Approx. Size: 1.26m x 1.77m Approx. Sill height: 0.98m		weights. Install replacement pulley linings on completion. <ul style="list-style-type: none"> • Replace 1no. cracked pane. • Allow to replace sash fastener. 	
W139	Courtyard	Casement windows with a painted timber construction featuring single glazing.	<ul style="list-style-type: none"> • Worn paint decoration and bare timber along glazing bars and window frames. • External flaking paint decoration. 	<ul style="list-style-type: none"> • Rub down, prime and redecorate all joinery inside and out. 	W139(a) – W139(d)
W140	South Elevation	Two casement windows with a painted timber construction featuring single textured glazing. Brass window stays and casement hooks fitted to the interior.	<ul style="list-style-type: none"> • The exterior is temporarily boarded over by a corrugated steel sheet. • Cracked external sill and flaking paint decoration. • Fixing holes in frame. • Glazing intact. • Window furniture has a new appearance. 	<ul style="list-style-type: none"> • Fill screw holes with a wood filler. • Undertake epoxy repairs to the cracked concrete sill and redecorate. • Rub down and redecorate the external joinery. 	W140(a) – W140(b)
