## Visit Report

07 February 2014

16, Downside Crescent  
London  
NW3 2AP

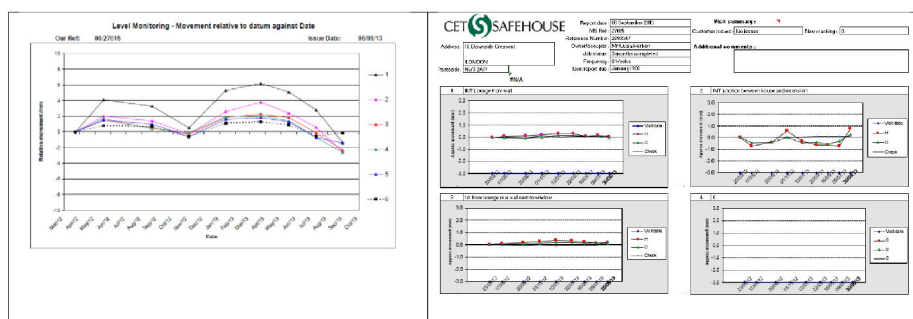
In addition a programme of crack width monitoring was undertaken incorporating the cracking to the internal cross wall between the ground floor front bedroom and rear lounge, a crack adjacent to the first floor bedroom window together with the vertical crack between the rear extension and the main building. The monitoring of the cracking to the internal cross wall and within the rear first floor bedroom has not demonstrated any significant progression, whereas the crack between the main building and rear extension has shown a pattern of cyclical movement with the crack opening during the summer and closing over the winter.

It would therefore appear that it is only the rear single storey extension that continues to be affected as a result of vegetation related subsidence.
