Arboricultural Appraisal Report

Subsidence Damage Investigation at:

1C Spencer Rise
London
NW5 1AR

CLIENT: Crawford & Company
CLIENT REF: [REDACTED]
MWA REF: [REDACTED]
MWA CONSULTANT: Andy Clark
REPORT DATE: 02/09/2020

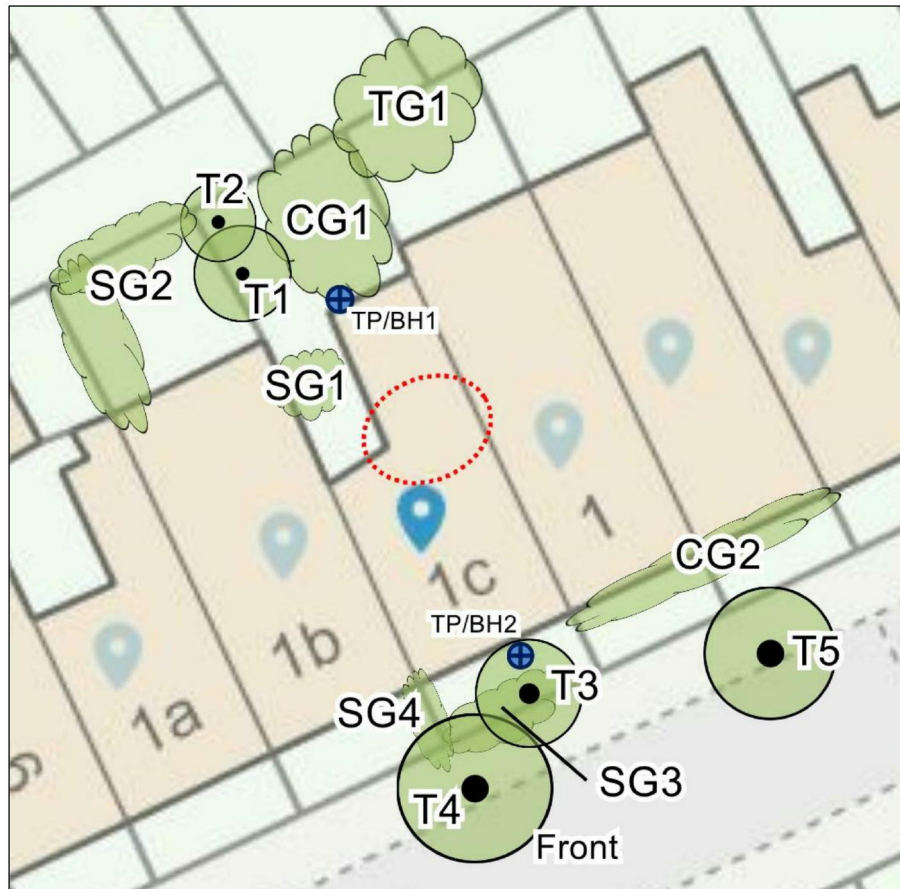
Site Plan

Irrespective of the identification of recovered root samples, the roots of the T1 Ceanothus and the SG1 shrub group at the rear will also be present below the foundations of the rear projection and influencing soil moisture and volumes.
