APPENDIX 3: DRYING OUT WORKS- SCOPE AND EXTENT OF WORKS

Site Note 7: Preliminary Damp Condition Investigation (Masonry)- March 2020

Site Note 7: Preliminary Damp Condition Investigation (Masonry)

The Hope Project (KOKO): Phase 1 of the preliminary damp condition Investigation

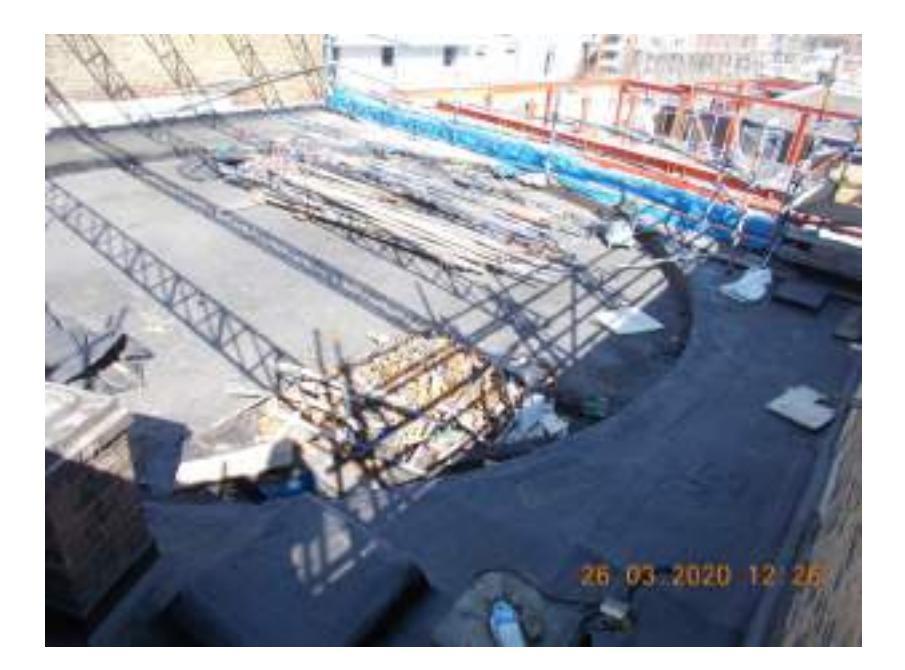
Fig 1:

Roof scape at west end; showing roof coverings above the main auditorium, with new poured liquid waterproof membrane covering

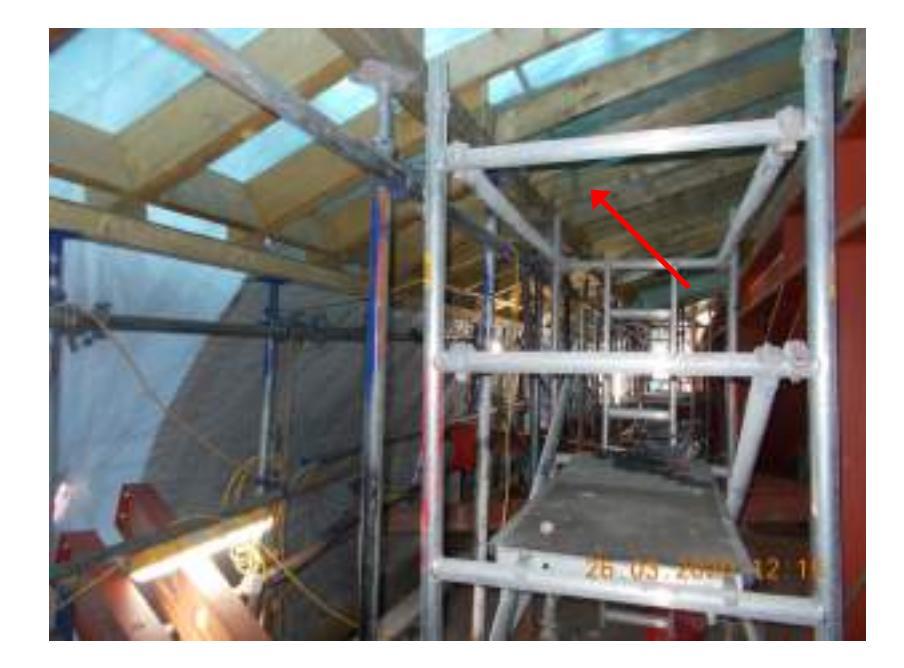
Fig 2:

Roof to east of auditorium; showing typical temporary roof coverings over the west area of the auditorium roof and adjacent to the fire damaged dome floor structure during works

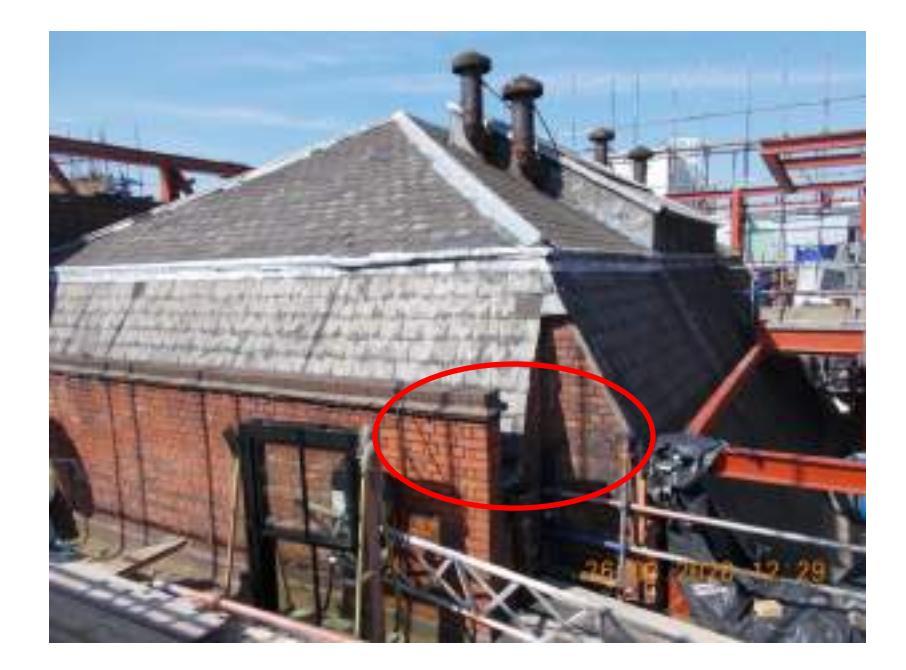
Fig 3:

Retained structures at roof level; showing vulnerable parapet gutter to the south of RM.SB-04 vulnerable to blockage and overcharging

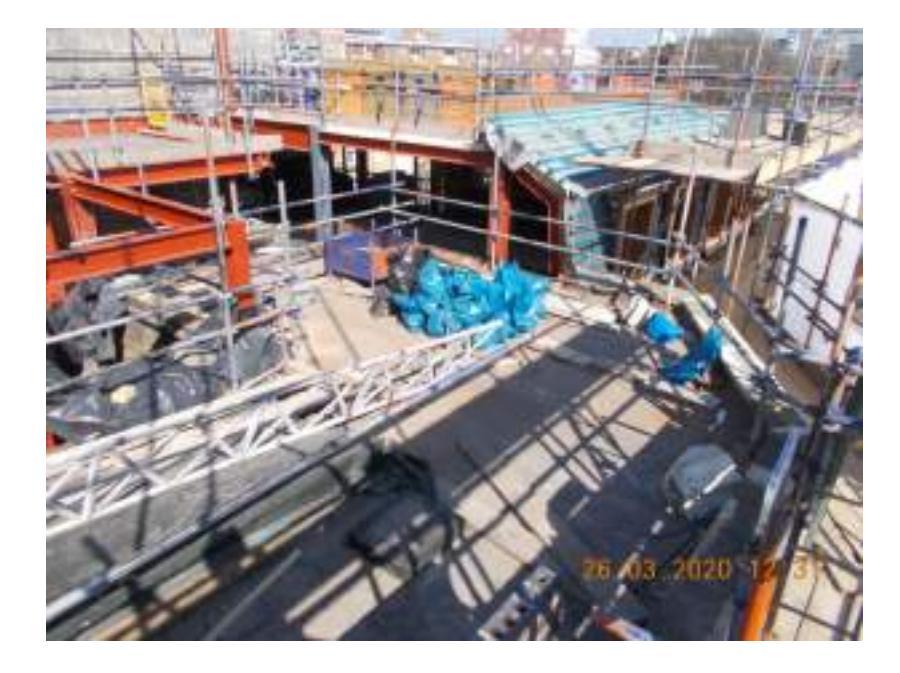
Fig 4:

Roofscape, east end, looking east; showing general arrangement of newly constructed roof structures prior to introduction of temporary roof

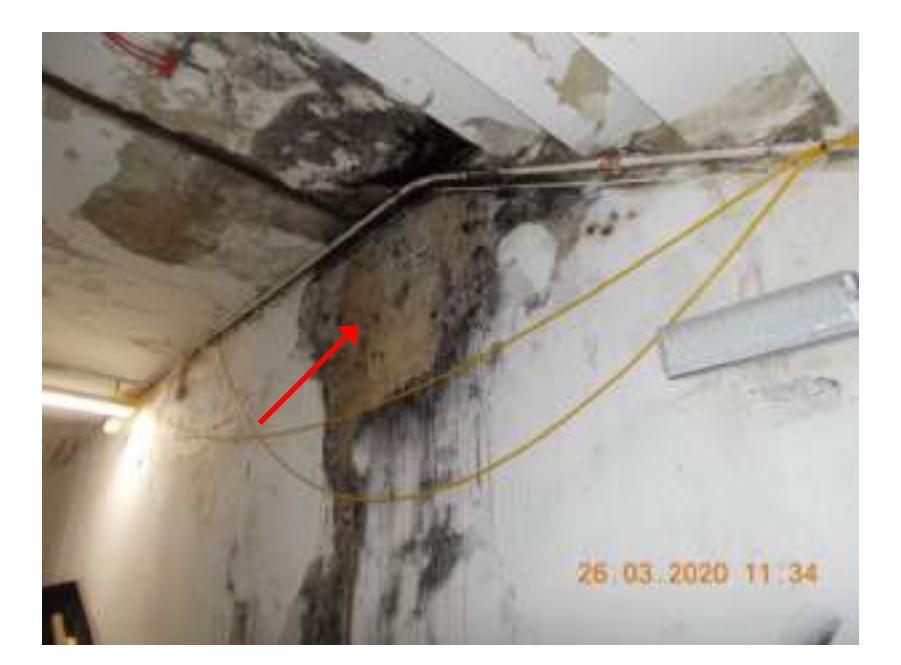
Fig 5:

Interior, escape stair on north side, RM.2-24; showing damage to wall and ceiling structures where recent water penetration had drained through the soffit from roof level and exasperated/ accelerated conditions for decay

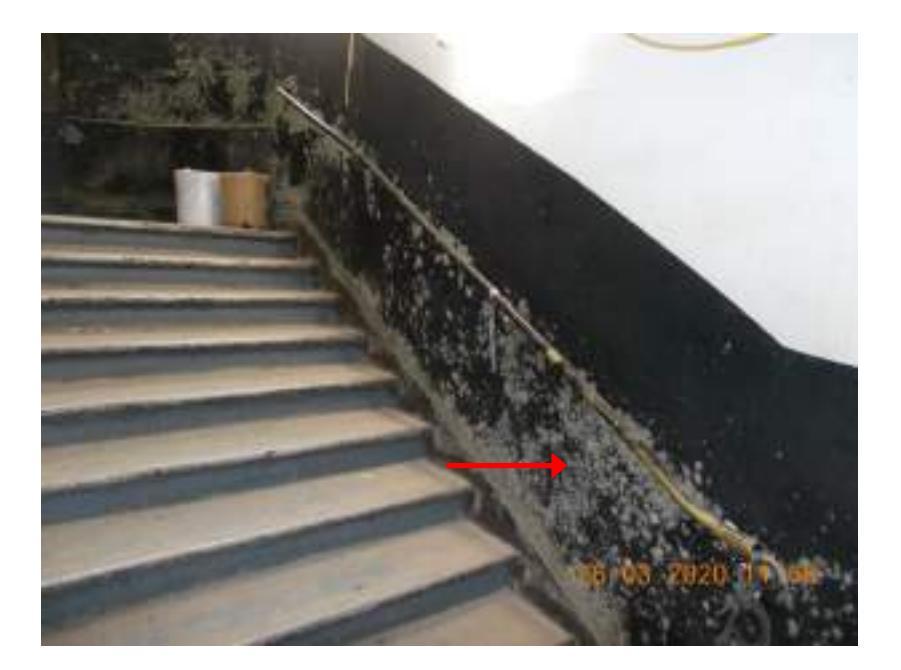
Fig 7:

First floor escape stair on south side, accessed from RM.1-10; showing surface mould growth sustained by enhanced humidity and restricted through ventilation exasperated by the retained moisture within the fabric of the property from the recent substantial water penetration

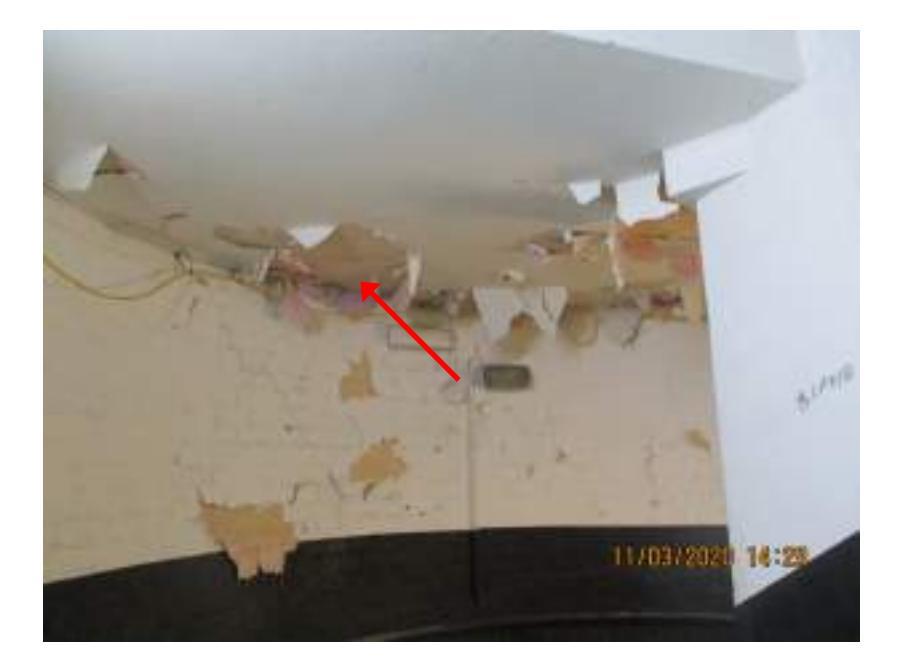
Fig 9:

Escape stair, north side, RM.G-24; showing typical failure of impermeable paint finishes following recent chronic intermittent condensation

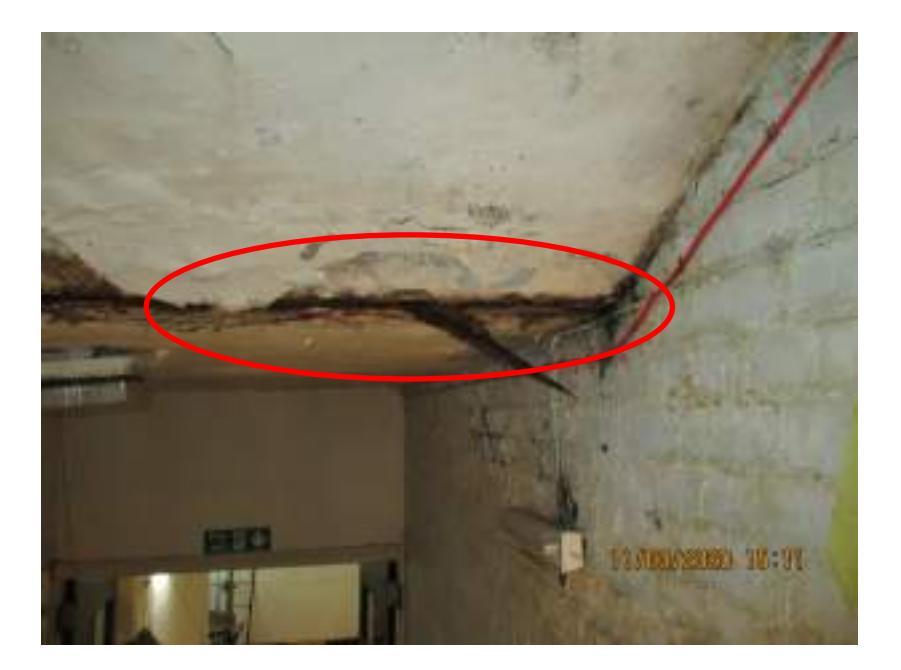
Fig 11:

Escape stair at ground floor level on south side, RM.G-07; showing historic corrosion of embedded steel structure and salt efflorescence damage to ceiling and wall finishes now substantially exasperated and accelerated by recent fire related moisture penetration

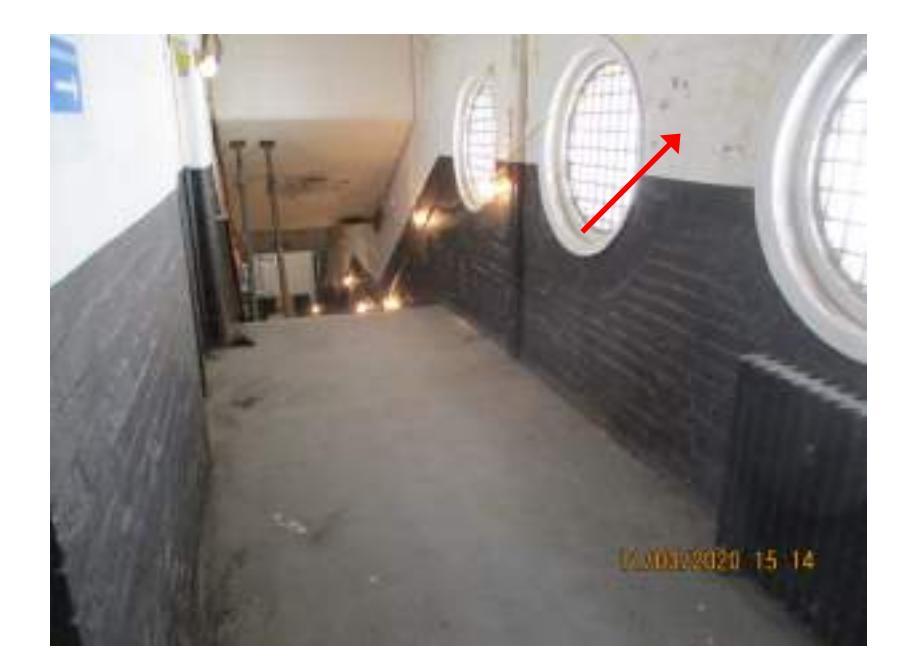
Fig 13:

Head of escape stair on south side, RM.3-17; showing salt damage to paint finishes focussed on brickwork joints to external wall

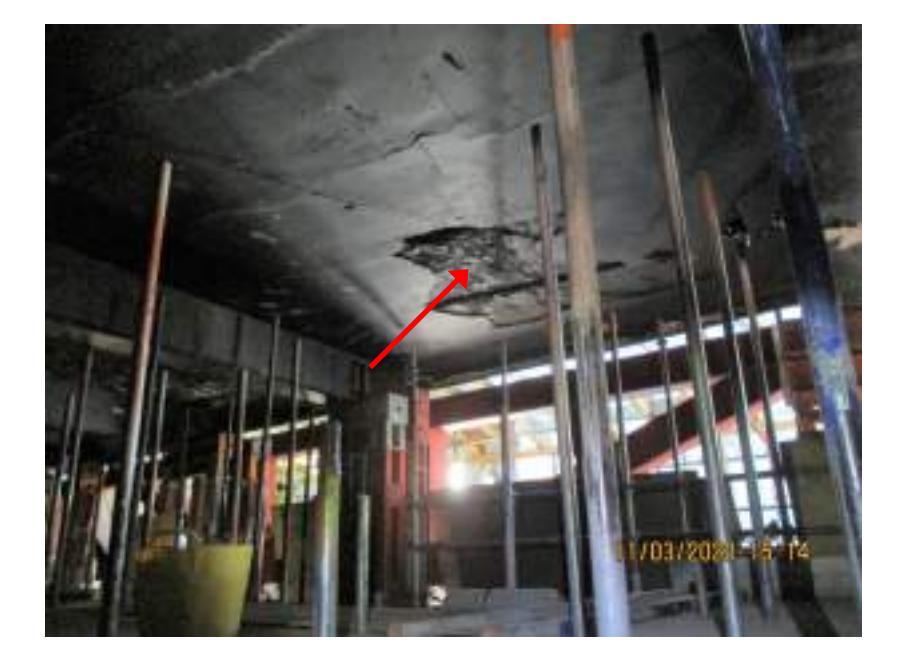
Fig 14:

Third floor balcony, RM.3-13; showing failure of plaster finishes where chronic fire related water penetration had drained through the structure from above

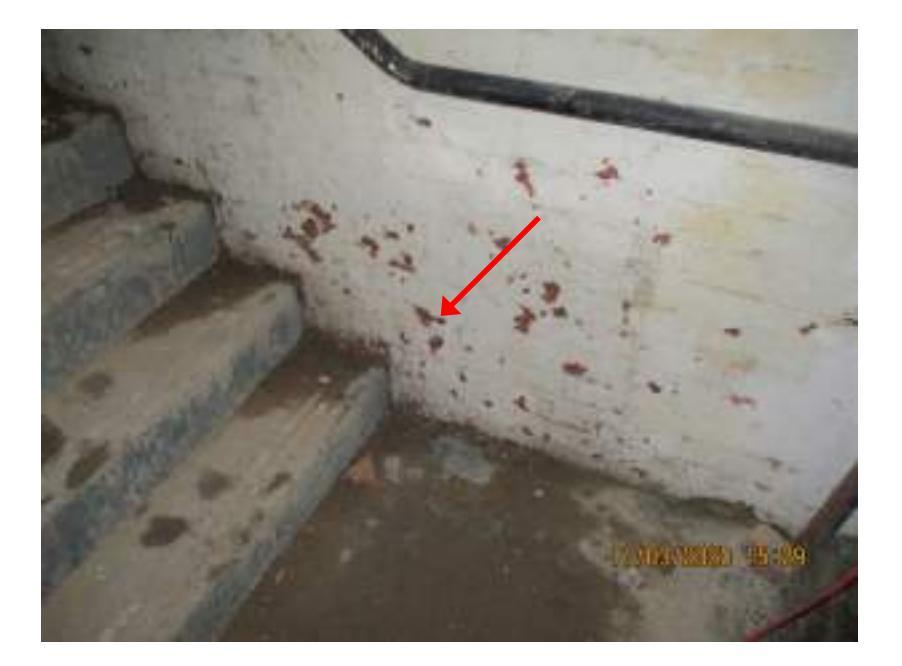
Fig 15:

Basement, east side, RM.B-18; showing persistently damp conditions at low level where recent moisture penetration had collected/migrated at lower levels

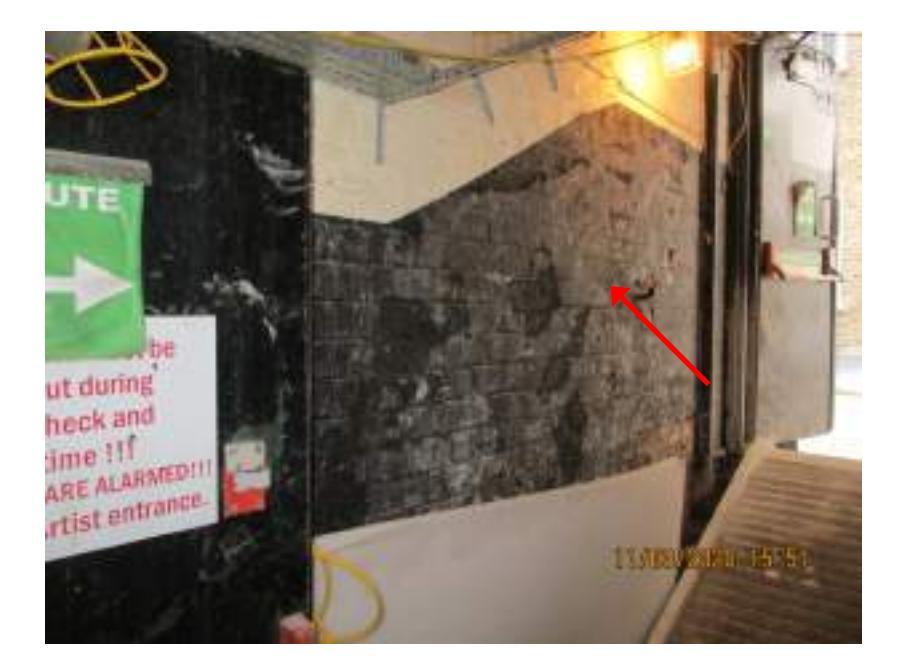
Fig 17:

Escape and service corridor on ground floor north side, DG-18; showing surface efflorescence of hygroscopic salts in areas that also show high residual moisture contents in brickwork. Area highly likely to be exasperated by negative conditions brought on by migrating moisture from the recent fire related water penetration

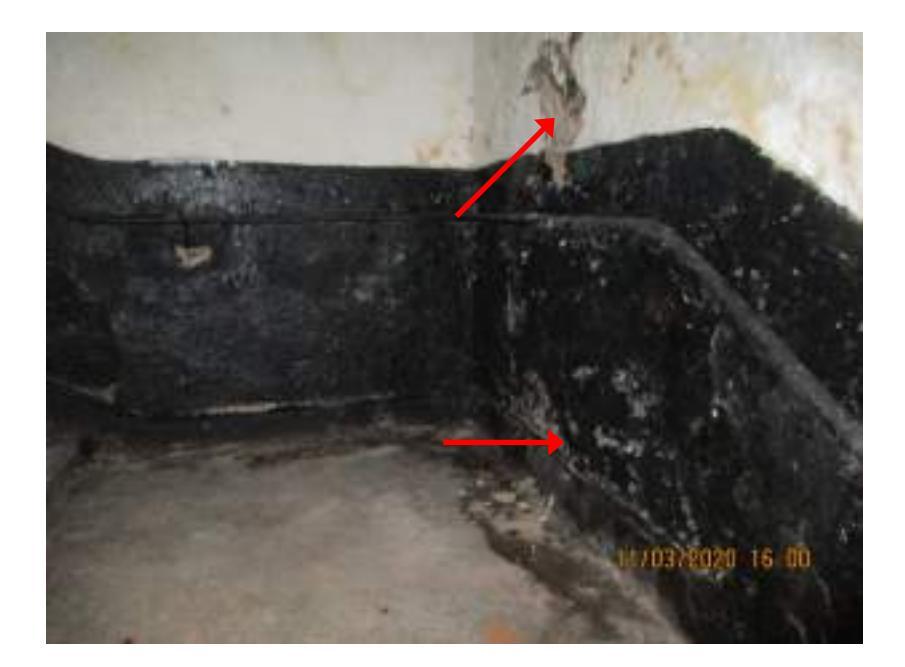
Fig 19:

Fire escape on north side, RM.B-40; showing salt and water damage to impermeable paint finishes trapping moisture within the masonry elements subject to chronic recent moisture penetration

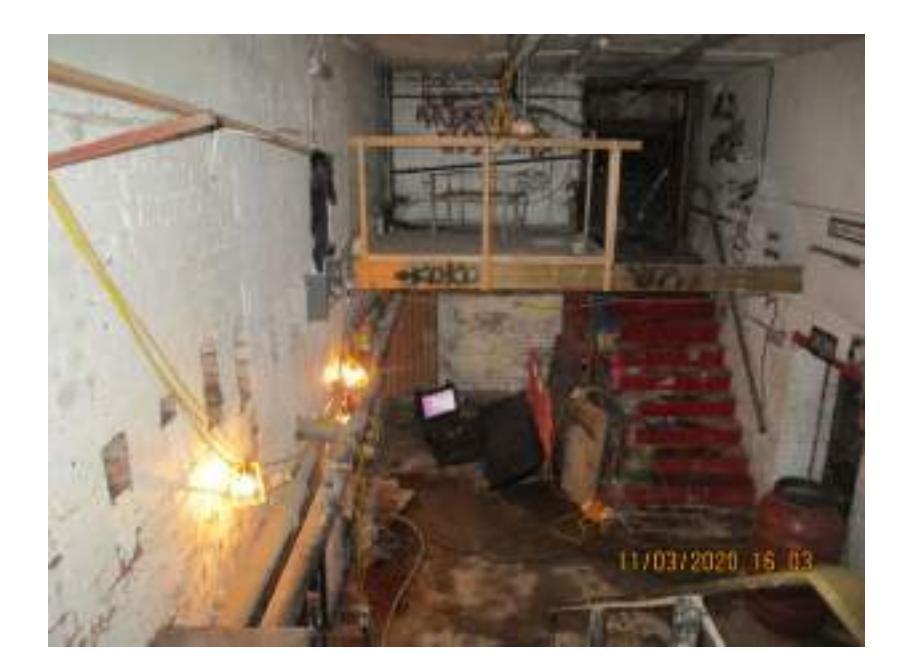
Fig 21:

Lower basement, north side, RM.SB-11; showing generally damp conditions around structures at low level. However no active decay organisms detected

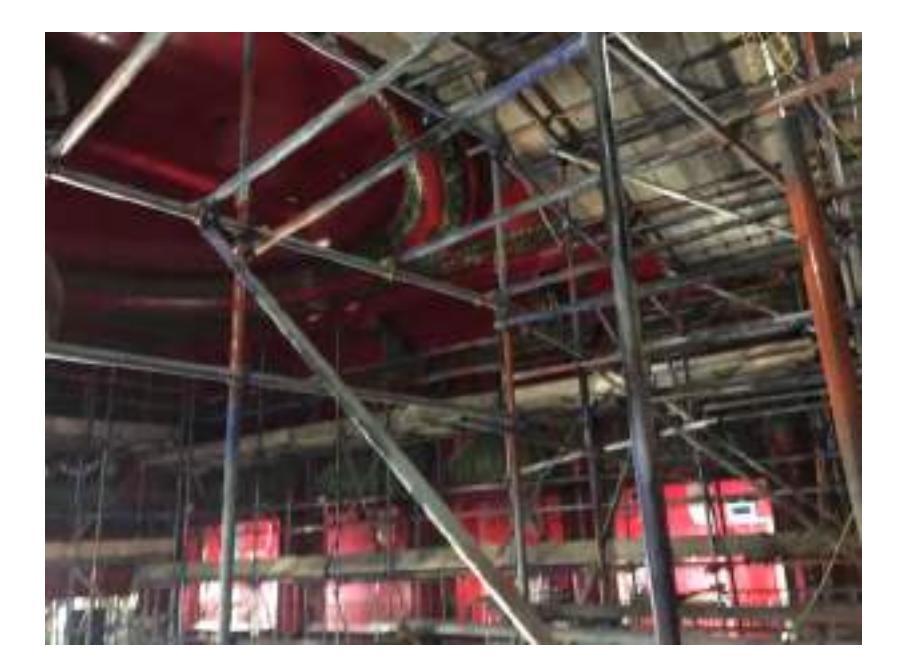
Fig 1:

Auditorium ceiling structures; showing general view from below looking south. Note west area inaccessible from below and supported with scaffold structures, historic plaster understood to be severely damaged to this area

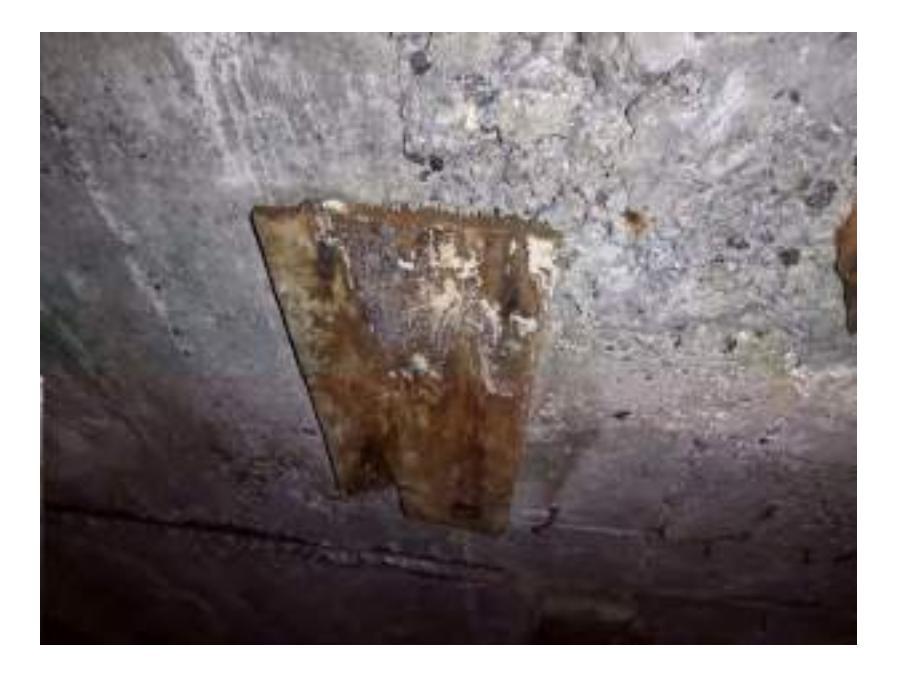
Fig 4:

Auditorium ceiling structures; showing typical image of what appears to be original former board section to solid roof structure above, still in place and subject to decay

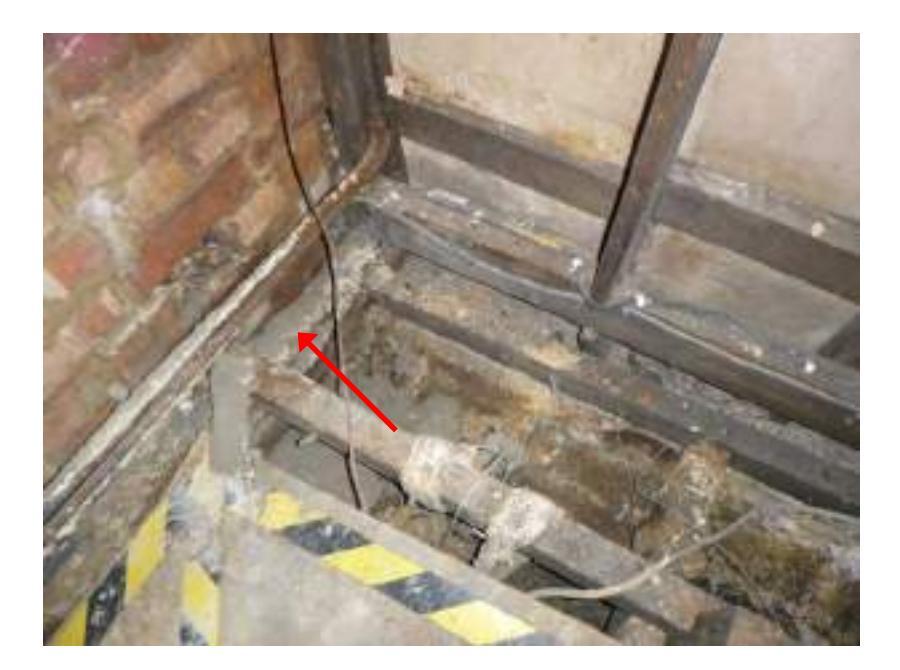
Fig 5:

Auditorium ceiling structures; showing south-west corner where area had been exposed to chronic moisture penetration. Note south wall plate partly embedded and concealed by loose building debris and vulnerable to decay

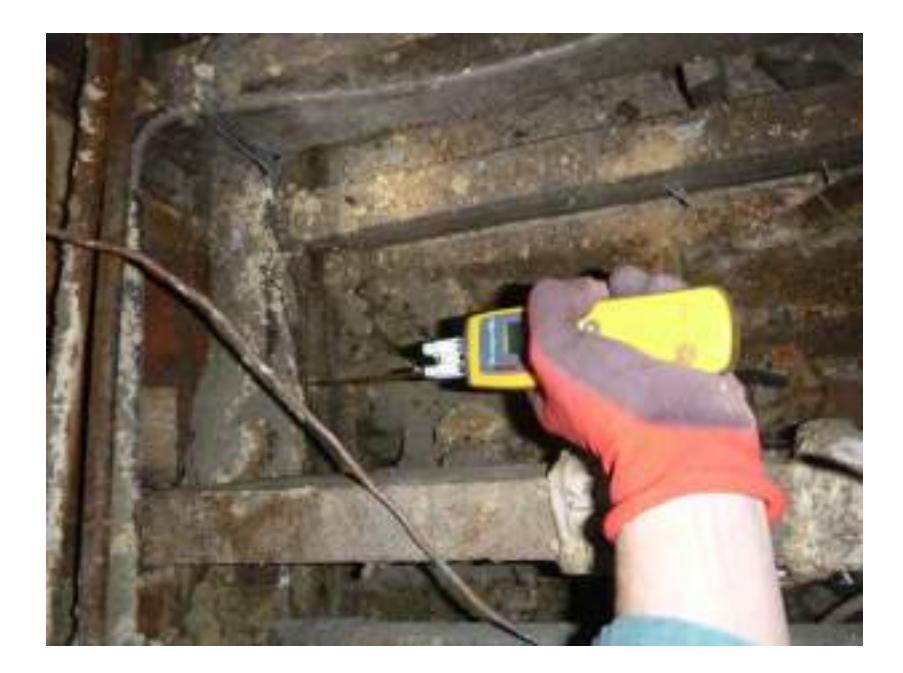
Fig 7:

Auditorium ceiling structures; showing south-west partially embedded wall plate with a raised deep moisture content of ~16 per cent

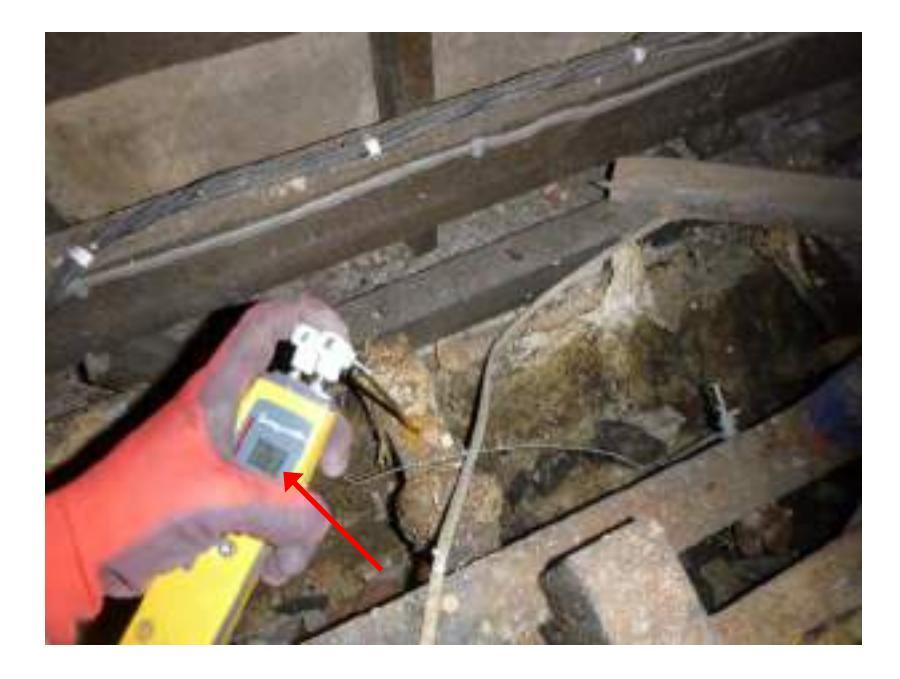
Fig 10:

Auditorium ceiling structures; showing deep moisture content reading of noggin, plaster joist elements raised at ~18 per cent

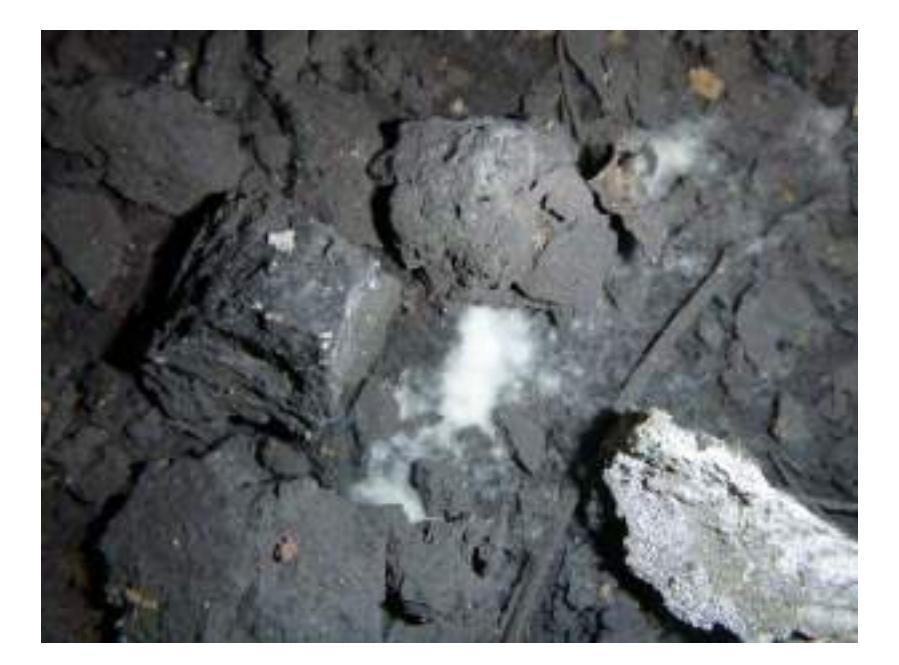
Fig 11:

Auditorium ceiling structures; showing west area with visible mould growth suggestive of damp plaster. If left unchecked this may lead to severe plaster fungus

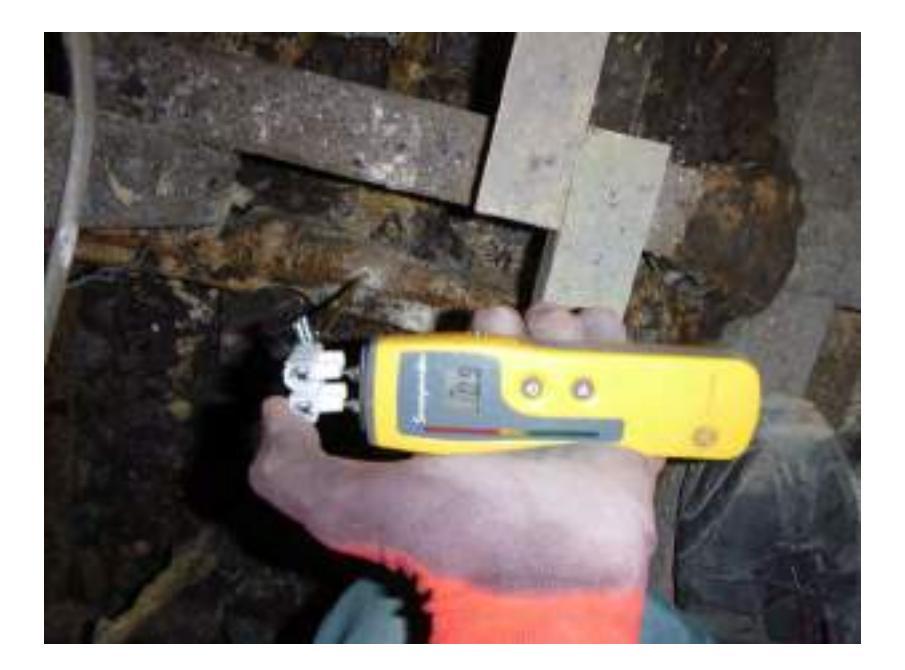
Fig 13:

Auditorium ceiling structures; showing deep moisture content of west elevation plaster retaining batten concealed with a reinforced plaster and hessian mesh. Timber reading dry at ~11%

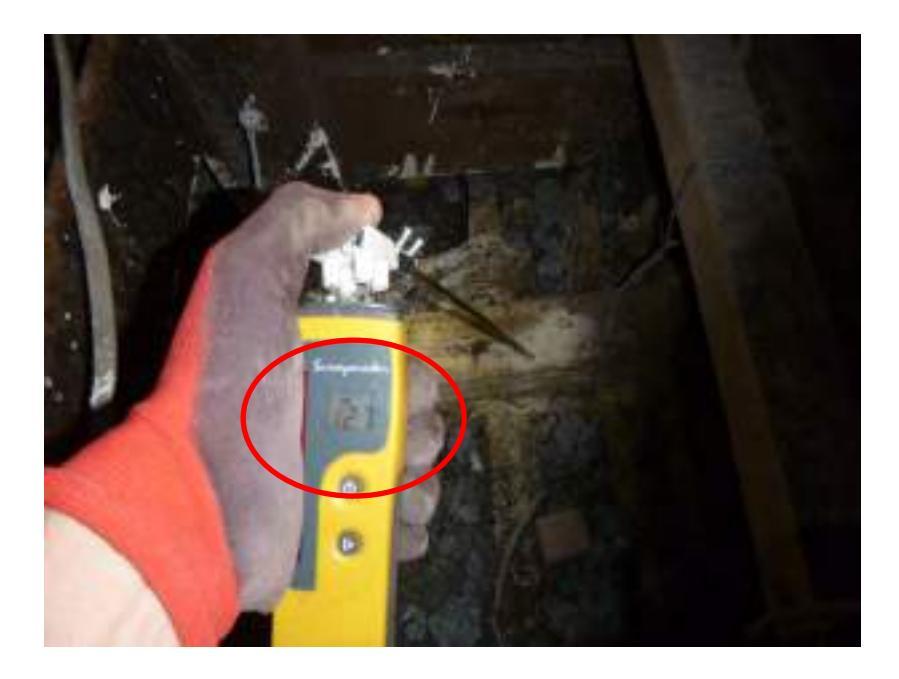
Fig 15:

Auditorium ceiling structures; showing deep moisture content of west elevation plaster retaining batten concealed with a reinforced plaster and hessian mesh. Timber reading dry at ~13%

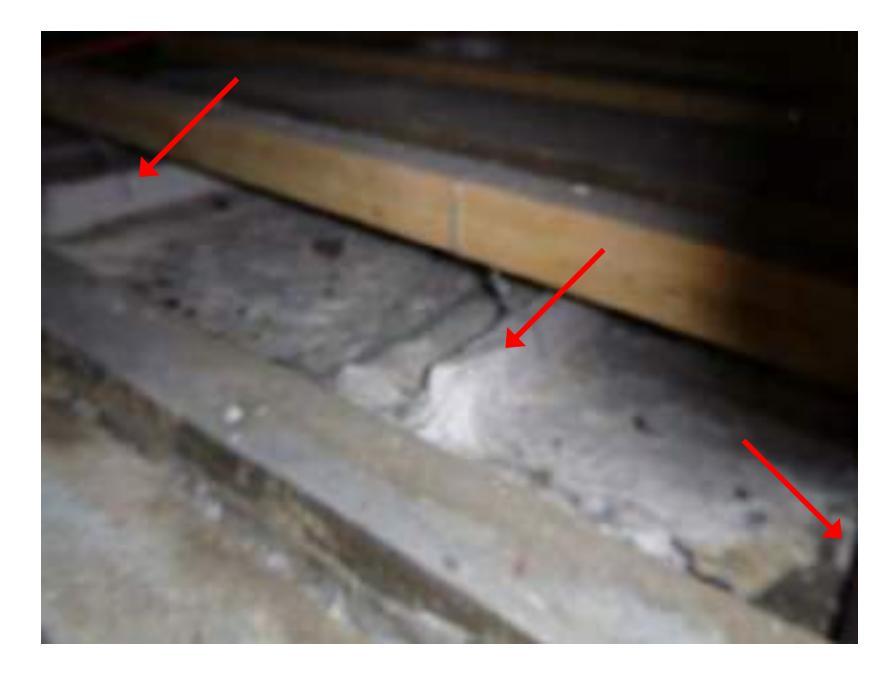
Fig 16:

Auditorium ceiling structures; showing typical detail of recently repaired plaster battens concealed with a reinforced plaster and hessian mesh which may hinder the drying of any entrapped moisture

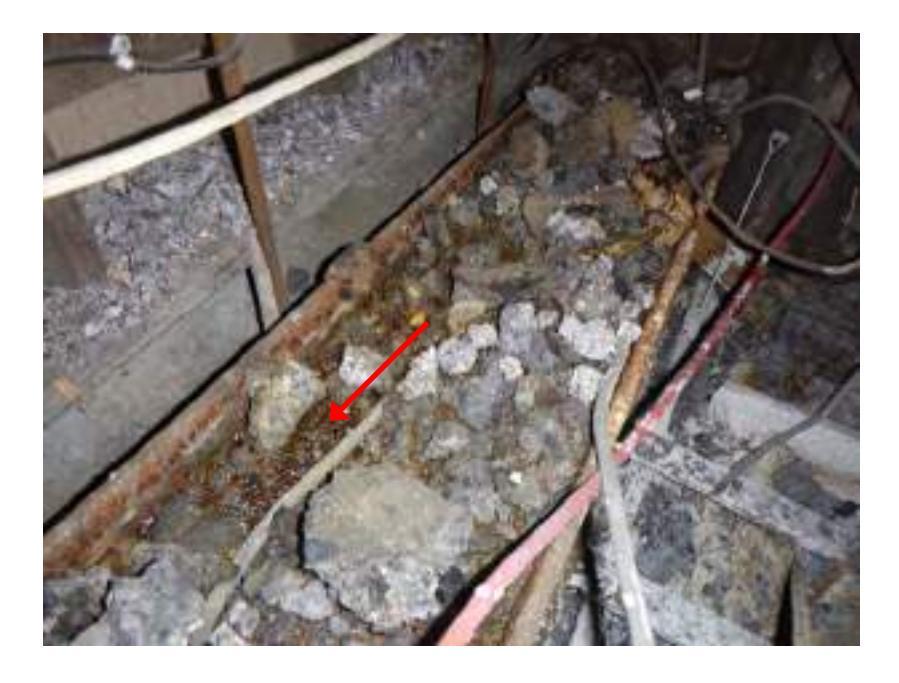
Fig 18:

Auditorium ceiling structures; showing typical detail of top face of suspended RSJ with significant debris trapping moisture and subject to continuing corrosion

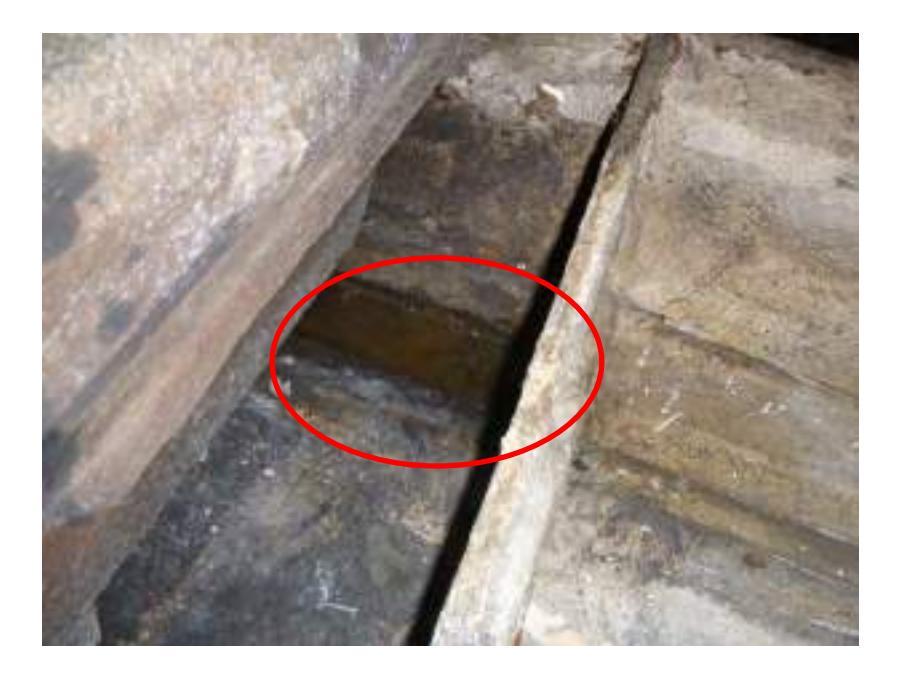
Fig 20:

Auditorium ceiling structures; showing area of ponding water beneath ineffective leak containing tray at northwest area over-spilling onto vulnerable plaster and timber elements beneath and causing the conditions for damp and decay. Leak judged to be still active to this area. All timbers showing high surface and deep moisture contents to this area

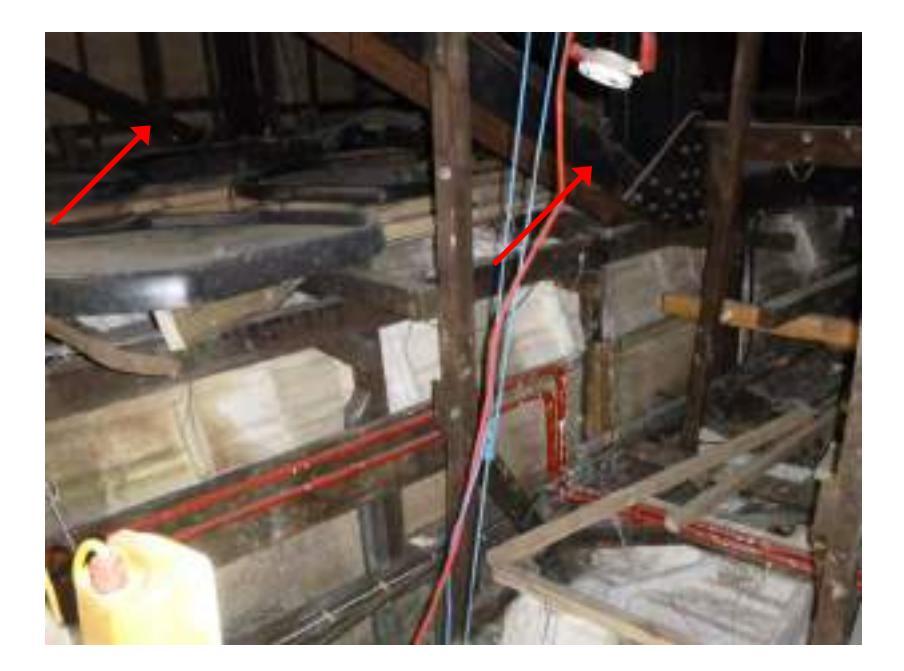
Fig 21:

Auditorium ceiling structures; showing area of raised west flat ceiling structures in general. Note west flat ceiling area defined as area between two western (north-south running) trussed bay RSJ division structures

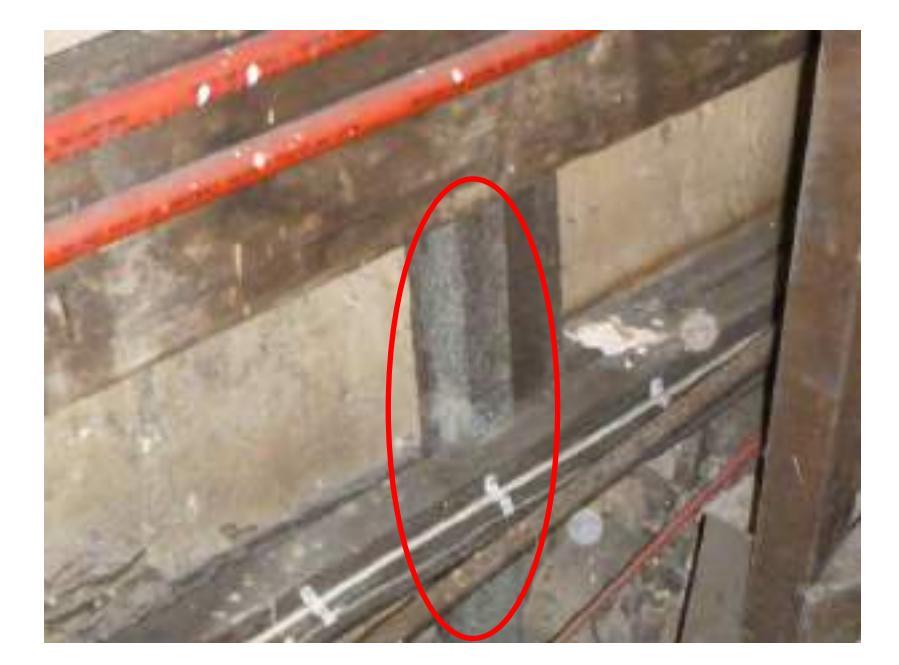
Fig 23:

Auditorium ceiling structures; showing typical upright timber stud element between most vulnerable west bay and the adjacent bay to the east. Note evident mould growth to timber surface suggesting of past chronic moisture penetration and subsequent ineffective ventilation/drying of area

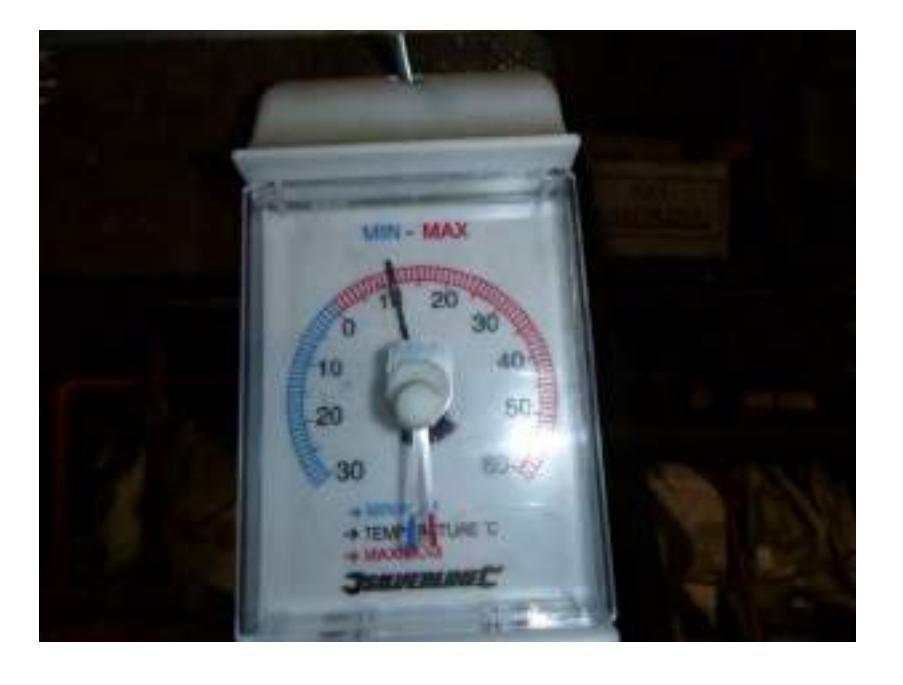
Fig 26:

Auditorium ceiling structures; showing roof void temperature at the time of investigation recorded at ~10 degrees centigrade. Outside temperatures at the same time were recorded as ~22 degrees centigrade. A ~12 degree difference suggestive of thermal inertia and a high potential for condensation conditions between varying internal and external temperatures leading to surface mould growth

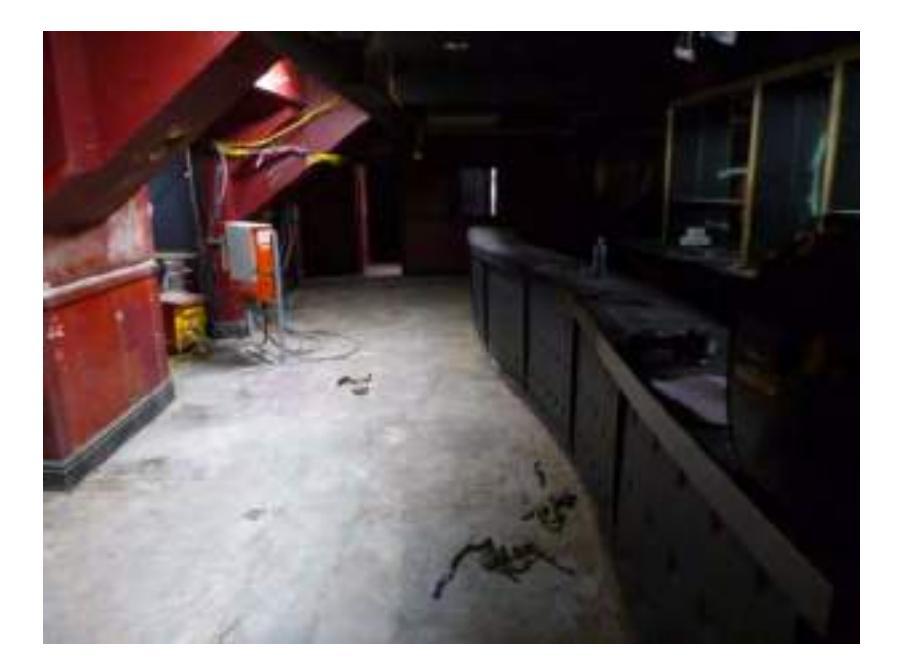
Fig 27:

Second floor ceiling structures, RM.2-16; showing area in general. All ceiling structures of solid construction apart from north bay where ceiling joists were discovered. These appeared to have originally formed (or replaced) a now defunct floor level, now concealed by a newer division solid floor structure from above

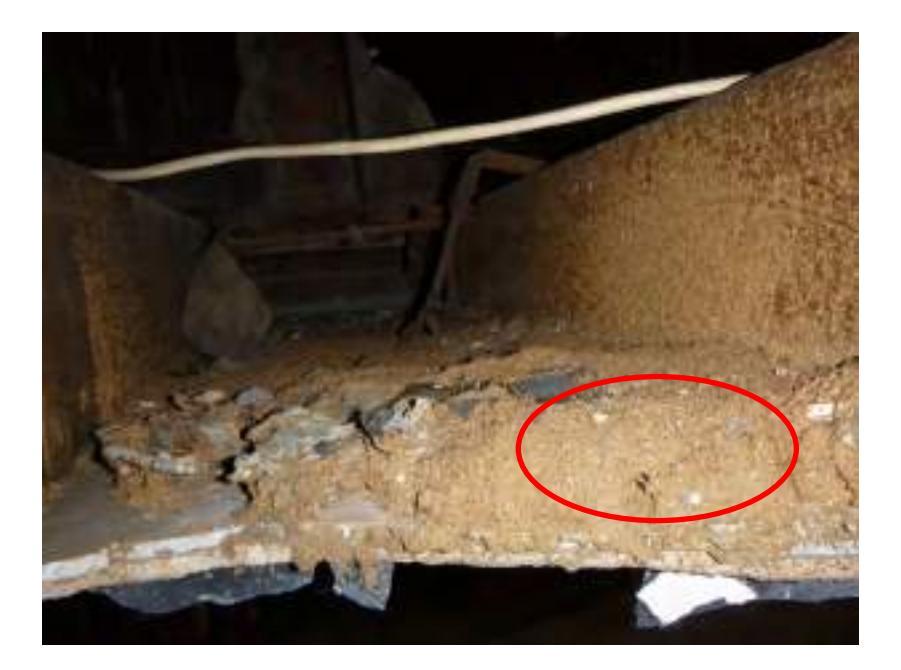
Fig 29:

Second floor ceiling structures, RM.2-16; showing large amounts of debris between ceiling joists trapping moisture and promoting the conditions for damp and decay

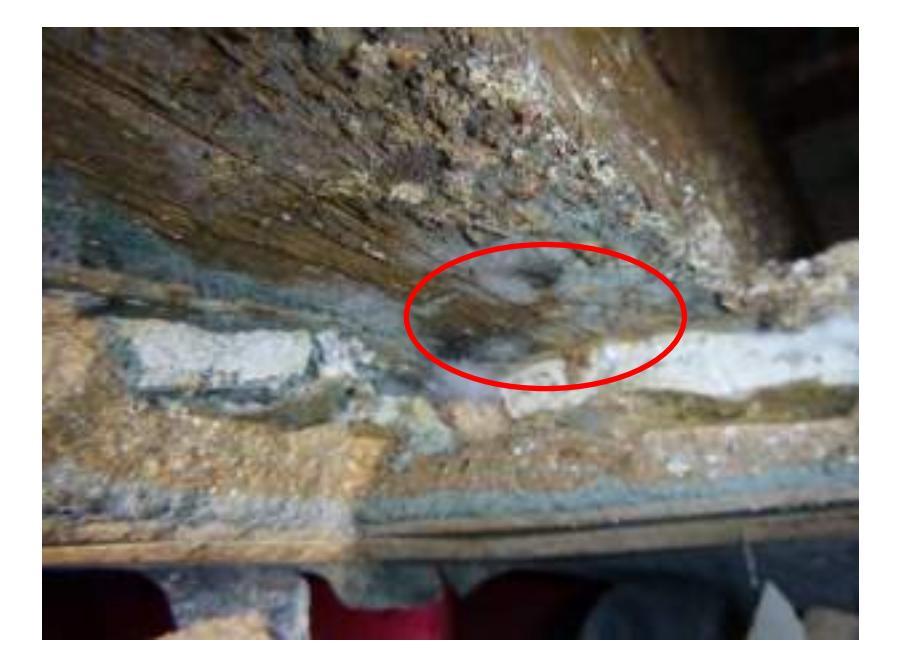
Fig 30:

Second floor ceiling structures, RM.2-16 showing active mould growth to undersides of ceiling joists due to moisture being retained within wet ceiling plaster elements

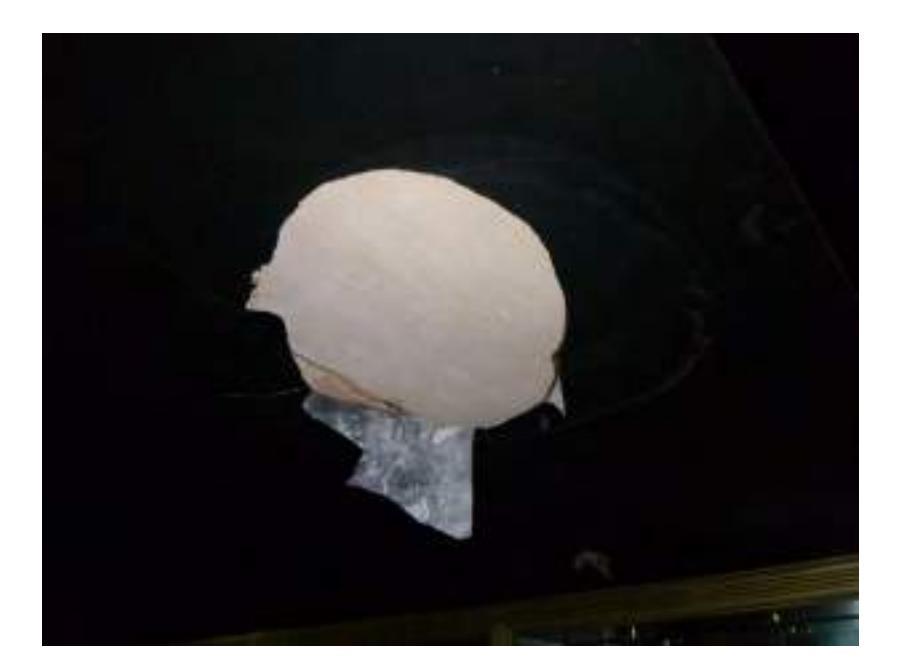
Fig 31:

Second floor ceiling structures, RM.2-16; showing typical image of water ponding damage to underside of boxed beam RSJ. Plaster and concealed boxing timbers likely to be wet and highly vulnerable to damp and decay in these areas

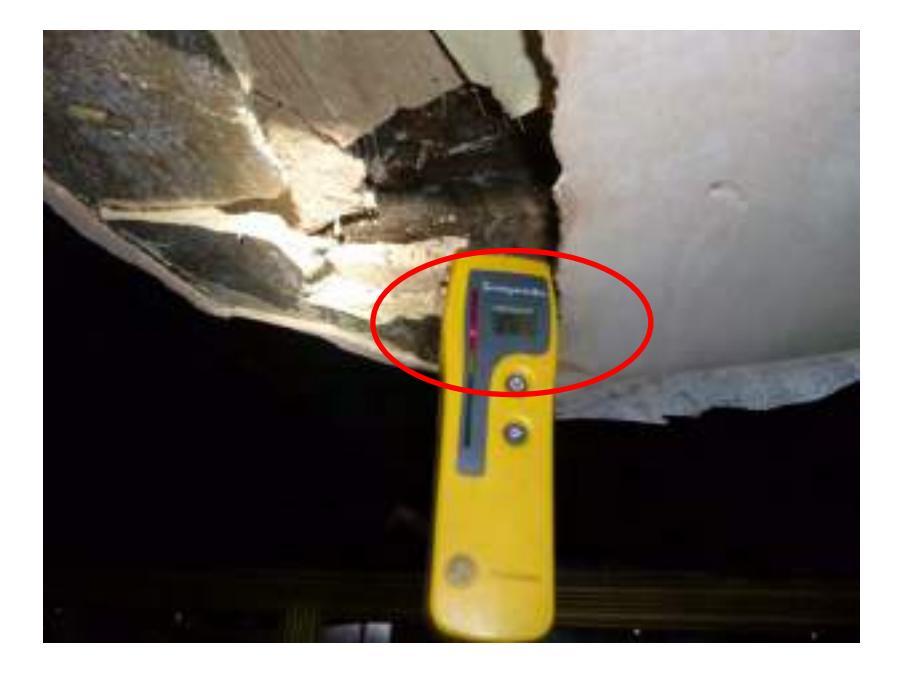
Fig 32:

Second floor ceiling structures, RM.2-16; showing exposed wet timber element within typical boxed beam RSJ structure. Plaster and concealed boxing timbers were found to be wet and highly vulnerable to damp and decay in these areas

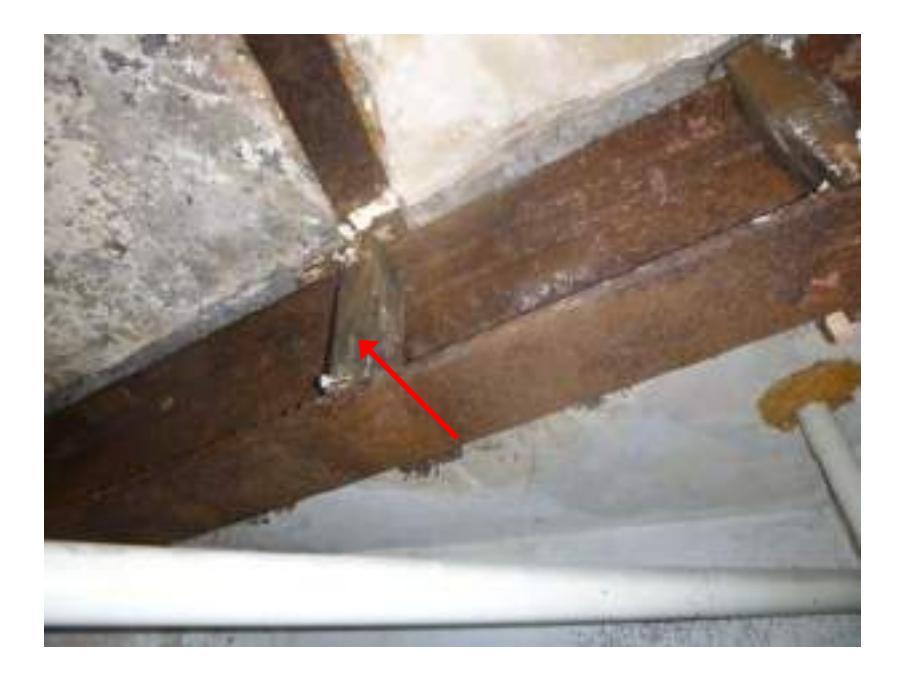
Fig 34:

Second floor ceiling structures, RM.2.21; showing exposed RSJ structure which may resemble those still boxed and concealed/vulnerable to damp and decay within the adjacent room RM.2.16. Note infill bonding timbers still in situ
