APPENDIX 3: DRYING OUT WORKS- SCOPE AND EXTENT OF WORKS

Site Note 7: Preliminary Damp Condition Investigation (Masonry)- March 2020

Site Note 7: Preliminary Damp Condition Investigation (Masonry)

The Hope Project (KOKO): Phase 1 of the preliminary damp condition Investigation

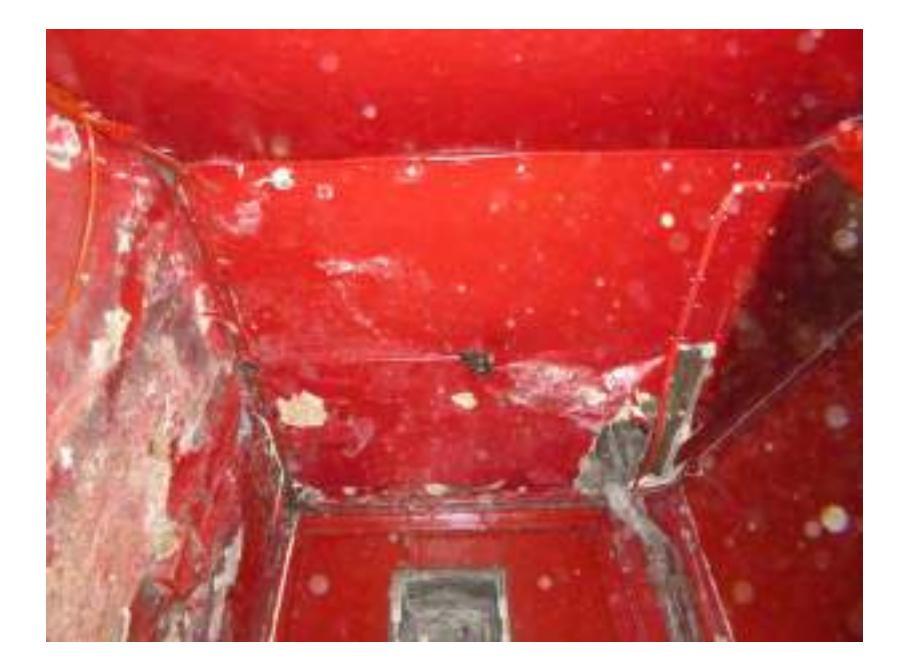
Fig 35:

Second floor ceiling structures, RM.2.22; showing historic timber and plaster ceiling structures above main access north-west stairs subject to damp and decay

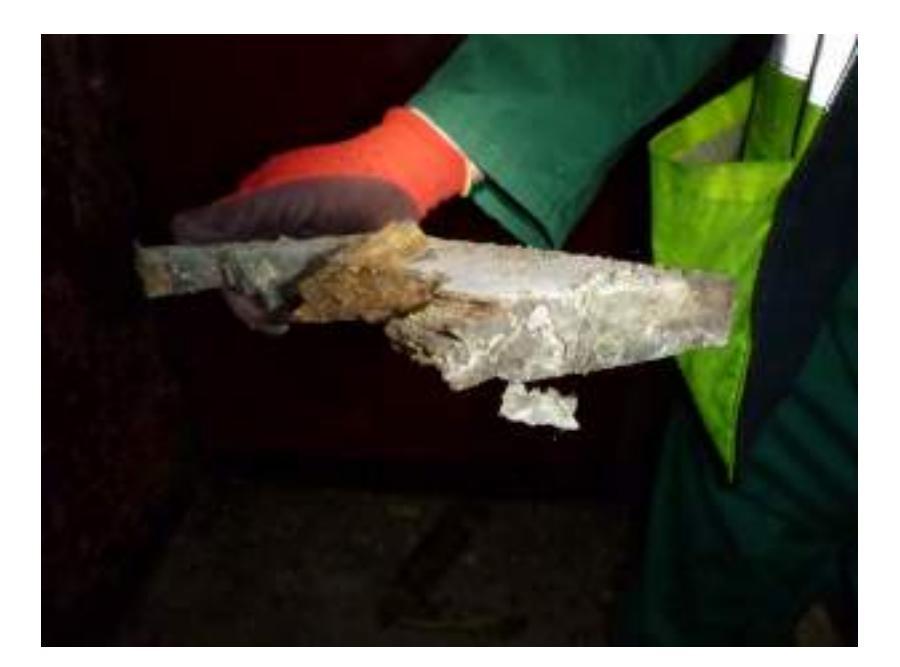
Fig 37:

Second floor ceiling structures, RM.2.22; showing decayed ceiling timber element taken from the historic timber and plaster ceiling structure above main access north-west stairs subject to damp and decay

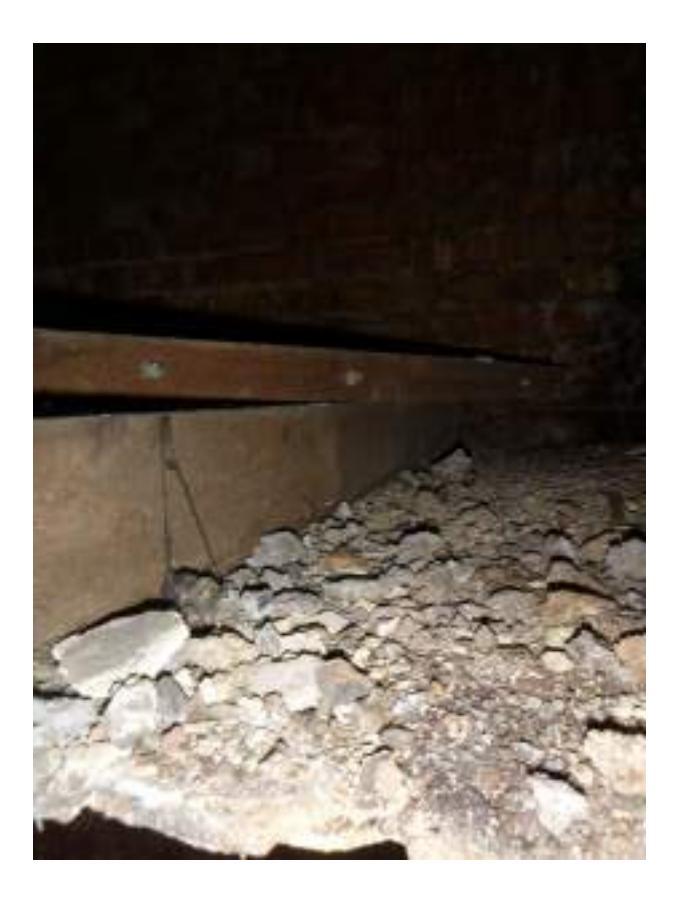
Fig 39:

Second floor ceiling structures, RM.2.22; showing central ceiling joist element free from mould growth. Also note rubble build-up adding weight to historic plaster ceiling and potentially trapping moisture

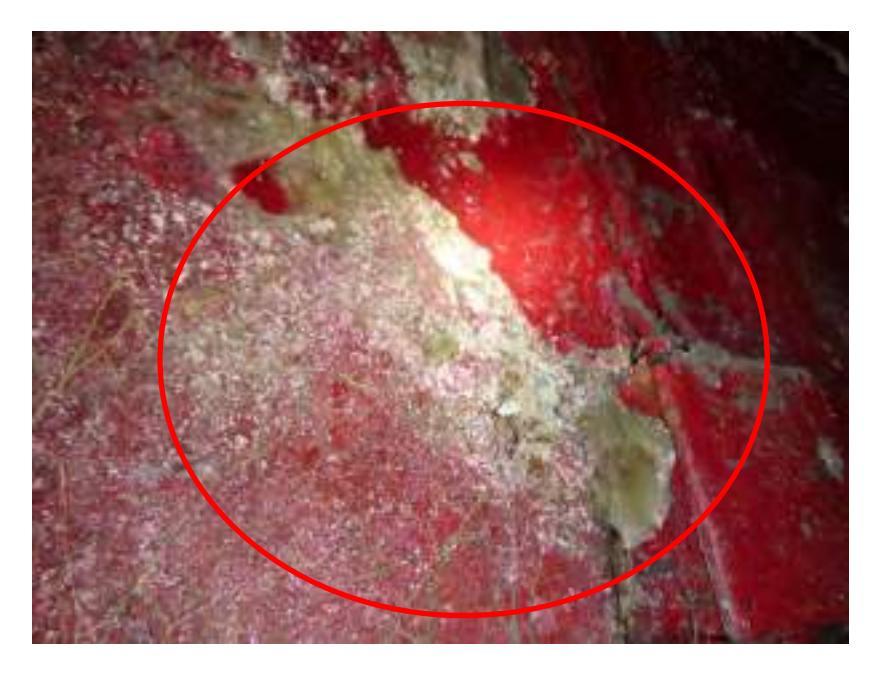
Fig 40:

Second floor ceiling structures, RM.2.22; showing rendered masonry wall to main access north-west stairs subject to what appeared to be active dry rot mycelium

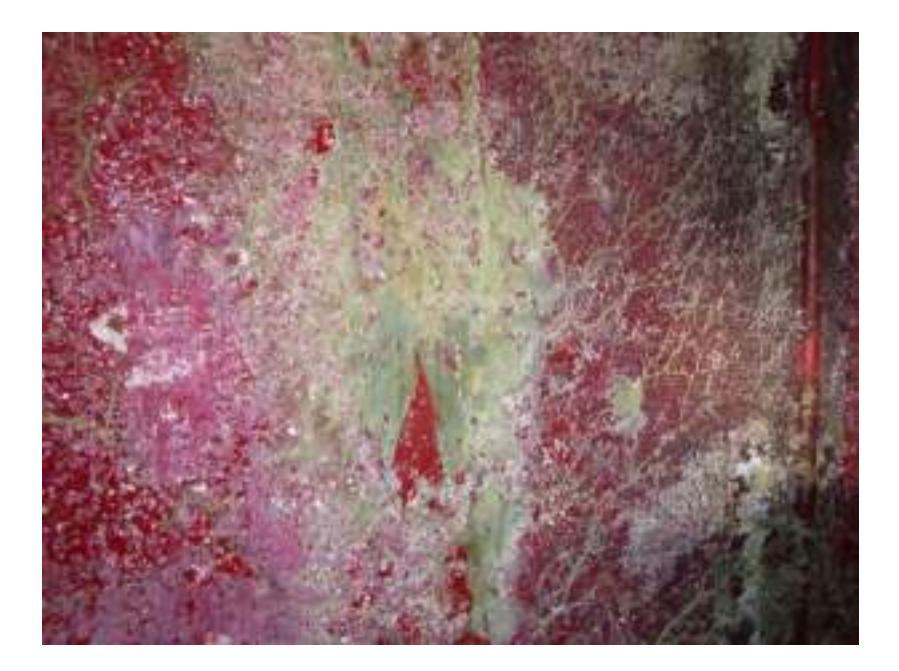
Fig 41:

Second floor ceiling structures, RM.2.22; showing rendered masonry wall to main access north-west stairs subject to what appeared to be active dry rot mycelium

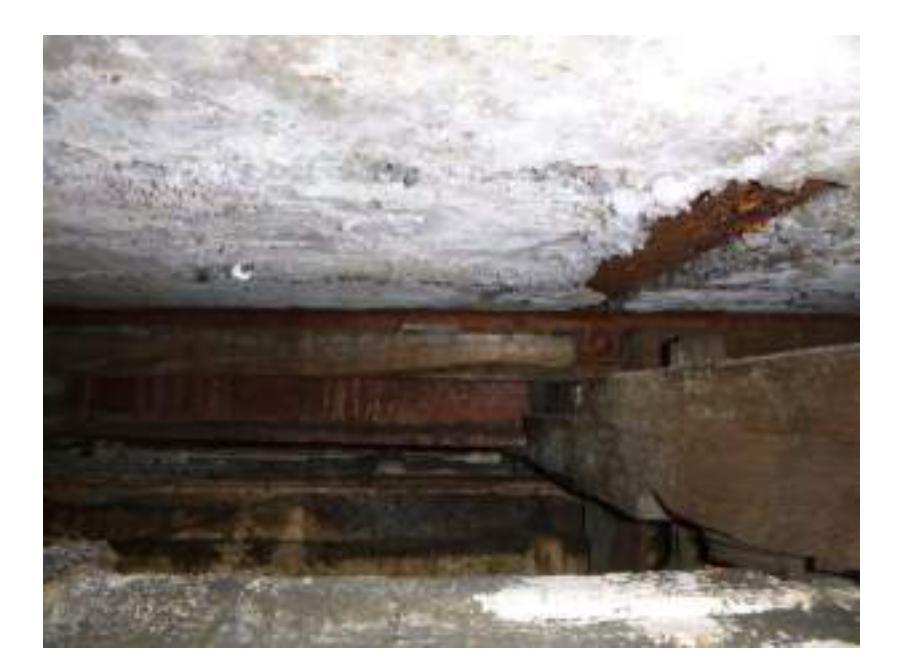
Fig 43:

First floor ceiling structures, RM.1-14; showing ceiling void at approximately 180mm depth beneath a solid floor structure above of clinker ash concrete. Note ceiling joists suspended from RSJs

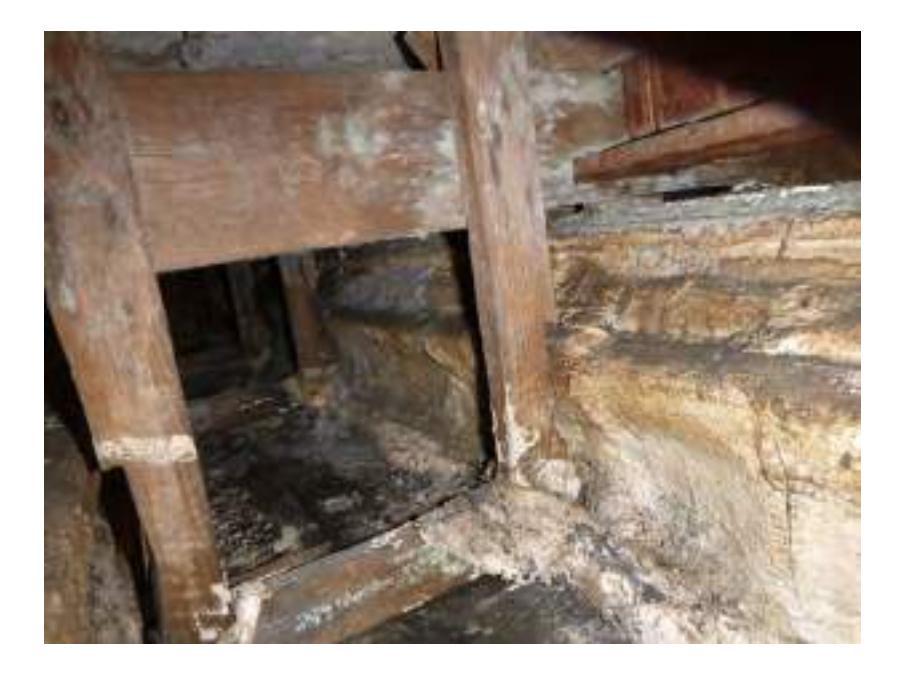
Fig 44:

First floor ceiling structures, RM.1-14; showing internal view of false/hollow beam boxing. Note relatively simple construction of horizontal timber battens at ~600mm centres, suspended from perpendicular ceiling joists

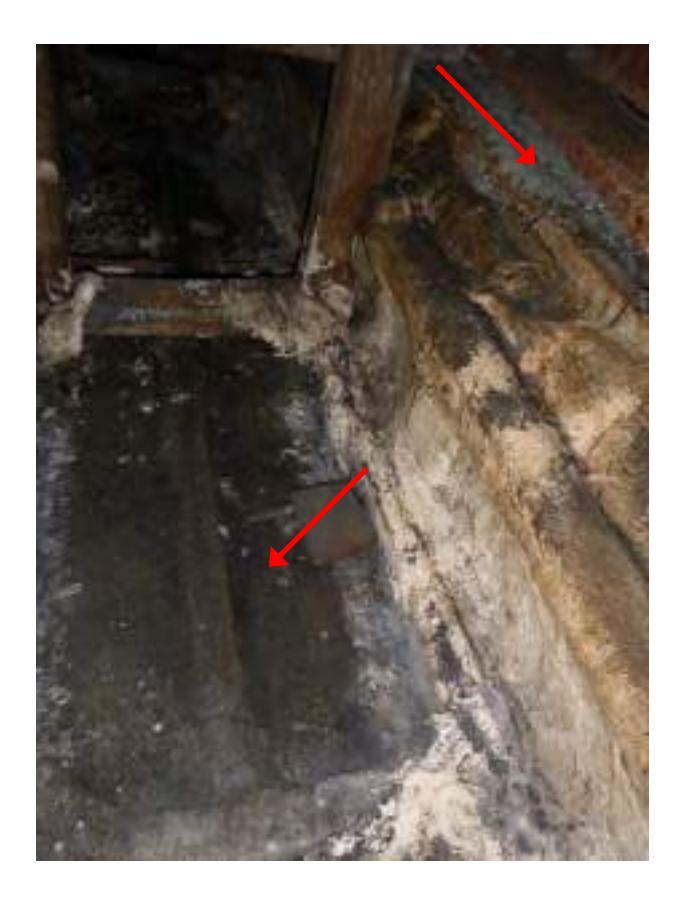
Fig 45:

First floor ceiling structures, RM.1-14; showing internal view of false/hollow beam boxing. Note beam boxing acting as a moisture well/reservoir leading to conditions for damp and decay

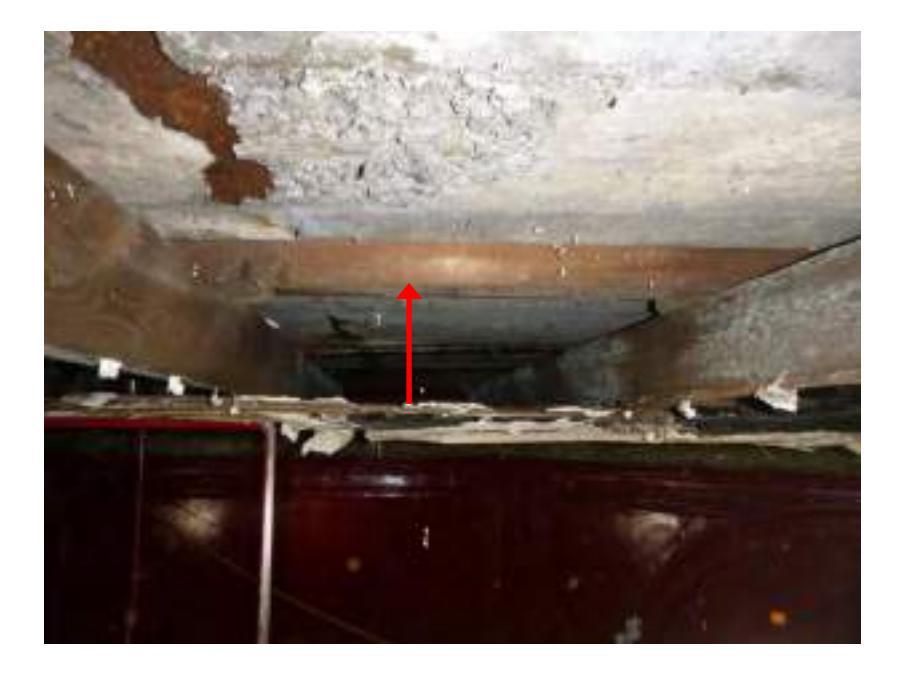
Fig 46:

First floor ceiling structures, RM.1-14; showing ceiling void structure. Note ~80x55mm plate set perpendicular to ceiling joists and nailed into clinker slab above. Its role was to support the midspan of the ceiling joists structure

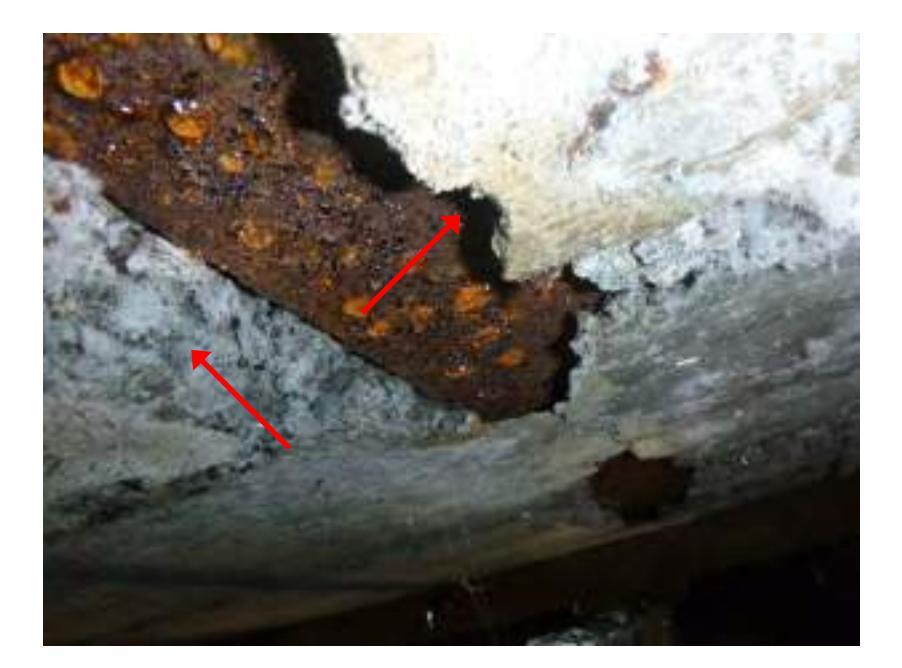
Fig 47:

First floor ceiling structures, RM.1-14; showing typical image of partially exposed embedded RSJ within clinker slab. Note evident corrosion and relatively poorly formed concrete delaminating from the steel element

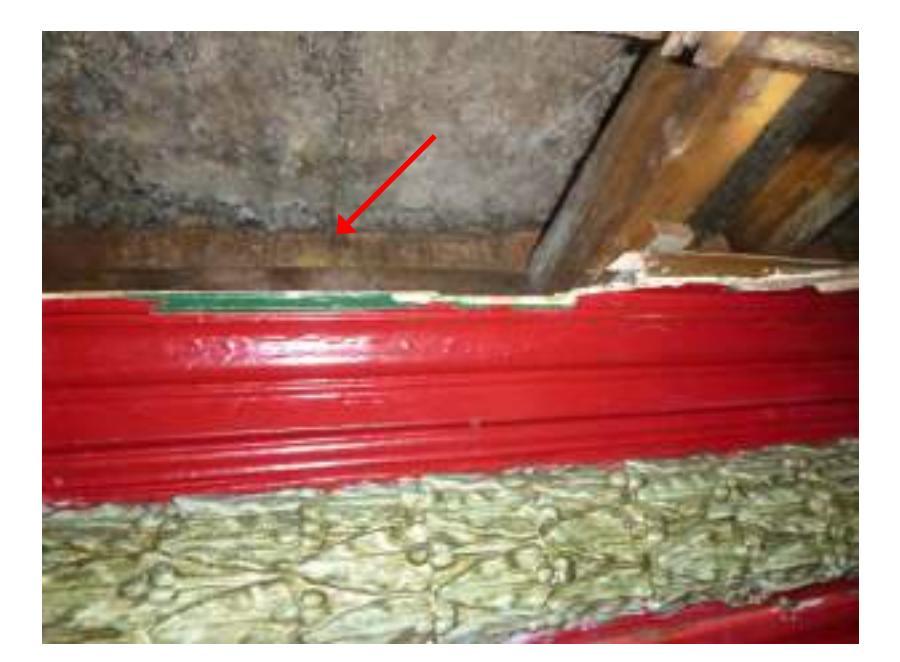
Fig 49:

First floor ceiling structures, RM.1-14; showing detail where the ceiling elements meet the west masonry wall and are supported onto a timber plate nailed to the masonry wall

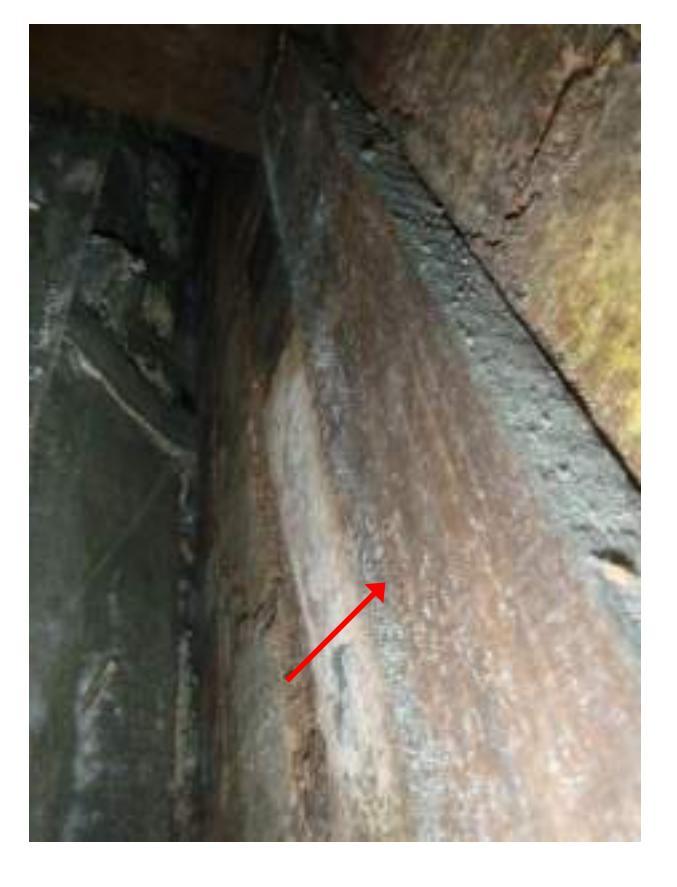
Fig 50:

First floor ceiling structures, RM.1-14; showing detail where the ceiling elements meet the west masonry wall and are supported onto a timber plate nailed to the masonry wall. Note timber plate subject to surface mould growth and vulnerable to damp and decay issues being in contact with a damp masonry wall

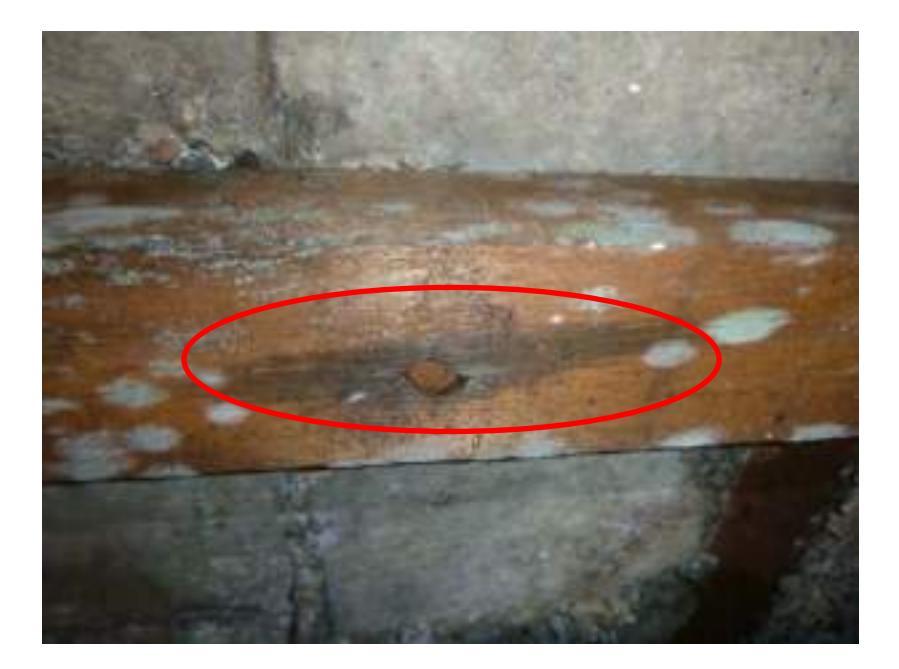
Fig 51:

First floor ceiling structures, RM.1-14; showing ceiling plate element supporting central span of ceiling joists structure. Note surface mould growth as well as evident corrosion to nail fixing into suspected wet masonry slab. Corrosion likely to worsen as moisture migrates down the structures from the upper levels

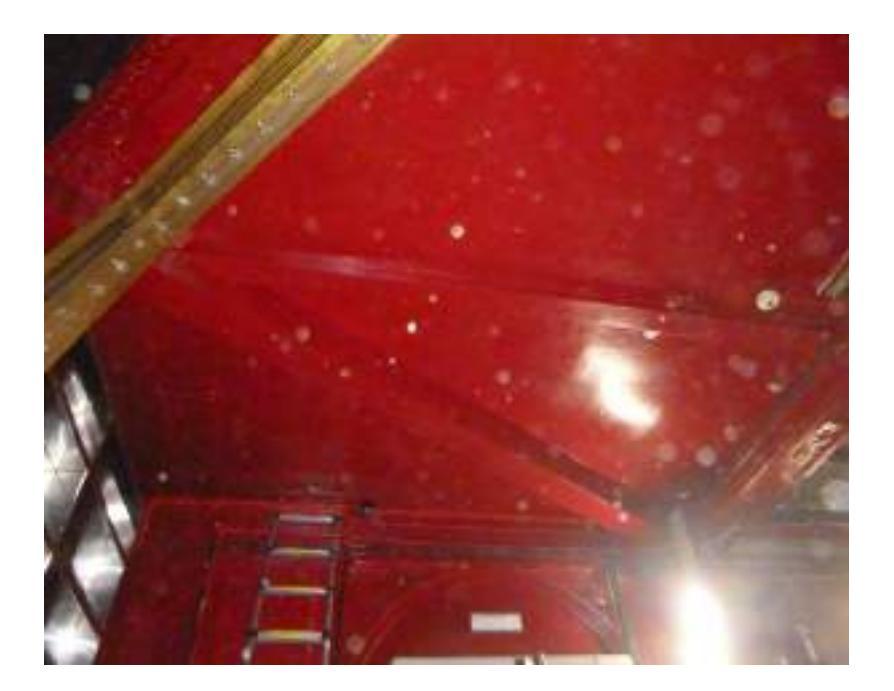
Fig 53:

First floor ceiling structures, RM.1-14; showing non-historic plastered south bay with newer addition 2no. RSJs

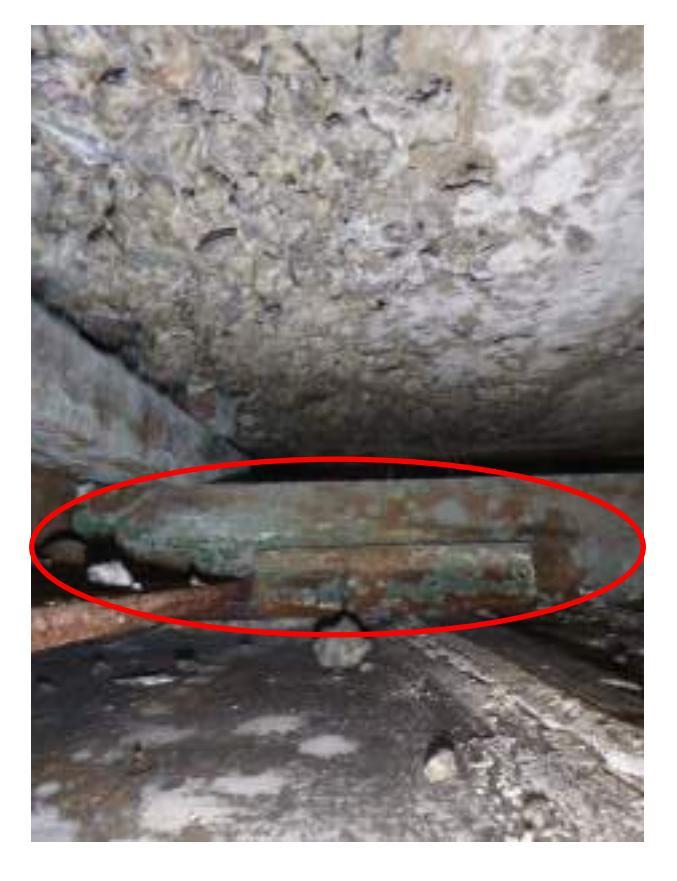
Fig 54:

First floor ceiling structures, RM.1-14; showing ceiling void at ~120mm above non-historic plastered south bay. Note void without provision for ventilation and highly vulnerable to interstitial condensations and entrapment of moisture leading to increased surface mould growth and the conditions for damp and decay

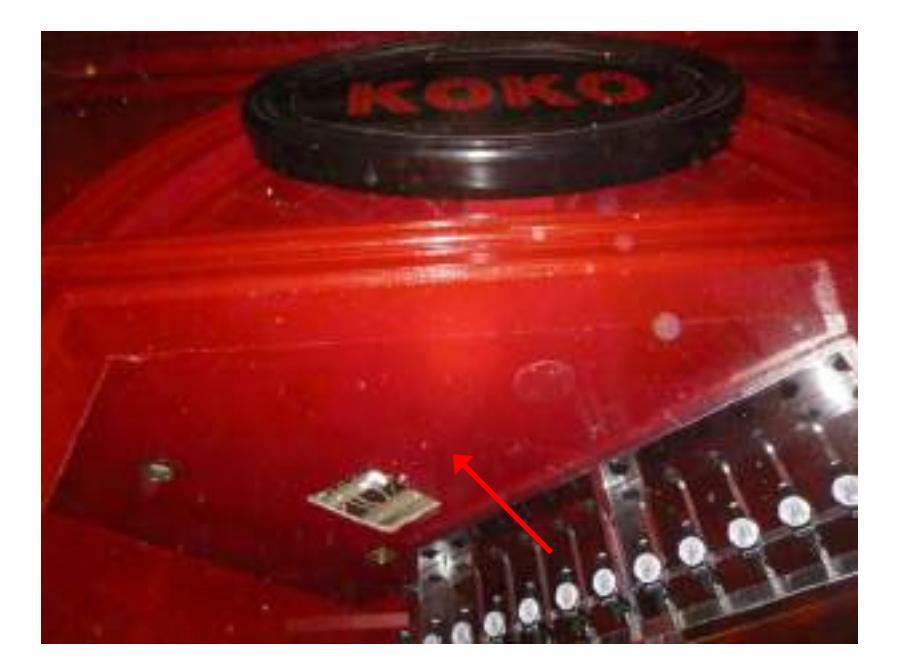
Fig 55:

First floor ceiling structures, RM.1-14; showing north-east corner above bar/ historic entry point into auditorium now containing small non-historic suspended timber ceiling

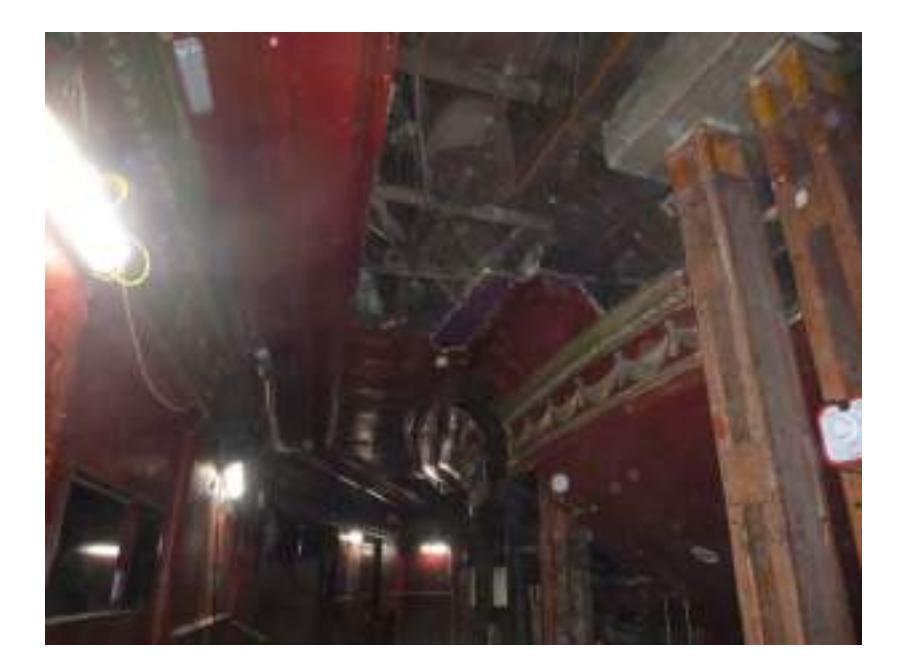
Fig 57:

First floor ceiling structures, RM.1-12; showing area in general looking north. Note significant damage/demolition works to historic ceiling elements as a result of remedial propping to balcony solid structures above

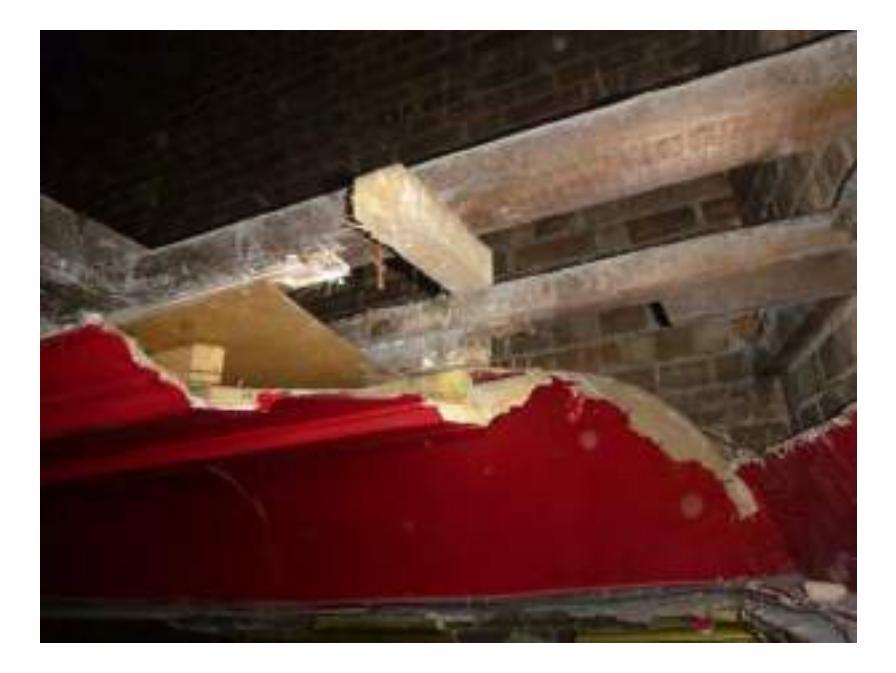
Fig 58:

First floor ceiling structures, RM.1-12; showing suspended ceiling structures supporting non-historic and poorly executed ceiling reproduction

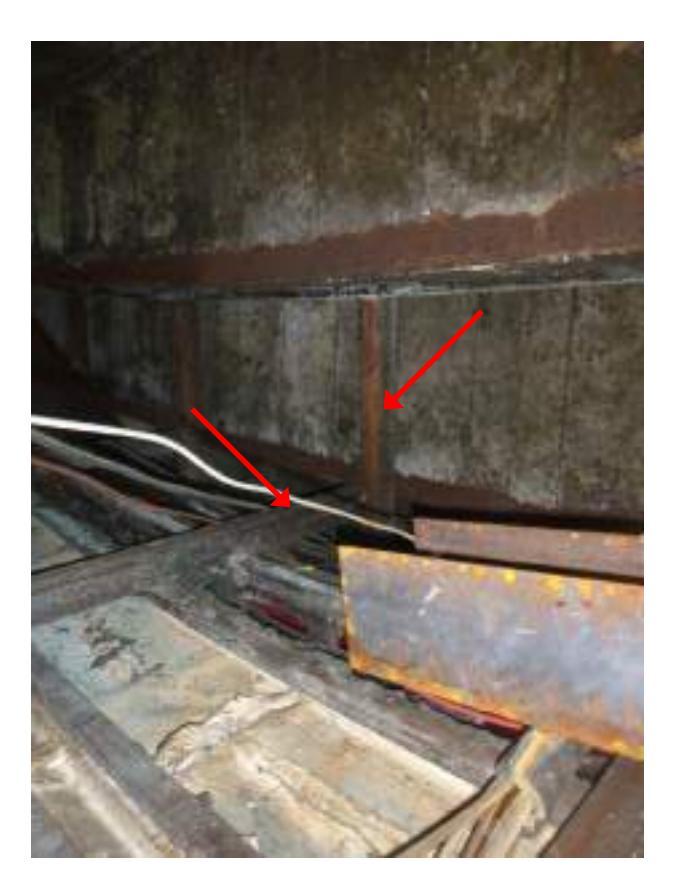
Fig 59:

First floor ceiling structures, RM.1-12; showing large ceiling void and detail where the ceiling joists meet the east solid balcony structures and are supported on/nailed to vertical timber studs

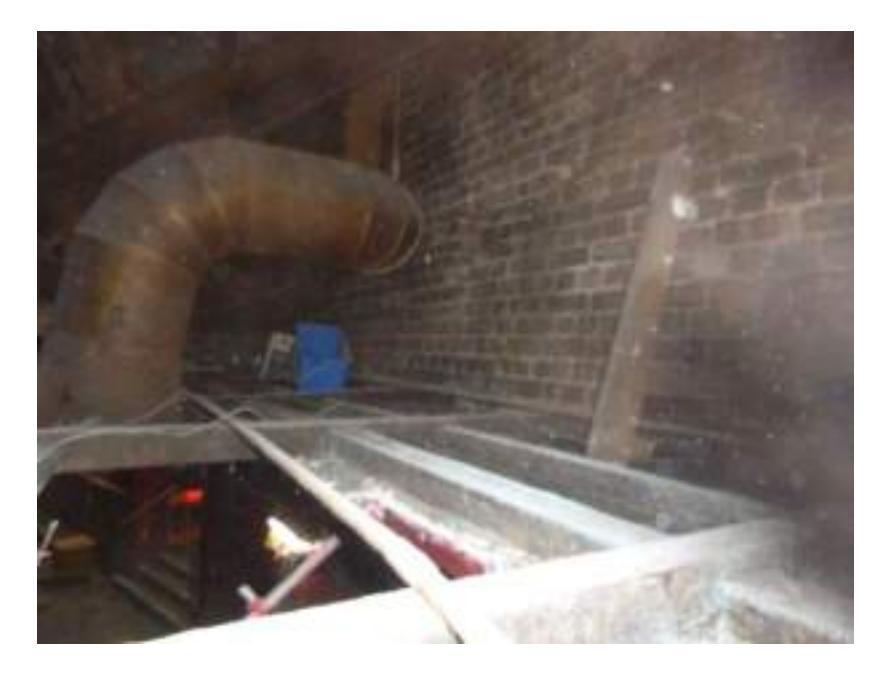
Fig 60:

First floor ceiling structures, RM.1-12; showing large ceiling void and detail where the ceiling joists meet the west partition masonry wall and are supported on/nailed to a horizontal timber plate

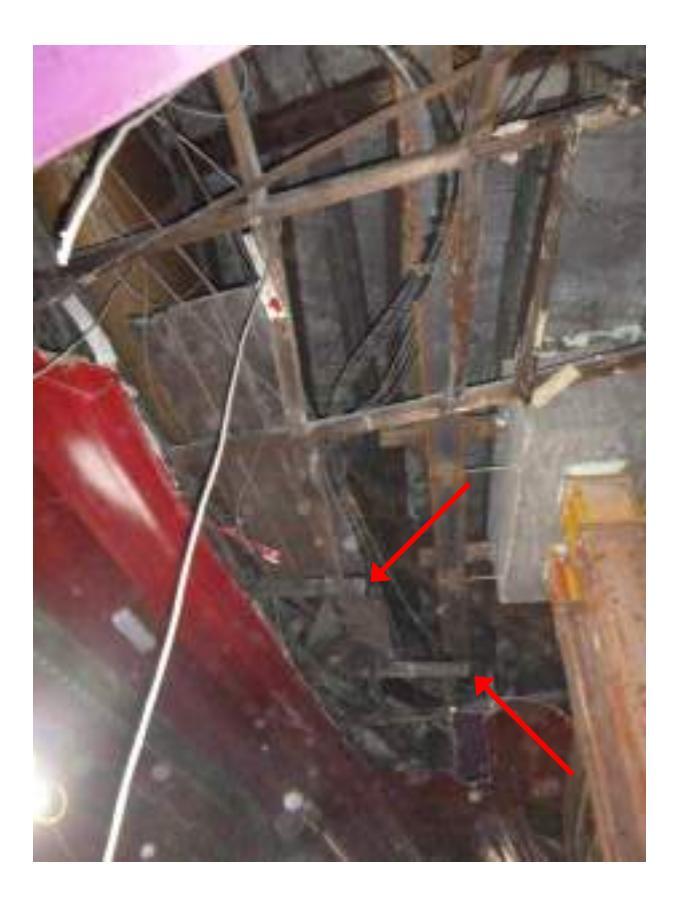
Fig 61:

First floor ceiling structures, RM.1-12; showing central area in general looking north. Note significant damage/ demolition works to historic ceiling elements as a result of remedial propping to balcony solid structures above. 2no. ceiling joists compromised in this area

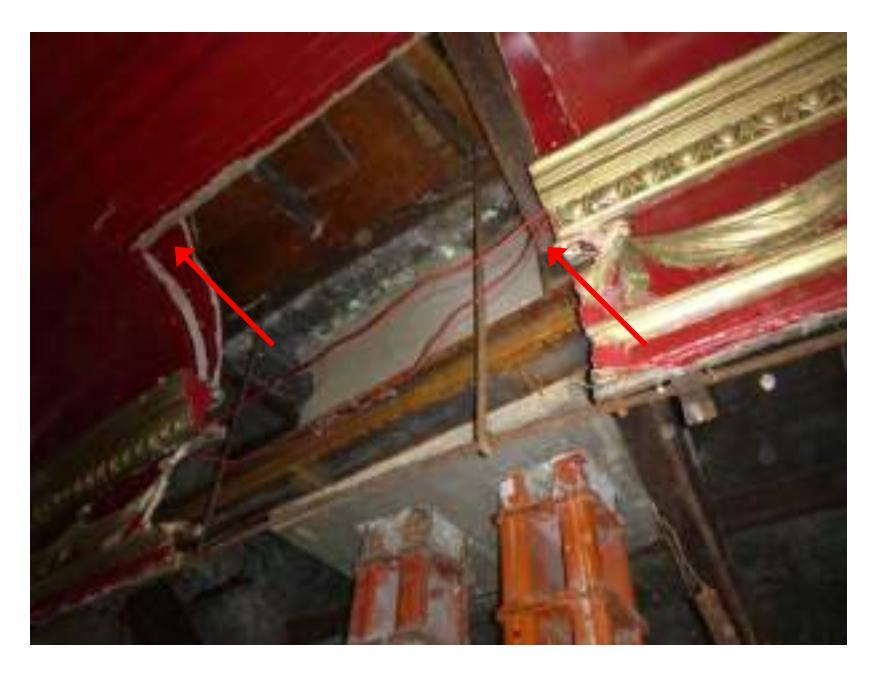
Fig 62:

First floor ceiling structures, RM.1-12; showing north area. Note significant damage/demolition works to historic ceiling elements as a result of remedial propping to balcony solid structures above. 2no. ceiling joists compromised in this area

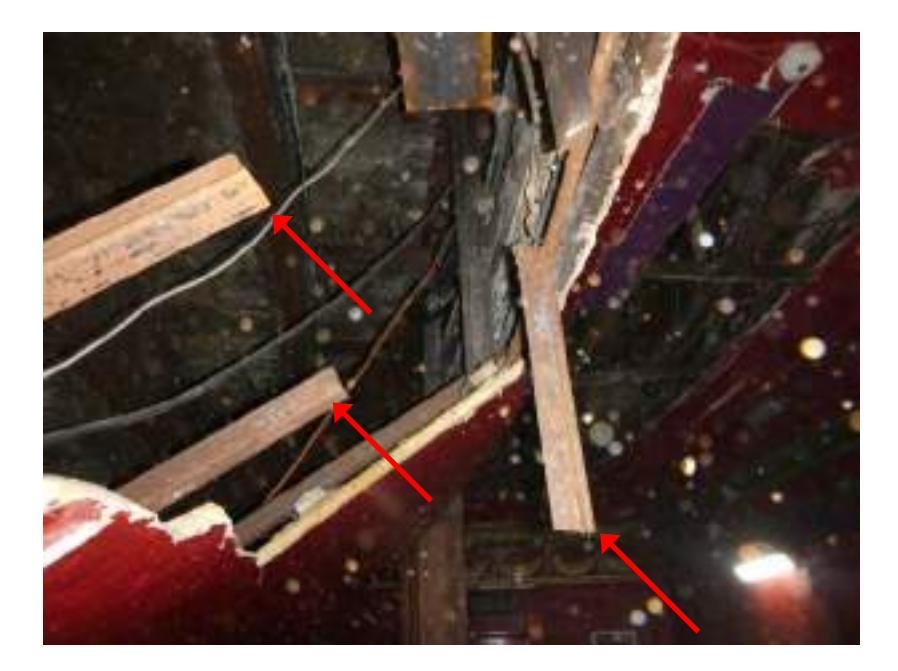
Fig 63:

First floor ceiling structures, RM.1-12; showing sloped balcony ceiling structures compromised by remedial and demolition works, Note 2no steel T -bar ceiling joists cut through in this location

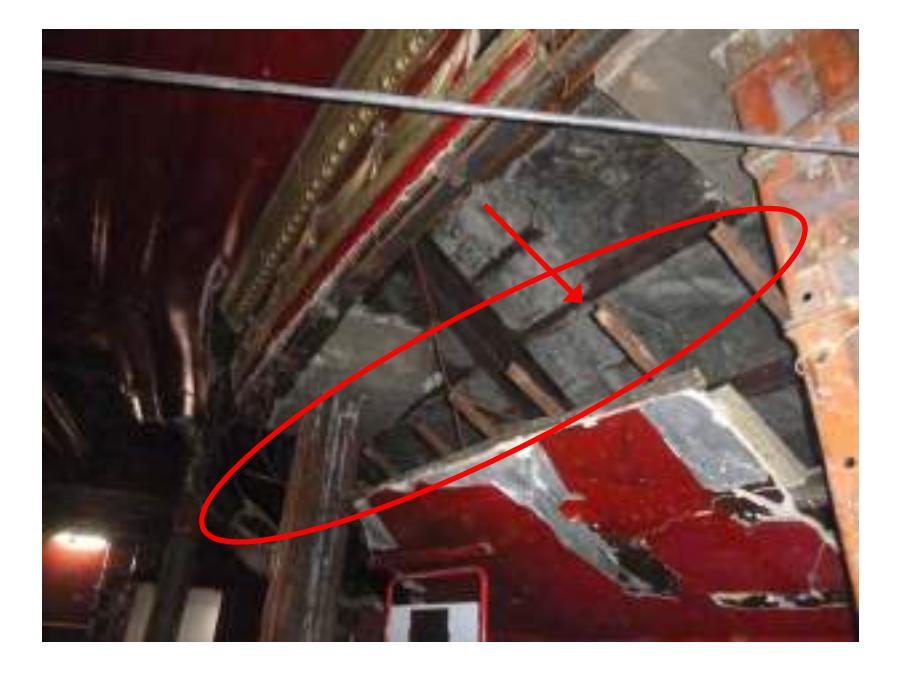
Fig 64:

First floor ceiling structures, RM.1-12; showing central area sloped balcony ceiling structures significantly structurally compromised by recent remedial and demolition works, Note 16no steel T-bar ceiling joists cut through in this location

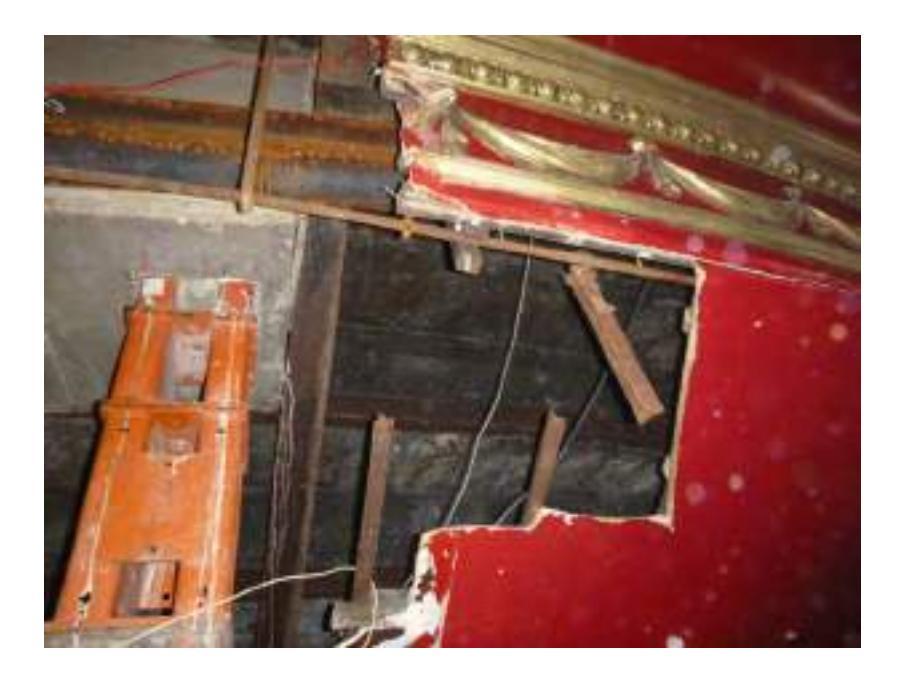
Fig 65:

First floor ceiling structures, RM.1-12; showing south area sloped balcony ceiling structures compromised by remedial and demolition works, Note 2no steel T-bar ceiling joists cut through in this location

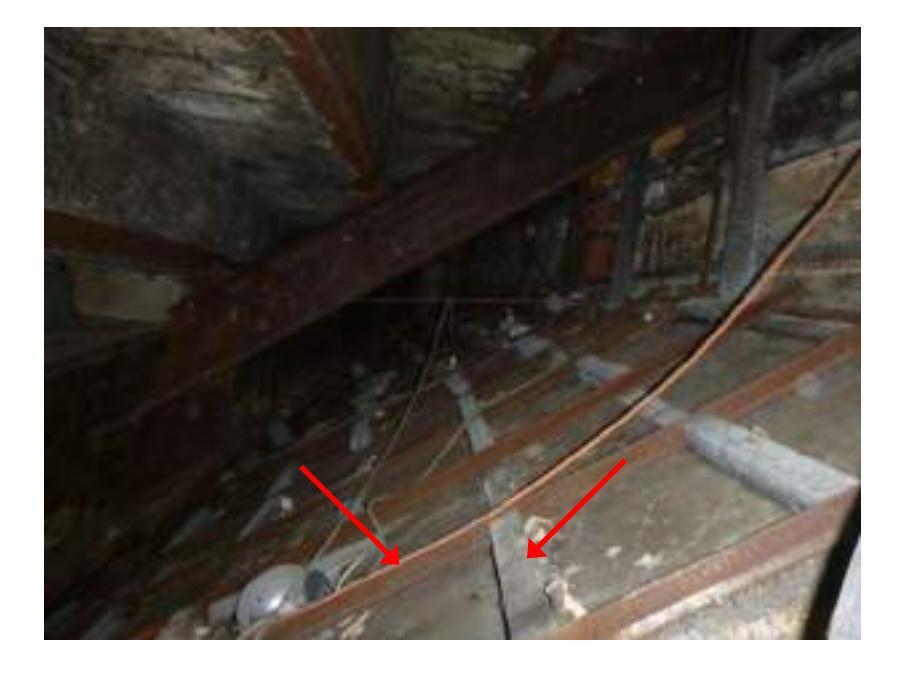
Fig 66:

First floor ceiling structures, RM.1-12; showing sloped balcony ceiling void. Note ceiling joist construction of steel T -bars with timber battens infill for plaster fixing locations

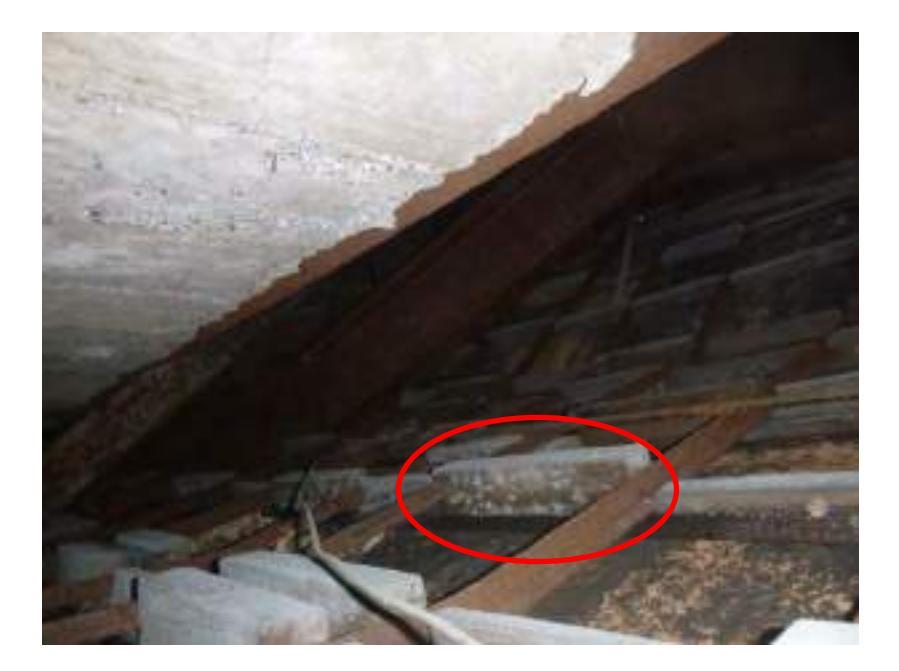
Fig 67:

First floor ceiling structures, RM.1-12; showing central area of unventilated sloped ceiling void beneath the second floor balcony structures. Note evidence of interstitial condensation forming mould spores to timber battens which may cause potential health hazards to those working on or occupying the structure

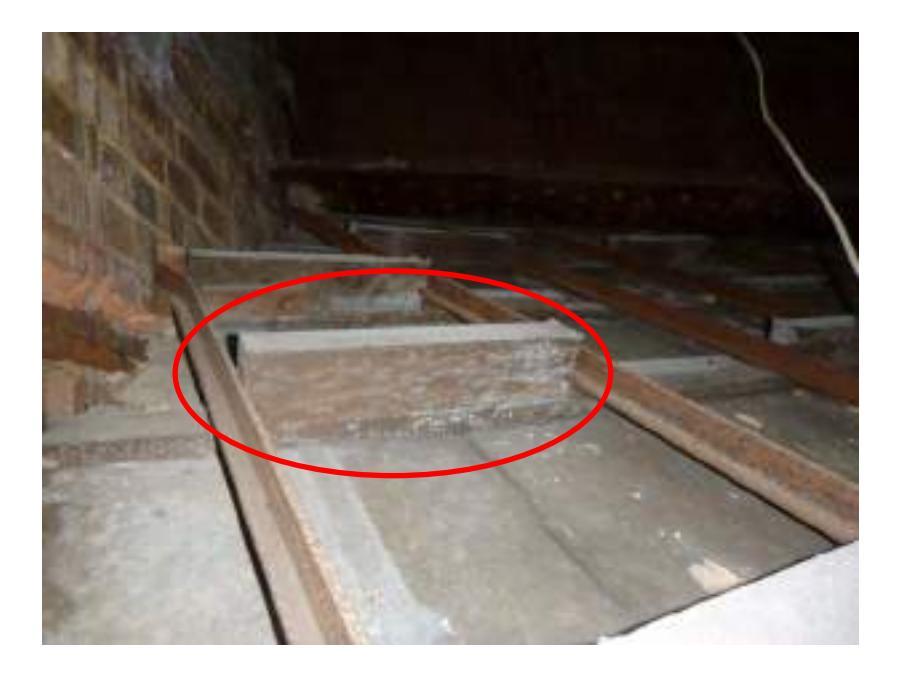
Fig 68:

First floor ceiling structures, RM.1-12; showing south area of unventilated sloped ceiling void beneath the second floor balcony structures. Note evidence of interstitial condensation forming mould spores to timber battens which may cause potential health hazards to those working on or occupying the structure

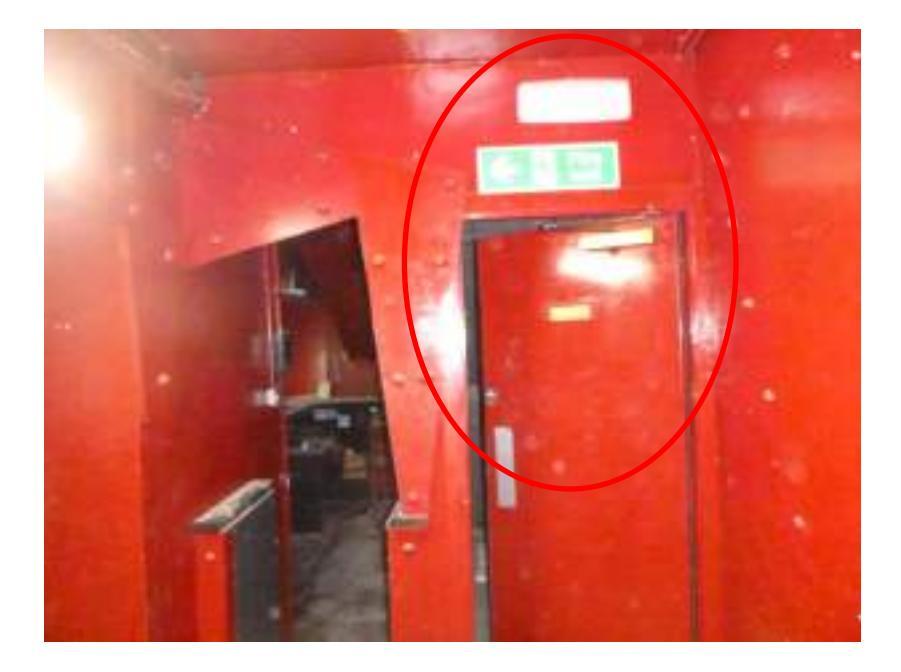
Fig 69:

First floor ceiling structures, RM.1-08; showing area to the south of the south auditorium balcony. WC with suspended ceiling beneath what appeared to be an artex ceiling possibly containing ACMs

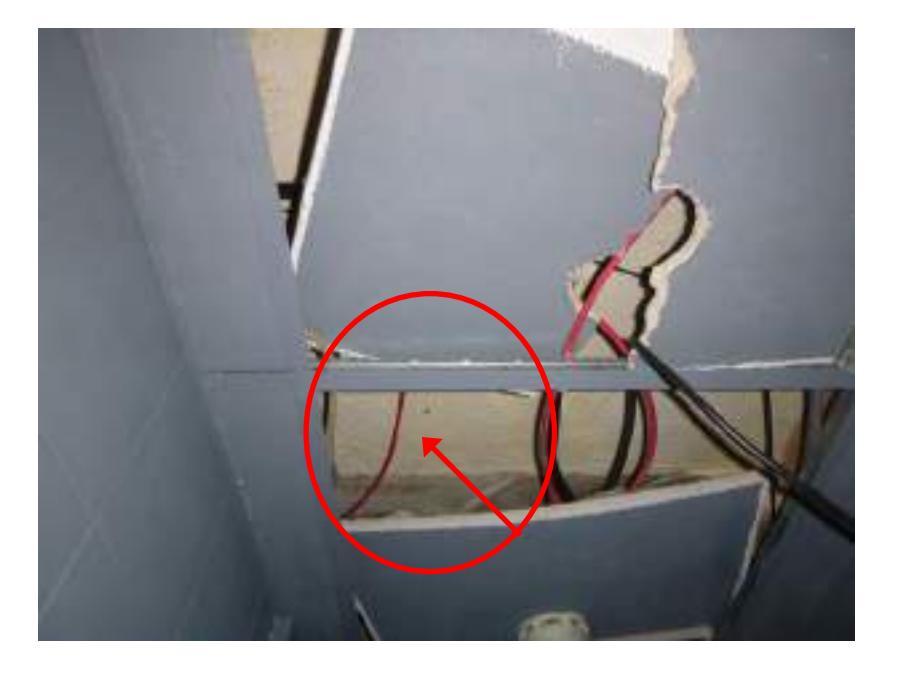
Fig 70:

First floor ceiling structures, RM.1-08; showing area to the south of the south auditorium balcony. WC with suspended ceiling beneath what appeared to be an artex ceiling possibly containing ACMs

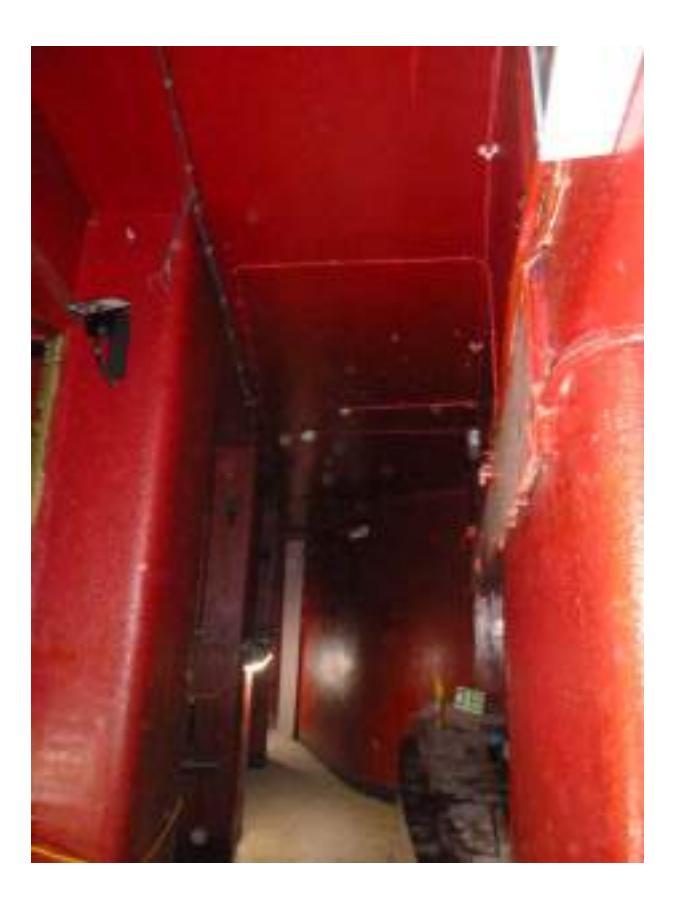
Fig 71:

First floor ceiling structures, RM.1-07; showing view looking east along the south auditorium balcony. Note ceilings of solid construction

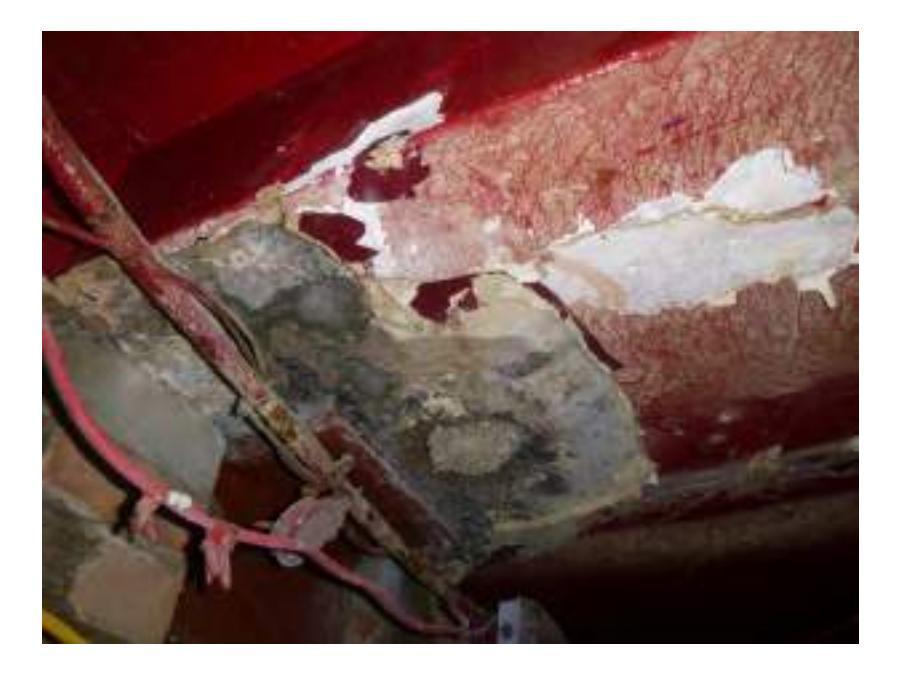
Fig 72:

First floor ceiling structures, RM.1-07; showing view of the south auditorium balcony subject to damp and decay. Note ceilings of solid construction

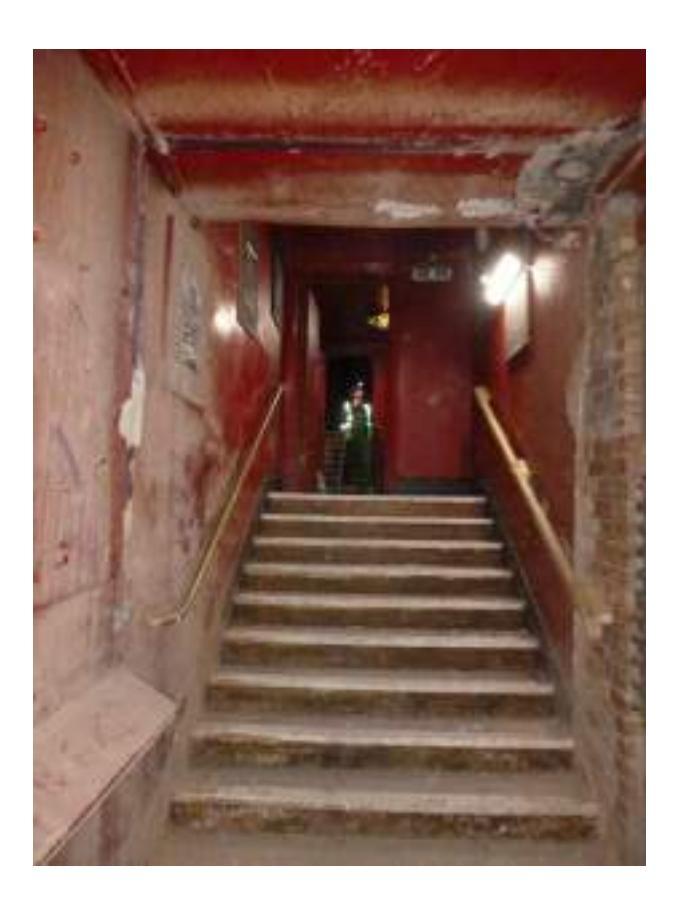
Fig 73:

First floor ceiling structures, RM.1-10; showing view looking west towards the principal south-west staircase. Ceilings in this area were of solid construction

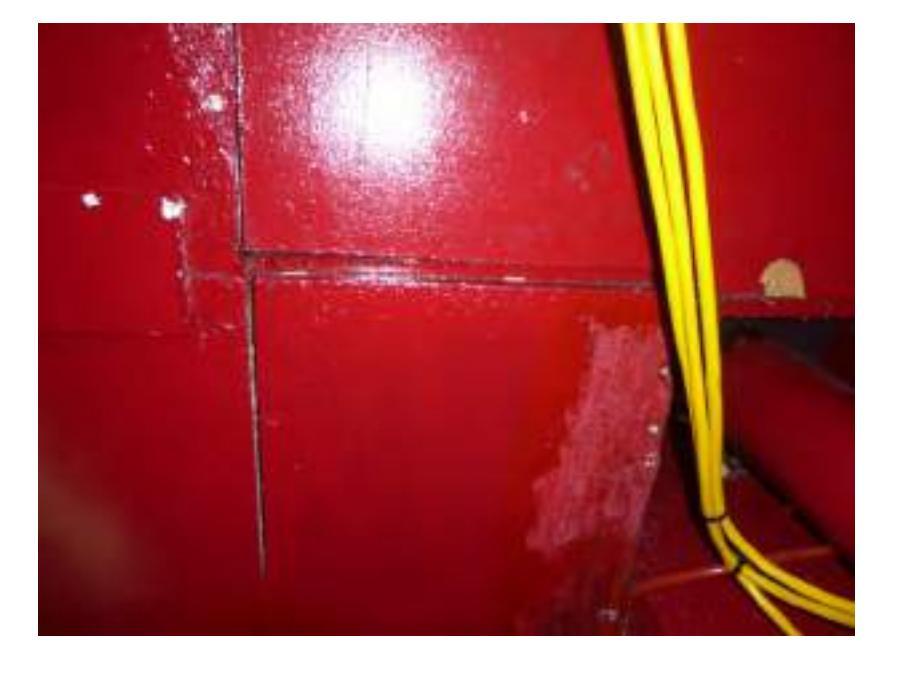
Fig 74:

First floor ceiling structures, D1-15; showing suspended ceiling above principal south-west staircase suspected to be clad in fibrous ACMs
