APPENDIX 3: DRYING OUT WORKS- SCOPE AND EXTENT OF WORKS

Site Note 7: Preliminary Damp Condition Investigation (Masonry)- March 2020

Site Note 7: Preliminary Damp Condition Investigation (Masonry)

The Hope Project (KOKO): Phase 1 of the preliminary damp condition Investigation

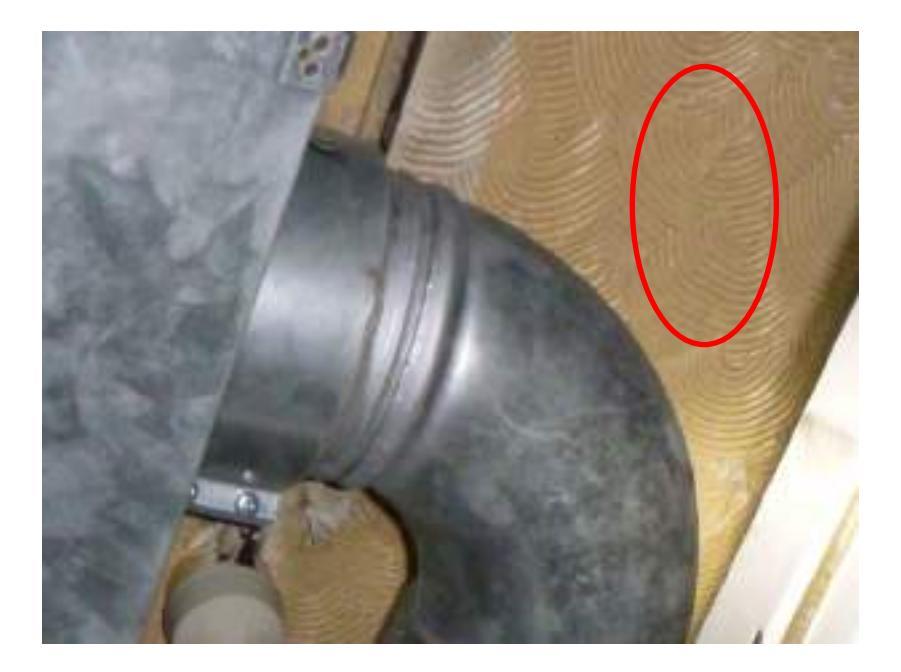
Fig 75:

Second floor ceiling structures, RM.2-17 (accessed from first floor D1-15); showing what appears to be an artex ACM decorative ceiling above a modern suspended ceiling structure

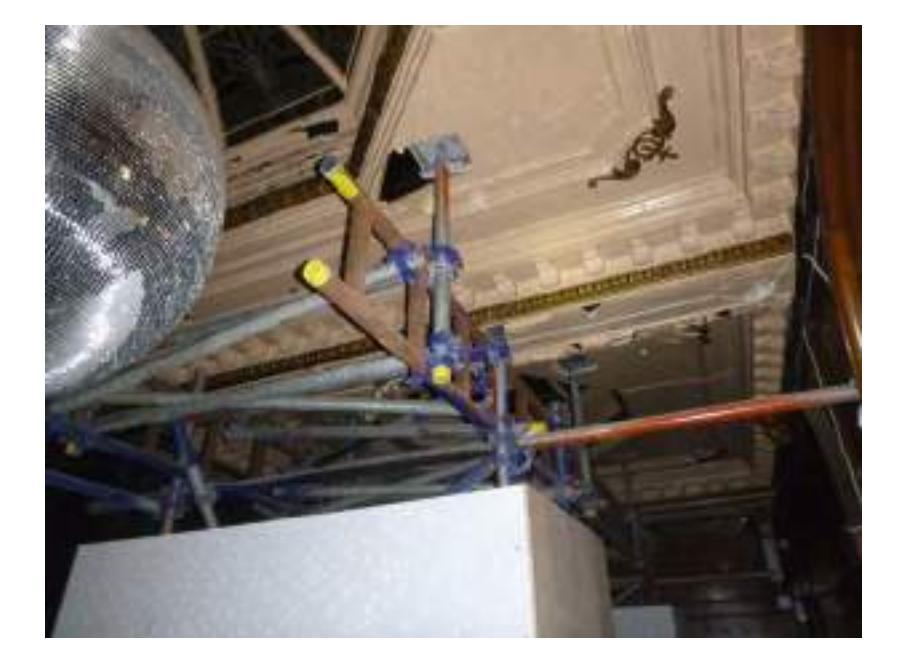
Fig 76:

Ground floor ceiling structures, RM.G-17; showing main entrance area beneath 3no. Large octagonal ceiling lights surrounded with decorative ceiling plaster and timber elements now subject to damp and decay issues from moisture penetration likely caused by the January 2020 fire fighting efforts

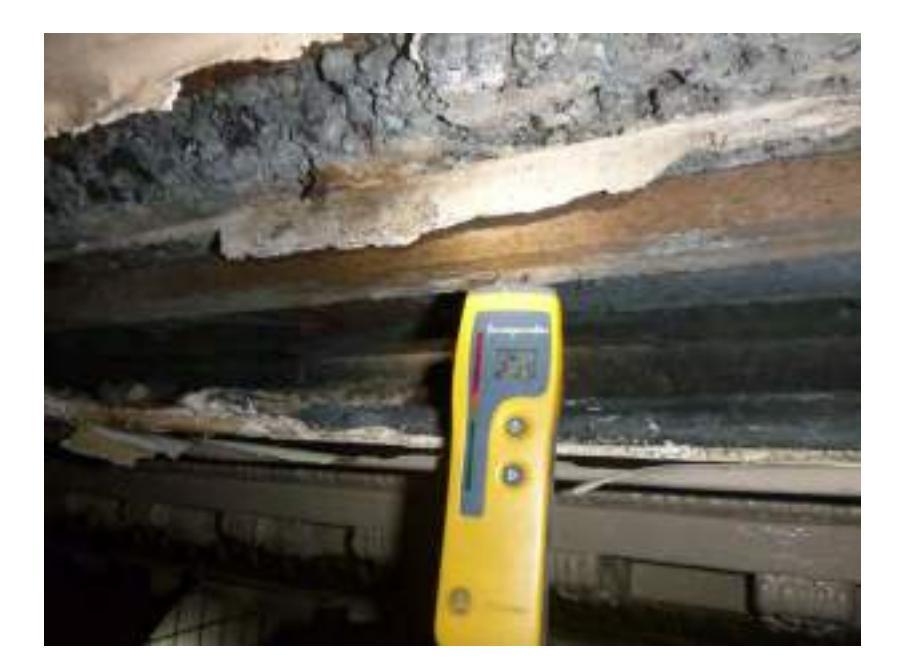
Fig 77:

Ground floor ceiling structures, RM.G-17; showing ceiling void at ~120mm depth to decorative plaster ceiling around octagonal ceiling light. Note timbers recorded as wet with moisture content readings of ~22 per cent. Ceiling voids require ventilation

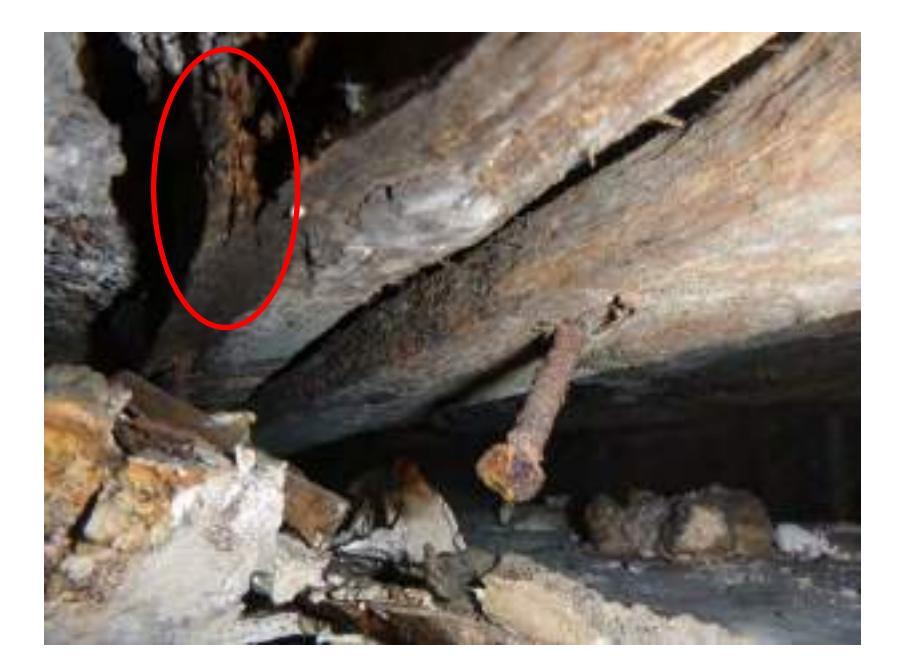
Fig 79:

Ground floor ceiling structures, RM.G-17; showing ceiling void above entrance lobby incorporating 3no. octagonal ceiling lights. Note timber battens visibly damp with soft frassy areas of remaining sapwood highly vulnerable to decay

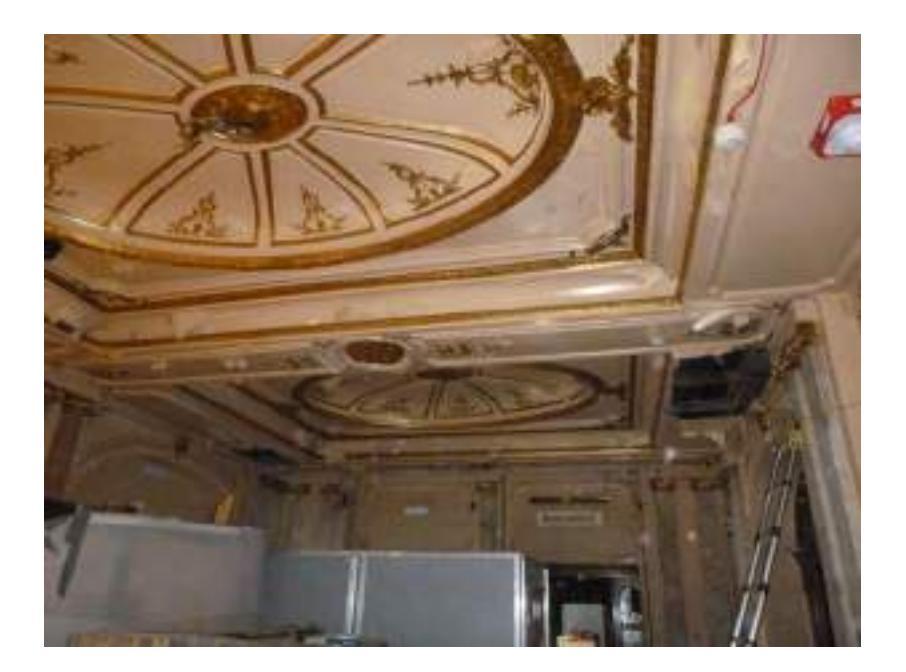
Fig 81:

Ground floor ceiling structures, RM.G-13; showing grand entrance/ticket office with fine decorative plaster ceiling subject to damp and decay issues caused by the January 2020 fire fighting efforts

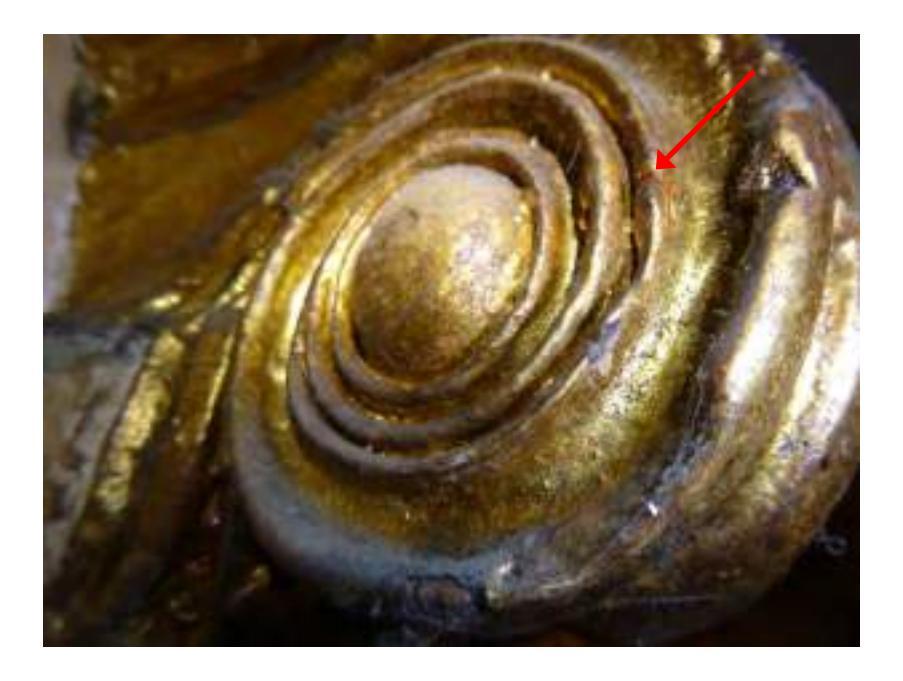
Fig 82:

Ground floor ceiling structures, RM.G-13; showing decorative plaster scroll with visible red or terra-cotta 'bole' suggesting some areas of possible historic gold leaf still remain

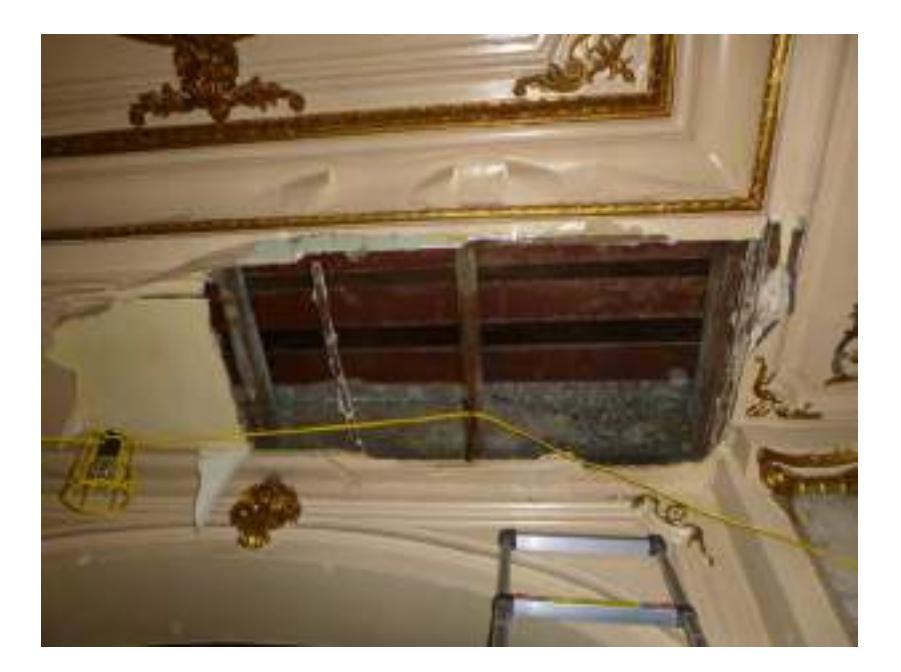
Fig 83:

Ground floor ceiling structures, RM.G-13; showing moisture damaged collapsed ceiling area at south-west area revealing 3no. RSJ structures within ceiling void supporting west elevation

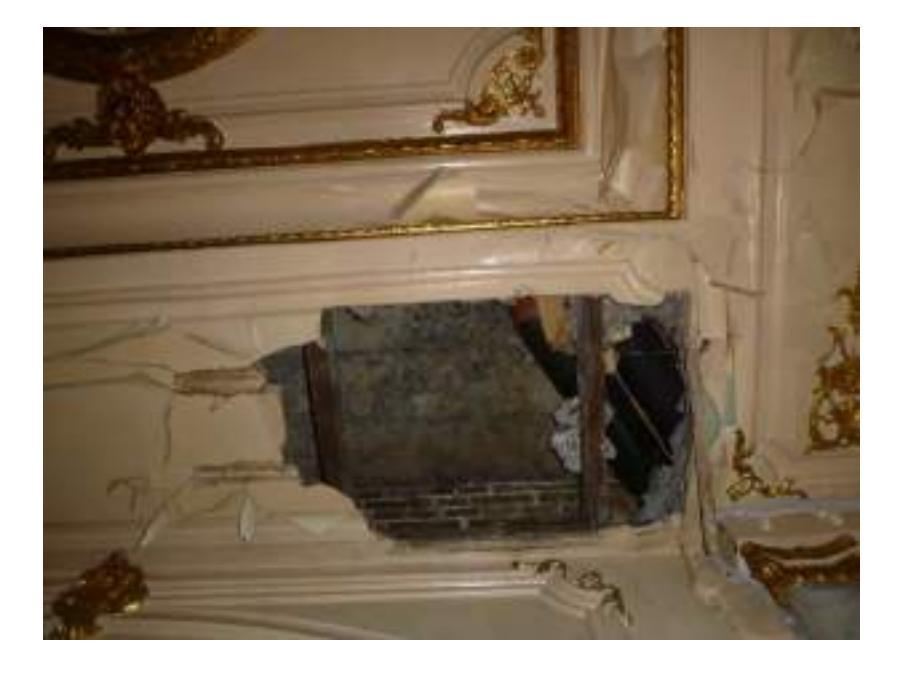
Fig 84:

Ground floor ceiling structures, RM.G-13; showing moisture damaged collapsed ceiling area at south-east area revealing ceiling void and perimeter ceiling joists structures beneath solid clinker floor structure above

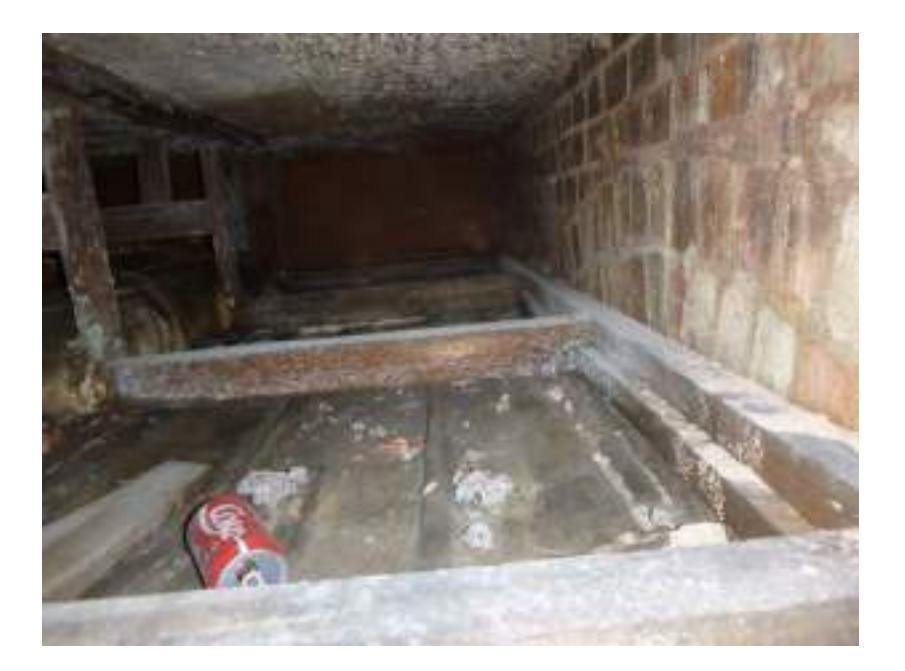
Fig 85:

Ground floor ceiling structures, RM.G-13; showing ceiling void at south-east corner. Note constructional detail of ceiling joists supported on a horizontal timber plate nailed to the masonry brick wall. Also note timbers subject to widespread surface mould growth as a result of trapped moisture and interstitial condensation with no provision for suitable ventilation

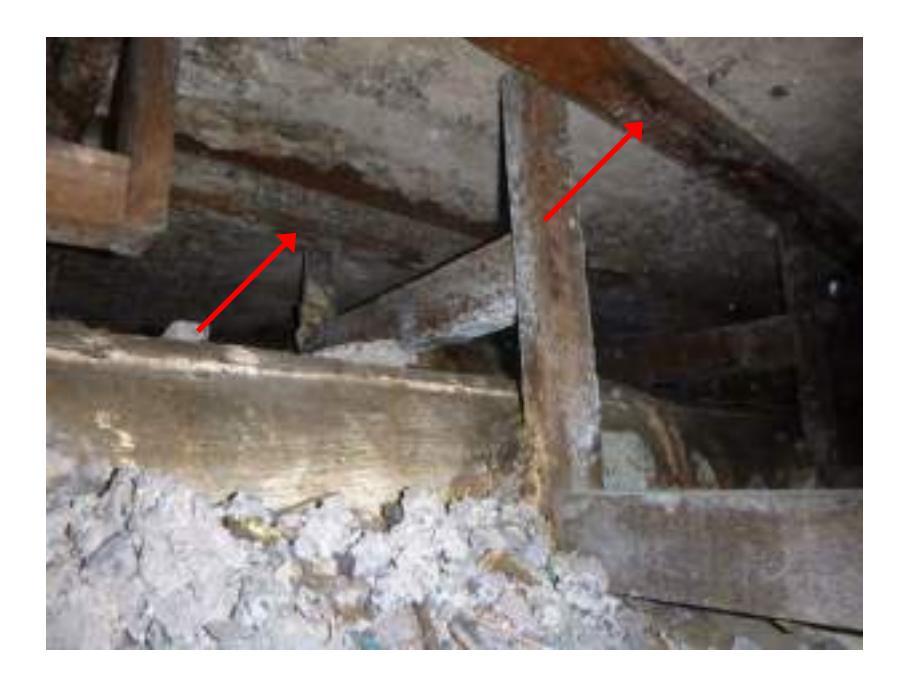
Fig 86:

Ground floor ceiling structures, RM.G-13; showing ceiling void at south-east area looking west. Note constructional detail of stepped ceiling timbers fixed to the solid clinker floor structure above via continuous timber plates. Also note timbers subject to widespread surface mould growth as a result of trapped moisture and interstitial condensation with no provision for suitable ventilation

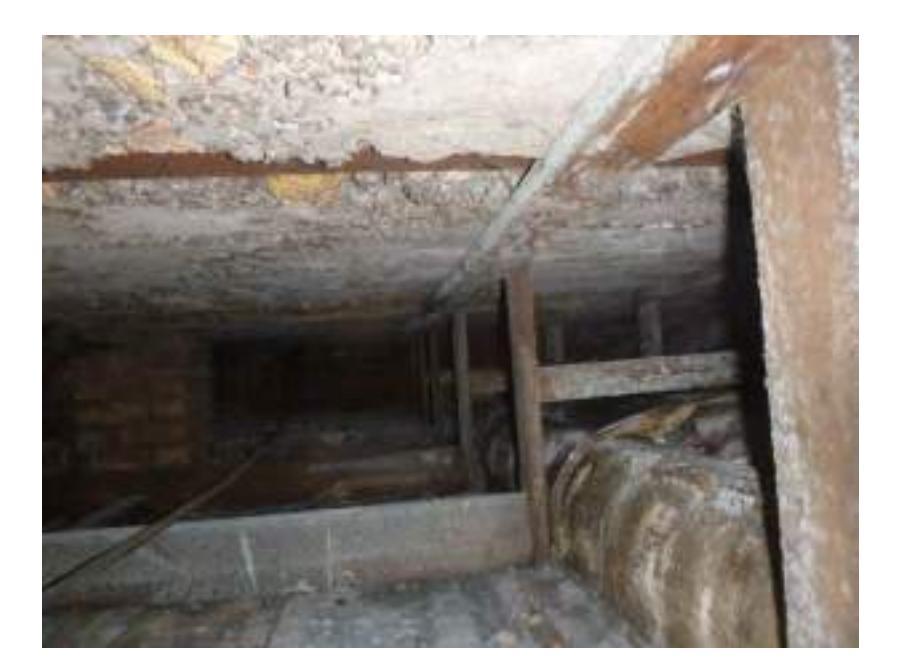
Fig 87:

Ground floor ceiling structures, RM.G-13; showing ceiling void at south-east area looking west. Note constructional detail of stepped ceiling timbers fixed to the solid clinker floor structure above via continuous timber plates. Also note significant mould growth to all visible timber elements

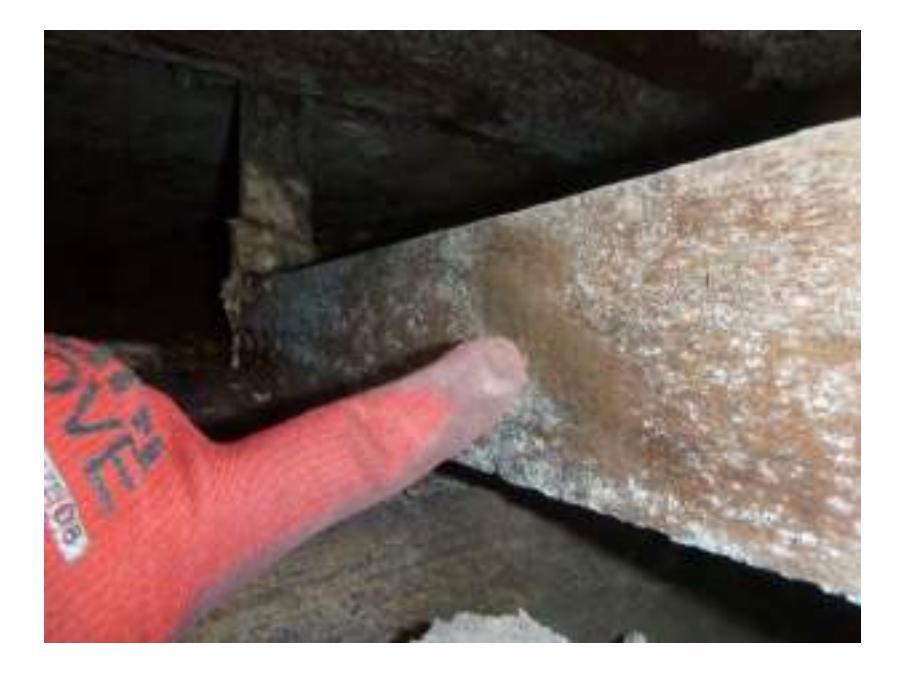
Fig 88:

Ground floor ceiling structures, RM.G-13; showing ceiling void at south-east area. Note area of ceiling joist subject only to superficial surface mould spores/growth with area of mould easily removed. Timbers suitable for cleaning and mould removal

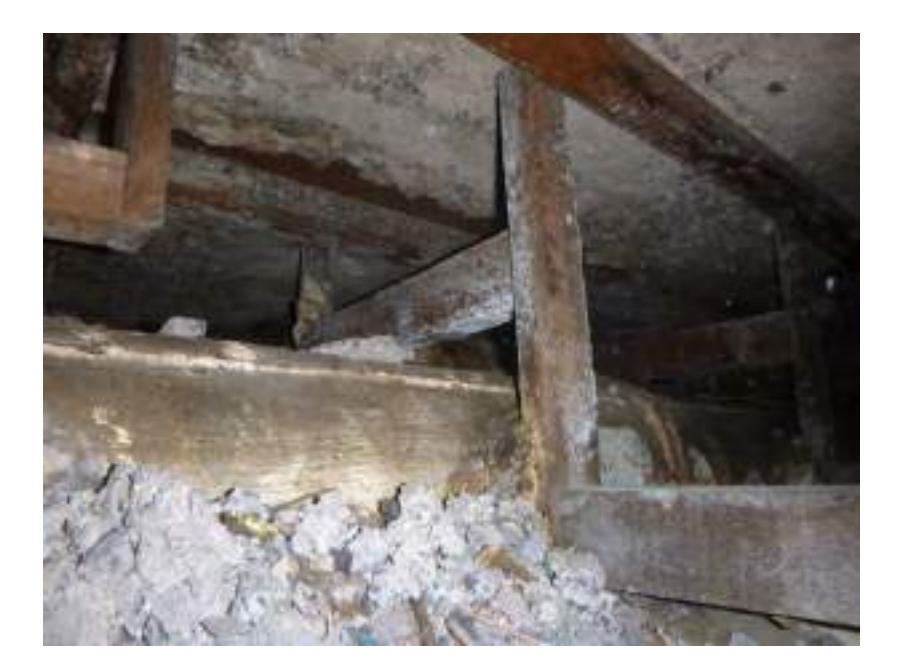
Fig 89:

Ground floor ceiling structures, RM.G-13; showing ceiling void at south-east area. Representative and vulnerable timbers were deep drilled and moisture probed. Sample areas showed surface moisture contents were wet at ~22+ per cent. However deep moisture contents were dry at ~14 per cent. Suggesting timbers were only superficially wet, but highly vulnerable to further damp and decay issues without proper drying down/ventilating

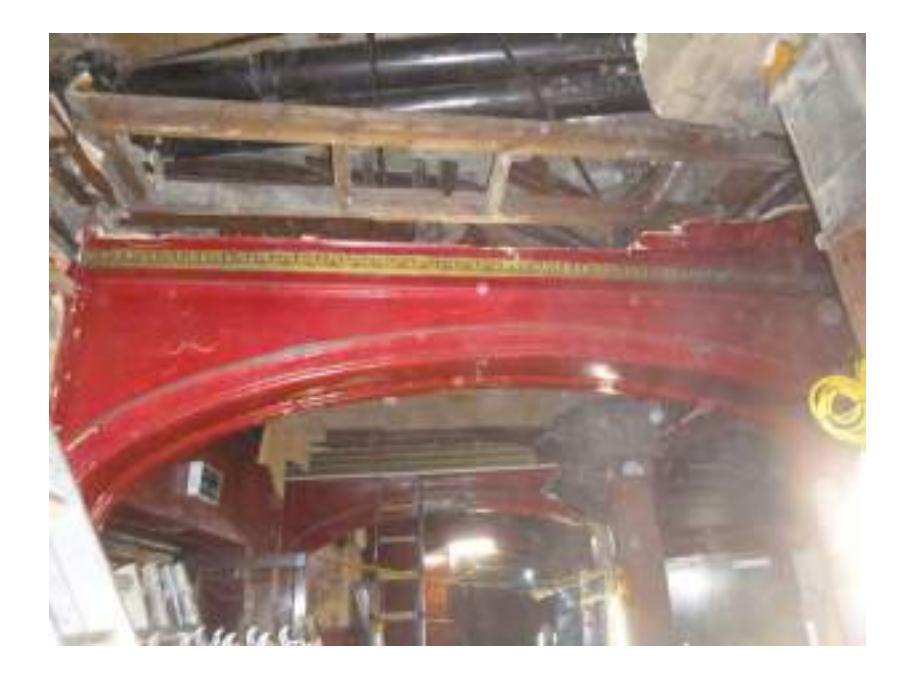
Fig 90:

Ground floor ceiling structures, RM.G-11; showing area in general looking north. Note historic ceiling structures have been heavily compromised by recent remedial and demolition works

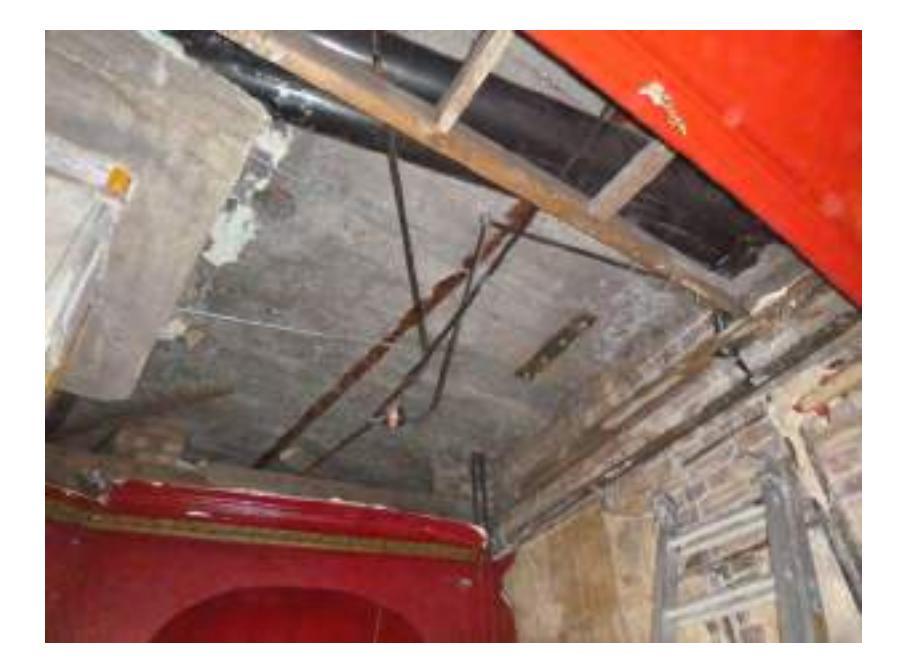
Fig 91:

Ground floor ceiling structures, RM.G-11; showing south bay area in general. Note historic ceiling structures in this area have been heavily compromised by recent remedial and demolition works. Estimated ~4-5 no. ceiling joists lost to this location

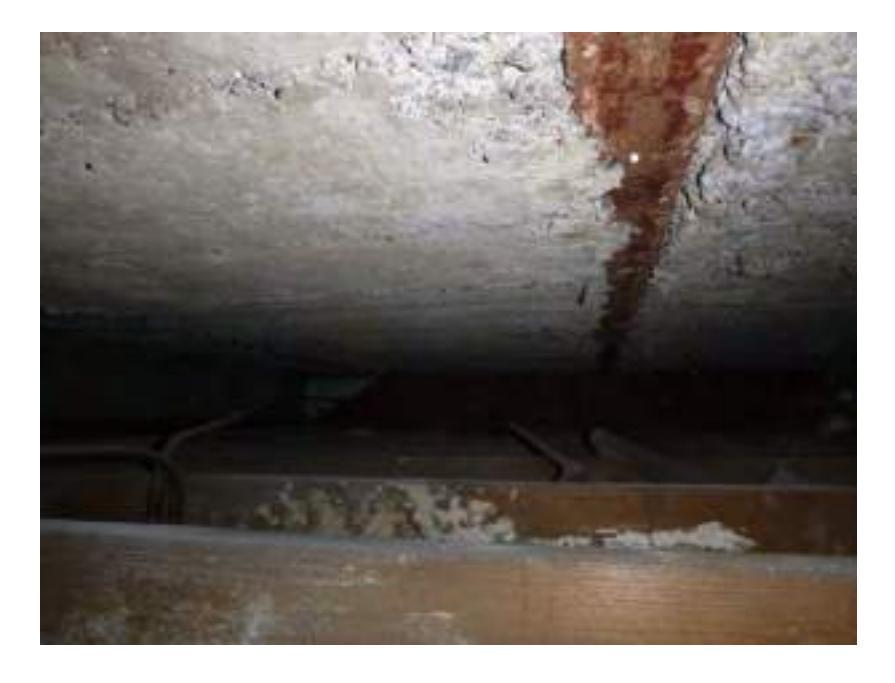
Fig 92:

Ground floor ceiling structures, RM.G-11; showing ~150mm ceiling void beneath solid floor clinker concrete structures above

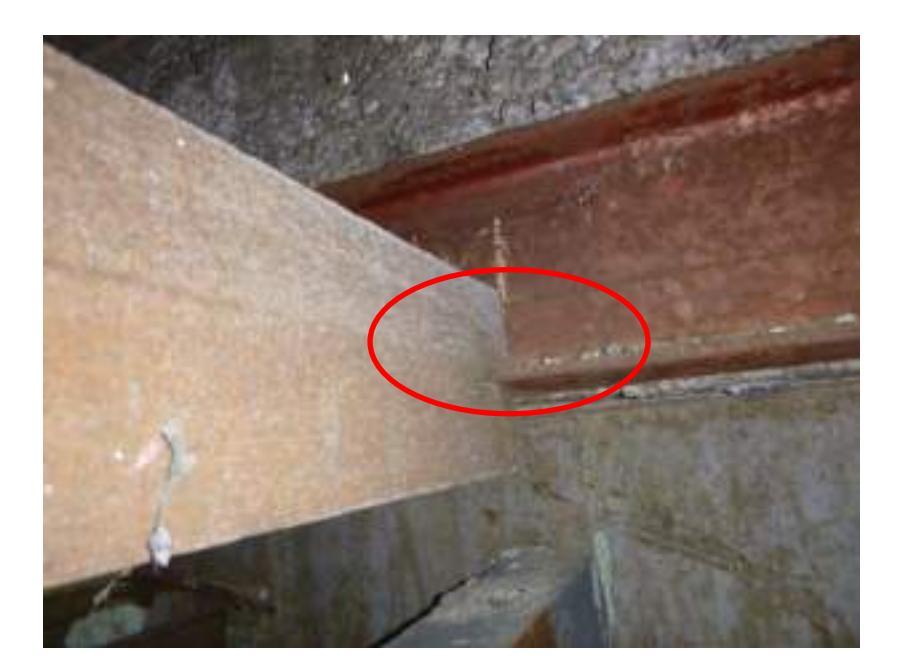
Fig 93:

Ground floor ceiling structures, RM.G-11; showing detail of ceiling joists supported by horizontal RSJ at east auditorium boundary wall

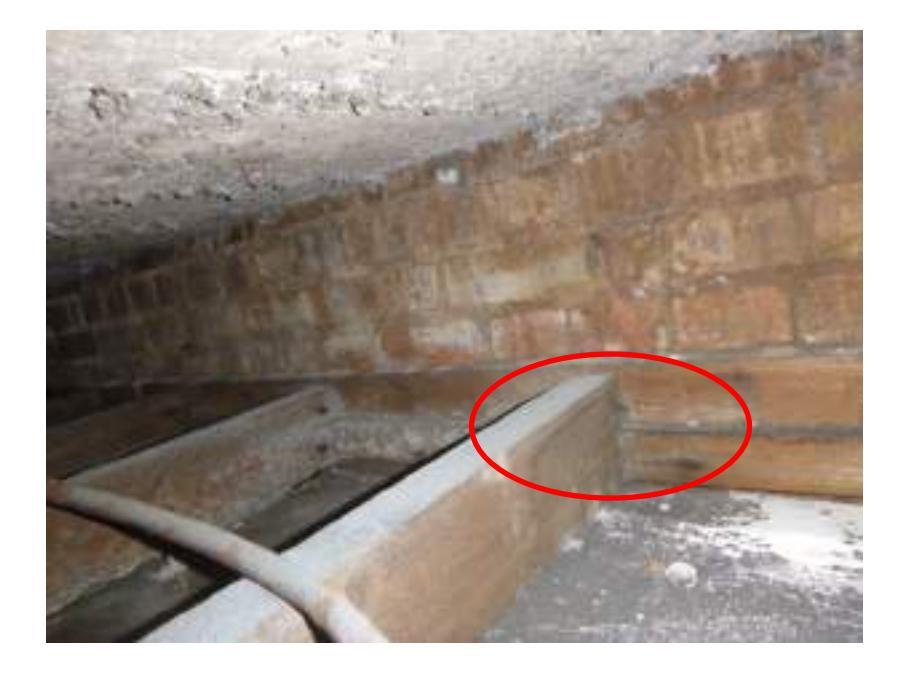
Fig 94:

Ground floor ceiling structures, RM.G-11; showing detail of ceiling joists supported by horizontal timber plate, nailed to west partition entrance lobby wall

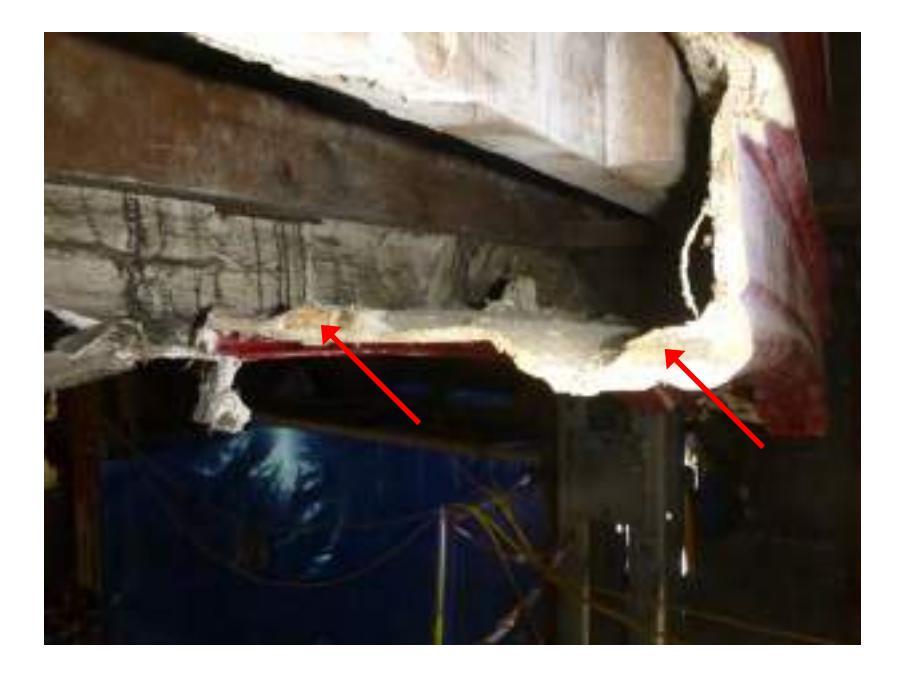
Fig 95:

Ground floor ceiling structures, RM.G-11; showing detail of boxed bressumer decorative plaster detail. Note section revealing size and location of embedded softwood lathes highly vulnerable to moisture entrapment and damp and decay issues

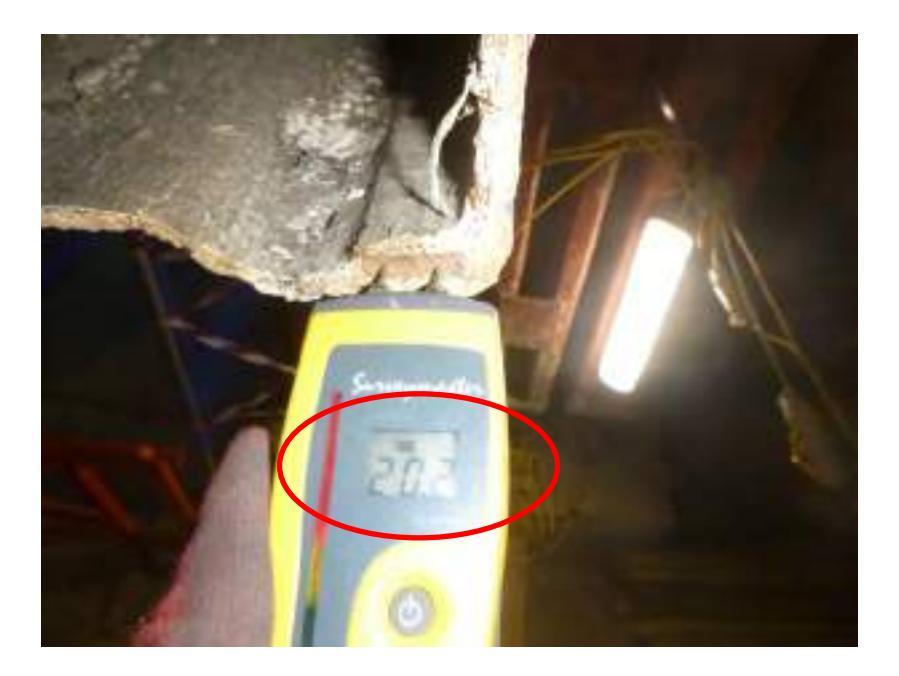
Fig 96:

Ground floor ceiling structures, RM.G-11; showing detail of boxed bressumer decorative plaster detail. Note section revealing size and location of embedded softwood lathes highly vulnerable to moisture entrapment and damp and decay issues. Moisture content reading showing 'wet' at ~20 per cent

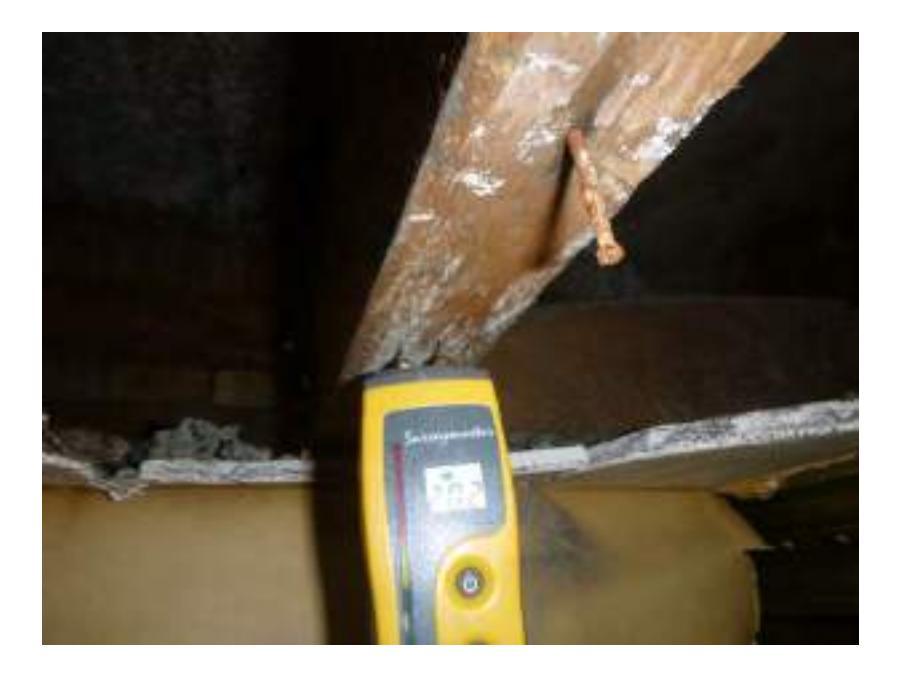
Fig 97:

Ground floor ceiling structures, RM.G-11; showing damaged ceiling plaster element revealing mould to ceiling joist element within void. Surface moisture content showing high moisture retention at ~20 per cent

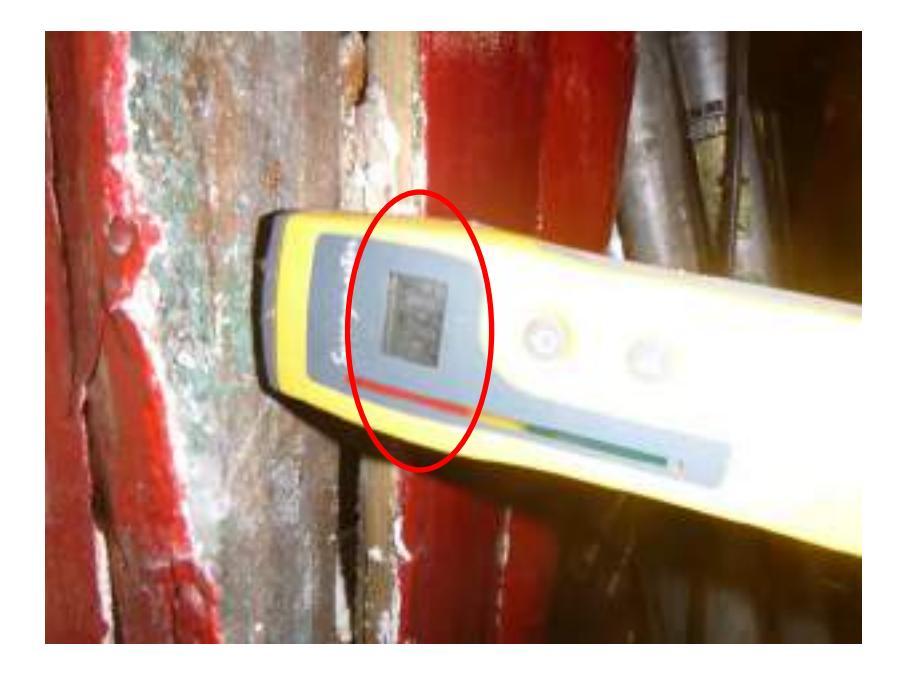
Fig 98:

Ground floor ceiling structures, RM.G-11; showing revealed stud element within boxed decorative arch subject to significant mould growth and onset of decay organisms. Surface moisture content showing high moisture retention at ~25 per cent

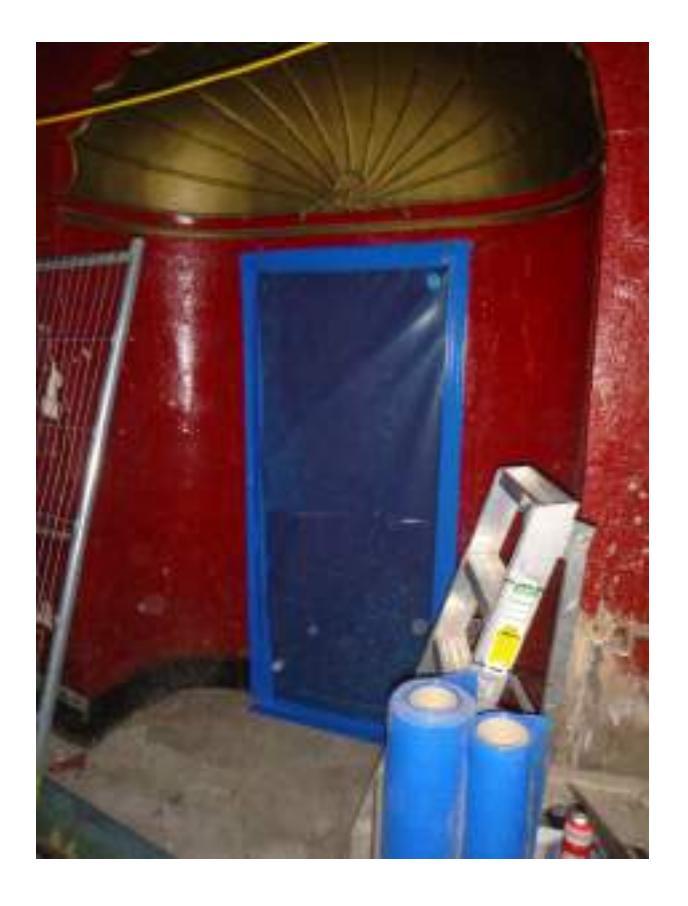
Fig 99:

Ground floor ceiling structures, RM.G-11; showing no access to balcony ceiling structures at the time of investigation due the clearing of ACMs

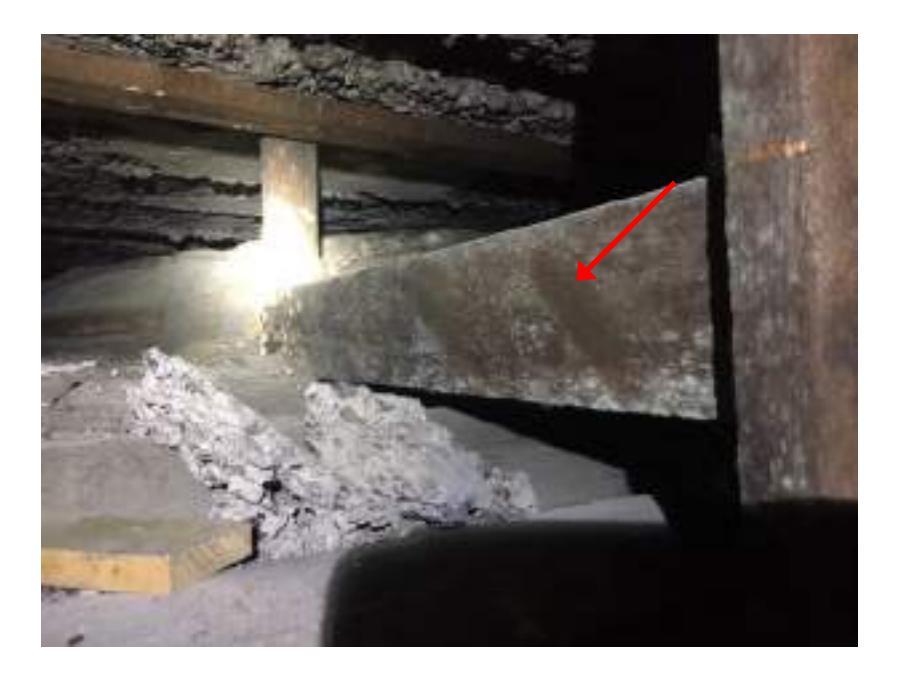
Fig 1:

Timber condition investigation; showing ceiling void at south-east corner of Room RMG13. Note historic ceiling timbers supporting plaster and lath ceiling structures subject to surface mould growth. However, surface mould growth does not appear to have worsened considerably since previous site visit at '14 April 2020'. See Fig. 2 beneath from previous site investigation

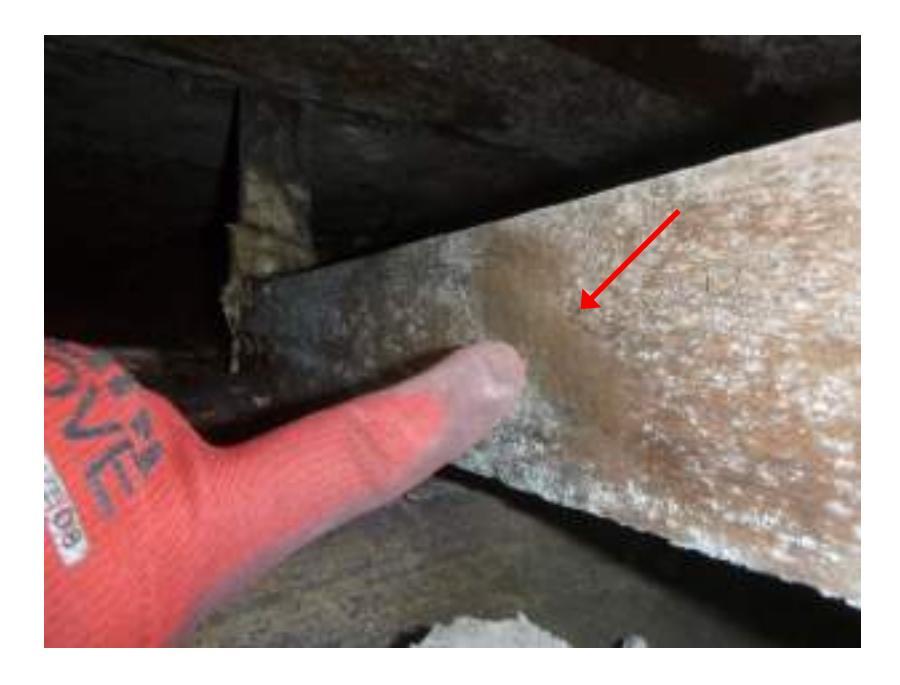
Fig 2:

Timber condition investigation; showing identical areas as depicted in Fig.1. taken approximately ~4 months previously. Note localised mould contamination/growth unchanged

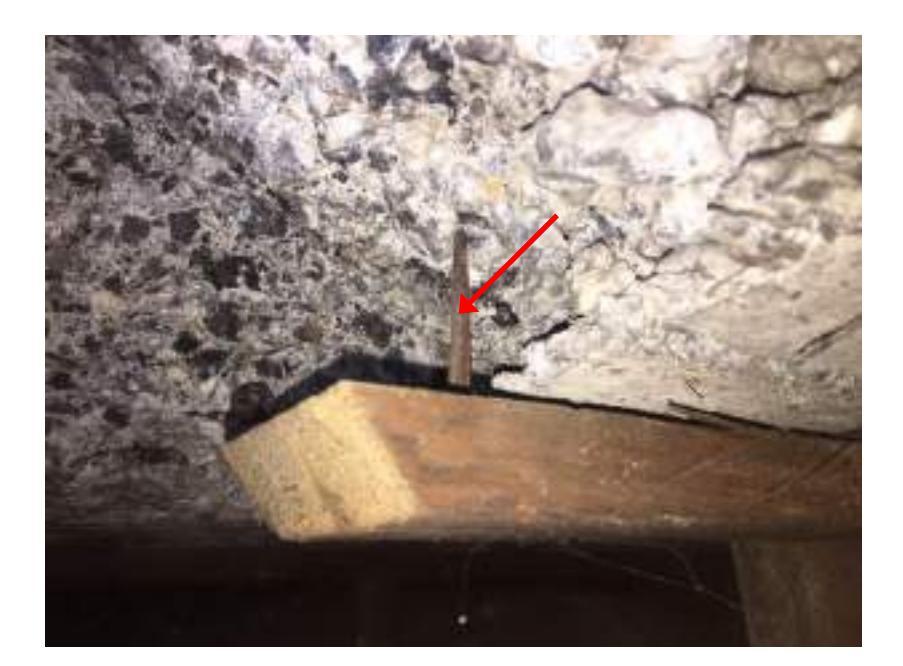
Fig 3:

Timber condition investigation; showing detail of timber plate supporting historic lath and plaster ceiling. Note localised damage to concrete clinker floor structures above have revealed depth and condition of cut nail fixings

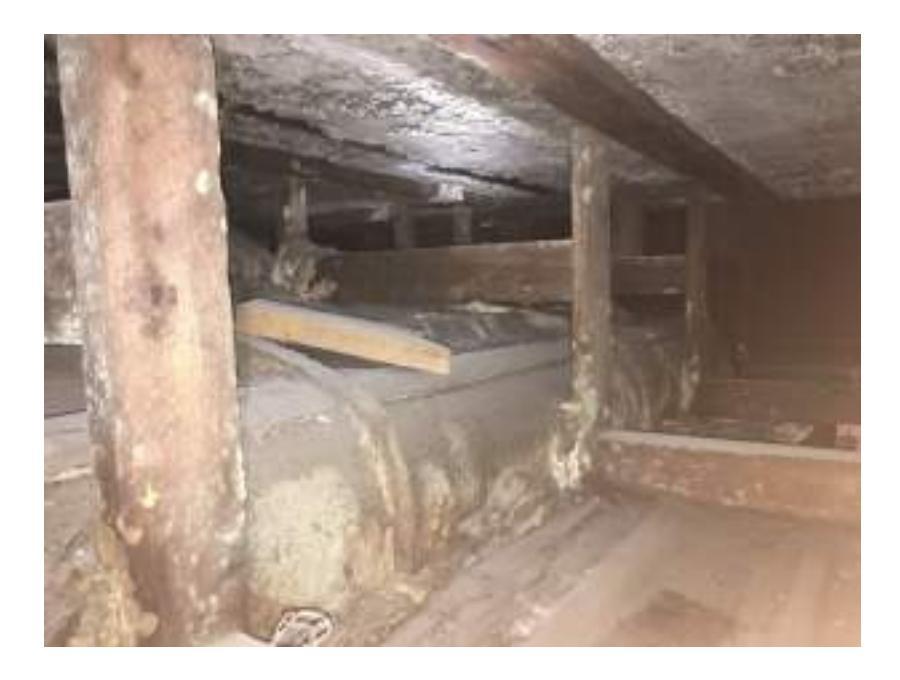
Fig 4:

Timber condition investigation; showing void looking north. Note structures appear to be visibly dry and mould activity lessening

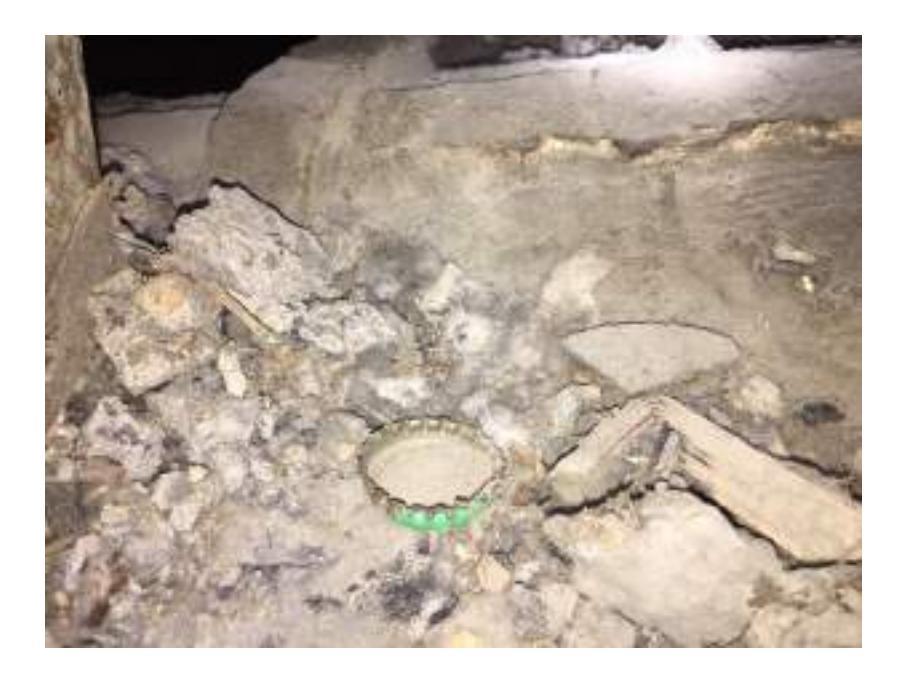
Fig 5:

Timber condition investigation; showing significant amount of debris still within ceiling void which is helping to trap moisture and prevent drying out of structure

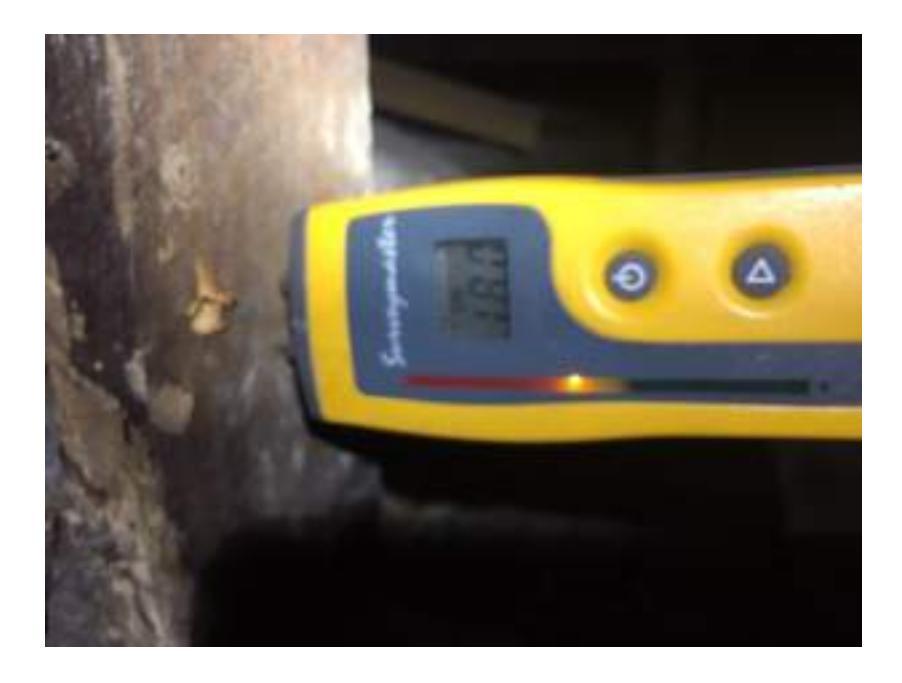
Fig 6:

Timber condition investigation; showing typical surface moisture contents elevated at 18%. However, significantly drier than previous surface moisture contents at 21-22% and above. Structures apparently are drying out

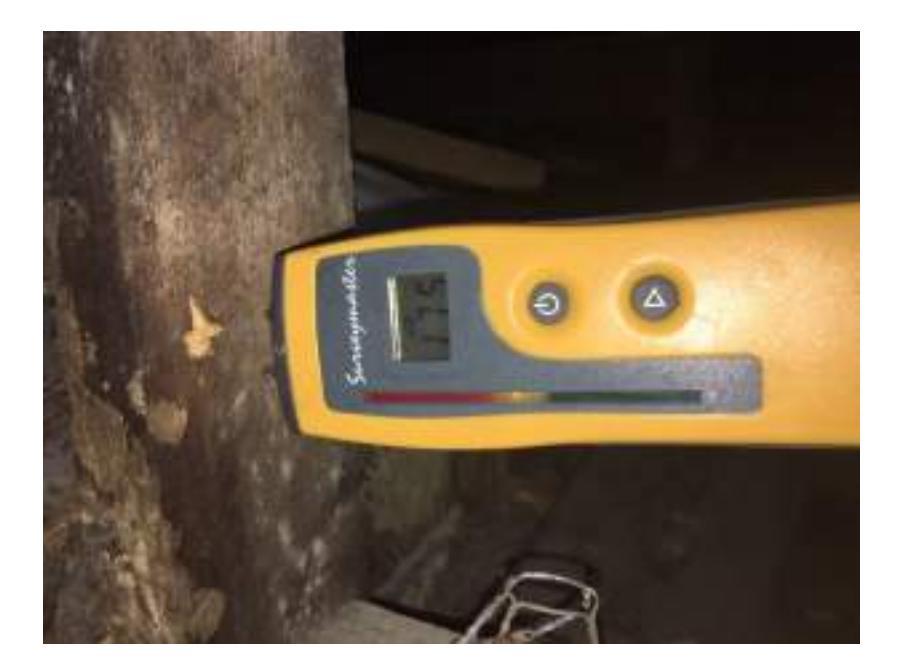
Fig 7:

Timber condition investigation; showing surface moisture content of vertical timber batten supporting historic decorative plaster ceiling with surface moisture content at 17-18%, which although elevated, is too low to support active decay organisms

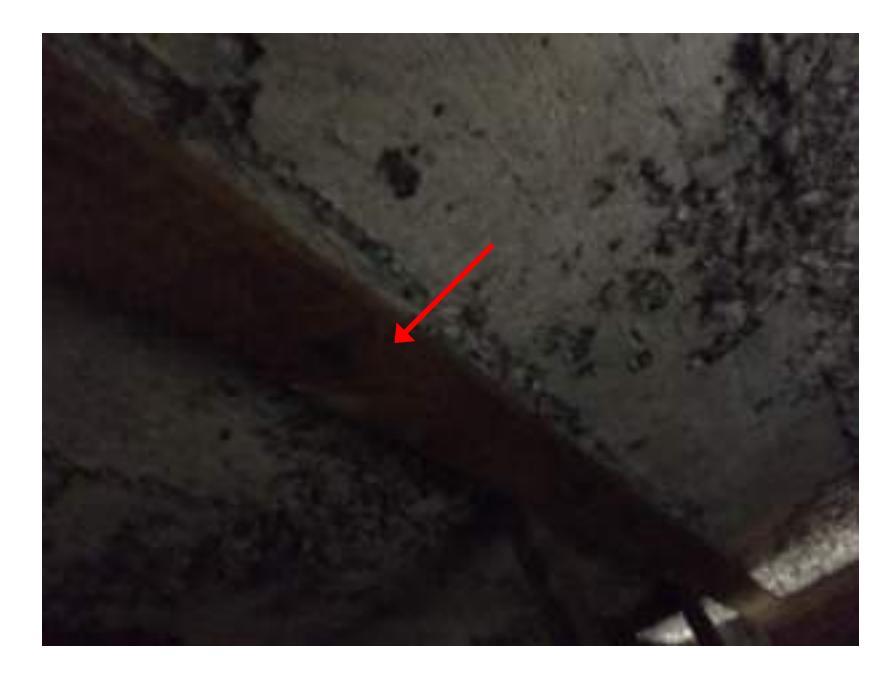
Fig 8:

Timber condition investigation; showing horizontal plate supporting decorative plaster and lath ceiling running parallel with central spine RSJ

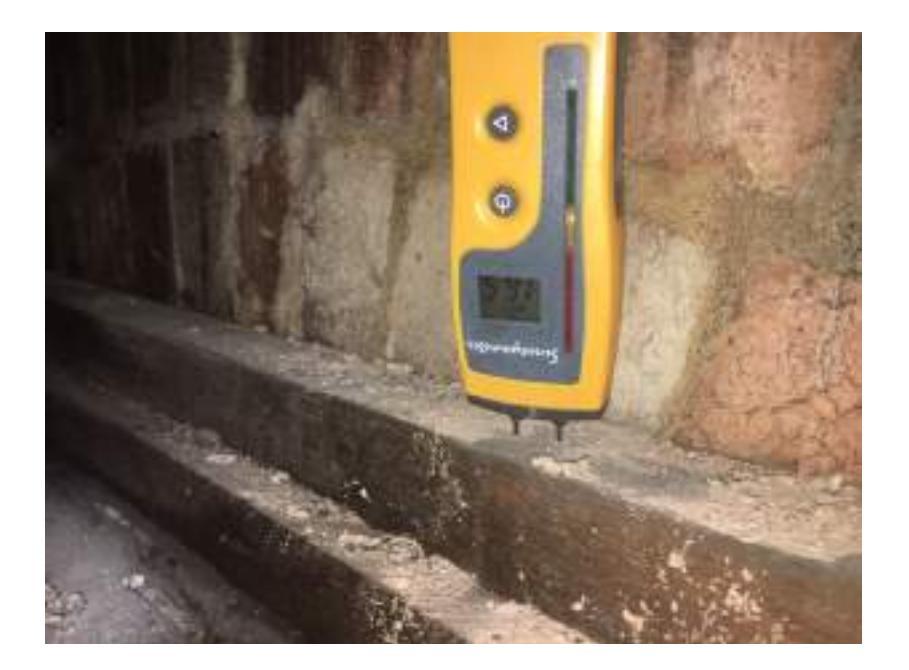
Fig 9:

Timber condition investigation; showing wall plate supporting external perimeter of ceiling structures with elevated surface moisture content at 16.5%, which was too low to support decay organisms

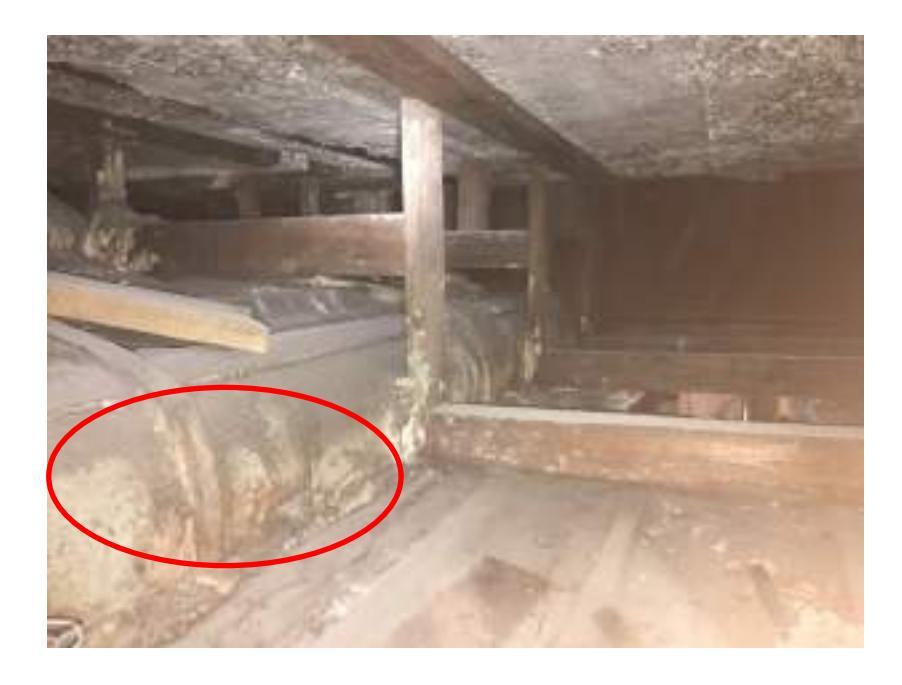
Fig 10:

Timber condition investigation; showing ceiling void subject to what appears to be no longer active surface mould growth during recent summer months and a period of drying out

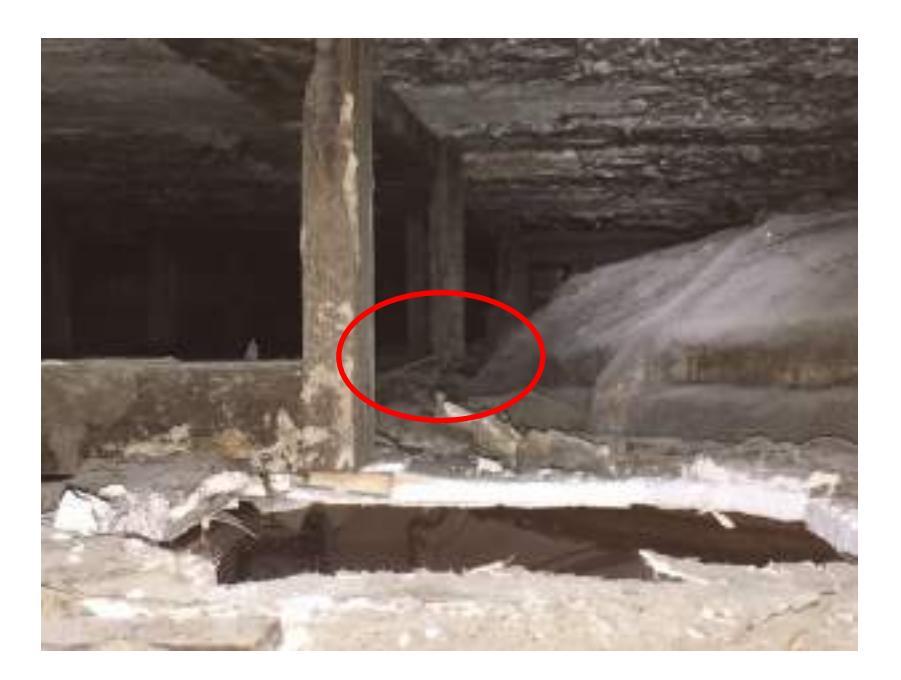
Fig 11:

Timber condition investigation; showing failed timber connection between vertical and horizontal members possibly due to the increased weight of plaster during periods of saturation post firefighting efforts. Timber connection requires strengthening/making good
