APPENDIX 3: DRYING OUT WORKS- SCOPE AND EXTENT OF WORKS

Site Note 7: Preliminary Damp Condition Investigation (Masonry)- March 2020

Site Note 7: Preliminary Damp Condition Investigation (Masonry)

The Hope Project (KOKO): Phase 1 of the preliminary damp condition Investigation

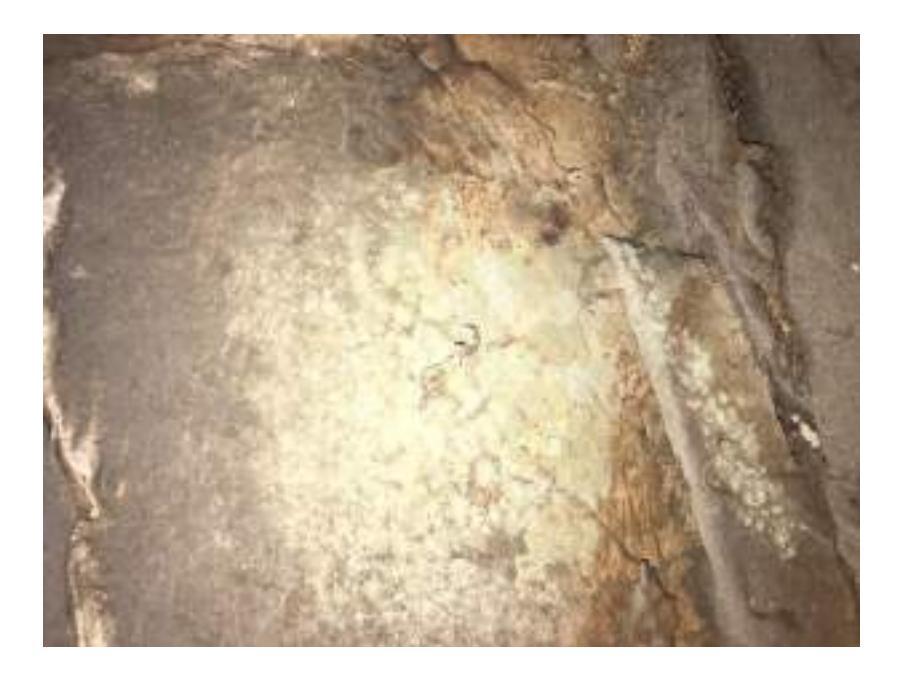
Fig 12:

Timber condition investigation; showing fairly extensive surface mould growth. However, mould growth deemed relatively in-active and surface and deep moisture contents too low to support further mould growth at the time of investigation

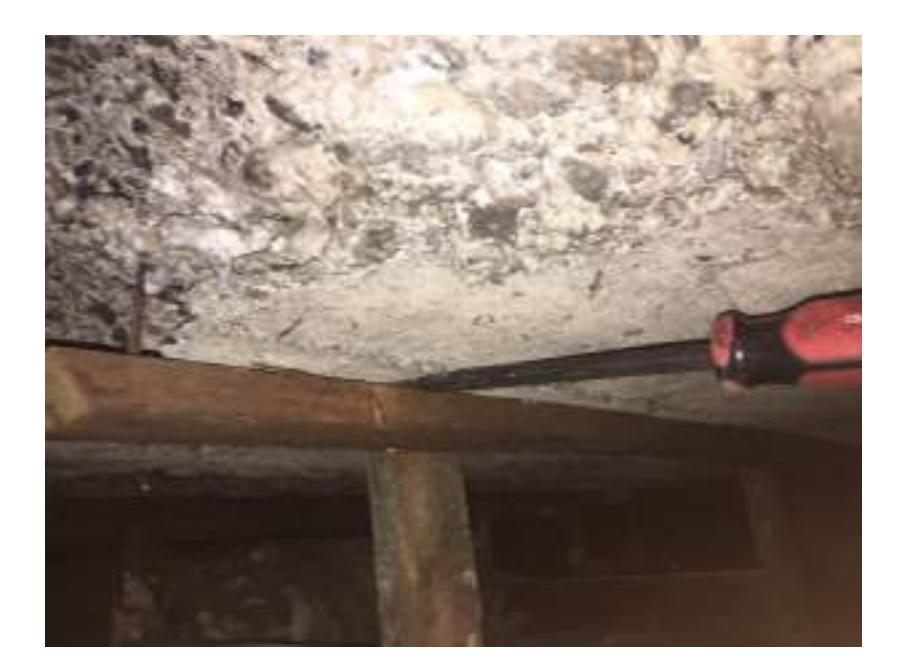
Fig 13:

The continuous ceiling plate steel fixings, usually at ~600mm centres, were visibly corroded with blue ferrous staining to the surrounding timber. Although likely of historic origin, the prolonged historic corrosion and potential weakening of the fixings grounding is likely to be exacerbated by the sudden increase in trapped moisture within the property, as well as the build-up of interstitial condensation within the ceiling voids will degrade the already evident corrosion leading to eventual possible failure of the structural ceiling plates	The corrosion state and structural adequacy of existing steel fixings within ceiling plate structures should be determined by H+R, Structural Engineer and the specialist Plaster Restorers. Allowance should be made for repair or replacement as directed by the Structural Engineer, and for provision of 'cathodic protection' as necessary, so as to minimise further corrosion during and after refurbishment. In addition to this, H+R recommend that should the ceiling plate timbers subject to fixings corrosion be deemed retainable upon refurbishment, additional non-corrosive fixings be introduced to provide adequate structural adhesion should the existing historic fixings fail

Timber condition investigation; showing example of plate fixtures to clinker concrete slab above. Note that plate can be relatively easily removed suggesting typical failure and corrosion of embedded fixings

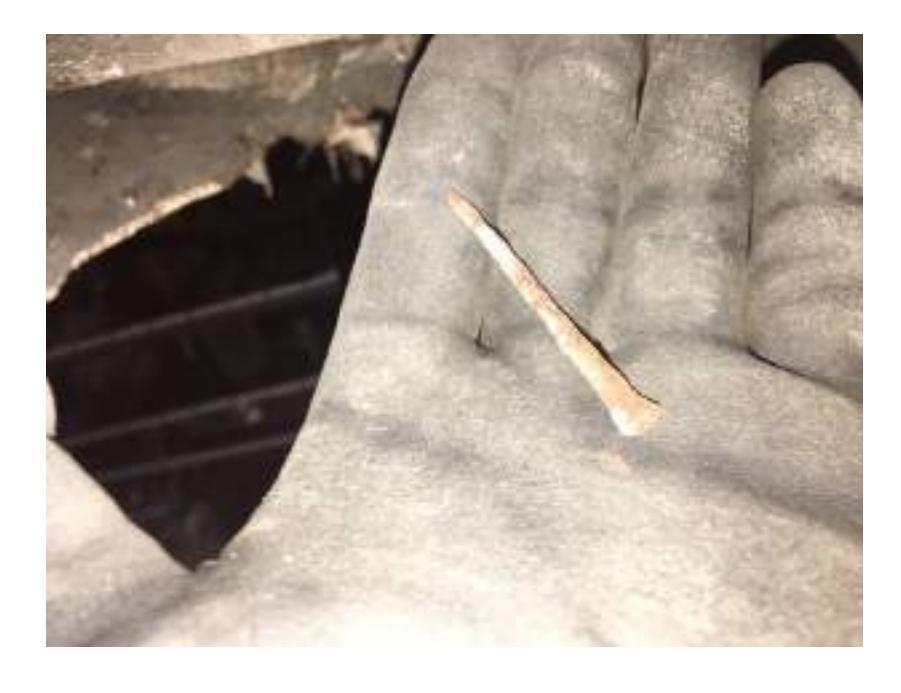
Fig 14:

Timber condition investigation; showing retrieved embedded fixing subject to fairly extensive corrosion

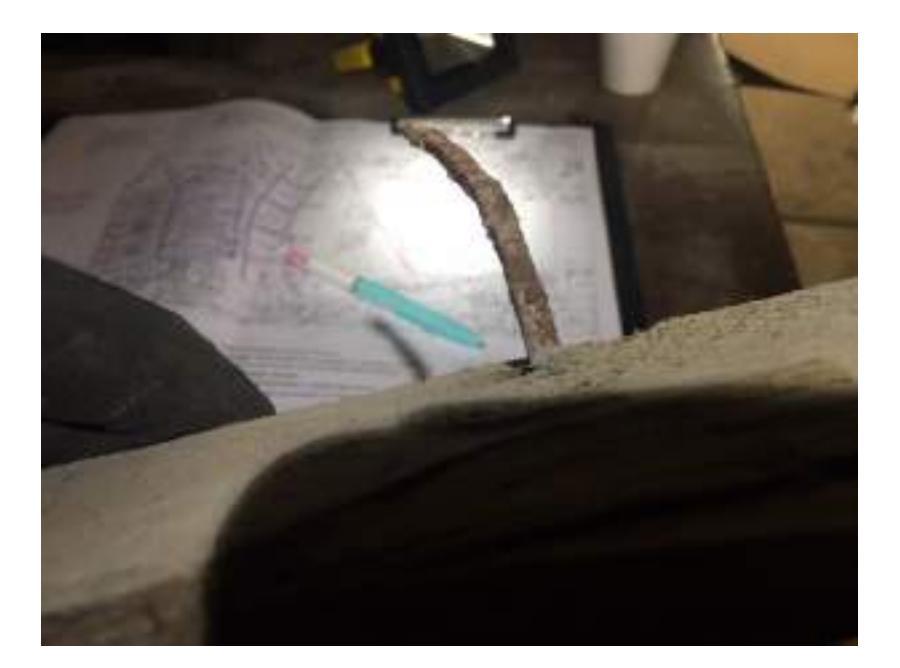
Fig 15:

Timber condition investigation; showing retrieved fixing from plate into clinker floor structure above. Note fixing heavily corroded and liable failure

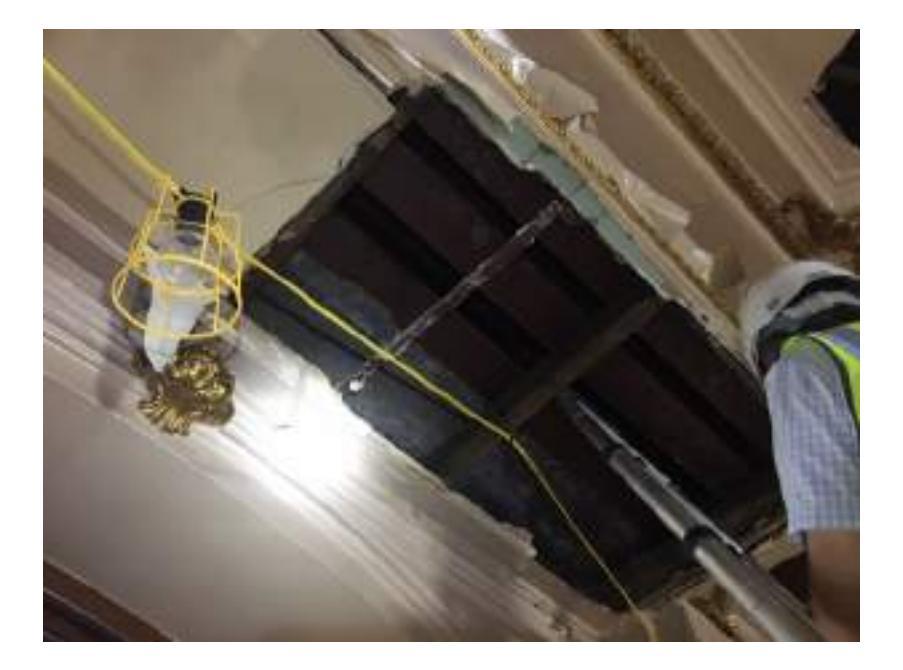
Fig 16:

Timber condition investigation; showing west perimeter wall of Room RMG13 supported via 3 no. north/south RSJ structures which in turn support west perimeter decorative plaster and lath ceilings

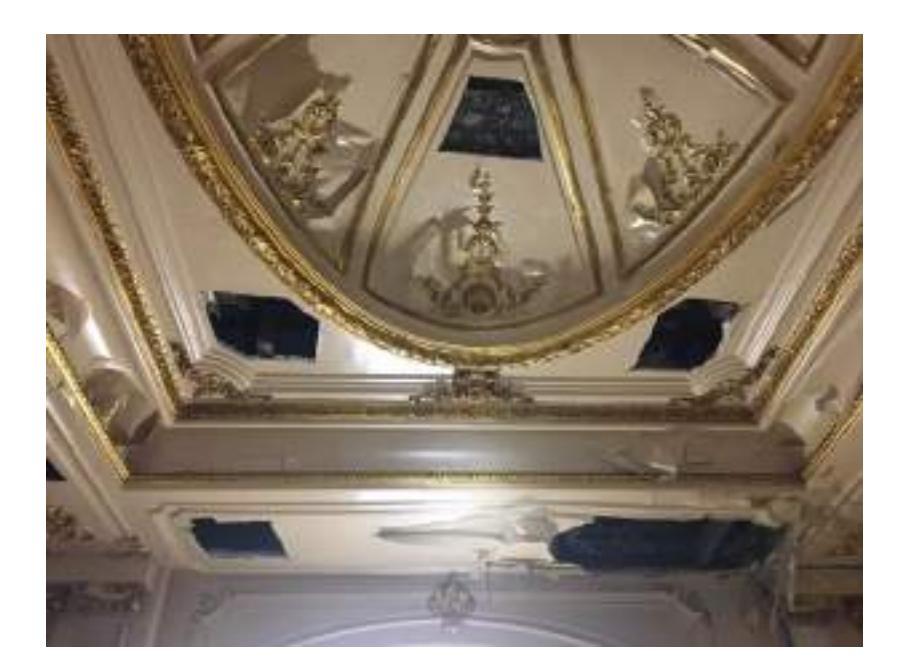
Fig 17:

Timber condition investigation; showing typical area of exposure to ceiling voids for increased ventilation and drying out

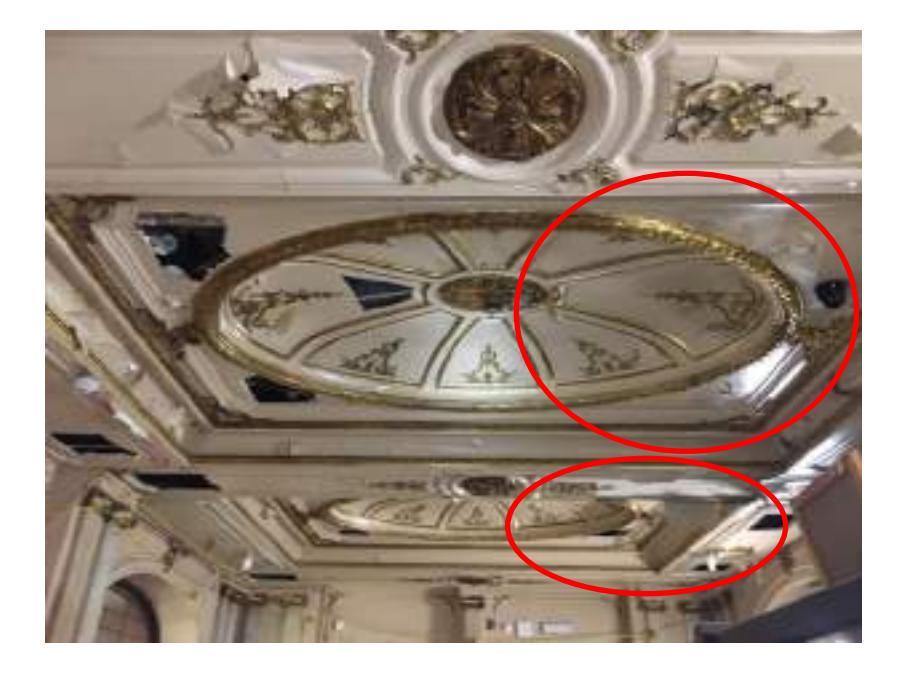
Fig 18:

Timber condition investigation; showing room in general looking north. Note previous efforts at exposure to blank panel areas to avoid damage to decorative areas. However, multiple areas remain which still require opening to aid in additional through ventilation of ceiling voids

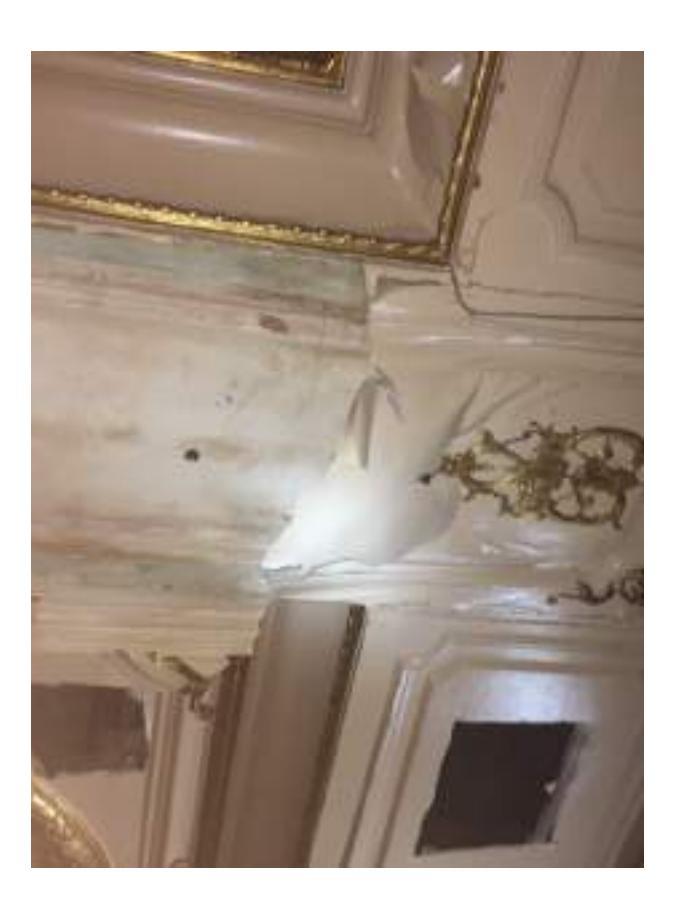
Fig 19:

Timber condition investigation; showing complete separation of previous inappropriate film forming paints

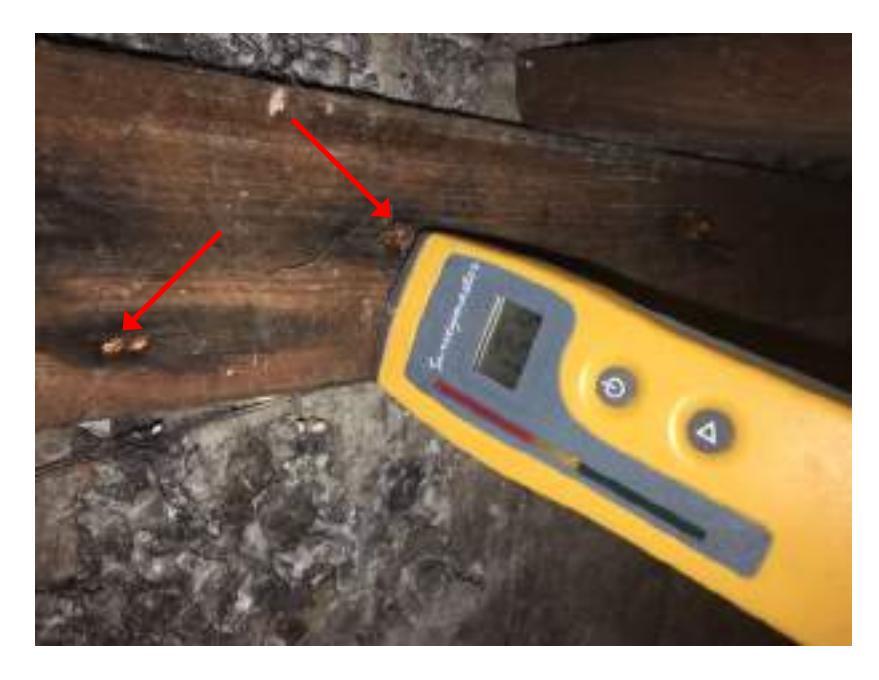
Fig 20:

Timber condition investigation; showing surface moisture content of ceiling plate at central south area at 16%. Note visibly corroded nail heads
