LOCKER & RILEY

Koko, Camden, London.

Project Title: *Koko*

L&R Reference: J2016 Koko.

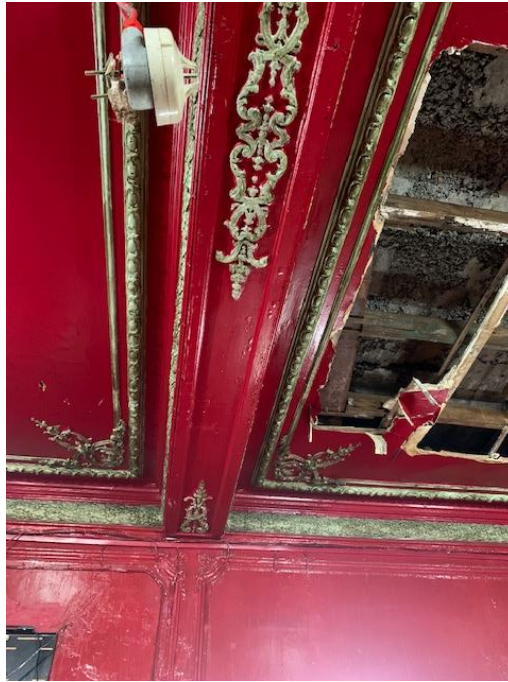
- The walls and ceiling soffits are coated with thick red paint. In many areas this has ‘blistered’ due to the trapped moisture held in the masonry walls behind. The Report by *Catherine* Hassall (March 2020) confirms that the red surface paint covers a succession of applications including to some surfaces a gypsum skim coat. The removal of these paint layers by chemical and mechanical means would be time consuming and expensive with an uncertain outcome given the damp status of the plaster substrate.

- The complete removal of the wall plaster to reveal the masonry substrate is the only way to ensure successful drying out. Retention of wall plaster greatly hinders and prevents the loss of trapped moisture in the masonry which will leave a legacy of potential efflorescence of salts, conditions suitable for fungal attack on timber and the appearance of ‘damp patches’ and discolouration on completed decorated walls.

- It was not possible to closely inspect the timber support system below the concrete soffit nor assess the integrity of the remaining fibrous plaster cornice and soffit.

- At this preliminary stage and subject to the reports by the Asbestos Consultant, the Structural Engineer, the paint and timber/damp specialists we would suggest the following:

1. ceiling corner enrichments,
 2. decorative cornice,
 3. beam casing including the ornate relief details
 4. wall mouldings.
 - The condition and integrity of the fibrous plaster cornice and remaining ceiling soffit should be closely inspected.

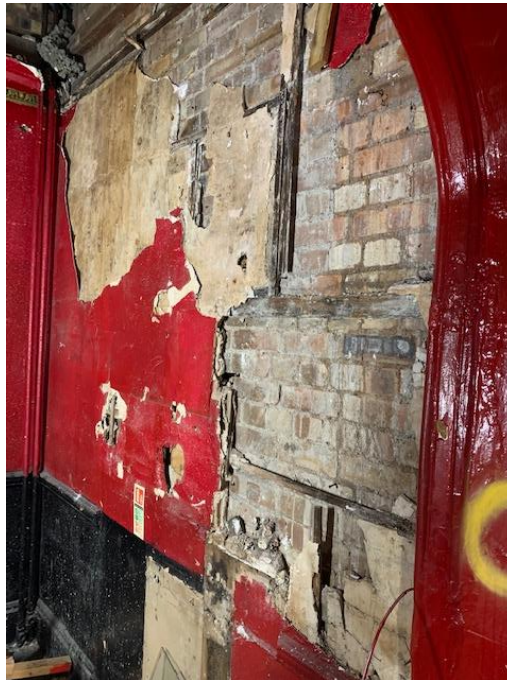
- The arches and pilasters have lost small sections due to the structural works, however the poor condition and fragility of the ceiling, cornice and walls are as a consequence of the fire and subsequent water damage.
- The walls are plain with a simple dado rail and skirting. Much of the wall surface has been painted over a textured (paper?) surface with a thick gloss red paint.
- It was not possible to closely inspect the timber support system below the concrete soffit nor assess the integrity of the remaining fibrous plaster cornice and soffit due to issues of access and the risk of asbestos.

- At this preliminary stage and subject to the reports by the Asbestos Consultant, the Structural Engineer, the paint and timber/damp specialists we would suggest the following:
 - It is L&R's consideration that much of the remaining sections of plaster ceiling, cornice and frieze will be lost. Therefore, samples and squeezes should be taken of the following mouldings:
 1. Arch and pilaster sections.
 2. Egg and Dart cornice.
 3. Niche heads.
 - Chases are cut into the wall plaster to determine the condition of the masonry and substrate behind.
 - Removal of the wall plaster would greatly enhance the drying process and greatly remove the risk of legacy issues such as efflorescence, fungal attack and staining/damp on finished decorative surfaces.

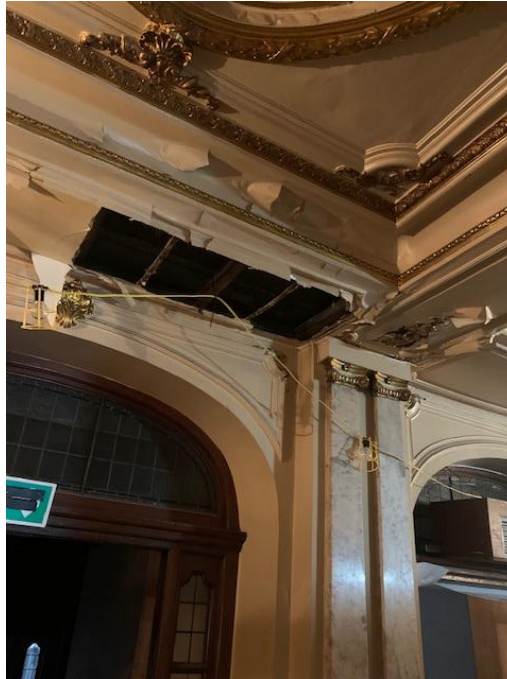
- This Foyer area consists of three bays each containing a shallow oval dome and an enriched cove to the perimeter. The dividing beams have decorative elements in relief. The walls are decorated with marble pilasters and panels with ornate quadrant corners.
- The ceilings, cornice and beams are of fibrous plaster construction suspended from the concrete slab above on timber joists and noggins. The recent ingress of water has caused the failure and loss of some sections of ceiling soffit. Further areas appear to be in a poor condition and are at risk of collapse.

- Chases are cut into the wall plaster to determine the condition of the masonry and substrate behind.
- Sample areas of wall and ceiling should be paint stripped. This would help to determine the value and benefit of such a task

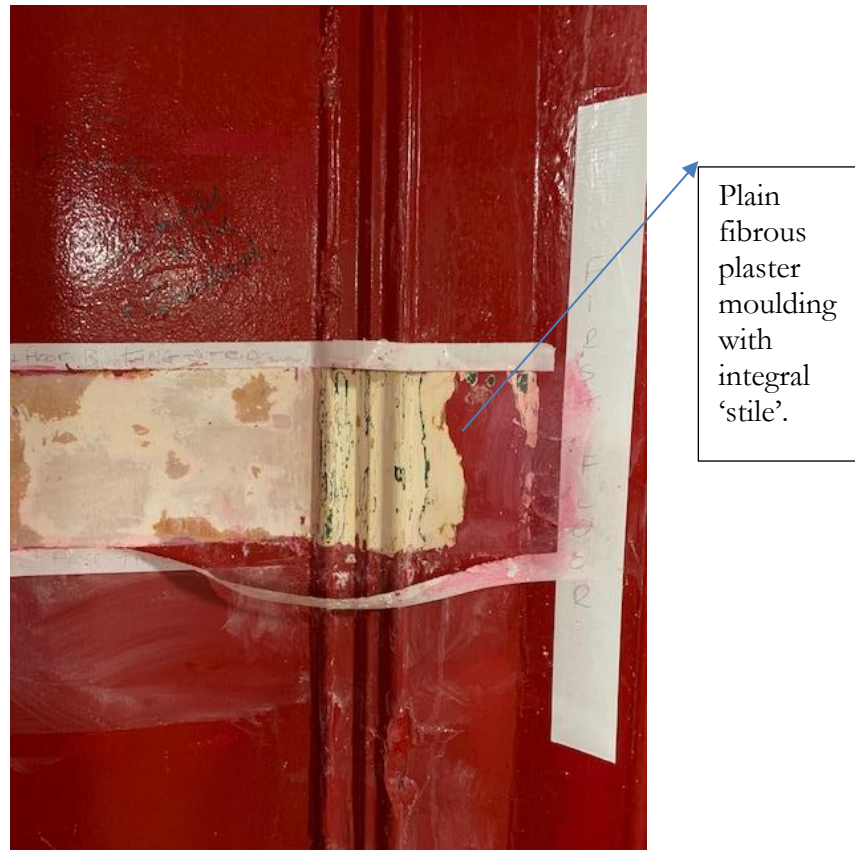
- It was possible to confirm that the following samples and squeezes were required:
 - Ceiling corner enrichments,
 - Decorative cornice,
 - Beam casing including the ornate relief details

- Plain wall moulding including enriched quadrant corner.

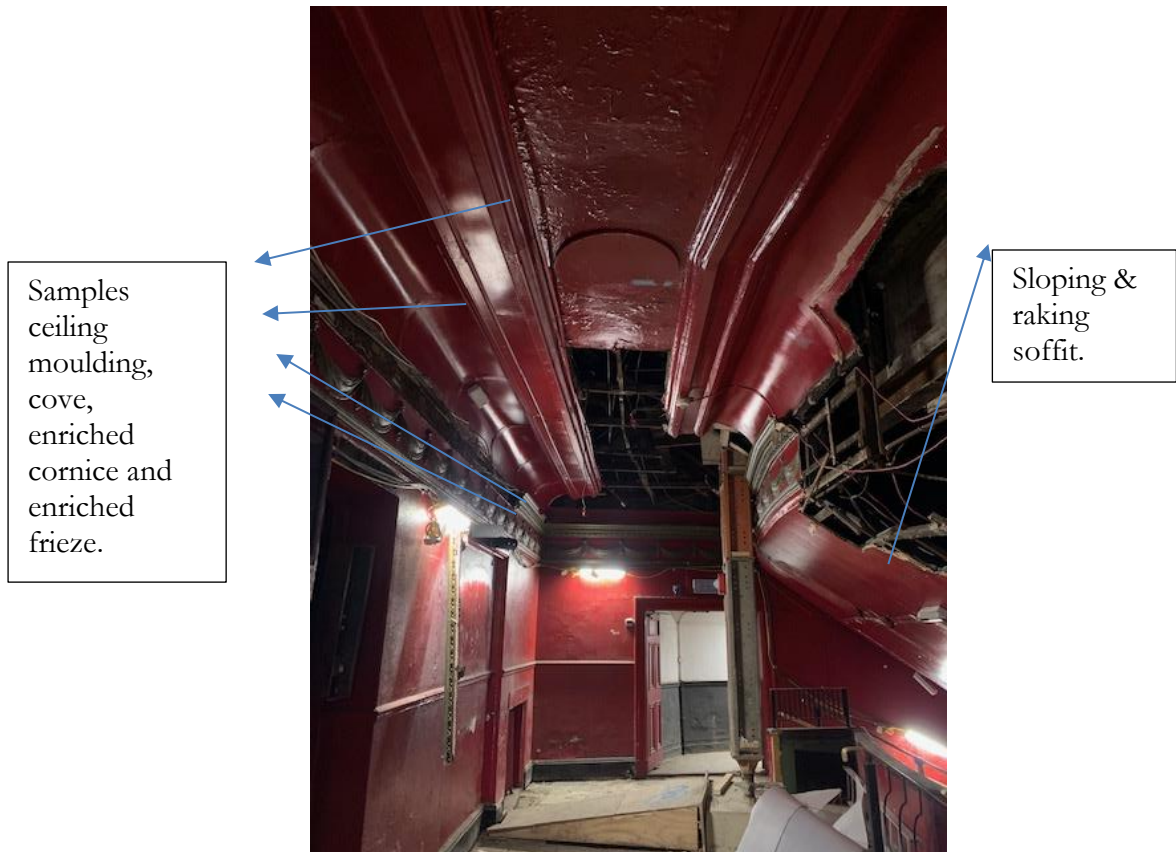
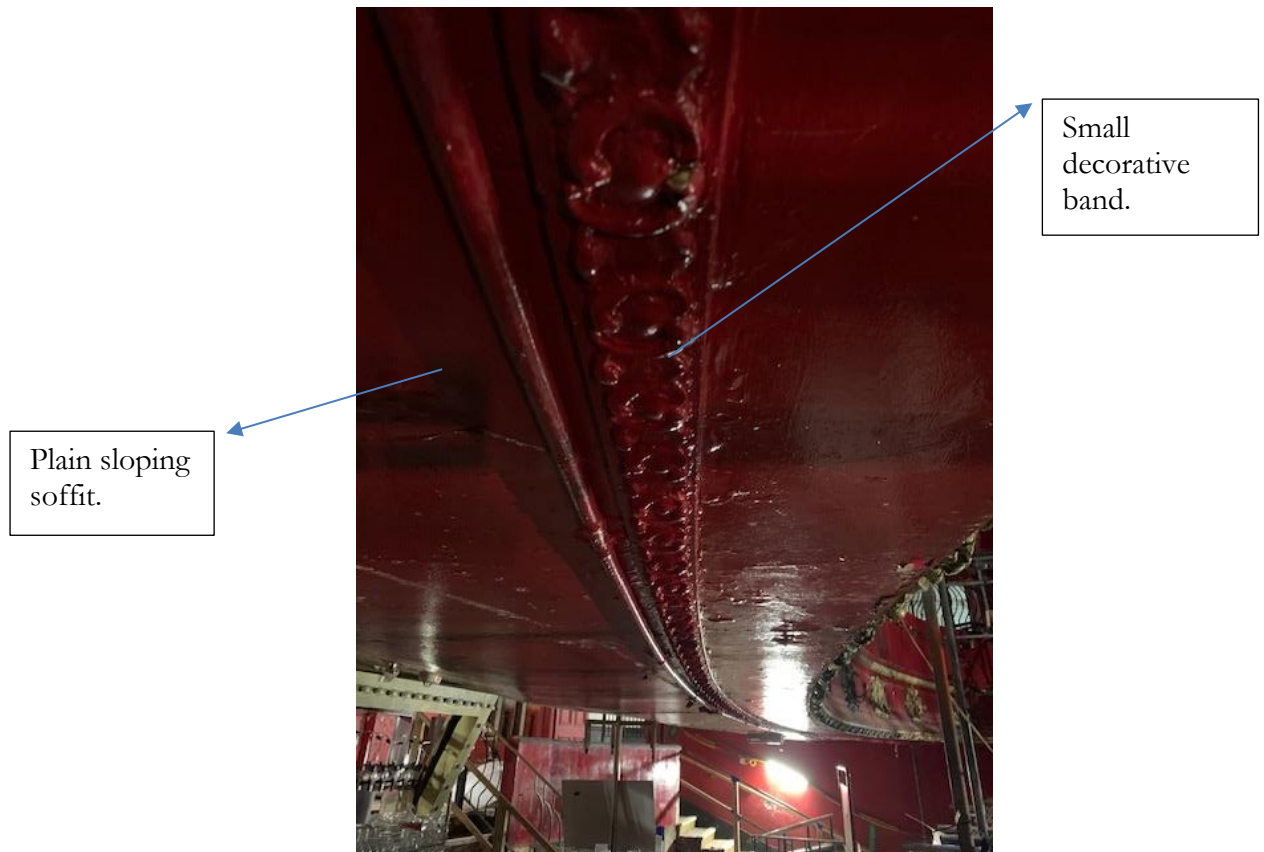
2.2.Room 1.12. Lobby at back of Auditorium.

- The *Hutton & Rostron Report* confirmed that the supporting timber and steel elements behind the ceiling had been badly affected by water ingress and were vulnerable to fungal decay. Their Report also identified the ceiling void is contaminated by ACM's.

- Therefore, samples and squeezes should be taken of the following mouldings:
 - Plain cove and ceiling band.

- Egg and Dart cornice and frieze.
- Small decorative band at lower end of raking soffit.

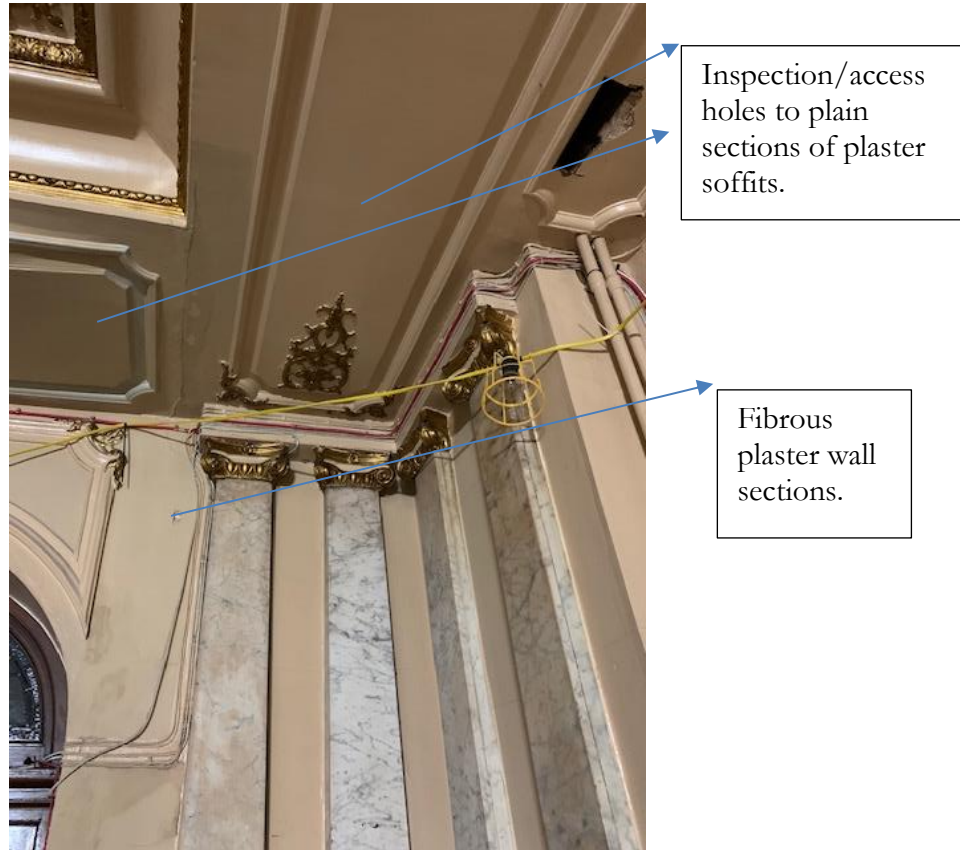
- The walls are also fabricated in fibrous plaster and fixed to timber noggins secured to the masonry walls. It can be assumed that water has penetrated these masonry walls and has affected the timber battens/noggins behind.

- Similarly, L&R would propose to cut inspection holes into the fibrous plaster wall sections at suitable sites. This would aid the drying process and allow further inspection of the timber fixings behind and if applicable to secure with plaster, quadaxial and wire ties.

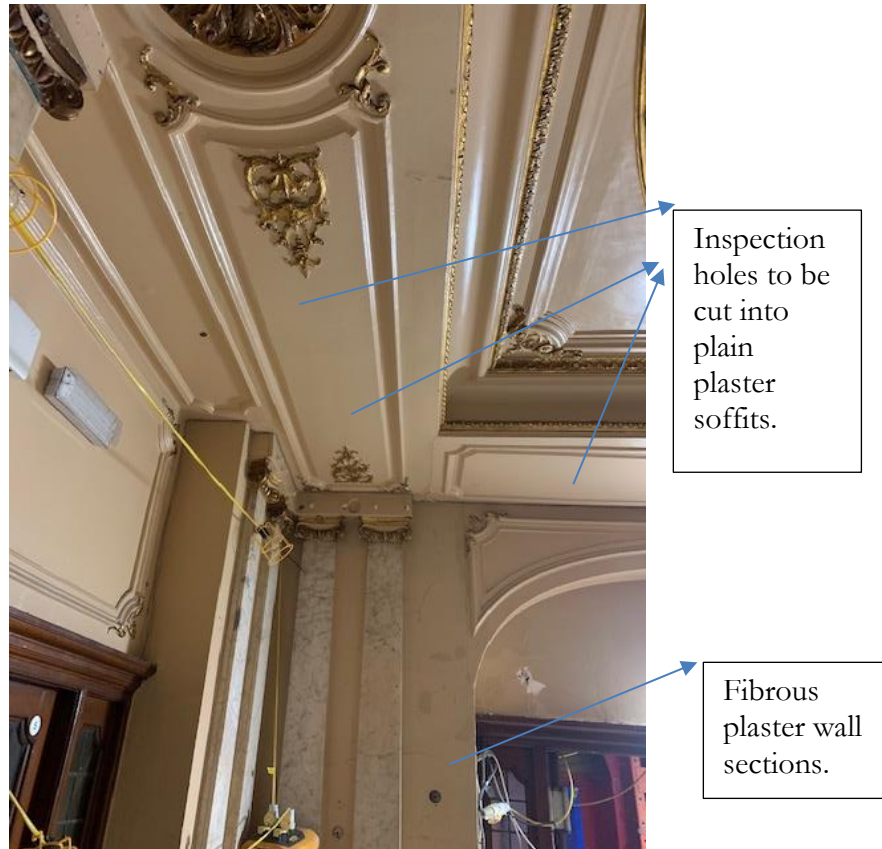
2.5. Ground Floor G-17 Entrance Foyer.

- Close access to this area was not possible due to the amount of builders rubbish and debris on the floor in this area. Furthermore, the ceiling and walls were obscured with scaffolding making any close inspection impossible.
- The presence of this scaffolding makes an assessment of the plasterwork's status and condition difficult. It is highly probable that significant amounts of water from the fire have penetrated the plaster soffits and skylights. However, at this stage we would assume like the neighbouring ceiling in G13 the intention must be to save and conserve the plasterwork to these coffers.
- L&R would advise that access is made possible as soon as is reasonably possible to allow a close inspection of the ceiling soffit plasterwork.

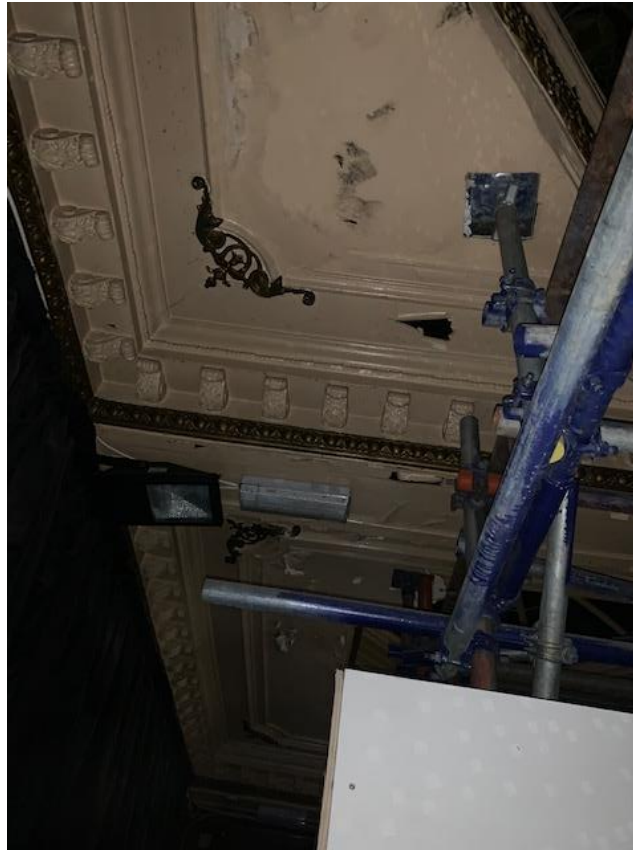
2.6.Room 3.09. Third Floor level, Western End of Main Auditorium.

- Access was possible to the central part of this rectangular ceiling via a bespoke scaffold on 5th May 2020.
- L&R have in their Contract works up to November 2019 carried out some major securing works to the back of this fibrous plaster ceiling. This involved the introduction of wires and gypsum plaster with quadaxial wadding to the back of the ceiling. In addition, some of the missing decorative plaster elements to the face of the ceiling were moulded and replaced to match the existing.

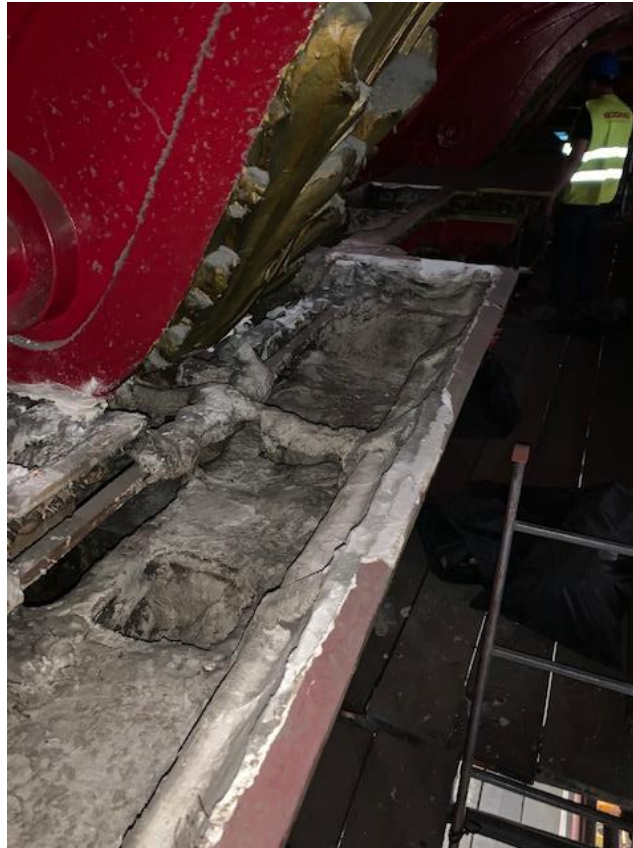
- Access to the Northern elevation was possible to the upper area below the modillioned cornice on the 5th May 2020.
- L&R have to complete their contracted works to secure the projecting modillion enriched cornice.

- Our limited inspection of the fibrous plaster walls on the Northern elevation revealed little evidence of any substantial water ingress from the January 2020 fire. It is possible that moisture has affected the masonry structure behind. The H&R investigation did not include for the Auditorium walls due to access issues and the discovery of ACM's.
- L&R would recommend that some inspection holes are cut into the fibrous plaster wall mouldings to allow access to view the status and condition of the timber support system behind.

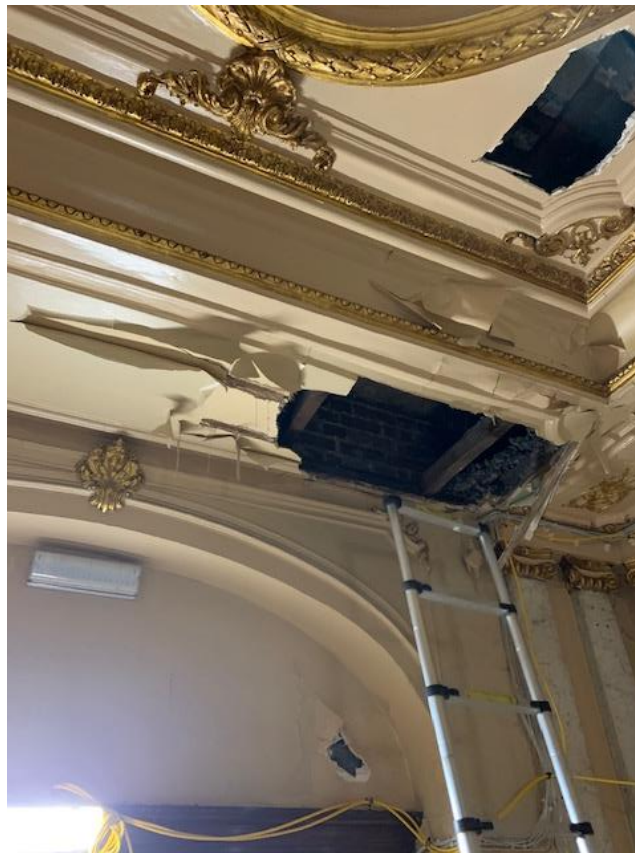
- Our inspection showed that the fibrous plaster was in a weak and poor condition as a consequence of its exposure to water ingress and the damp conditions. The plaster wads tying the casts to the timber were observed to be friable and weak. Applied pressure from below to the plaster soffit produced cracking and movement demonstrating its weak condition.
- The H&R Report will detail and fully describe the status and condition of the timber structure.

- The walls are constructed in fibrous plaster sections fixed to timber battens off the masonry walls. Our initial investigation showed that they are in a better condition than the ceiling having been less affected by water and damp. However, some further investigation should be carried out to assess the masonry for water penetration.

- Some of the 'gold painted' enrichments are made of composition and applied to the fibrous plaster soffit. The damp conditions have caused some sections of moulding to detach and are lost and missing.
