KOKO THEATRE

CAMDEN HIGH STREET

An examination of the paint in rooms at the west end of the building, below the Dome, to determine the types of paint used since 1900, to identify areas where lead paints have been used, and establish if early paint layers have survived

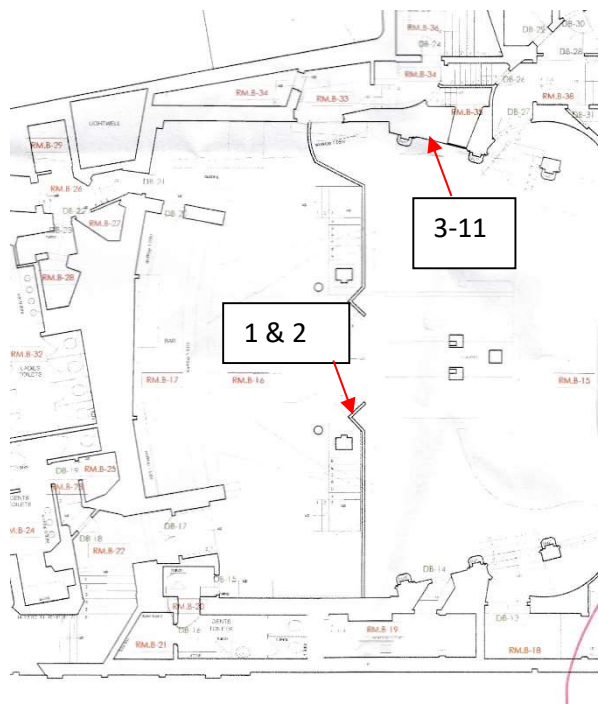
LOCATION OF SAMPLES

- 1 Figure in front of stage
 2 gold of figure
 3 background to figure

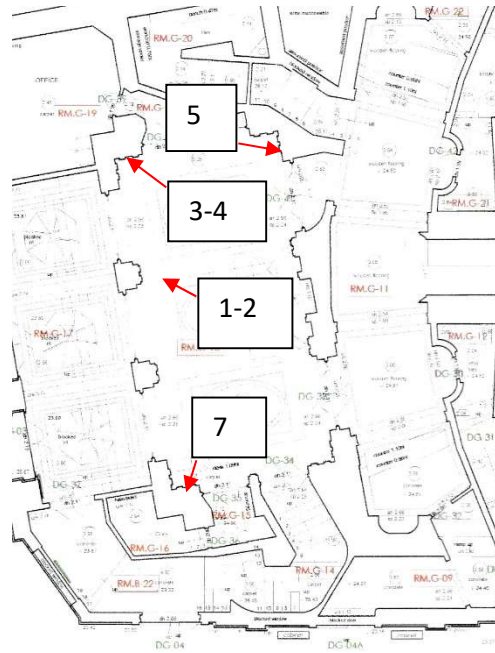
LOCATION OF SAMPLES

- Ceiling
- 1 cream on flat area
 - 2 gold moulding

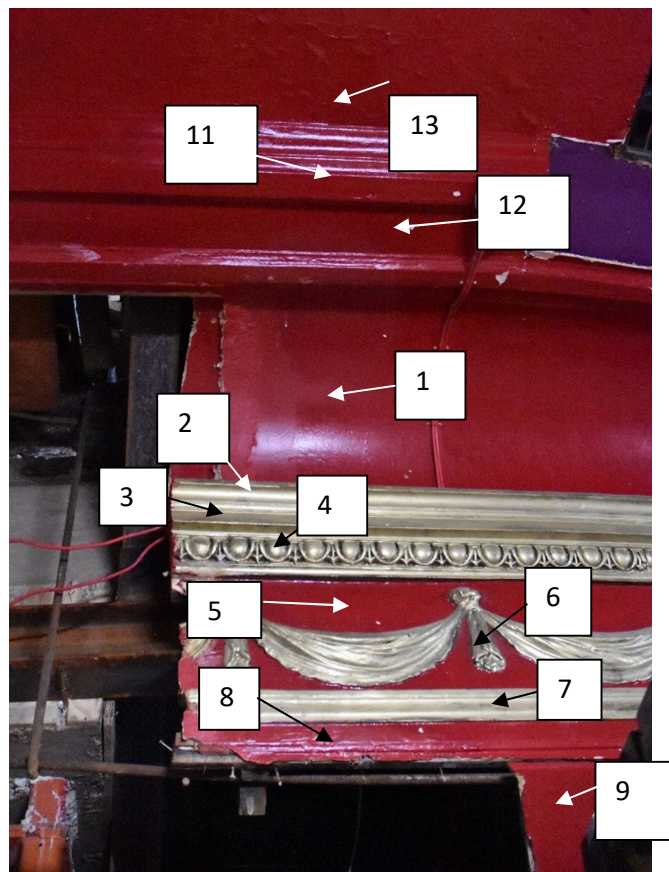
LOCATION OF SAMPLES

- East wall, south end
- 1 cove
 - 2 top of cornice
 - 3 middle of cornice
 - 4 egg & dart on cornice
 - 5 background to frieze
 - 6 swag on frieze
 - 7 moulding at base of frieze
 - 8 below frieze

- 9 sloping section

- 11 moulding on ceiling
- 12 between mouldings
- 13 centre of ceiling

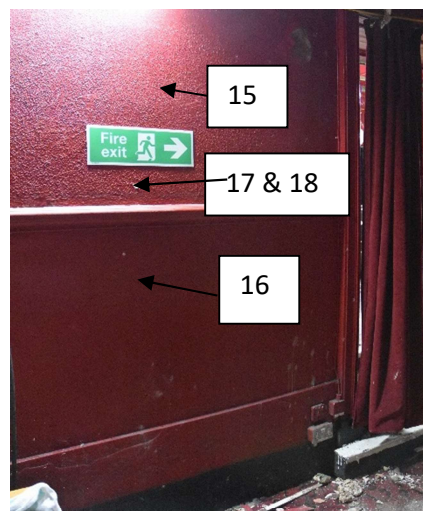
- 14 west wall at north end, head level

- West wall, south end
- 15 above dado rail
 - 16 below dado rail
 - 17 example of textured surface
 - 18 layers below textured surface

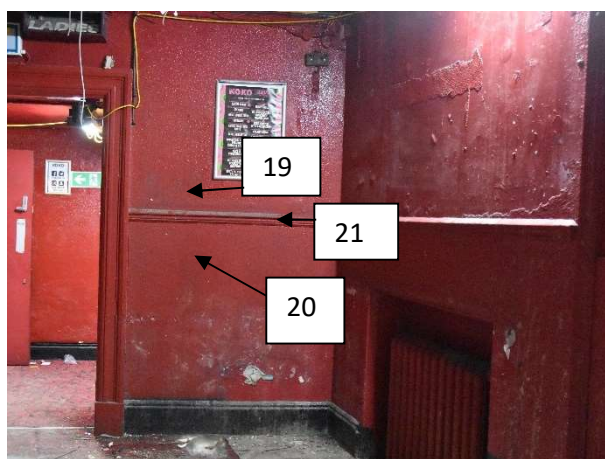
South wall

- 19 above rail
- 20 below rail
- 21 rail

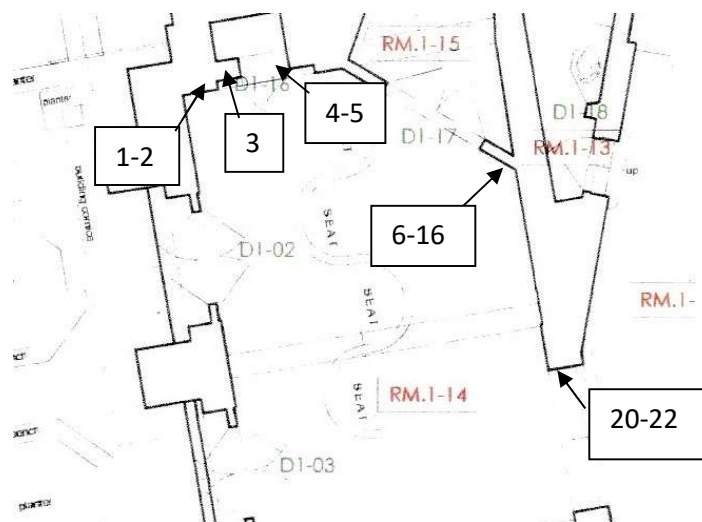
LOCATION OF SAMPLES

- North wall – west end
- 1 Flat of wall above dado rail
 - 2 panel border above dado rail
 - 3 wall next to door
 - 4 architrave of door D1.16
 - 5 door D1.16

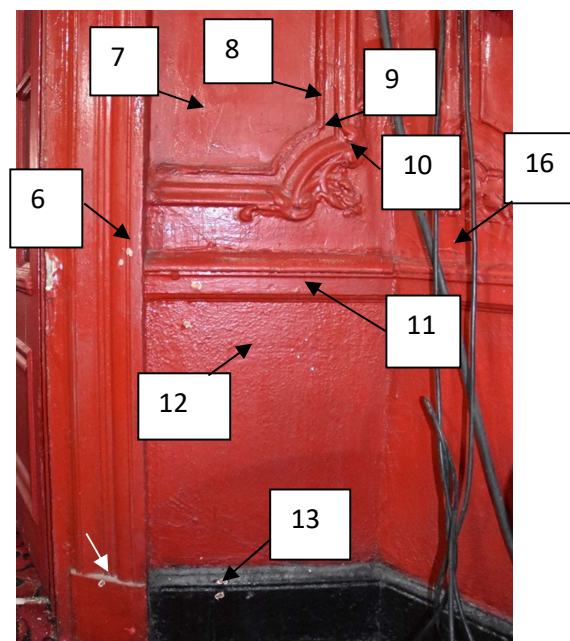
- North wall, east end
- 6 architrave of door
 - 7 panel on wall above dado
 - 8 inner panel border on wall above dado
 - 9 flat between panel borders
 - 10 outer panel border
 - 11 dado rail
 - 12 below dado rail
 - 13 skirting moulding
 - 16 flat of upper wall between dado rail and panel border

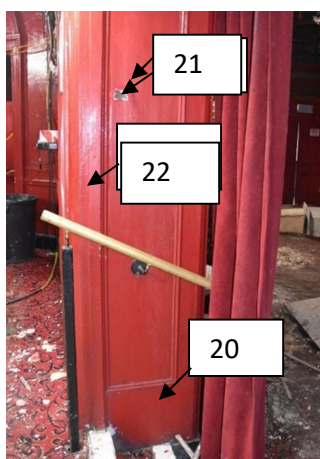
- East wall – entrance to Room 1.12
- Panelled wooden reveal of opening
- 20 base of reveal
 - 21 panel on reveal
 - 22 moulding around panel

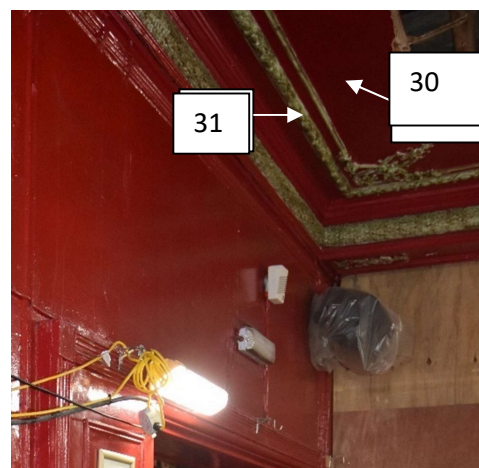
Ceiling – SE corner

- 30 flat panel
- 31 - gold moulding

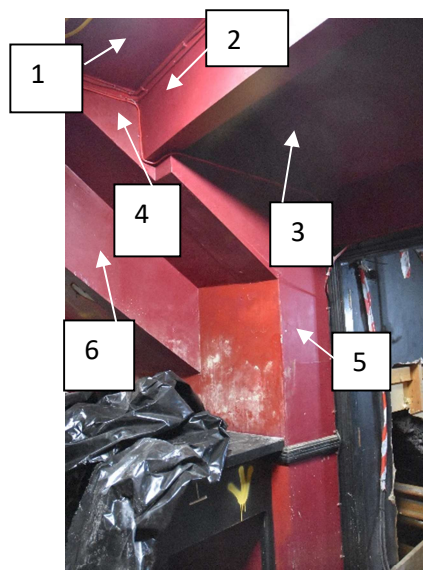
1-6 Side of opening to Auditorium

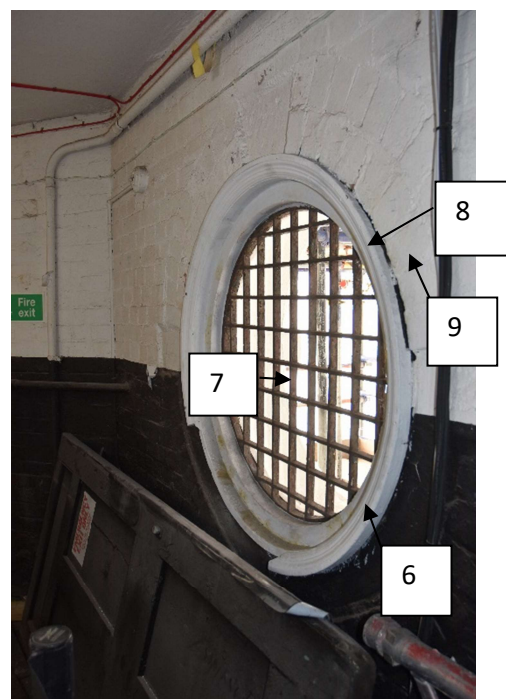
West window [W3.08]

6 frame – lower part

7 iron grille

8 bricks around window

9 frame – upper part

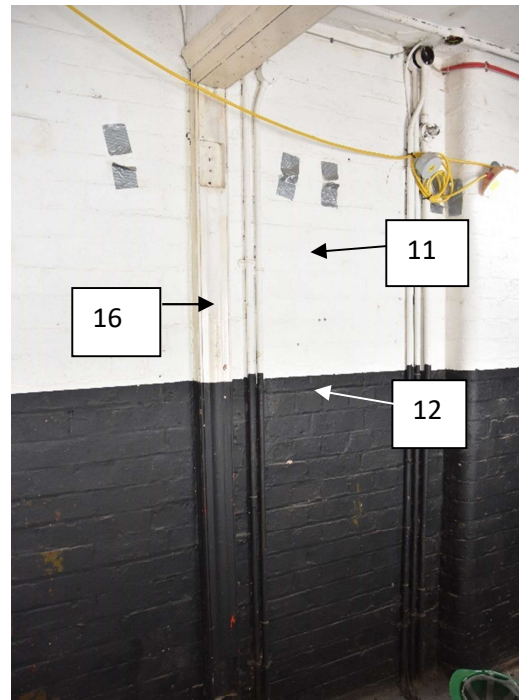
North wall of Stairs to right of removed door

- 11 high level
- 12 low level
- 16 architrave
- 17 high level next to first flight down

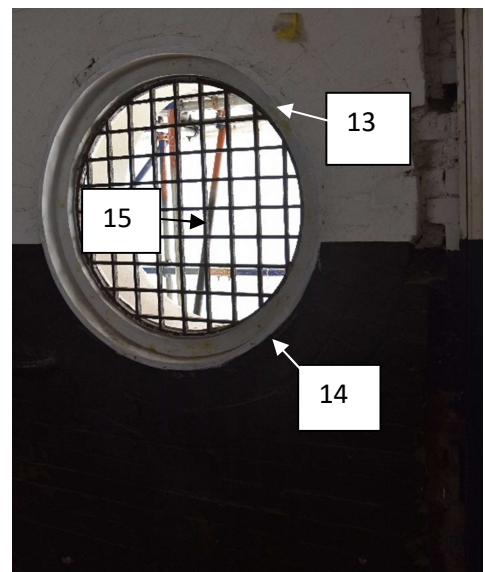
Window in south wall [W3.08B]

- 13 upper part of frame
- 14 lower part of frame
- 15 grille

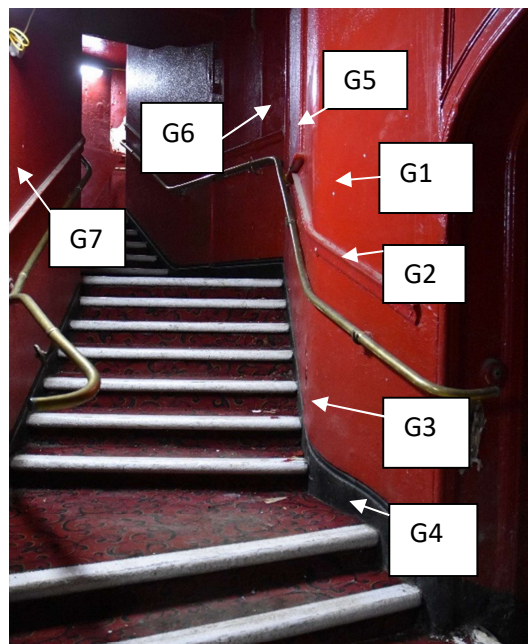
LOCATION OF SAMPLES

- G1 Ground floor first flight up – north wall
smooth plaster above dado rail
- G2 dado rail
- G3 below dado rail
- G4 skirting
- G5 frame of blocked window
- G7 Ground floor first flight up, south wall,
above dado rail
- G6 First flight up – half landing
north wall, textured paint above dado rail

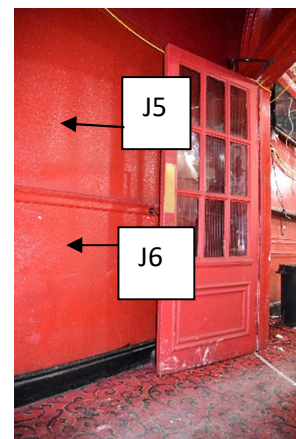
- J5 First floor landing
east wall – above dado rail
- J6 east wall – below dado rail

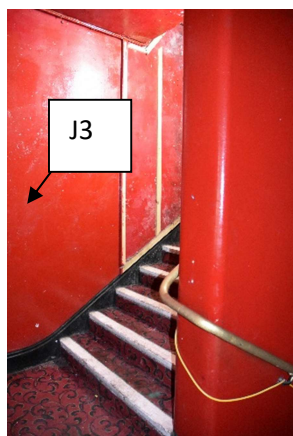
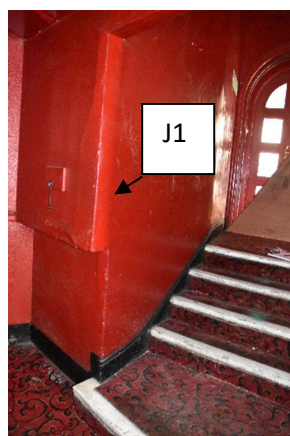
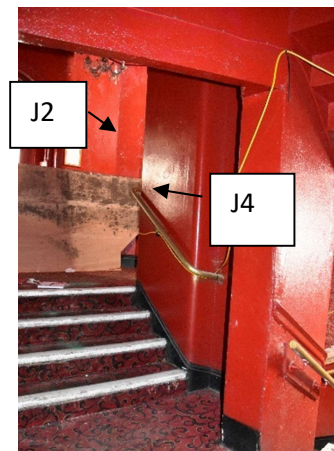
Lead paint Found in samples from the ceiling of the second floor landing and in a few samples taken from the walls between ground and first and between first and second.

- J1 First floor to second floor
south wall of stairs going up
- J2 west wall of stairs going up
- J3 north wall of second flight to second floor
- J4 centre wall of stairs

- B9 Second floor landing
flat of ceiling of second floor landing
- B10 beam above second floor landing – side
- B11 beam above second floor landing
