**The Hope Project, KOKO**

Photographs  
05 August 2020  
Not to scale

Job no. 146-89 Site Note 8 ADDENDUM Page11 © Copyright Hutton+Rostron 2020

## The Hope Project (KOKO): Timber floor structures condition Investigation

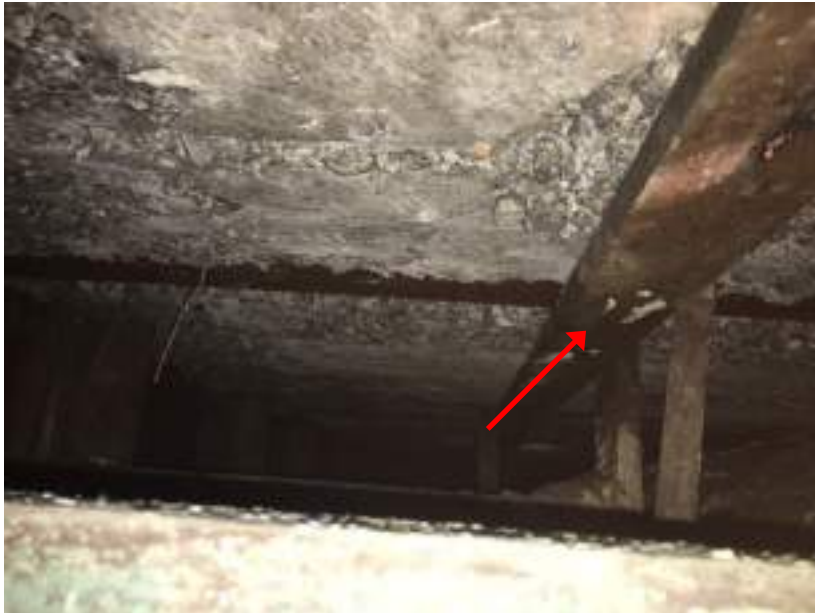
**Fig 21:**

Timber condition investigation; showing central ceiling plate supporting historic plaster and lath ceiling running parallel to principal spine RSJs. Note limited access to plate for inspection and for planned improved fixings

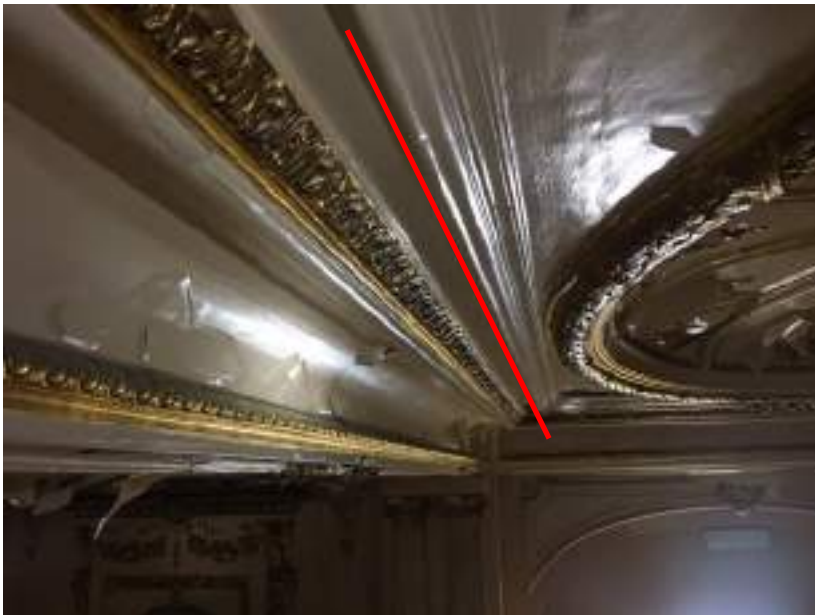
**Fig 22:**

Timber condition investigation; showing approximate location of inaccessible ceiling plate

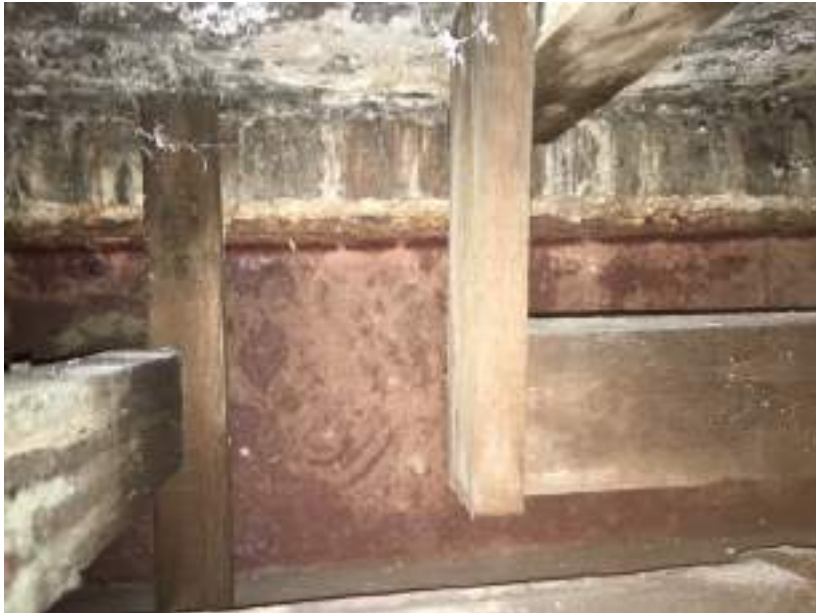
**Fig 23:**

Timber condition investigation; showing typical view of west perimeter ceiling structure supported onto perimeter RSJs

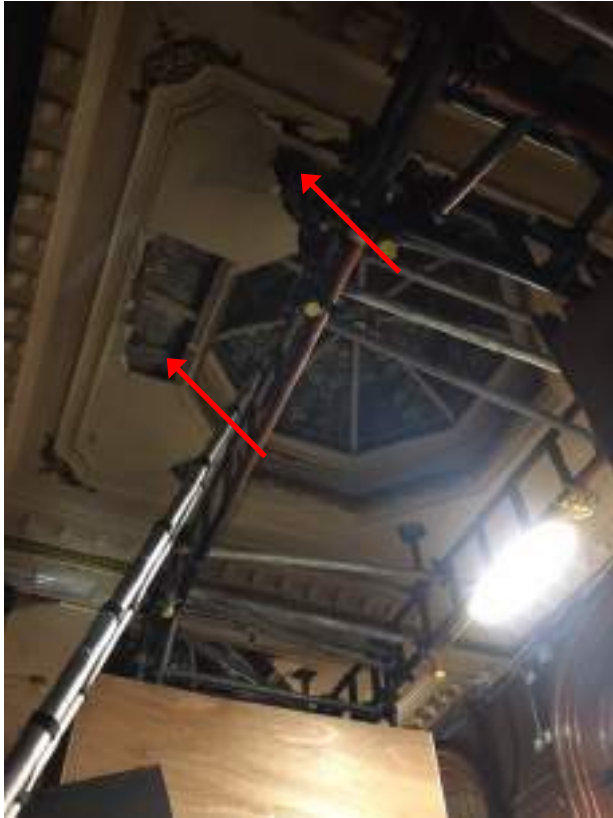
**Fig 25:**

Timber condition investigation; showing south lightwell to ceiling structures RMG17. Note localised water penetration has resulted in failure to non-historic plasterboard finishes around ceiling lights

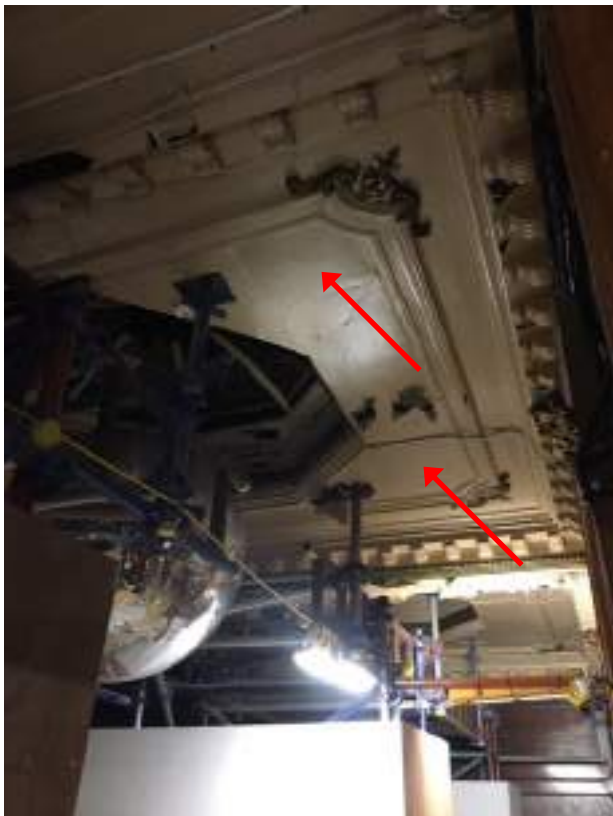
**Fig 26:**

Timber condition investigation; showing decorative plaster and lath and plasterboard ceiling finishes to central bay of RMG17 without appropriate exposure of ceiling voids to aid ventilation

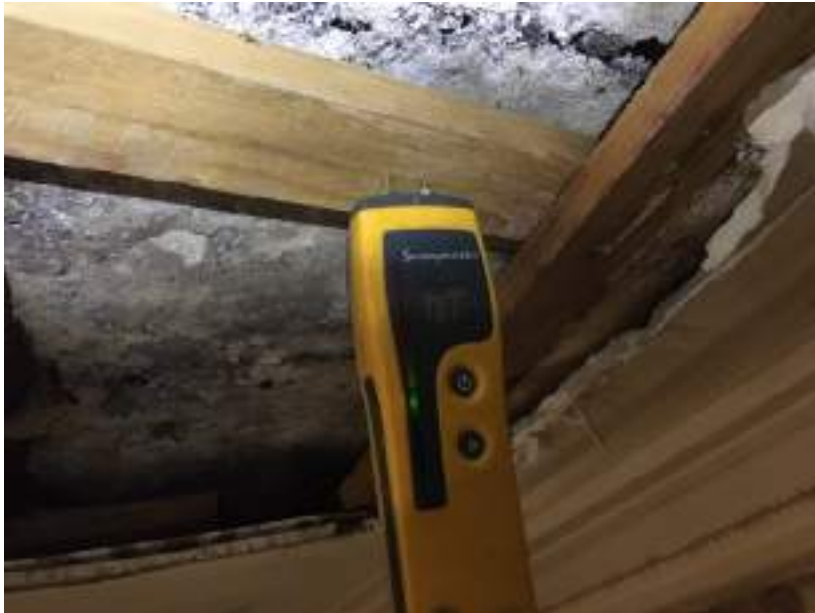
**Fig 27:**

Timber condition investigation; showing non-historic previous generation remedial softwood timbers supporting new addition plasterboard ceilings with surface moisture content at 14% which, although elevated, is too low to support decay organisms

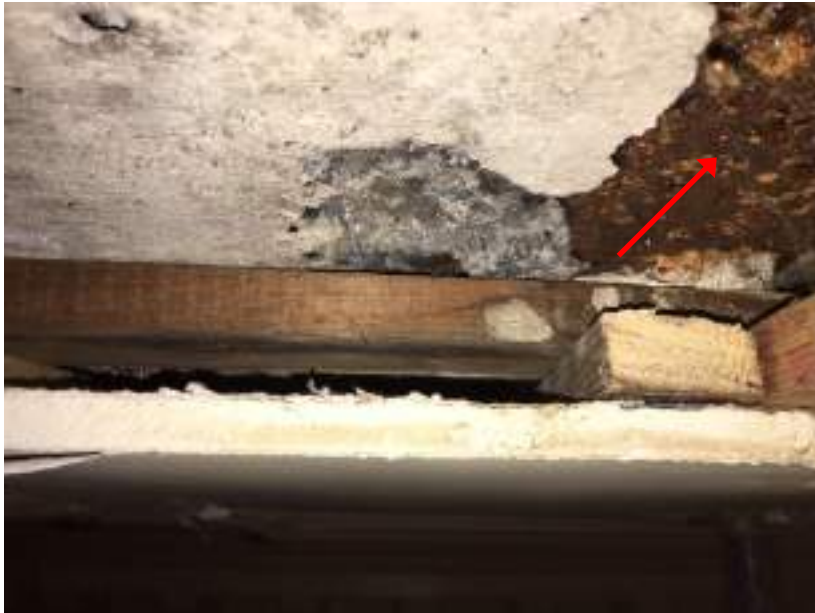
**Fig 29:**

Timber condition investigation; showing further extensive surface corrosion to partially embedded RSJs supporting the south ceiling lights

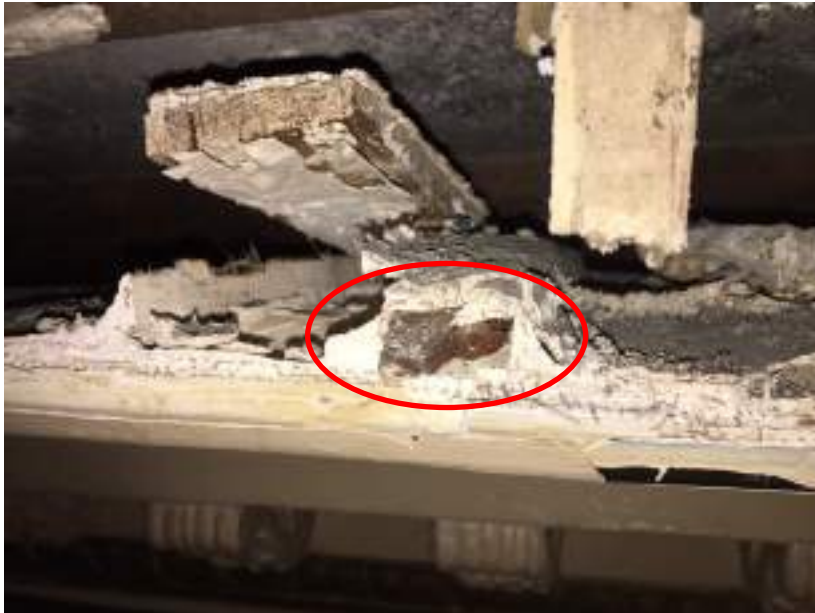
**Fig 31:**

Timber condition investigation; showing close-up view of typical embedded lath to historic fibrous plaster and lath ceiling subject to decay

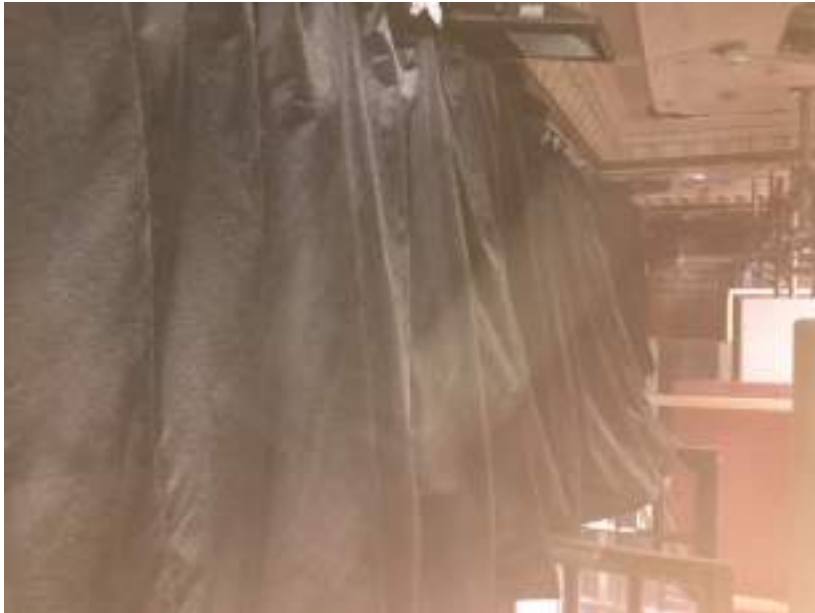
**Fig 33:**

Timber condition investigation; showing remaining blackout curtains to west elevation. Curtains requiring removal to aid ventilation of area and windows beneath opened for additional ventilation

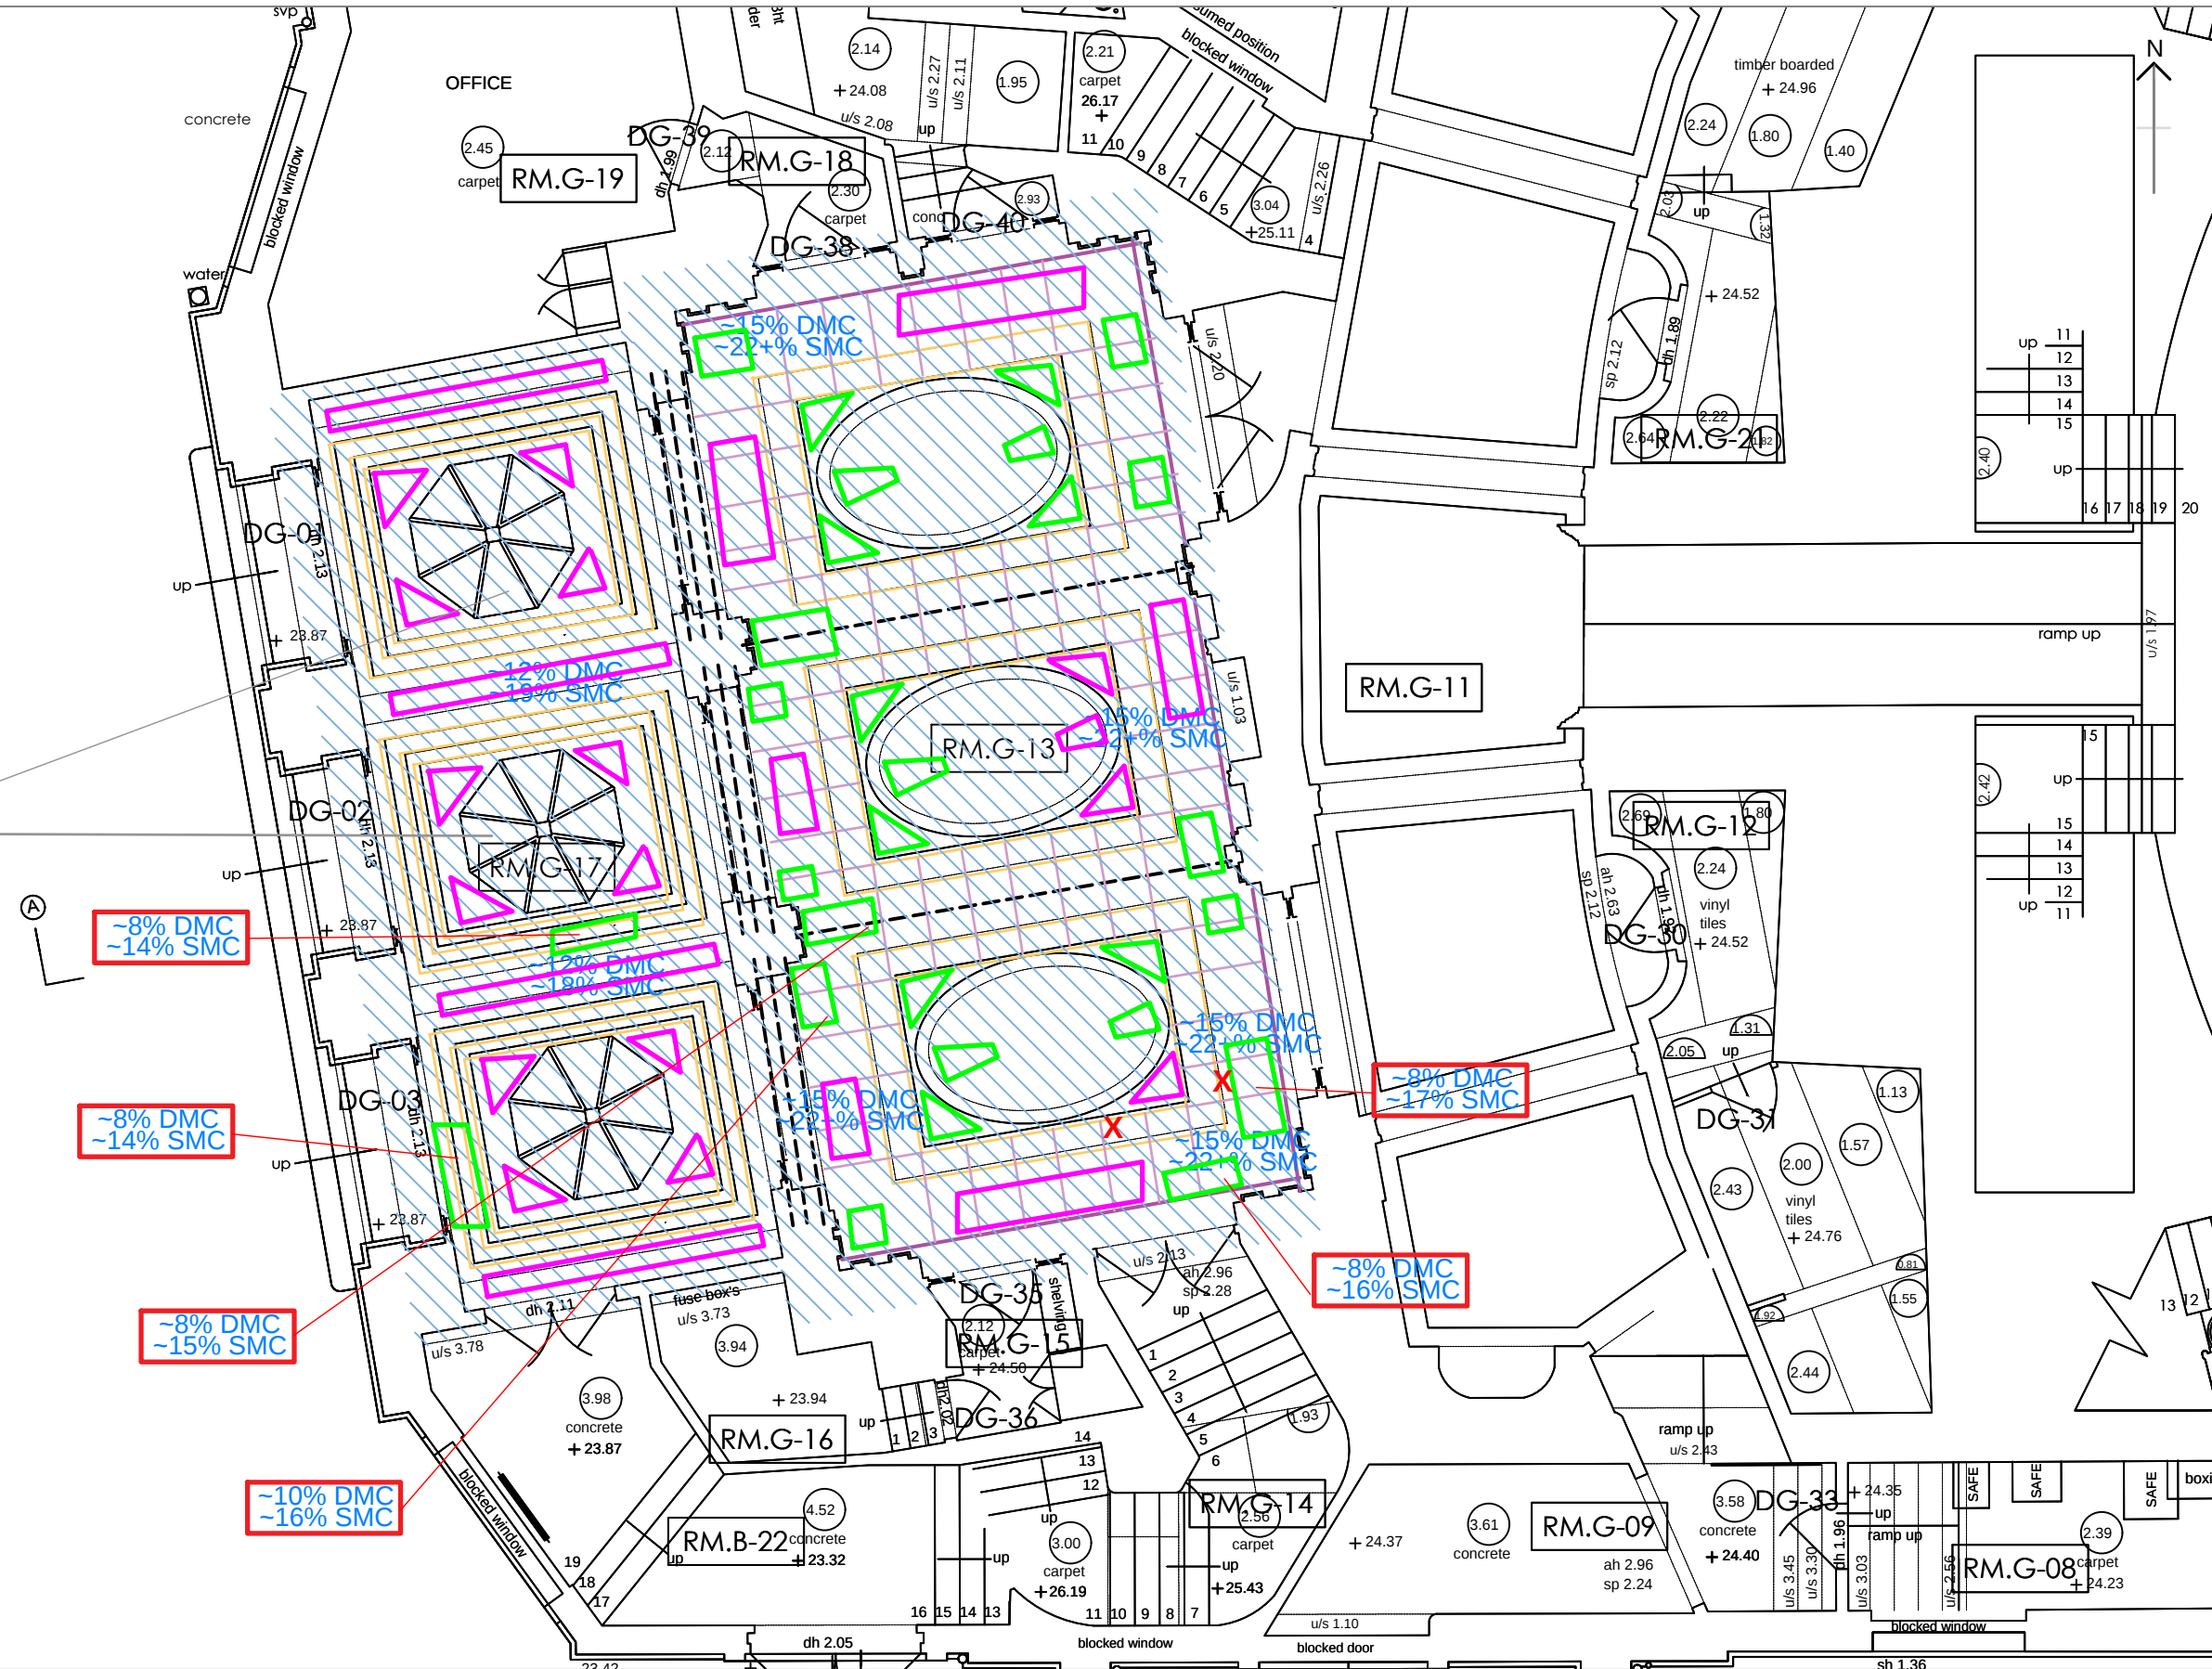
Limited access to ceiling voids within RM.G-17.  
Voids subject to moderate levels of surface mould growth

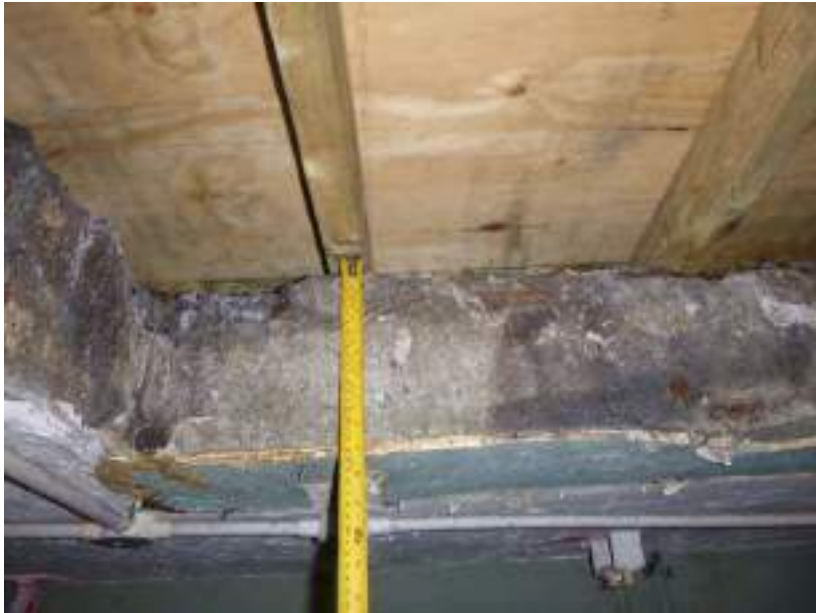
**Fig 1:**

Floor structures, fourth floor, RM.4-02; showing solid floor structures at ~220mm depth. Solid floor structures were not the focus of this investigation

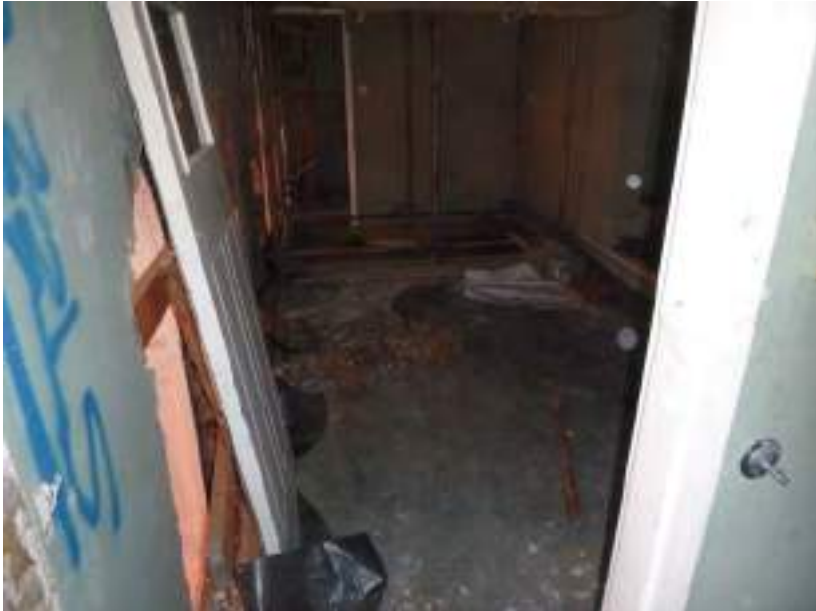
**Fig 3:**

Floor structures, third floor, RM.3-12 towards RM.3-13; showing likely newer addition intermediate floor of solid construction with finishes removed

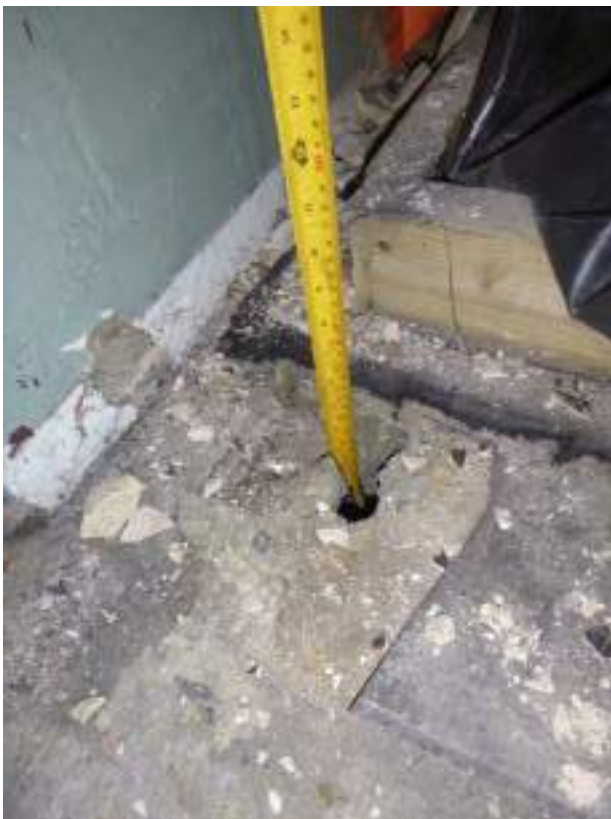
**Fig 4:**

Floor structures, third floor, RM.3-12; showing likely newer addition solid floor slab at ~120mm

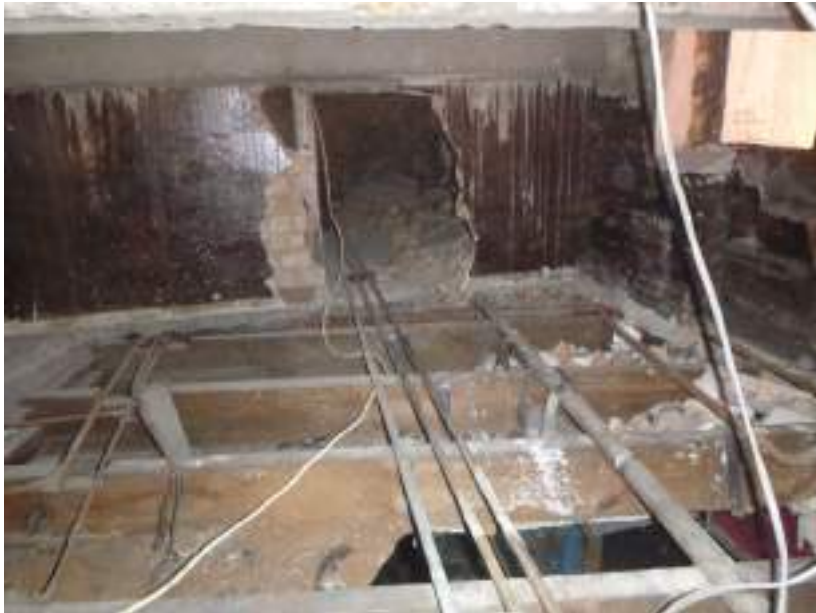
**Fig 5:**

Floor structures, third floor, RM.3-14; showing defunct historic floor structures/level beneath likely newer addition solid floor slab above. Timber structures now serving as ceiling joists to bar area beneath. Note substantial build-up of debris within void

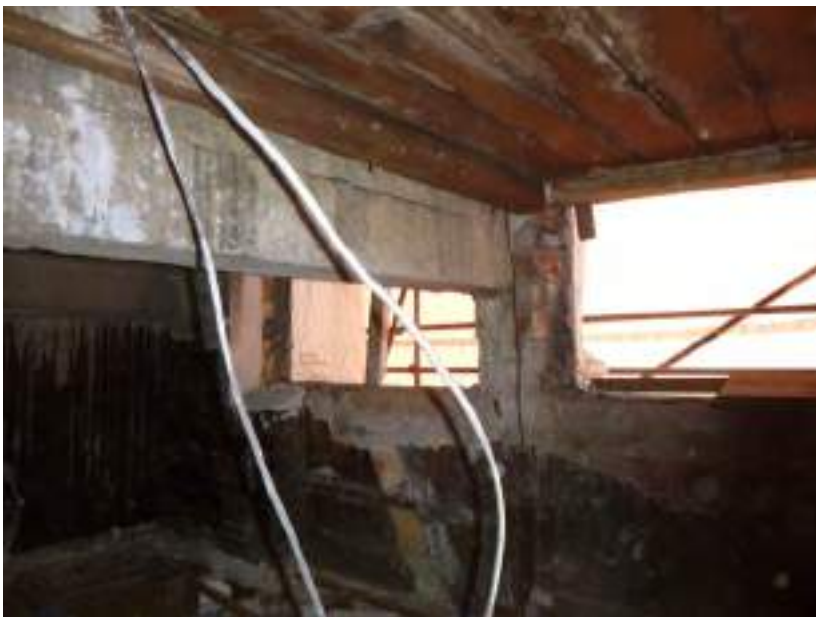
**Fig 6:**

Floor structures, third floor, RM.3-14; showing void beneath likely newer addition floor structures/stairs landing at north end

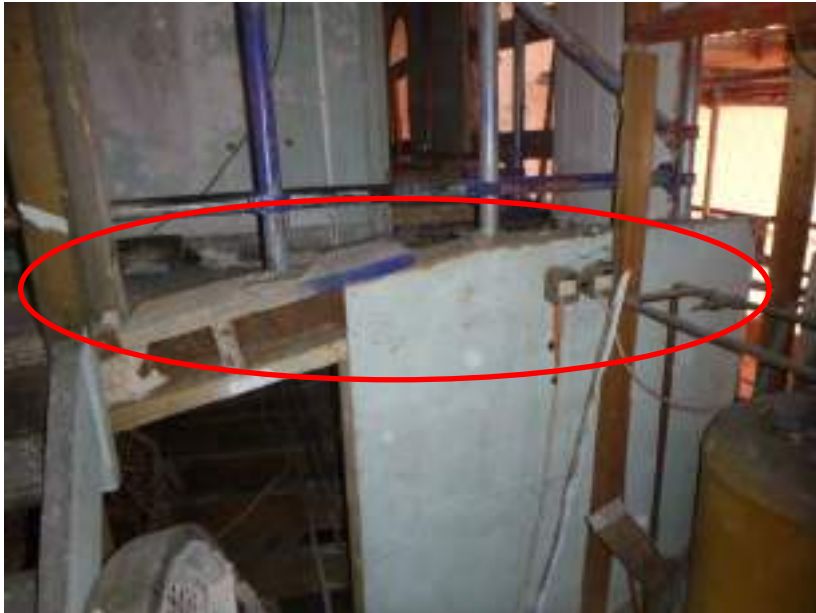
**Fig 7:**

Floor structures, third floor, RM.3-16; showing image of historic floor area with new split level creating void beneath

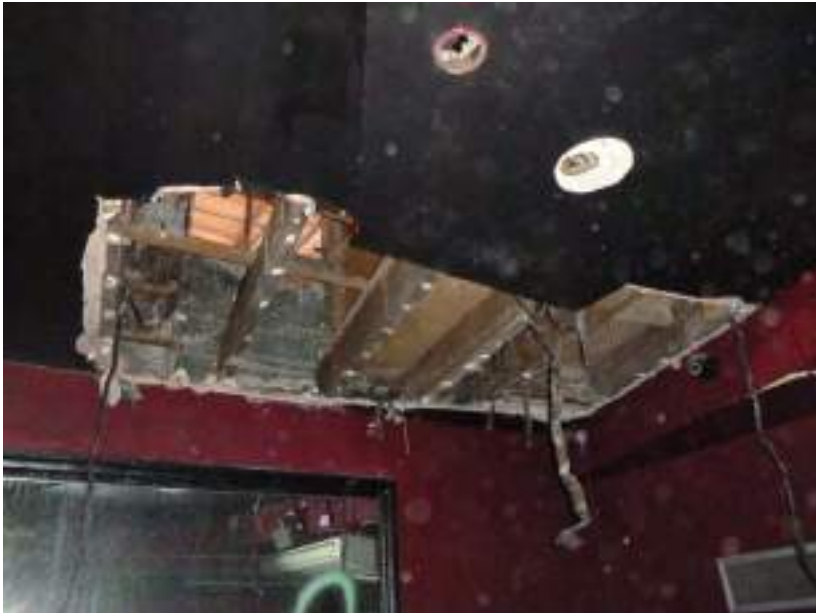
**Fig 9:**

Floor structures, third floor, RM.3-14; showing historic defunct floor level forming ceiling structures to north area of bar. Note significant fire related water damage to non-historic plaster structures. Representative and vulnerable timber bearing ends were deep drilled and moisture probed. No structural decay detected, typical deep moisture contents raised at ~18 per cent and surface moisture contents at ~22 per cent which is high enough to support decay organisms

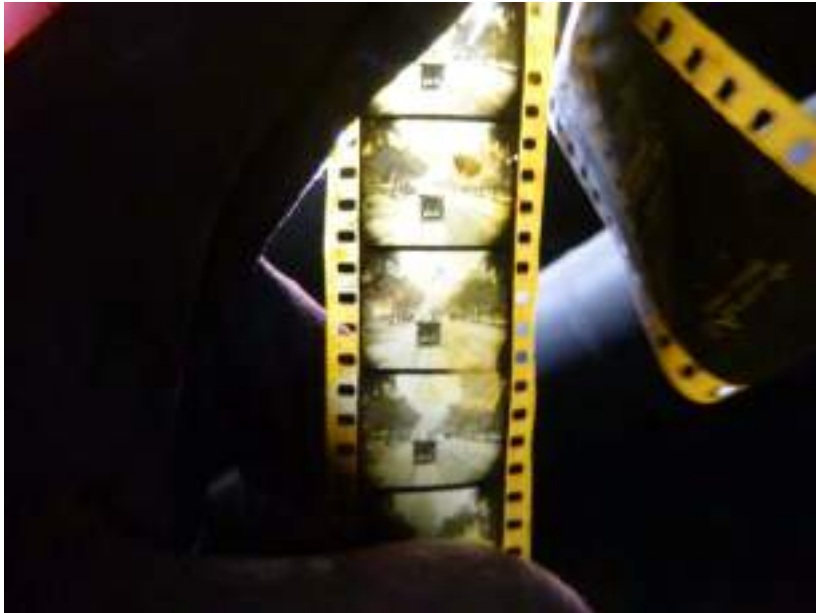
**Fig 11:**

Floor structures, third floor, RM.3-14; showing potentially historically significant film real/artefacts removed from floor void by author for documentation. NB historic film real was often made from highly flammable material and should not be left within floor voids

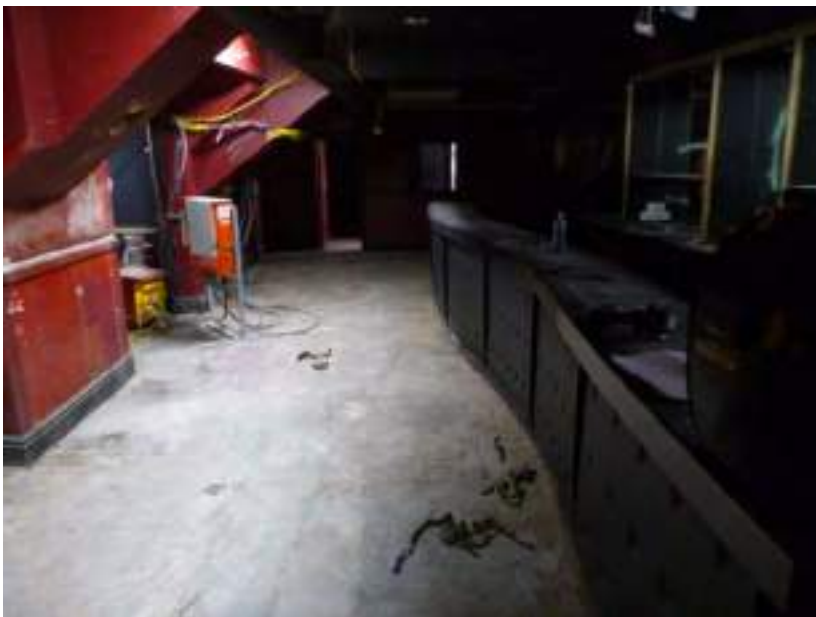
**Fig 12:**

Floor structures, second floor, RM.2-16; showing view in general looking south. Note floors of solid construction

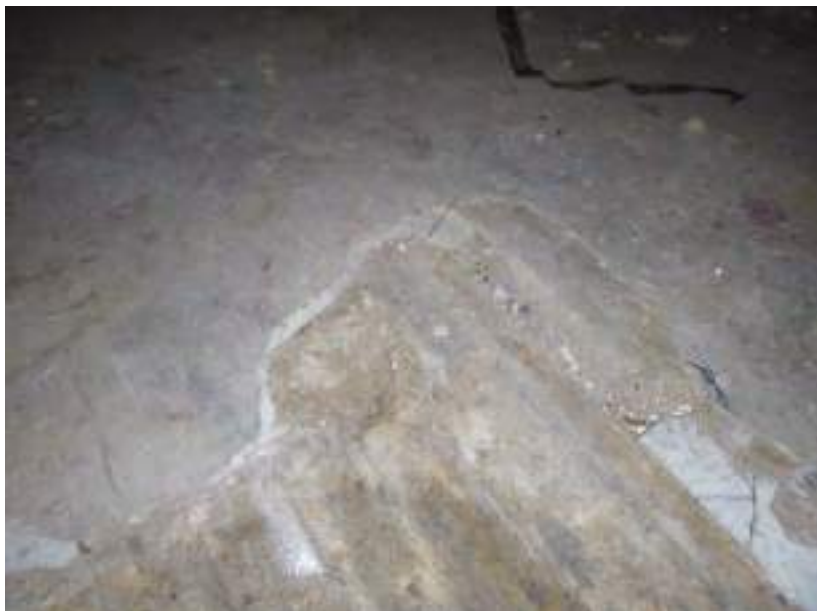
**Fig 13:**

Floor structures, second floor, RM.2-22; showing small area of historic timber floor structures over solid floor slab beneath partially concealed by ~10mm floor screed

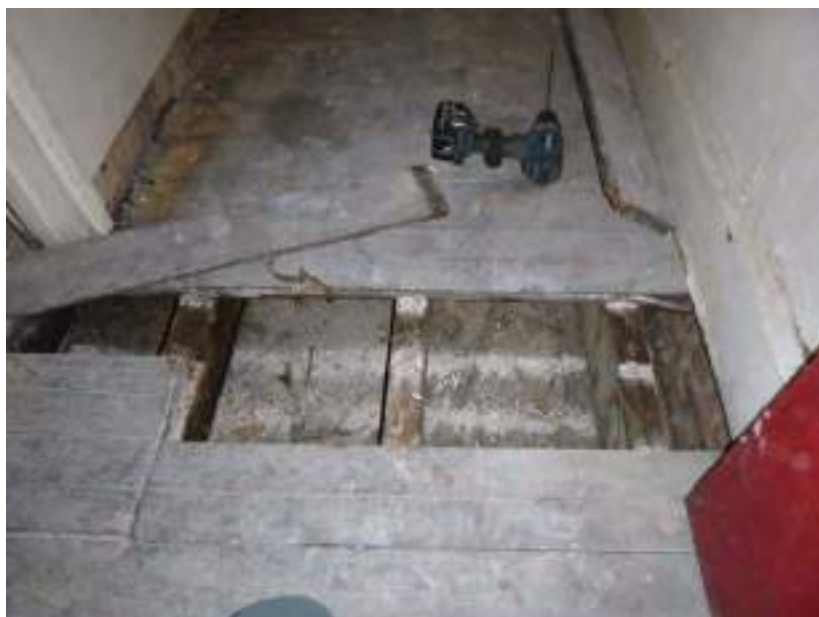
**Fig 14:**

Floor structures, second floor, RM.2-20; showing timber floor structures supported directly onto clinker ash concrete structures beneath. No decay detected . Timber moisture contents too low to support decay organisms

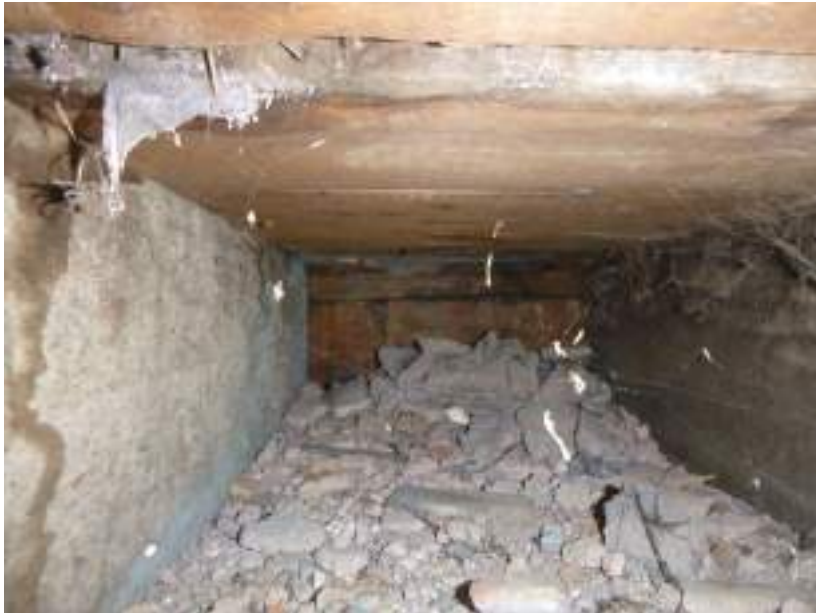
**Fig 15:**

Floor structures, second floor, RM.2-20; showing timber floor structures supported directly onto clinker ash concrete structures beneath. No decay detected. Timber moisture contents too low to support decay organisms

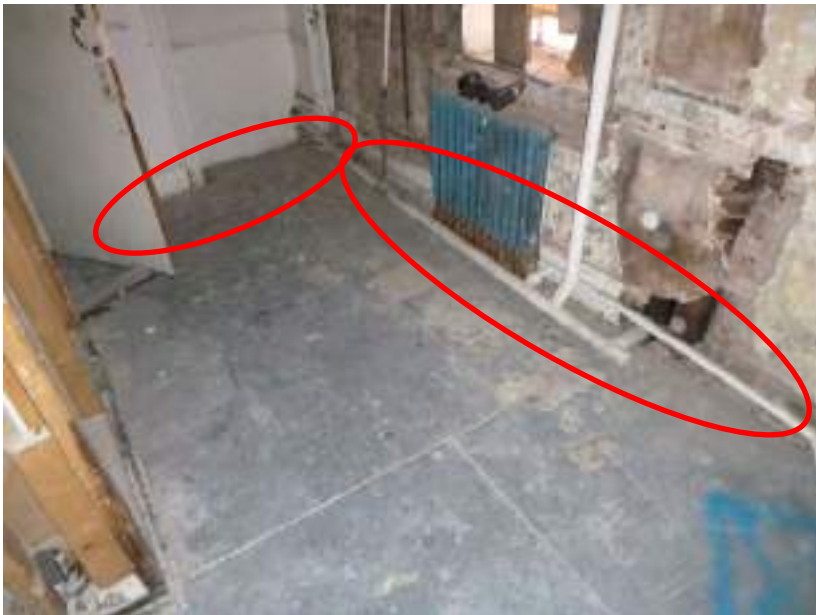
**Fig 16:**

Floor structures, second floor, RM.2-21; showing concealed floor structures by hardboard and floorboard covering. Most vulnerable zones highlighted in red. Requires exposure

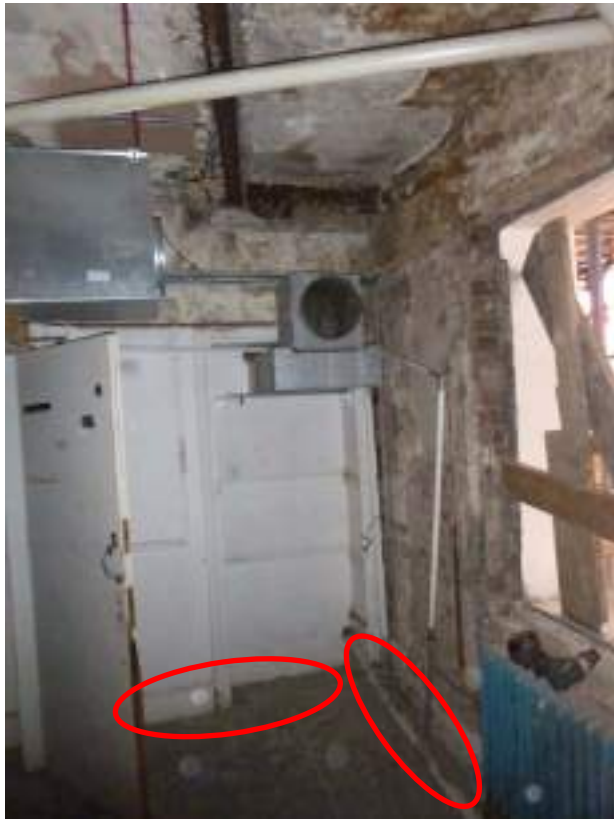
**Fig 17:**

Floor structures, second floor, RM.2-20; showing visibly fire related moisture damaged structures above vulnerable concealed floor structures

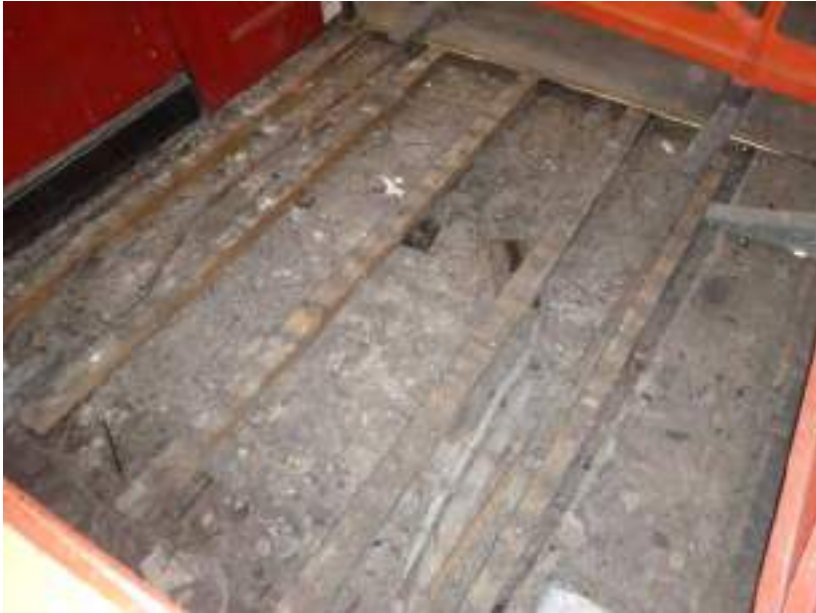
**Fig 19:**

Floor structures, first floor, RM.1-14; showing remaining timber floor elements laid onto solid floor. Area inaccessible due to known hazardous materials. However structures clearly well ventilated and no decay or trapped moisture suspected

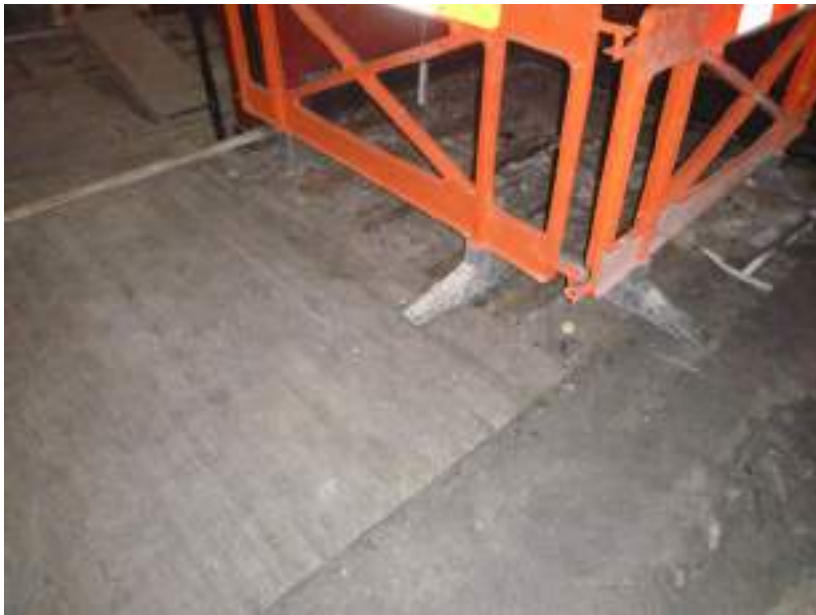
**Fig 20:**

Floor structures, first floor, RM.1-14; showing remaining timber floor elements laid onto solid floor. Area inaccessible due to known hazardous materials. However structures clearly well ventilated and no decay or trapped moisture suspected

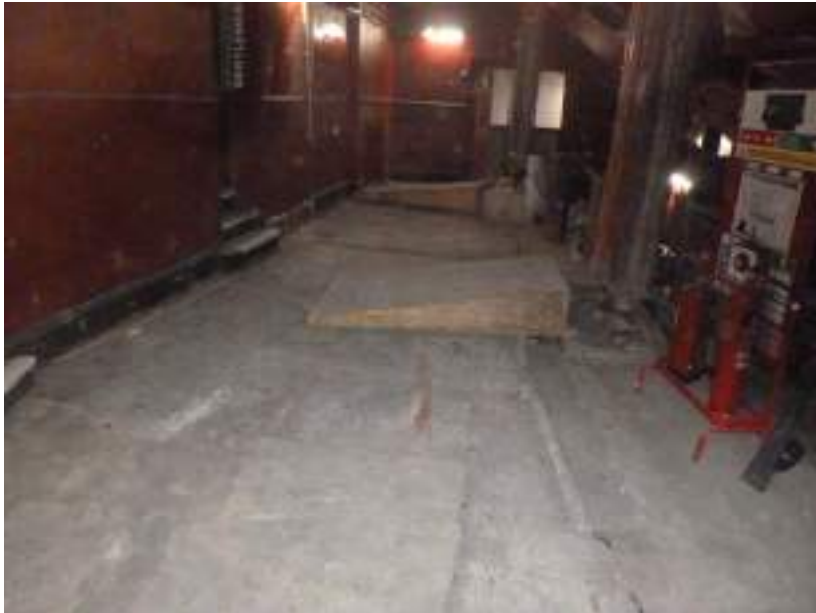
**Fig 21:**

Floor structures, first floor, RM.1-12;  
showing area in general looking north.  
Floor finishes removed revealing solid  
floor slab beneath

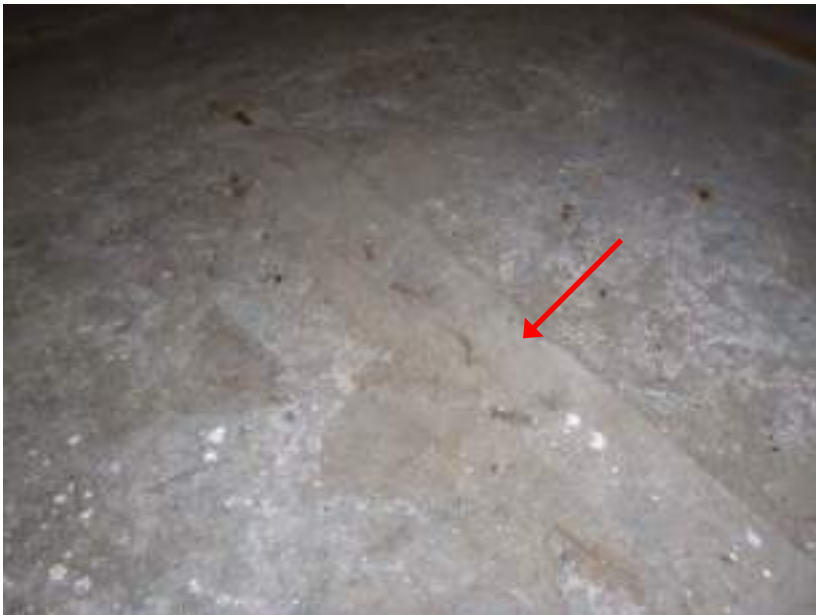
**Fig 22:**

- 4 Grounding timbers: There was widespread evidence of historic grounding timbers partially embedded (with only the upper face exposed - these timbers were likely inserted during the curing process) into the solid floor slabs as fixing locations for floor battens, joists, plates or floorboards directly. Being partially embedded into damp and potentially damp masonry structures, these timber elements were highly vulnerable to damp and decay issues, albeit localised and non-structural in consequence. Typical moisture contents readings showed highly elevated moisture

contents at ~15-20 per cent with some (superficial) decay already evident to the undersides of select groundings lifted for inspection

Floor structures, first floor, RM.1-12;  
showing typical detail of remaining  
floorboard grounding embedded into  
damp floor slab and vulnerable to  
damp and decay. Note floorboard nail  
fixings still visible

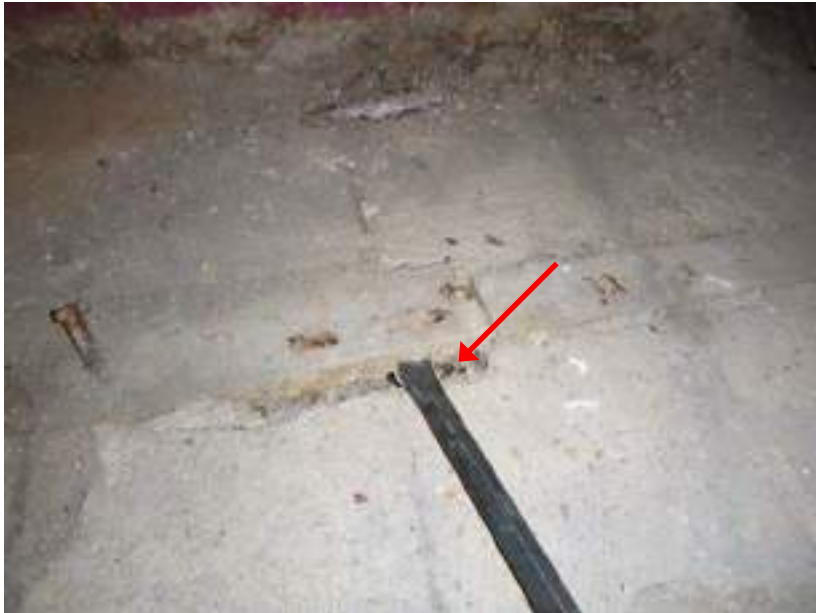
**Fig 23:**

Floor structures, first floor, RM.1-12; showing typical detail of remaining floorboard grounding embedded into damp floor slab with visible superficial decay to its underside. Note floorboard nail fixings still visible

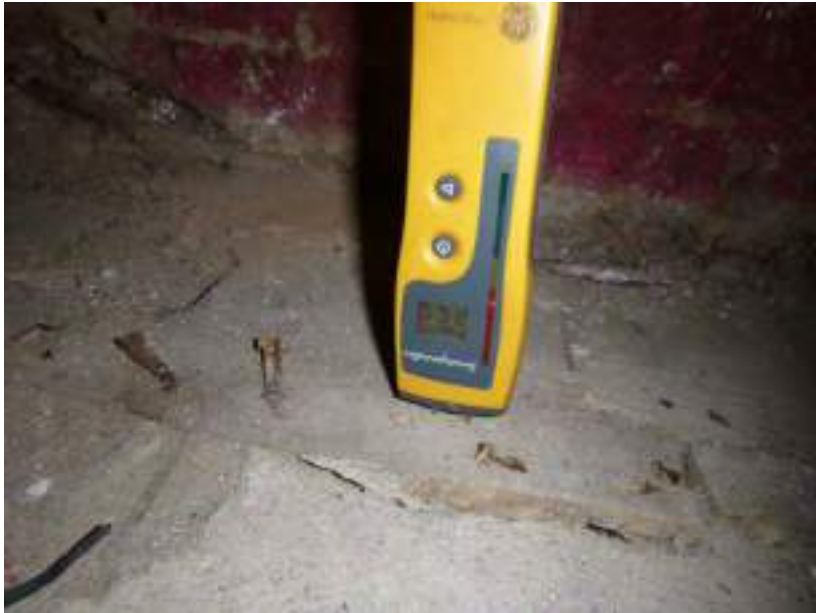
**Fig 25:**

Floor structures, first floor, RM.1-12; showing typical detail of remaining floorboard grounding embedded into damp floor slab with a moisture content of ~26 per cent. Which is high enough to support decay organisms

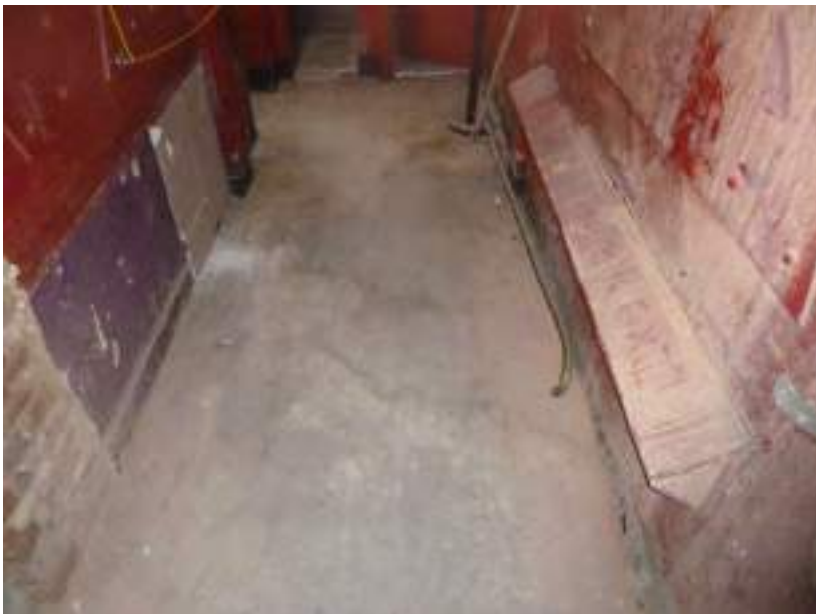
**Fig 26:**

Floor structures, first floor, RM.1-09; showing area in general. Floor structures of solid construction

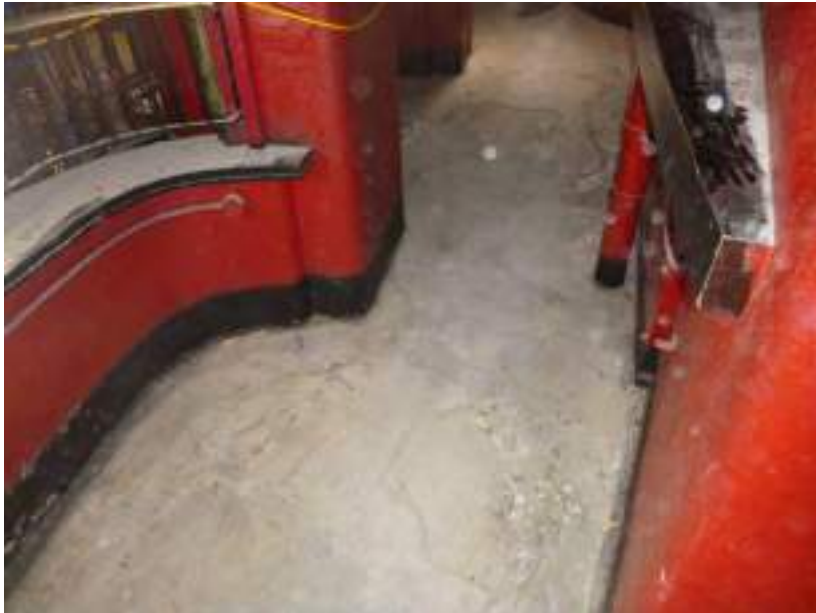
**Fig 27:**

Floor structures, first floor, RM.1-07; showing south balcony area looking east. Note floor structures of solid construction with floorboards laid/fixed onto perpendicular battens/groundings set into floor slab

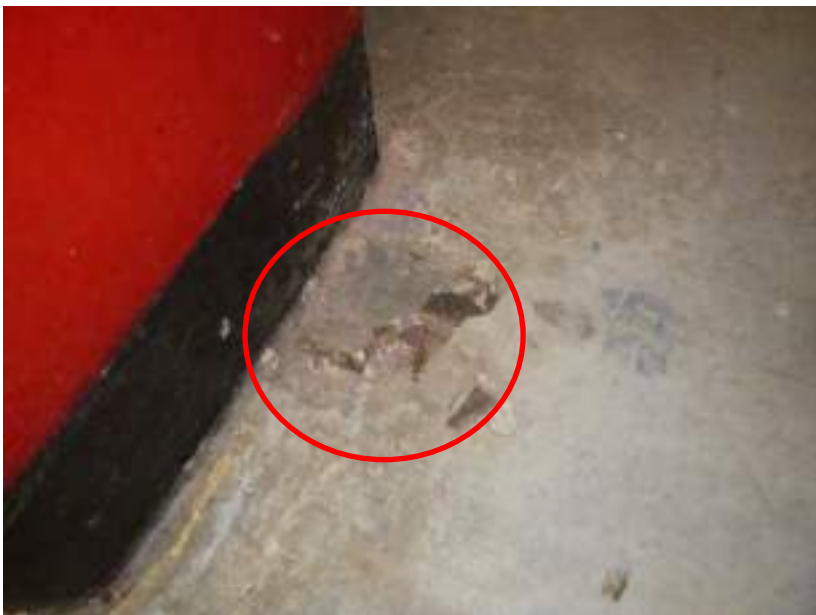
**Fig 28:**

Floor structures, first floor, RM.1-07; showing south balcony south-west area, showing visibly damp area of partially revealed floorboards beneath screed surface. Concealed floorboards to this area vulnerable to damp and decay

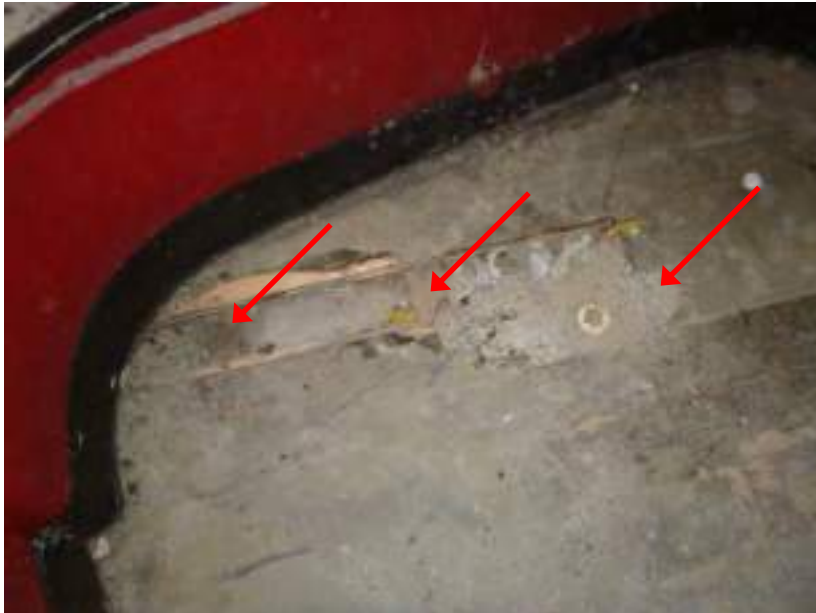
**Fig 29:**

Floor structures, first floor, RM.1-07;  
showing south balcony floor structures  
of solid construction with floorboards  
laid/fixed onto perpendicular battens/  
groundings set into floor slab

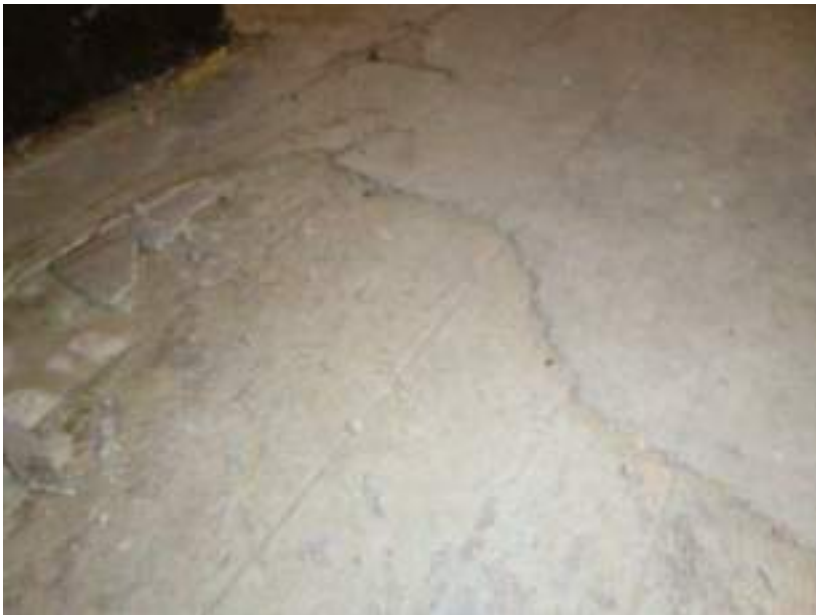
**Fig 30:**

Floor structures, first floor, RM.1-07;  
showing south balcony floorboards  
exposed beneath damaged surface of  
<5mm screed
