**The Hope Project, KOKO**

Photographs  
05 August 2020  
Not to scale

Job no. 146-89 Site Note 8 ADDENDUM Page11 © Copyright Hutton+Rostron 2020

## The Hope Project (KOKO): Timber floor structures condition Investigation

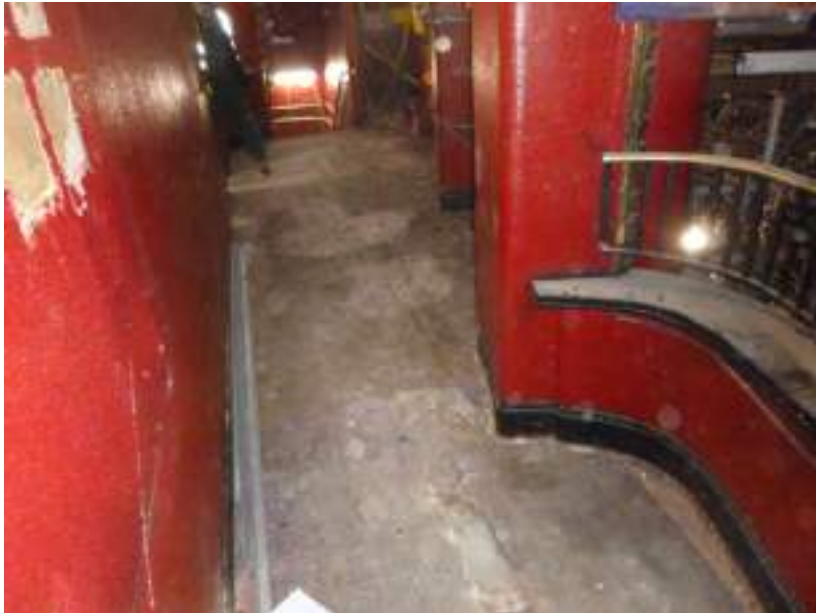
**Fig 31:**

Floor structures, first floor, RM.1-18; showing royal box in general looking east. Floor structures of solid construction with floorboards laid/fixed onto perpendicular battens/groundings set into floor slab

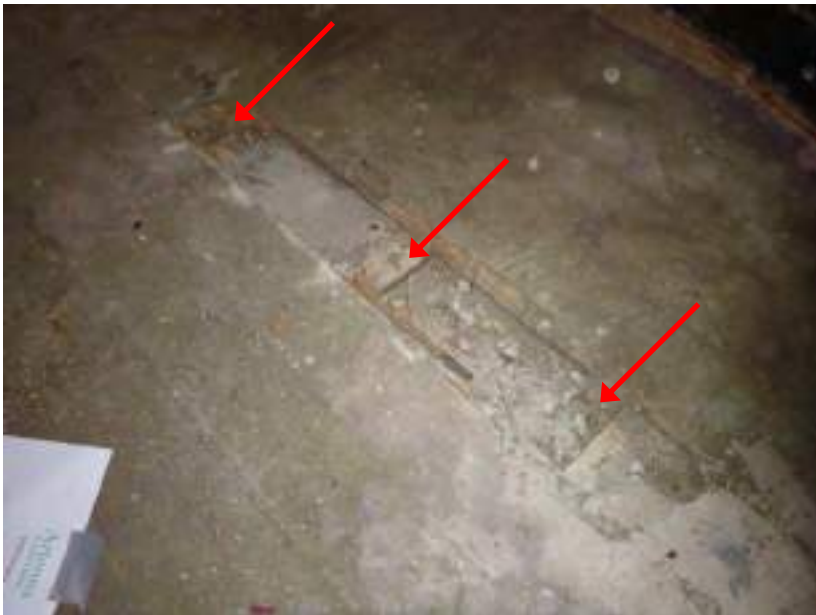
**Fig 32:**

Floor structures, first floor, RM.1-18; showing royal box floor structures comprising of solid construction with floorboards laid/fixed onto perpendicular battens/groundings set into floor slab

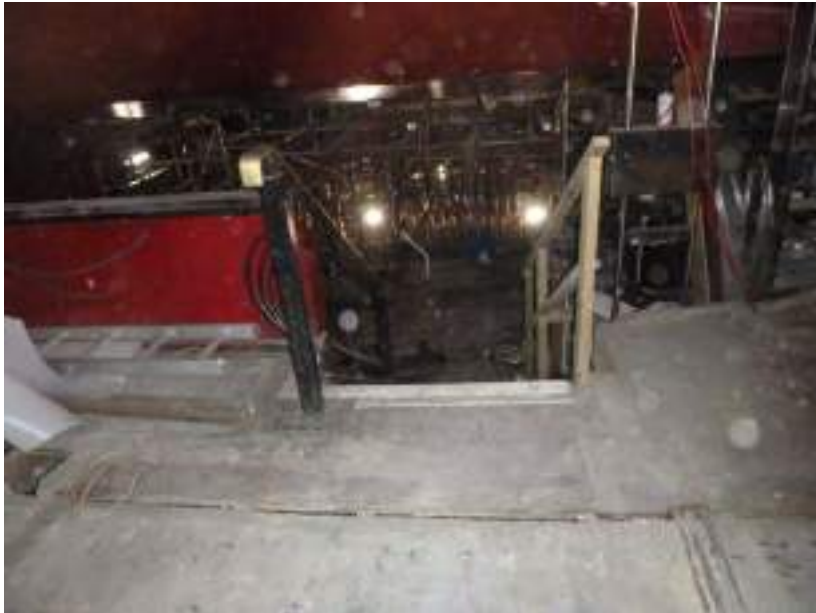
**Fig 33:**

Floor structures, first floor, RM.1-12; showing east area/juncture of floor structures between solid floor and balcony tiered floor of suspended timber floor construction. Structures inaccessible at the time of investigation due to known ACMs. However, structures within void suspected of being damp and mould affected

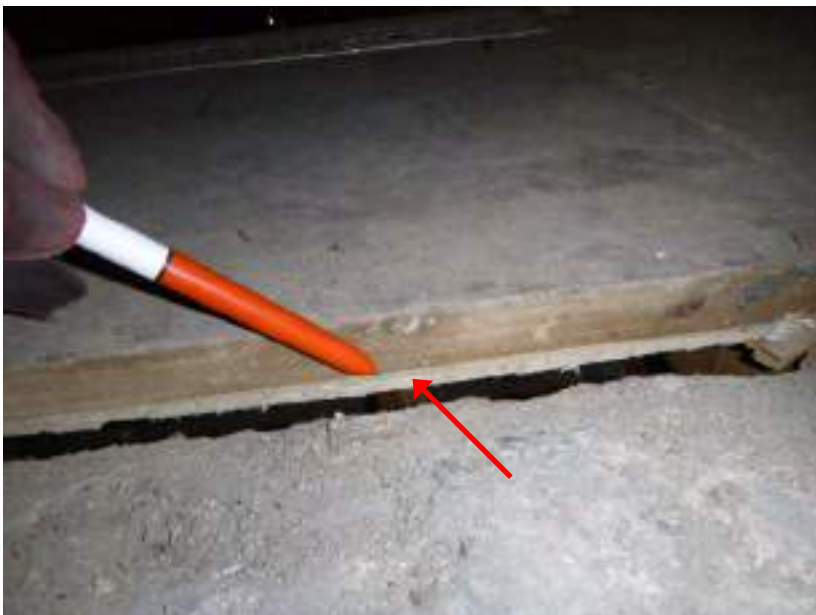
**Fig 34:**

Floor structures, first floor, RM.1-12; showing east area/juncture of floor structures between solid floor and balcony tiered floor of suspended timber floor construction. Structures inaccessible at the time of investigation due to known ACMs. However, structures within void suspected of being damp and mould affected

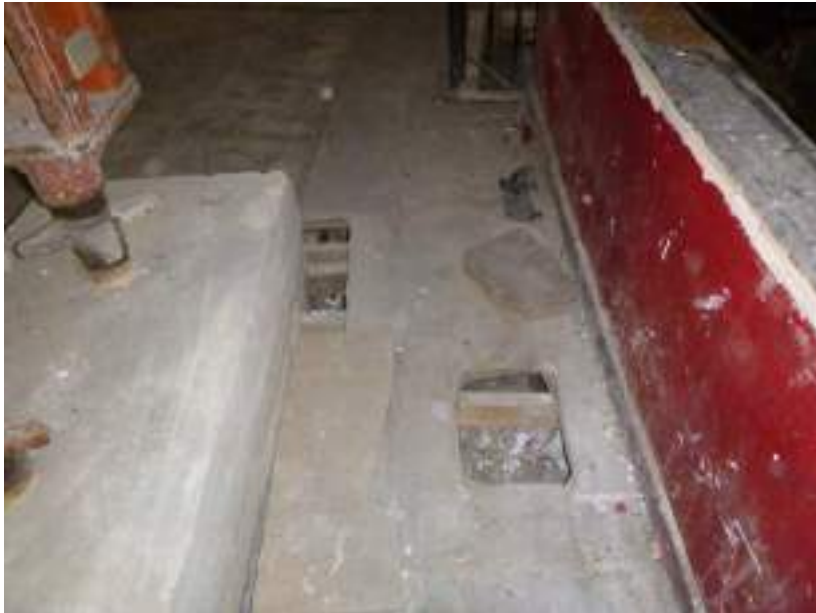
**Fig 35:**

Floor structures, first floor, RM. 1-12; showing partially exposed area of south floor structures between solid floor and balcony tiered floor. Structures inaccessible at the time of investigation due to known ACMs. However, structures within void suspected of being damp and mould affected

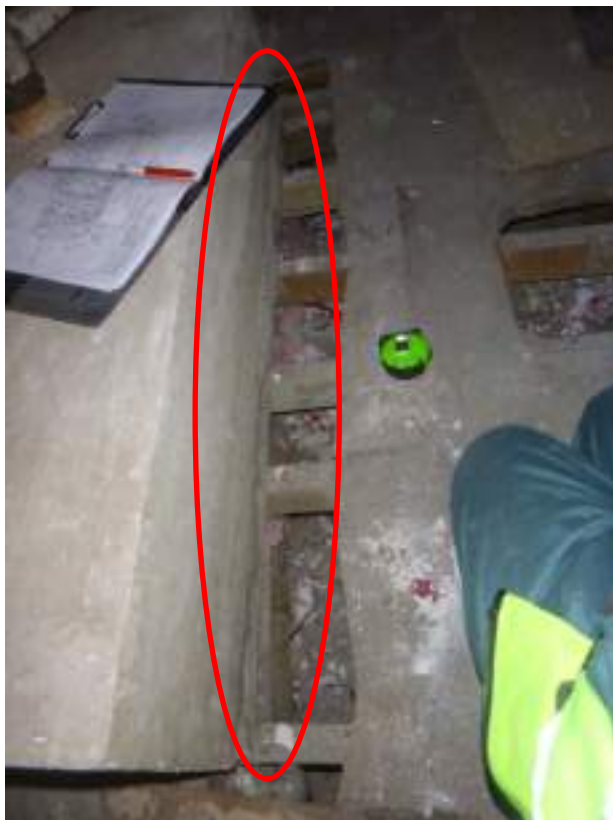
**Fig 36:**

Floor structures, first floor, RM. 1-12; showing partially exposed area of south floor structures between solid floor and balcony tiered floor. Note juncture of timber elements where they have been cut short by the introduction of remedial structural works

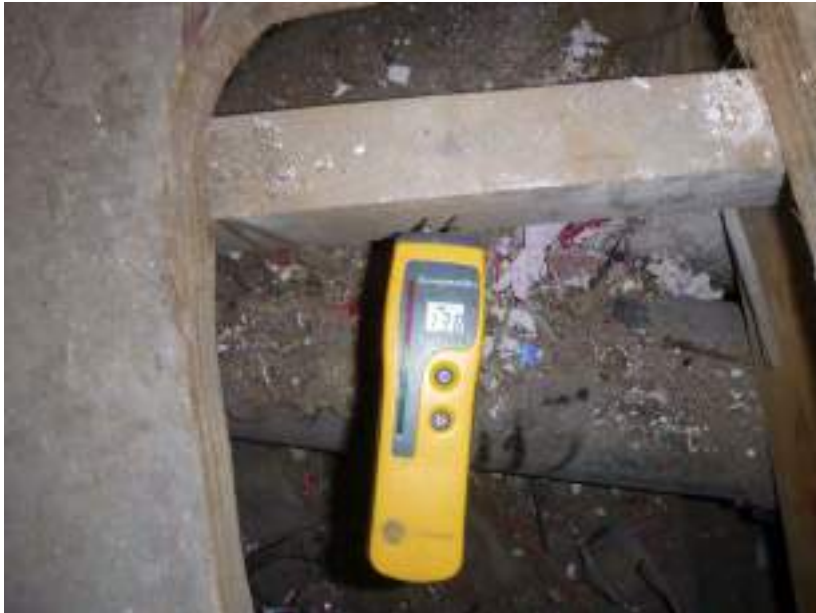
**Fig 37:**

Floor structures, first floor, RM.1-12; showing partially exposed area of south floor structures between solid floor and balcony tiered floor. Surface content reading showing dry at ~14 per cent. However, inaccessible structures within void suspected of being damp and mould affected

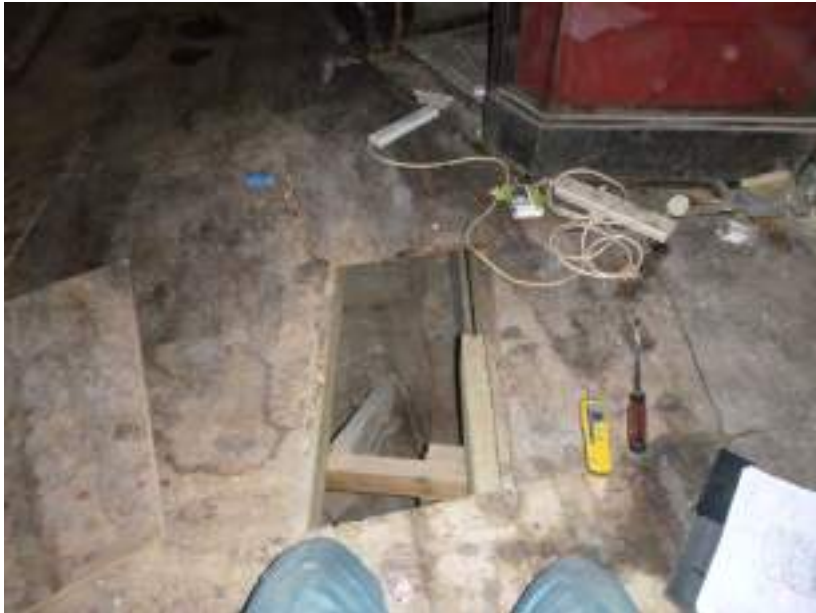
**Fig 39:**

Floor structures, first floor balcony, RM.1-11; showing north area of bar with access into floor void for visual inspection only

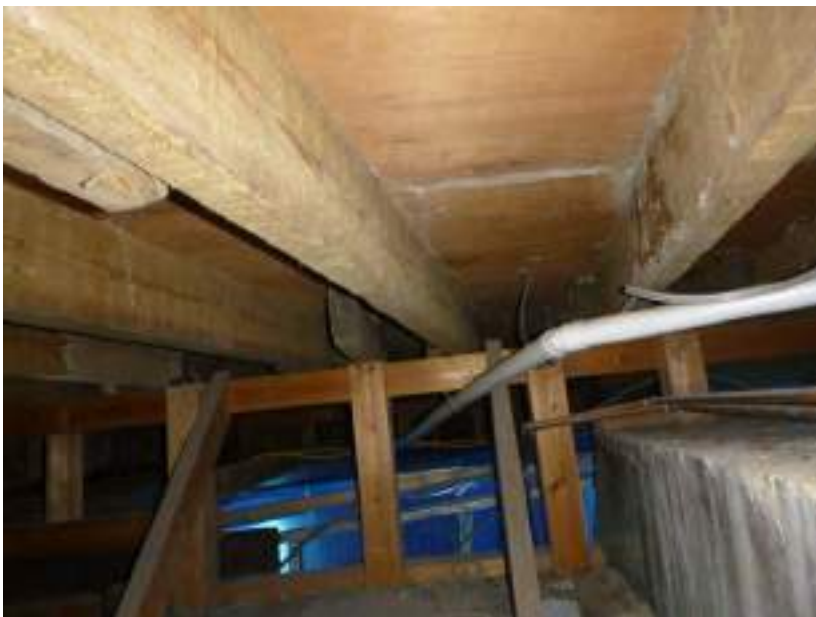
**Fig 40:**

Floor structures, first floor balcony, RM.1-11; showing north area of bar floor void. Note suspended timber floor construction supported by perpendicular dwarf studwork walls

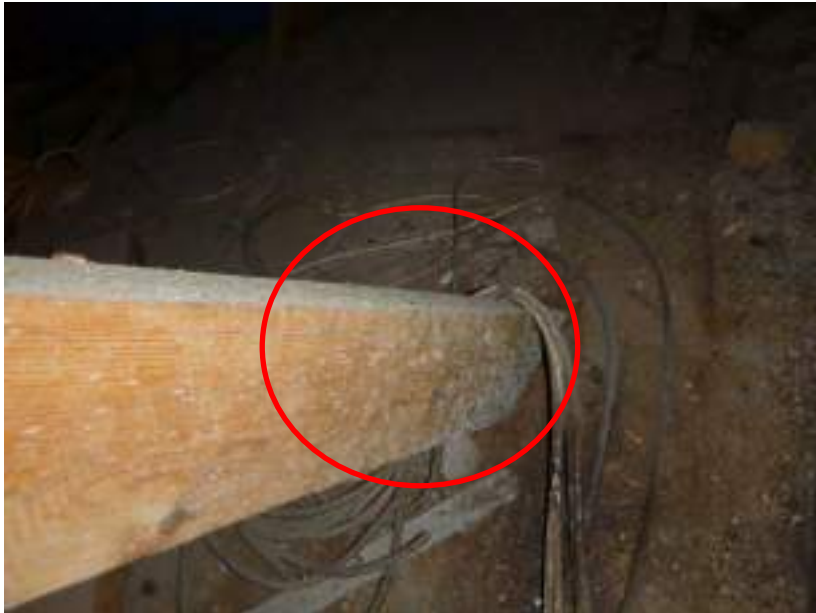
**Fig 41:**

Floor structures, first floor balcony, RM.1-11; showing north area of bar with timbers within floor void visibly subject to surface mould growth as a result of recent moisture penetration and inadequate ventilation

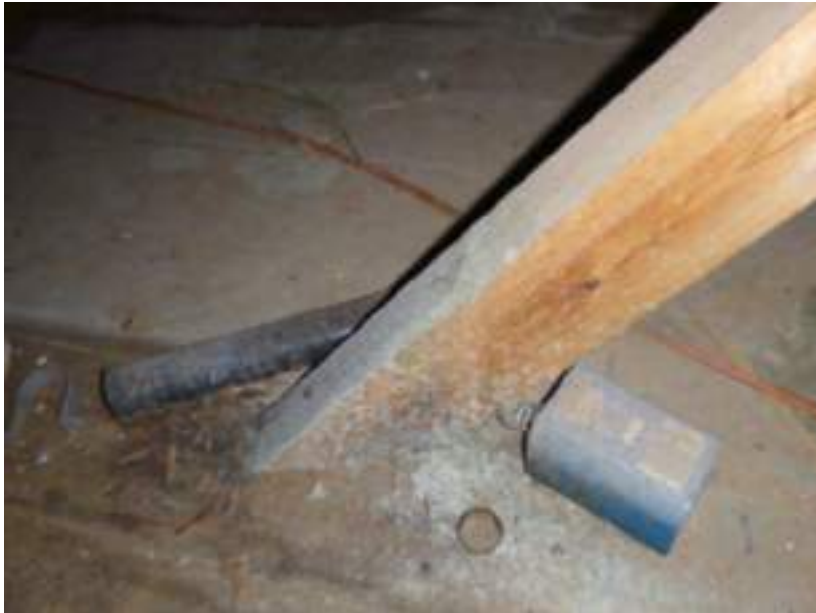
**Fig 43:**

Floor structures, first floor balcony, RM.1-11; showing south area of bar with timbers within floor void visibly subject to surface mould growth as a result of recent moisture penetration and inadequate ventilation

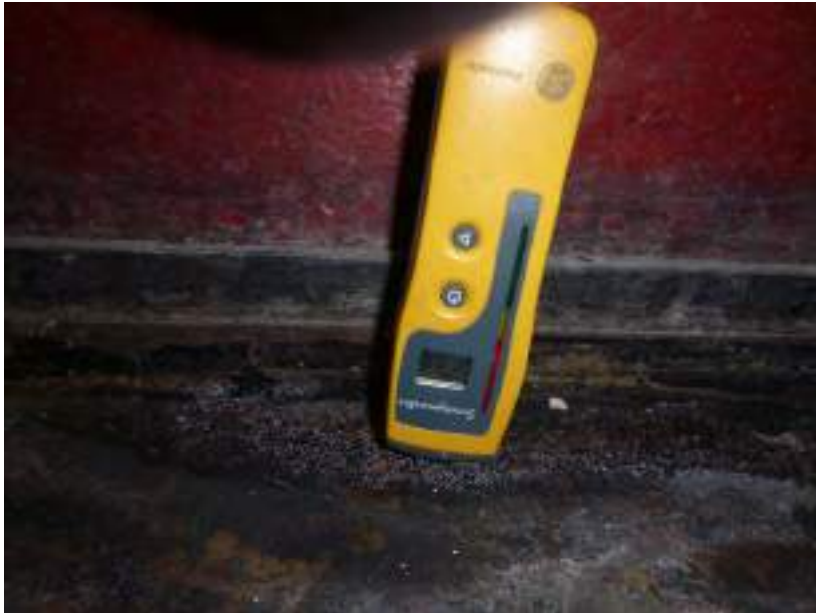
**Fig 45:**

Floor structures, first floor balcony, RM.1-11; showing south area subject to visible water and salts damage. Floorboards showing moisture contents at ~29 per cent

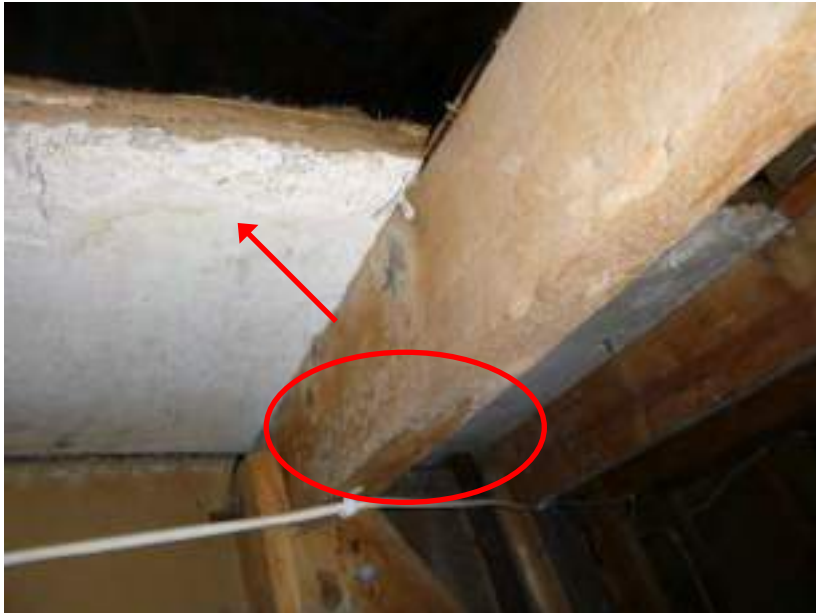
**Fig 47:**

Floor structures, first floor balcony, RM.1-11; showing south lower tier area. Note visible ACM sandwiched between floorboard and joist elements. Also note available timbers visibly subject to surface mould growth

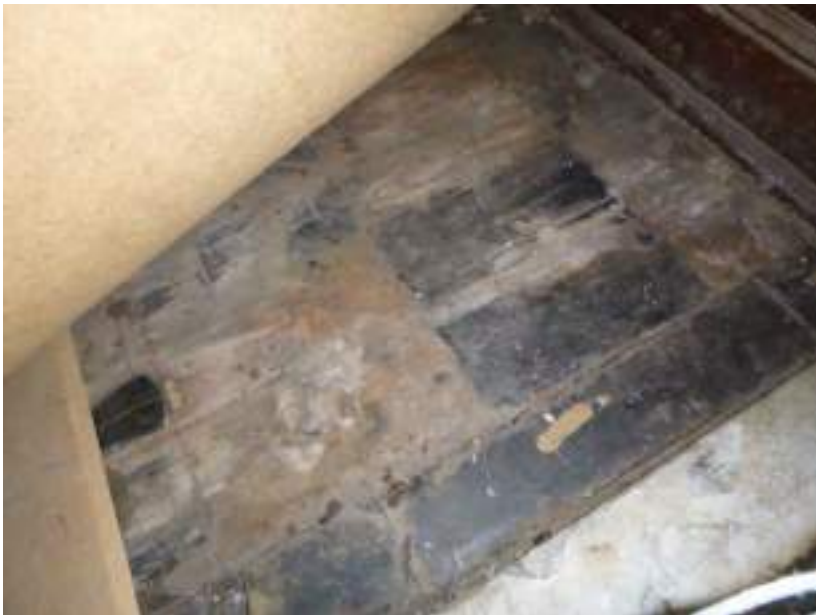
**Fig 48:**

Floor structures, Ground floor, RM.G-13; showing typical image of historic black and white tiled solid floor structures beneath protective boarding's. Timber floorboards understood to have been removed previously during phase 1 strip-out

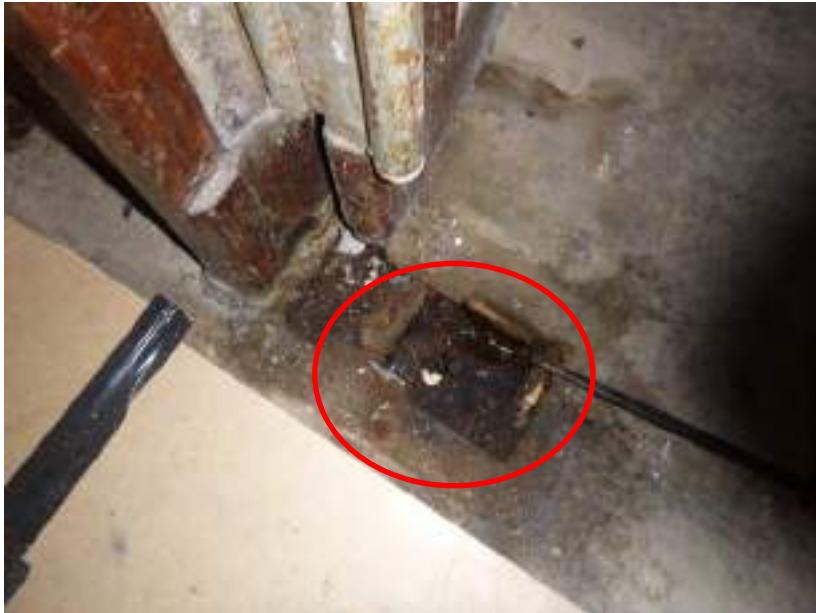
**Fig 49:**

Floor structures, Ground floor, RM.G-13; showing south-east area adjacent to DG-35. Note visible water collecting within cavity in solid floor structures as a result of the fire related water penetration. Door joinery highly vulnerable to decay in this area

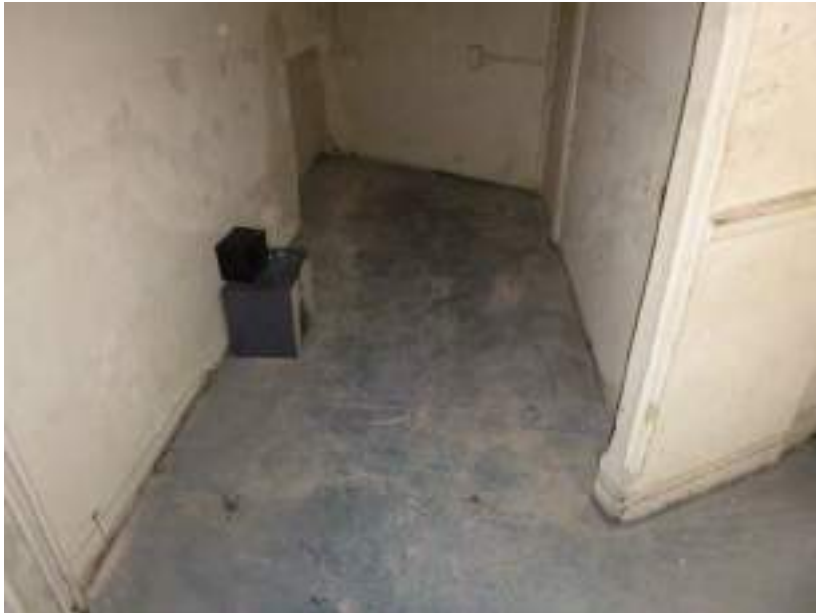
**Fig 51:**

Floor structures, Ground floor, RM.G-09; showing view looking west of non-historic suspended timber floor over suspected blocked staircase/exit. No decay suspected

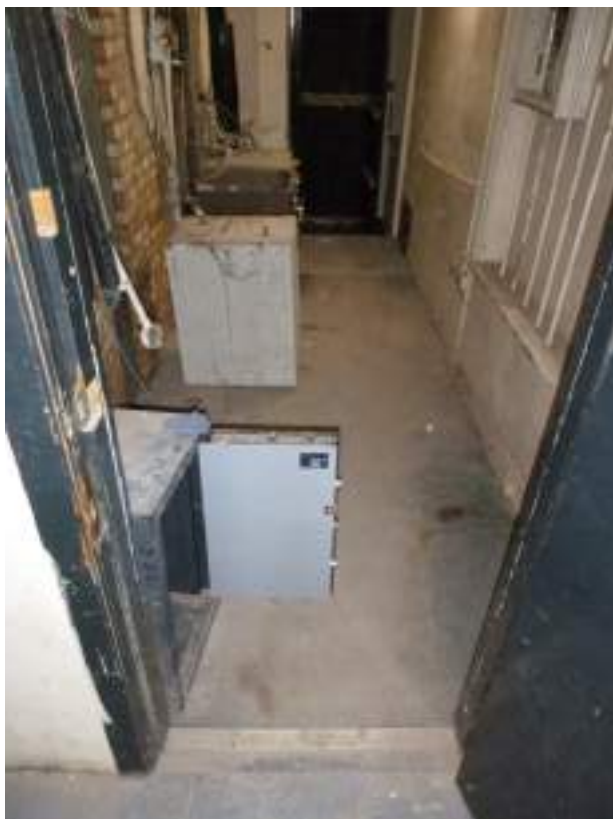
**Fig 52:**

Floor structures, Ground floor, RM.G-08; showing view looking east of non-historic suspended timber floor over solid floor structures. No decay suspected

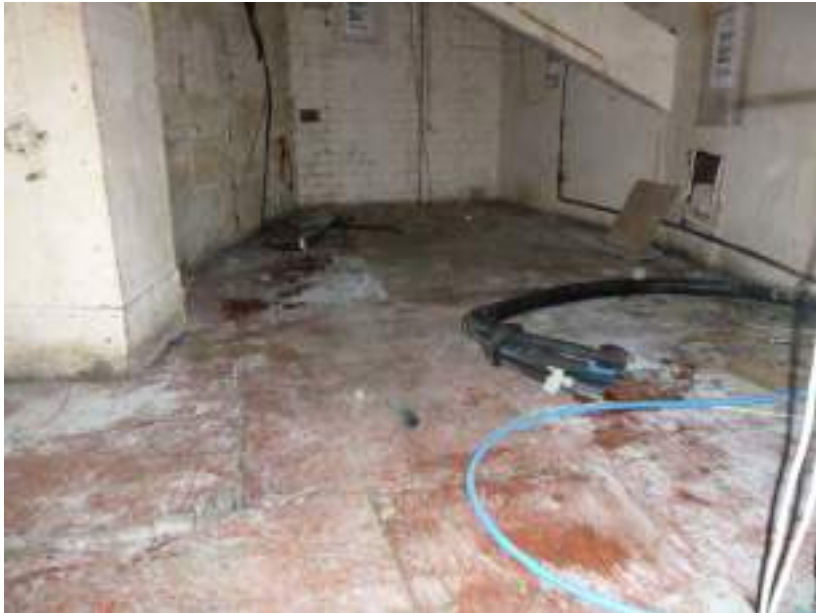
**Fig 53:**

Floor structures, Ground floor, RM.G-21; showing suspended timber floor structures inaccessible for investigation due to known ACMs within void

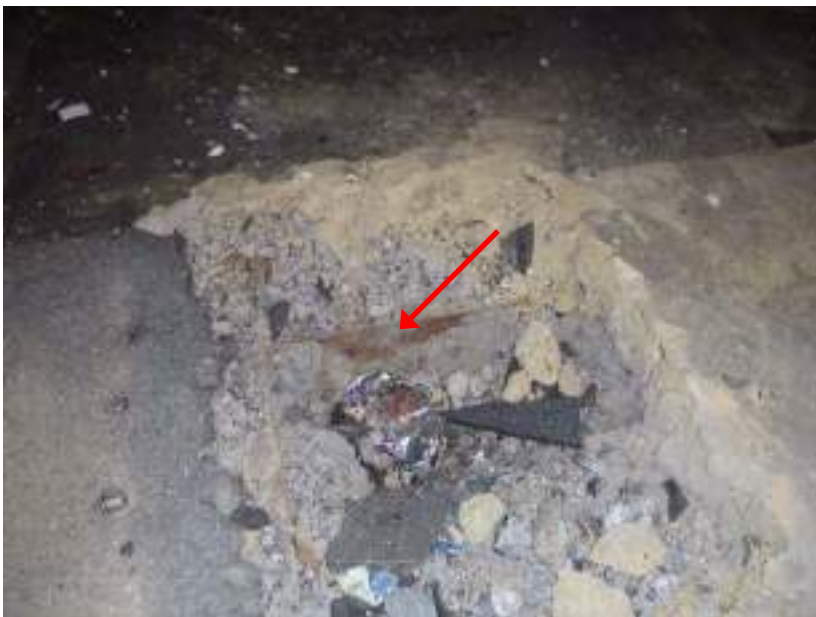
**Fig 54:**

Floor structures, Ground floor, RM.G-19; showing superficially excavated solid floor structure with visible embedded steel reinforcement

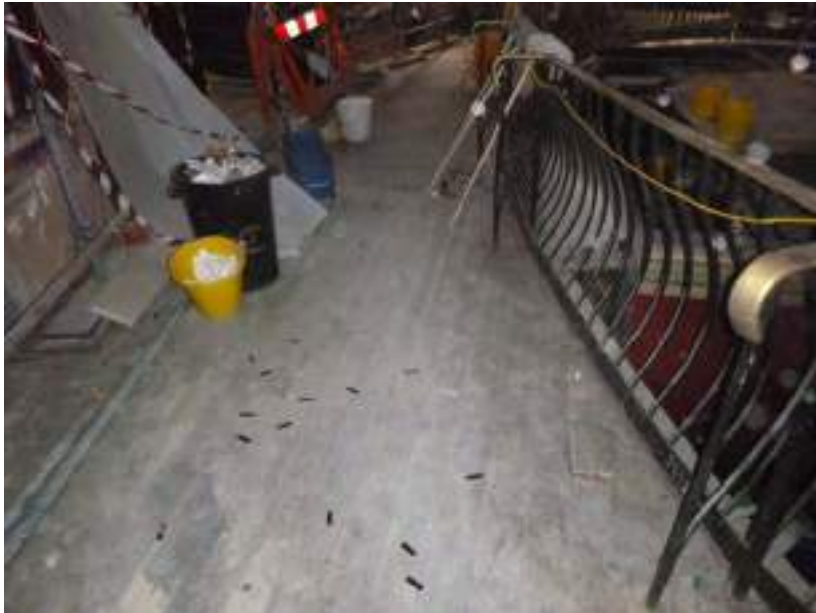
**Fig 55:**

Floor structures, Ground floor balcony, RM.G-10; showing general view looking north. Known ACMs within floor void

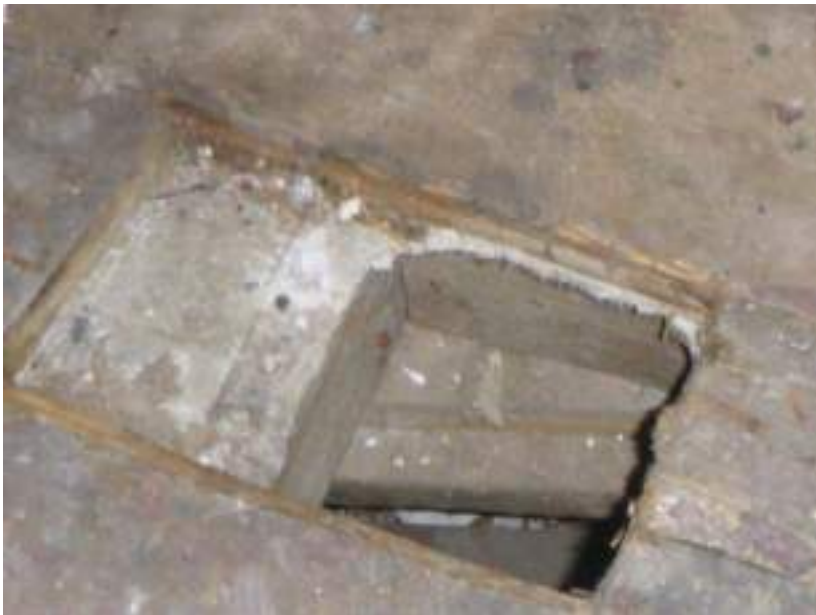
**Fig 56:**

Floor structures, Ground floor balcony, RM.G-10; showing visual access to floor void. Note ACM sandwiched between floorboards and floor joist elements. Structures within void suspected of being highly vulnerable to damp and decay issues

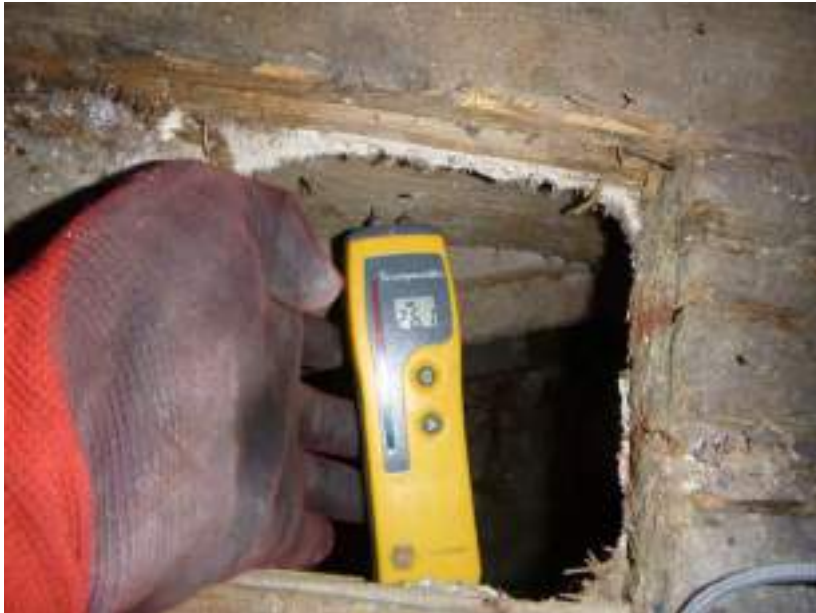
**Fig 57:**

Floor structures, Ground floor balcony, RM.G-10; showing vulnerable timber element within floor void with a surface moisture content at ~26 per cent. Which is high enough to support decay organisms

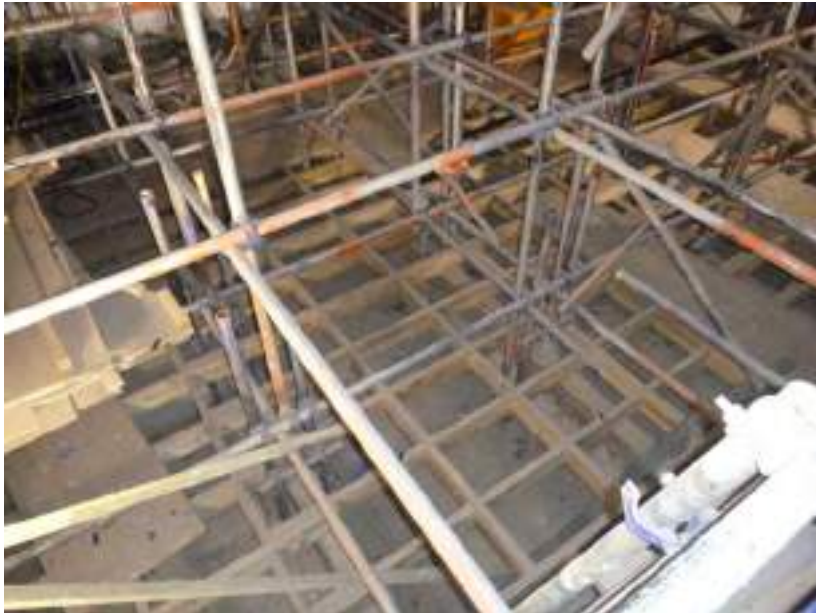
**Fig 59:**

Floor structures, Basement floor, RM.B -15; showing general view of main auditorium floor currently exposed and of modern construction

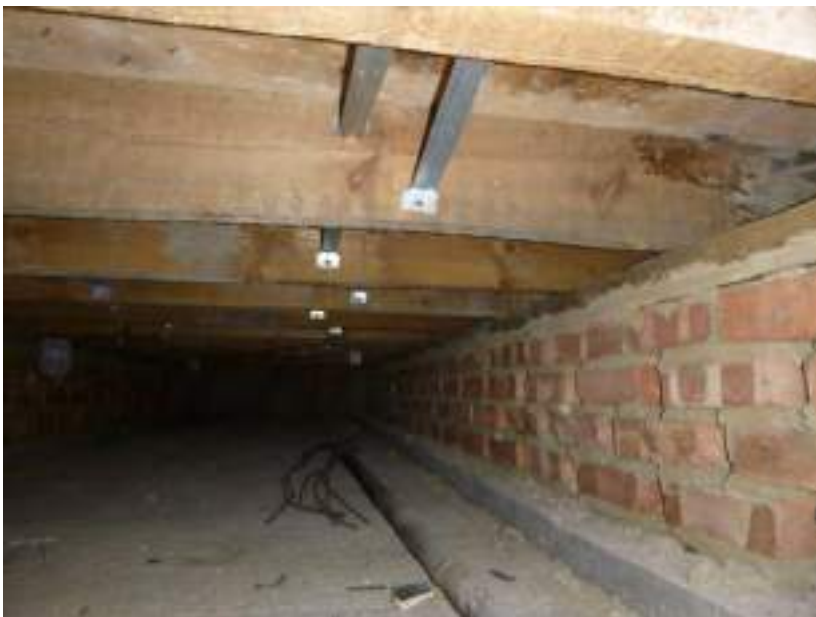
**Fig 60:**

Floor structures, Basement floor, RM.B -15; showing currently exposed structures of sound modern construction. Note dwarf brick wall with ventilation slots

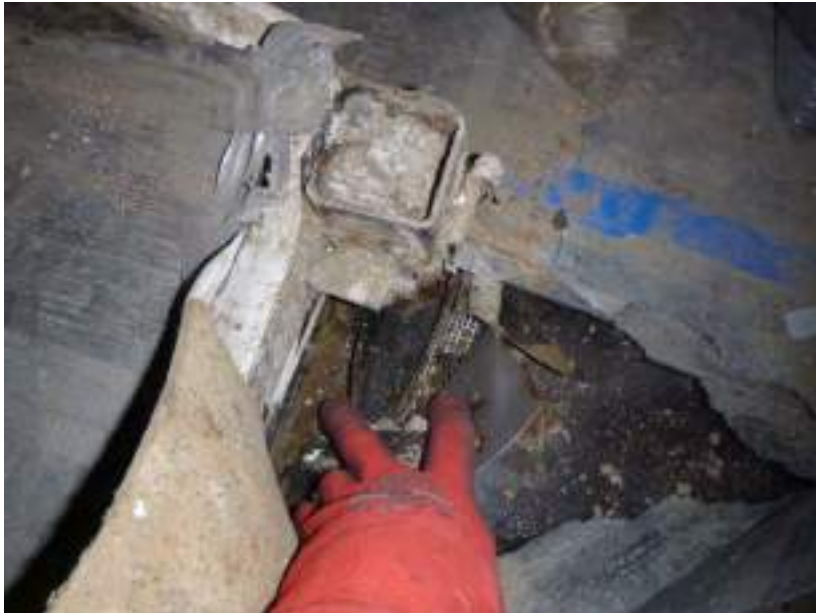
**Fig 61:**

Floor structures, Basement floor, RM.B -11; showing stage floor structure with finishes visibly damp. Note multiple (<4no.) layers of impermeable membrane/floor finishes to stage floor. These all appeared to be trapping/retaining moisture and may be creating the conditions for damp and decay to structures beneath

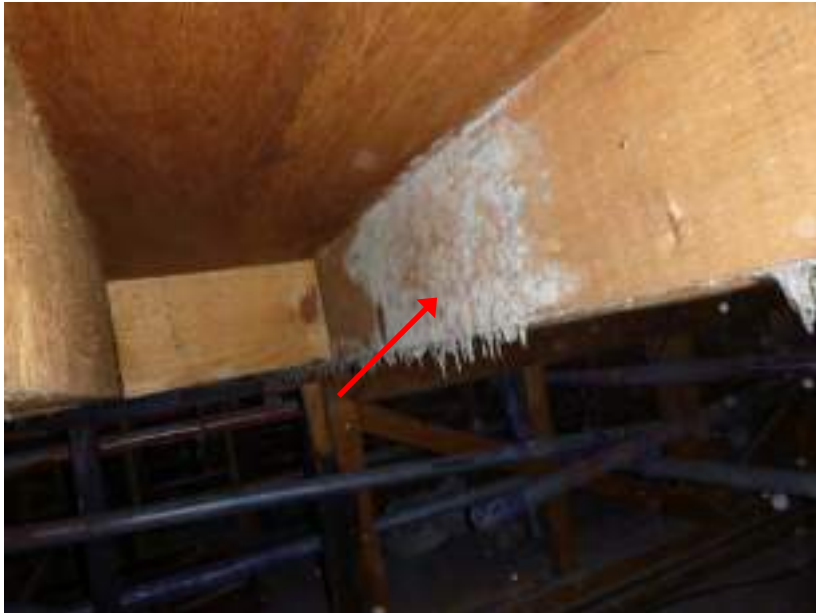
**Fig 63:**

Floor structures, Basement floor, RM.B -11; showing typical view of stage floor structures from below. Note visible active surface mould growth suggestive of damp conditions and inadequate ventilation

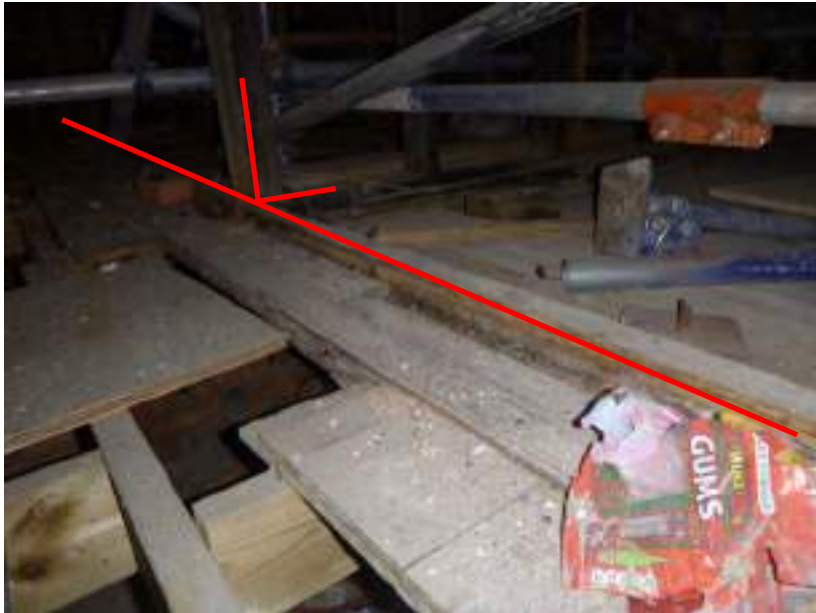
**Fig 65:**

Floor structures, Basement floor, RM.B -11; showing stage floor structures west perimeter stud work subject to active decay at post feet and horizontal plate elements. Timber moisture contents at ~30+ per cent

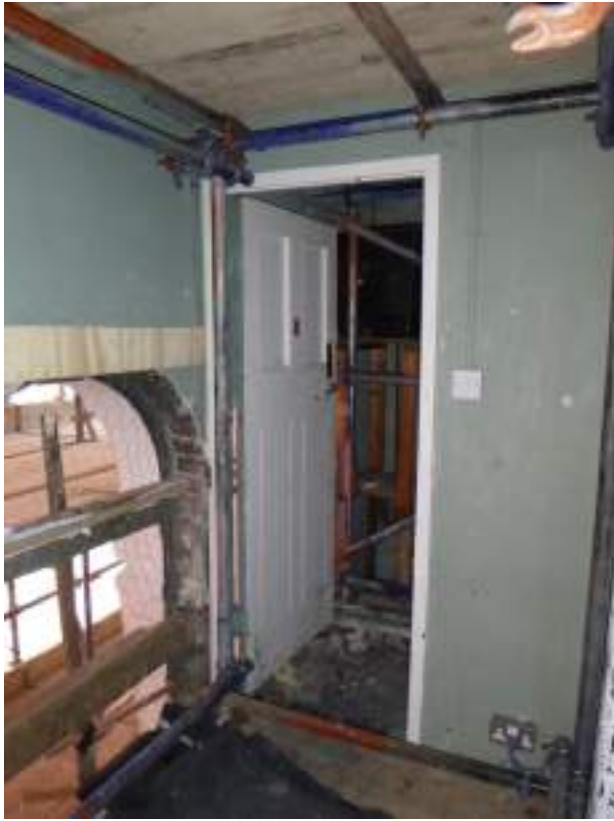
**Fig 1:**

Third floor; showing door D3-13

Mechanical damage was noted to door, framing, and to surrounding architrave which was likely to have been exacerbated by the fire-fighting efforts and subsequent immediate post-fire remedial works

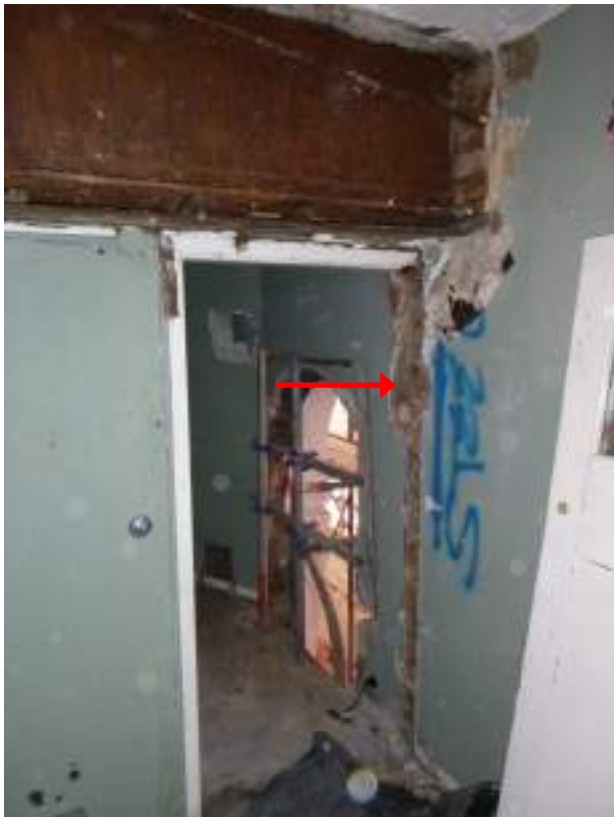
**Fig 2:**

Third floor; showing door D3-12

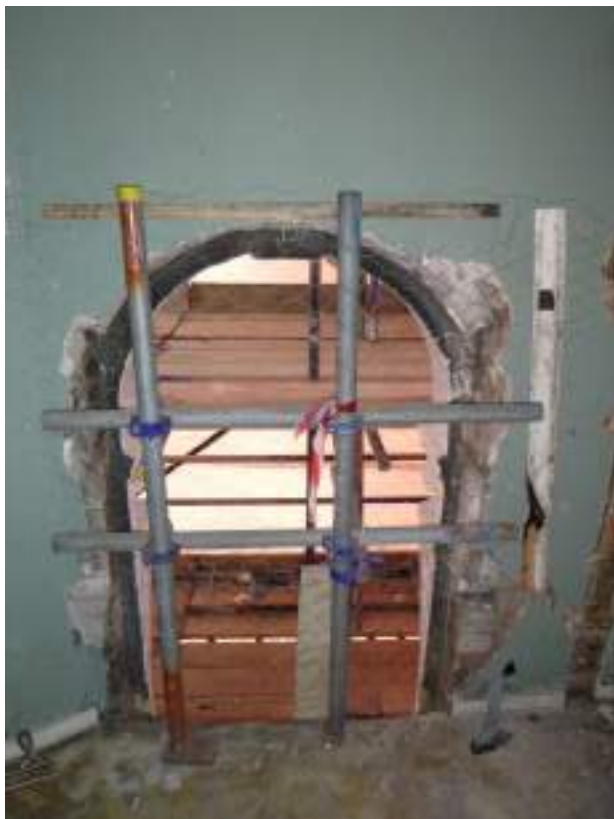
**Fig 4:**

Third floor; showing window W3-07

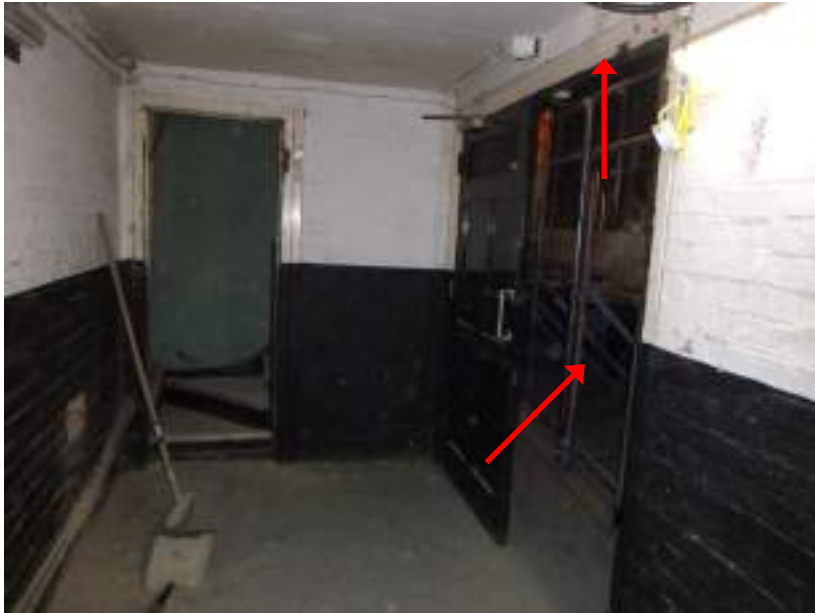
**Fig 5:**

Third floor; showing doors D3-10 and D3-11

The south door of D3-10 and door D3-11 were removed from hinges and stored nearby on edge

Note architrave missing from D3-10

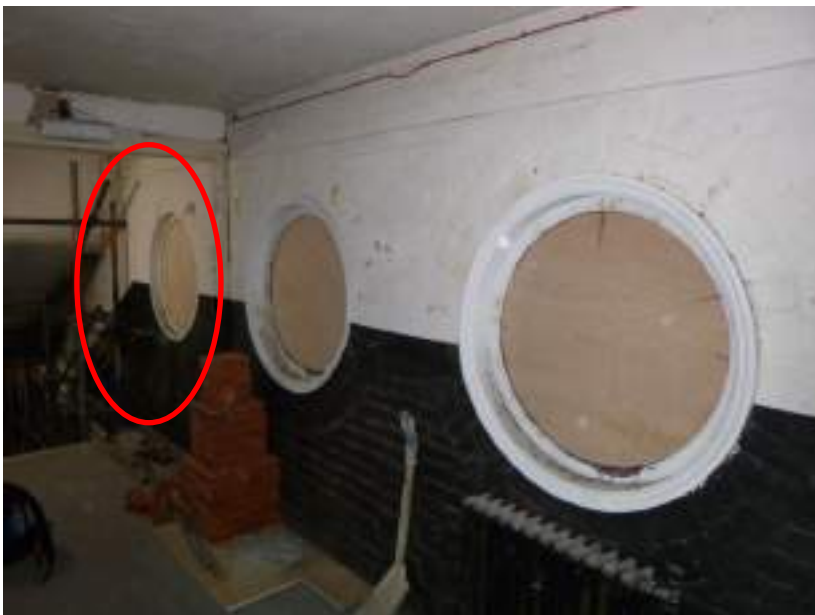
**Fig 6:**

Third floor; showing windows W3-08 A, B, and C

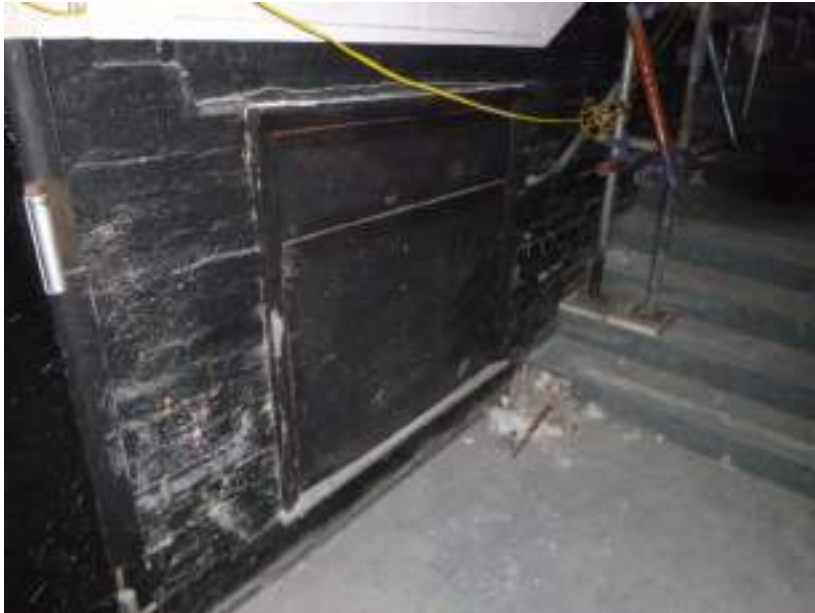
**Fig 7:**

Third floor; showing an historically blocked window in the stairwell up to the third floor

Windows were boarded up at the time of survey; however, were suspected to be vulnerable to issues with damp and decay during and after post-fire remedial works

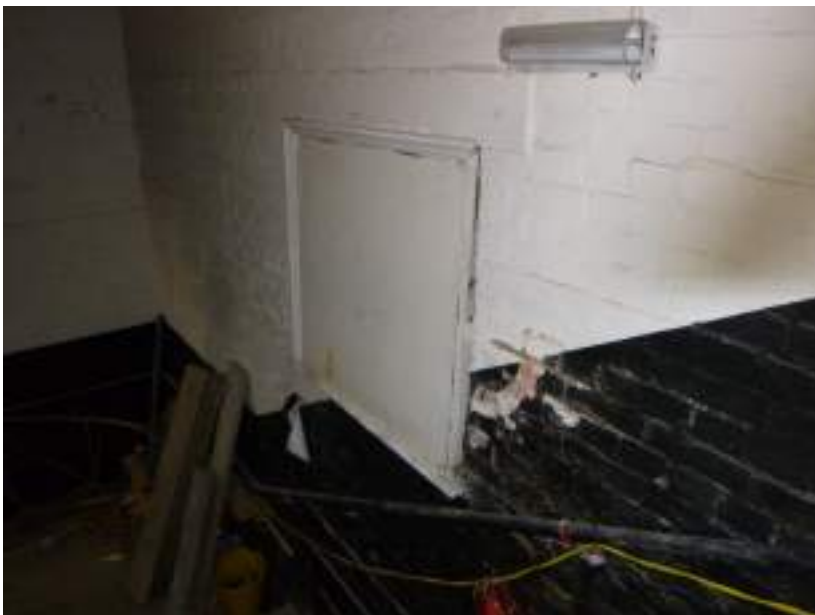
**Fig 8:**

Third floor; showing an historically blocked window in the stairwell up to the third floor

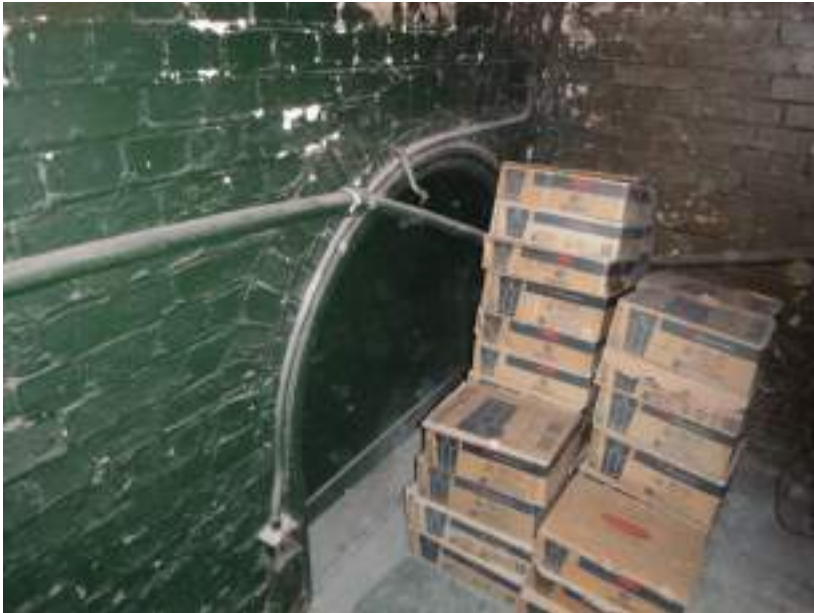
**Fig 9:**

Second floor mezzanine; showing an historically blocked window on the west side of the building

Windows were boarded up at the time of survey; however, were suspected to be vulnerable to issues with damp and decay during and after post-fire remedial works

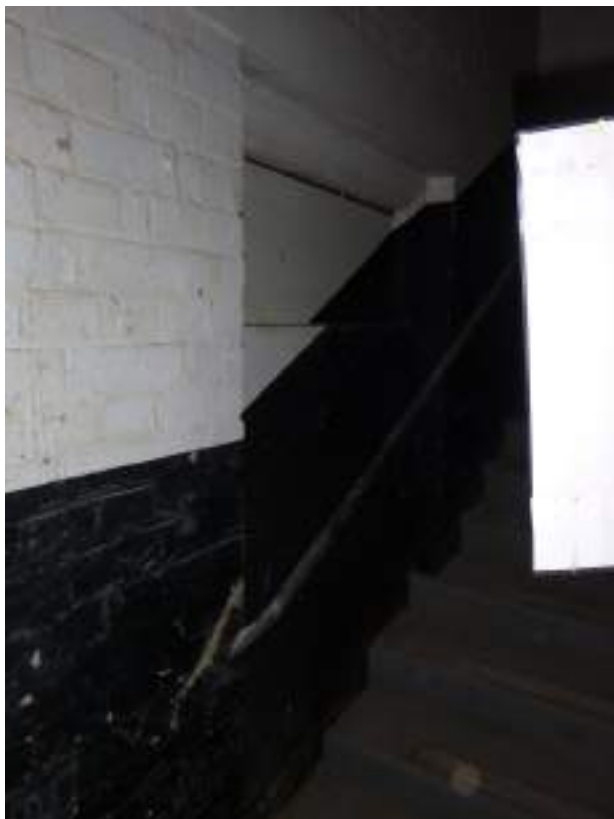
**Fig 10:**

Second floor mezzanine; showing an historically blocked window on the west side of the building

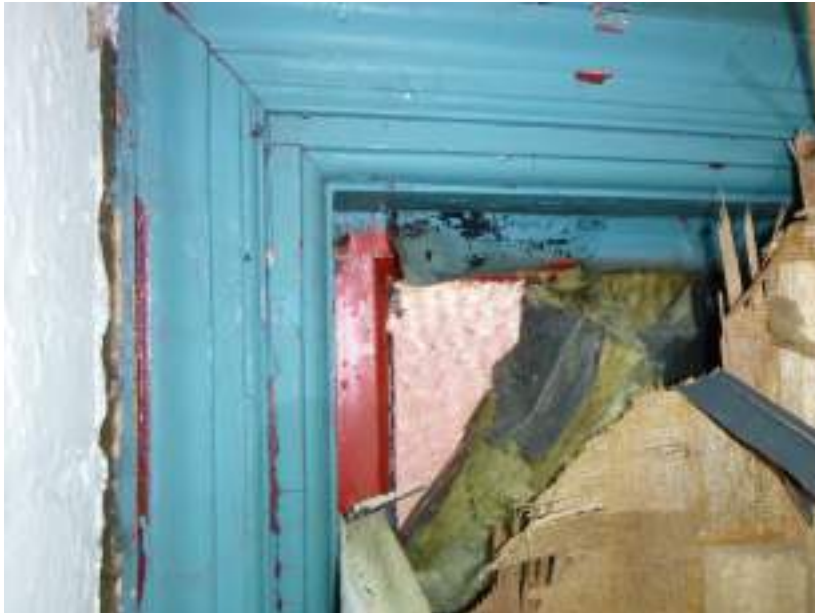
**Fig 11:**

Second floor; showing historic window elements behind plywood sheeting at the intermediate level between first and second floors, on the south side of the building

Windows were boarded up at the time of survey; however, were suspected to be vulnerable to issues with damp and decay during and after post-fire remedial works

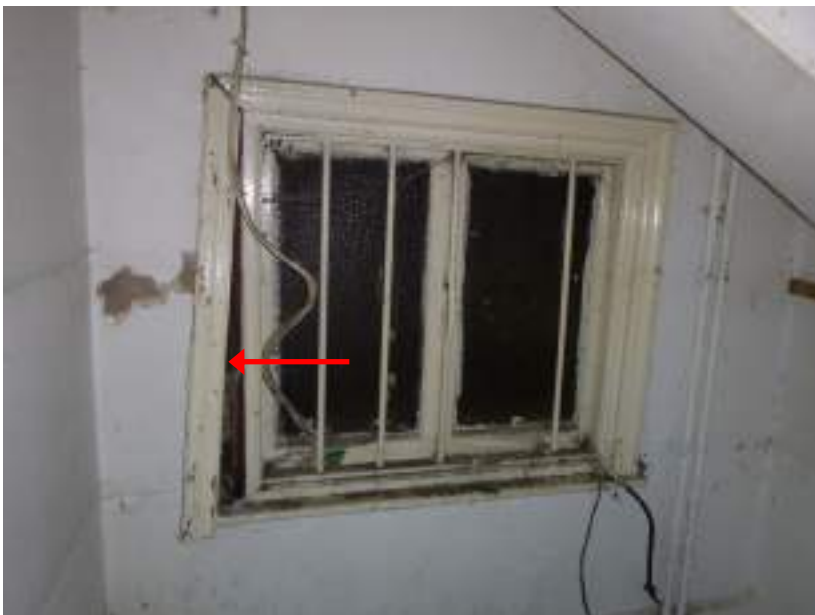
**Fig 12:**

Second floor; showing window W2—25

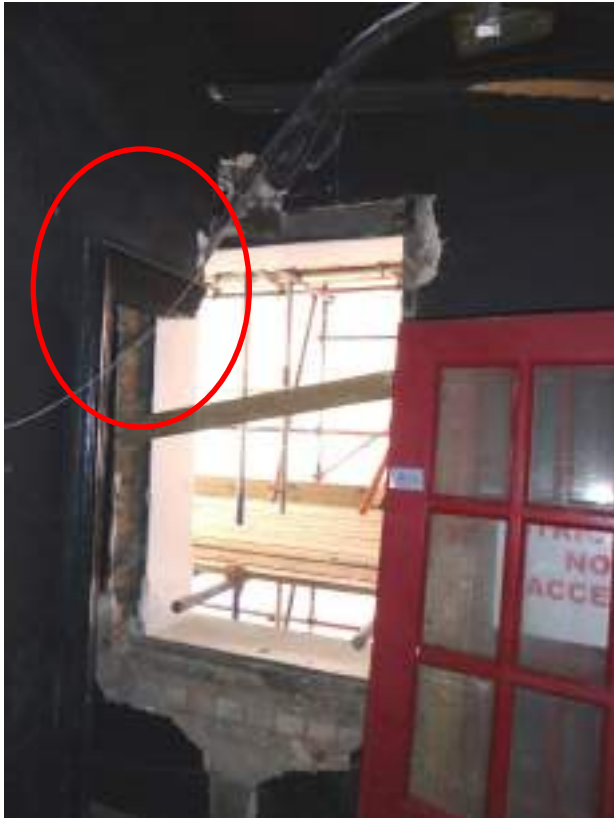
**Fig 13:**

Second floor; showing window opening W2-08

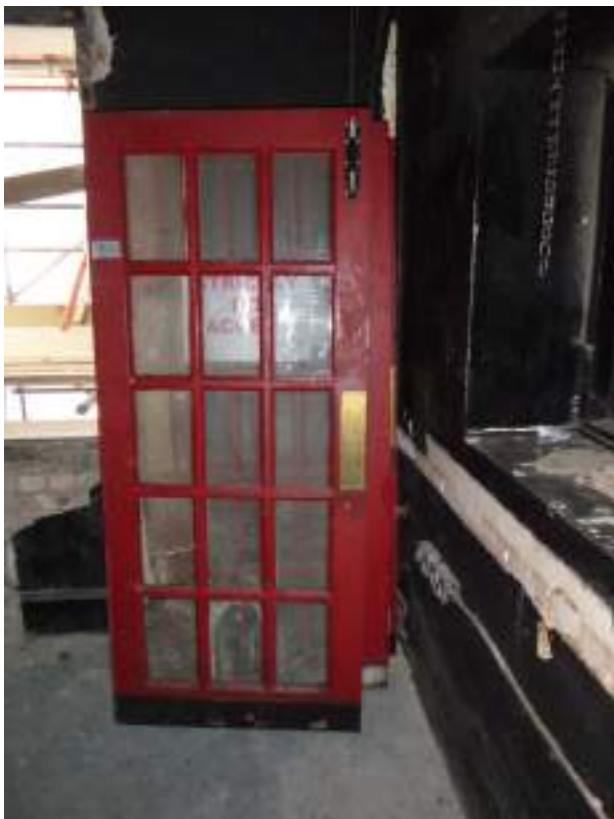
**Fig 14:**

Sash and framing timbers had been removed to provide access to the scaffold. This had resulted in damage to the door frame of doorway D2-18

Door was stacked to the side along with doors from door openings D2-13 and 14

Second floor; showing door D2-14

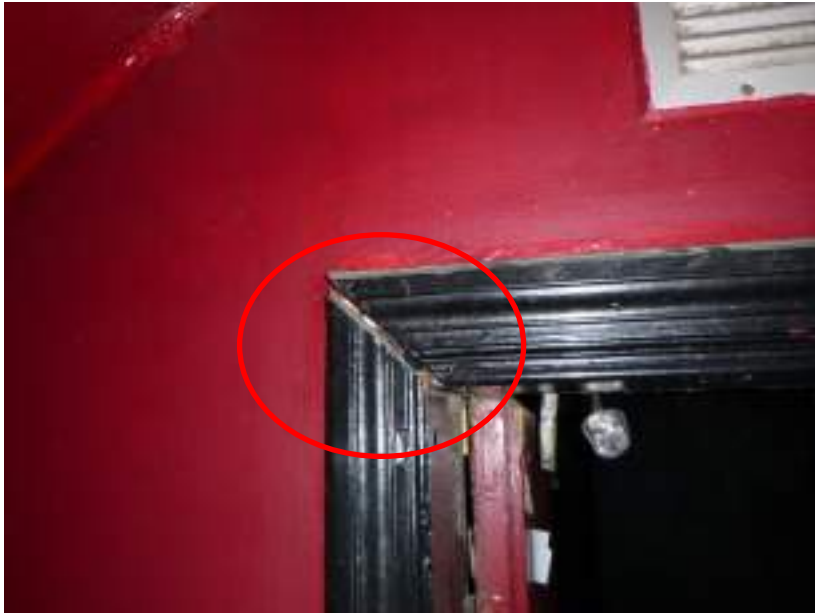
**Fig 15:**

Second floor; showing doorway D2-16

The architrave was opening slightly at the east mitre, although dust accumulation within the joint indicated this was historic and not a result of the fire-fighting efforts; however, these effects may have been exacerbated by the water penetration
