**The Hope Project, KOKO**

Photographs  
05 August 2020  
Not to scale

Job no. 146-89 Site Note 8 ADDENDUM Page11 © Copyright Hutton+Rostron 2020

## The Hope Project (KOKO): Timber floor structures condition Investigation

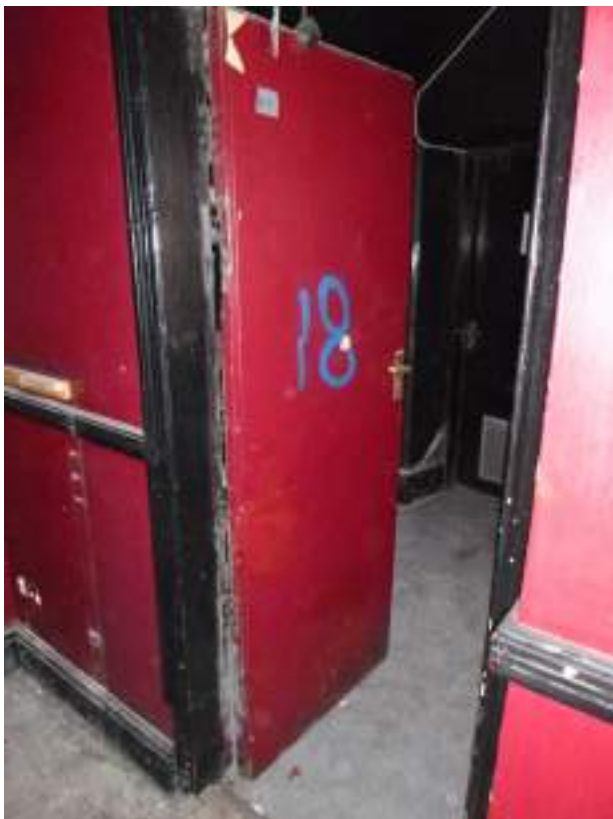
**Fig 16:**

Second floor; showing doorway D2-16

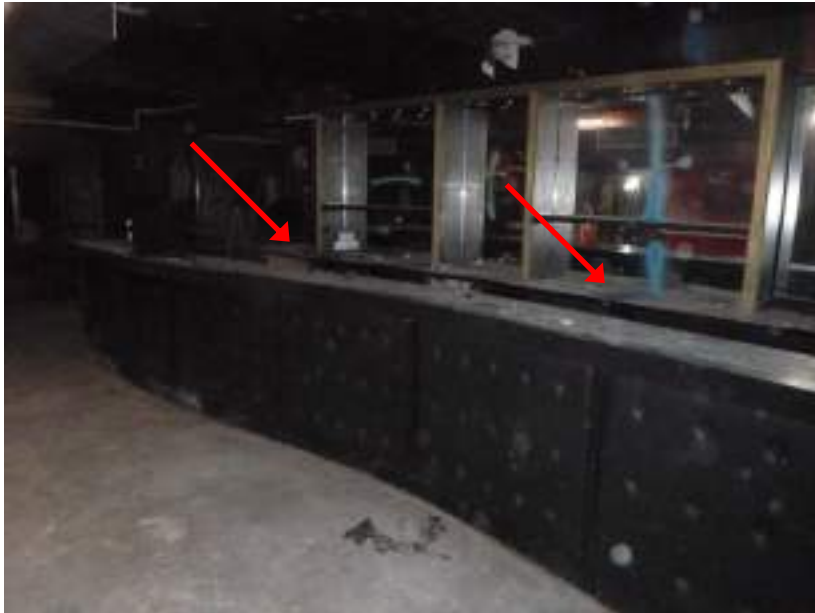
**Fig 17:**

Second floor; showing room RM.2-16

Bar elements were likely to have been saturated during fire-fighting efforts and can be discarded and replaced with new to match existing, after the drying phase

Bar furniture in RM.2-16 likely to have been saturated during fire-fighting efforts and highly vulnerable to issues with damp and decay during and after post-fire remedial works  
*Remove and replace all bar furniture, worktops, and associated joinery with new to match existing*

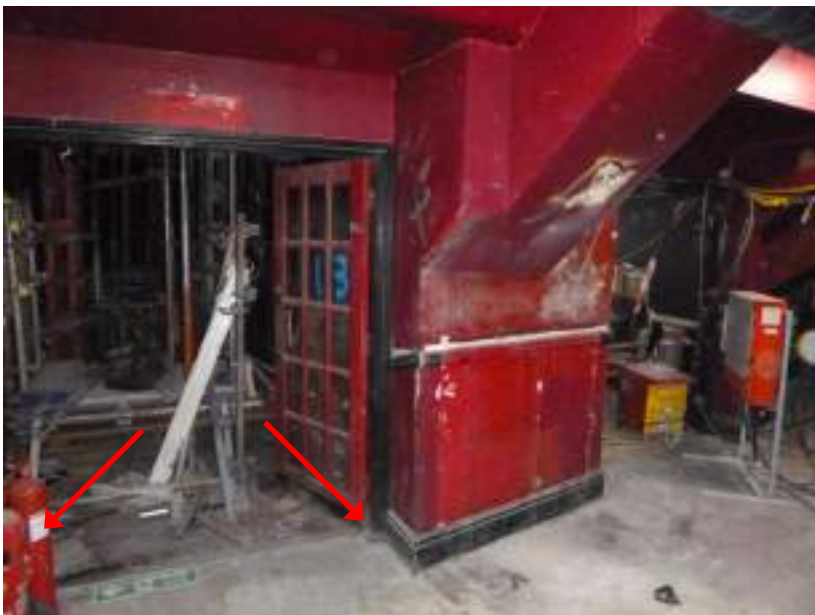
**Fig 18:**

Second floor; showing doorway D2-14

The north door had been removed and stacked in RM.2-17 on-edge. Moisture was noted to be collecting in pockets at the base of jambs of both doorways D2-13 and 14 and is likely to lead to localised wet rot decay of timber door framing. Moisture contents were at fibre saturation (over 30 per cent w/w) at the base of door jambs

Water collecting at base of jambs. Moisture content high enough for decay to occur. Doors stacked on-edge in room RM.2-17  
*Door frames should be removed and reinstated with new to match existing after drying phase with provision for isolation from masonry*

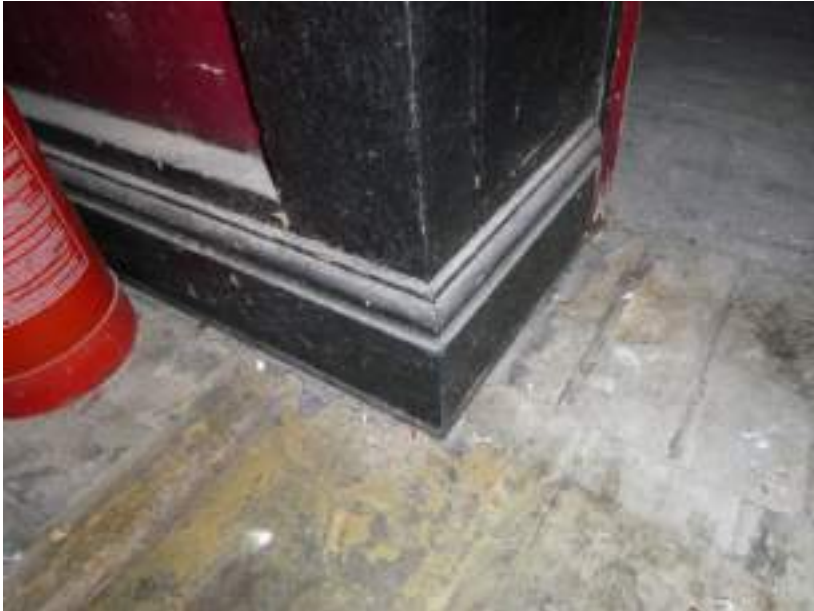
**Fig 19:**

Second floor; showing timber skirting to the south of doorway D2-13

Moisture content readings taken from skirting in this area were mostly well below the decay threshold of ~20 per cent w/w; however, issues with damp and decay were considered likely to affect timbers in contact with damp masonry during and after the post-fire remedial works

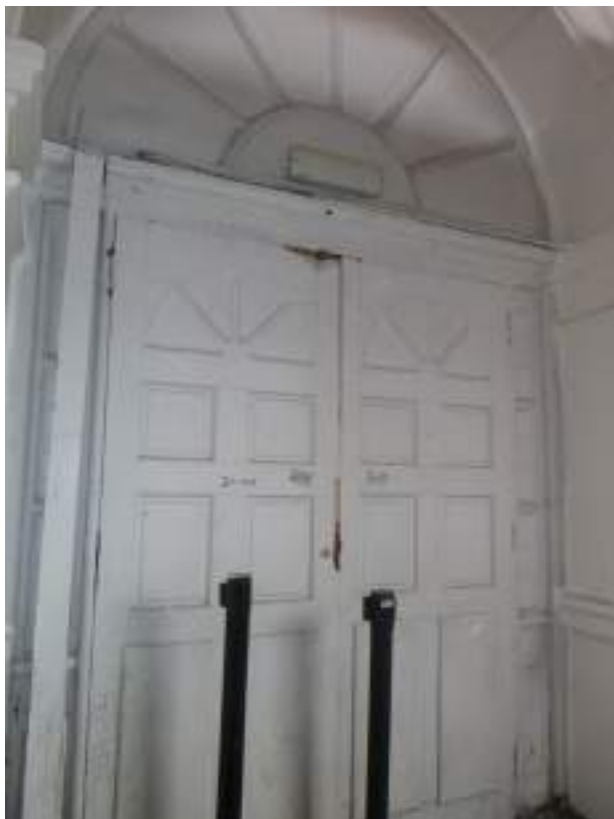
**Fig 20:**

First floor; showing door D1-04

These doors may be of historic significance but were noted to be of a tropical hardwood timber, and heavily painted, including over the leaded and glazed side panels which may reduce their historic integrity further. Although framing was deemed to most likely be of some age

Moisture content of architrave at floor level was high enough for decay to occur at the time of survey

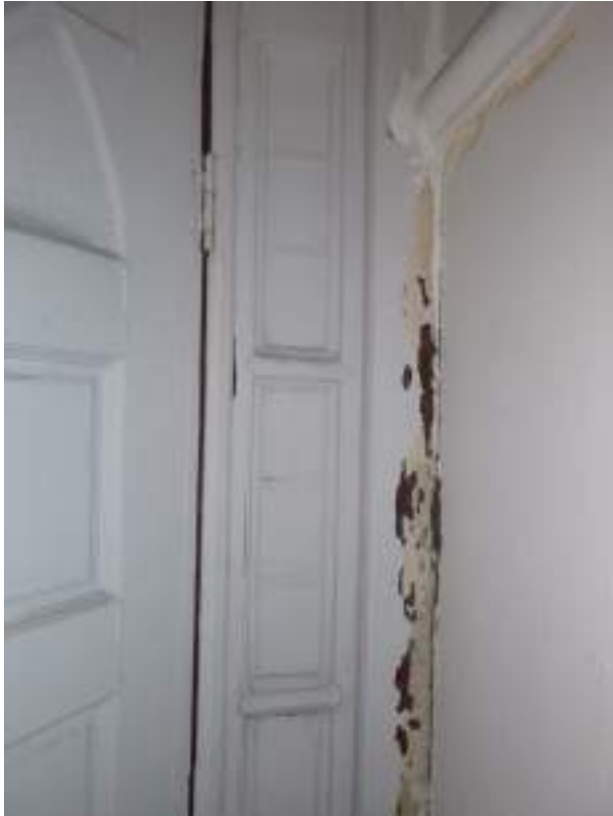
**Fig 21:**

First floor; showing the painted, glazed and leaded side panels of door D1-03

Moisture contents of architrave at floor level was noted to be above the level required for decay to occur

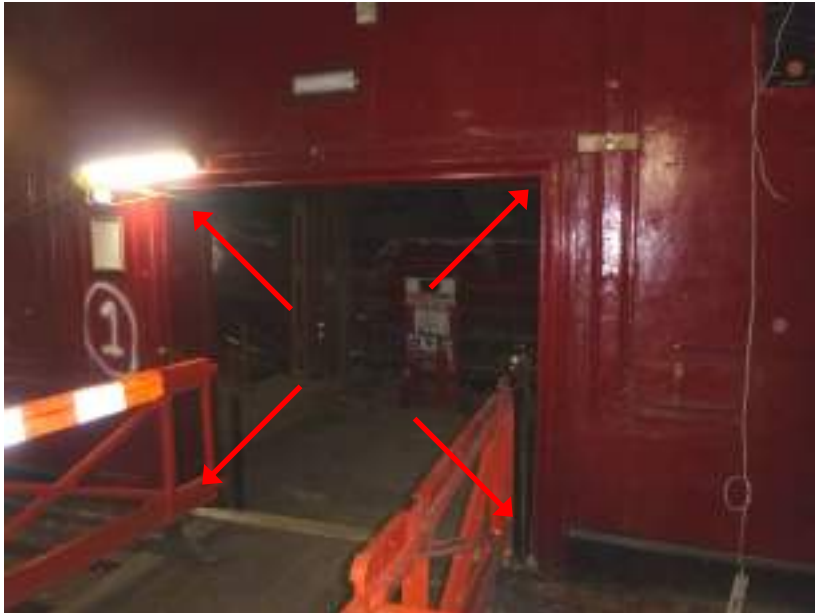
**Fig 23:**

First floor; showing the doorway through to the balcony from the bar area at first floor level

Moisture content readings taken from the architrave and framing around the opening were generally above the level required for decay to occur indicating elevated moisture retained within the masonry mass leaving timbers in contact vulnerable to issues with damp and decay

Timber framing elements and architrave of opening between balcony and bar area all at over 20% moisture content, high enough for decay to occur  
*Non-historic material can be removed to allow masonry to dry, and discarded*

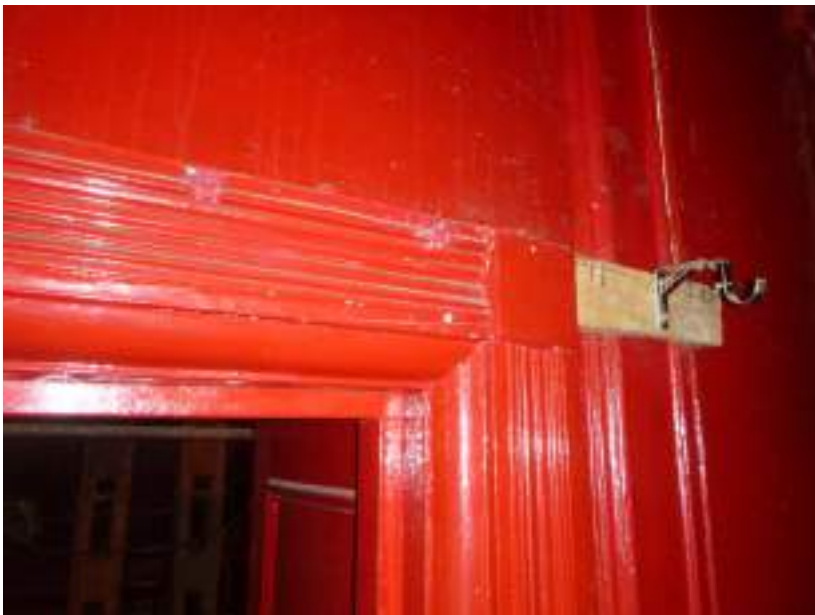
**Fig 24:**

First floor; showing square corner detailing of the architrave around the doorway through to the balcony from the first floor bar area

Moisture content readings taken from the architrave and framing around the opening were generally above the level required for decay to occur

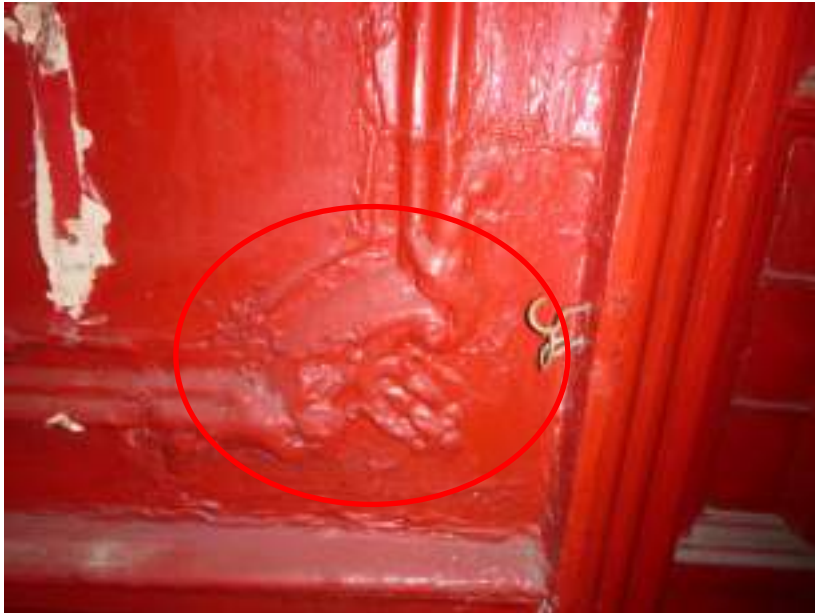
**Fig 25:**

First floor; showing significant reduction of detail on plaster-run mouldings on decorative panelling in RM.2-14 due to excessive painting on past refurbishments

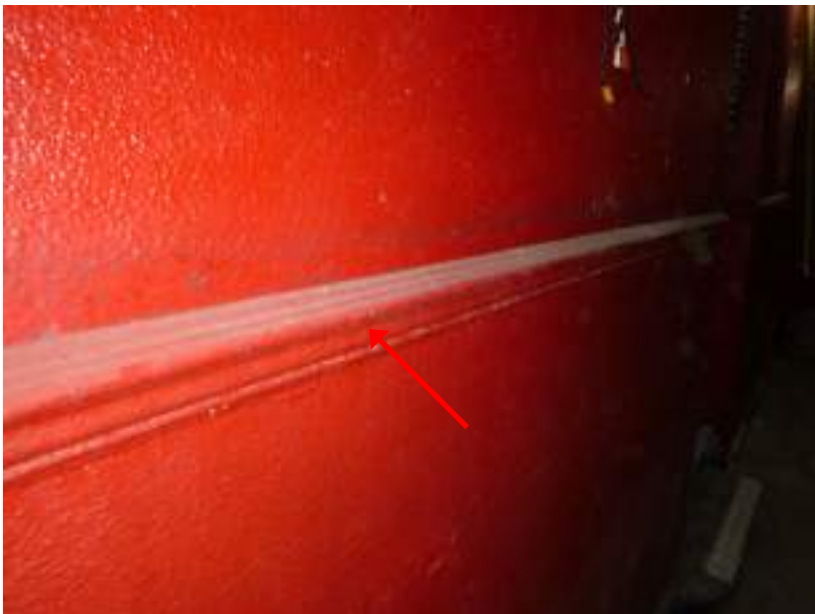
**Fig 26:**

First floor; showing timber dado rail in RM.2-12

Secondary timber elements in this area in contact with the west masonry wall were deemed vulnerable to issues with damp and decay due to retained moisture within the masonry mass. Moisture contents of timbers were recorded at well over the decay threshold of ~20 per cent w/w

Moisture contents of all secondary timbers in contact with masonry wall to west recorded at over the decay threshold of ~20% w/w  
*Secondary timbers to be removed and re-instated with new to match existing after drying phase, with provision for isolation from damp masonry*

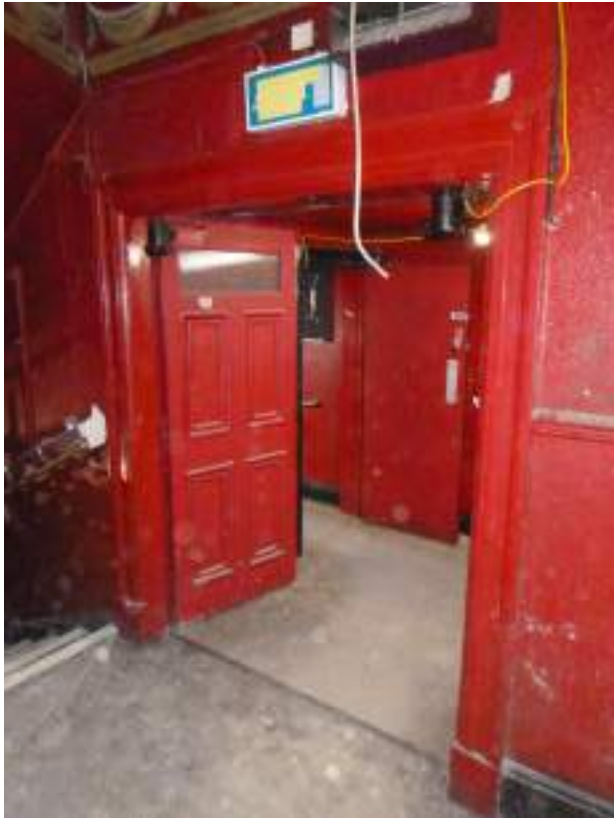
**Fig 27:**

First floor; showing doorway D1-14

Non-historic secondary timber elements can be either discarded or retained at the discretion of the Architect or Conservation Officer. Historic secondary timbers should be removed for off-site storage

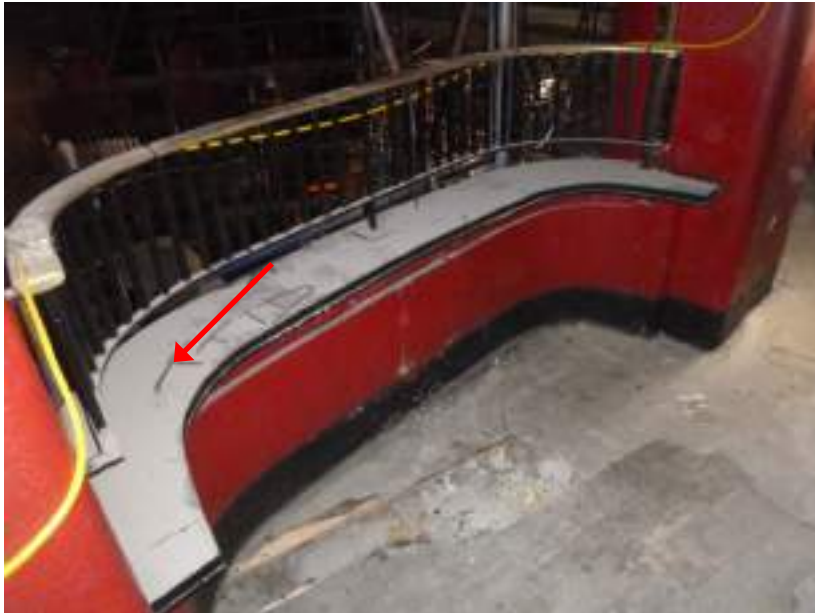
**Fig 29:**

First floor; showing the balcony on the south side of the main auditorium

Secondary timbers in contact with damp affected masonry should be removed and either discarded or retained for off-site storage

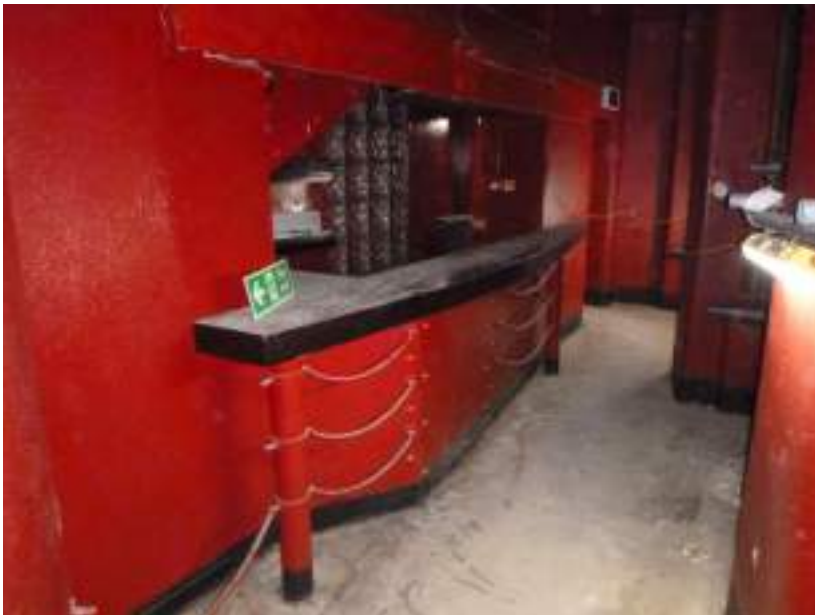
**Fig 30:**

First floor; showing the first floor balcony bar area to the south of the main auditorium

Bar furniture was deemed likely to have been saturated during fire-fighting efforts and will almost certainly be affected by issues with damp and decay during and after post-fire remedial works

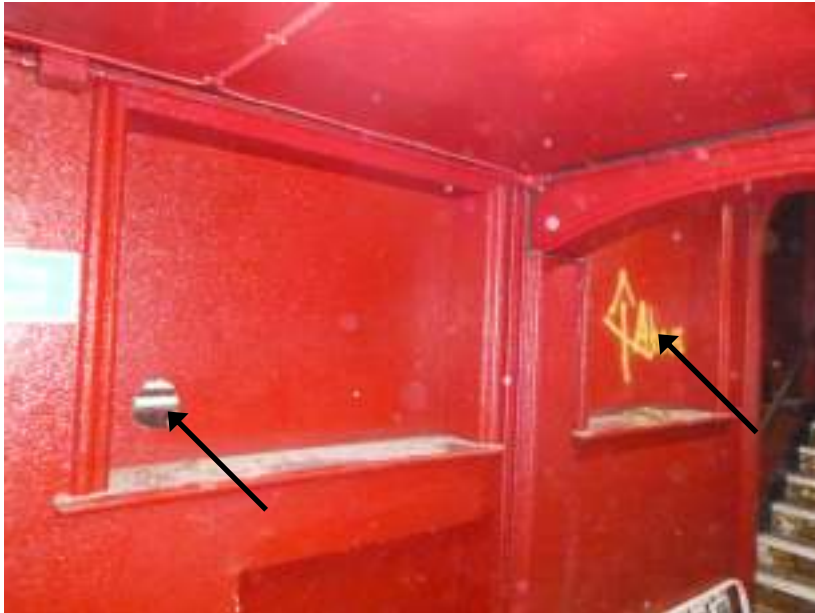
**Fig 31:**

First floor; showing boarded-up windows on the south façade of the building

Limited access through holes in the boards revealed historic windows behind

Consideration should be given to using these to increase through-ventilation of the structure to aid in the drying process

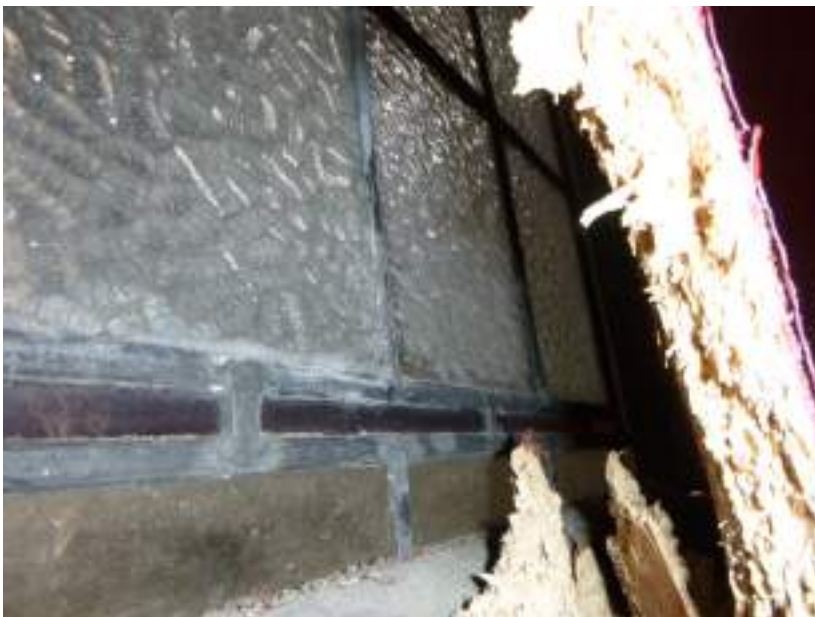
**Fig 32:**

First floor; showing historic windows behind boarding as described in Fig. 31 above

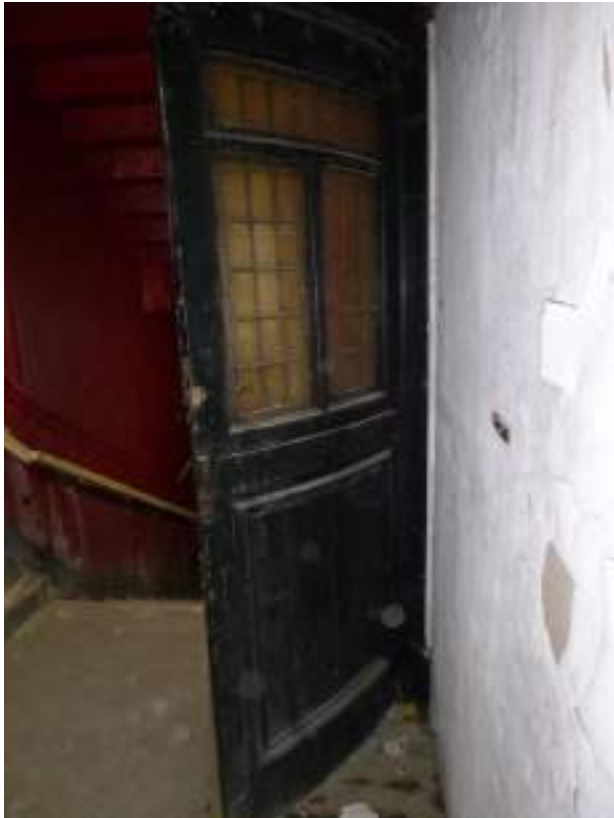
**Fig 33:**

Ground floor; showing the curved door of DG-46

The door is of significant historic importance, but appeared to be well out of the area affected by the fire-and subsequent fire-fighting efforts, and as such was unaffected by issues with damp and decay

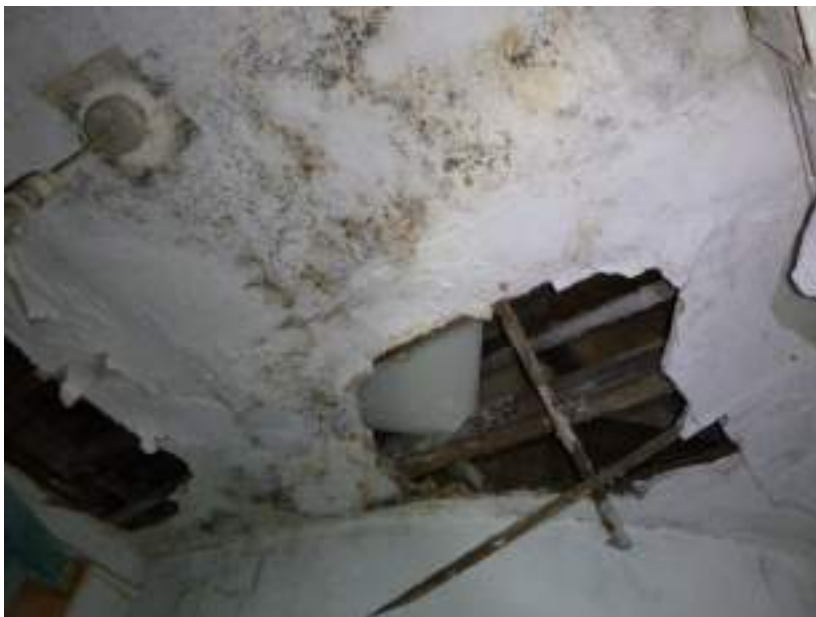
**Fig 34:**

Ground floor; showing partial ceiling collapse in RM.G-25 almost certainly associated with historic water penetration, and not a result of fire-fighting efforts

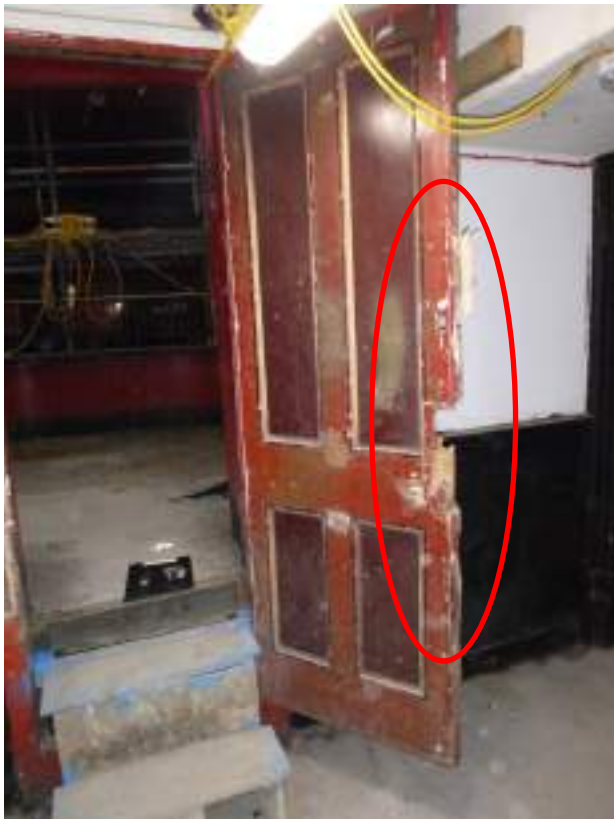
**Fig 35:**

First floor; showing doorway between Royal box and RM.1-17

The damage to the door was likely to have been exacerbated by the water penetration during fire-fighting efforts, or the immediate post-fire remedial works

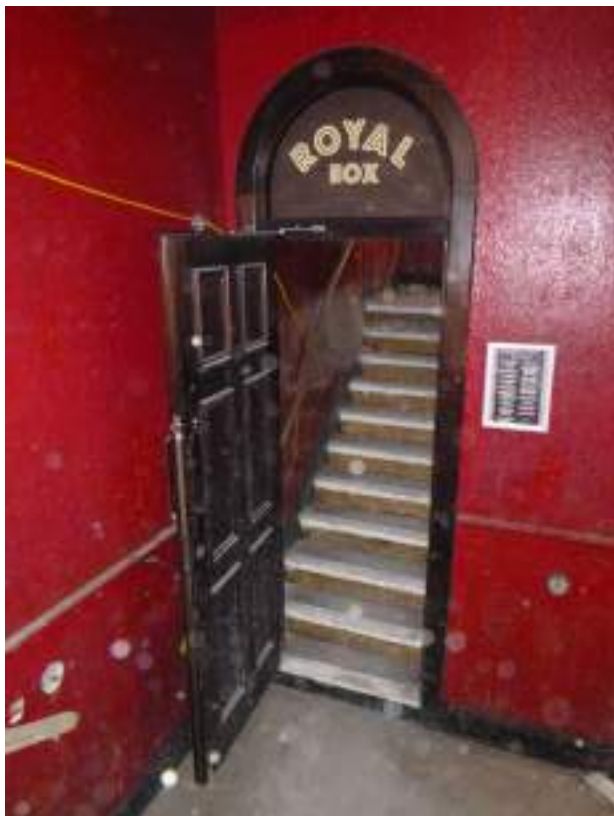
**Fig 36:**

First floor; showing the door through to the Royal box access stairway—DG-45. Non-historic doors to be retained in-situ should be carefully wedged in an open position to allow through-ventilation of the structure during the drying phase

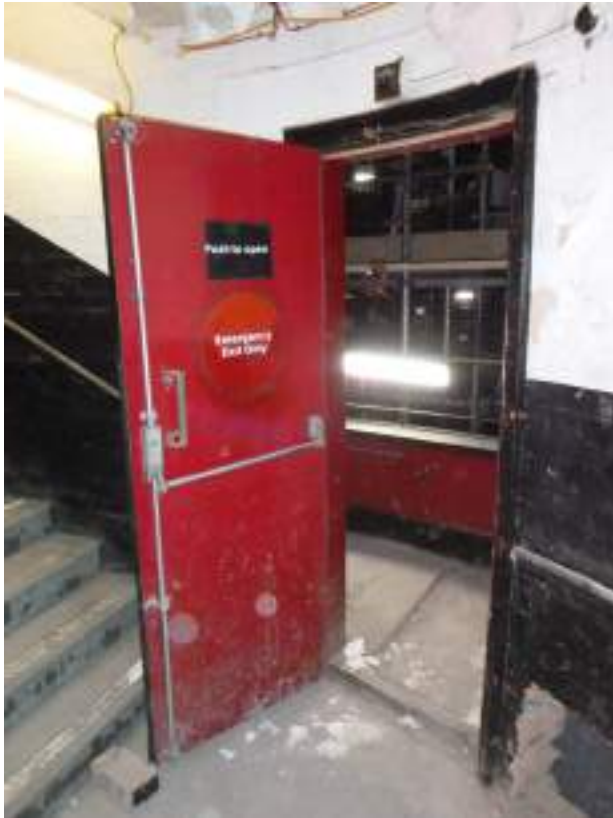
**Fig 37:**

First floor; showing doorway D1-11

Non-historic doors to be retained in-situ should be carefully wedged in an open position to allow through-ventilation of the structure during the drying phase

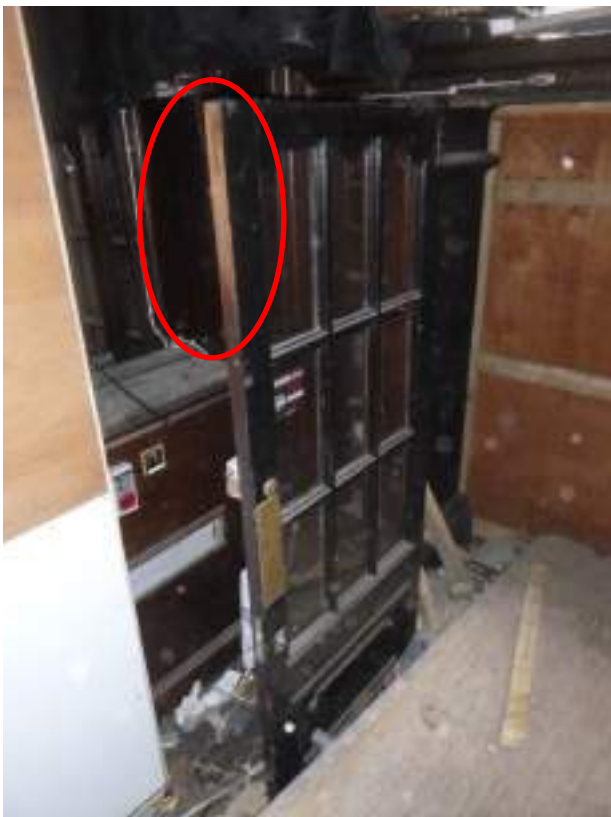
**Fig 38:**

Ground floor; showing door DG-02

Previous planing of the door revealed material of tropical hardwood which may indicate door replacement has occurred in the past

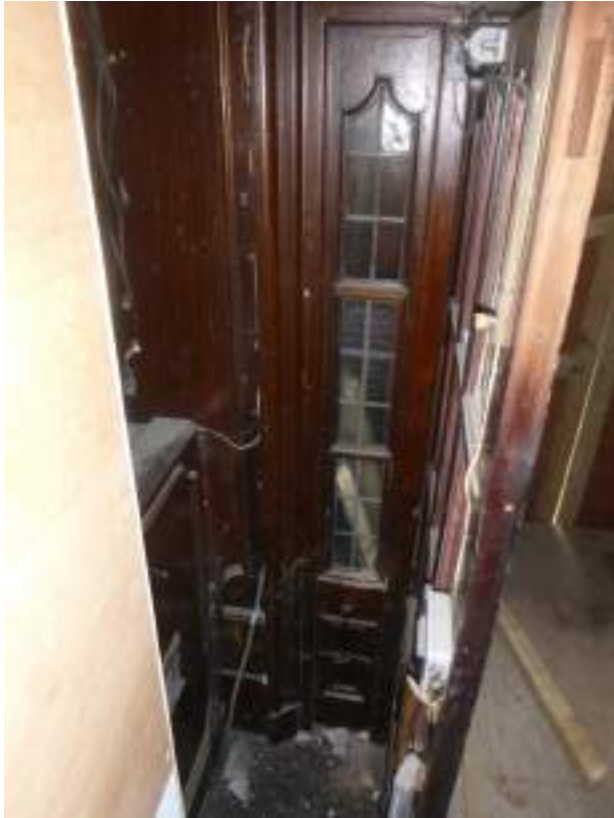
**Fig 39:**

Ground floor; showing glazed and leaded side panels to doors at this level, mirroring those seen above at first floor

Historic doors should be removed for off-site storage

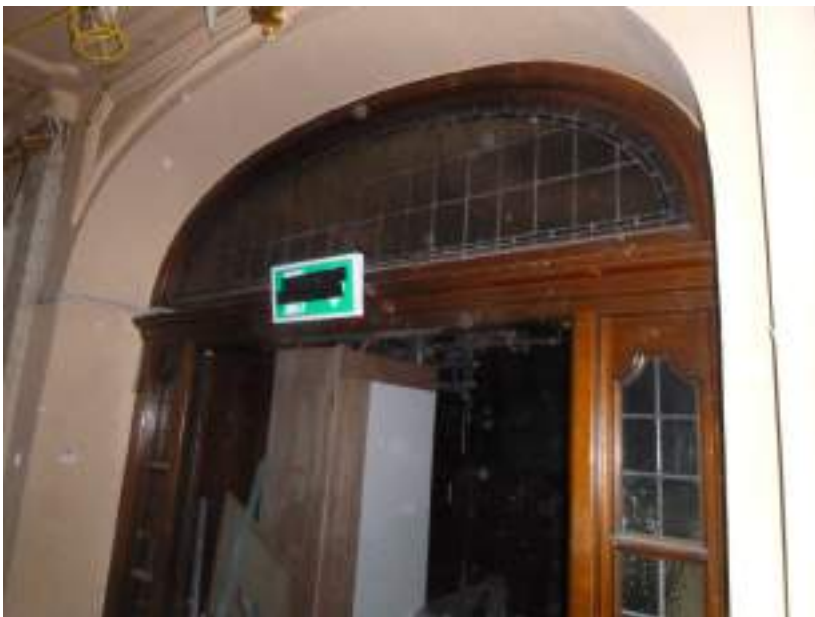
**Fig 40:**

Ground floor; showing timber framing and glazed panels of doorway through from the entrance into the main foyer

Timber was preliminarily identified as being of oak (*Quercus spp*). Liquid water was noted to be collecting in pockets previously housing pivot hinges at the base of jambs

Retained moisture within the masonry masses leaves joinery in contact highly vulnerable to issues with damp and decay during and after post-fire remedial works

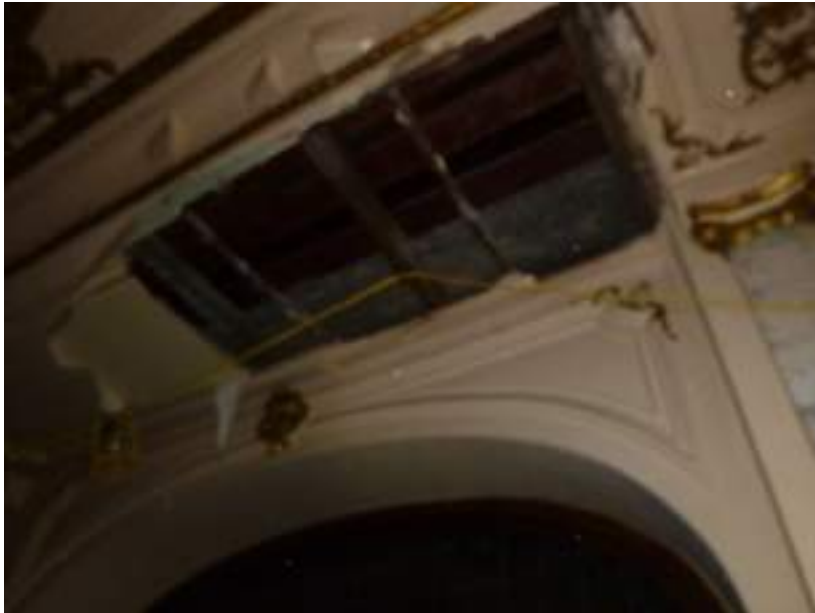
**Fig 41:**

Ground floor; showing loss of plaster above timber framing almost certainly a result of water penetration following fire-fighting efforts. This suggested that moisture retained within masonry is likely to be elevated and leaves timber in contact with, or embedded into masonry vulnerable to issues with damp and decay

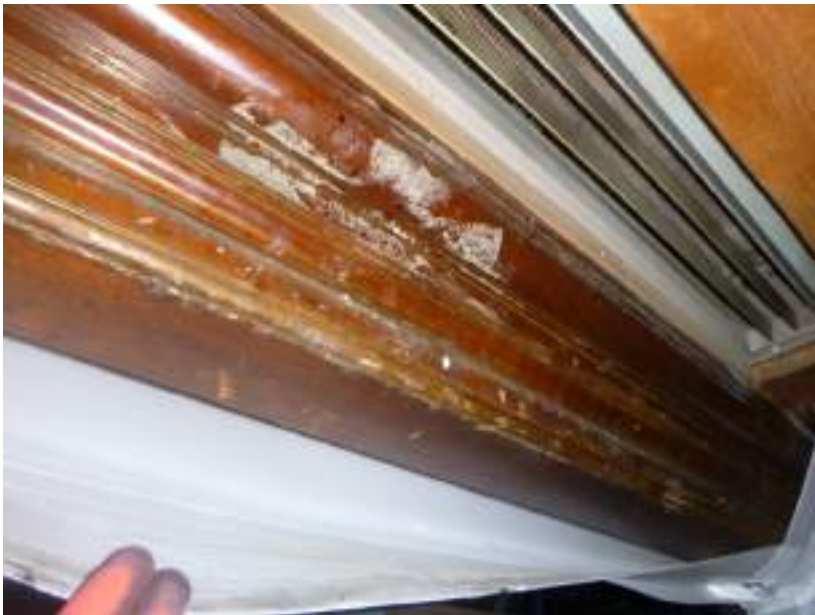
**Fig 42:**

Ground floor; showing a section of timber framing of one of the doorways through from the entrance into the main foyer

Retained moisture within the masonry masses leaves joinery in contact highly vulnerable to issues with damp and decay during and after post-fire remedial works

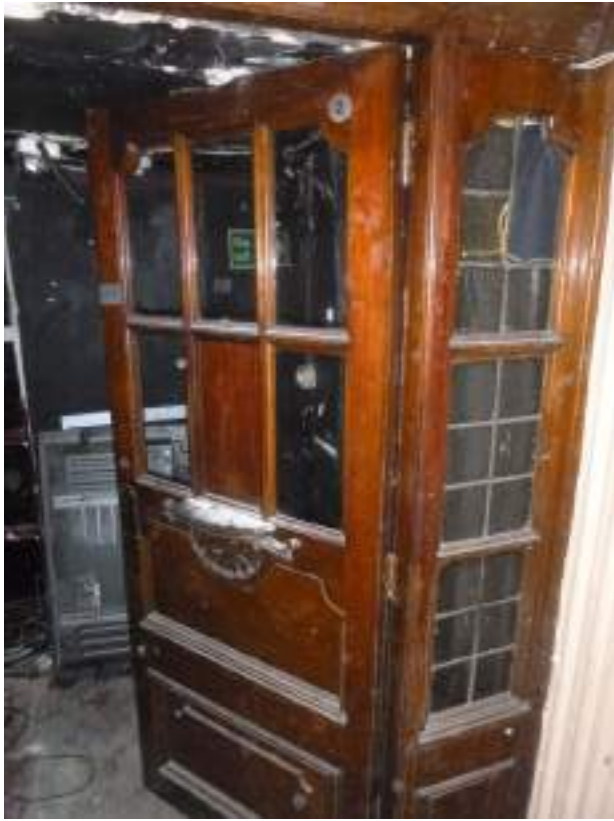
**Fig 43:**

Ground floor; showing door DG-35

The retained moisture within the masonry mass leaves joinery items below and adjacent vulnerable to issues with damp and decay during and after refurbishment

Historic joinery should be removed for off-site storage

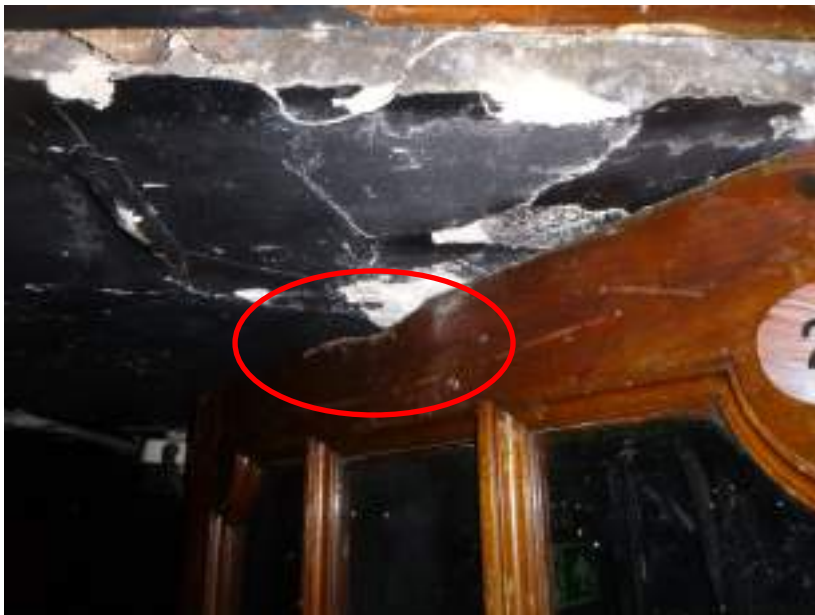
**Fig 44:**

Ground floor; showing the drop in the ceiling above door DG-35

The retained moisture within the masonry mass leaves joinery items below and adjacent vulnerable to issues with damp and decay during and after refurbishment

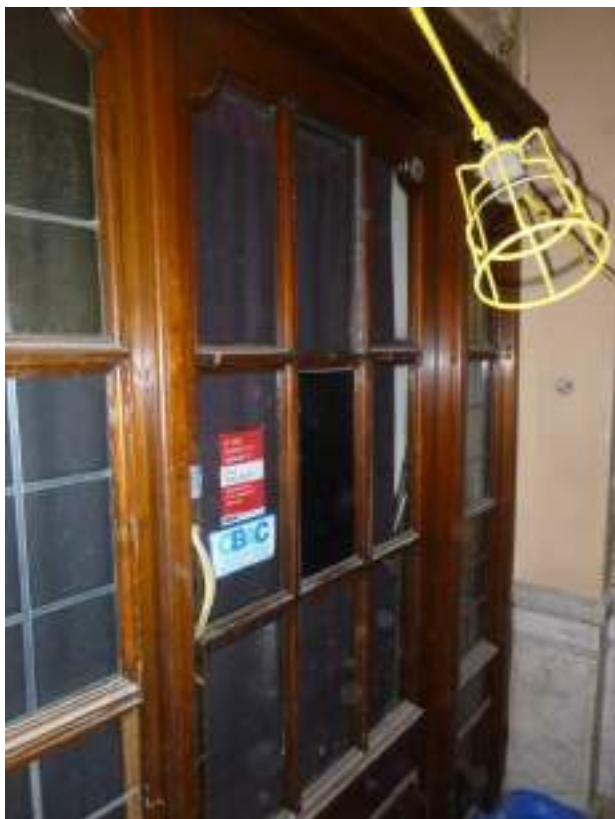
**Fig 45:**

Ground floor; showing door DG-40

The retained moisture within the masonry mass leaves joinery items below and adjacent vulnerable to issues with damp and decay during and after refurbishment

Historic joinery should be removed for off-site storage

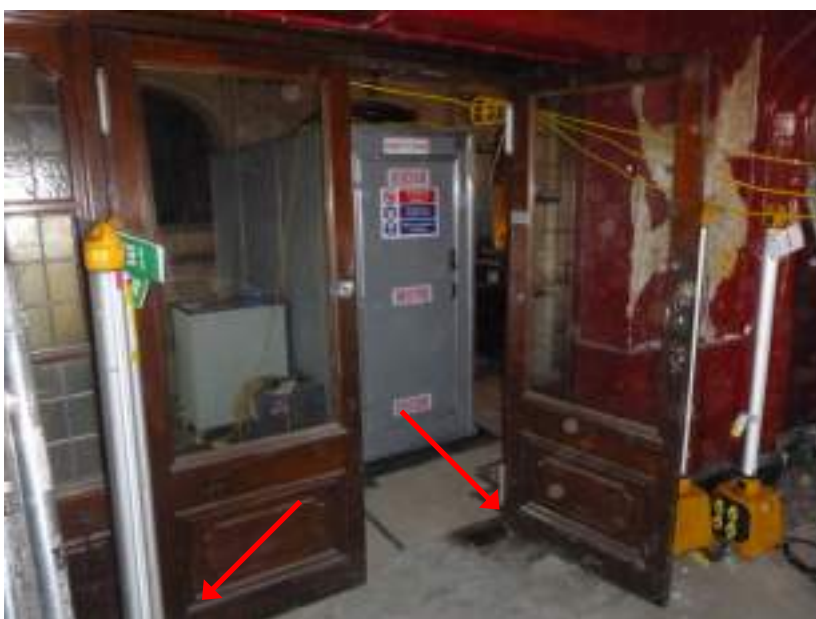
**Fig 46:**

Ground floor; showing door DG-33, which was mirrored to the north with door set DG-41

The retained moisture within the masonry mass leaves joinery items below and adjacent vulnerable to issues with damp and decay during and after refurbishment

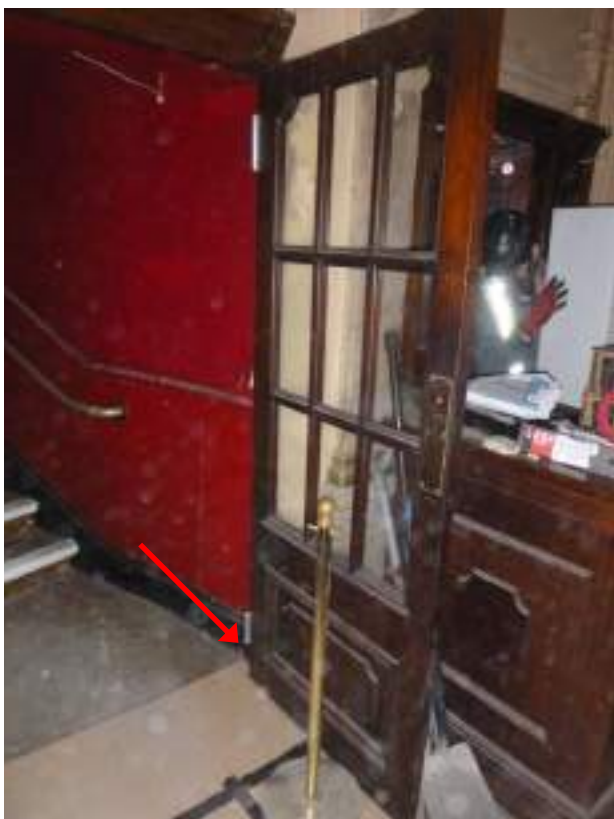
**Fig 48:**

Ground floor; showing the west door of doorway DG-34

Moisture content were elevated at the base of jambs

The retained moisture within the masonry mass leaves joinery items below and adjacent vulnerable to issues with damp and decay during and after refurbishment

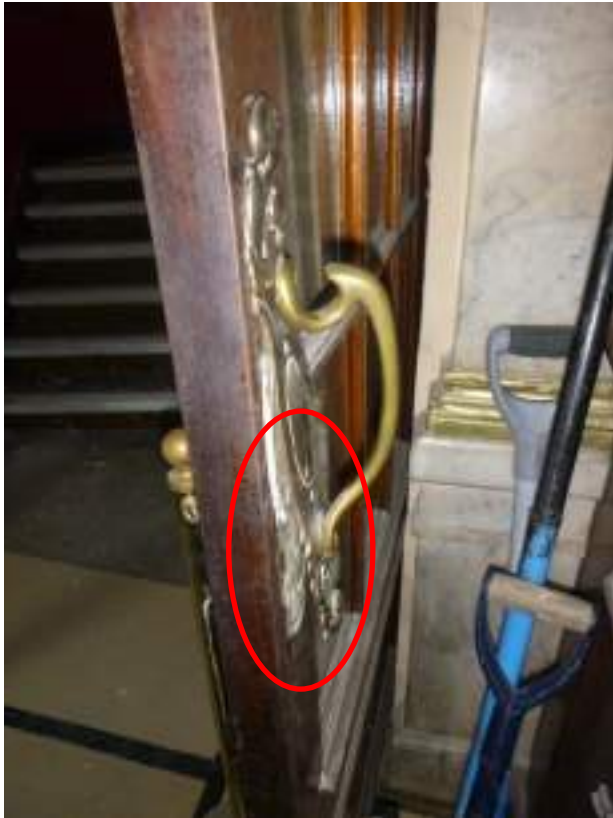
**Fig 49:**

Ground floor; showing the damaged brass ironmongery of door DG-34 on the west door

Damage such as this may have been exacerbated by the immediate post-fire remedial works

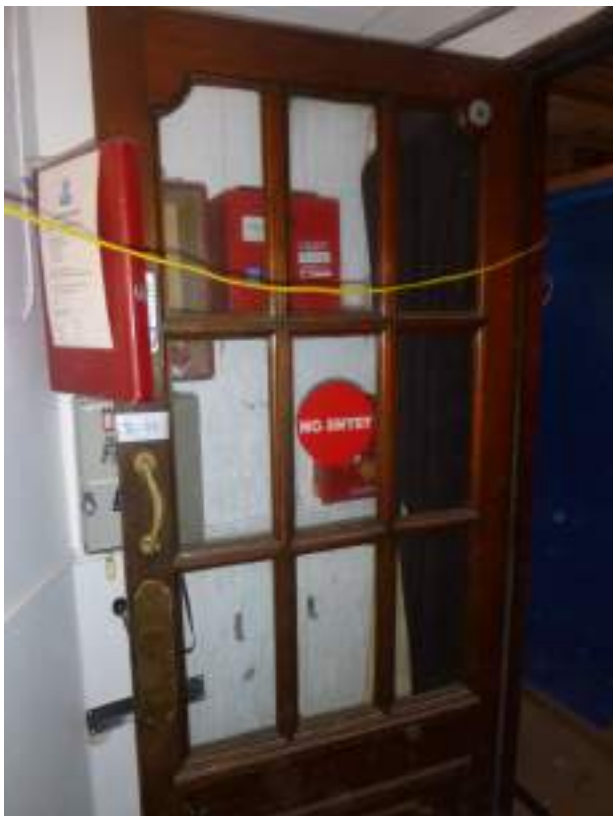
**Fig 50:**

Ground floor; showing the south door of DG-41

The retained moisture within the masonry mass leaves joinery items below and adjacent vulnerable to issues with damp and decay during and after refurbishment

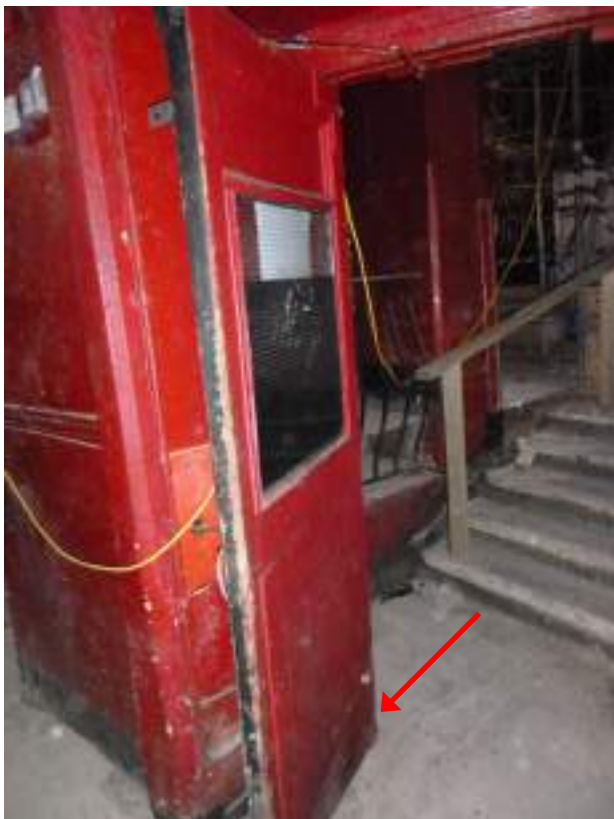
**Fig 52:**

Basement; showing the curved doors of DB-27

Again, moisture was noted to collecting in the pockets at the bases of jambs. Moisture content readings were above the level required for decay at the time of survey

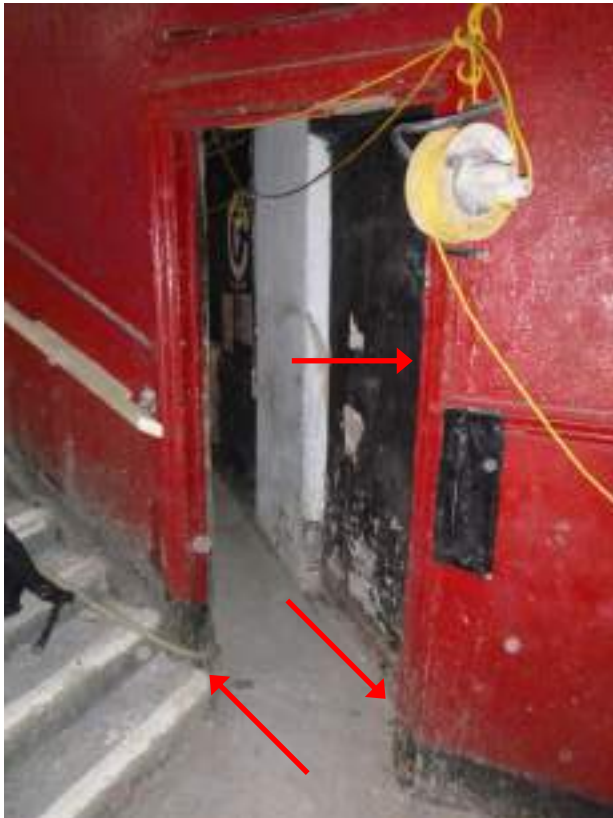
**Fig 53:**

Basement; showing door DB-31 leading into the lower basement area to the east side of the auditorium

Door jambs were loose around the frame, although this was most likely associated with historic issues with dampness and not a direct result of the water penetration during fire-fighting efforts

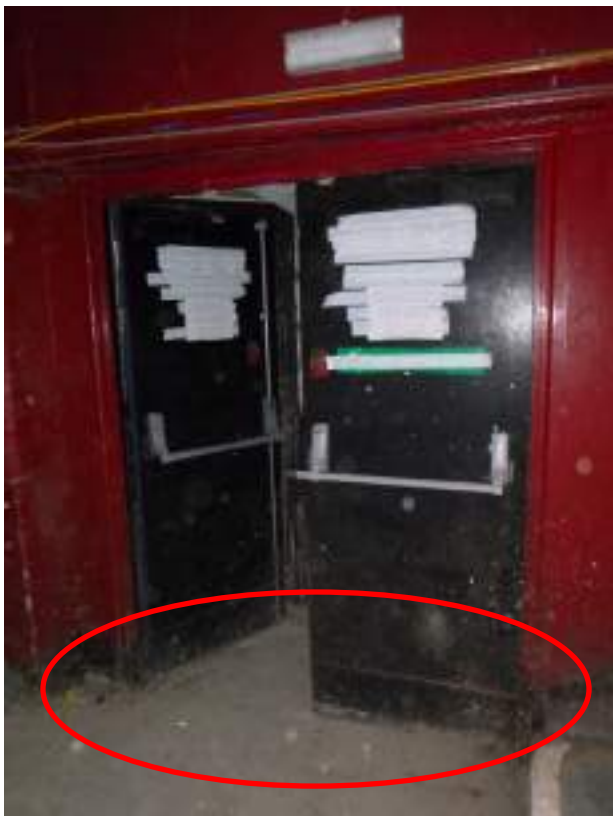
**Fig 54:**

Basement; showing door DB-29 through to the north-east corner stairwell

Again, moisture content readings at the bases of jambs were elevated and generally above the level required for decay to occur at the time of survey

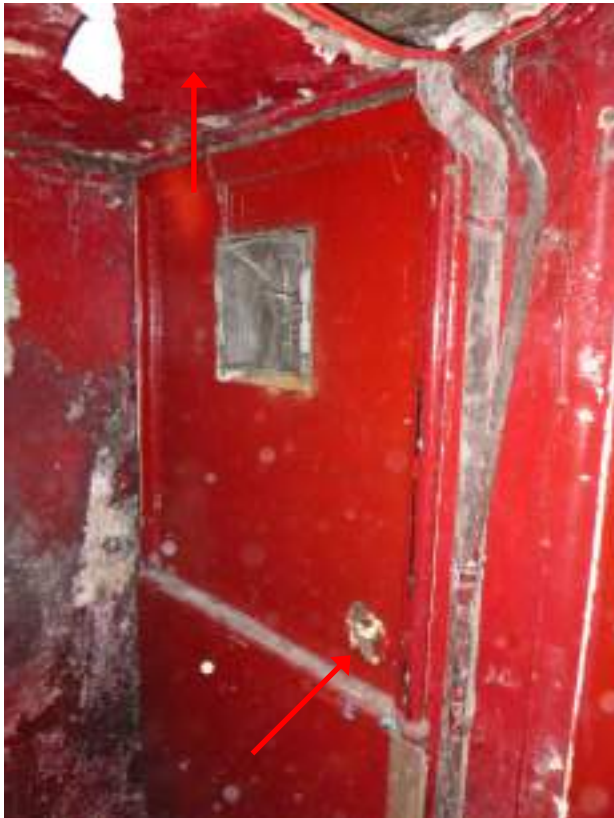
**Fig 55:**

Second floor; showing the decayed window at second floor level in the north-west corner stairwell

Dry rot mycelial growth was noted in the ceiling void and around the window frame, and hygroscopic salt efflorescence was noted to the masonry wall to the north

Historic dry rot infection of masonry, timber window frame structurally decayed  
*Frame and sash should be removed, repaired, and reinstated with provision for isolation after drying phase*
