**The Hope Project, KOKO**

Photographs  
05 August 2020  
Not to scale

Job no. 146-89 Site Note 8 ADDENDUM Page11 © Copyright Hutton+Rostron 2020

## The Hope Project (KOKO): Timber floor structures condition Investigation

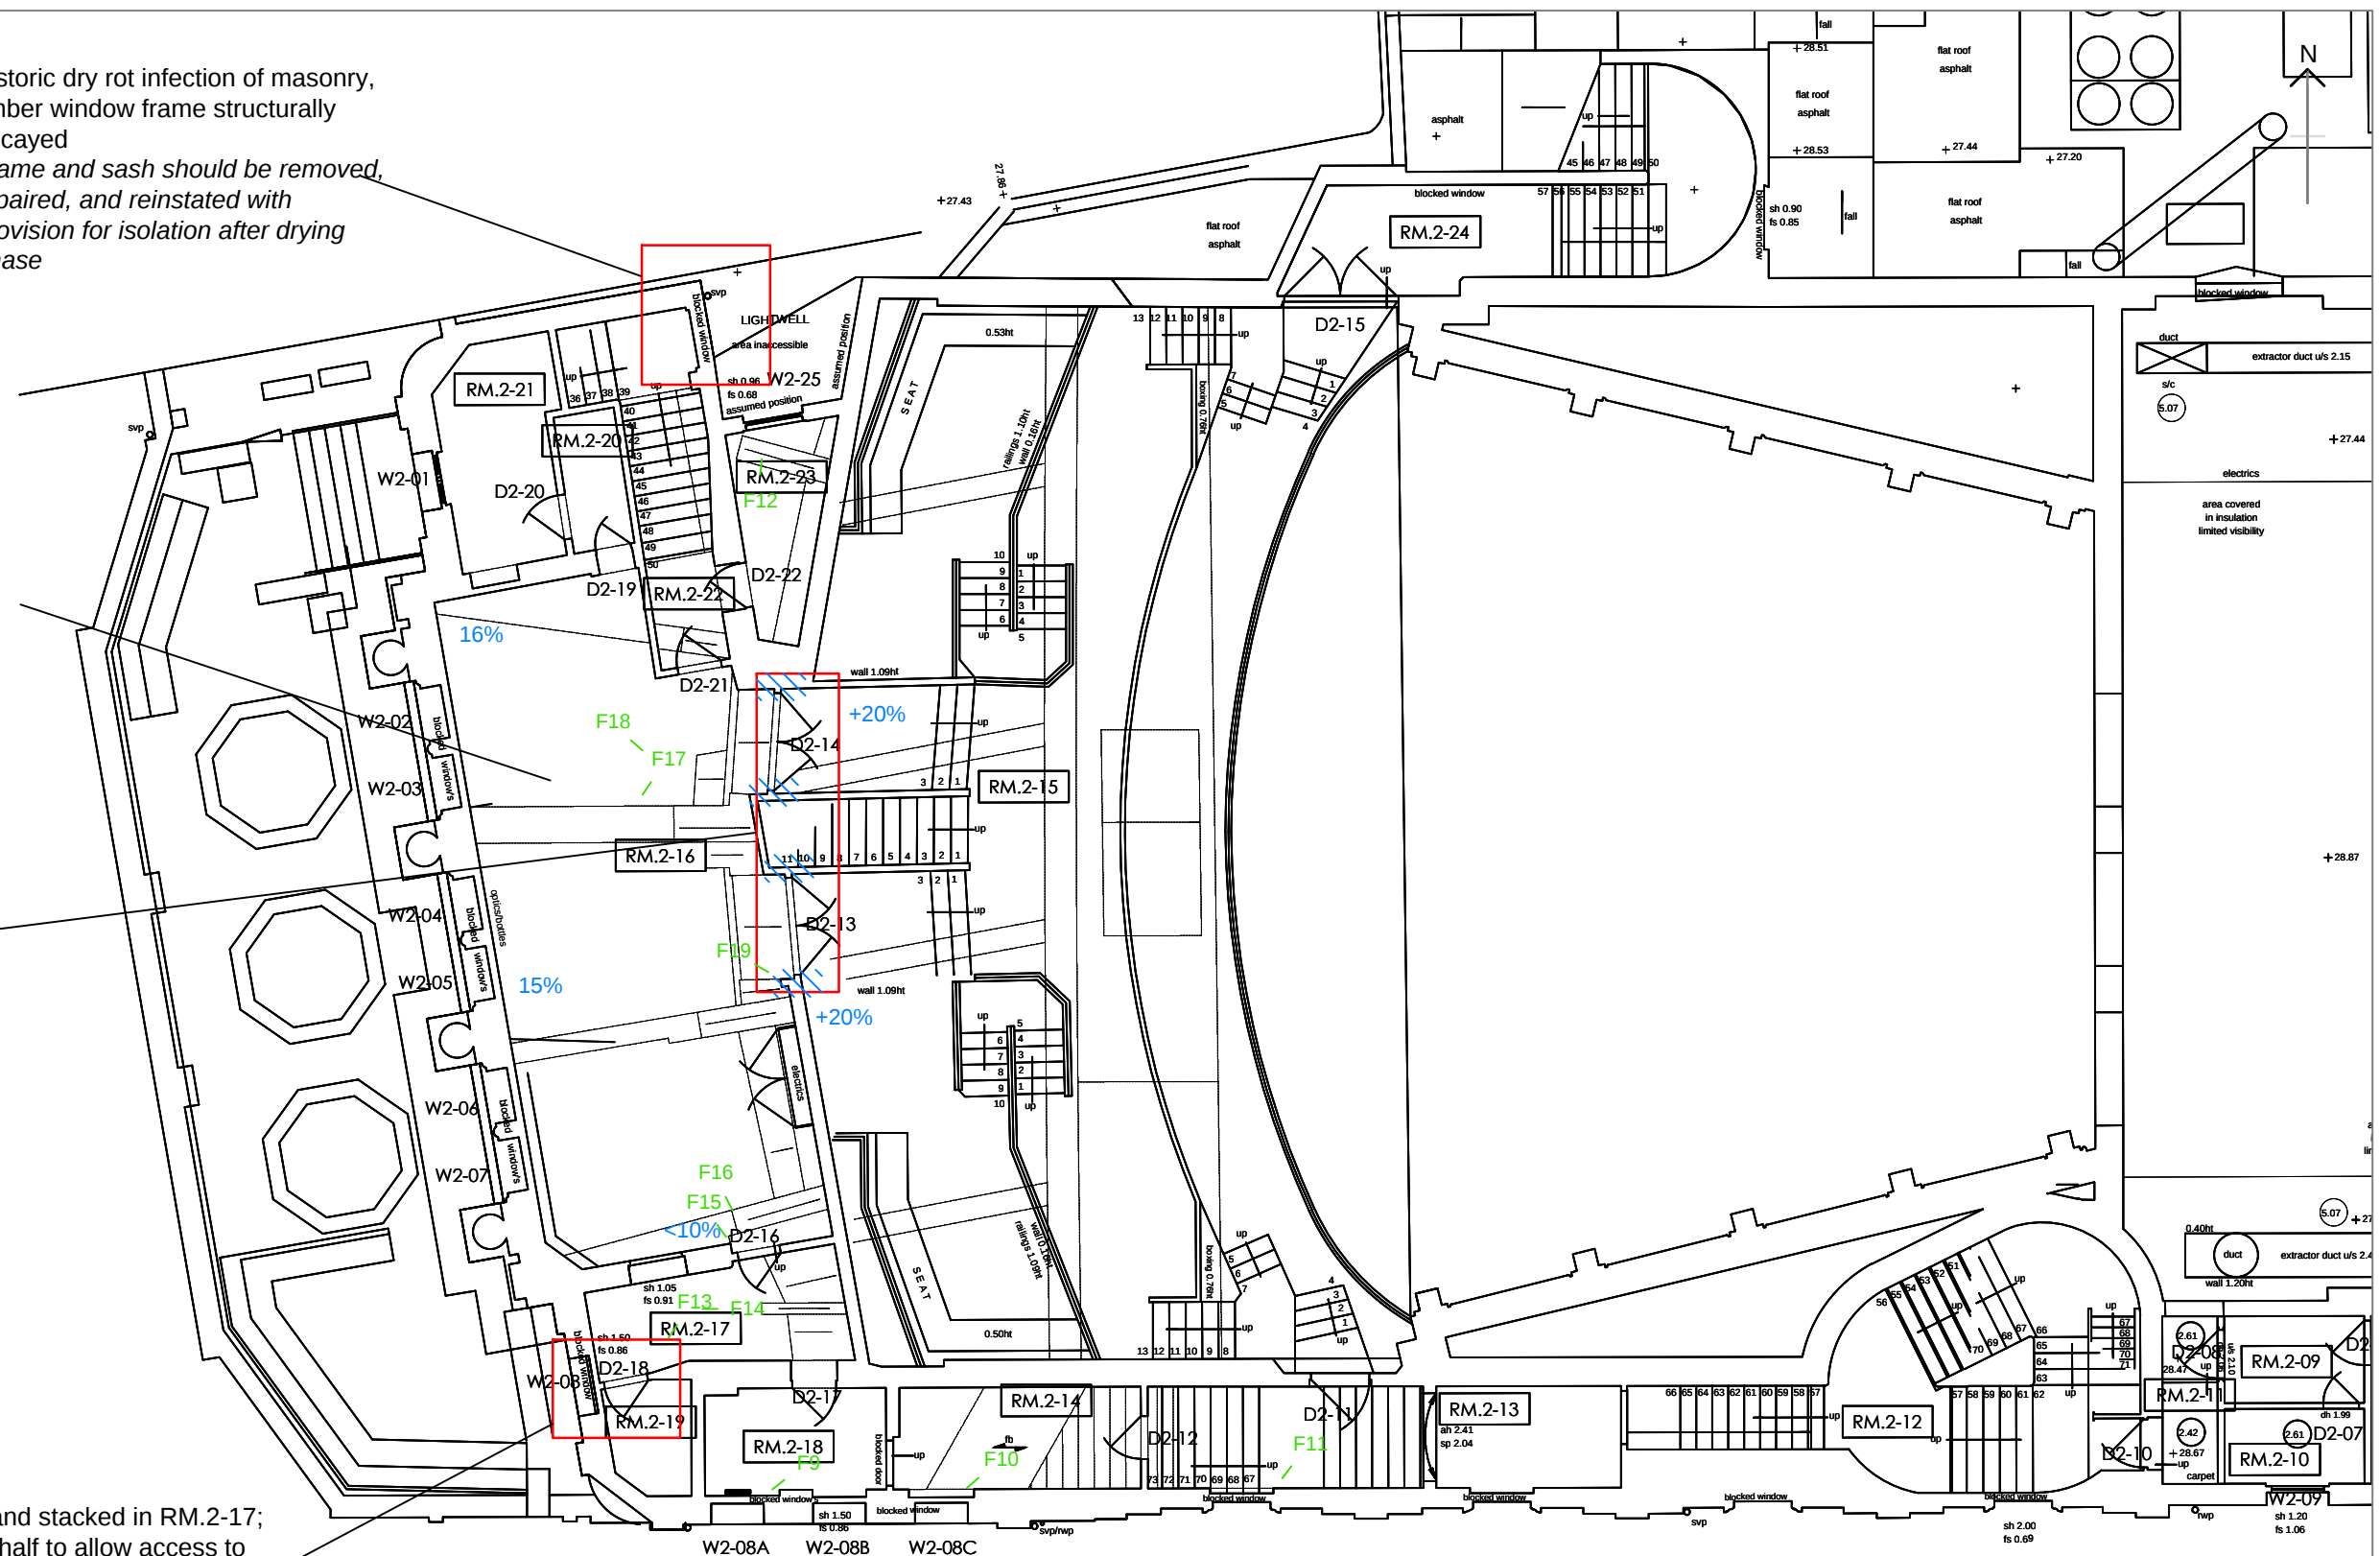
## The Hope Project / KOKO - Second Floor

Timber framing elements and architrave of opening between balcony and bar area all at over 20% moisture content, high enough for decay to occur  
*Non-historic material can be removed to allow masonry to dry, and discarded*

Moisture contents of all secondary timbers in contact with masonry wall to west recorded at over the decay threshold of ~20% w/w  
*Secondary timbers to be removed and re-instated with new to match existing after drying phase, with provision for isolation from damp masonry*

Area directly below dome roof and likely to have been saturated during fire-fighting efforts; evidenced by partial ceiling collapse. All secondary timbers deemed highly vulnerable to issues with damp and decay during and after post-fire remedial works  
*Historic joinery to be removed and stored off-site. Non-historic doors to be stored on-site should be laid flat and isolated from potentially damp masonry by sacrificial timber battens/pallets. Non-historic doors to be retained in-situ to be wedged open to allow through-ventilation of the structure*

Bar furniture in RM.1-14 likely to have been saturated by water during fire-fighting efforts and are subsequently highly vulnerable to issues with damp and decay during and after post-fire remedial works  
*All bar furniture to be removed and replaced with new to match existing after the drying phase*

Moisture contents at base of all architrave at fibre-saturation (over 30% w/w). Doors to be removed and replaced with perforated steel mesh for security and to maintain through-ventilation of the structure  
*Architrave to be removed and re-instated with new to match existing, with provision for isolation from damp masonry after drying phase*

Windows boarded up at time of survey  
*Consideration should be given to opening-up windows to increase provision for through-ventilation of the structure*

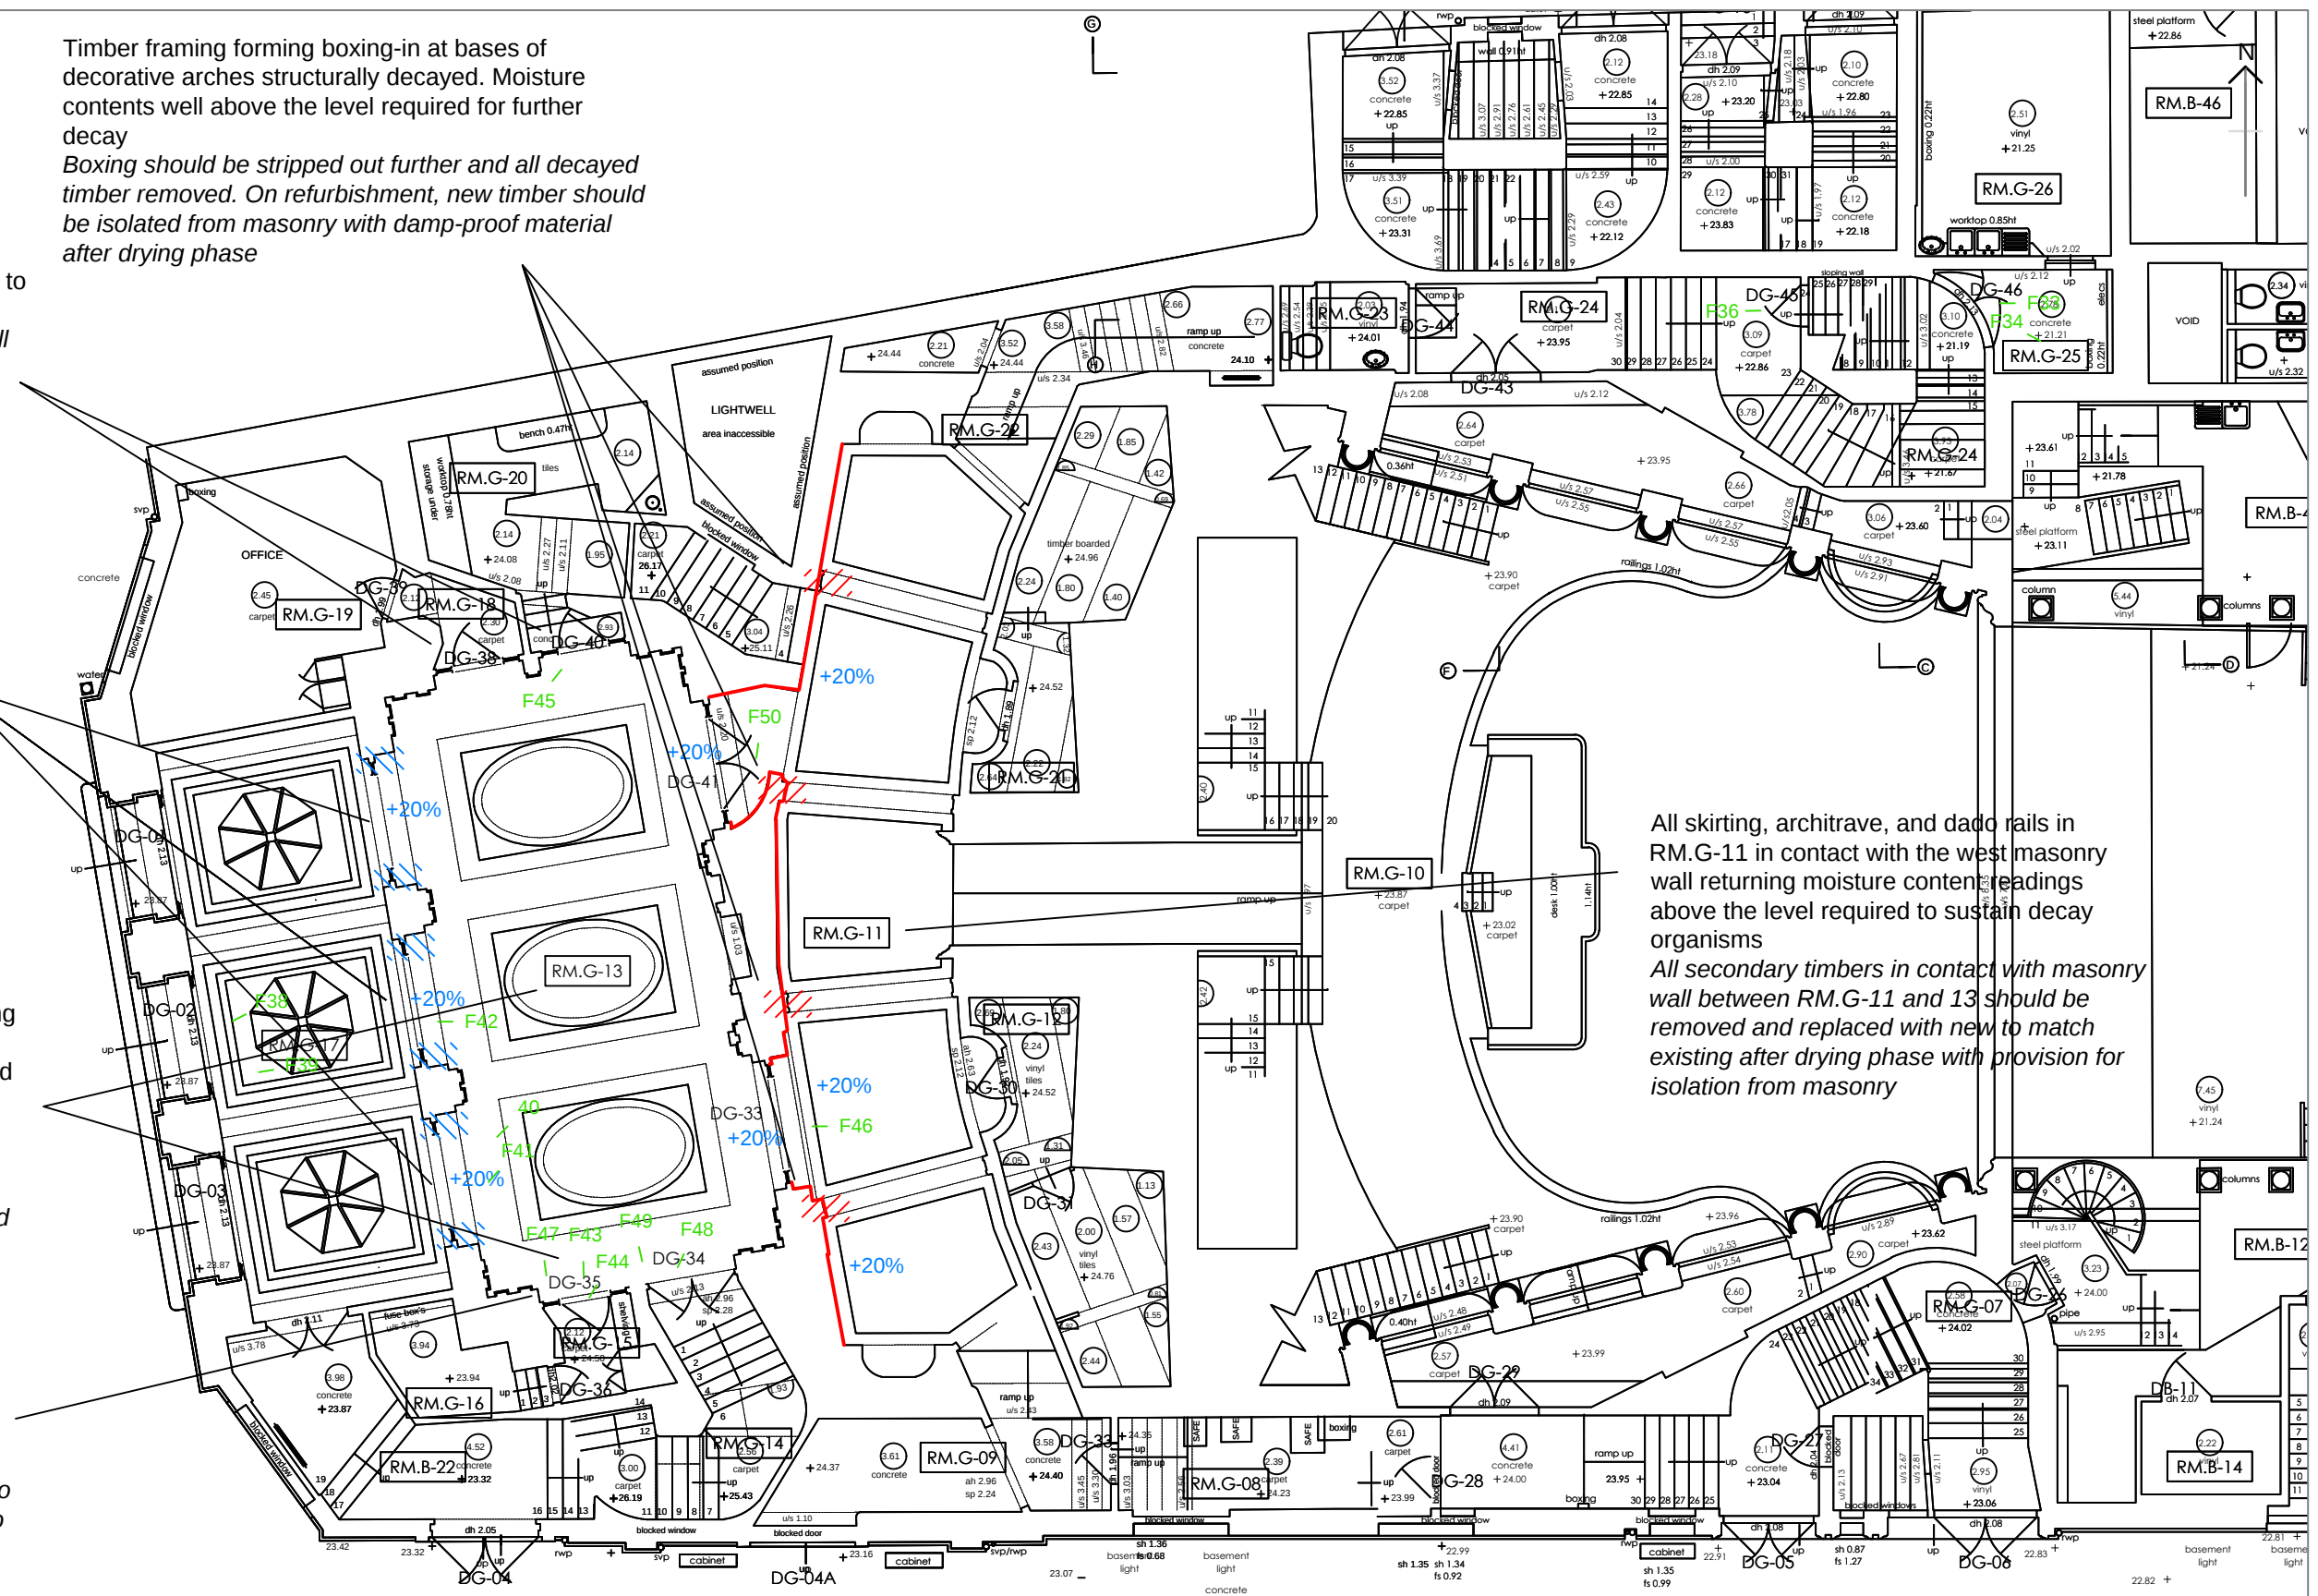
All skirting, architrave, and dado rails in RM.G-11 in contact with the west masonry wall returning moisture content readings above the level required to sustain decay organisms  
*All secondary timbers in contact with masonry wall between RM.G-11 and 13 should be removed and replaced with new to match existing after drying phase with provision for isolation from masonry*

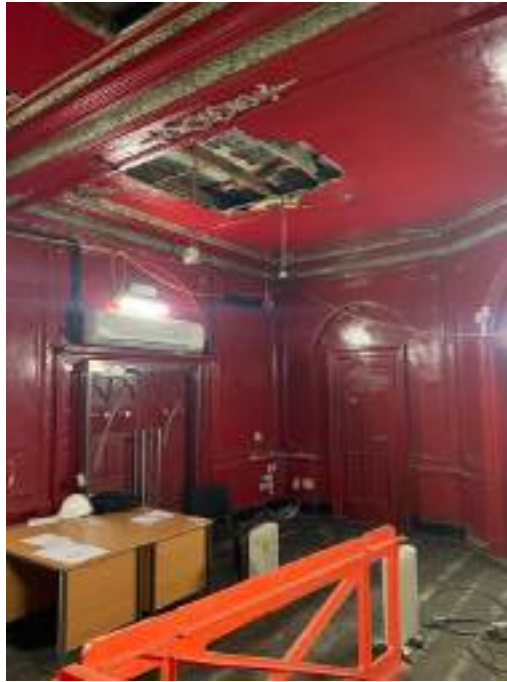
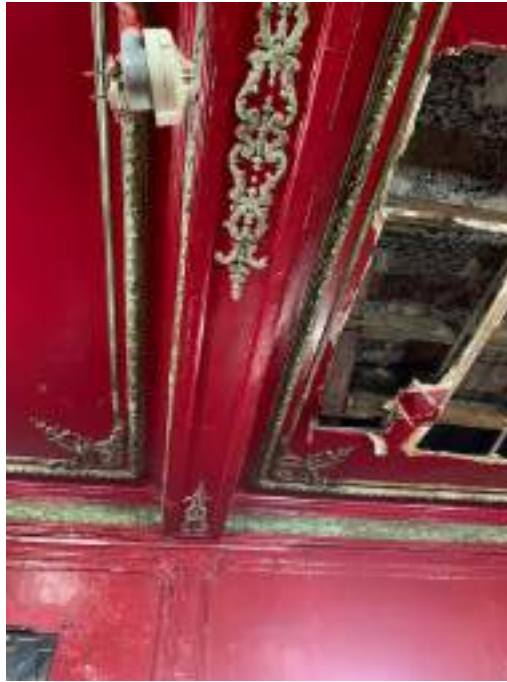
### 2.1. Room 1.14 Bar.

- The walls and ceiling soffits are coated with thick red paint. In many areas this has ‘blistered’ due to the trapped moisture held in the masonry walls behind. The Report by *Catherine* Hassall (March 2020) confirms that the red surface paint covers a succession of applications including to some surfaces a gypsum skim coat. The removal of these paint layers by chemical and mechanical means would be time consuming and expensive with an uncertain outcome given the damp status of the plaster substrate.

- The complete removal of the wall plaster to reveal the masonry substrate is the only way to ensure successful drying out. Retention of wall plaster greatly hinders and prevents the loss of trapped moisture in the masonry which will leave a legacy of potential efflorescence of salts, conditions suitable for fungal attack on timber and the appearance of ‘damp patches’ and discolouration on completed decorated walls.

- It was not possible to closely inspect the timber support system below the concrete soffit nor assess the integrity of the remaining fibrous plaster cornice and soffit.

1. ceiling corner enrichments,
    2. decorative cornice,
    3. beam casing including the ornate relief details
    4. wall mouldings.
  - o The condition and integrity of the fibrous plaster cornice and remaining ceiling soffit should be closely inspected.

- o It is anticipated that due to the condition of the timber supporting structure and the damp condition of the existing plasterwork as a consequence of the January 2020 fire that there will be further loss of plasterwork and which will lead to 100% replacement.

- o Replacement and renewal of decorative plasterwork can be achieved by creating moulds from samples/squeezes obtained from site.

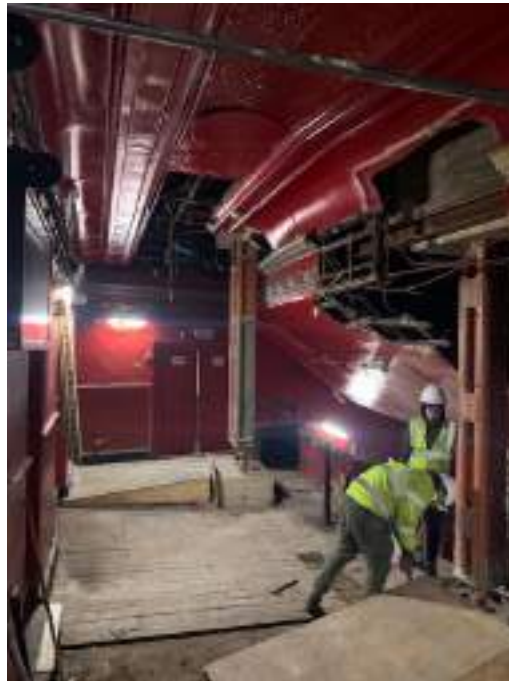
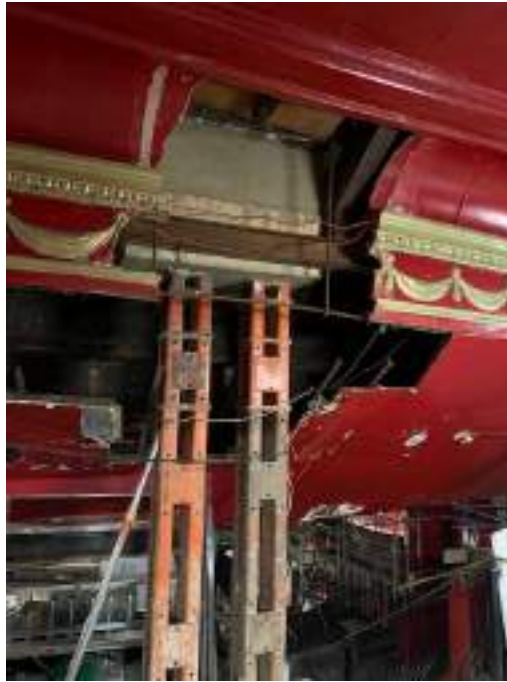
- The condition of the fibrous plaster cornice, frieze and ceiling is very poor due to the considerable amounts of fire related water and the ongoing damp conditions. Considerable sections of plaster ceiling and cove have been lost and those that remain appear to be in a fragile state.

- The insertion of structural piers was permitted by Planning Application nr 2019/0695/L and granted on 15<sup>th</sup> May 2019. There has been some loss of plaster fabric due to their insertion but this has greatly been compounded by the damage caused by the fire and water penetration since January 2020.

- The walls are plain with a simple dado rail and skirting. Much of the wall surface has been painted over a textured ( paper?) surface with a thick gloss red paint.

- It was not possible to closely inspect the timber support system below the concrete soffit nor assess the integrity of the remaining fibrous plaster cornice and soffit.
- At this preliminary stage and subject to the reports by the Asbestos Consultant, the Structural Engineer, the paint and timber/damp specialists we would suggest the following:
  - It is L&R's consideration that all of the remaining sections of plaster ceiling, cornice and frieze will be lost due to the irreversible damage caused by the fire and water ingress.. Therefore, samples and squeezes should be taken of the following mouldings:
    1. Plain cove and ceiling band.
    2. Egg and Dart cornice and frieze.
  - Chases are cut into the wall plaster to determine the condition of the masonry and substrate behind with the assumption that it will be removed to aid the drying process.

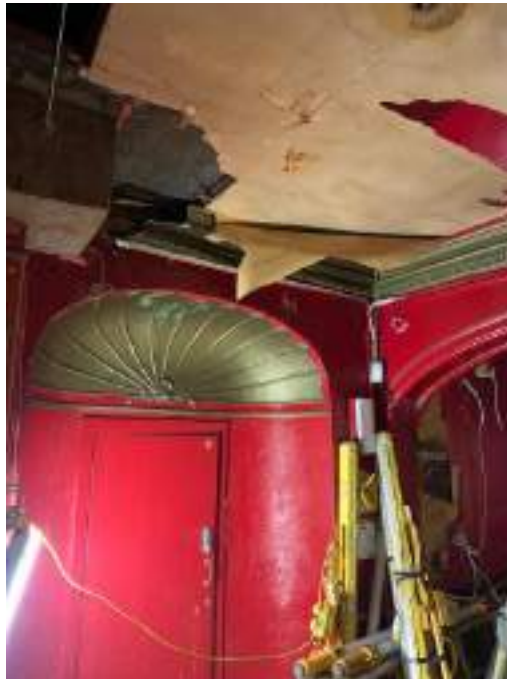
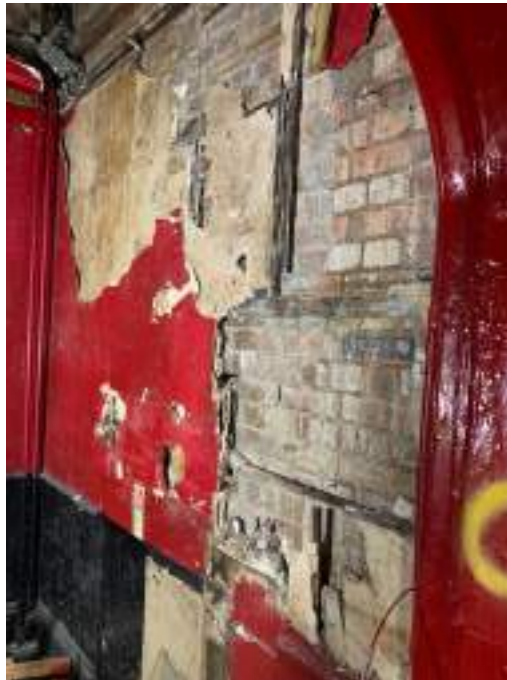
### 2.3.Room G-11.

- The Entrance Hall/Foyer on the Ground Floor of the Theatre. The area is divided by four wide plain arches and pilasters into five bays. Each bay has a plain fibrous plaster flat ceiling with a egg and dart cornice to the perimeter. The North elevation has two matching profiled fibrous plaster niche heads above door openings into the main auditorium.
- The insertion of structural piers was permitted by Planning Application nr 2019/0695/L and granted on 15<sup>th</sup> May 2019. There has been some loss of plaster fabric due to their insertion but this has greatly been compounded by the damage caused by the fire and water penetration since January 2020.

- The arches and pilasters have lost small sections due to the structural works, however the poor condition and fragility of the ceiling, cornice and walls are as a consequence of the fire and subsequent water damage.
- The walls are plain with a simple dado rail and skirting. Much of the wall surface has been painted over a textured ( paper?) surface with a thick gloss red paint.
- It was not possible to closely inspect the timber support system below the concrete soffit nor assess the integrity of the remaining fibrous plaster cornice and soffit due to issues of access and the risk of asbestos.

- At this preliminary stage and subject to the reports by the Asbestos Consultant, the Structural Engineer, the paint and timber/damp specialists we would suggest the following:
  - o It is L&R's consideration that much of the remaining sections of plaster ceiling, cornice and frieze will be lost. Therefore, samples and squeezes should be taken of the following mouldings:
    1. Arch and pilaster sections.
    2. Egg and Dart cornice.
    3. Niche heads.
  - o Chases are cut into the wall plaster to determine the condition of the masonry and substrate behind.
  - o Removal of the wall plaster would greatly enhance the drying process and greatly remove the risk of legacy issues such as efflorescence, fungal attack and staining/damp on finished decorative surfaces.

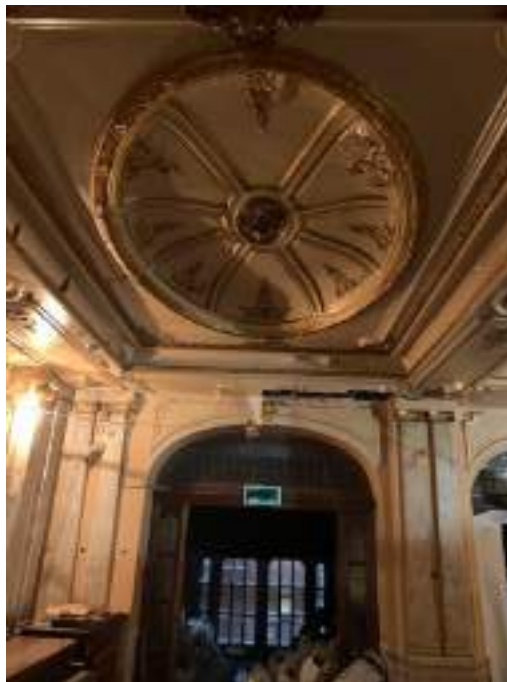
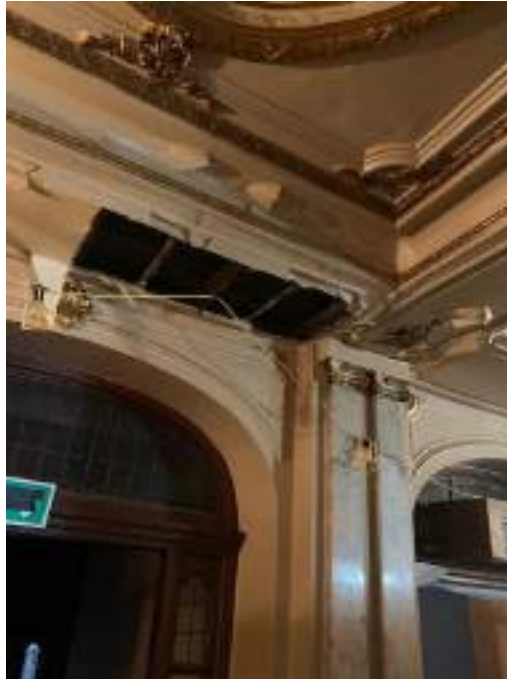
## 2.4. Room G-13.

- This Foyer area consists of three bays each containing a shallow oval dome and an enriched cove to the perimeter. The dividing beams have decorative elements in relief. The walls are decorated with marble pilasters and panels with ornate quadrant corners.
- The ceilings, cornice and beams are of fibrous plaster construction suspended from the concrete slab above on timber joists and noggins. The recent ingress of water has caused the failure and loss of some sections of ceiling soffit. Further areas appear to be in a poor condition and are at risk of collapse.

- It was not possible to closely inspect the timber support system below the concrete soffit nor assess the integrity of the remaining fibrous plaster cornice and soffit due to lack of close access and the potential of ACM's within the ceiling void.
- At this preliminary stage and subject to the reports by the Asbestos Consultant, the Structural Engineer, the paint and timber/damp specialists we would suggest the following:
  - It is probable that some areas and sections of the ceiling, beam and cornice may be lost. Therefore, samples and squeezes should be taken of the following mouldings:
    1. Beam sections.
    2. Enriched cornice.

- o Chases are cut into the wall plaster to determine the condition of the masonry and substrate behind.
- o Sample areas of wall and ceiling should be paint stripped. This would help to determine the value and benefit of such a task

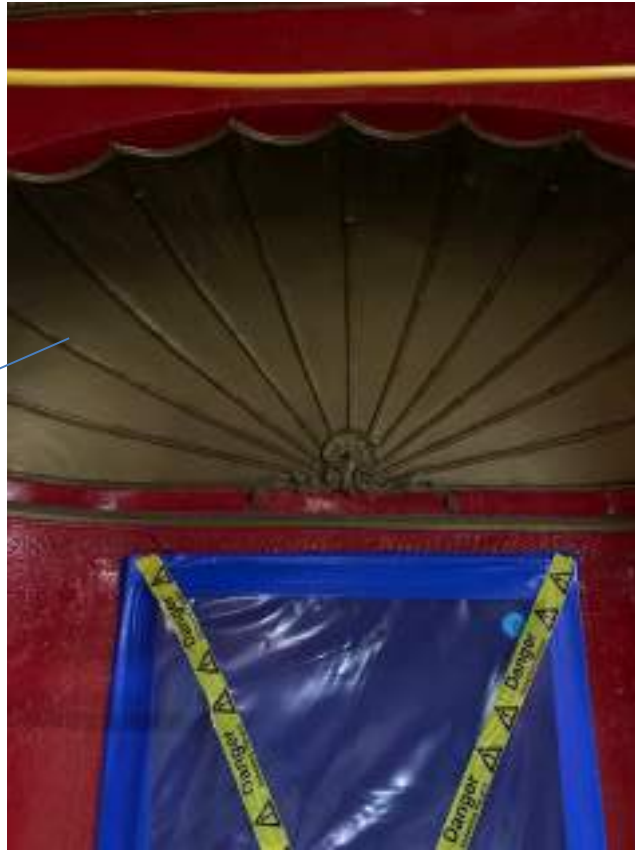
Decorative  
niche hood.

- The *H&R Report* confirmed the threat posed by the retention of moisture within the structure behind the ceilings, arch and pilaster fibrous plaster due to the absence of ventilation.
- It remains L&R's consideration that much of the remaining sections of plaster ceiling, cornice, arches and pilasters will be lost as their condition is so poor as a consequence of the water ingress following the fire. Therefore, samples and squeezes should be taken of the following mouldings:
  - Arch and pilaster sections.
  - Egg and Dart cornice.
- Every effort should be made to protect the decorative niche hoods (2nr) and the plain niche hoods (2nr) as they are in a reasonable condition and should remain insitu. L&R would suggest that their condition is monitored on a regular basis and any threat to their status from the removal of ACM's is assessed.

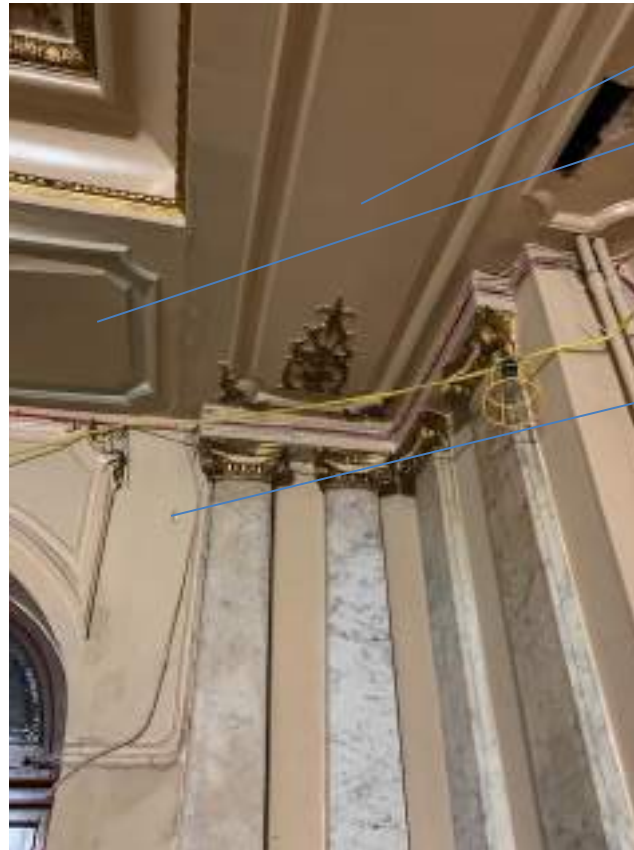
Inspection/access holes to plain sections of plaster soffits.

- The inspection on 5<sup>th</sup> May 2020 of this area confirmed that the condition of the plaster ceiling had deteriorated in recent weeks. It is thought that damp is penetrating through the fibrous plaster and ‘pushing’ off the layers of paint.

- The walls are also fabricated in fibrous plaster and fixed to timber noggins secured to the masonry walls. It can be assumed that water has penetrated these masonry walls and has affected the timber battens/noggins behind.

- L&R would recommend that these holes and securing works are carried out as soon as possible to ensure the maximum amount of plaster fabric can be retained.

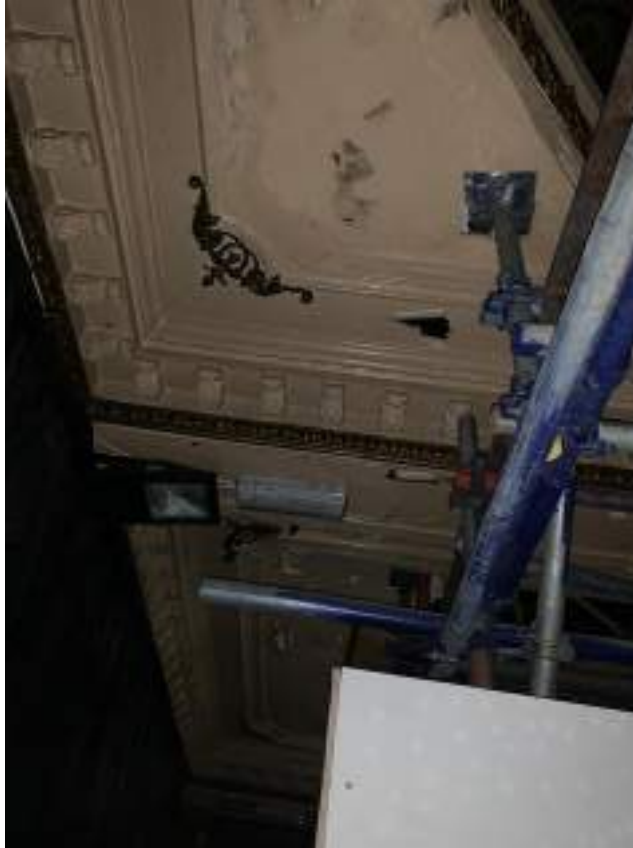
### 2.5. Ground Floor G-17 Entrance Foyer.

- Close access to this area was not possible due to the amount of builders rubbish and debris on the floor in this area. Furthermore, the ceiling and walls were obscured with scaffolding making any close inspection impossible.
- The presence of this scaffolding makes an assessment of the plasterwork's status and condition difficult. It is highly probable that significant amounts of water from the fire have penetrated the plaster soffits and skylights. However, at this stage we would assume like the neighbouring ceiling in G13 the intention must be to save and conserve the plasterwork to these coffers.
- L&R would advise that access is made possible as soon as is reasonably possible to allow a close inspection of the ceiling soffit plasterwork.

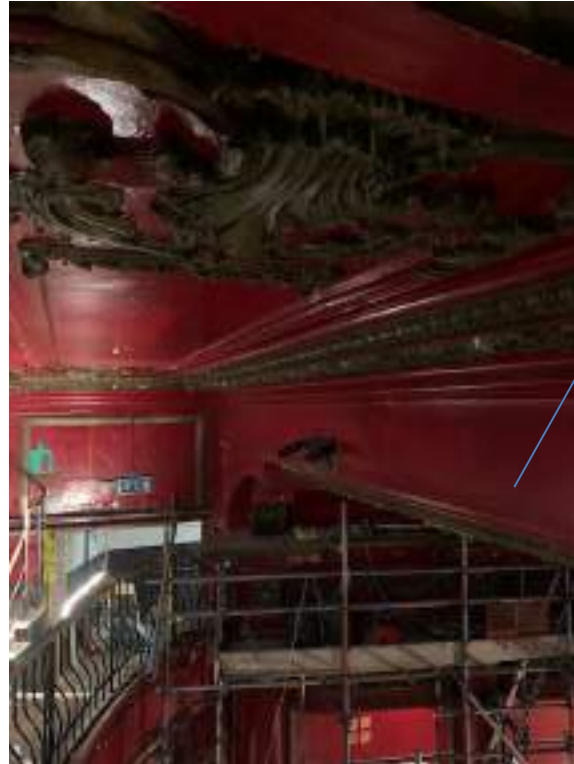
- Close investigation from below reveals that the original plaster face with its layer of red paint is structurally weak in places. In particular the red painted fibrous plaster downstand to the Auditorium dome itself was found to be in a

very poor condition. The black soffit and upstand on the other side is in a similar poor condition.

Red painted  
downstand  
in a very  
poor  
condition.

- L&R would confirm its earlier recommendation that the fibrous plaster soffit with its decorative enrichments forming two matching bays and to include the red painted downstand and black painted upstand should be carefully taken down and replaced with new sections to match the existing.
- L&R have reached this conclusion on the basis of the widespread and significant water ingress as a consequence of the fire in January 2020. Water ingress and persistent damp conditions are well known factors leading to the degradation and eventual failure of hessian embedded within the fibrous plaster casts and supporting wads. The combination of this threat and that highlighted in the H&R Report of the legacy risk of timber decay in the supporting structure supports this recommendation.

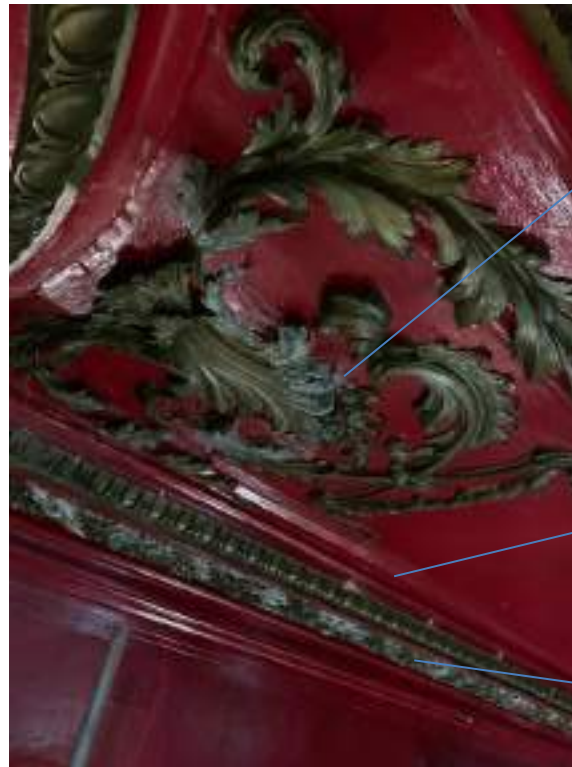
Large  
scroll  
enrichment  
.

Egg and Dart  
enriched cornice.

Enriched band.

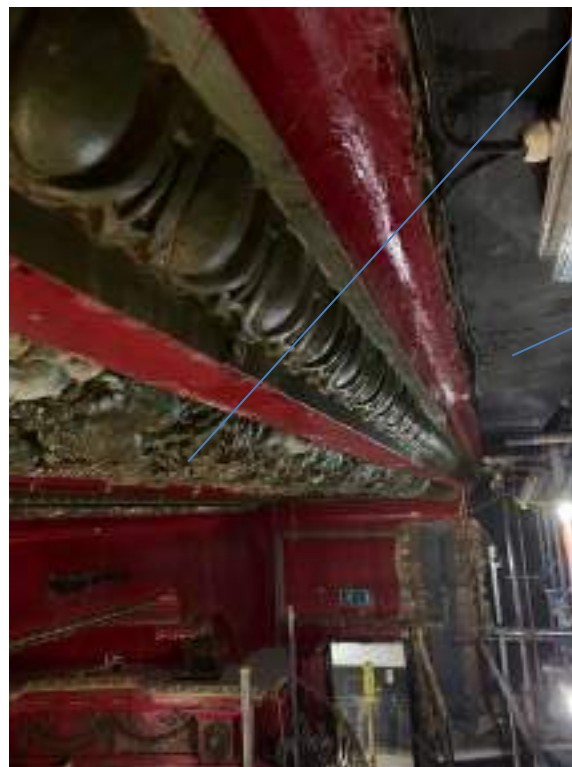
Black soffit and  
upstand.

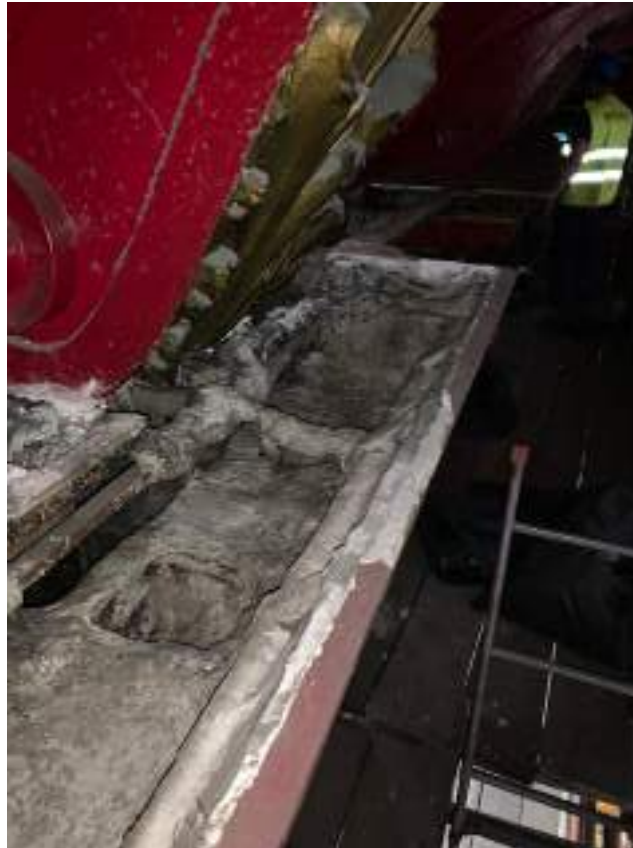
- Our limited inspection of the fibrous plaster walls on the Northern elevation revealed little evidence of any substantial water ingress from the January 2020 fire. It is possible that moisture has affected the masonry structure behind. The H&R investigation did not include for the Auditorium walls due to access issues and the discovery of ACM's.
- L&R would recommend that some inspection holes are cut into the fibrous plaster wall mouldings to allow access to view the status and condition of the timber support system behind.

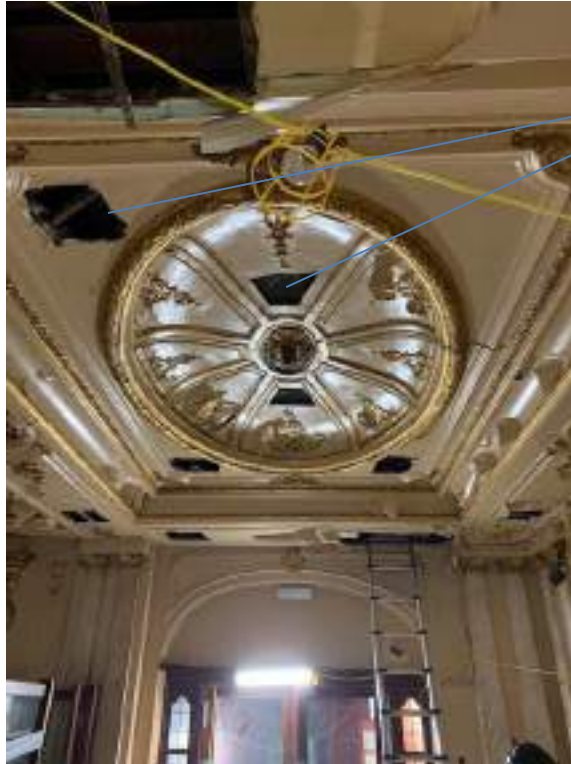
Inspection  
holes.

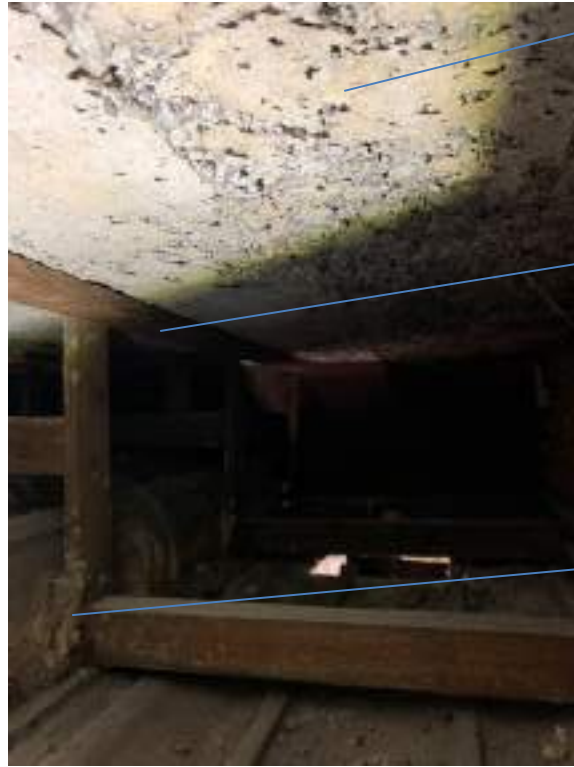
Clinker concrete soffit.

Timber battens secured with nails to the clinker soffit.

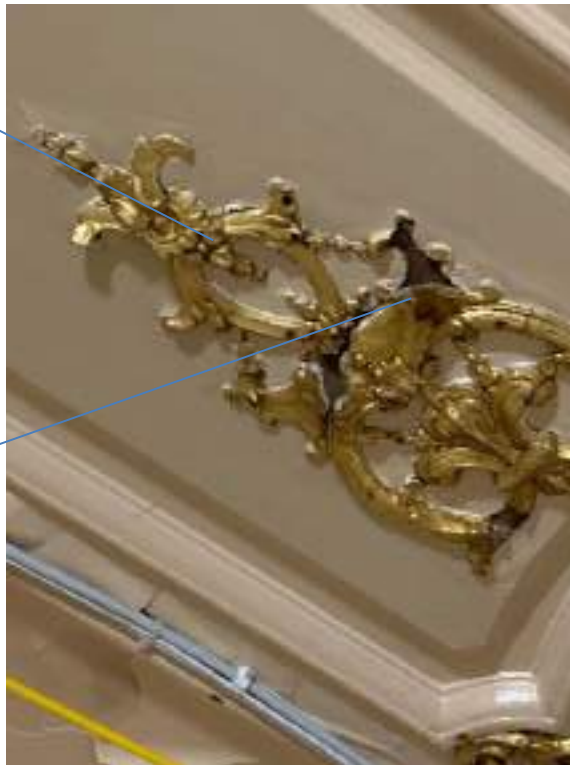
Decorative element of composition applied to beam soffit.

Section of detached composition detail.

- New fibrous plaster sections are cast from moulds and installed in place and made good to the existing sections where applicable.
  - Any missing and damaged enrichment is moulded, cast in plaster and fixed in place to match the existing.

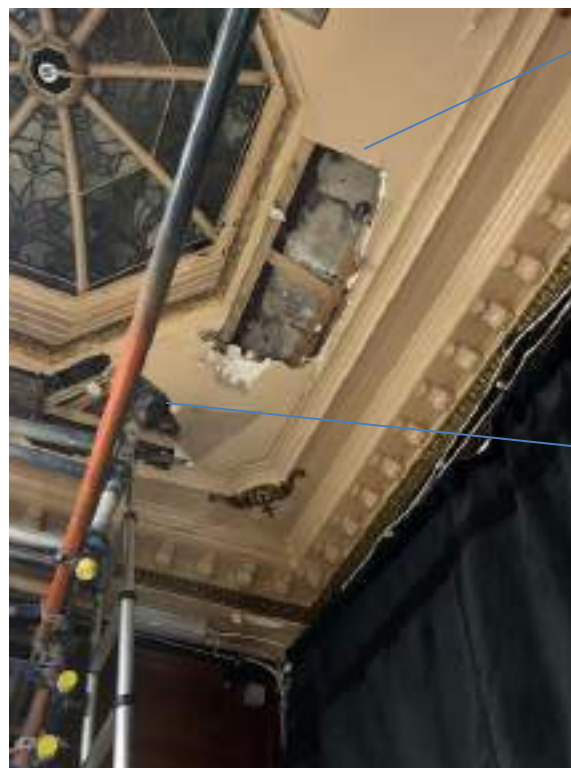
- Some damage has been caused to the plaster soffit by the insertion of supporting scaffolding in order to reach the concrete clinker behind. This loss of plaster has exposed the clinker soffit and the timber supporting structure. It was noted that some of the flat soffit has been 'repaired' with modern plasterboard which would indicate some earlier issues with water ingress.

Section of  
'modern'  
plasterboard  
repair with  
timber  
supports.

Loss and  
damage  
caused by  
insertion of  
structural  
scaffolding.

- Sections of plasterboard are to be carefully removed and replaced with new fibrous plaster sections. Any defective timber supports are to be removed and new metal channel installed to provide a secure fixing for the new plaster soffit.
- New relief plaster mouldings including decorative quadrant corners are to be replaced as applicable to match the existing.
- Cracks, holes and chases in the existing remaining plaster sections are to be repaired and made good. As required existing sections of plaster cornice would be re-secured with screws.
