Catherine Hassall
Historic Paint Specialist

Historic paint schemes

KOKO THEATRE

An examination of the historical paint schemes

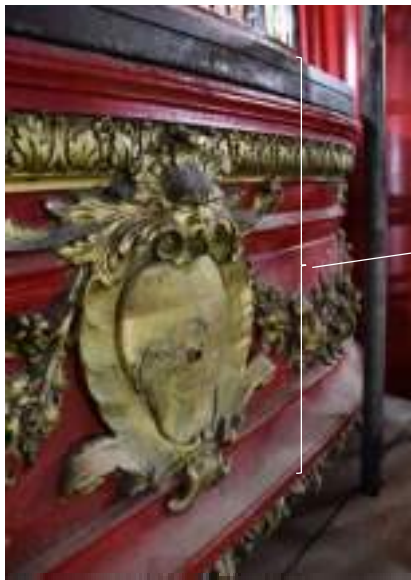
Cream and gold were also used for the box fronts and gallery fronts. These had become very worn, so gold was only picked up in a few samples, and the extent of the gilding is not certain.

cream and gold

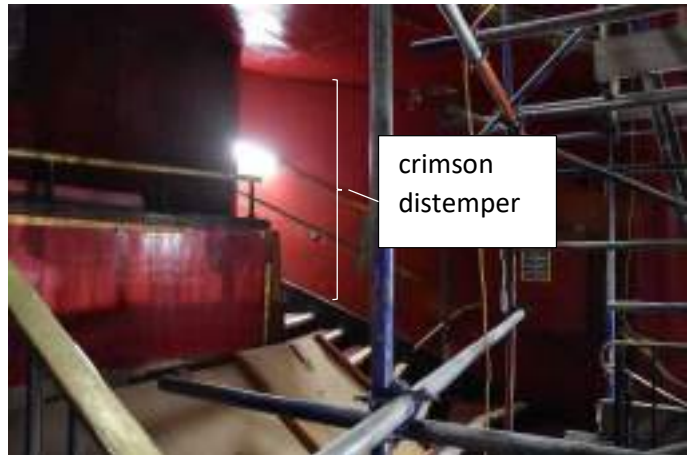
Area behind Balconies.

crimson distemper

The same crimson, cream and gold decoration was also used in the area behind the balconies: cream and gold on the ceiling and cornice; crimson on the walls.

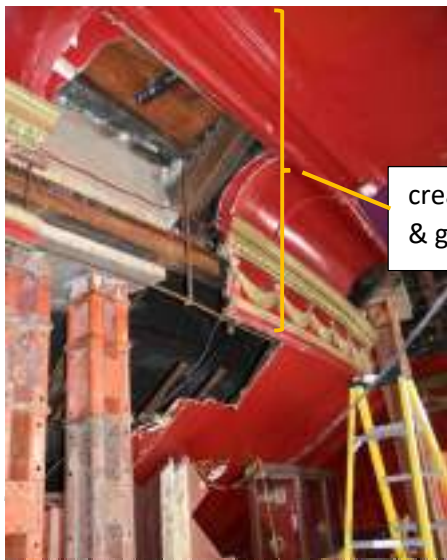
cream & gold

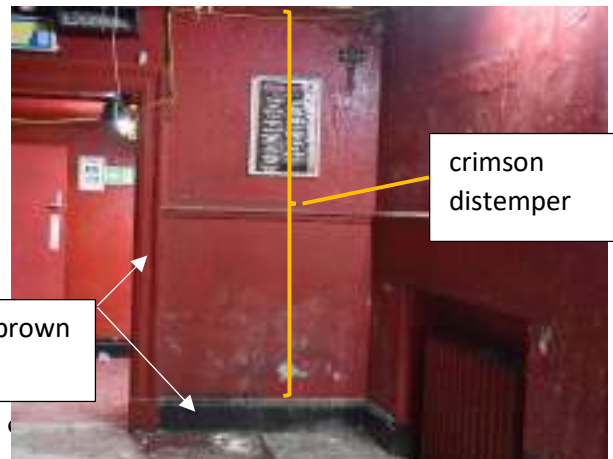
crimson distemper

brown

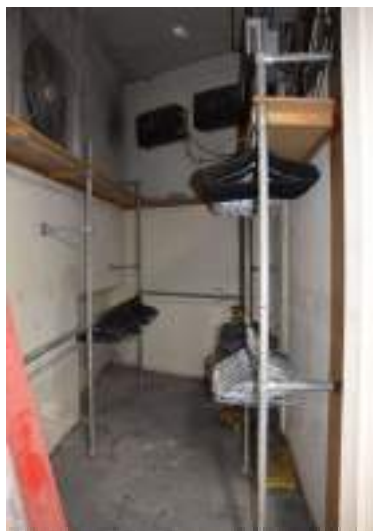
SOUTH EAST ROOM – G.08

The upper wall has been re-plastered, but the lower wall has original lime plaster, and the samples show that this area was originally decorated the same as the Lobby [G.13] throughout the early part of the twentieth century.

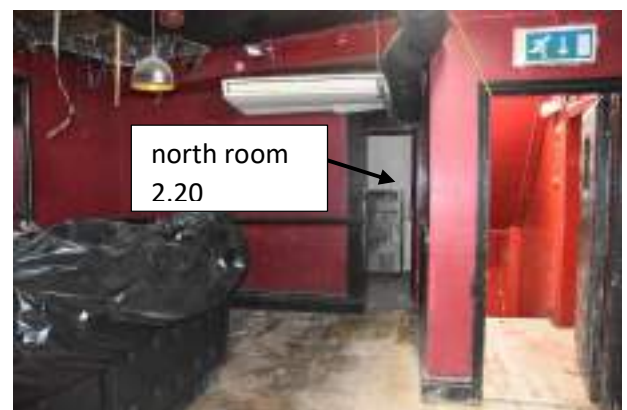
THE PROJECTION ROOM – [3.13]

- 3 The third floor was inserted, and stairs built at the north and south ends. The paint suggests that the area was subdivided as it is now, but the present north and south partitions must be later replacements because they are missing schemes 3-6.

This was the first scheme on the un-plastered brick and on the iron shutters in the east wall.

in 1913 the
walls painted black

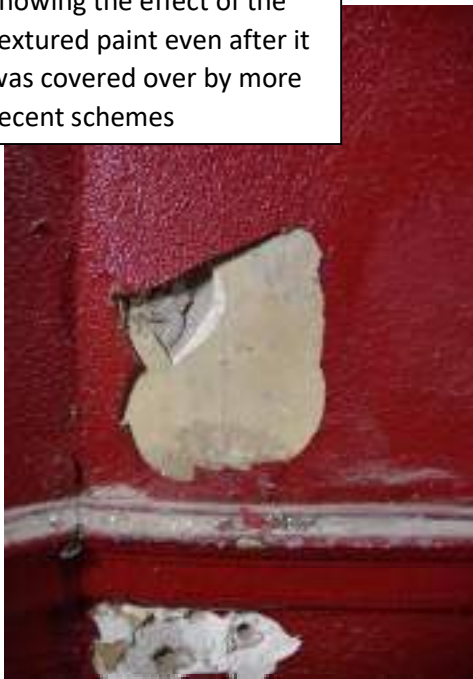
The stairs from ground floor to first floor were painted with a distinctive textured paint involving a rough pink undercoat followed by a dark red glaze. This red was used from floor to ceiling.

showing the effect of the textured paint even after it was covered over by more recent schemes

textured paint scheme

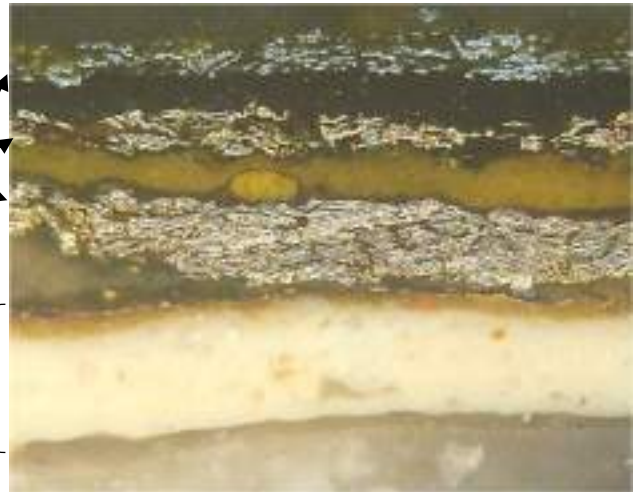
SAMPLE H.53

Wall behind figure

original cream oil paint

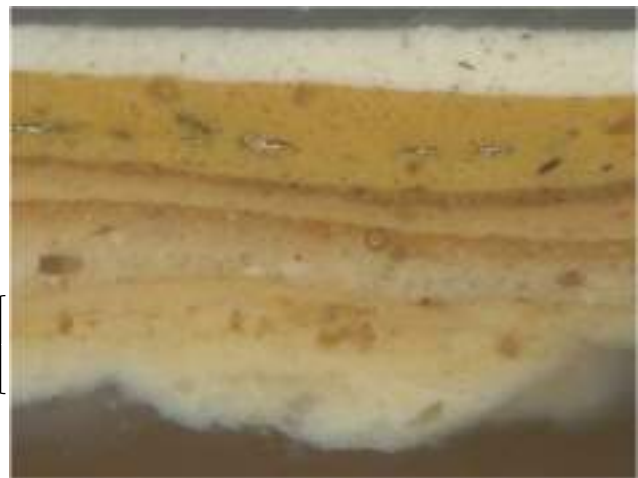
SAMPLE H.54

Door architrave

present red
later C20th schemes
original varnish

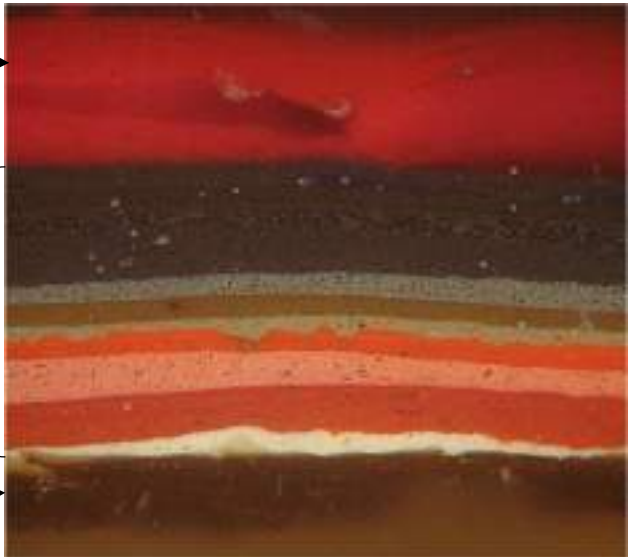
SAMPLE H.55

Back wall of niche

original crimson distemper
plaster

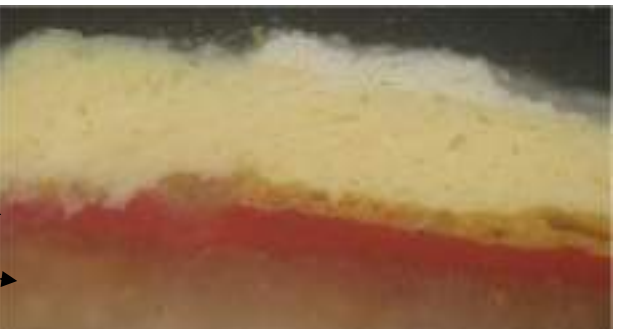
SAMPLE F.4

layers of later 'gold' paint

original gilding

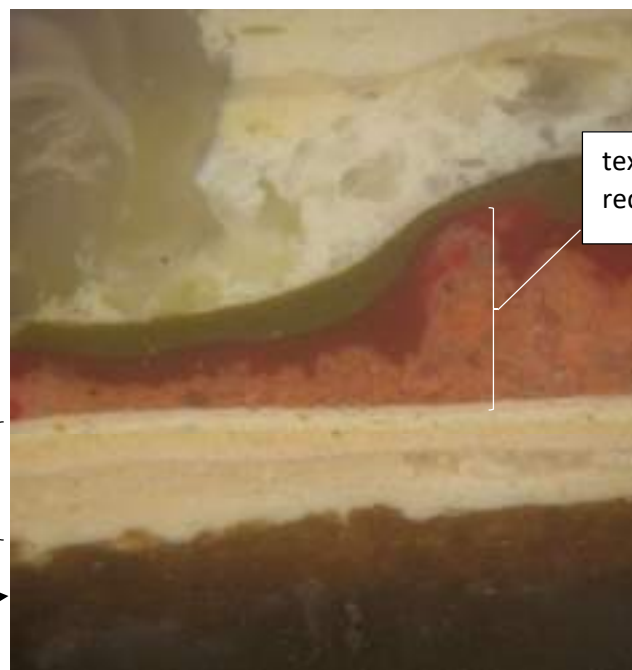
SAMPLE RS.18

The dado rail was certainly the same cream colour, and the skirting the same brown colour as used on the Stairs [RS.18, p.31]. Nothing has survived on the walls above the dado, and it is likely to have been a distemper as was used on the Stairs. The plaster is not stained, so it was a light colour.

Skirting

post-WW2 textured red paint

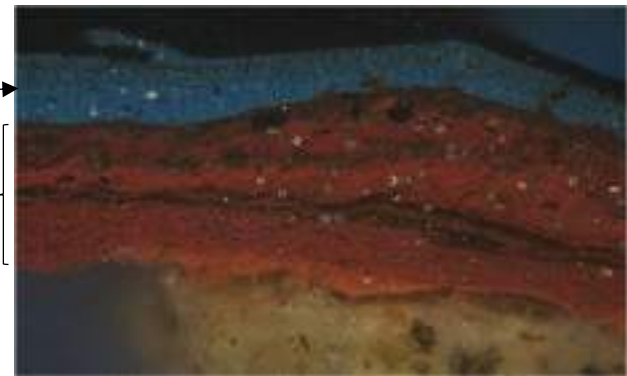
SAMPLE RS.20

Below dado rail

mid C20th blue

red lead

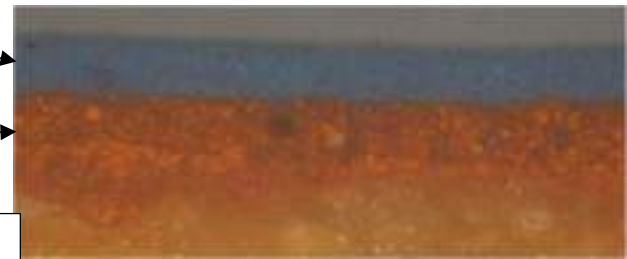
SAMPLE RS.21

mid C20th textured red

early C20th pinks & brown

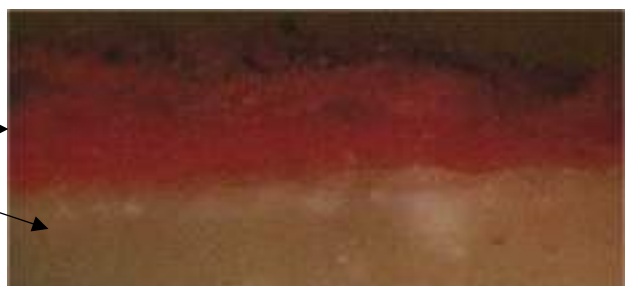
SAMPLE A.9

North wall – above dado

later C20th paints

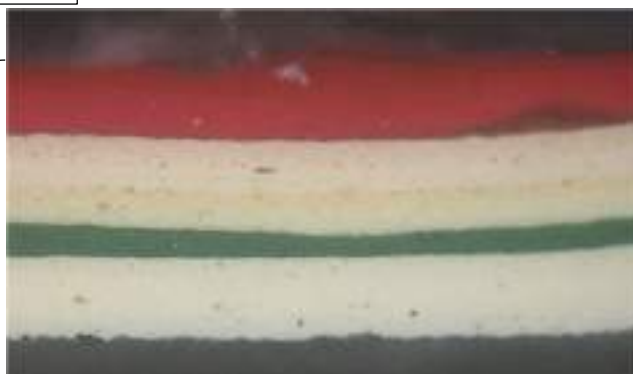
Fragment (ii)
Lower layers

pre-WW2 lead-based
oil paints, all cream coloured

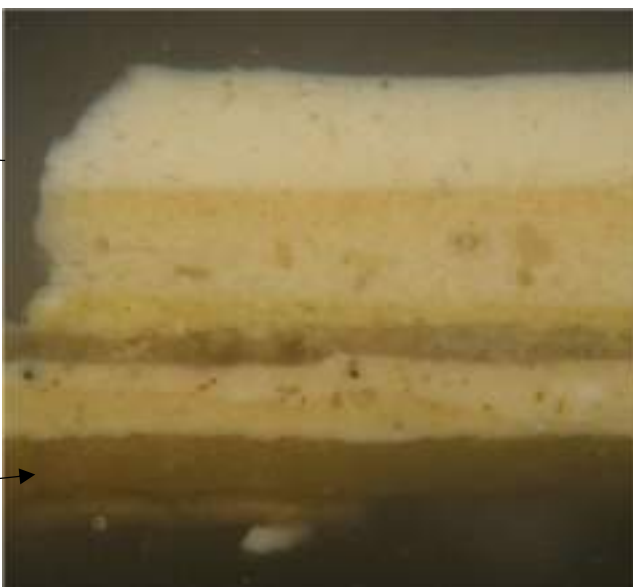
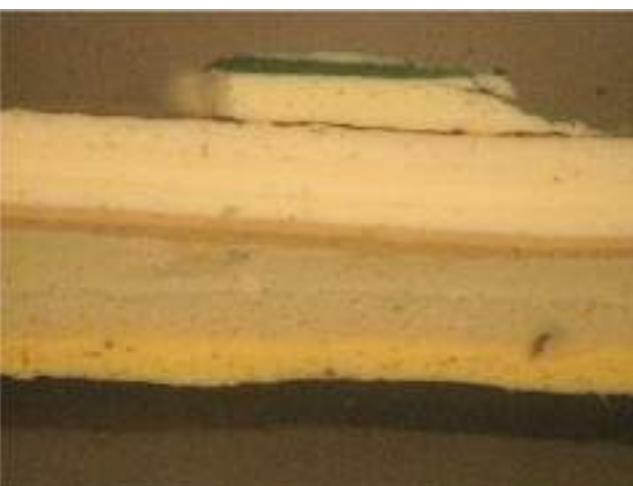
SAMPLE A.11

The wood of the dado panelling and all the doors was stained brown and then given a thick coat of varnish [A.11, p.32].

Dado rail

Fragment (i)
Upper layers

post-WW2 paints

Fragment (ii)
wood and first layer

original varnish

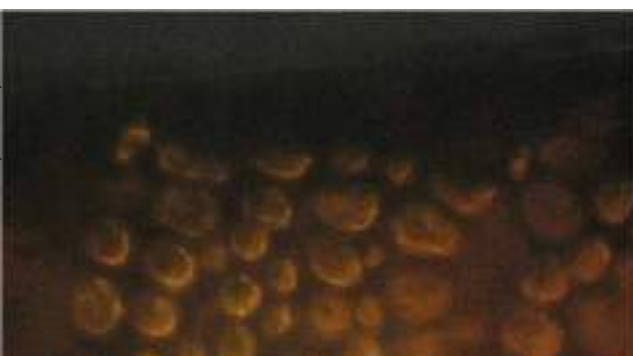
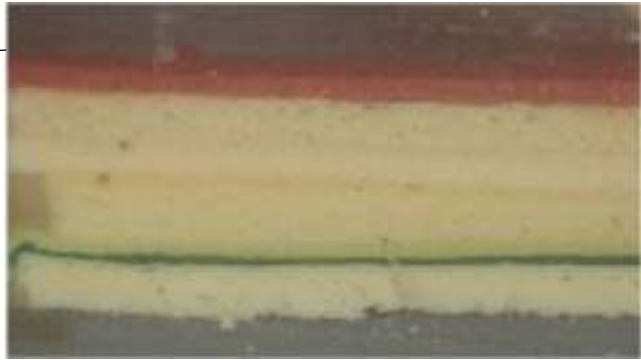
SAMPLE A.31

Ceiling

upper layers

later C20th paints

Fragment (ii)

Lower layers

cream-coloured paints
based on lead white

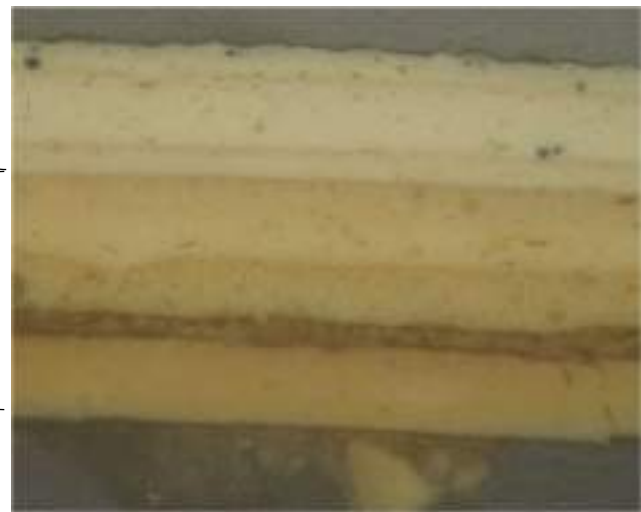
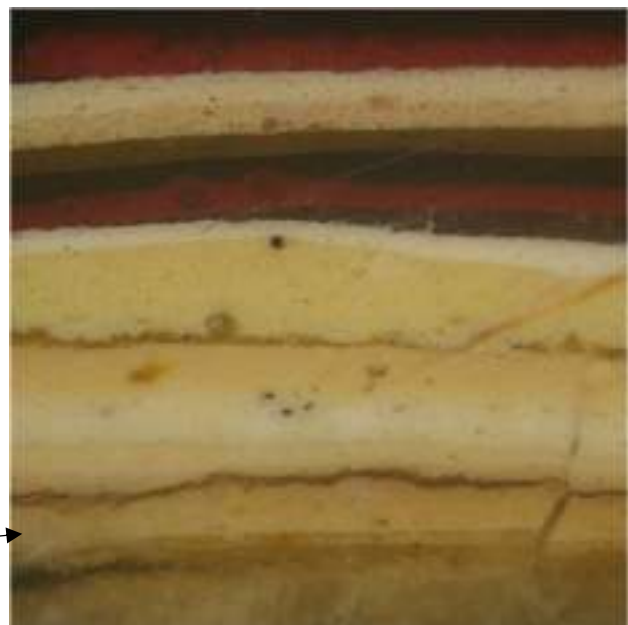
SAMPLE E.5

1st FLOOR LOBBY TO
BALCONY

Dark colours, including reds
introduced after WW2.

original cream on
plaster

Detail of first scheme

cream coloured paint with
thin glaze over the top

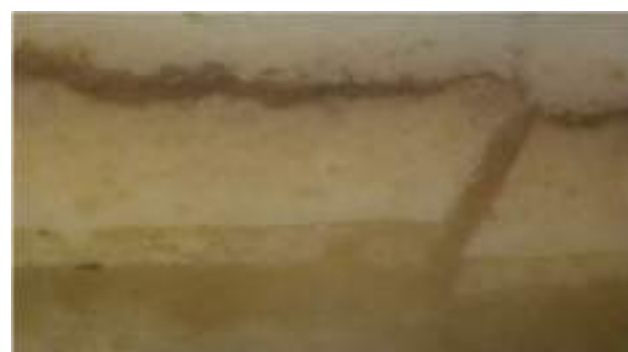
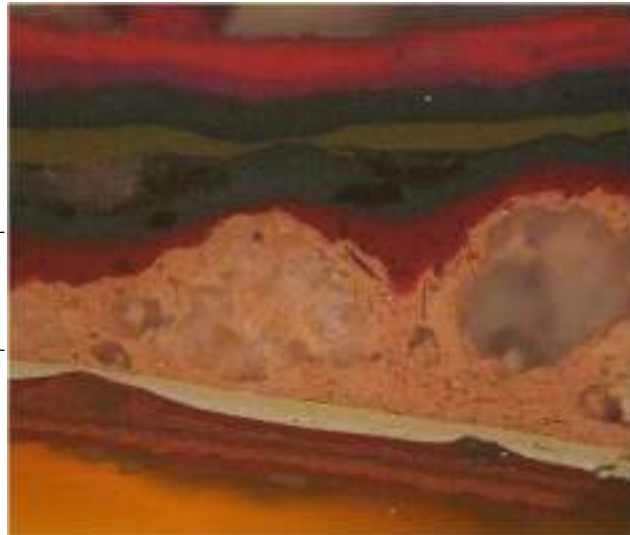
SAMPLE E.25

West wall, north end, below rail

Upper layers

mid C20th textured red paint

Fragment (ii)

Plaster & first layers

original crimson distemper

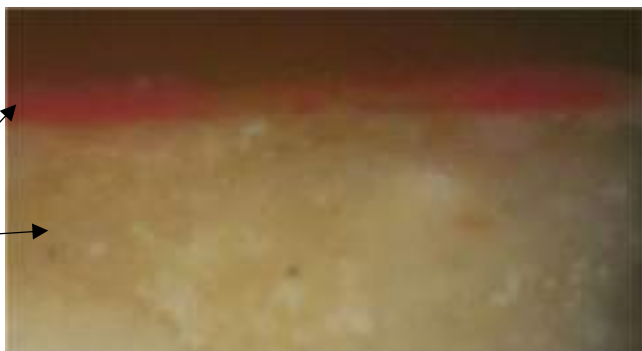
SAMPLE B.18

Traces of an off-white distemper were found on the upper walls [B.18, p.34]. The lower walls have all been re-plastered, so no evidence remains. The dado rail was given a dark brown varnish.

2nd FLOOR - WEST ROOM

trace of distemper

original lime plaster

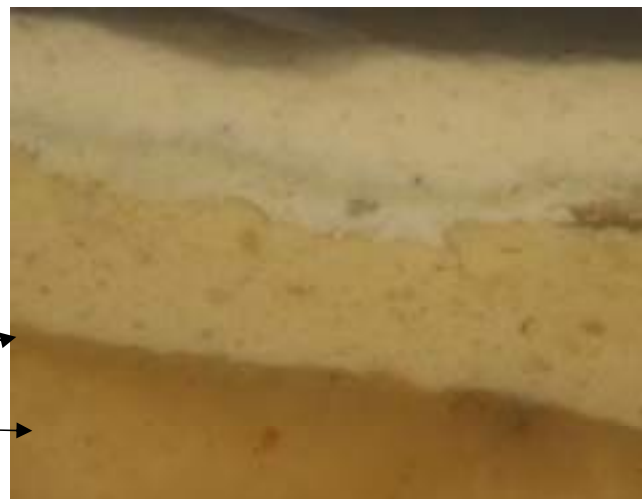
SAMPLE B.19

Dado rail

The wood has been stripped but traces of original varnish survive

original varnish

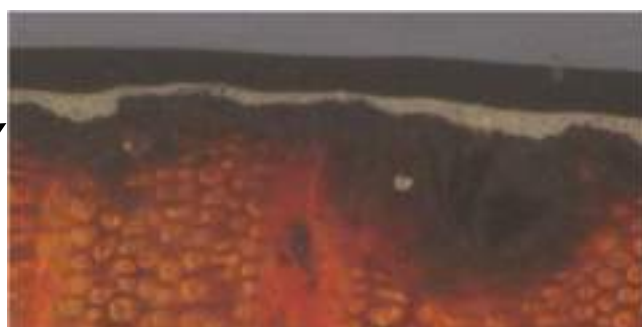
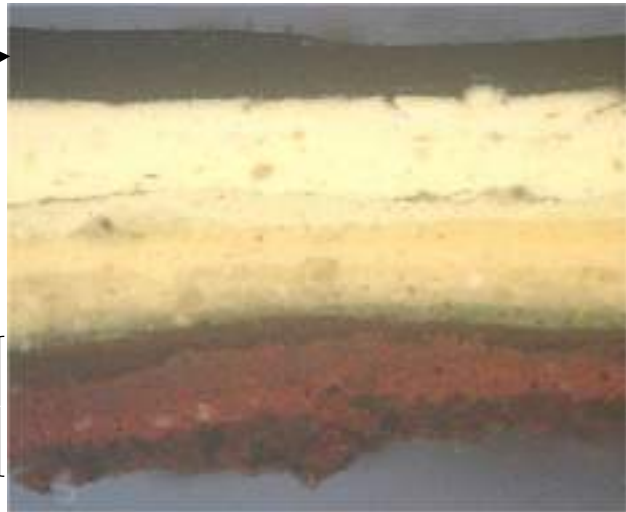
SAMPLE B.53

The brown is clearly original because the walls were prepared with the same priming layer as found on the South Stairs, but the brown is different from any other paint used in the theatre in 1900. It was an unusual mixture of iron oxide brown and a small amount of red lead [B.53, p.35].

2ND FLOOR – SOUTH ROOM

Upper layers

showing that the room was dark in early years

3 lots of early C20th dark brown

Fragment (ii)

Plaster and first layers

Showing the original brown which is a mixture of iron oxides and some red lead

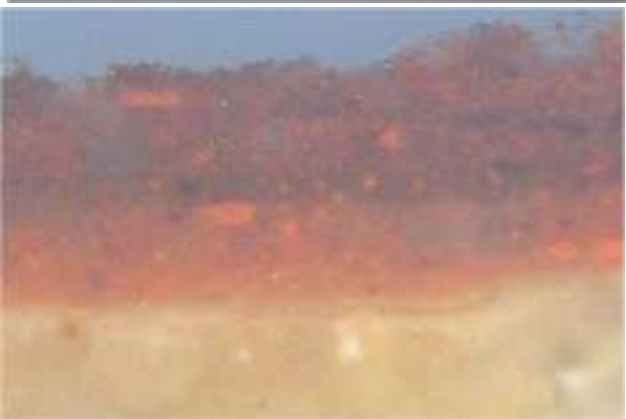
SAMPLE C.6

PROJECTION ROOM -

Very first layers missing, but showing the dark browns used for a painted dado in the later C20th

1913 black →

plaster →

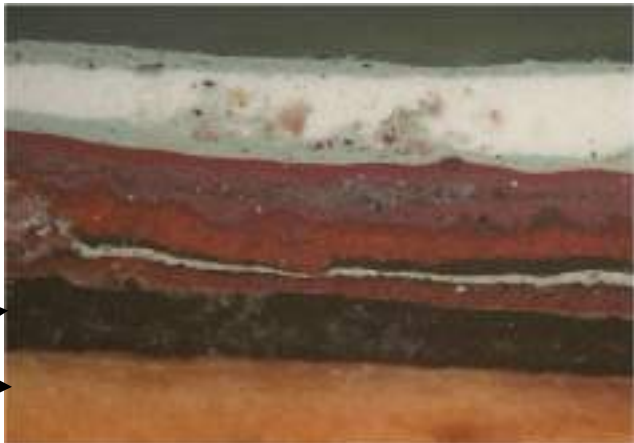
SAMPLE C.12

East wall – high up

1913 black →

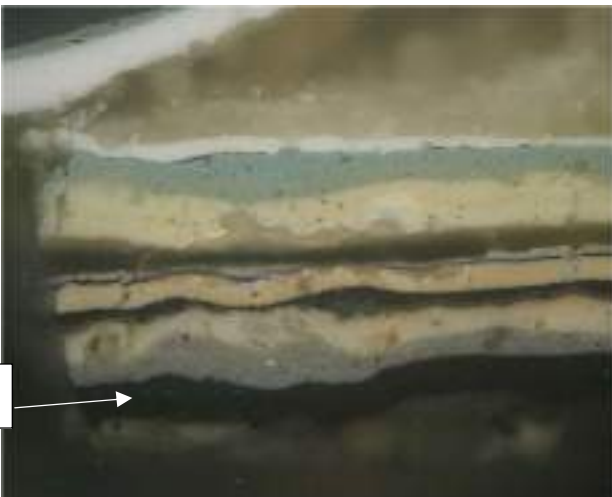
SAMPLE C.19

Stairs from Projection room to
Balcony level – original south wall

A different shade of red compared
to the red used in the
Auditorium.

pre-1913 reds

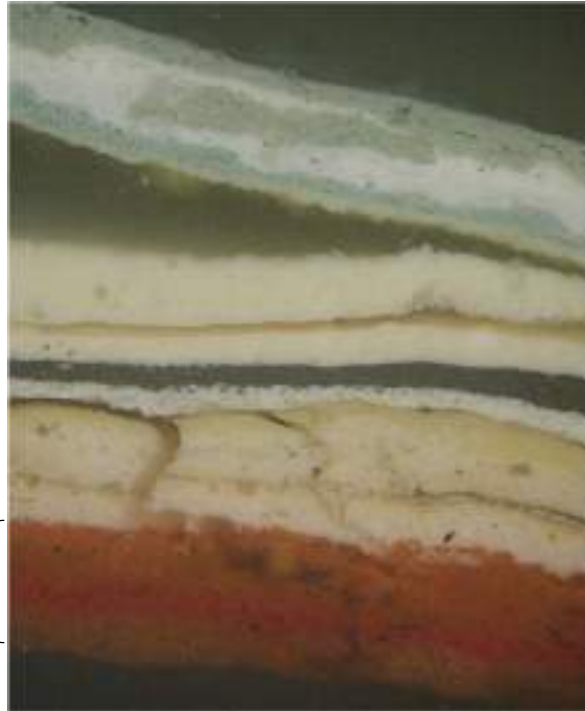
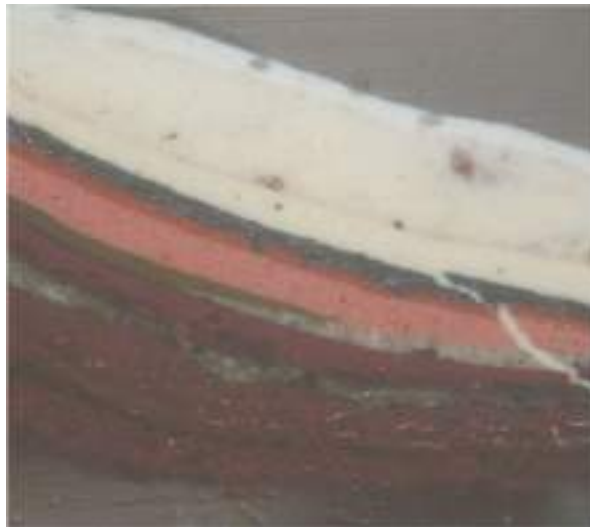
SAMPLE D.9

SOUTH STAIRS

Upper layers

Showing that it is painted white
today, but in the early years was
always brown.

Fragment (ii)

Lower layers

original brown on buff
undercoat

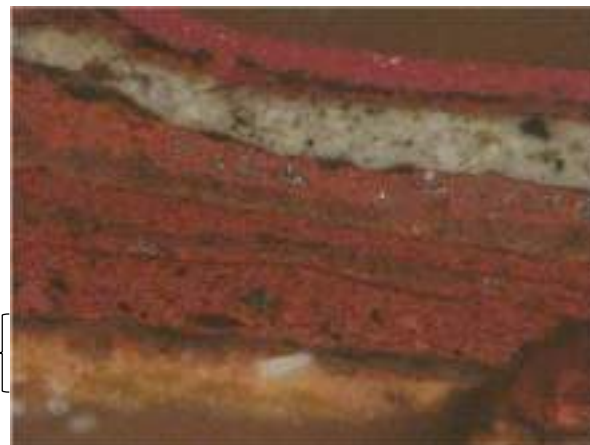
SAMPLE Q.4

South wall, going down - high level

Most paints missing, but the original has survived on mortar

original pinkish colour
over pale pink primer

mortar

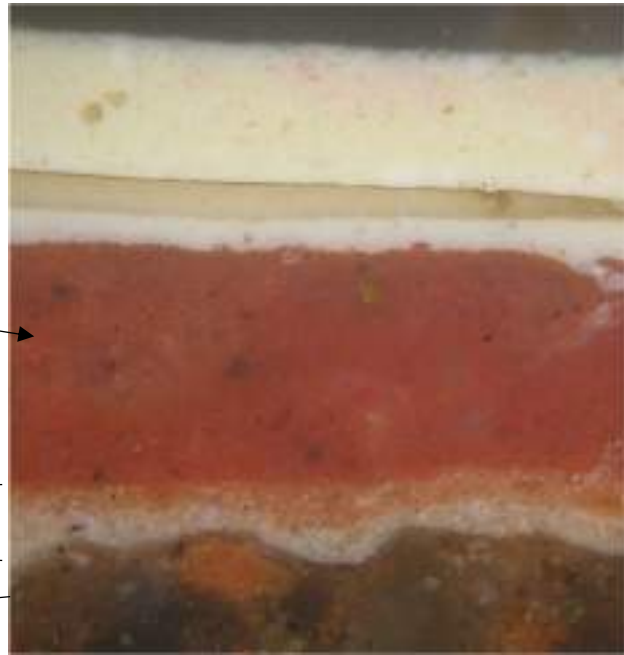
SAMPLE Q.5

South wall, going down – low level

original brown
over pale pink
primer

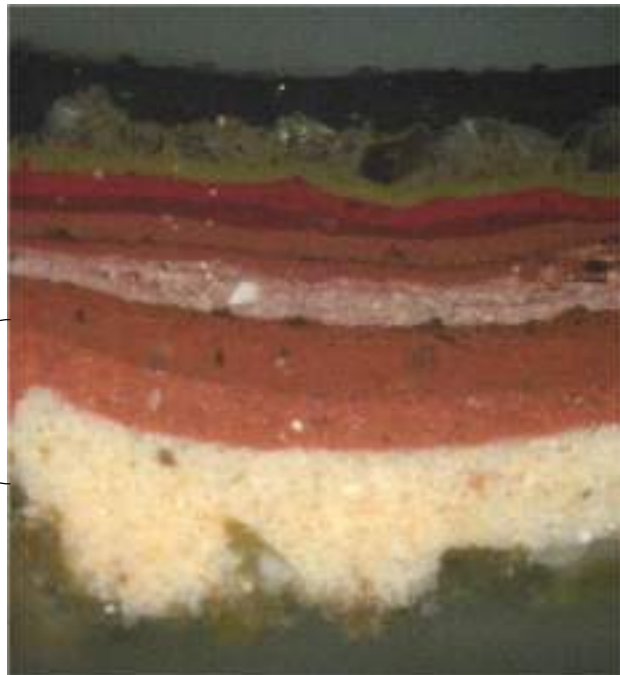
SAMPLE R.1

2nd SET OF SOUTH STAIRS

Originally painted crimson from floor to ceiling

original distemper

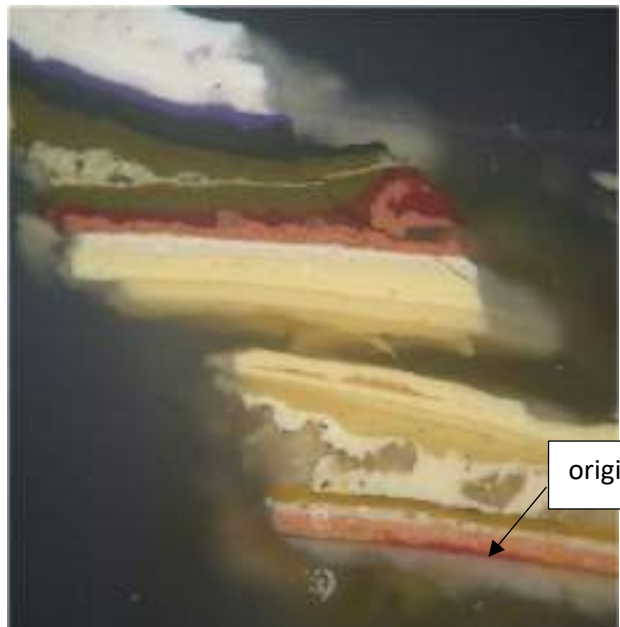
SAMPLE R.2
Wall at low level

As in Sample R.1 on previous page,
crimson distemper is the 1st scheme

mid C20th textured red

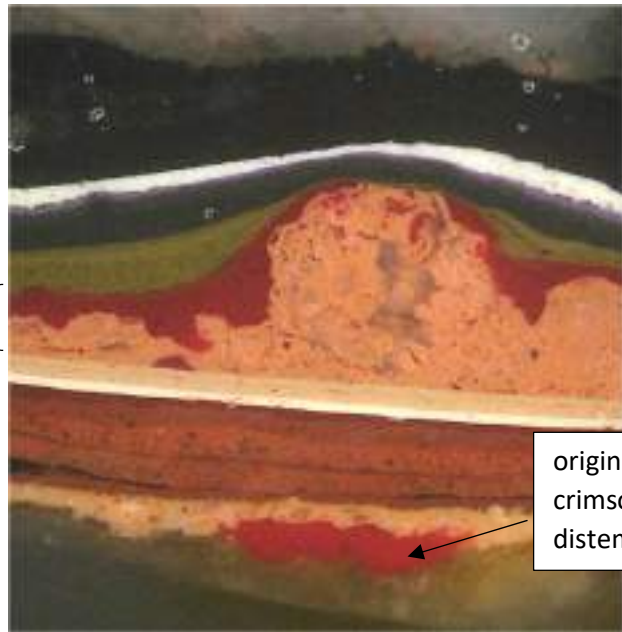
original
crimson
distemper

**NORTH STAIRS BEHIND
ROYAL BOX**

mid C20th
textured red paint

varnished
pink oil paint of 2nd
scheme

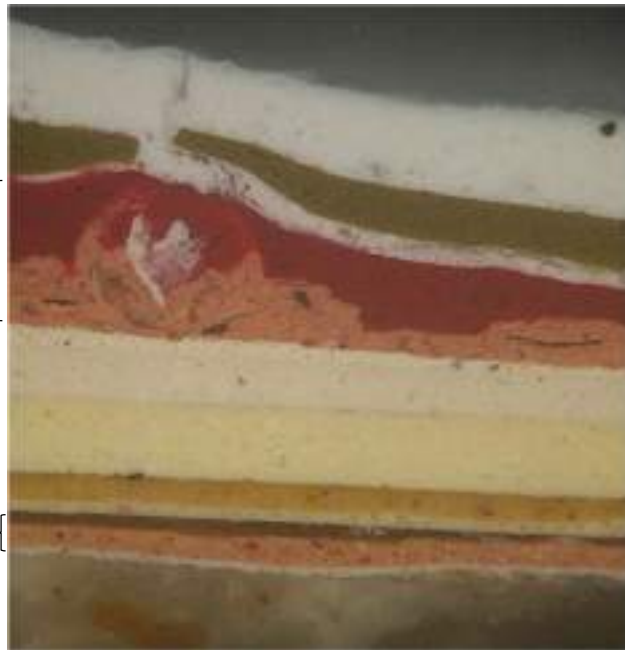
SAMPLE P.4
Cement skirting

Showing that in the early
years the skirting was always brown.

mid C20th
textured red

original dark brown

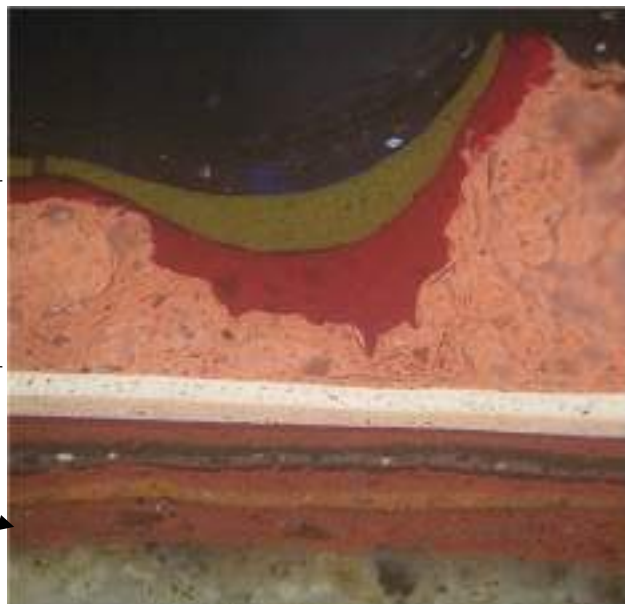
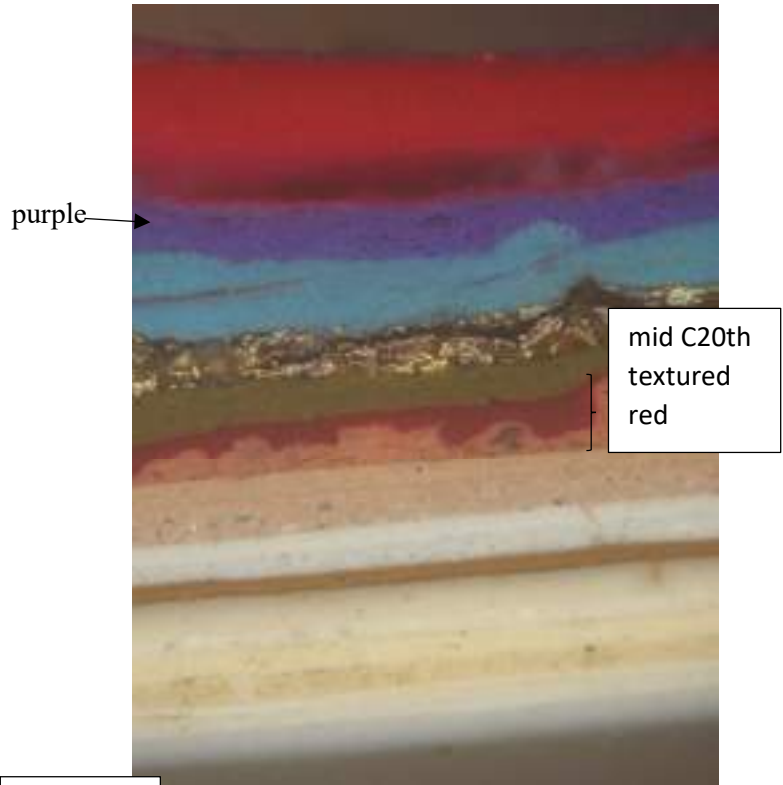
SAMPLE RS.6

WEST STAIRS

Fragment (i)
Upper layers

Showing the rail was originally the same cream colour as used on the embossed wall paper

Fragment (ii) – wood & first layers

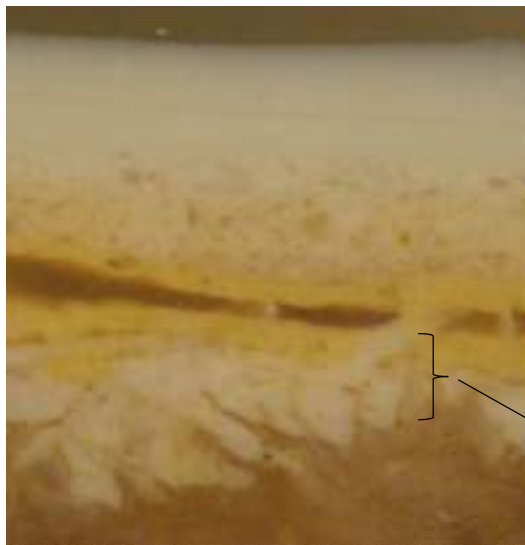
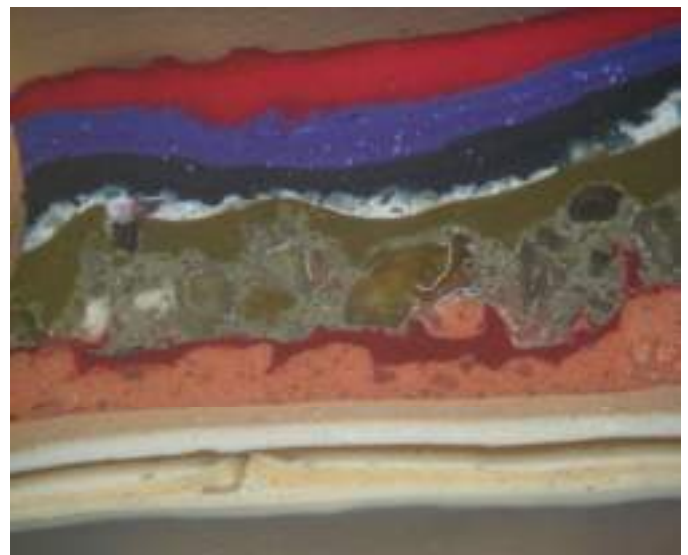
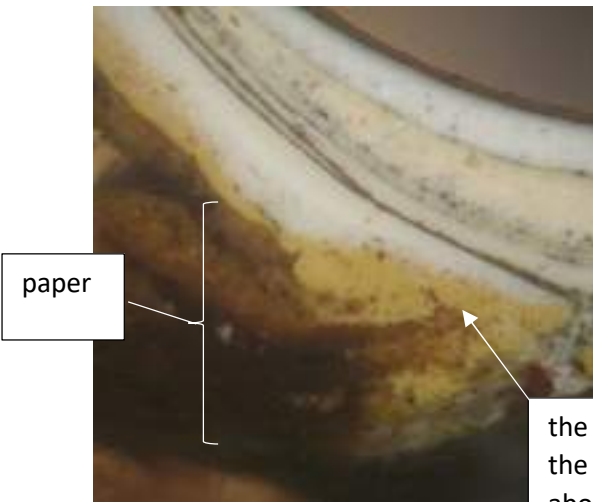
SAMPLE RS.10

original cream

Fragment (i)
Upper layers

Fragment (ii) – paper & lower layers

the same cream as on the rail - Sample RS6 above

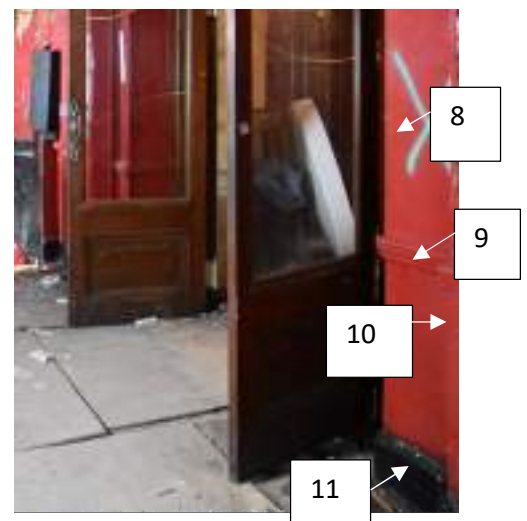
GROUND FLOOR – LOBBY AREA

- west wall, south end
- F8 above dado rail
- F9 dado rail
- F10 below dado rail
- F11 skirting

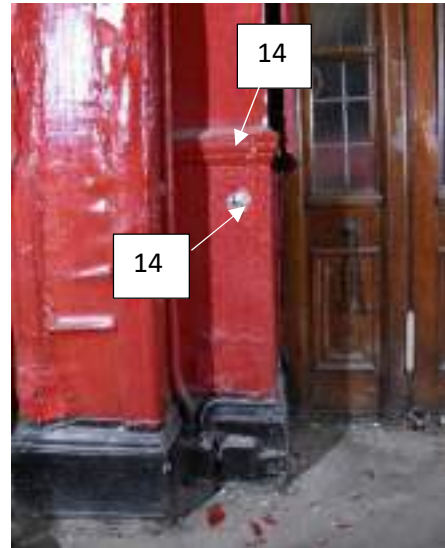
- South doorway to Main Entrance
- RS14 dado rail
- RS15 dado

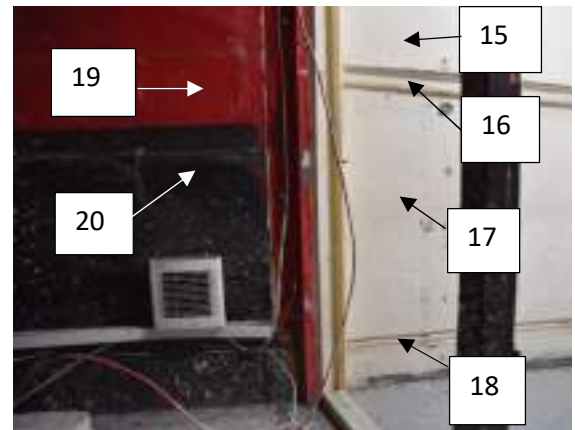
- South end of east wall
- right of doorway
- RS15 above dado
- RS16 dado rail
- RS17 dado
- RS18 skirting

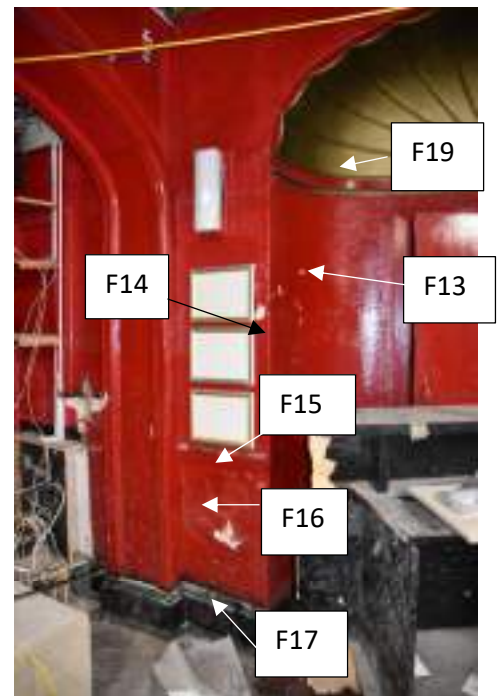
- East wall, north end
- F13 back of niche
- F14 above dado rail
- F15 dado rail
- F16 below dado rail
- F17 skirting
- F19 gold top of niche

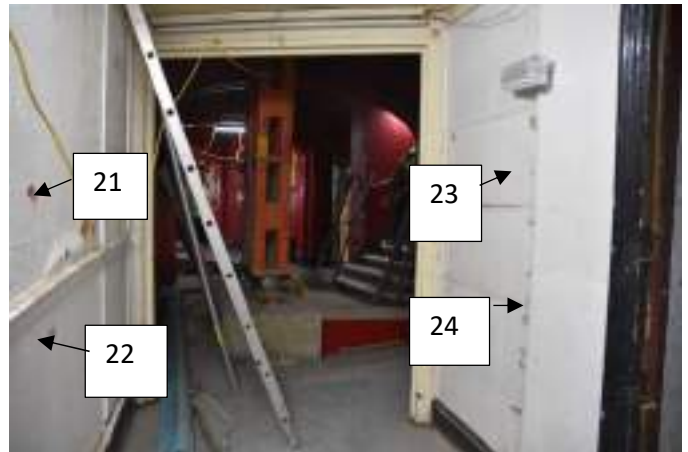
GROUND FLOOR – NORTH ROOM

East wall
 RS.21 above dado
 RS.22 below dado

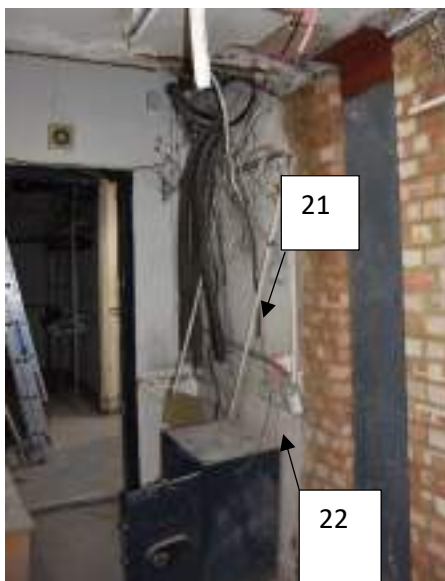
Room G.08
 F.21 above dado rail
 F.22 below rail

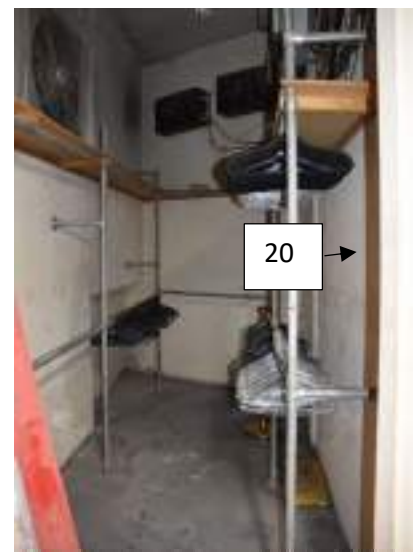
Room G.09

F.20 above dado rail

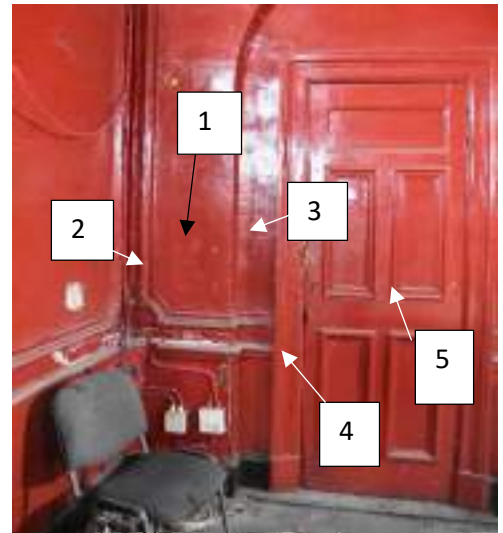
North wall – west end

- 1 flat of wall above dado rail
- 2 panel border above dado rail
- 3 wall next to door
- 4 architrave of door D1.16
- 5 door D1.16

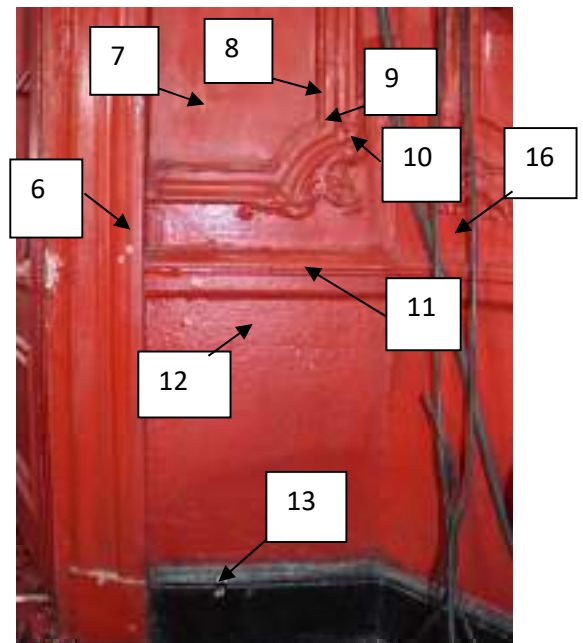
North wall, east end

- 6 architrave of door
- 7 panel on wall above dado
- 8 inner panel border on wall above dado
- 9 flat between panel borders
- 10 outer panel border
- 11 dado rail
- 12 below dado rail
- 13 skirting moulding
- 16 flat of upper wall between dado rail and panel border

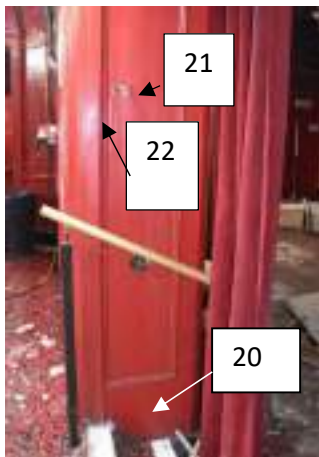
East wall – entrance to Room 1.12
 Panelled wooden reveal of opening

- 20 base of reveal
- 21 panel on reveal
- 22 moulding around panel

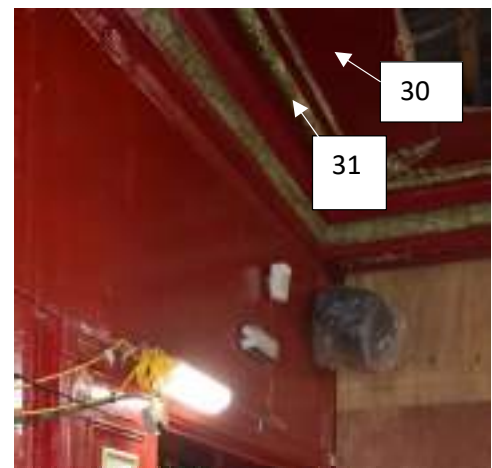
Ceiling – SE corner

- 30 flat panel
- 31 - gold moulding

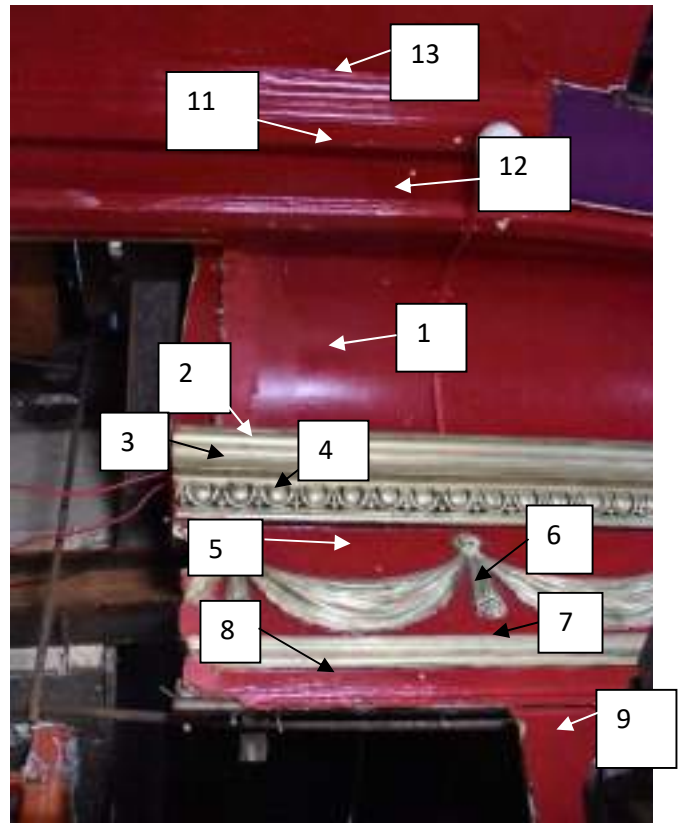
LOBBY BEHIND FIRST FLOOR BALCONY
[1.12]

- 1 cove
- 2 top of cornice
- 3 middle of cornice
- 4 egg & dart on cornice
- 5 background to frieze
- 6 swag on frieze
- 7 moulding at base of frieze
- 8 below frieze

- 9 sloping section

- 11 moulding on ceiling
- 12 between mouldings
- 13 centre of ceiling

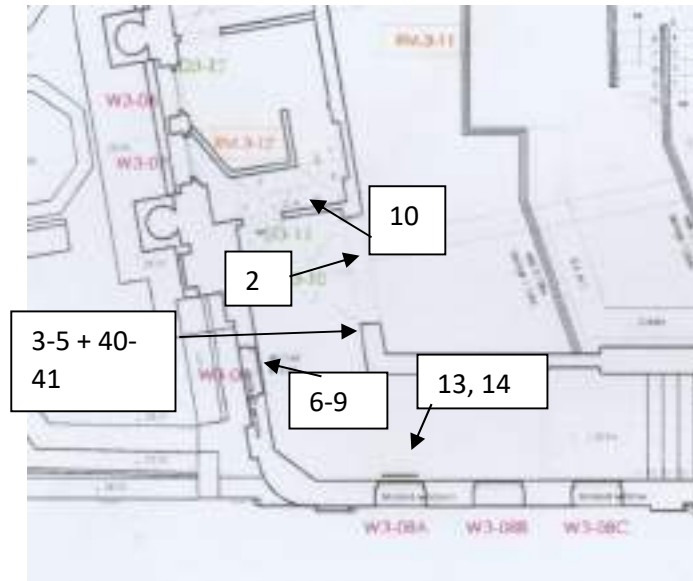
SOUTH STAIRS – 3.10 - Basement

- D.2 door to Balcony
- D.3& D.40 wall at eye level
- D.4 wall at shoulder level
- D.5 & D.41 wall at knee height
- D.10 partition wall

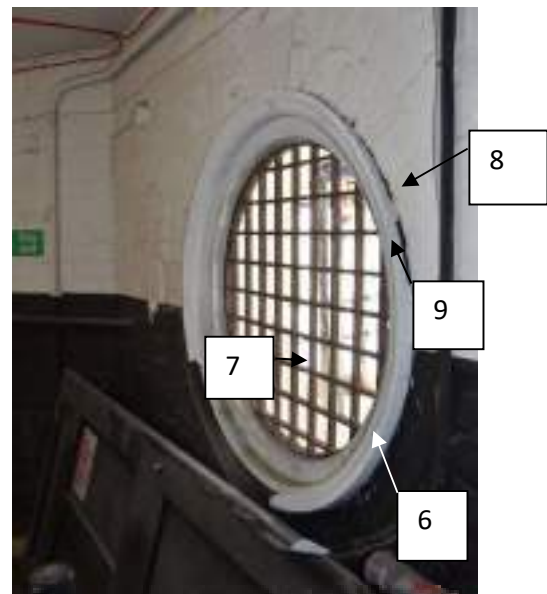
- West window [W3.08]
- 6 frame – lower part
- 7 iron grille
- 8 bricks around window
- 9 frame – upper part

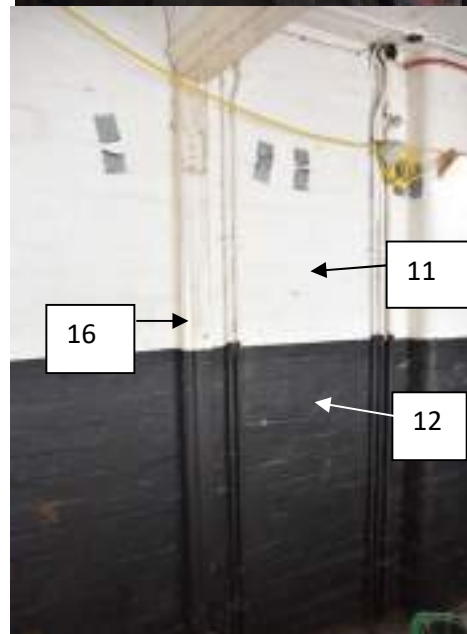
North wall of Stairs to right of removed door

- 11 high level
- 12 low level
- 16 architrave
- 17 high level next to first flight down

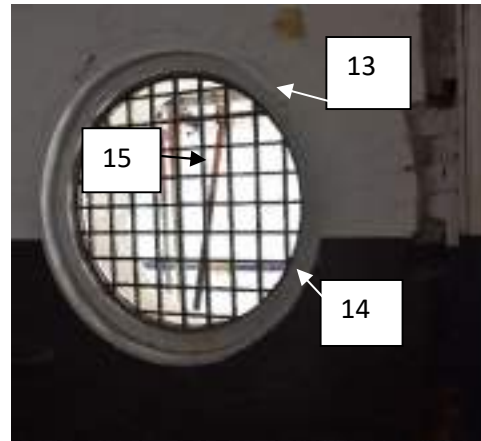
Window in south wall [W3.08B]

- 13 upper part of frame
- 14 lower part of frame
- 15 grille

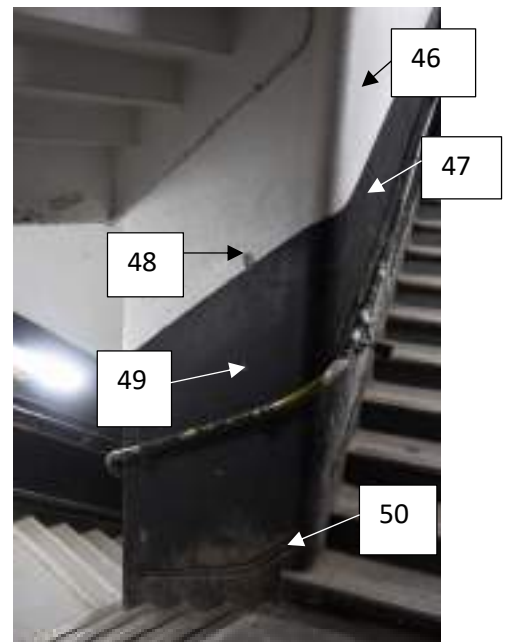
South Stairs - Ground to Basement - Plastered

- D.46 above dado
- D.47 below dado
- D.50 skirting

- D.48 above dado
- D.49 below dado

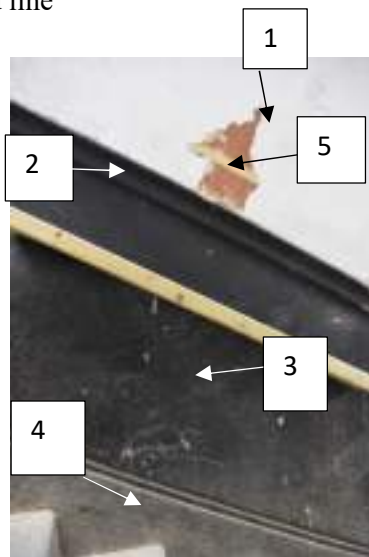
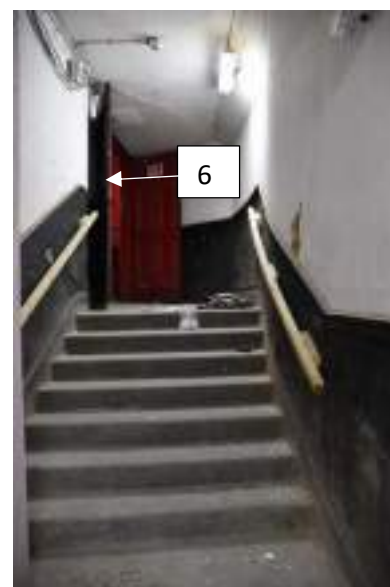
Between First Floor & Royal Box level

- P.6 door to first floor lobby

- P.1 north wall above dado rail
- P.2 dado rail
- P.3 below dado rail
- P.4 skirting
- P.5 painted line

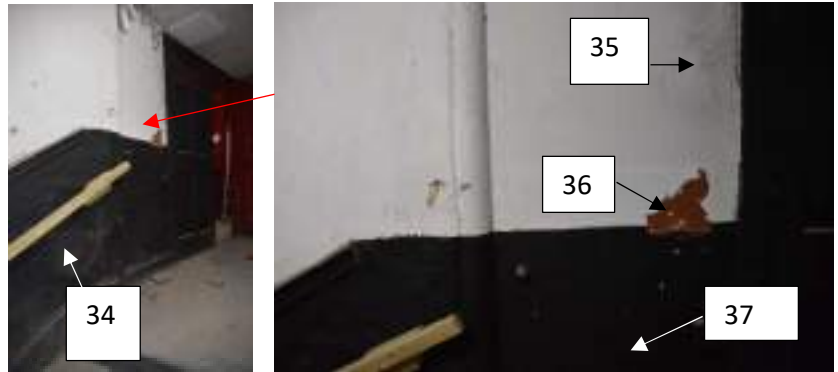
Section of south wall with no rail
 P.35 high level
 P.36 just above the black
 P.36 low level

P.34 south wall with rail
 below rail

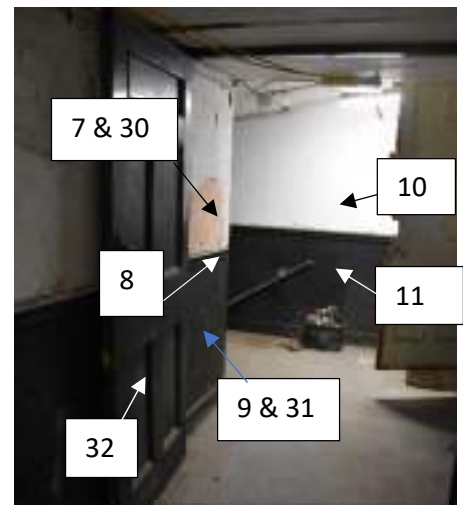
Royal Box level

P.7 & P.30 North wall
 above rail
 P.8 rail
 P.9 & P.31 below rail

P.10 East wall
 above rail
 P.11 below rail

P.32 door

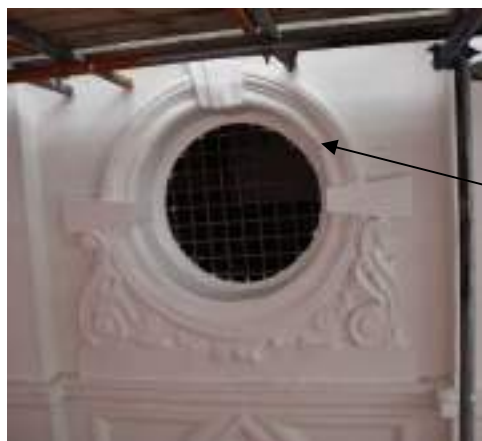
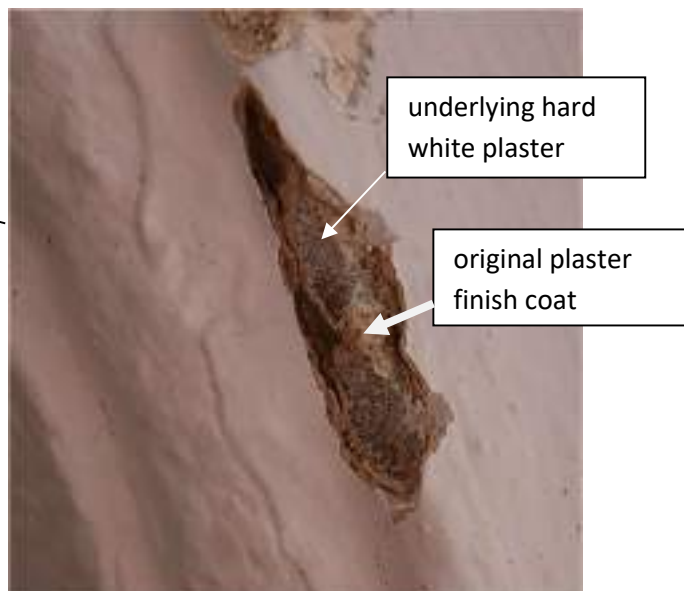
The surface of the plaster was sealed with some kind of clear organic coating.

This plaster finish was left untouched until the second half of the twentieth century
