Catherine Hassall
Historic Paint Specialist

Historic paint schemes

KOKO THEATRE

An examination of the historical paint schemes

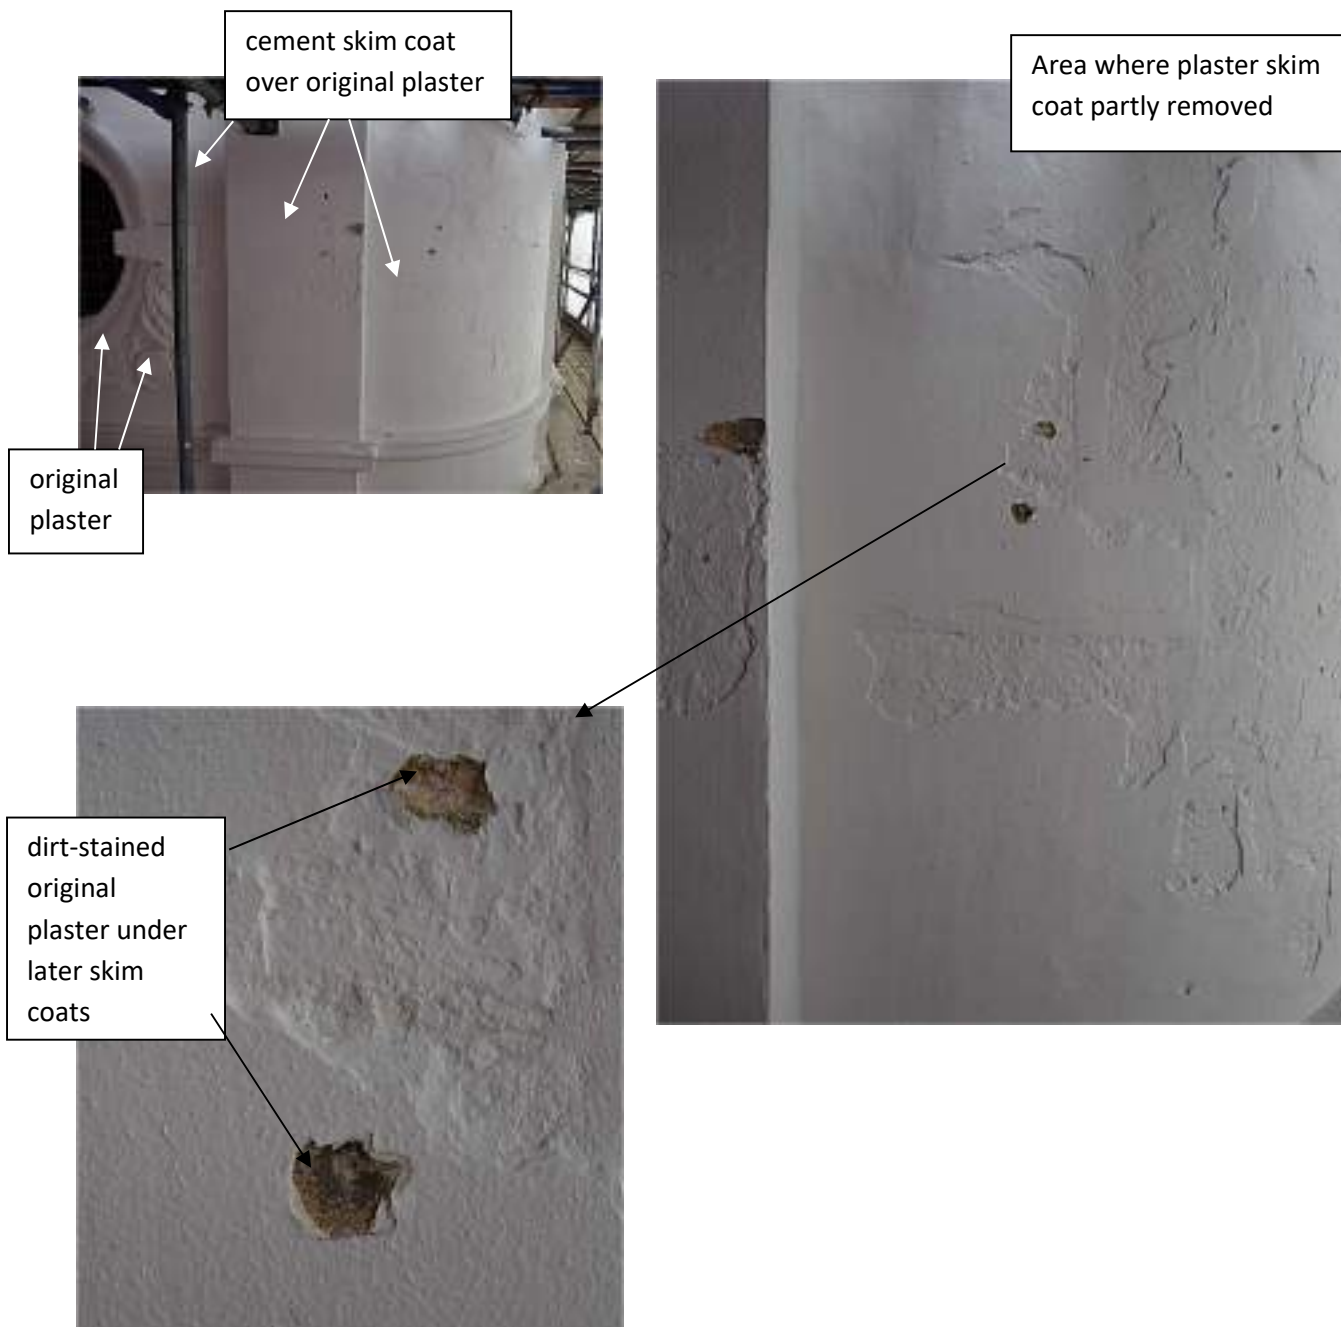
On the SW corner of the building, attempts appear to have been made to remove this coating.

The penultimate time the building was decorated a white plaster skim coat was applied to flat parts of the walls.

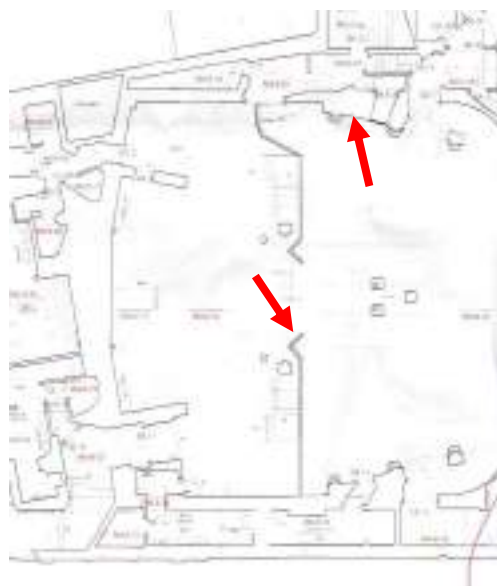
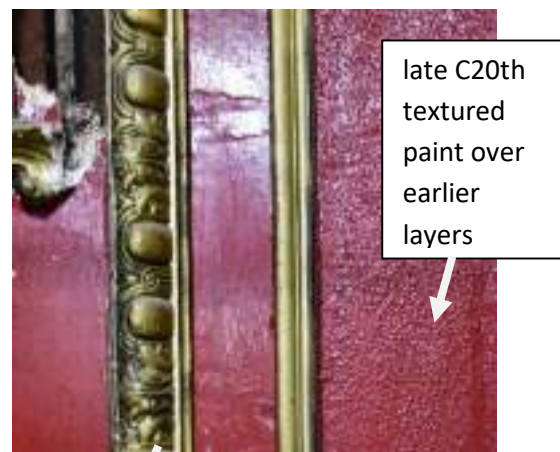
BASEMENT AREA - ROOM B.16

This area was painted less often than the circulation areas.

Lead paint Found on the walls and the figures set against the walls.
Not found on the suspended ceiling above the stage or the figure in front of the stage.

Towards the end of the twentieth century a textured alkyd paint was applied to the centre of the wall panels.

Most recent red paint The red seen today on the walls is not a standard house paint. It is still flexible, with a rubbery texture and is unaffected by a range of solvents.

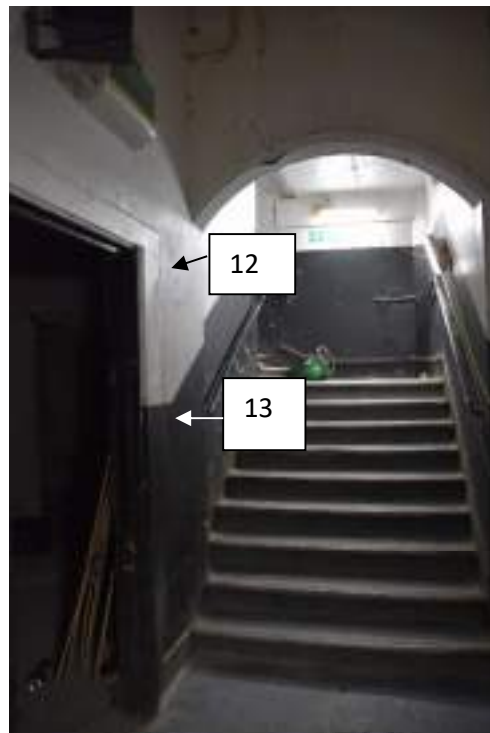
SOUTH STAIRS
BASEMENT TO GROUND FLOOR
B-18

Two samples were taken from the north wall: one above the painted dado and one on the painted dado

Lead paint	Present in both samples
Original paint	Red distemper.
Early C20th paints	Three lots of oil paint based on lead white .
Later C20th paints	Six lots of alkyd paint some based on lithopone white, some on titanium dioxide white.
Most recent paints	Two lots of emulsion paint

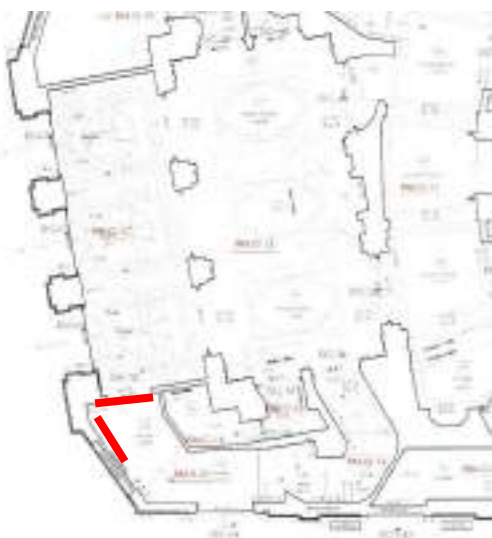
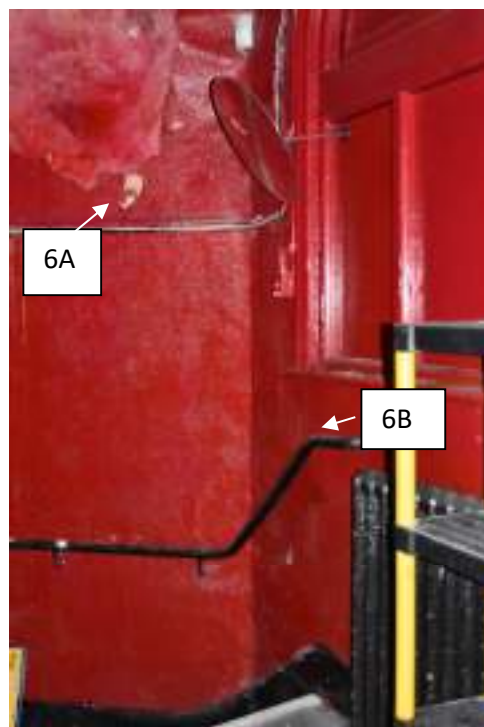
SOUTH STAIRS - BASEMENT TO GROUND FLOOR ROOM B.22

Only two samples were taken, one from the south wall, one from the west wall.

Lead paint	Present on the walls, sealed under the later plaster skim coat.
Original paint	Coat of distemper which may have been a temporary scheme, followed by pink, lead-based oil paint on the walls. Treatment of ceiling unknown
Early C20th paints	Two lots of oil paint based on lead white.
Later C20th Paints	Four lots of alkyd paint , including one with a textured finish.
Later C20th re-plastering	A skim coat of gypsum plaster was applied over early paint layers at some point in the late C20th. Since then the area has been painted twice.

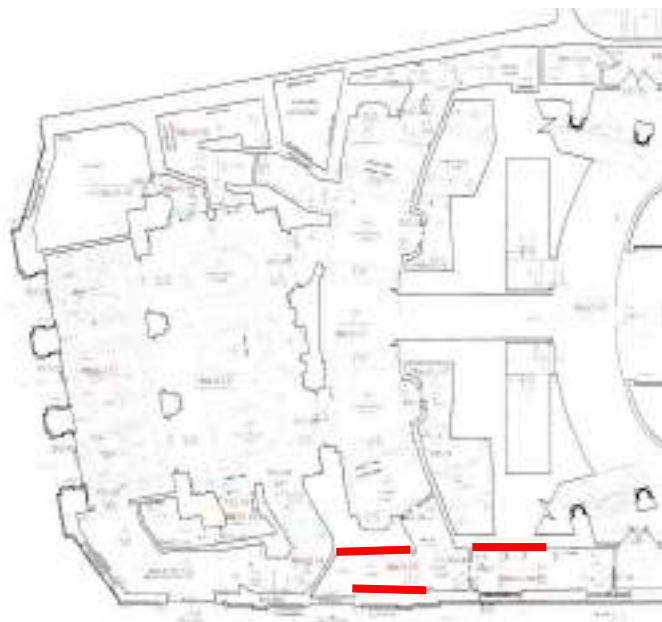
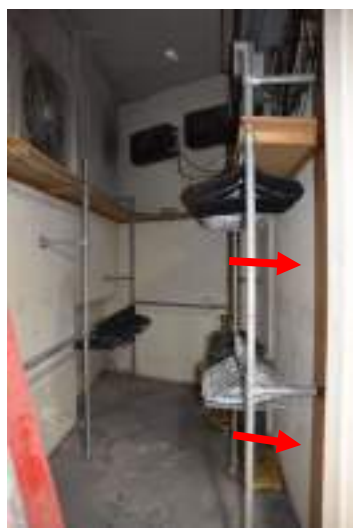
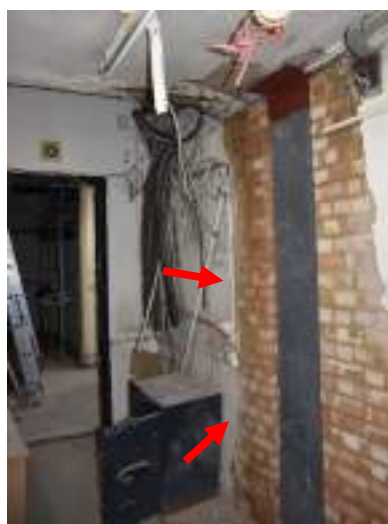
GROUND FLOOR – SOUTH ROOMS G08 & G09

Samples were taken from the north wall of both rooms

Lead paint	Present on the walls of both rooms
Original paint	Cream coloured oil paint based on lead white
Early C20th schemes	Two more lead-based oil paints
Later C20th schemes	Alkyd paints based on titanium white, including the textured paint used throughout Koko
Most recent paints	Three lots of emulsion paint

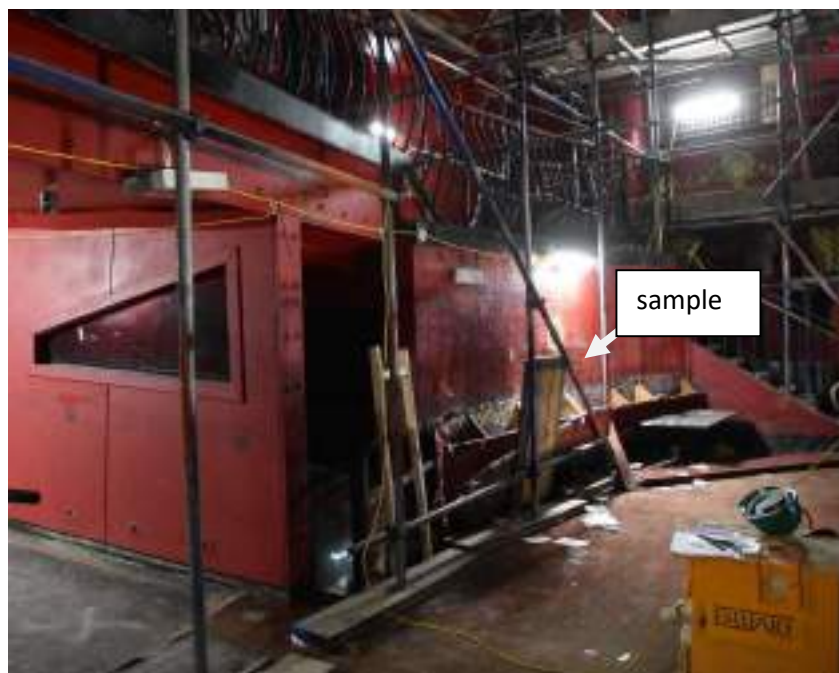
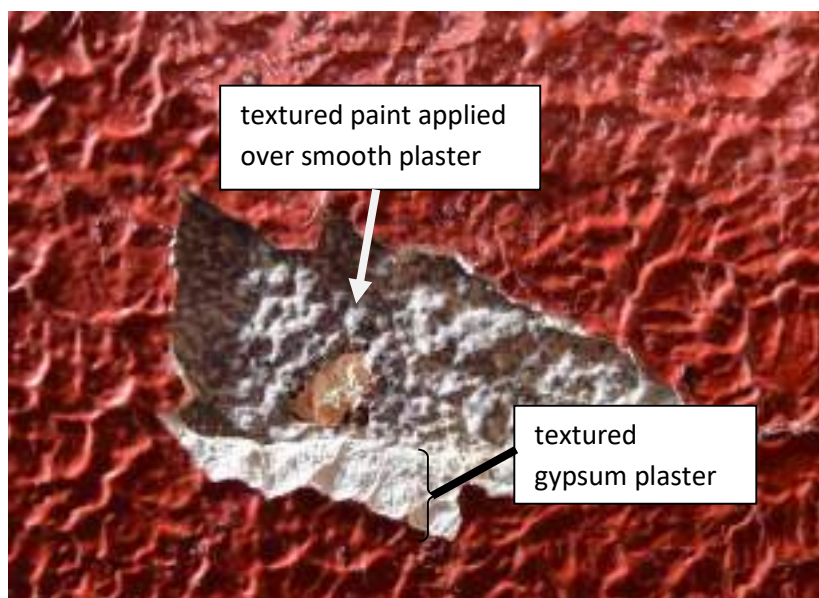
GROUND FLOOR BALCONY G10

The walls in this area have all been recently re-plastered, or faced with hardboard, so no early paints have survived.

One sample was taken from the west wall, where the wall has a textured finish. Underneath the most recent paints, which were applied over textured plaster, is an earlier textured alkyd paint applied over smooth gypsum plaster.

No lead paint in G10

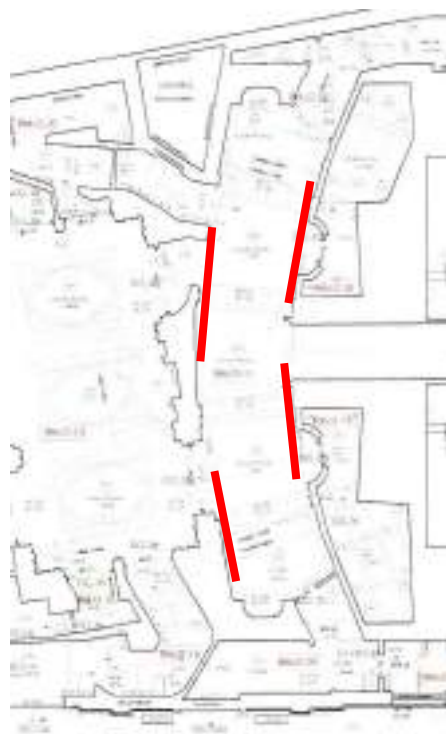
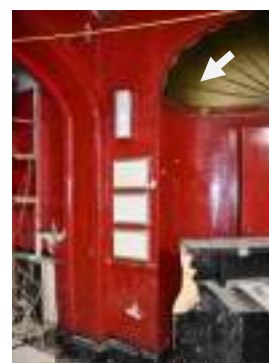
GROUND FLOOR – LOBBY BETWEEN ENTRANCE & AUDITORIUM ROOM G.11

Samples were taken from west and east walls, as listed on the next page. The ceiling was not examined.

No original paint was found in the samples from the walls and it is likely that lining paper was used, and that when this was removed in the later C20th the early paints were all lost.

Lead paint Present only in samples taken from gold arched tops of the niches. None on the walls or arches.

Original paint No longer present on the plaster walls.

Early C20th paints No longer present

Most recent paint. The red seen today on the walls is not a standard house paint. It is still flexible, with a rubbery texture and is unaffected by a range of solvents

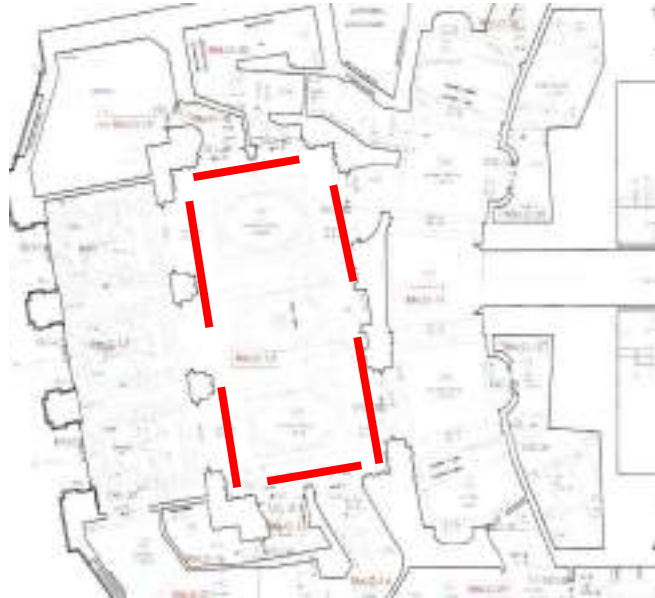
GROUND FLOOR MAIN ENTRANCE ROOM G.13

This room has never been stripped or re-plastered, and the early paint schemes are present on all surfaces.

Lead paint	Present on the ceiling and on the plaster walls. At least five layers of lead paint.
Original paint	Cream oil paint on ceiling, buff oil paint on walls, and mouldings picked out in gold leaf, using an oil size.
Early C20th paints	Four lots of oil paint based on lead white . The original oil gilding now covered with 'gold' paint in a shellac medium.
Later C20th paints	Three lots of alkyd paint based on titanium dioxide white. 'Gold' paint in a shellac medium used on mouldings

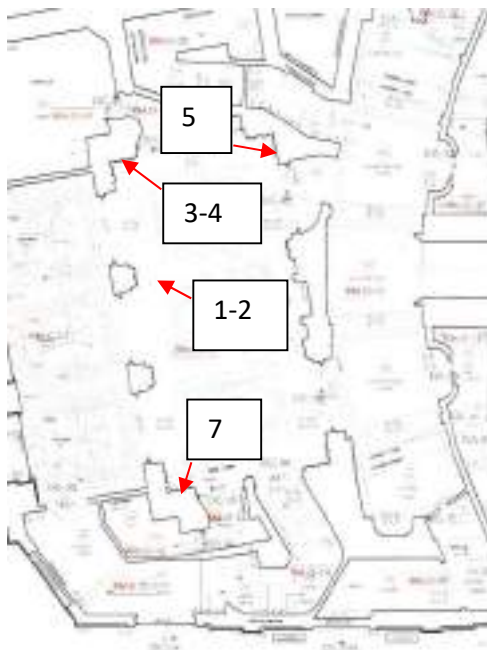
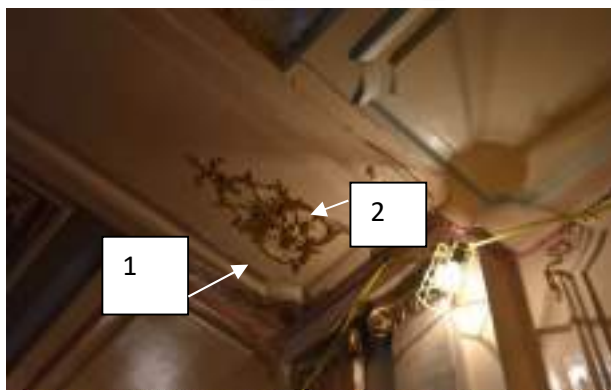
LOCATION OF SAMPLES

- 1 Ceiling cream on flat area
- 2 gold moulding

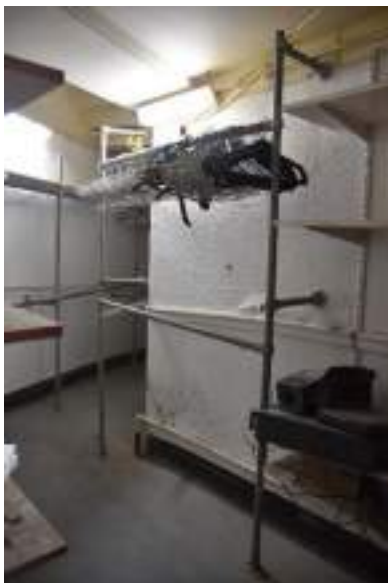
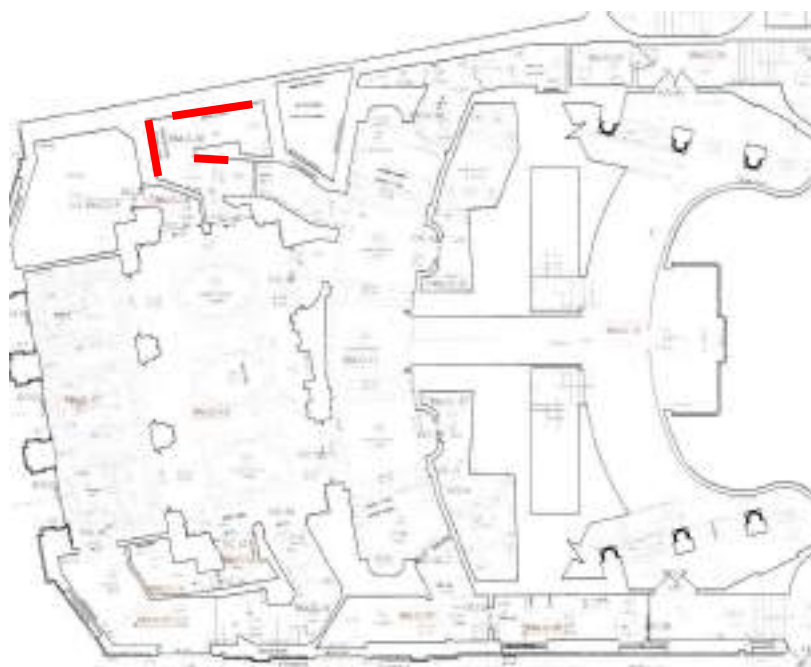
GROUND FLOOR – G20

The room appears to have been re-plastered at some point in the later C20th and no early paints were found.

Lead paints	none present
Original scheme	no longer present
Early C20th schemes	no longer present
Later C20th schemes	alkyd paints based on titanium white
Most recent paint	white emulsion

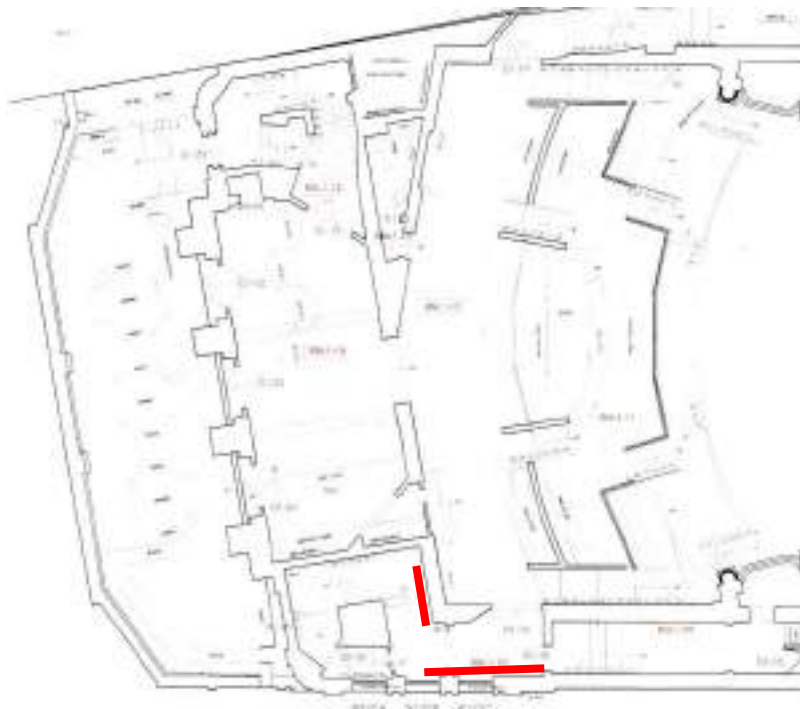
FIRST FLOOR
SOUTH STAIRS LANDING
ROOM 1.10

Samples were taken from the south wall of the landing and the east wall of the stairs leading down.

| Early C20th schemes | The original scheme repeated four times using lead-based oil paints. |
| Later C20th schemes | <p>The windows on the south wall were blocked up using gypsum plaster, and then a textured paint was applied to all walls.</p> <p>Since then the area has been painted four more times with alkyd paints.</p> |

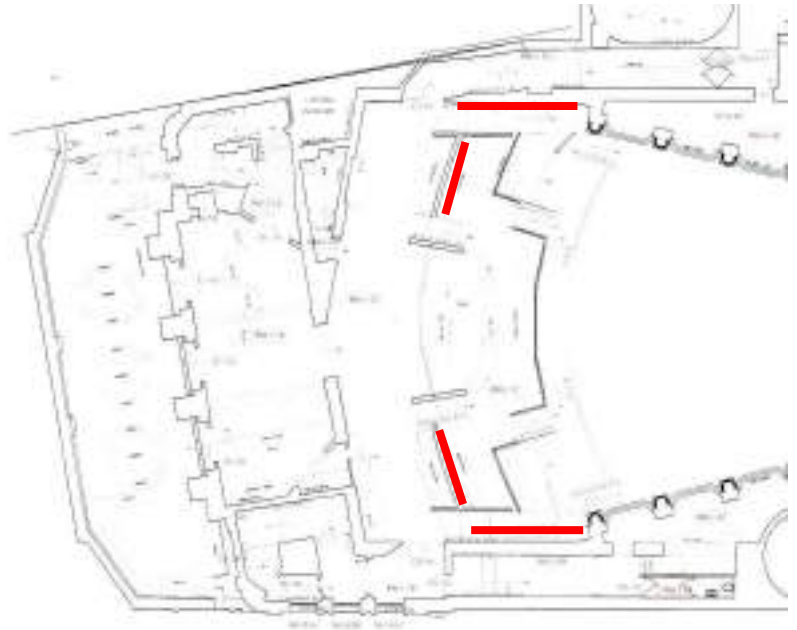
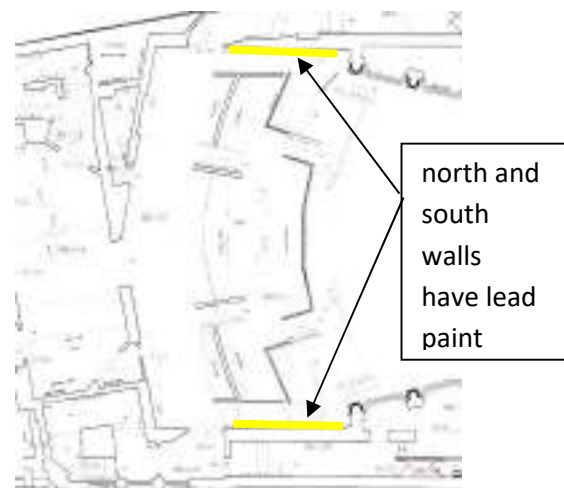
FIRST FLOOR BALCONY ROOM 1.11

This is only present on the front of the second floor balcony and on the north and south walls

N & S walls painted with red distemper
Balcony front painted with cream oil paint topped with a yellow glaze.

Four lots of lead-based oil paint found on the balcony front and north and south walls

The red seen today is not a standard house paint. It is still flexible, with a rubbery texture, and is unaffected by a range of solvents

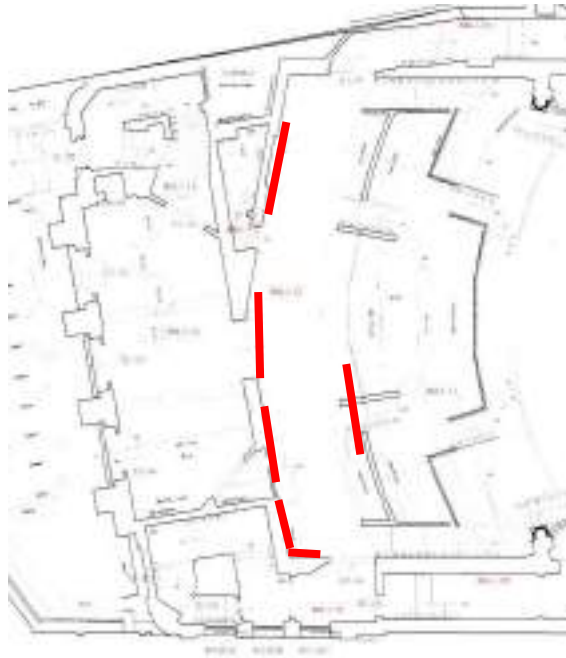
FIRST FLOOR – LOBBY AT BACK OF AUDITORIUM ROOM 1.12

Lead paint	Present in all samples from walls and ceilings.
Original paint	A cream coloured oil paint with red and yellow oil glazes on the surface.
Early C20th paints	Two lots of oil paint, one with a glazed surface.
Later C20th paints	Four lots of alkyd paint. On the last two occasions the mouldings have been picked out in 'gold' paint consisting of copper filings in a shellac medium.
Most recent scheme	The red seen today on walls, ceiling and joinery is not a standard house paint. It is still flexible, with a rubbery texture, and is unaffected by a range of solvents

The only feature which did not have original paint layers was the moulding between the cove and the ceiling

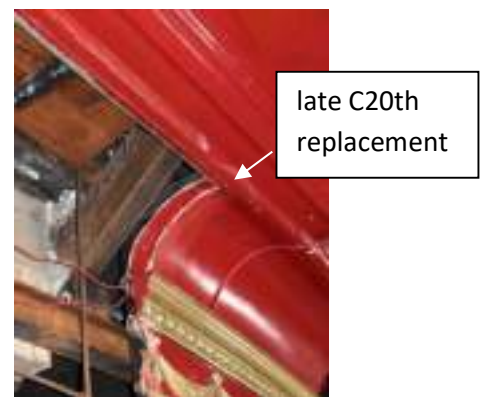
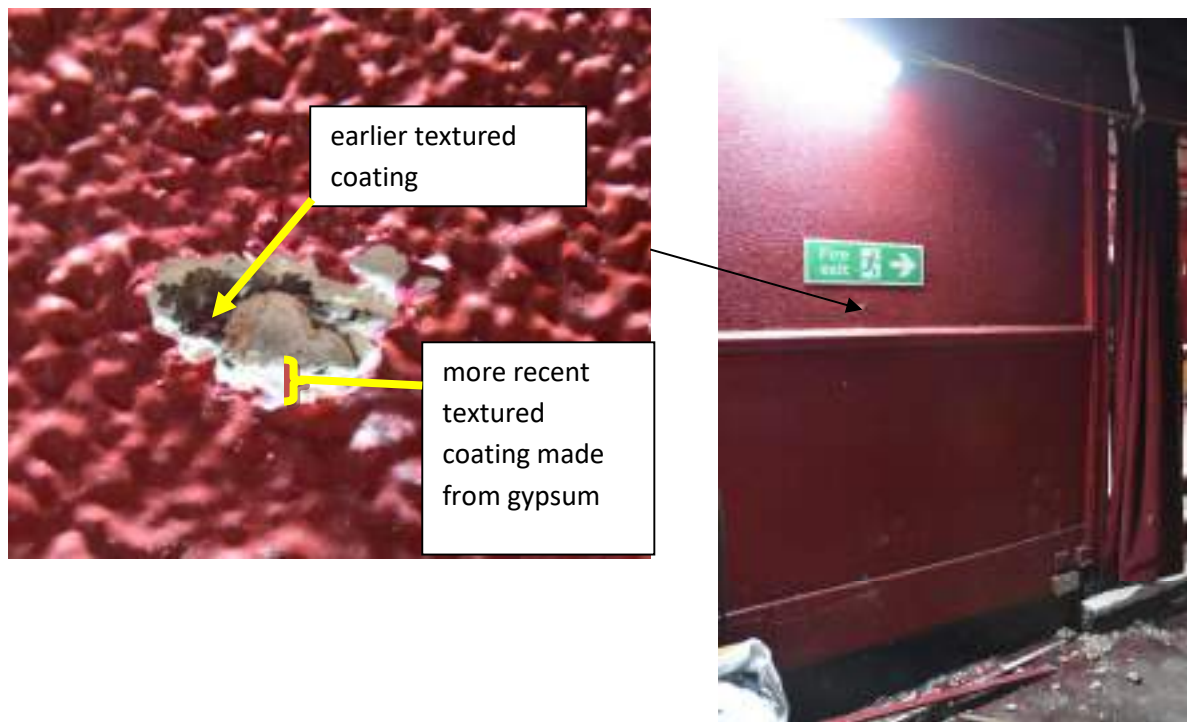
Like many rooms in Koko, the walls have been given a textured finish in the later C20th, but in this room two lots of textured coating were applied.

The first textured coating was the one applied throughout the building, involving a paint mixed with small granules.

The second textured coating, which was only applied in this room and in G.10 on the floor below, followed structural work. The texture was created with gypsum plaster

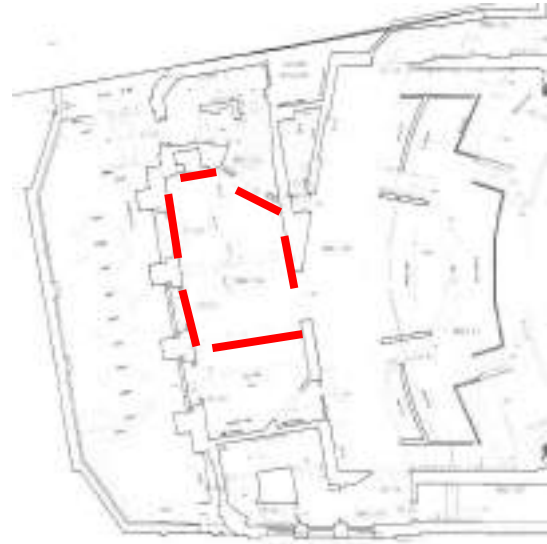
FIRST FLOOR – ROOM 1.14

Lead paint	Present on all surfaces – walls, ceiling and joinery.
Original paint	The original paint scheme is still present on all surfaces under layer layers. The 1900 decoration involved cream coloured oil paint on the plaster walls and ceilings. Brown varnish was used on all the joinery.
Early C20th paints	Five lots of oil paint based on lead white
Later C20th paints	Six lots of alkyd paint most based on titanium dioxide white.
Most recent paint	The red seen today on walls, ceiling and joinery is not a standard house paint. It is still flexible, with a rubbery texture and is unaffected by a range of solvents.

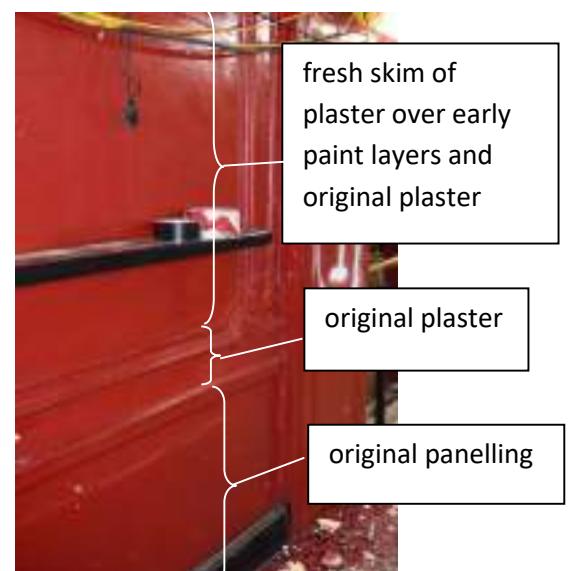
The wall panels above the dado were given a fresh coat of gypsum plaster. This sealed in all the earlier paint layers.

On top of that fresh plaster are just sets of paint layers.

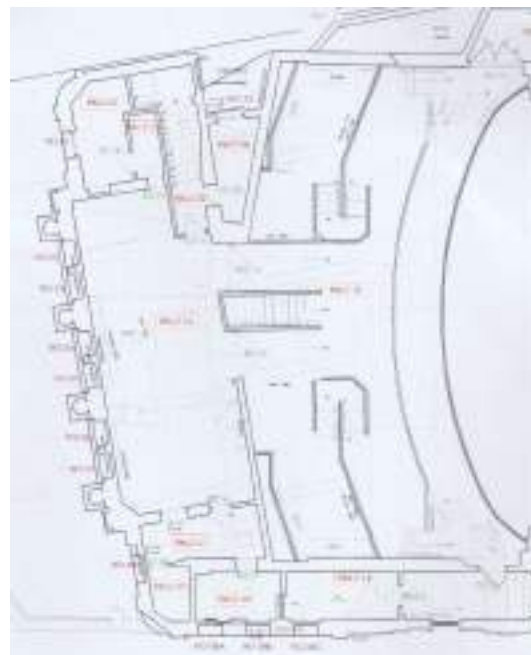
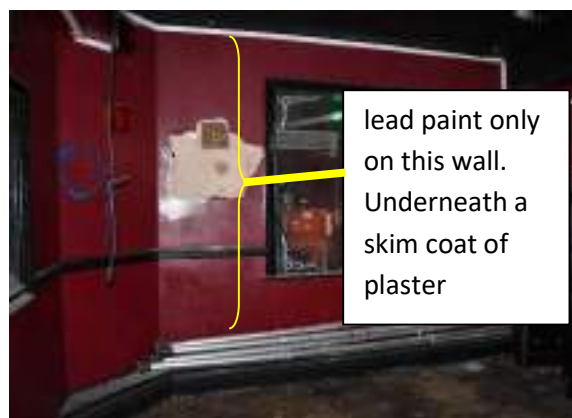
SECOND FLOOR BAR ROOM 2.16

Present only on the west wall, at the south end. There is no lead paint on the ceiling which has been re-plastered, or on the woodwork, which has been recently stripped.

White distemper, followed by cream-coloured oil paint on the walls.

Wallpaper or lining was used at some point in the early years. The paper has gone, but a thick layer of glue was found over the first oil paint. The paper was later removed and the repainted with oil paints.

At some point in the recent past the whole room was almost completely re-plastered. A small patch of original plaster survived on the west wall, as shown above. This patch was covered over with a skim coat of the new plaster.

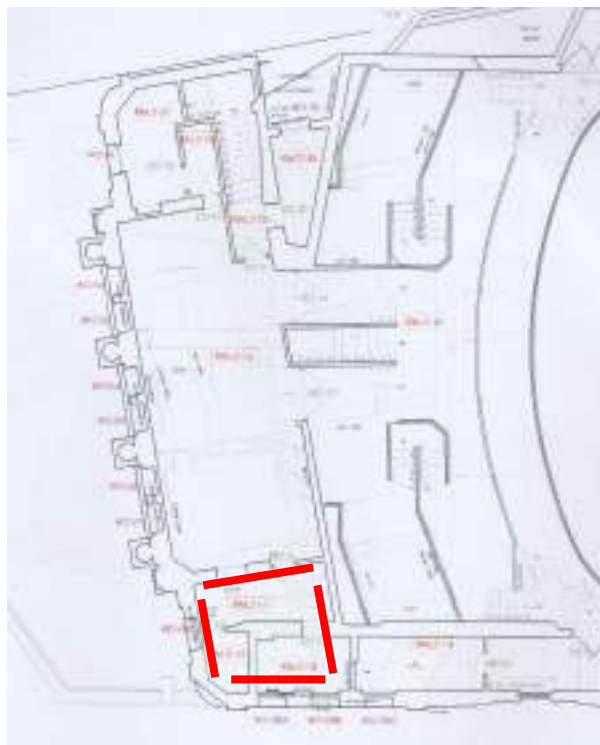
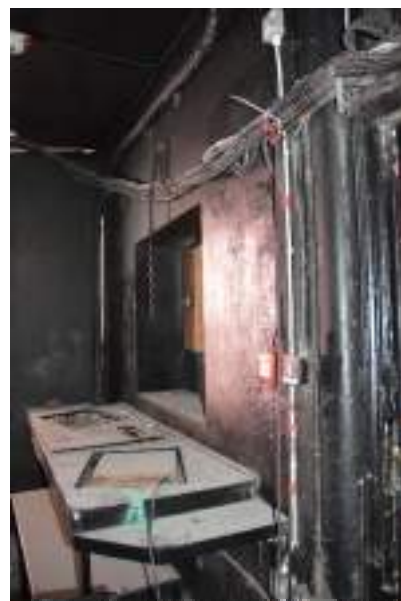
ROOMS SOUTH OF THE BAR
ROOMS 2.17, 2.18 & 2.19

Lead paint	Present on the walls of 2.17 and 2.19 Not present in 2.18
Original scheme	dark brown oil paint on all surfaces
Early C20th schemes	four lots of oil paint
Late C20th schemes	Three lots of emulsion paints followed by alkyd paints with a gloss finish.

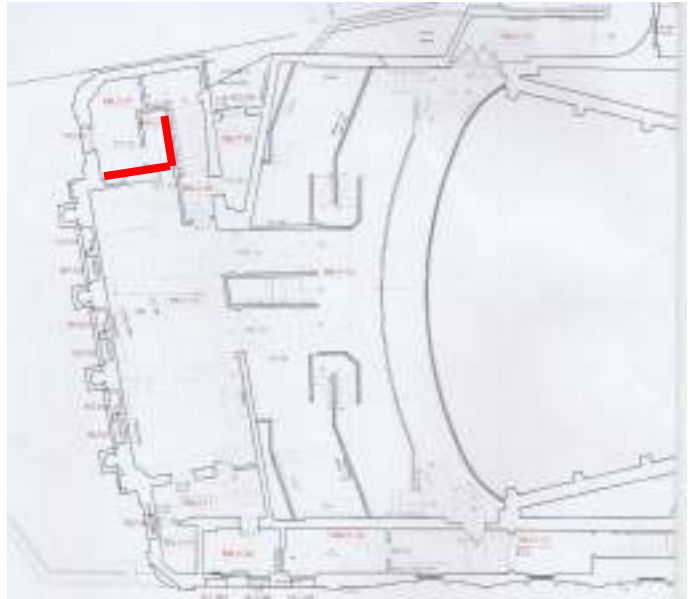
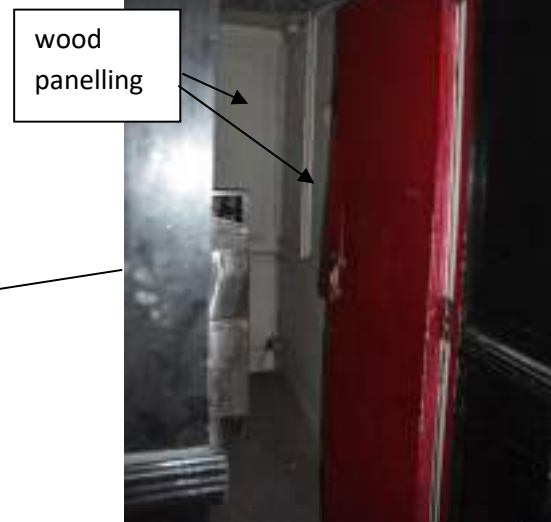
ROOMS NORTH OF THE BAR ROOMS 2.20 & 2.21

This area was probably originally a single room. The NS partition which divides it dates to the later C20th.

The walls of the room are lined with the original
wood panelling.

The room has been painted very infrequently compared to other rooms in Koko.

Lead paint	Present on the panelled walls
Original decoration	white, lead-based oil paint. This remained in place until the middle of the century.
Later decorations	In the later C20th the room was painted four times with alkyd paints

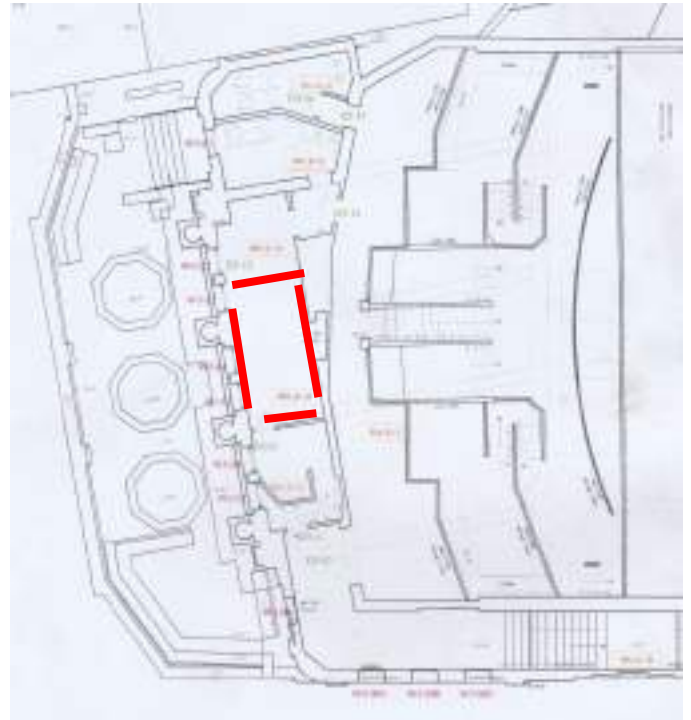
THIRD FLOOR –
PROJECTION ROOM
ROOM 3.13

Original lime plaster and earliest paint layers were found only on the west and east walls. The north and south partitions, which are coated in gypsum plaster, must have been built when the theatre became a cinema,

Lead paint	Present on the west, north and east walls, and on the ceiling, but not on the south wall or any of the woodwork.
Original paint	Red distemper on the walls, white distemper on the ceiling. Original paint found only on the west and east walls.
Early C20th paints	Painted with black oil paint in 1913 when the room became a projection room, then the walls and the ceiling were painted a further six times with lead based oil paints . One of these oil paint schemes was varnished.
Later C20th paints	Wall and ceiling painted twice with alkyd paints.
Most recent paint	Pale green emulsion paint on the walls, and white emulsion paint on the ceiling.

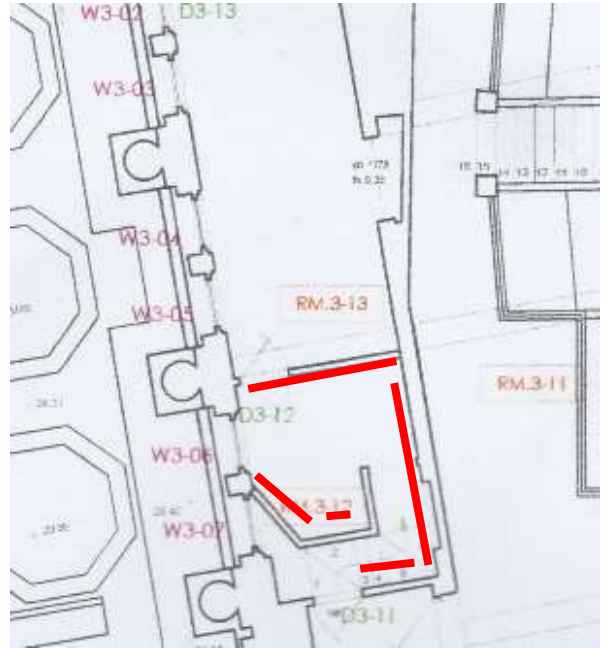
THIRD FLOOR
 LOBBY SOUTH OF PROJECTION
 ROOM - ROOM 3.12

Lead paint Found only on the south and east walls of the lobby and on a patch of older plaster on the south wall of the stairs.

Late C20th plastering The north wall of the Lobby and the south walls of the Lobby and Stairs have been recently re-plastered.

On the south wall of the Stairs this plaster was applied over a patch of original plaster and early paints.

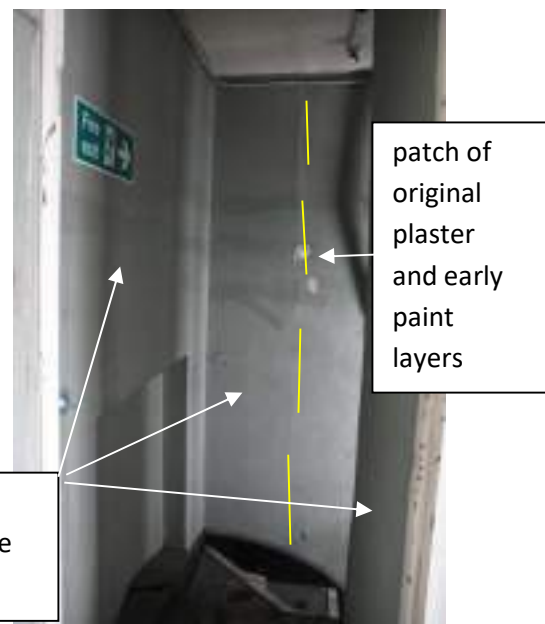
Late C20th gypsum plaster and just three lots of alkyd paints

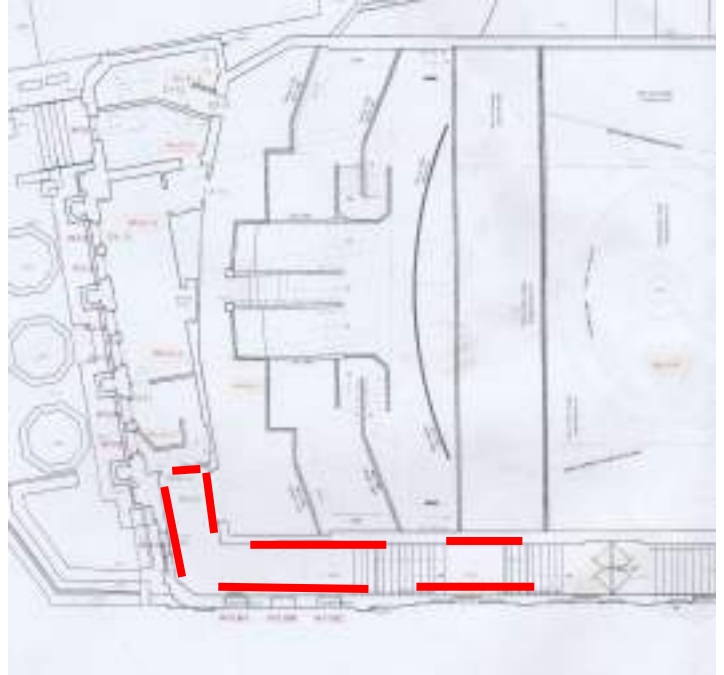
SOUTH STAIRS – THIRD FLOOR ROOM 3.10

Lead paint	Present in all samples from walls and woodwork. Not present on the ceilings which have been recently been re-plastered.
Original paint	A red soft distemper was used from floor to ceiling on the walls. The paint was applied directly to the bricks. Brown oil paints were used on the woodwork and iron window grilles
Early C20th paints	Distempers initially continued to be used, but then there was a switch to oil paints, and up to six lots of oil paint were used on the walls.
Later C20th paints	Three lots of alkyd paint and one emulsion paint
Most recent paint	Emulsion paint

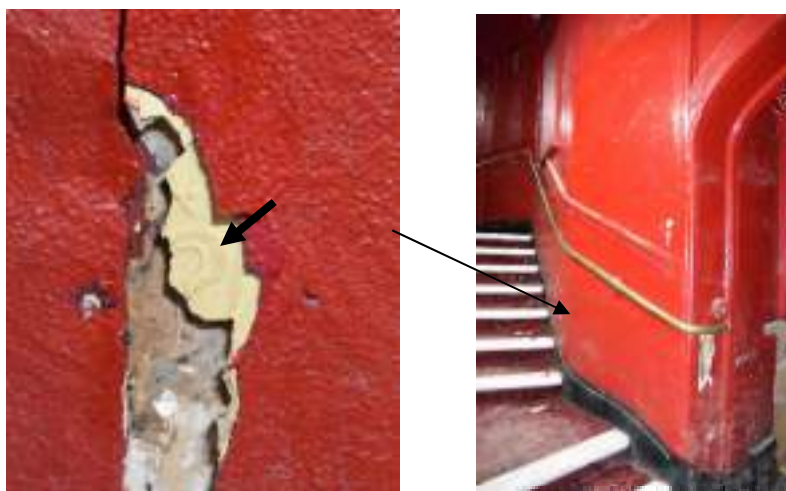
Lead paint	Found in samples from the ceiling of the second floor landing and in a few samples taken from the walls between ground and first and between first and second.
Original paint	white distemper on the ceiling, and red distemper on the walls
Early C20th paints	Embossed wallpaper with cream-coloured oil paint on the surface was used for the walls below the dado rail. Some has survived, at ground floor level, but elsewhere it appears to have all been removed.

The paper was re-painted twice with lead-based oil paints

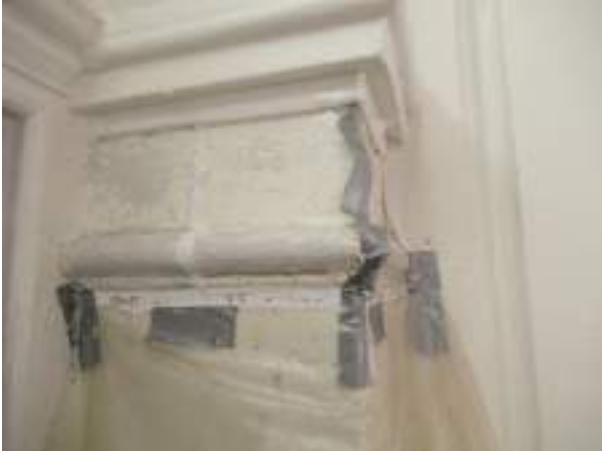
<p>Following a dwell time of overnight Products removed by hand scraping and hot water spray. Revealed underlying decorators filling over previous paint applications.</p> <p>Products have softened paint, however, ineffective without the use of superheated steam to aid removal.</p>
2	Tavec 201	Pre application

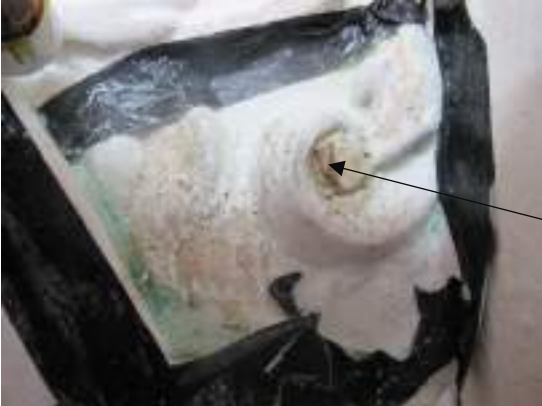
<p>Dwell time overnight. Existing paint was softened to some degree. Difficulty in removing by hand due to underlying paint coats. Superheated steam required to make removal more effective. Partial paint removal revealed underlying substrate to be "roman cement" stucco.</p>
3	Kling strip	1

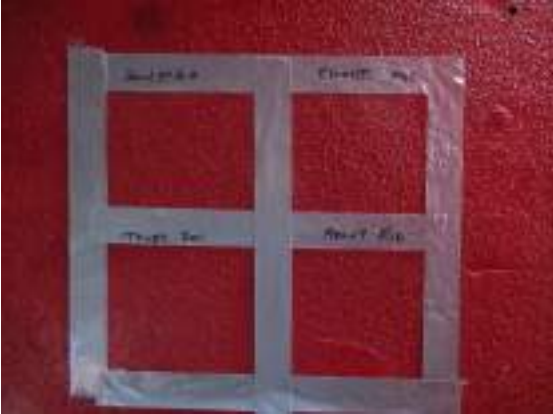
<p>Dwell time overnight. All products easily removed upper layers. Solvistrip and Tavec 201 loosened underlying cream paint coat sufficiently to scrape off by hand. Conclusion- Tavec 201 or Solvistrip the most suitable products</p>

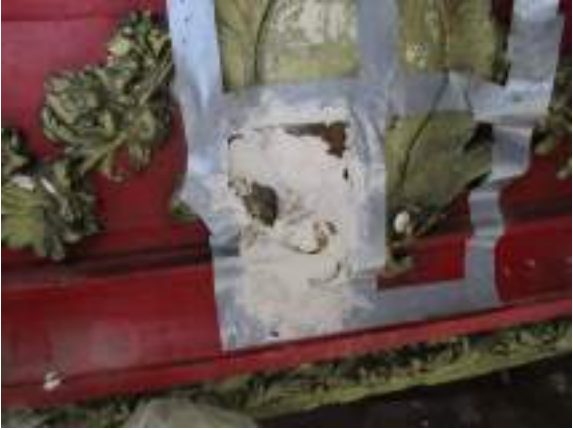
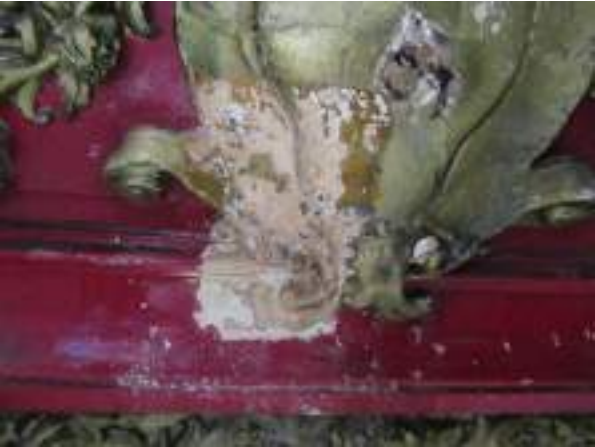
<p>Kling strip easily applied over moulded areas and thickness built up allows for better penetration of paint layers.</p> <p>Following 1st application some residue was visible, however appeared to breakdown the gold paint quite well</p>

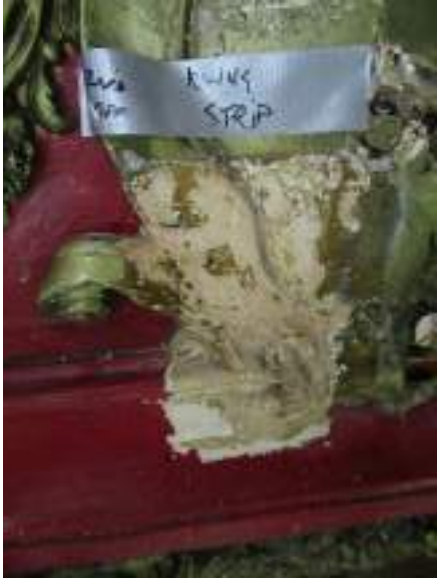
<p>Dwell time 3 hours 2nd application removed slightly more base coat revealing some of the finer details of the mouldings</p>
6	Solvistrip Remmers Age Tavec 201 Paint Rid	1 st application

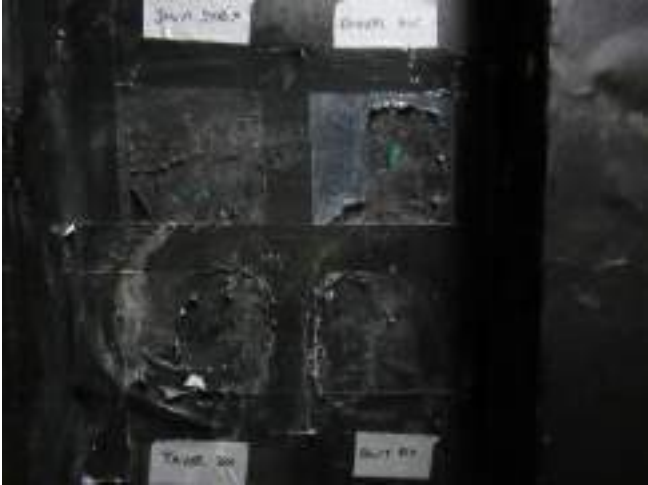
<p>All product had little effect upon the paint layers.</p> <p>Top coat appears to be rubbery consistency which was softened by all products, however, it was impossible to remove with hand scrapers and hot water spray. Tavec 201 possibly had more effect than other products.</p> <p>Conclusion. Superheated steam required for this surface.</p>
7	Solvstrip Tavec 201 Remmers Age Paint Rid	During 1 st application

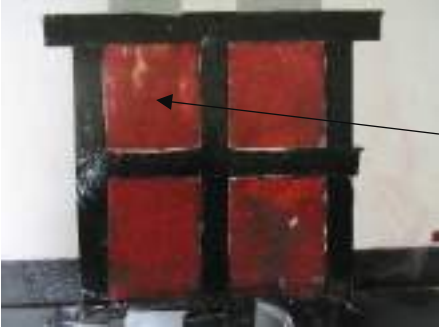
<p>Dwell time 2 hours.</p> <p>Further layer removed to a slightly lighter base coat. Solvistrip appeared to be the most effective.</p>
