Asbestos Survey Report

ASBESTOS SURVEY
REPORT NO: A-44387 – ISSUE 6

DATE ISSUED: 06/08/2020

Site Address:
KoKo Night Club
Heritage Areas Survey
1A Camden High St
London
NW1 7JE

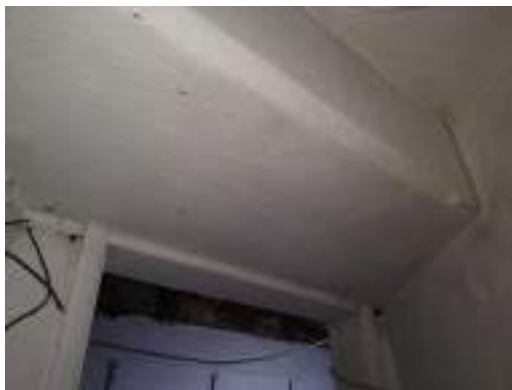
Inspection no:	S001	Type:	Sampled
Room/Area	Basement. RM.B-19 [001]		
Location/Element	Paint to walls and ceiling		
Notes			
Product Type	N/A	Score:	N/A
Damage/Deterioration	N/A	Score:	N/A
Surface Treatment	N/A	Score:	N/A
Asbestos Type	NAD	Score:	N/A
Extent	5 m ²		
Recommended Action	N/A	Total Score	0

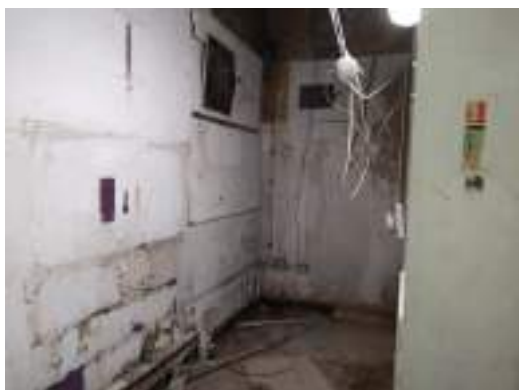
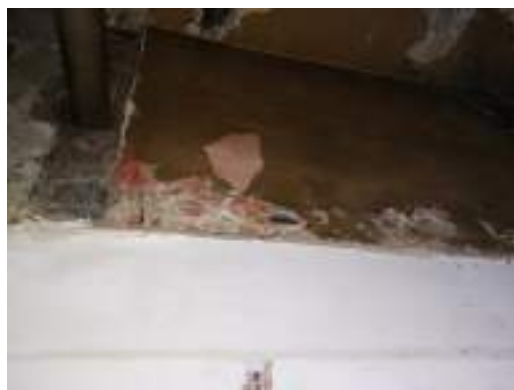
Inspection no:	S232	Type:	Sampled
Room/Area	Basement. RM.B-19 [001]		
Location/Element	Textured coating to walls under paint		
Notes			
Product Type	Textured Coating	Score:	1
Damage/Deterioration	Low Damage	Score:	1
Surface Treatment	Sealed	Score:	1
Asbestos Type	Chrysotile	Score:	1
Extent	20 m ²		
Recommended Action	Remove	Total Score	4

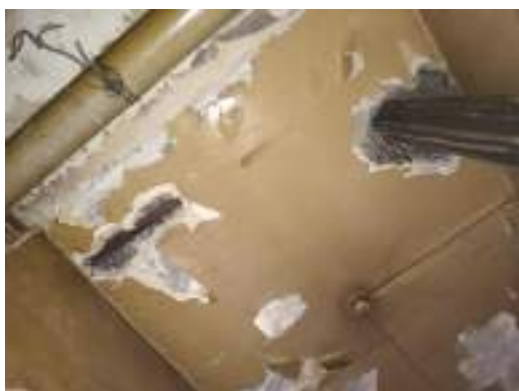
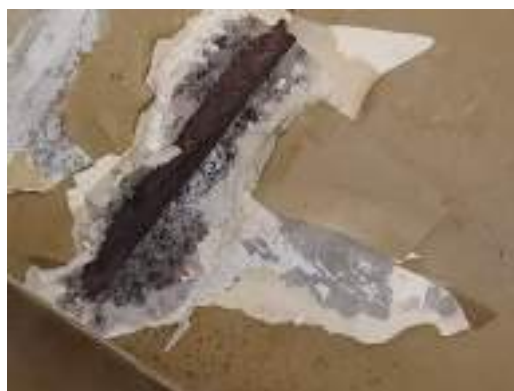
Inspection no:	S234	Type:	Sampled
Room/Area	Basement. RM.B-19 [001]		
Location/Element	Textured coating to ceiling under paint		
Notes			
Product Type	Textured Coating	Score:	1
Damage/Deterioration	Low Damage	Score:	1
Surface Treatment	Sealed	Score:	1
Asbestos Type	Chrysotile	Score:	1
Extent	10 m ²		
Recommended Action	Remove	Total Score	4

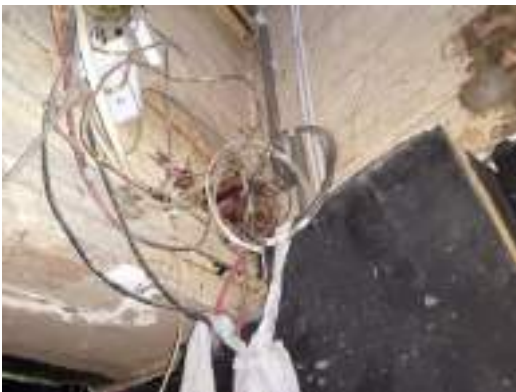
Inspection no:	S002	Type:	Sampled
Room/Area	Basement. RM.B-33 [002]		
Location/Element	Debris where pipes pass through wall		
Notes			
Product Type	N/A	Score:	N/A
Damage/Deterioration	N/A	Score:	N/A
Surface Treatment	N/A	Score:	N/A
Asbestos Type	NAD	Score:	N/A
Extent	0.1 m ²		
Recommended Action	N/A	Total Score	0

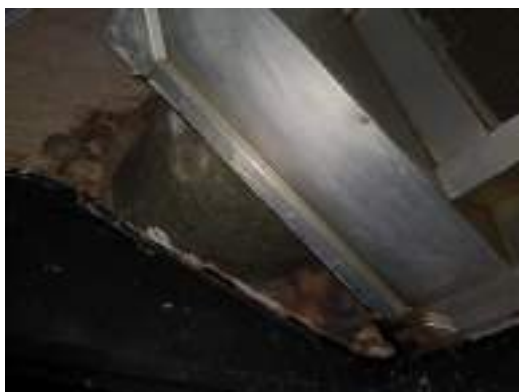
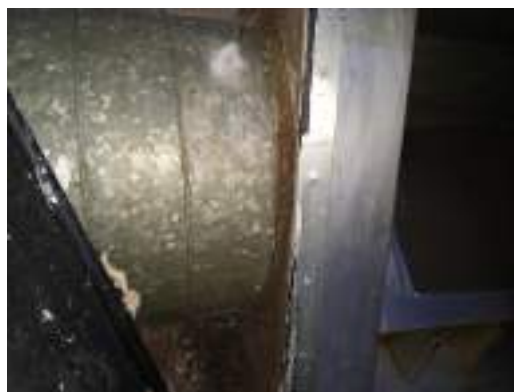
Inspection no:	S003	Type:	Sampled
Room/Area	Basement. RM.B-33 [002]		
Location/Element	Beige mastic to ductwork		
Notes			
Product Type	N/A	Score:	N/A
Damage/Deterioration	N/A	Score:	N/A
Surface Treatment	N/A	Score:	N/A
Asbestos Type	NAD	Score:	N/A
Extent	0.1 lin m		
Recommended Action	N/A	Total Score	0

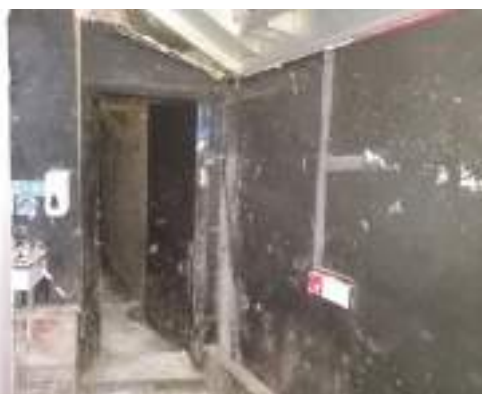
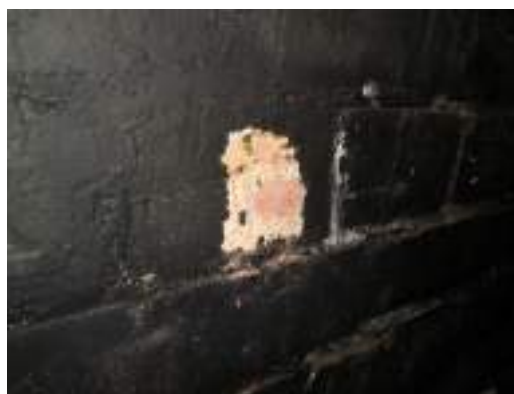
Inspection no:	S225	Type:	Sampled
Room/Area	Basement. RM.B-33 [002]		
Location/Element	Paint to walls		
Notes			
Product Type	N/A	Score:	N/A
Damage/Deterioration	N/A	Score:	N/A
Surface Treatment	N/A	Score:	N/A
Asbestos Type	NAD	Score:	N/A
Extent	12 m ²		
Recommended Action	N/A	Total Score	0

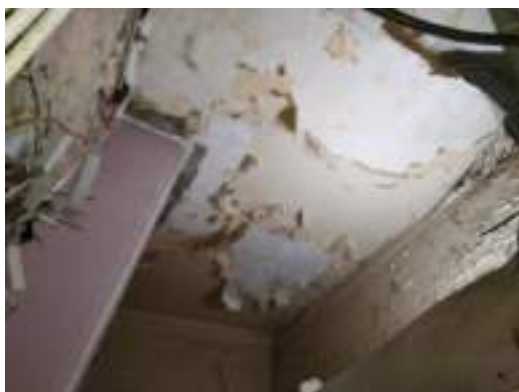
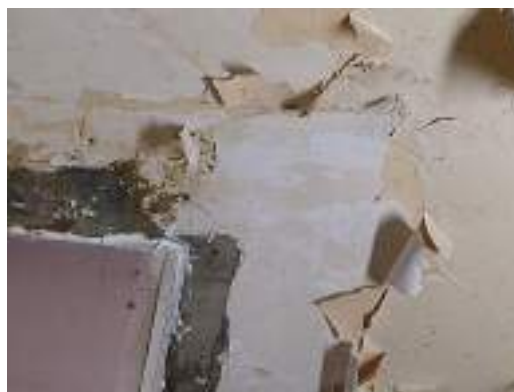
Inspection no:	S226	Type:	Sampled
Room/Area	Basement. RM.B-33 [002]		
Location/Element	Paint to ceiling		
Notes			
Product Type	N/A	Score:	N/A
Damage/Deterioration	N/A	Score:	N/A
Surface Treatment	N/A	Score:	N/A
Asbestos Type	NAD	Score:	N/A
Extent	5 m ²		
Recommended Action	N/A	Total Score	0

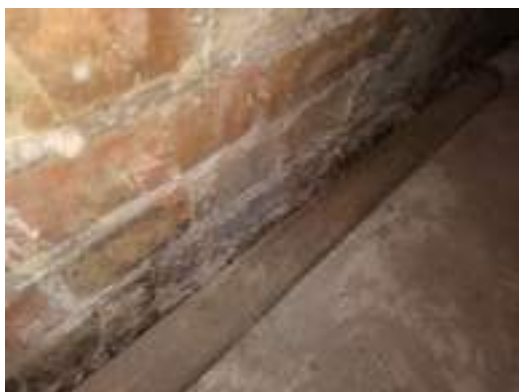
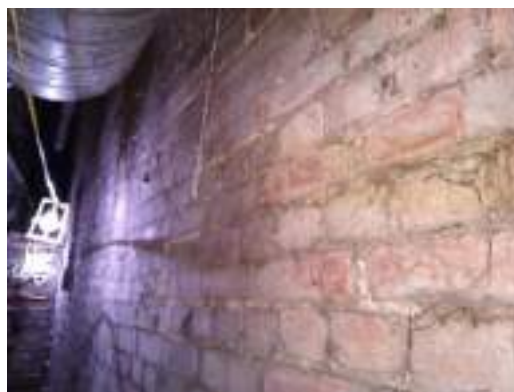
Inspection no:	S011	Type:	Sampled
Room/Area	Basement. RM.B-34 [003]		
Location/Element	Residue to walls		
Notes			
Product Type	N/A	Score:	N/A
Damage/Deterioration	N/A	Score:	N/A
Surface Treatment	N/A	Score:	N/A
Asbestos Type	NAD	Score:	N/A
Extent	Throughout m ²		
Recommended Action	N/A	Total Score	0

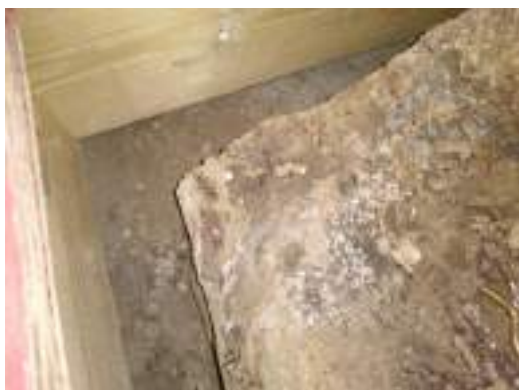
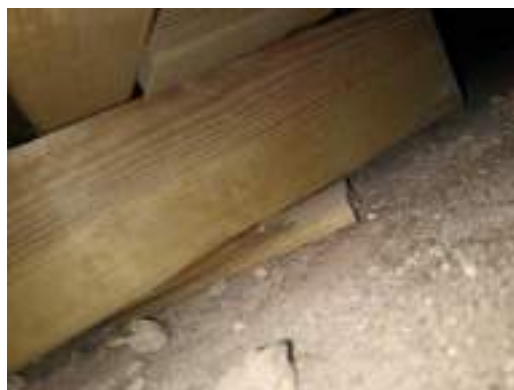
Inspection no:	S004	Type:	Sampled
Room/Area	Basement. RM.B-16-1 [004]		
Location/Element	Debris within floor void		
Notes	Quantity for targeted area of survey.		
Product Type	N/A	Score:	N/A
Damage/Deterioration	N/A	Score:	N/A
Surface Treatment	N/A	Score:	N/A
Asbestos Type	NAD	Score:	N/A
Extent	20 m ²		
Recommended Action	N/A	Total Score	0

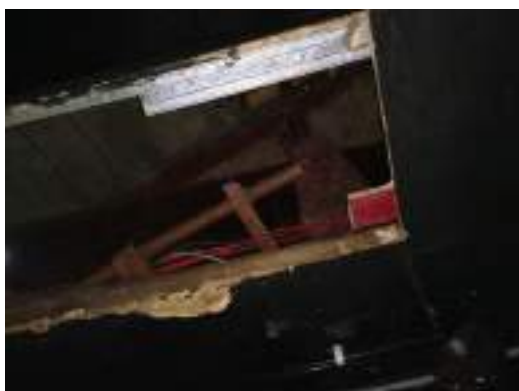
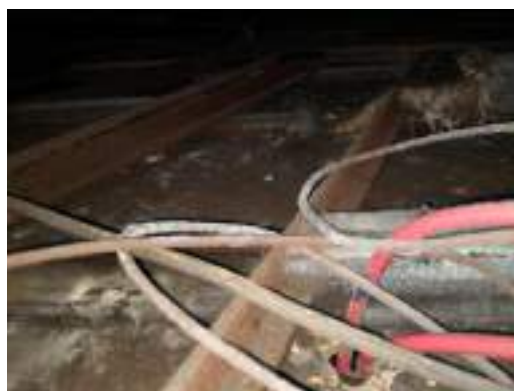
Inspection no:	S005	Type:	Sampled
Room/Area	Basement. RM.B-16-1 [004]		
Location/Element	Debris within ceiling void		
Notes	Quantity for targeted area of survey.		
Product Type	N/A	Score:	N/A
Damage/Deterioration	N/A	Score:	N/A
Surface Treatment	N/A	Score:	N/A
Asbestos Type	NAD	Score:	N/A
Extent	20 m ²		
Recommended Action	N/A	Total Score	0

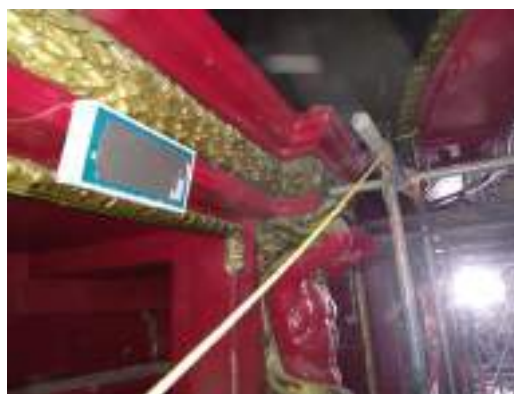
Inspection no: N015
Room/Area Basement. RM.B-16 [005]
Location/Element North side walls. Statues and covings
Notes No access behind statues and covings due to heritage.
Product Type N/A
Damage/Deterioration N/A
Surface Treatment N/A
Asbestos Type
Extent
Recommended Action N/A

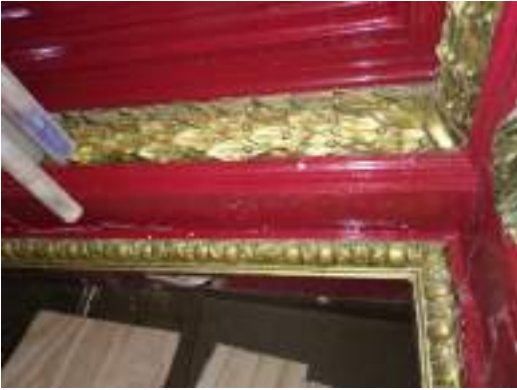
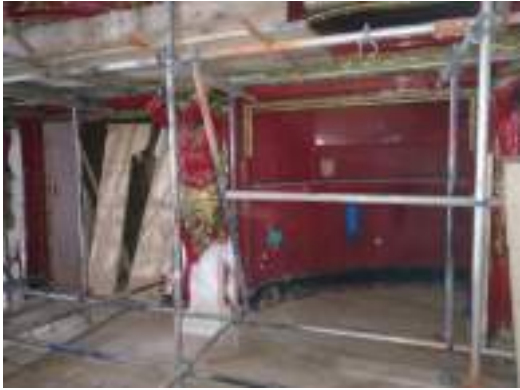
Inspection no:	N016	Type:	Inaccessible
Room/Area	Basement. RM.B-16 [005]		
Location/Element	South side walls. Statues and covings		
Notes	No access behind statues and covings due to heritage.		
Product Type	N/A	Score:	N/A
Damage/Deterioration	N/A	Score:	N/A
Surface Treatment	N/A	Score:	N/A
Asbestos Type		Score:	N/A
Extent			
Recommended Action	N/A	Total Score

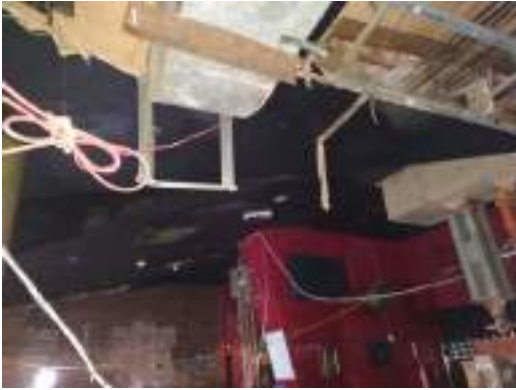
Inspection no:	R006	Type:	Referred Sample
Room/Area	Basement. RM.B-16 [005]		
Location/Element	Insulating board within ceiling		
Notes			
Product Type	Insulating Board	Score:	2
Damage/Deterioration	High Damage	Score:	3
Surface Treatment	Partially Unsealed	Score:	2
Asbestos Type	Amosite	Score:	2
Extent	50 m ²		
Recommended Action	Remove	Total Score	9

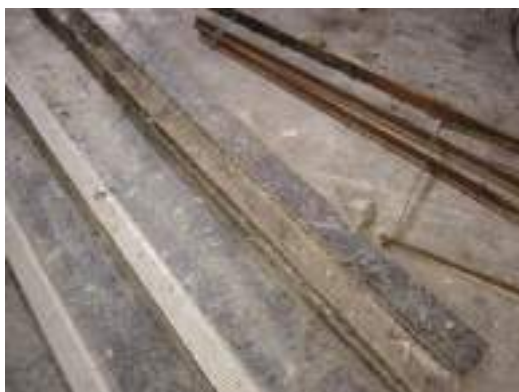
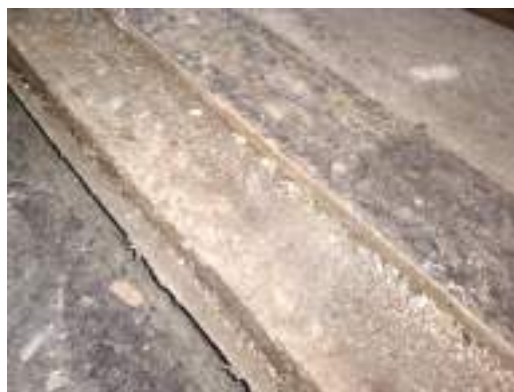
Inspection no:	S006	Type:	Sampled
Room/Area	Basement. RM.B-16 [005]		
Location/Element	Insulating board within ceiling		
Notes			
Product Type	Insulating Board	Score:	2
Damage/Deterioration	High Damage	Score:	3
Surface Treatment	Partially Unsealed	Score:	2
Asbestos Type	Amosite	Score:	2
Extent	50 m ²		
Recommended Action	Remove	Total Score	9

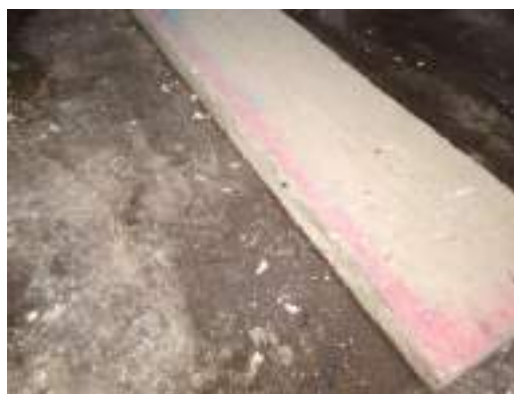
Inspection no:	S007	Type:	Sampled
Room/Area	Basement. RM.B-16 [005]		
Location/Element	Insulating board debris near stairs		
Notes			
Product Type	Insulating Board Debris	Score:	2
Damage/Deterioration	High Damage	Score:	3
Surface Treatment	Partially Unsealed	Score:	2
Asbestos Type	Amosite	Score:	2
Extent	2 m ²		
Recommended Action	Remove	Total Score	9

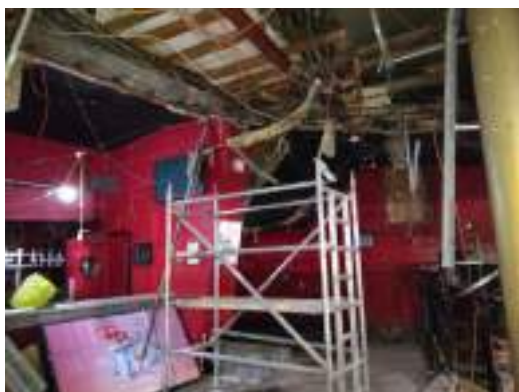
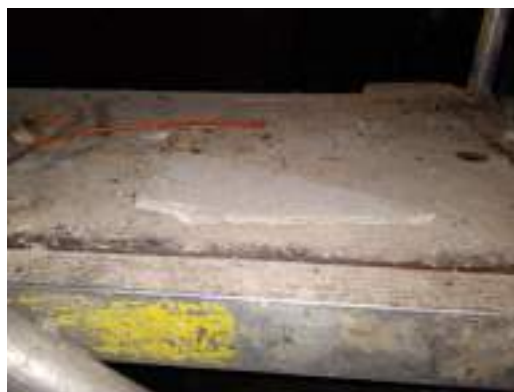
Inspection no:	S008	Type:	Sampled
Room/Area	Basement. RM.B-16 [005]		
Location/Element	Insulating board debris to floor near column		
Notes			
Product Type	Insulating Board Debris	Score:	2
Damage/Deterioration	High Damage	Score:	3
Surface Treatment	Partially Unsealed	Score:	2
Asbestos Type	Amosite	Score:	2
Extent	2 m ²		
Recommended Action	Remove	Total Score	9

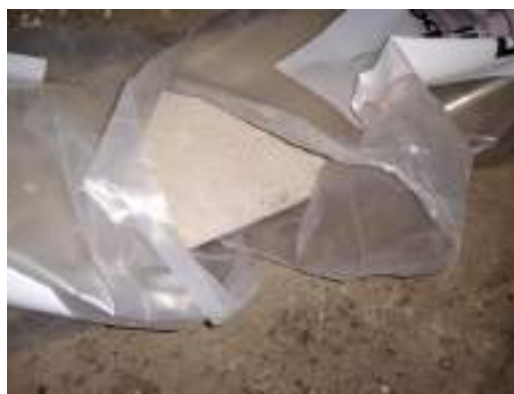
Inspection no:	S009	Type:	Sampled
Room/Area	Basement. RM.B-16 [005]		
Location/Element	Insulating board debris on podium		
Notes			
Product Type	Insulating Board Debris	Score:	2
Damage/Deterioration	High Damage	Score:	3
Surface Treatment	Partially Unsealed	Score:	2
Asbestos Type	Amosite	Score:	2
Extent	1 m ²		
Recommended Action	Remove	Total Score	9

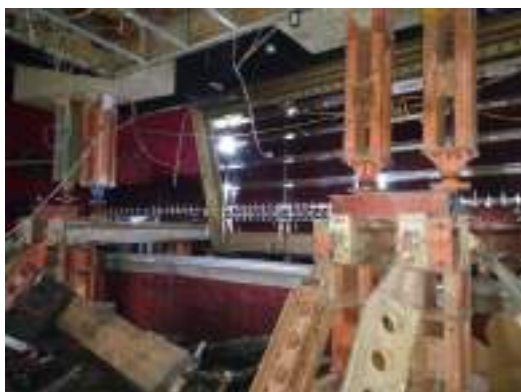
Inspection no:	S010	Type:	Sampled
Room/Area	Basement. RM.B-16 [005]		
Location/Element	Loose panels within rubble bag		
Notes			
Product Type	Insulating Board Debris	Score:	2
Damage/Deterioration	High Damage	Score:	3
Surface Treatment	Partially Unsealed	Score:	2
Asbestos Type	Amosite	Score:	2
Extent	1 m ²		
Recommended Action	Remove	Total Score	9

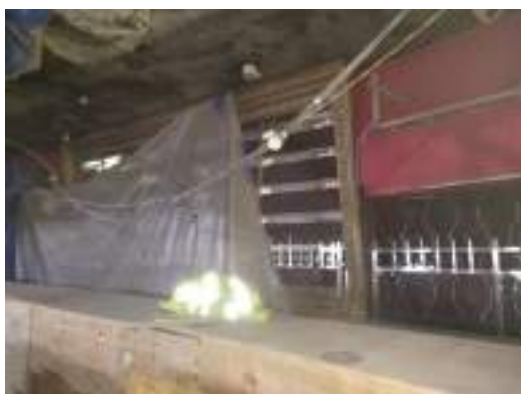
Inspection no:	N003	Type:	Inaccessible
Room/Area	Basement. RM.B-17 [006]		
Location/Element	Limited access to wall		
Notes	Limited access to wall during revisit on the 29/7/2020 due to glass/mirrored cladding.		
Product Type	N/A	Score:	N/A
Damage/Deterioration	N/A	Score:	N/A
Surface Treatment	N/A	Score:	N/A
Asbestos Type		Score:	N/A
Extent			
Recommended Action	N/A	Total Score

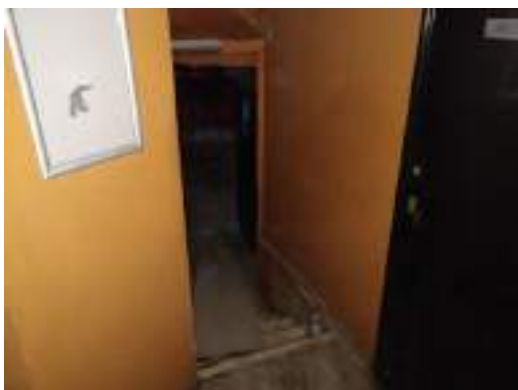
Inspection no:	S240	Type:	Sampled
Room/Area	Basement. RM.B-17 [006]		
Location/Element	Paint to wall		
Notes			
Product Type	Textured Coating	Score:	1
Damage/Deterioration	Low Damage	Score:	1
Surface Treatment	Sealed	Score:	1
Asbestos Type	Chrysotile	Score:	1
Extent	80 m ²		
Recommended Action	Remove	Total Score	4

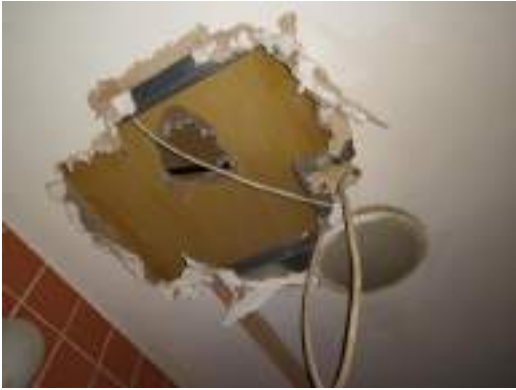
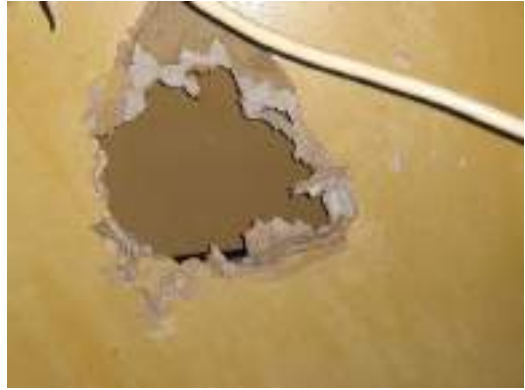
Inspection no:	S194	Type:	Sampled
Room/Area	Basement. RM.B-32 [013]		
Location/Element	Paint to ceiling		
Notes			
Product Type	N/A	Score:	N/A
Damage/Deterioration	N/A	Score:	N/A
Surface Treatment	N/A	Score:	N/A
Asbestos Type	NAD	Score:	N/A
Extent	15 m ²		
Recommended Action	N/A	Total Score	0

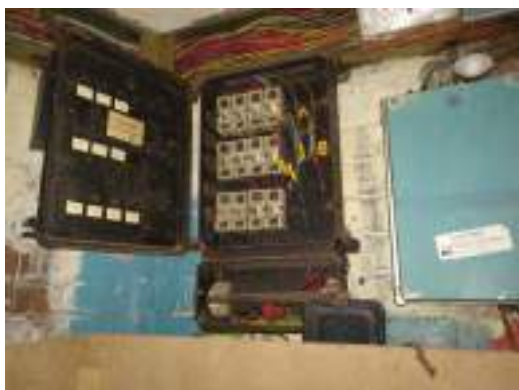
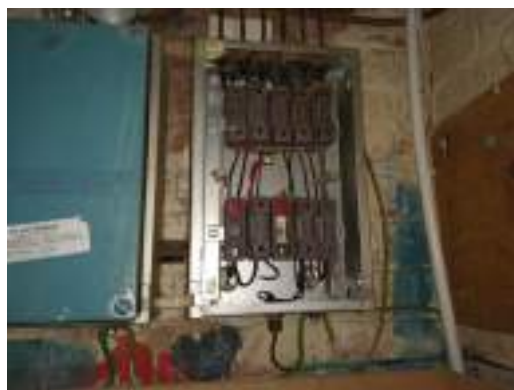
Inspection no:	S013	Type:	Sampled
Room/Area	Basement. RM.B-21 [014]		
Location/Element	Flashguards within electrical units		
Notes	3x units.		
Product Type	Textile Flash Guard	Score:	2
Damage/Deterioration	Medium Damage	Score:	2
Surface Treatment	Partially Unsealed	Score:	2
Asbestos Type	Chrysotile	Score:	1
Extent	3 no		
Recommended Action	Remove	Total Score	7

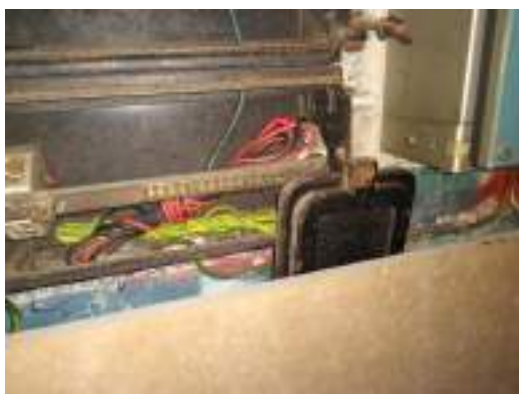
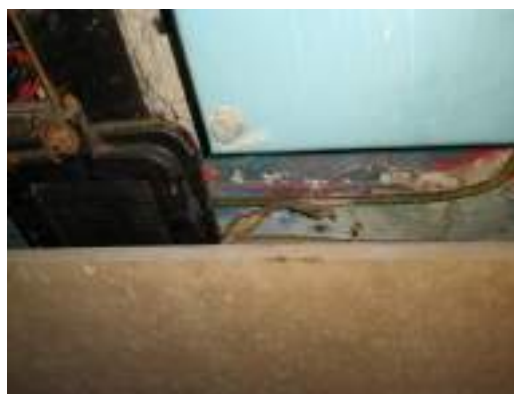
Inspection no:	S014	Type:	Sampled
Room/Area	Basement. RM.B-21 [014]		
Location/Element	Rope seal to fusebox		
Notes			
Product Type	N/A	Score:	N/A
Damage/Deterioration	N/A	Score:	N/A
Surface Treatment	N/A	Score:	N/A
Asbestos Type	NAD	Score:	N/A
Extent	1 no		
Recommended Action	N/A	Total Score	0

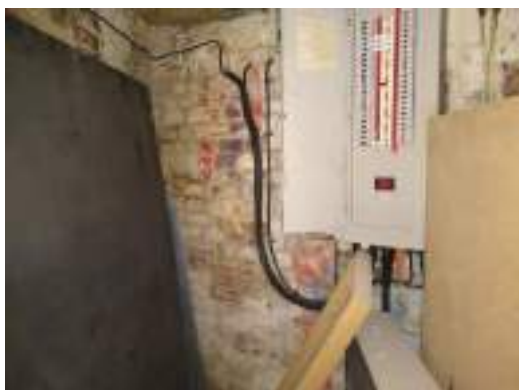
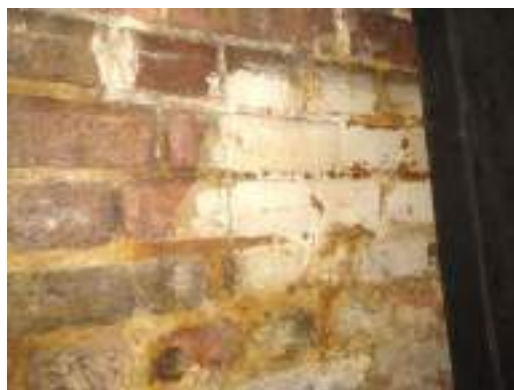
Inspection no:	S205	Type:	Sampled
Room/Area	Basement. RM.B-21 [014]		
Location/Element	Paint to walls		
Notes			
Product Type	N/A	Score:	N/A
Damage/Deterioration	N/A	Score:	N/A
Surface Treatment	N/A	Score:	N/A
Asbestos Type	NAD	Score:	N/A
Extent	10 m ²		
Recommended Action	N/A	Total Score	0

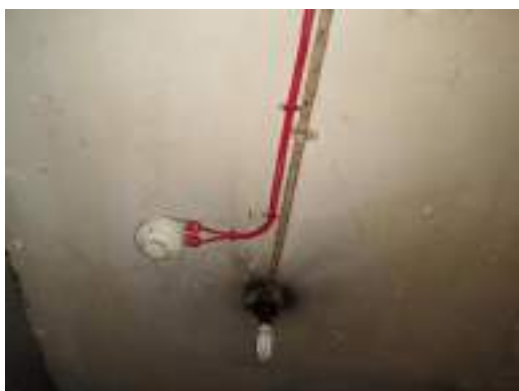
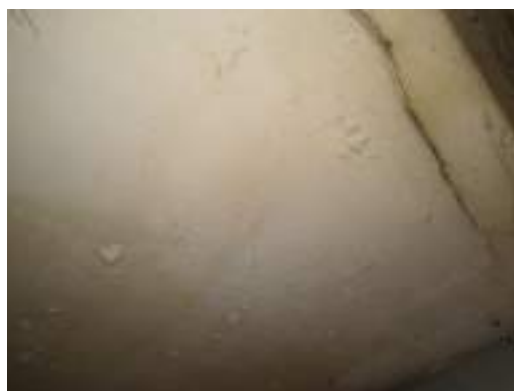
Inspection no:	S206	Type:	Sampled
Room/Area	Basement. RM.B-21 [014]		
Location/Element	Paint to ceiling		
Notes			
Product Type	N/A	Score:	N/A
Damage/Deterioration	N/A	Score:	N/A
Surface Treatment	N/A	Score:	N/A
Asbestos Type	NAD	Score:	N/A
Extent	4 m ²		
Recommended Action	N/A	Total Score	0

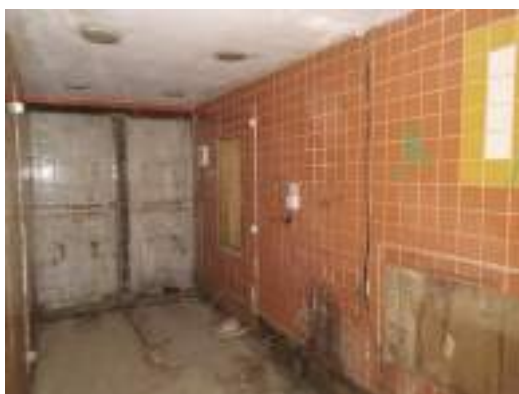
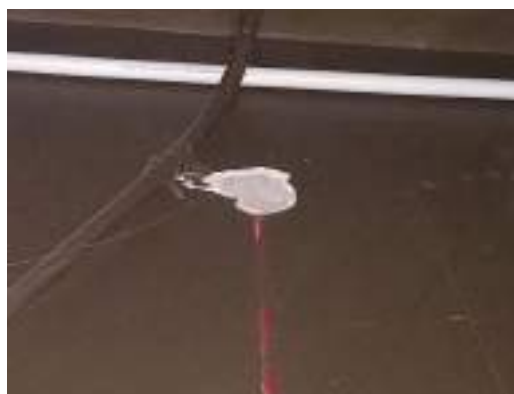
Inspection no:	S203	Type:	Sampled
Room/Area	Basement. RM.B-20 [015]		
Location/Element	Paint to walls		
Notes			
Product Type	N/A	Score:	N/A
Damage/Deterioration	N/A	Score:	N/A
Surface Treatment	N/A	Score:	N/A
Asbestos Type	NAD	Score:	N/A
Extent	20 m ²		
Recommended Action	N/A	Total Score	0

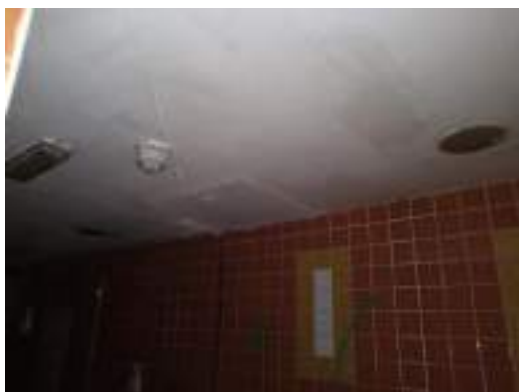
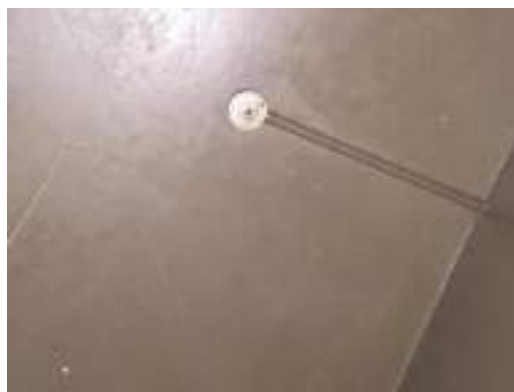
Inspection no:	S204	Type:	Sampled
Room/Area	Basement. RM.B-20 [015]		
Location/Element	Paint to ceiling		
Notes			
Product Type	N/A	Score:	N/A
Damage/Deterioration	N/A	Score:	N/A
Surface Treatment	N/A	Score:	N/A
Asbestos Type	NAD	Score:	N/A
Extent	10 m ²		
Recommended Action	N/A	Total Score	0

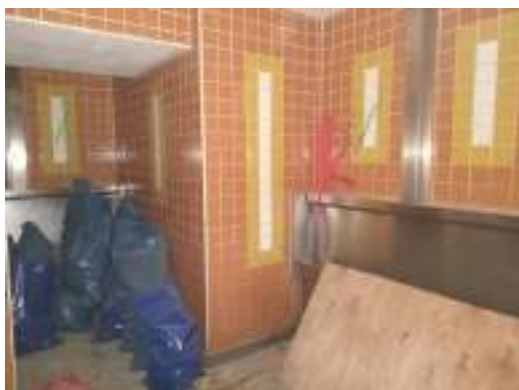
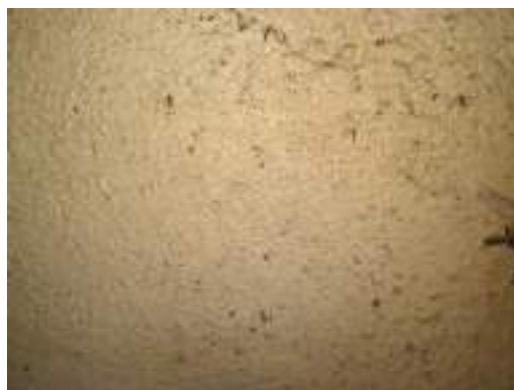
Inspection no:	S195	Type:	Sampled
Room/Area	Basement. RM.B-24 [016]		
Location/Element	Paint to walls		
Notes			
Product Type	N/A	Score:	N/A
Damage/Deterioration	N/A	Score:	N/A
Surface Treatment	N/A	Score:	N/A
Asbestos Type	NAD	Score:	N/A
Extent	20 m ²		
Recommended Action	N/A	Total Score	0

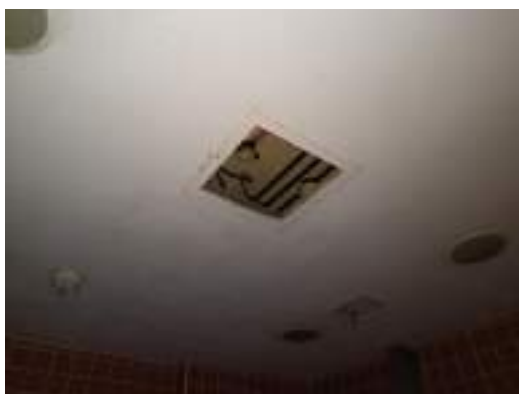
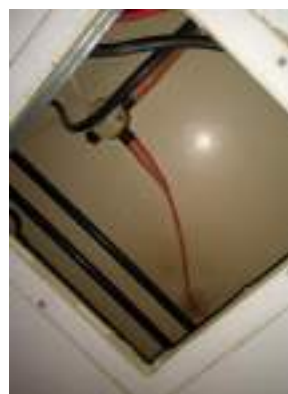
Inspection no:	S196	Type:	Sampled
Room/Area	Basement. RM.B-24 [016]		
Location/Element	Paint to ceiling		
Notes			
Product Type	N/A	Score:	N/A
Damage/Deterioration	N/A	Score:	N/A
Surface Treatment	N/A	Score:	N/A
Asbestos Type	NAD	Score:	N/A
Extent	12 m ²		
Recommended Action	N/A	Total Score	0

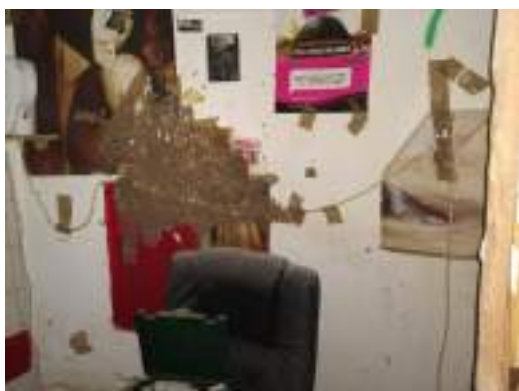
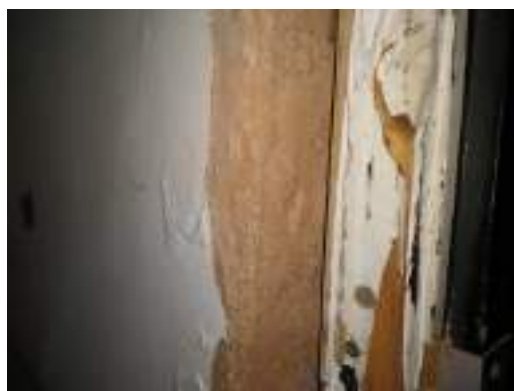
Inspection no:	S199	Type:	Sampled
Room/Area	Basement. RM.B-25 [017]		
Location/Element	Paint to walls		
Notes			
Product Type	N/A	Score:	N/A
Damage/Deterioration	N/A	Score:	N/A
Surface Treatment	N/A	Score:	N/A
Asbestos Type	NAD	Score:	N/A
Extent	8 m ²		
Recommended Action	N/A	Total Score	0

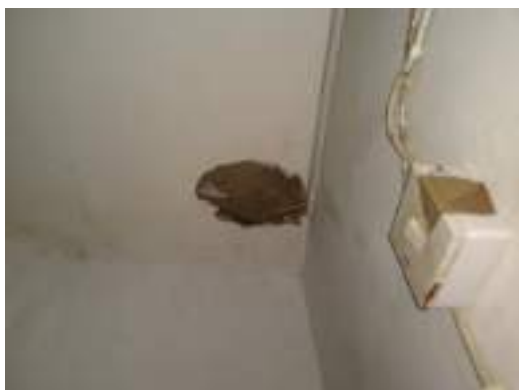
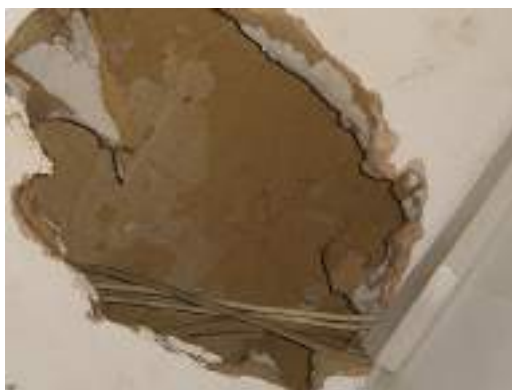
Inspection no:	S200	Type:	Sampled
Room/Area	Basement. RM.B-25 [017]		
Location/Element	Ceiling		
Notes			
Product Type	Textured Coating	Score:	1
Damage/Deterioration	Low Damage	Score:	1
Surface Treatment	Sealed	Score:	1
Asbestos Type	Chrysotile	Score:	1
Extent	3 m ²		
Recommended Action	Remove	Total Score	4

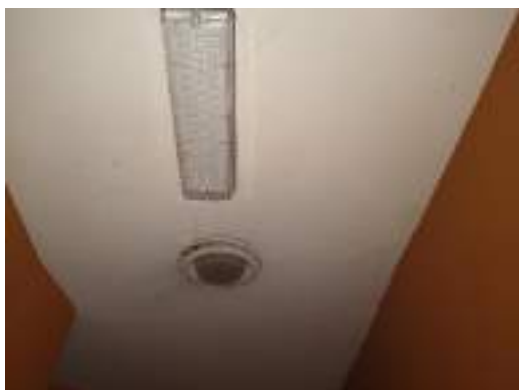
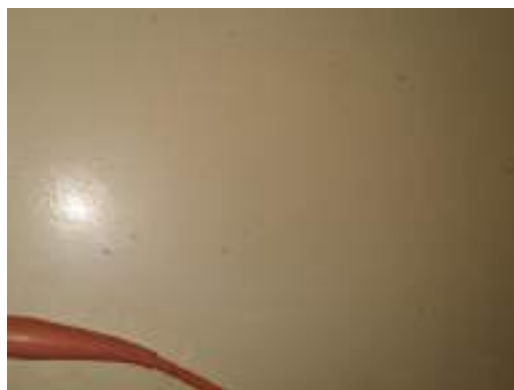
Inspection no:	S198	Type:	Sampled
Room/Area	Basement. RM.B-23 [018]		
Location/Element	Paint to ceiling		
Notes			
Product Type	N/A	Score:	N/A
Damage/Deterioration	N/A	Score:	N/A
Surface Treatment	N/A	Score:	N/A
Asbestos Type	NAD	Score:	N/A
Extent	3 m ²		
Recommended Action	N/A	Total Score	0

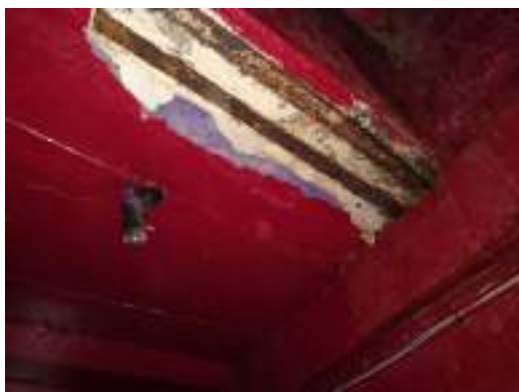
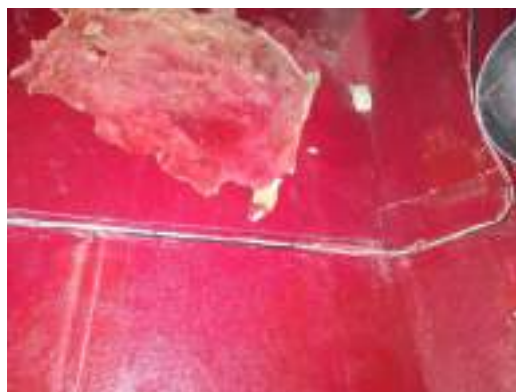
Inspection no:	S015	Type:	Sampled
Room/Area	Basement. RM.B-22 [019]		
Location/Element	Paint to walls and ceiling		
Notes			
Product Type	N/A	Score:	N/A
Damage/Deterioration	N/A	Score:	N/A
Surface Treatment	N/A	Score:	N/A
Asbestos Type	NAD	Score:	N/A
Extent	100 m ²		
Recommended Action	N/A	Total Score	0

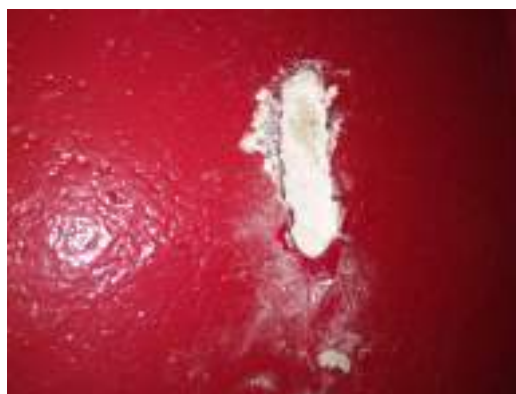
Inspection no:	S201	Type:	Sampled
Room/Area	Basement. RM.B-22 [019]		
Location/Element	Textured coating to walls under paint		
Notes			
Product Type	Textured Coating	Score:	1
Damage/Deterioration	Low Damage	Score:	1
Surface Treatment	Sealed	Score:	1
Asbestos Type	Chrysotile	Score:	1
Extent	25 m ²		
Recommended Action	Remove	Total Score	4

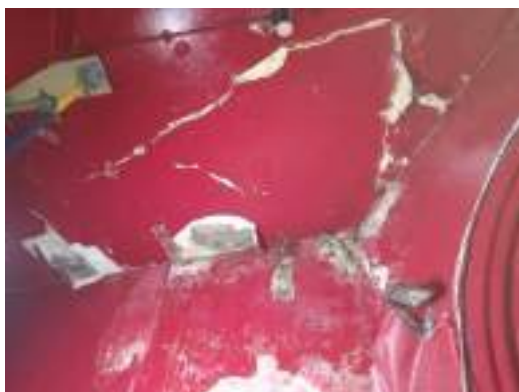
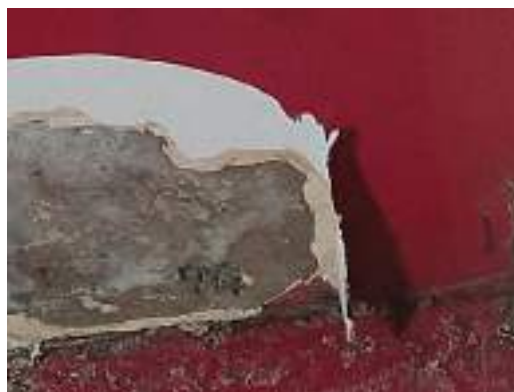
Inspection no:	S305	Type:	Sampled
Room/Area	Ground Floor. RM.B-22 [019]		
Location/Element	Paint to ceiling		
Notes			
Product Type	N/A	Score:	N/A
Damage/Deterioration	N/A	Score:	N/A
Surface Treatment	N/A	Score:	N/A
Asbestos Type	NAD	Score:	N/A
Extent	10 m ²		
Recommended Action	N/A	Total Score	0

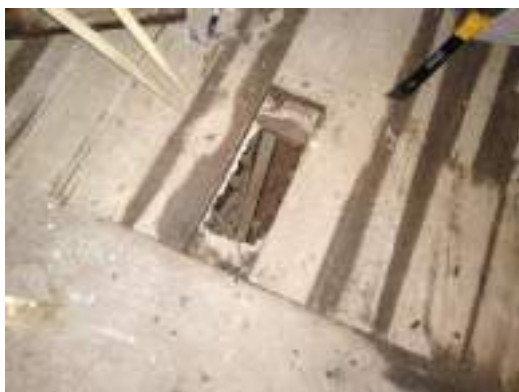
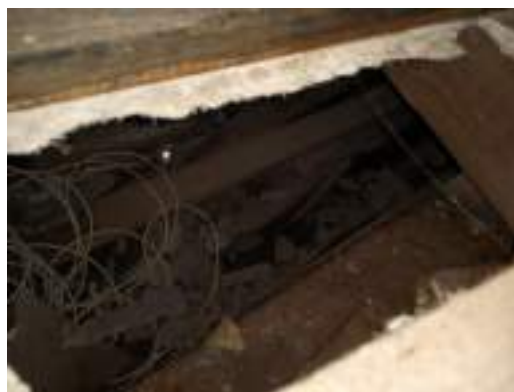
Inspection no:	S016	Type:	Sampled
Room/Area	Ground Floor. RM.G-10 [020]		
Location/Element	Panelling to underside of timber floor		
Notes	Visible debris throughout void.		
Product Type	Insulating Board	Score:	2
Damage/Deterioration	High Damage	Score:	3
Surface Treatment	Partially Unsealed	Score:	2
Asbestos Type	Amosite	Score:	2
Extent	60 m ²		
Recommended Action	Remove	Total Score	9

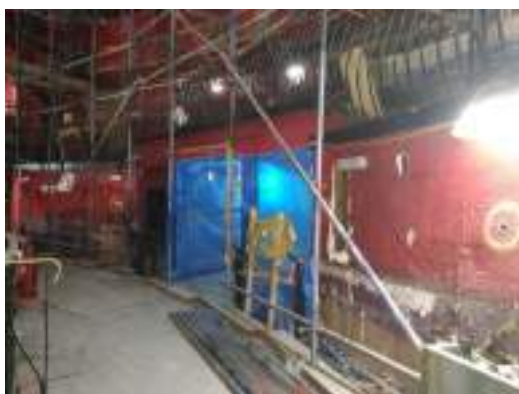
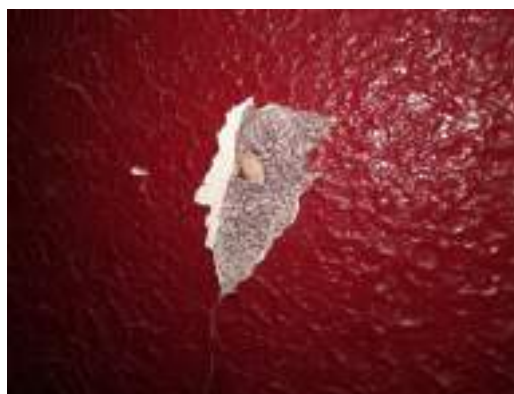
Inspection no:	S322	Type:	Sampled
Room/Area	Ground Floor. RM.G-10 [020]		
Location/Element	Paint to walls		
Notes			
Product Type	N/A	Score:	N/A
Damage/Deterioration	N/A	Score:	N/A
Surface Treatment	N/A	Score:	N/A
Asbestos Type	NAD	Score:	N/A
Extent	30 m ²		
Recommended Action	N/A	Total Score	0

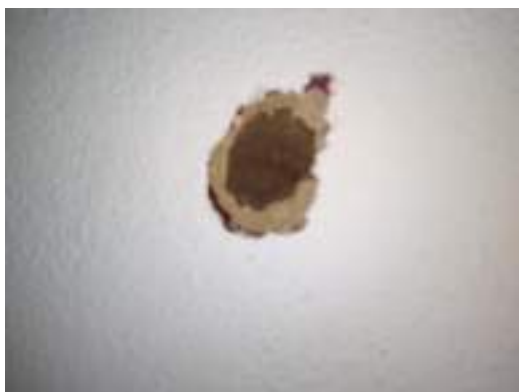
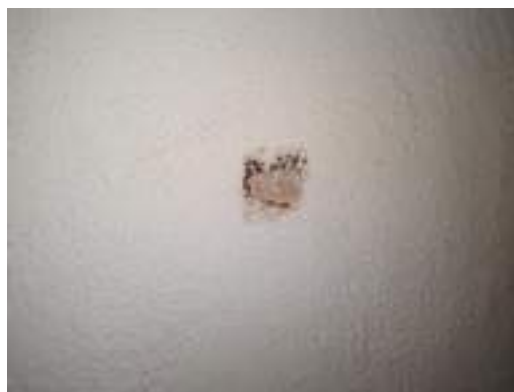
Inspection no:	S328	Type:	Sampled
Room/Area	Ground Floor. RM.G-23 [022]		
Location/Element	Paint to walls		
Notes			
Product Type	Textured Coating	Score:	1
Damage/Deterioration	Low Damage	Score:	1
Surface Treatment	Sealed	Score:	1
Asbestos Type	Chrysotile	Score:	1
Extent	10 m ²		
Recommended Action	Remove	Total Score	4

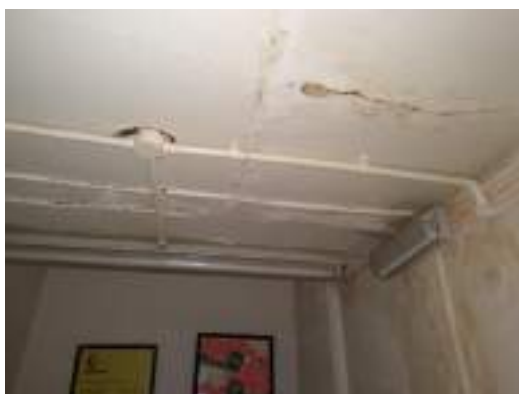
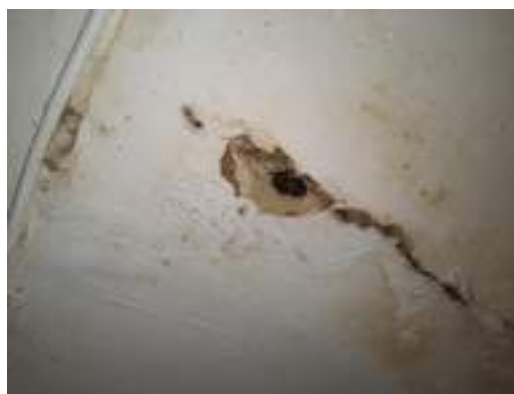
Inspection no:	S329	Type:	Sampled
Room/Area	Ground Floor. RM.G-23 [022]		
Location/Element	Paint to ceiling		
Notes			
Product Type	N/A	Score:	N/A
Damage/Deterioration	N/A	Score:	N/A
Surface Treatment	N/A	Score:	N/A
Asbestos Type	NAD	Score:	N/A
Extent	5 m ²		
Recommended Action	N/A	Total Score	0

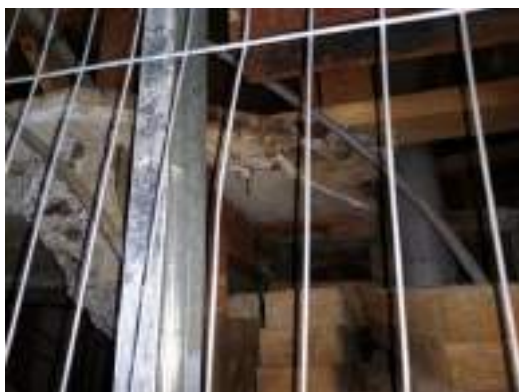
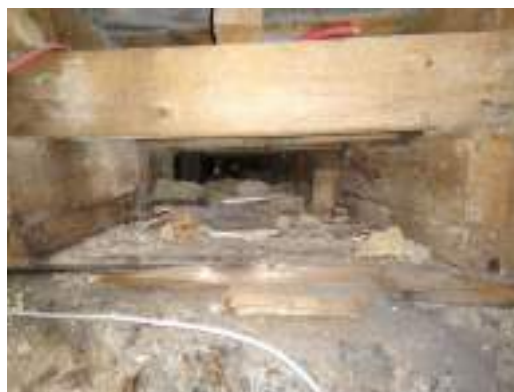
Inspection no:	R016	Type:	Referred Sample
Room/Area	Ground Floor. RM.G-11 [023]		
Location/Element	Panelling within void		
Notes	Panelling noted in ceiling void of basement. Panels and debris are present throughout void and most panels are double skinned, nailed directly into timber. Debris present resting on suspended ceiling below, in-between timbers, concrete and RSJs.		
Product Type	Insulating Board	Score:	2
Damage/Deterioration	High Damage	Score:	3
Surface Treatment	Partially Unsealed	Score:	2
Asbestos Type	Amosite	Score:	2
Extent	200 m ²		
Recommended Action	Remove	Total Score	9

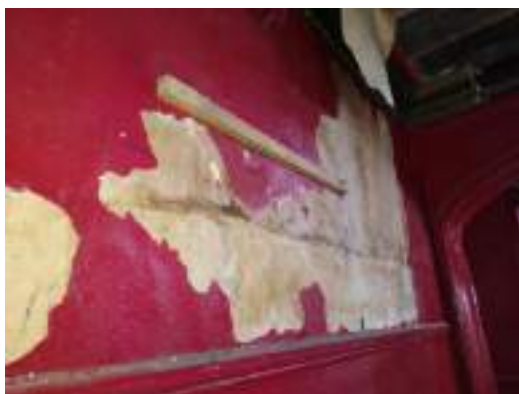
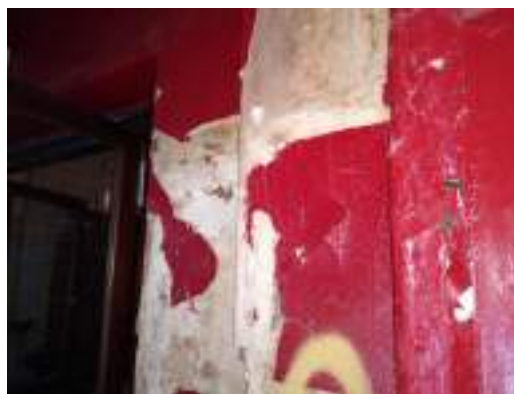
Inspection no:	S017	Type:	Sampled
Room/Area	Ground Floor. RM.G-11 [023]		
Location/Element	Paint to walls		
Notes			
Product Type	N/A	Score:	N/A
Damage/Deterioration	N/A	Score:	N/A
Surface Treatment	N/A	Score:	N/A
Asbestos Type	NAD	Score:	N/A
Extent	80 m ²		
Recommended Action	N/A	Total Score	0

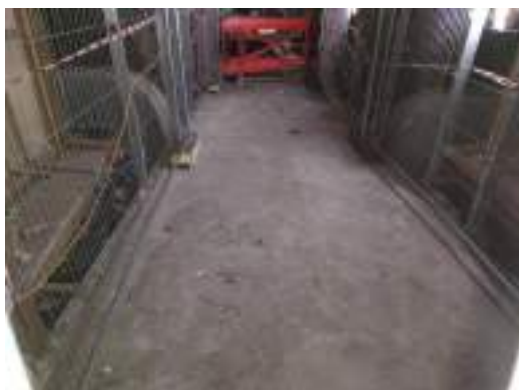
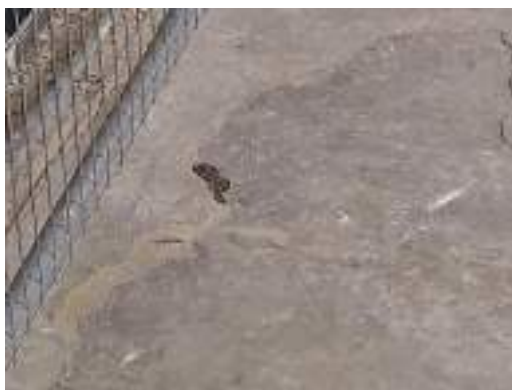
Inspection no:	S018	Type:	Sampled
Room/Area	Ground Floor. RM.G-11 [023]		
Location/Element	Bitumen to concrete floor of walkway		
Notes			
Product Type	N/A	Score:	N/A
Damage/Deterioration	N/A	Score:	N/A
Surface Treatment	N/A	Score:	N/A
Asbestos Type	NAD	Score:	N/A
Extent	20 m ²		
Recommended Action	N/A	Total Score	0

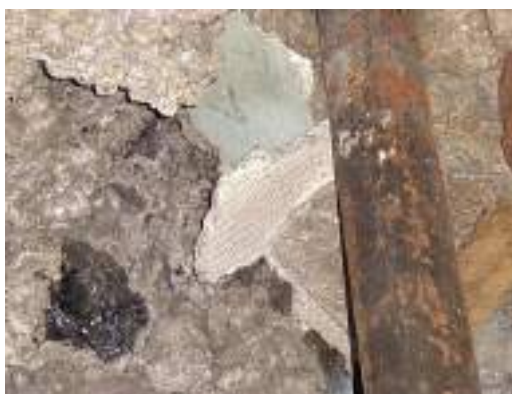
Inspection no:	S019	Type:	Sampled
Room/Area	Ground Floor. RM.G-11 [023]		
Location/Element	Shuttering where pipes pass through ceiling		
Notes			
Product Type	Insulating Board	Score:	2
Damage/Deterioration	Medium Damage	Score:	2
Surface Treatment	Partially Unsealed	Score:	2
Asbestos Type	Chrysotile	Score:	1
Extent	0.1 m ²		
Recommended Action	Remove	Total Score	7

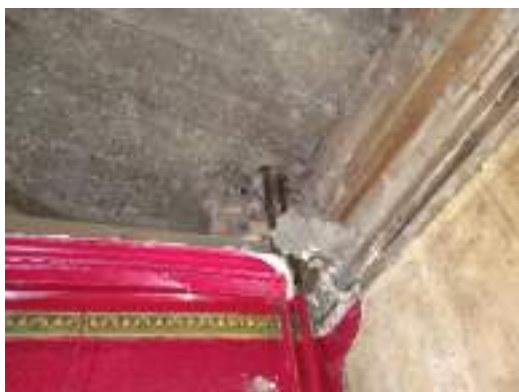
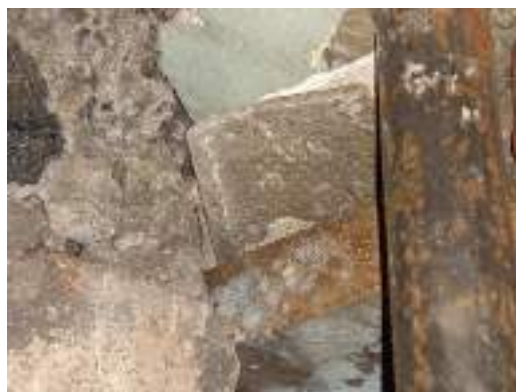
Inspection no:	S020	Type:	Sampled
Room/Area	Ground Floor. RM.G-11 [023]		
Location/Element	Shuttering where pipes pass through ceiling		
Notes			
Product Type	Cement	Score:	1
Damage/Deterioration	Medium Damage	Score:	2
Surface Treatment	Partially Unsealed	Score:	2
Asbestos Type	Chrysotile	Score:	1
Extent	0.1 m ²		
Recommended Action	Remove	Total Score	6

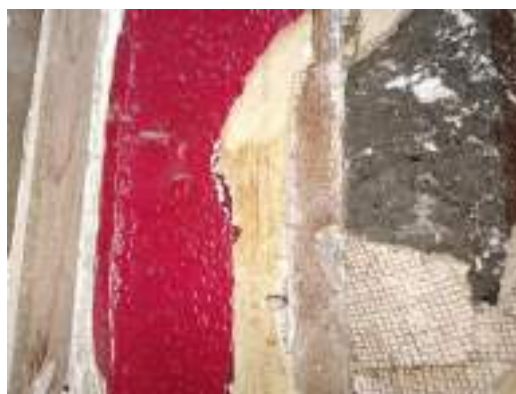
Inspection no:	S307	Type:	Sampled
Room/Area	Ground Floor. RM.G-11 [023]		
Location/Element	Textured coating to walls under paint		
Notes			
Product Type	Textured Coating	Score:	1
Damage/Deterioration	Low Damage	Score:	1
Surface Treatment	Sealed	Score:	1
Asbestos Type	Chrysotile	Score:	1
Extent	80 m ²		
Recommended Action	Remove	Total Score	4

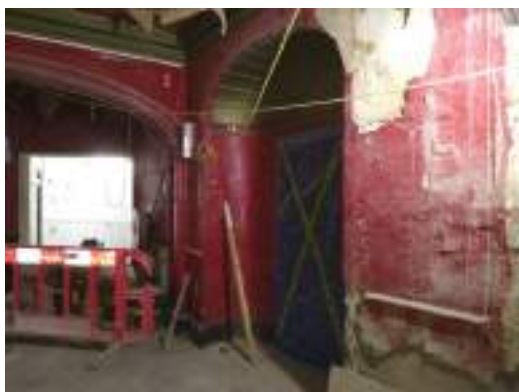
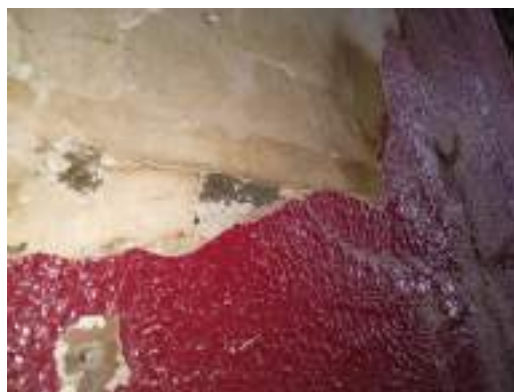
Inspection no:	S308	Type:	Sampled
Room/Area	Ground Floor. RM.G-11 [023]		
Location/Element	Textured coating to walls under paint		
Notes			
Product Type	Textured Coating	Score:	1
Damage/Deterioration	Low Damage	Score:	1
Surface Treatment	Sealed	Score:	1
Asbestos Type	Chrysotile	Score:	1
Extent	80 m ²		
Recommended Action	Remove	Total Score	4

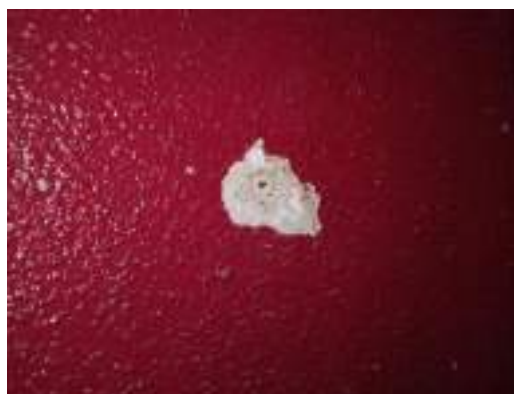
Inspection no:	S309	Type:	Sampled
Room/Area	Ground Floor. RM.G-11 [023]		
Location/Element	Textured coating to walls under paint		
Notes			
Product Type	Textured Coating	Score:	1
Damage/Deterioration	Low Damage	Score:	1
Surface Treatment	Sealed	Score:	1
Asbestos Type	Chrysotile	Score:	1
Extent	80 m ²		
Recommended Action	Remove	Total Score	4

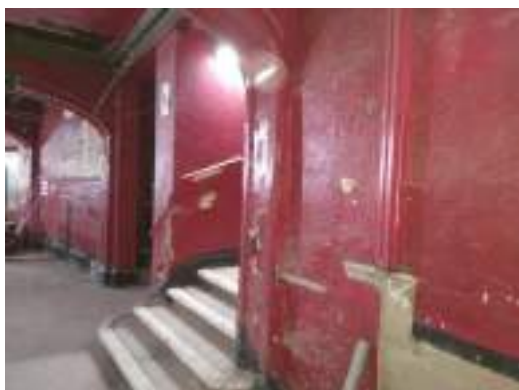
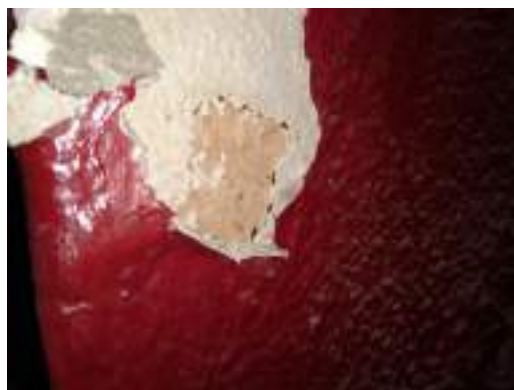
Inspection no:	S310	Type:	Sampled
Room/Area	Ground Floor. RM.G-11 [023]		
Location/Element	Paint to walls		
Notes			
Product Type	N/A	Score:	N/A
Damage/Deterioration	N/A	Score:	N/A
Surface Treatment	N/A	Score:	N/A
Asbestos Type	NAD	Score:	N/A
Extent	80 m ²		
Recommended Action	N/A	Total Score	0

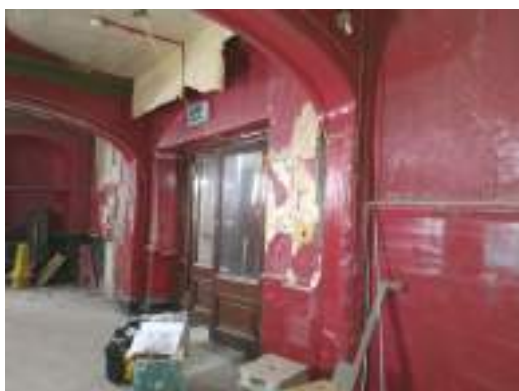
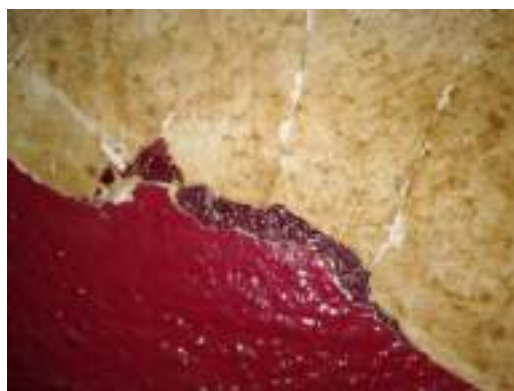
Inspection no:	S311	Type:	Sampled
Room/Area	Ground Floor. RM.G-11 [023]		
Location/Element	Textured coating to walls under paint		
Notes			
Product Type	Textured Coating	Score:	1
Damage/Deterioration	Low Damage	Score:	1
Surface Treatment	Sealed	Score:	1
Asbestos Type	Chrysotile	Score:	1
Extent	80 m ²		
Recommended Action	Remove	Total Score	4

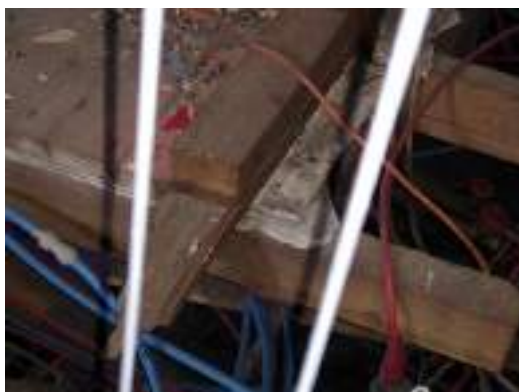
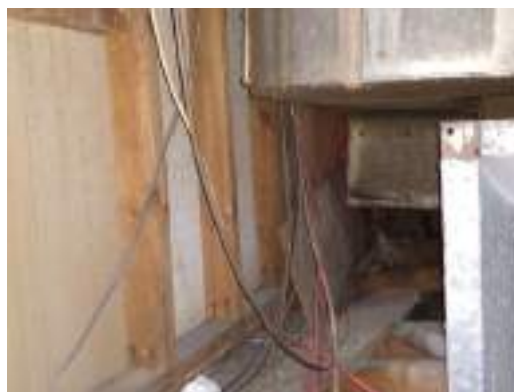
Inspection no:	R016	Type:	Referred Sample
Room/Area	Ground Floor. RM.G-21 [024]		
Location/Element	External panelling to room		
Notes	Nailed directly onto internal panelling and timbers. Floor is double skinned.		
Product Type	Insulating Board	Score:	2
Damage/Deterioration	High Damage	Score:	3
Surface Treatment	Partially Unsealed	Score:	2
Asbestos Type	Amosite	Score:	2
Extent	30 m ²		
Recommended Action	Remove	Total Score	9

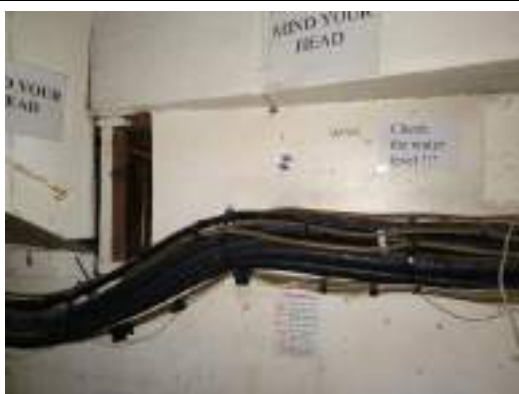
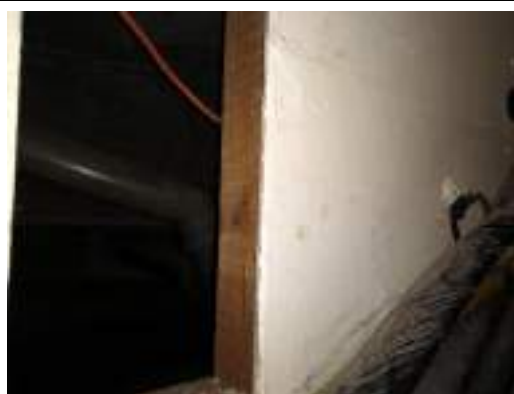
Inspection no:	S021	Type:	Sampled
Room/Area	Ground Floor. RM.G-21 [024]		
Location/Element	Internal wall panels		
Notes			
Product Type	N/A	Score:	N/A
Damage/Deterioration	N/A	Score:	N/A
Surface Treatment	N/A	Score:	N/A
Asbestos Type	NAD	Score:	N/A
Extent	20 m ²		
Recommended Action	N/A	Total Score	0
