Asbestos Survey Report

ASBESTOS SURVEY
REPORT NO: A-44387 – ISSUE 6

DATE ISSUED: 06/08/2020

Site Address:
KoKo Night Club
Heritage Areas Survey
1A Camden High St
London
NW1 7JE

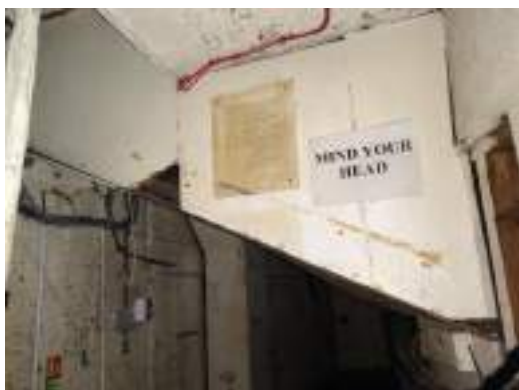
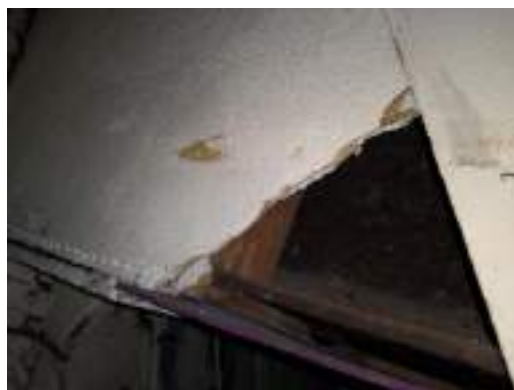
Inspection no:	S022	Type:	Sampled
Room/Area	Ground Floor. RM.G-21 [024]		
Location/Element	Cladding to beams		
Notes			
Product Type	N/A	Score:	N/A
Damage/Deterioration	N/A	Score:	N/A
Surface Treatment	N/A	Score:	N/A
Asbestos Type	NAD	Score:	N/A
Extent	5 m ²		
Recommended Action	N/A	Total Score	0

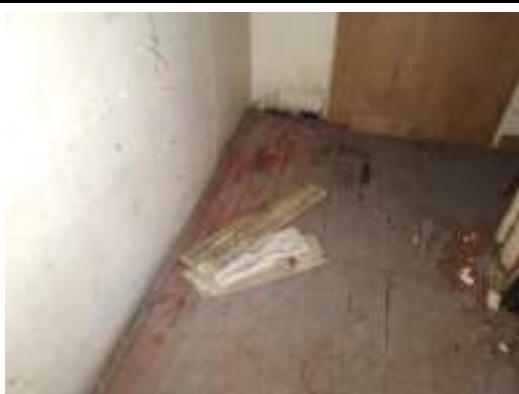
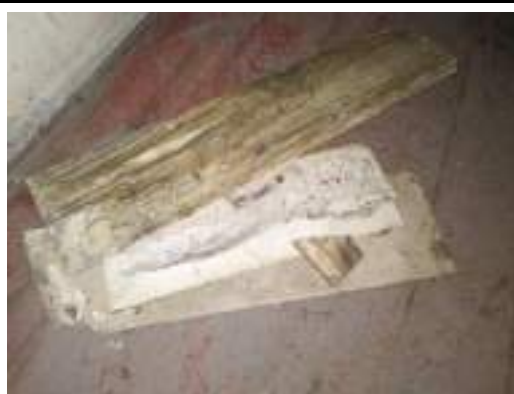
Inspection no:	S023	Type:	Sampled
Room/Area	Ground Floor. RM.G-21 [024]		
Location/Element	Loose panels		
Notes			
Product Type	N/A	Score:	N/A
Damage/Deterioration	N/A	Score:	N/A
Surface Treatment	N/A	Score:	N/A
Asbestos Type	NAD	Score:	N/A
Extent	1 m ²		
Recommended Action	N/A	Total Score	0

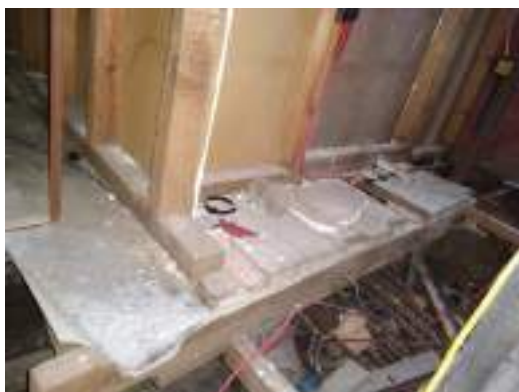
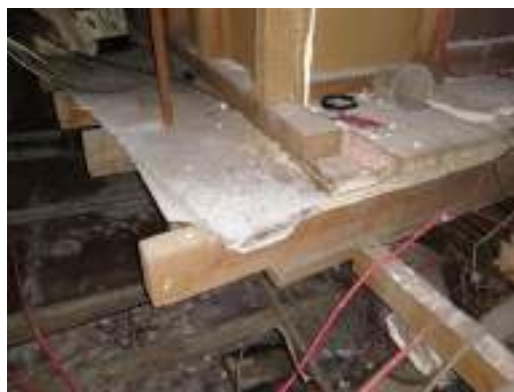
Inspection no:	R016	Type:	Referred Sample
Room/Area	Ground Floor. RM.G-12 [025]		
Location/Element	Panels beneath floor		
Notes	Nailed directly onto timber floor. Floor is double skinned.		
Product Type	Insulating Board	Score:	2
Damage/Deterioration	High Damage	Score:	3
Surface Treatment	Partially Unsealed	Score:	2
Asbestos Type	Amosite	Score:	2
Extent	20 m ²		
Recommended Action	Remove	Total Score	9

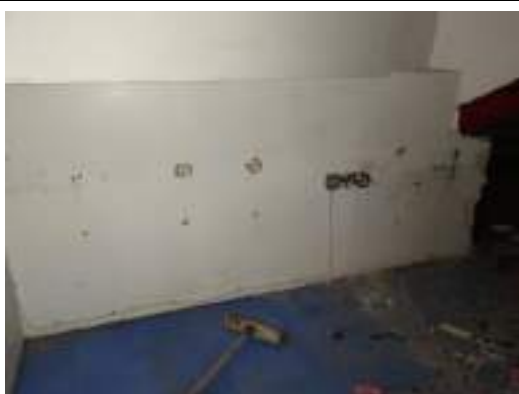
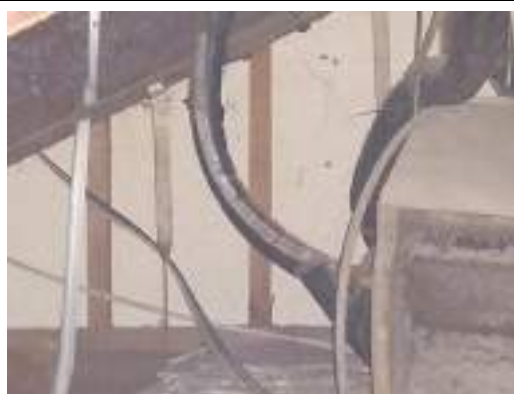
Inspection no:	R021	Type:	Referred Sample
Room/Area	Ground Floor. RM.G-12 [025]		
Location/Element	Wall panels		
Notes			
Product Type	Insulating Board	Score:	N/A
Damage/Deterioration	N/A	Score:	N/A
Surface Treatment	N/A	Score:	N/A
Asbestos Type	NAD	Score:	N/A
Extent	10 m ²		
Recommended Action	N/A	Total Score	0

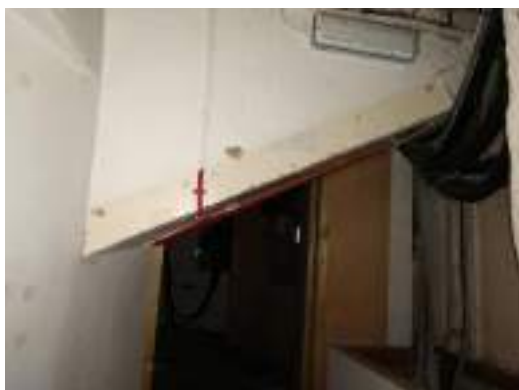
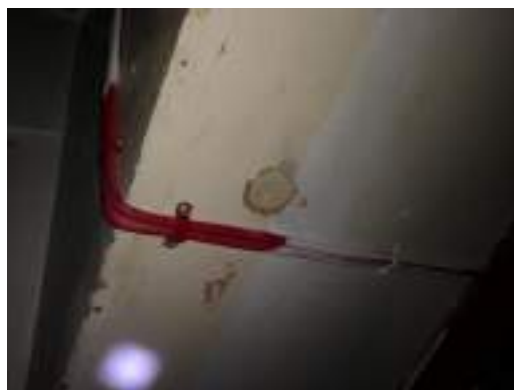
Inspection no:	R022	Type:	Referred Sample
Room/Area	Ground Floor. RM.G-12 [025]		
Location/Element	Cladding to beams		
Notes			
Product Type	Insulating Board	Score:	N/A
Damage/Deterioration	N/A	Score:	N/A
Surface Treatment	N/A	Score:	N/A
Asbestos Type	NAD	Score:	N/A
Extent	5 m ²		
Recommended Action	N/A	Total Score	0

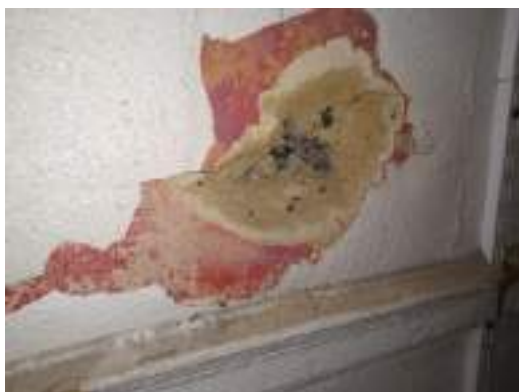
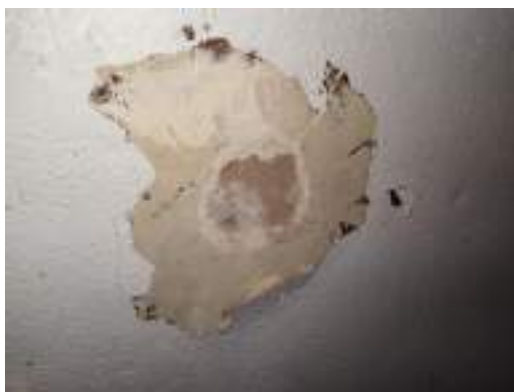
Inspection no:	S318	Type:	Sampled
Room/Area	Ground Floor. RM.G-22 [026]		
Location/Element	Paint to walls		
Notes			
Product Type	Textured Coating	Score:	1
Damage/Deterioration	Low Damage	Score:	1
Surface Treatment	Sealed	Score:	1
Asbestos Type	Chrysotile	Score:	1
Extent	20 m ²		
Recommended Action	Remove	Total Score	4

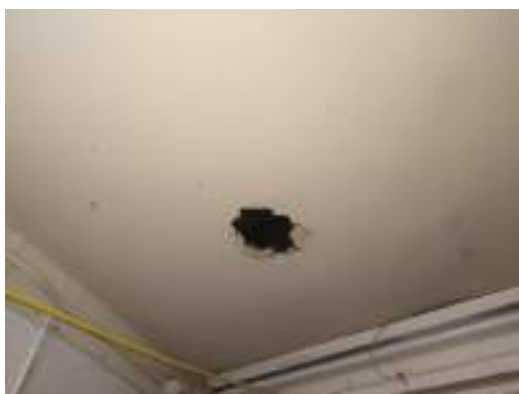
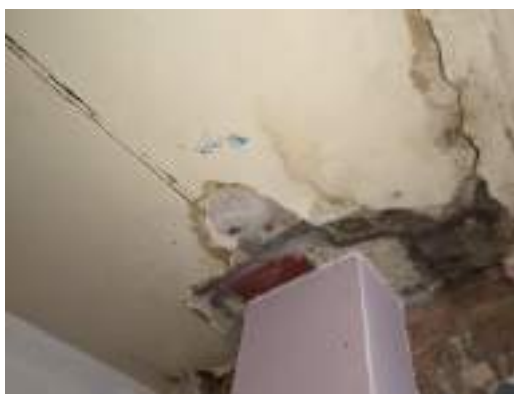
Inspection no:	S319	Type:	Sampled
Room/Area	Ground Floor. RM.G-22 [026]		
Location/Element	Paint to ceiling		
Notes			
Product Type	N/A	Score:	N/A
Damage/Deterioration	N/A	Score:	N/A
Surface Treatment	N/A	Score:	N/A
Asbestos Type	NAD	Score:	N/A
Extent	10 m ²		
Recommended Action	N/A	Total Score	0

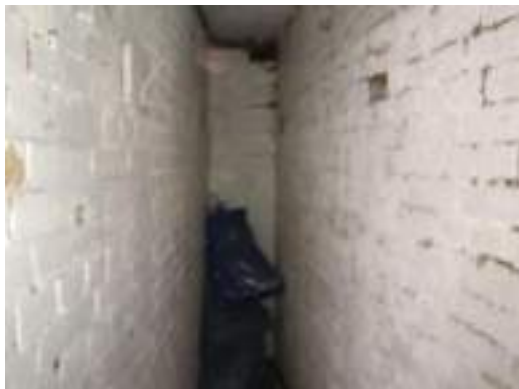
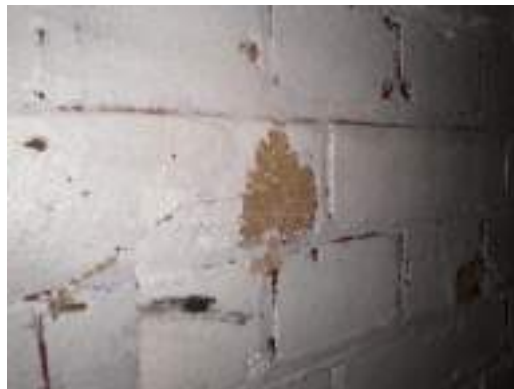
Inspection no:	S320	Type:	Sampled
Room/Area	Ground Floor. RM.G-22 [026]		
Location/Element	Paint to walls		
Notes			
Product Type	N/A	Score:	N/A
Damage/Deterioration	N/A	Score:	N/A
Surface Treatment	N/A	Score:	N/A
Asbestos Type	NAD	Score:	N/A
Extent	10 m ²		
Recommended Action	N/A	Total Score	0

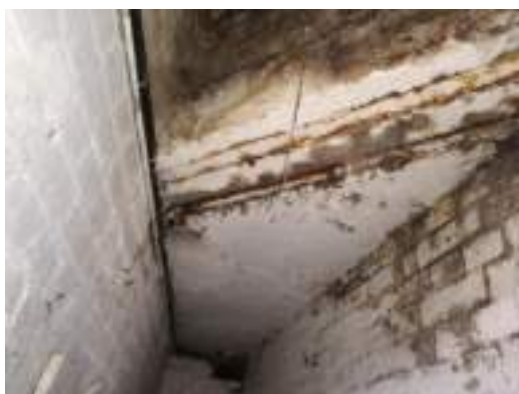
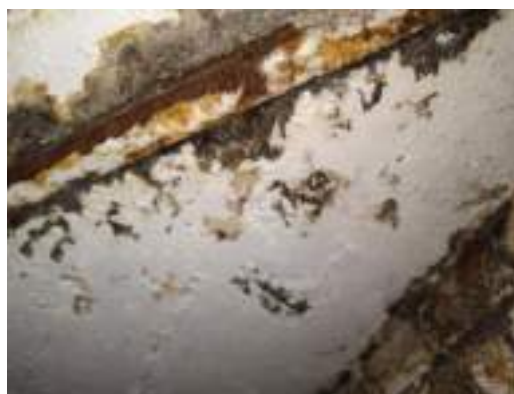
Inspection no:	S321	Type:	Sampled
Room/Area	Ground Floor. RM.G-22 [026]		
Location/Element	Paint to ceiling		
Notes			
Product Type	N/A	Score:	N/A
Damage/Deterioration	N/A	Score:	N/A
Surface Treatment	N/A	Score:	N/A
Asbestos Type	NAD	Score:	N/A
Extent	4 m ²		
Recommended Action	N/A	Total Score	0

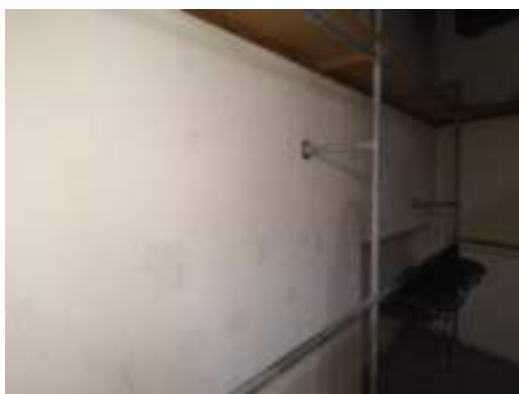
Inspection no:	S024	Type:	Sampled
Room/Area	Ground Floor. RM.G-09 [027]		
Location/Element	Paint to walls		
Notes			
Product Type	N/A	Score:	N/A
Damage/Deterioration	N/A	Score:	N/A
Surface Treatment	N/A	Score:	N/A
Asbestos Type	NAD	Score:	N/A
Extent	25 m ²		
Recommended Action	N/A	Total Score	0

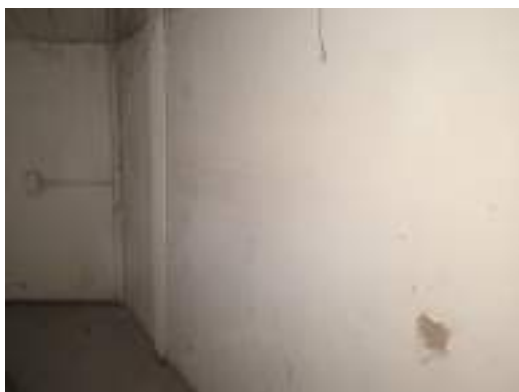
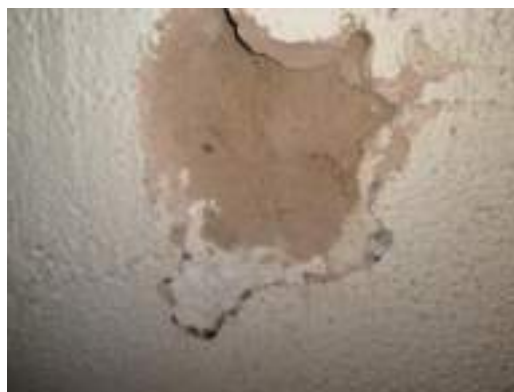
Inspection no:	S314	Type:	Sampled
Room/Area	Ground Floor. RM.G-09 [027]		
Location/Element	Textured coating to walls under paint		
Notes			
Product Type	Textured Coating	Score:	1
Damage/Deterioration	Low Damage	Score:	1
Surface Treatment	Sealed	Score:	1
Asbestos Type	Chrysotile	Score:	1
Extent	20 m ²		
Recommended Action	Remove	Total Score	4

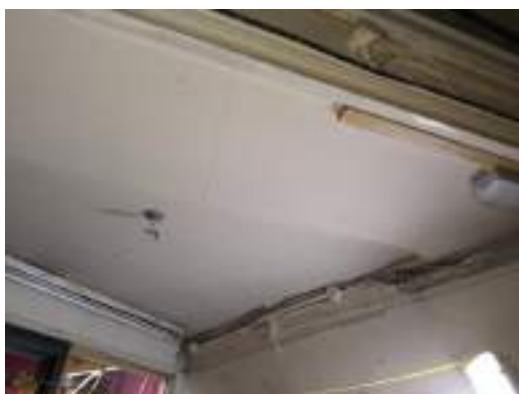
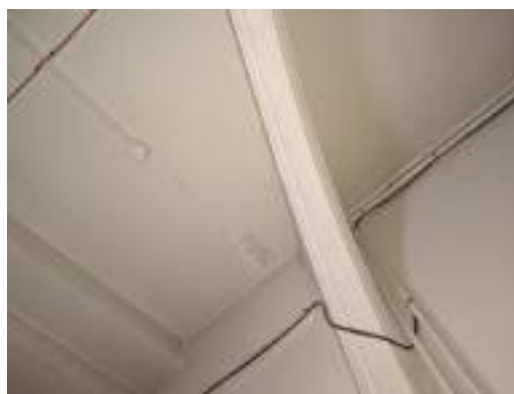
Inspection no:	S315	Type:	Sampled
Room/Area	Ground Floor. RM.G-09 [027]		
Location/Element	Paint to ceiling		
Notes			
Product Type	N/A	Score:	N/A
Damage/Deterioration	N/A	Score:	N/A
Surface Treatment	N/A	Score:	N/A
Asbestos Type	NAD	Score:	N/A
Extent	8 m ²		
Recommended Action	N/A	Total Score	0

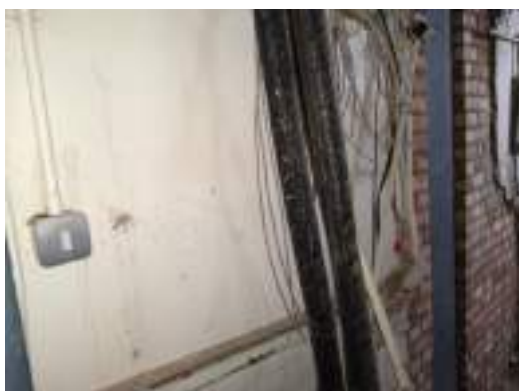
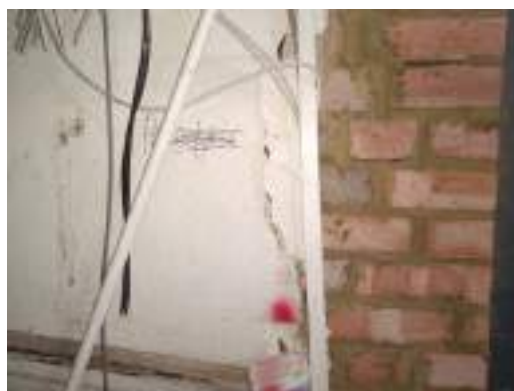
Inspection no:	R314	Type:	Referred Sample
Room/Area	Ground Floor. RM.G-08 [028]		
Location/Element	Textured paint to walls		
Notes			
Product Type	Textured Coating	Score:	1
Damage/Deterioration	Medium Damage	Score:	2
Surface Treatment	Sealed	Score:	1
Asbestos Type	Chrysotile	Score:	1
Extent	15 m ²		
Recommended Action	Remove	Total Score	5

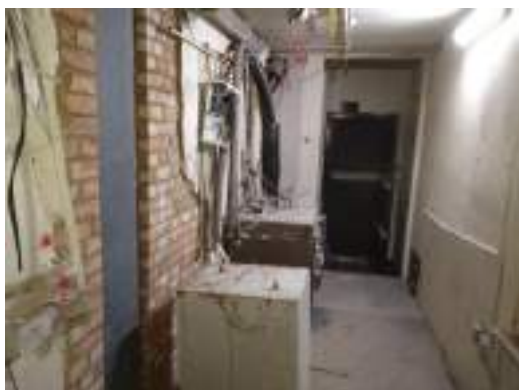
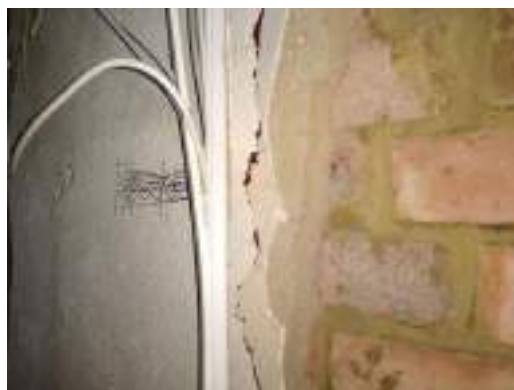
Inspection no:	S316	Type:	Sampled
Room/Area	Ground Floor. RM.G-08 [028]		
Location/Element	Paint to walls		
Notes			
Product Type	N/A	Score:	N/A
Damage/Deterioration	N/A	Score:	N/A
Surface Treatment	N/A	Score:	N/A
Asbestos Type	NAD	Score:	N/A
Extent	20 m ²		
Recommended Action	N/A	Total Score	0

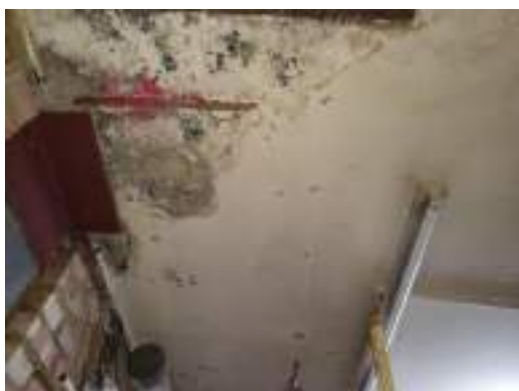
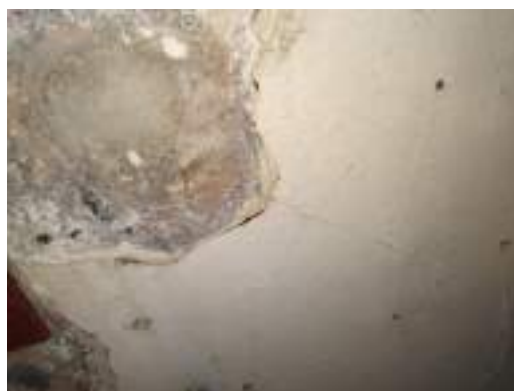
Inspection no:	S317	Type:	Sampled
Room/Area	Ground Floor. RM.G-08 [028]		
Location/Element	Paint to ceiling		
Notes			
Product Type	Textured Coating	Score:	1
Damage/Deterioration	Low Damage	Score:	1
Surface Treatment	Sealed	Score:	1
Asbestos Type	Chrysotile	Score:	1
Extent	10 m ²		
Recommended Action	Remove	Total Score	4

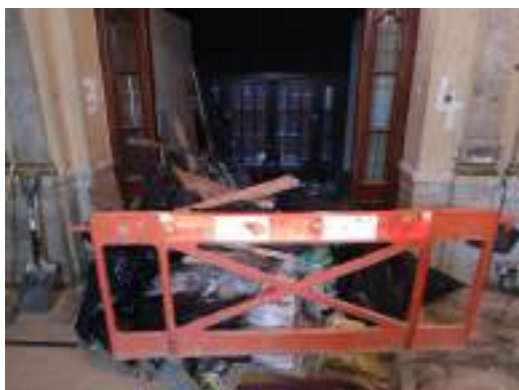
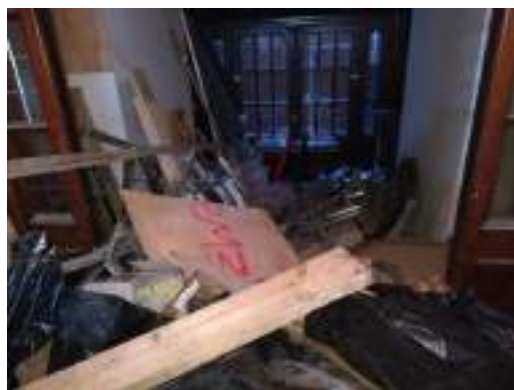
Inspection no:	P002	Type:	Presumed
Room/Area	Ground Floor. RM.G-13 [029]		
Location/Element	Contaminated debris within rubble bags		
Notes	Presumed as rubble within bags have been filled with debris and waste from basement ceiling where area is contaminated.		
Product Type	Insulating Board Debris	Score:	2
Damage/Deterioration	High Damage	Score:	3
Surface Treatment	Partially Unsealed	Score:	2
Asbestos Type	Amosite	Score:	2
Extent	All rubble and waste -		
Recommended Action	Remove	Total Score	9

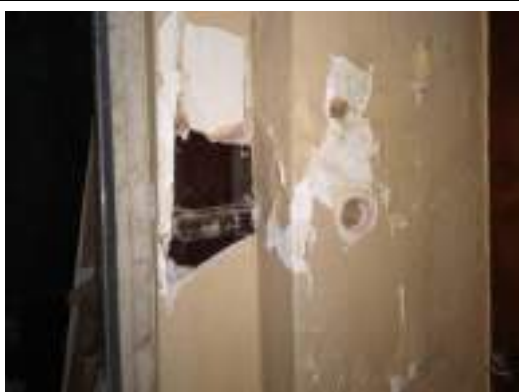
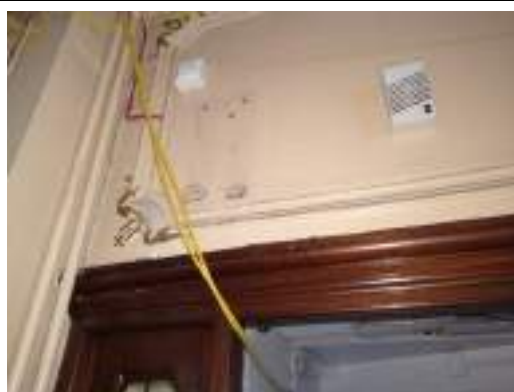
Inspection no:	S289	Type:	Sampled
Room/Area	Ground Floor. RM.G-13 [029]		
Location/Element	Paint to walls		
Notes			
Product Type	N/A	Score:	N/A
Damage/Deterioration	N/A	Score:	N/A
Surface Treatment	N/A	Score:	N/A
Asbestos Type	NAD	Score:	N/A
Extent	100 m ²		
Recommended Action	N/A	Total Score	0

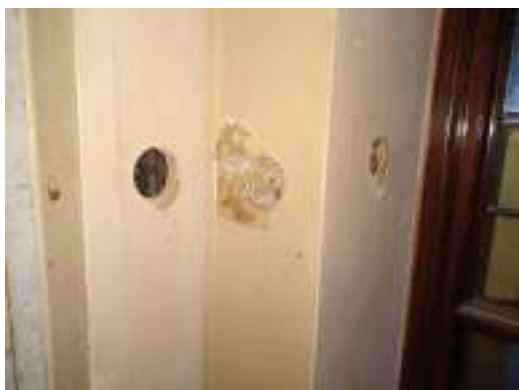
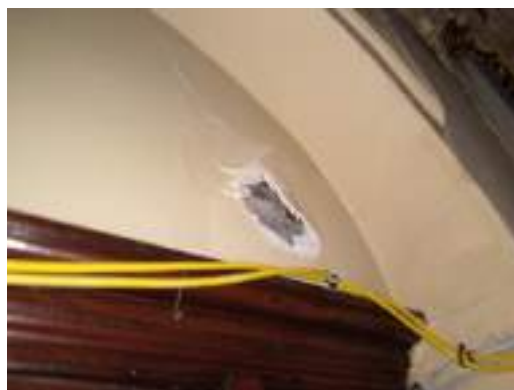
Inspection no:	S290	Type:	Sampled
Room/Area	Ground Floor. RM.G-13 [029]		
Location/Element	Paint to walls		
Notes			
Product Type	N/A	Score:	N/A
Damage/Deterioration	N/A	Score:	N/A
Surface Treatment	N/A	Score:	N/A
Asbestos Type	NAD	Score:	N/A
Extent	100 m ²		
Recommended Action	N/A	Total Score	0

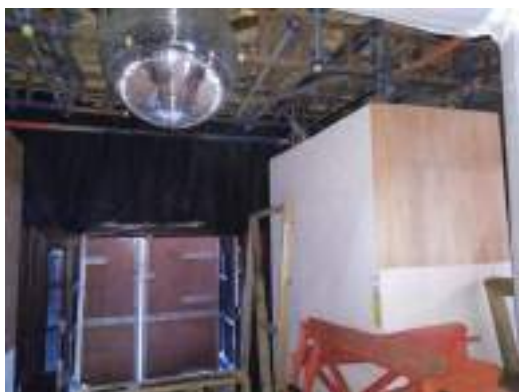
Inspection no:	S291	Type:	Sampled
Room/Area	Ground Floor. RM.G-13 [029]		
Location/Element	Paint to ceiling		
Notes			
Product Type	N/A	Score:	N/A
Damage/Deterioration	N/A	Score:	N/A
Surface Treatment	N/A	Score:	N/A
Asbestos Type	NAD	Score:	N/A
Extent	100+ m ²		
Recommended Action	N/A	Total Score	0

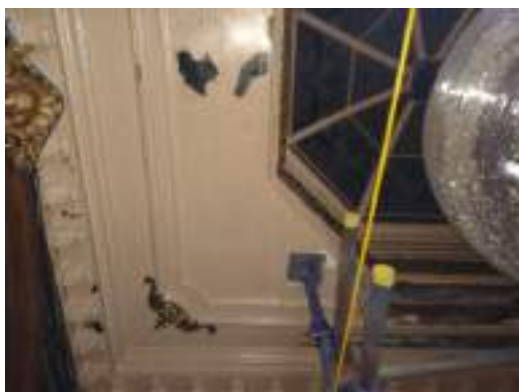
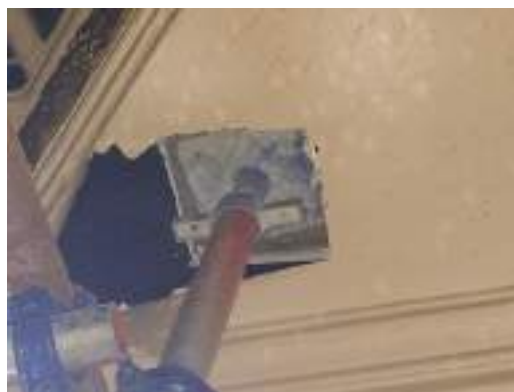
Inspection no:		Type:	
Room/Area	Ground Floor. RM.G-17 [030]		
Location/Element	Walls		
Notes			
Product Type	N/A	Score:	N/A
Damage/Deterioration	N/A	Score:	N/A
Surface Treatment	N/A	Score:	N/A
Asbestos Type		Score:	N/A
Extent			
Recommended Action	N/A	Total Score

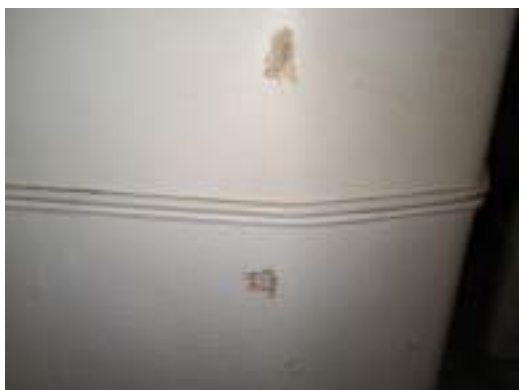
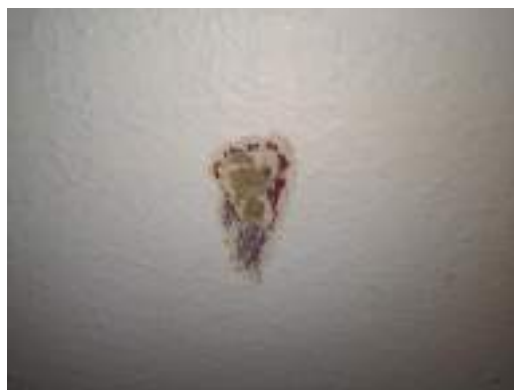
Inspection no:	S295	Type:	Sampled
Room/Area	Ground Floor. RM.G-18 [031]		
Location/Element	Paint to walls		
Notes			
Product Type	N/A	Score:	N/A
Damage/Deterioration	N/A	Score:	N/A
Surface Treatment	N/A	Score:	N/A
Asbestos Type	NAD	Score:	N/A
Extent	10 m ²		
Recommended Action	N/A	Total Score	0

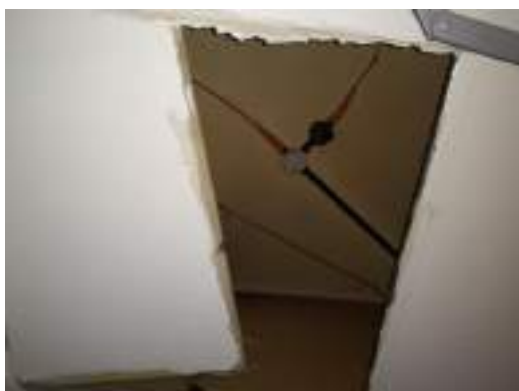
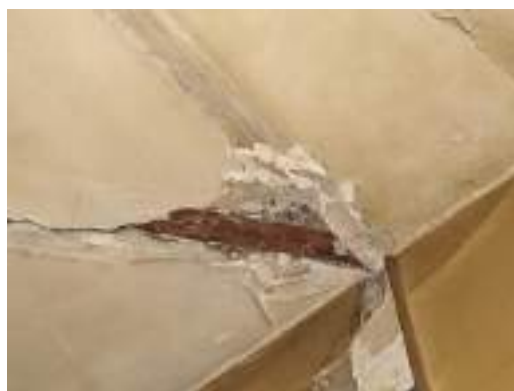
Inspection no:	S296	Type:	Sampled
Room/Area	Ground Floor. RM.G-18 [031]		
Location/Element	Paint to ceiling		
Notes			
Product Type	N/A	Score:	N/A
Damage/Deterioration	N/A	Score:	N/A
Surface Treatment	N/A	Score:	N/A
Asbestos Type	NAD	Score:	N/A
Extent	4 m ²		
Recommended Action	N/A	Total Score	0

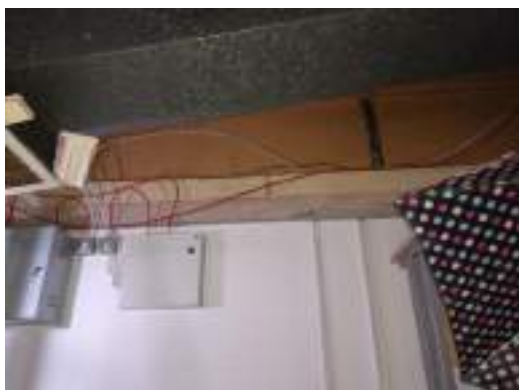
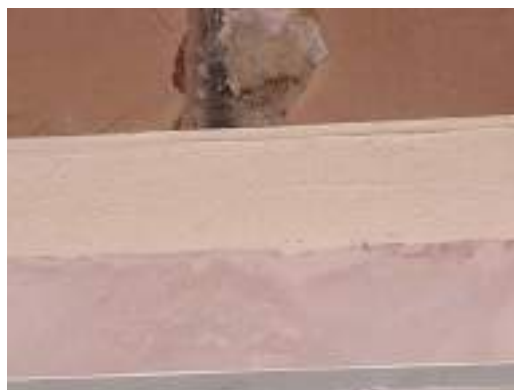
Inspection no:	R314	Type:	Referred Sample
Room/Area	Ground Floor. RM.G-19 [032]		
Location/Element	Textured paint to timber walls		
Notes			
Product Type	Textured Coating	Score:	1
Damage/Deterioration	Low Damage	Score:	1
Surface Treatment	Sealed	Score:	1
Asbestos Type	Chrysotile	Score:	1
Extent	30 m ²		
Recommended Action	Remove	Total Score	4

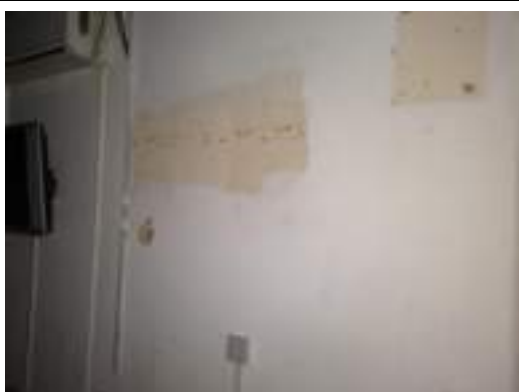
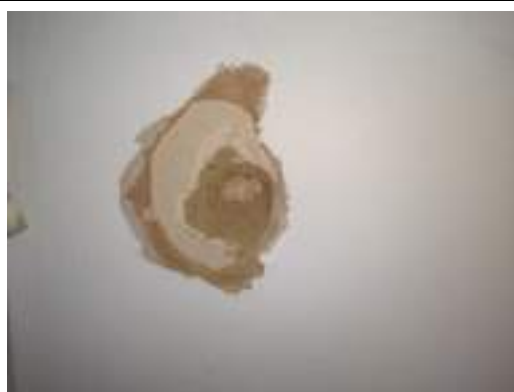
Inspection no:	S293	Type:	Sampled
Room/Area	Ground Floor. RM.G-19 [032]		
Location/Element	Paint to walls		
Notes			
Product Type	N/A	Score:	N/A
Damage/Deterioration	N/A	Score:	N/A
Surface Treatment	N/A	Score:	N/A
Asbestos Type	NAD	Score:	N/A
Extent	40 m ²		
Recommended Action	N/A	Total Score	0

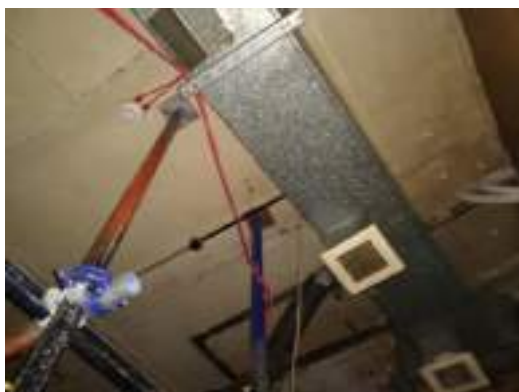
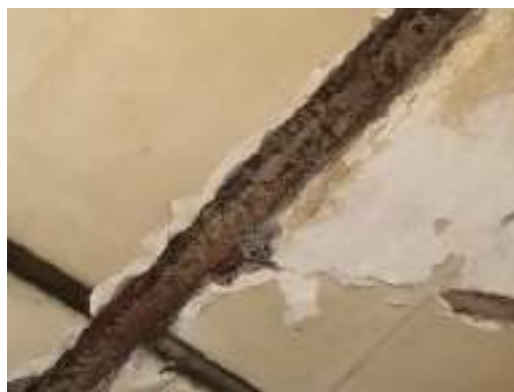
Inspection no:	S294	Type:	Sampled
Room/Area	Ground Floor. RM.G-19 [032]		
Location/Element	Paint to ceiling		
Notes			
Product Type	N/A	Score:	N/A
Damage/Deterioration	N/A	Score:	N/A
Surface Treatment	N/A	Score:	N/A
Asbestos Type	NAD	Score:	N/A
Extent	20 m ²		
Recommended Action	N/A	Total Score	0

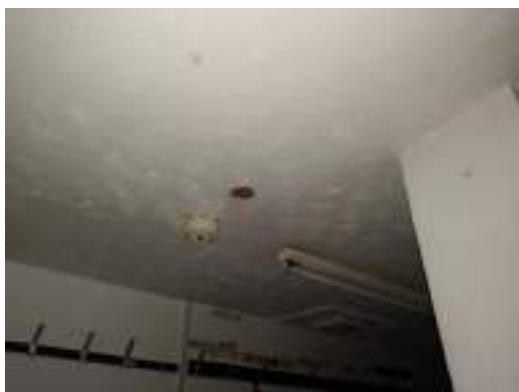
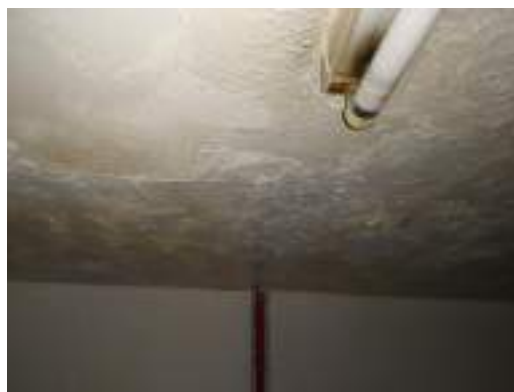
Inspection no:	S025	Type:	Sampled
Room/Area	Ground Floor. RM.G-20 [033]		
Location/Element	Textured coating to plasterboard ceiling		
Notes			
Product Type	N/A	Score:	N/A
Damage/Deterioration	N/A	Score:	N/A
Surface Treatment	N/A	Score:	N/A
Asbestos Type	NAD	Score:	N/A
Extent	6 m ²		
Recommended Action	N/A	Total Score	0

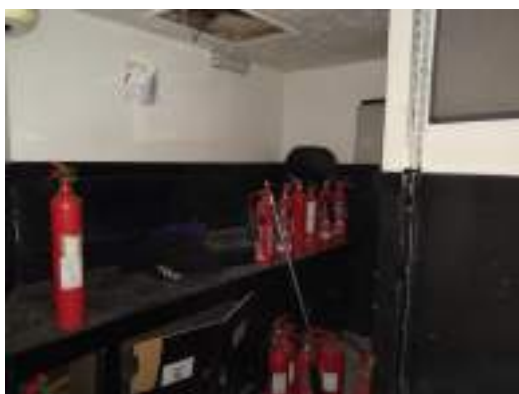
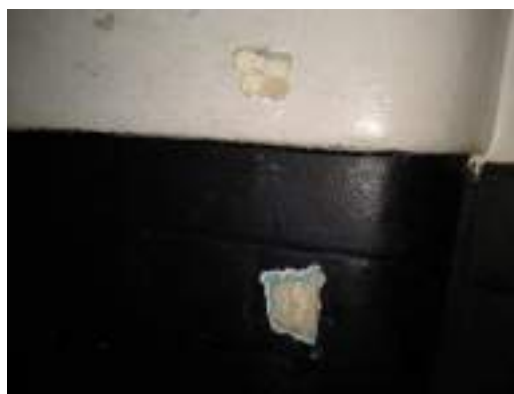
Inspection no:	S297	Type:	Sampled
Room/Area	Ground Floor. RM.G-20 [033]		
Location/Element	Paint to walls		
Notes			
Product Type	N/A	Score:	N/A
Damage/Deterioration	N/A	Score:	N/A
Surface Treatment	N/A	Score:	N/A
Asbestos Type	NAD	Score:	N/A
Extent	20 m ²		
Recommended Action	N/A	Total Score	0

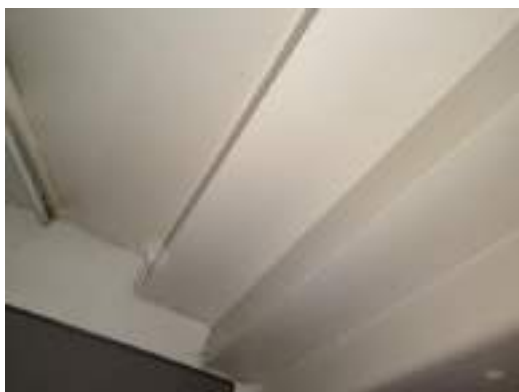
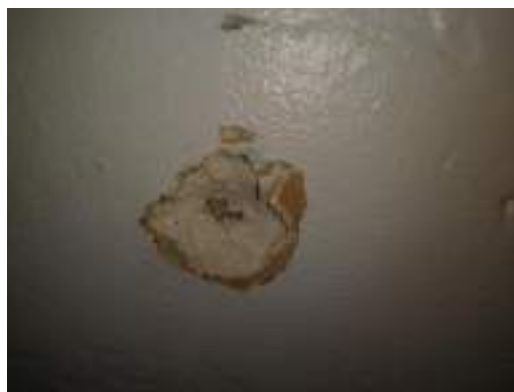
Inspection no:	S298	Type:	Sampled
Room/Area	Ground Floor. RM.G-20 [033]		
Location/Element	Paint to ceiling		
Notes			
Product Type	N/A	Score:	N/A
Damage/Deterioration	N/A	Score:	N/A
Surface Treatment	N/A	Score:	N/A
Asbestos Type	NAD	Score:	N/A
Extent	10 m ²		
Recommended Action	N/A	Total Score	0

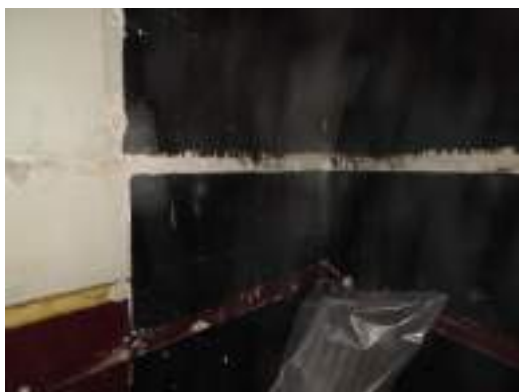
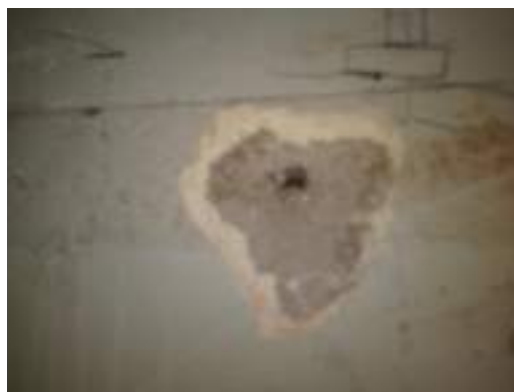
Inspection no:	S299	Type:	Sampled
Room/Area	Ground Floor. RM.G-15 [034]		
Location/Element	Paint to walls		
Notes			
Product Type	N/A	Score:	N/A
Damage/Deterioration	N/A	Score:	N/A
Surface Treatment	N/A	Score:	N/A
Asbestos Type	NAD	Score:	N/A
Extent	15 m ²		
Recommended Action	N/A	Total Score	0

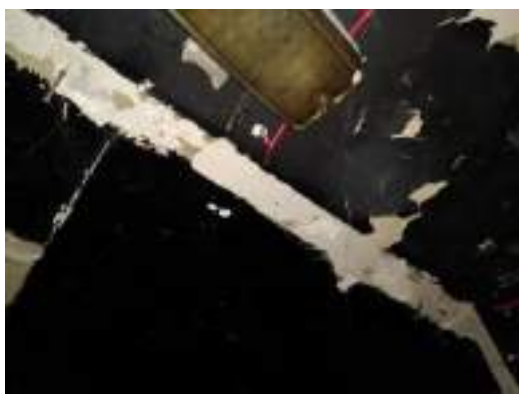
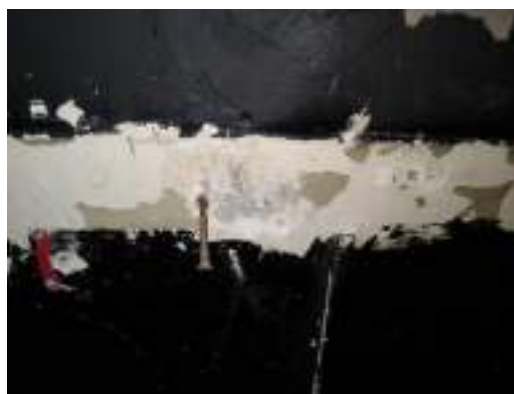
Inspection no:	S300	Type:	Sampled
Room/Area	Ground Floor. RM.G-15 [034]		
Location/Element	Paint to ceiling		
Notes			
Product Type	N/A	Score:	N/A
Damage/Deterioration	N/A	Score:	N/A
Surface Treatment	N/A	Score:	N/A
Asbestos Type	NAD	Score:	N/A
Extent	6 m ²		
Recommended Action	N/A	Total Score	0

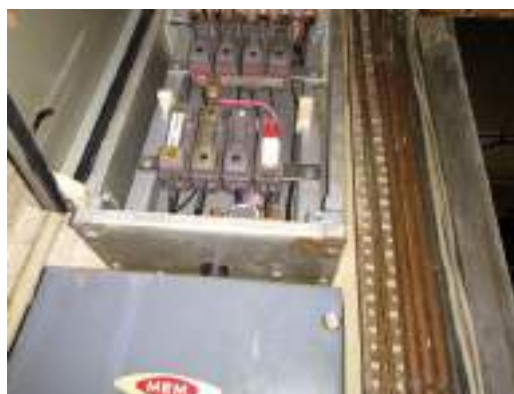
Inspection no:	S026	Type:	Sampled
Room/Area	Ground Floor. RM.G-16 [035]		
Location/Element	Textiles within electrical units		
Notes			
Product Type	Textile Flash Guard	Score:	2
Damage/Deterioration	Low Damage	Score:	1
Surface Treatment	Sealed	Score:	1
Asbestos Type	Chrysotile	Score:	1
Extent	4 units no		
Recommended Action	Remove	Total Score	5

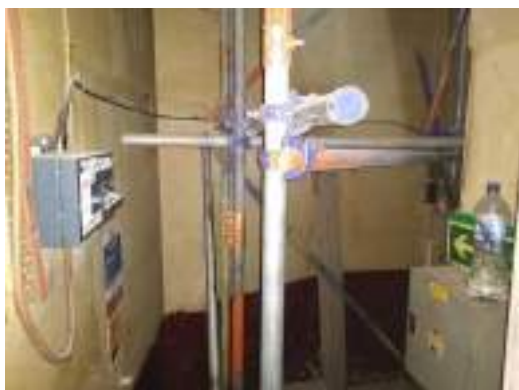
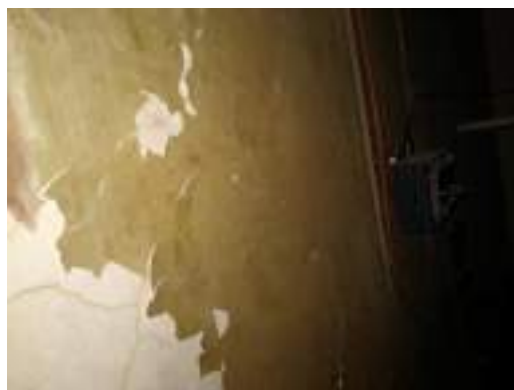
Inspection no:	S301	Type:	Sampled
Room/Area	Ground Floor. RM.G-16 [035]		
Location/Element	Paint to walls		
Notes			
Product Type	N/A	Score:	N/A
Damage/Deterioration	N/A	Score:	N/A
Surface Treatment	N/A	Score:	N/A
Asbestos Type	NAD	Score:	N/A
Extent	20 m ²		
Recommended Action	N/A	Total Score	0

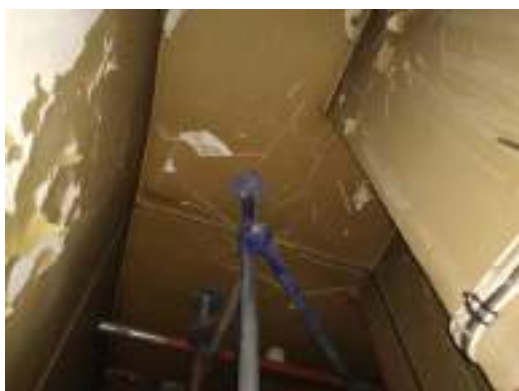
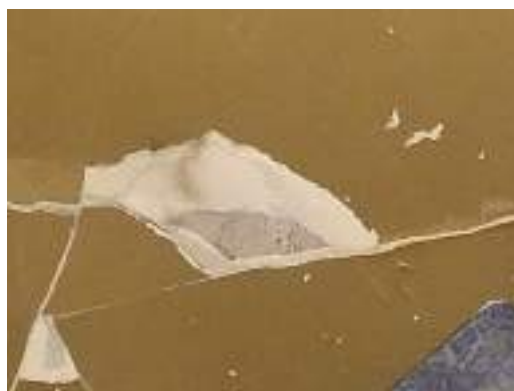
Inspection no:	S303	Type:	Sampled
Room/Area	Ground Floor. RM.G-16 [035]		
Location/Element	Paint to ceiling		
Notes			
Product Type	N/A	Score:	N/A
Damage/Deterioration	N/A	Score:	N/A
Surface Treatment	N/A	Score:	N/A
Asbestos Type	NAD	Score:	N/A
Extent	5 m ²		
Recommended Action	N/A	Total Score	0

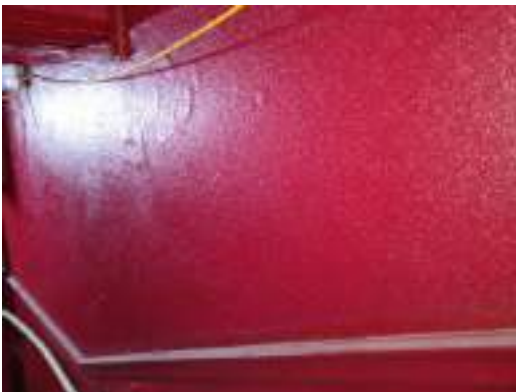
Inspection no:	R307	Type:	Referred Sample
Room/Area	Ground Floor. RM.G-14 [036]		
Location/Element	Textured paint to walls		
Notes			
Product Type	Textured Coating	Score:	1
Damage/Deterioration	Low Damage	Score:	1
Surface Treatment	Sealed	Score:	1
Asbestos Type	Chrysotile	Score:	1
Extent	50 m ²		
Recommended Action	Remove	Total Score	4

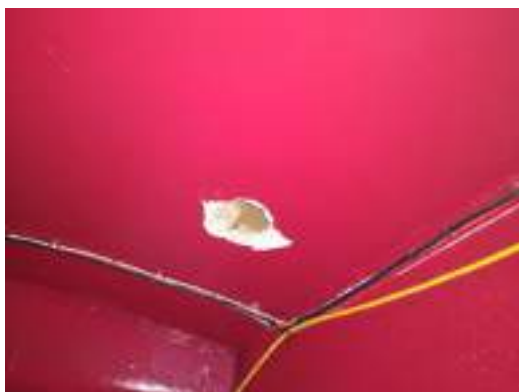
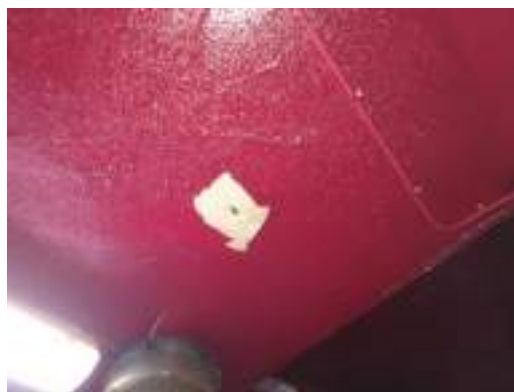
Inspection no:	S302	Type:	Sampled
Room/Area	Ground Floor. RM.G-14 [036]		
Location/Element	Paint to ceiling		
Notes			
Product Type	N/A	Score:	N/A
Damage/Deterioration	N/A	Score:	N/A
Surface Treatment	N/A	Score:	N/A
Asbestos Type	NAD	Score:	N/A
Extent	10 m ²		
Recommended Action	N/A	Total Score	0

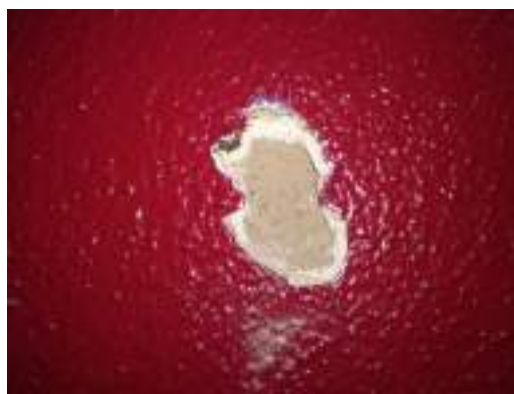
Inspection no:	S306	Type:	Sampled
Room/Area	Ground Floor. RM.G-14 [036]		
Location/Element	Textured coating under paint		
Notes			
Product Type	Textured Coating	Score:	1
Damage/Deterioration	Low Damage	Score:	1
Surface Treatment	Sealed	Score:	1
Asbestos Type	Chrysotile	Score:	1
Extent	15 m ²		
Recommended Action	Remove	Total Score	4

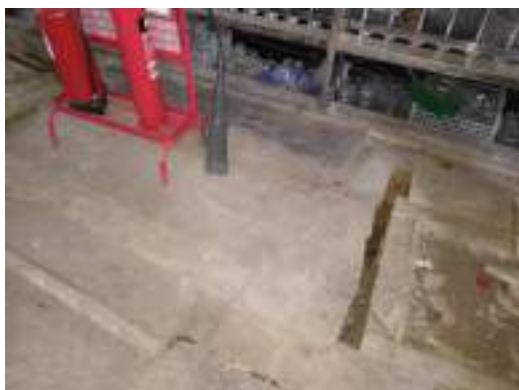
Inspection no:	P003	Type:	Presumed
Room/Area	1st Floor. RM.1-12 [037]		
Location/Element	Insulating board beneath timber floor		
Notes	Presumed as unable to lift up due to evidence throughout building of AIB nailed directly to timber floor. Debris will be present throughout void.		
Product Type	Insulating Board	Score:	2
Damage/Deterioration	High Damage	Score:	3
Surface Treatment	Partially Unsealed	Score:	2
Asbestos Type	Amosite	Score:	2
Extent	60 m ²		
Recommended Action	Remove	Total Score	9

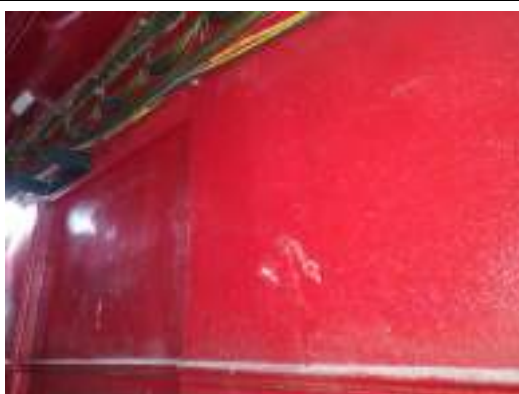
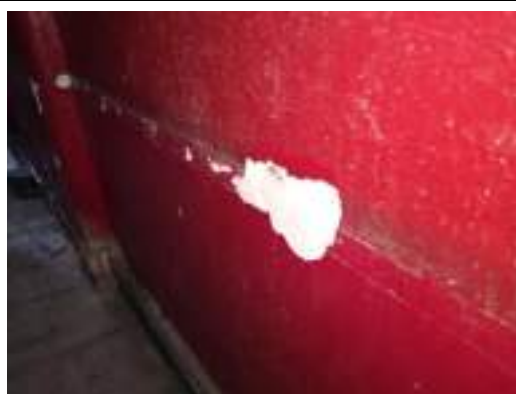
Inspection no:	S027	Type:	Sampled
Room/Area	1st Floor. RM.1-12 [037]		
Location/Element	Textured paint to brick walls		
Notes			
Product Type	N/A	Score:	N/A
Damage/Deterioration	N/A	Score:	N/A
Surface Treatment	N/A	Score:	N/A
Asbestos Type	NAD	Score:	N/A
Extent	80 m ²		
Recommended Action	N/A	Total Score	0

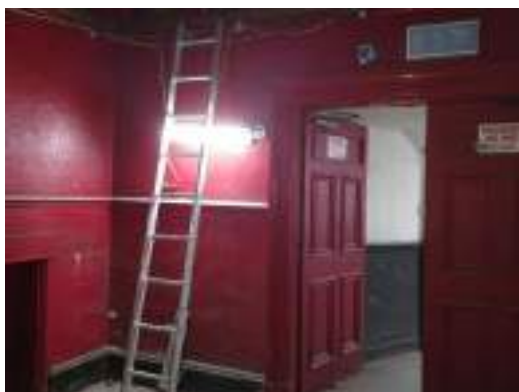
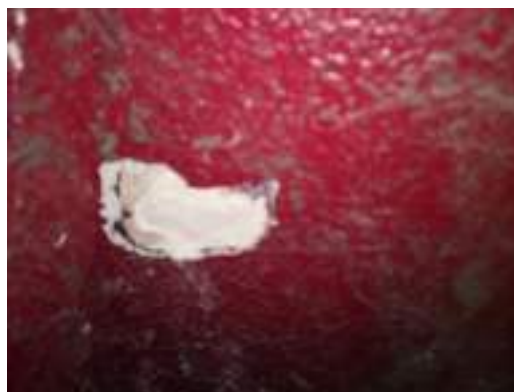
Inspection no:	S258	Type:	Sampled
Room/Area	1st Floor. RM.1-12 [037]		
Location/Element	Textured coating under paint		
Notes			
Product Type	Textured Coating	Score:	1
Damage/Deterioration	Low Damage	Score:	1
Surface Treatment	Sealed	Score:	1
Asbestos Type	Chrysotile	Score:	1
Extent	20 m ²		
Recommended Action	Remove	Total Score	4

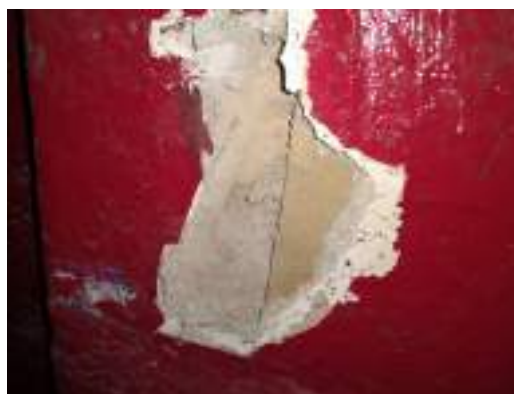
Inspection no:	S260	Type:	Sampled
Room/Area	1st Floor. RM.1-12 [037]		
Location/Element	Textured coating under paint		
Notes			
Product Type	Textured Coating	Score:	1
Damage/Deterioration	Low Damage	Score:	1
Surface Treatment	Sealed	Score:	1
Asbestos Type	Chrysotile	Score:	1
Extent	100 m ²		
Recommended Action	Remove	Total Score	4

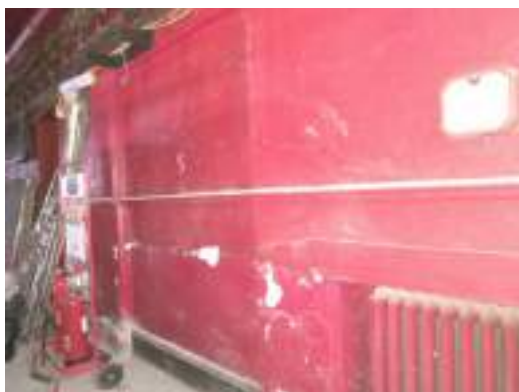
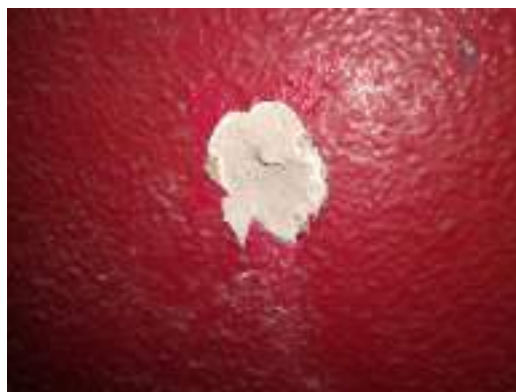
Inspection no:	S262	Type:	Sampled
Room/Area	1st Floor. RM.1-12 [037]		
Location/Element	Textured coating under paint		
Notes			
Product Type	Textured Coating	Score:	1
Damage/Deterioration	Low Damage	Score:	1
Surface Treatment	Sealed	Score:	1
Asbestos Type	Chrysotile	Score:	1
Extent	100 m ²		
Recommended Action	Remove	Total Score	4

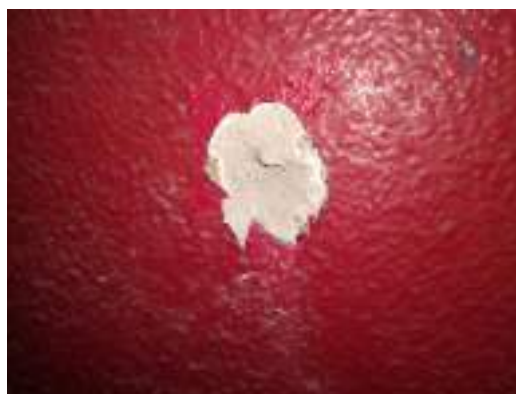
Inspection no:	S263	Type:	Sampled
Room/Area	1st Floor. RM.1-12 [037]		
Location/Element	Textured coating under paint		
Notes			
Product Type	Textured Coating	Score:	1
Damage/Deterioration	Low Damage	Score:	1
Surface Treatment	Sealed	Score:	1
Asbestos Type	Chrysotile	Score:	1
Extent	20 m ²		
Recommended Action	Remove	Total Score	4

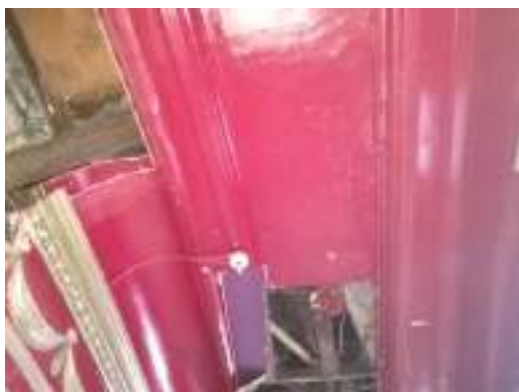
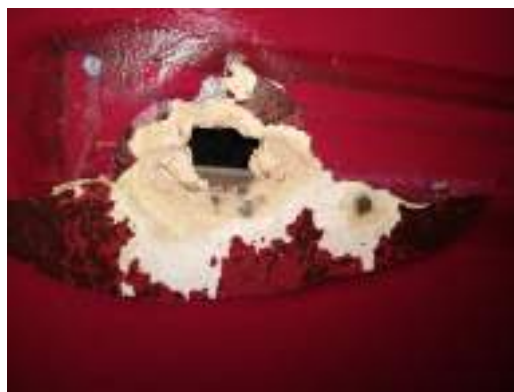
Inspection no:	S265	Type:	Sampled
Room/Area	1st Floor. RM.1-12 [037]		
Location/Element	Paint to ceiling		
Notes			
Product Type	N/A	Score:	N/A
Damage/Deterioration	N/A	Score:	N/A
Surface Treatment	N/A	Score:	N/A
Asbestos Type	NAD	Score:	N/A
Extent	100 m ²		
Recommended Action	N/A	Total Score	0

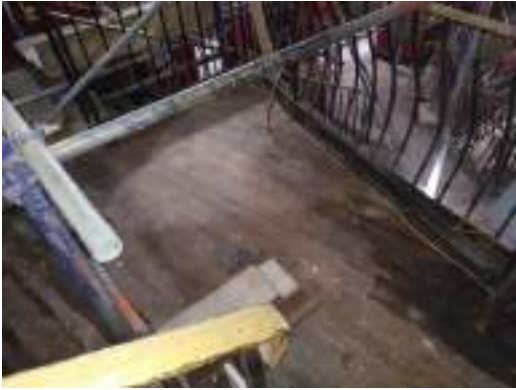
Inspection no:	P004	Type:	Presumed
Room/Area	1st Floor. RM.1-11 [038]		
Location/Element	Insulating board beneath timber floor		
Notes	Presumed as unable to lift up due to evidence throughout building of AIB nailed directly to timber floor. Debris will be present throughout void.		
Product Type	Insulating Board	Score:	2
Damage/Deterioration	High Damage	Score:	3
Surface Treatment	Partially Unsealed	Score:	2
Asbestos Type	Amosite	Score:	2
Extent	150 m ²		
Recommended Action	Remove	Total Score	9

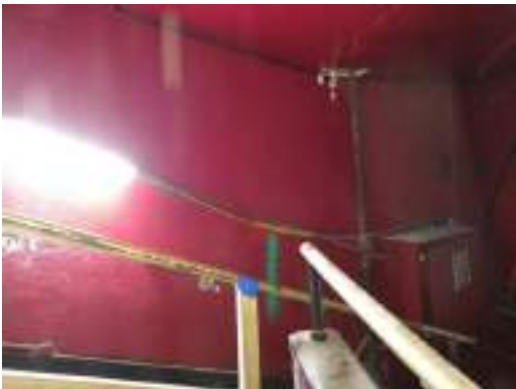
Inspection no:	R258	Type:	Referred Sample
Room/Area	1st Floor. RM.1-11 [038]		
Location/Element	Textured paint to brick walls		
Notes			
Product Type	Textured Coating	Score:	1
Damage/Deterioration	Medium Damage	Score:	2
Surface Treatment	Sealed	Score:	1
Asbestos Type	Chrysotile	Score:	1
Extent	30 m ²		
Recommended Action	Remove	Total Score	5

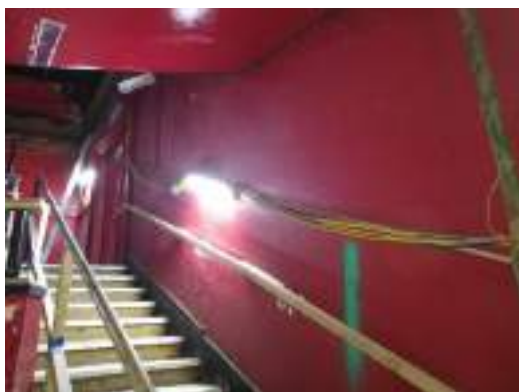
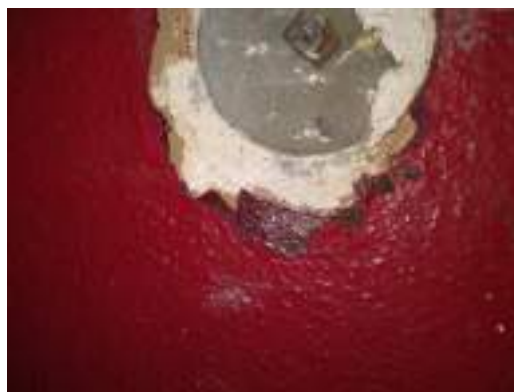
Inspection no:	S256	Type:	Sampled
Room/Area	1st Floor. RM.1-11 [038]		
Location/Element	Paint to walls		
Notes			
Product Type	Textured Coating	Score:	1
Damage/Deterioration	Low Damage	Score:	1
Surface Treatment	Sealed	Score:	1
Asbestos Type	Chrysotile	Score:	1
Extent	100 m ²		
Recommended Action	Remove	Total Score	4

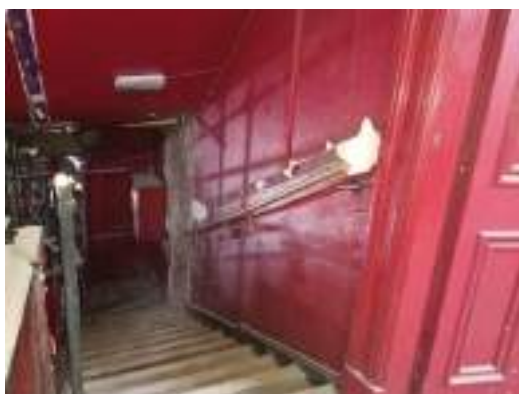
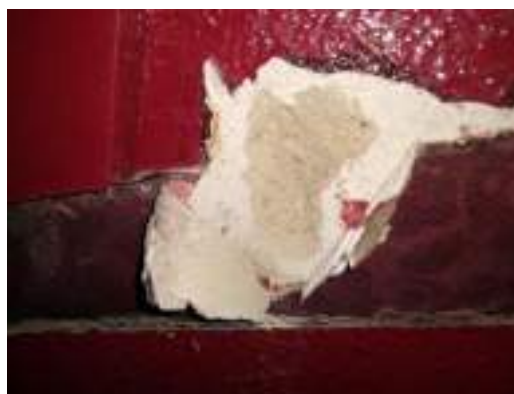
Inspection no:	S264	Type:	Sampled
Room/Area	1st Floor. RM.1-11 [038]		
Location/Element	Paint to walls		
Notes			
Product Type	Textured Coating	Score:	1
Damage/Deterioration	Low Damage	Score:	1
Surface Treatment	Sealed	Score:	1
Asbestos Type	Chrysotile	Score:	1
Extent	100 m ²		
Recommended Action	Remove	Total Score	4

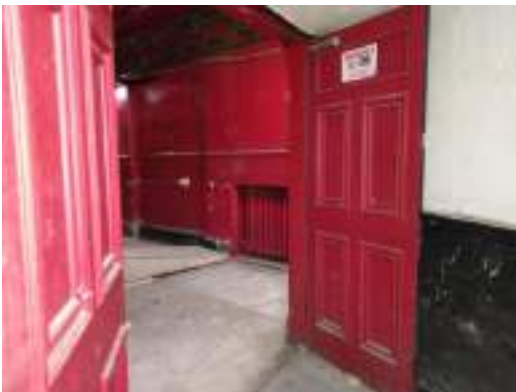
Inspection no:	S028	Type:	Sampled
Room/Area	1st Floor. RM.1-16 [039]		
Location/Element	Infill panels to doors		
Notes			
Product Type	Insulating Board	Score:	2
Damage/Deterioration	Low Damage	Score:	1
Surface Treatment	Sealed	Score:	1
Asbestos Type	Chrysotile	Score:	1
Extent	2 no		
Recommended Action	Remove	Total Score	5

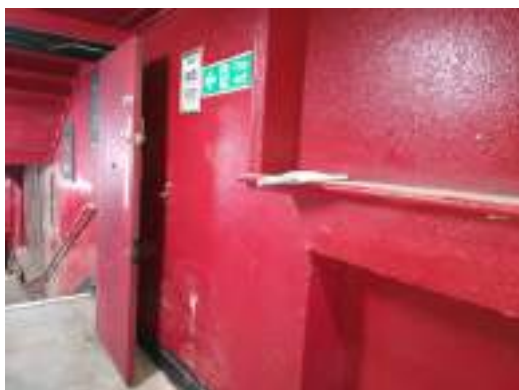
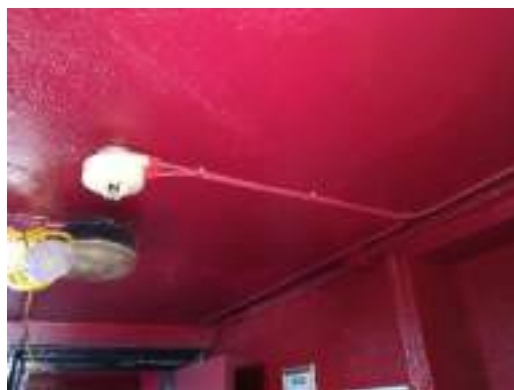
Inspection no:	R258	Type:	Referred Sample
Room/Area	1st Floor. RM.1-10 [041]		
Location/Element	Textured paint to brick walls and concrete ceiling		
Notes			
Product Type	Textured Coating	Score:	1
Damage/Deterioration	Low Damage	Score:	1
Surface Treatment	Sealed	Score:	1
Asbestos Type	Chrysotile	Score:	1
Extent	15 m ²		
Recommended Action	Remove	Total Score	4

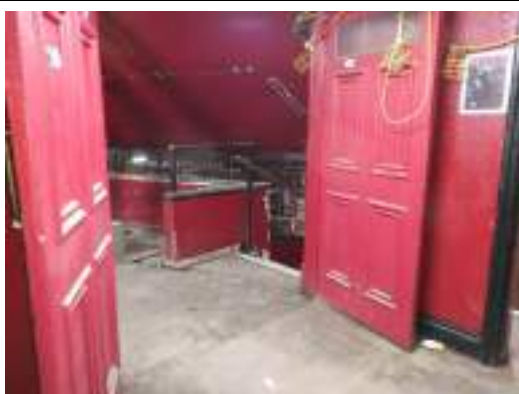
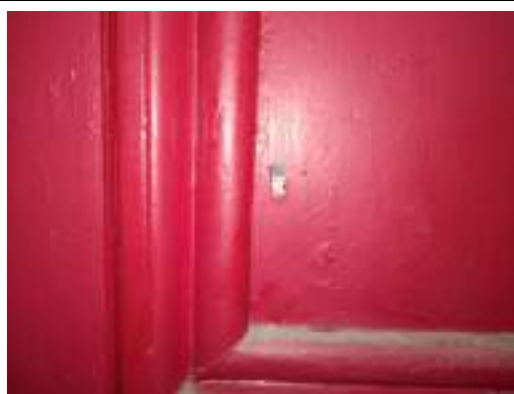
Inspection no:	R028	Type:	Referred Sample
Room/Area	1st Floor. RM.1-10 [041]		
Location/Element	Infill panels to doors		
Notes			
Product Type	Insulating Board	Score:	2
Damage/Deterioration	Low Damage	Score:	1
Surface Treatment	Sealed	Score:	1
Asbestos Type	Chrysotile	Score:	1
Extent	2 no		
Recommended Action	Remove	Total Score	5
