Asbestos Survey Report

ASBESTOS SURVEY
REPORT NO: A-44387 – ISSUE 6

DATE ISSUED: 06/08/2020

Site Address:
KoKo Night Club
Heritage Areas Survey
1A Camden High St
London
NW1 7JE

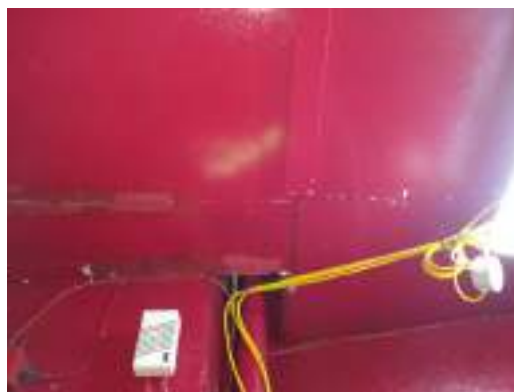
Inspection no:	S029	Type:	Sampled
Room/Area	1st Floor. RM.1-10 [041]		
Location/Element	Suspended ceiling		
Notes			
Product Type	N/A	Score:	N/A
Damage/Deterioration	N/A	Score:	N/A
Surface Treatment	N/A	Score:	N/A
Asbestos Type	NAD	Score:	N/A
Extent	4 m ²		
Recommended Action	N/A	Total Score	0

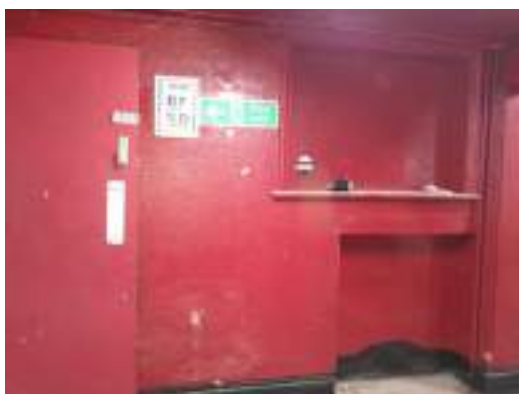
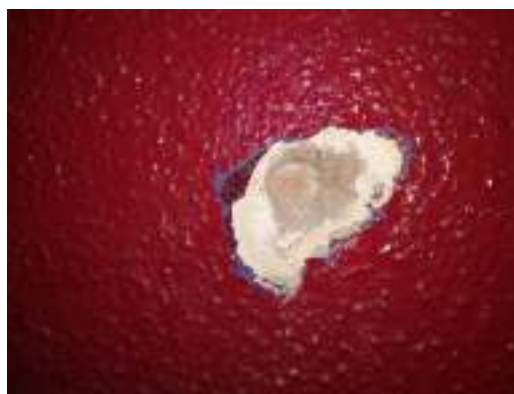
Inspection no:	S266	Type:	Sampled
Room/Area	1st Floor. RM.1-10 [041]		
Location/Element	Paint to walls		
Notes			
Product Type	Textured Coating	Score:	1
Damage/Deterioration	Low Damage	Score:	1
Surface Treatment	Sealed	Score:	1
Asbestos Type	Chrysotile	Score:	1
Extent	10 m ²		
Recommended Action	Remove	Total Score	4

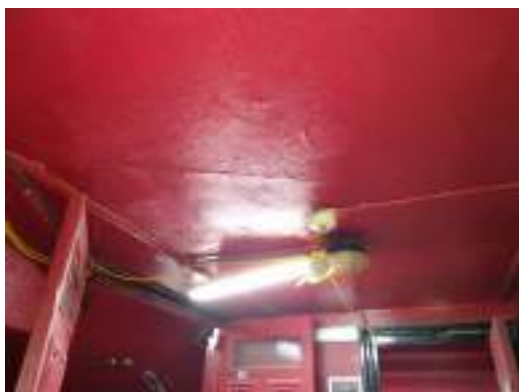
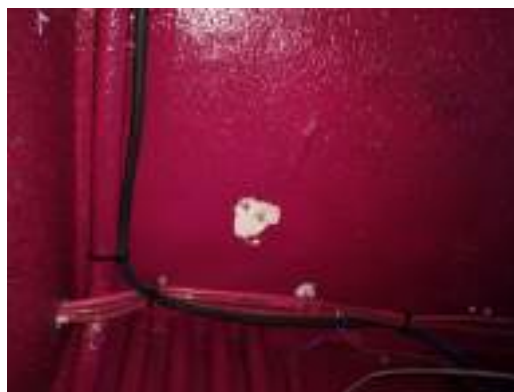
Inspection no:	S267	Type:	Sampled
Room/Area	1st Floor. RM.1-10 [041]		
Location/Element	Paint to ceiling		
Notes			
Product Type	N/A	Score:	N/A
Damage/Deterioration	N/A	Score:	N/A
Surface Treatment	N/A	Score:	N/A
Asbestos Type	NAD	Score:	N/A
Extent	4 m ²		
Recommended Action	N/A	Total Score	0

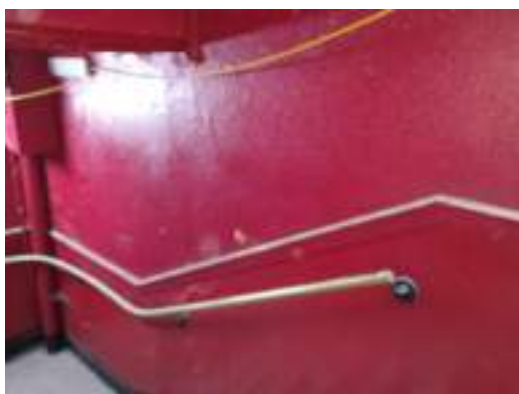
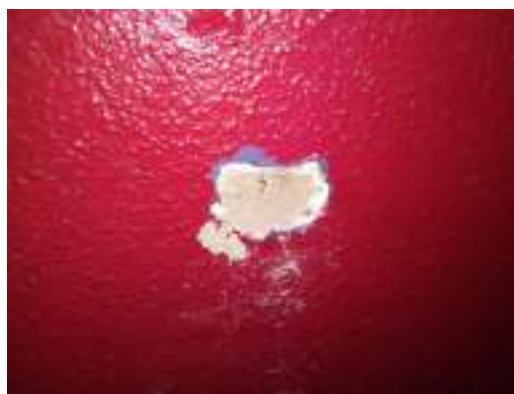
Inspection no:	S268	Type:	Sampled
Room/Area	1st Floor. RM.1-10 [041]		
Location/Element	Paint to walls		
Notes			
Product Type	Textured Coating	Score:	1
Damage/Deterioration	Low Damage	Score:	1
Surface Treatment	Sealed	Score:	1
Asbestos Type	Chrysotile	Score:	1
Extent	20 m ²		
Recommended Action	Remove	Total Score	4

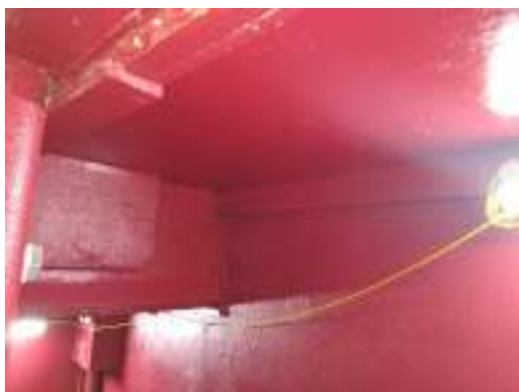
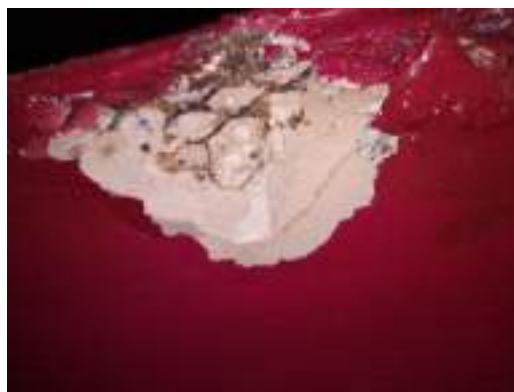
Inspection no:	S269	Type:	Sampled
Room/Area	1st Floor. RM.1-10 [041]		
Location/Element	Paint to ceiling		
Notes			
Product Type	N/A	Score:	N/A
Damage/Deterioration	N/A	Score:	N/A
Surface Treatment	N/A	Score:	N/A
Asbestos Type	NAD	Score:	N/A
Extent	10 m ²		
Recommended Action	N/A	Total Score	0

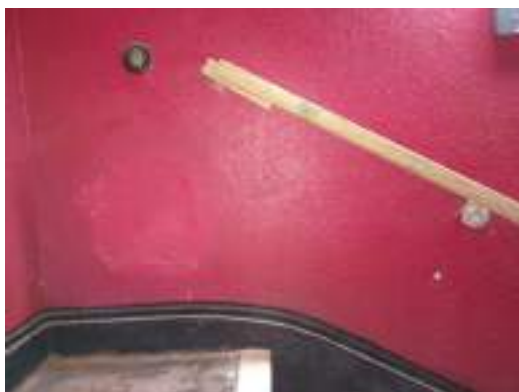
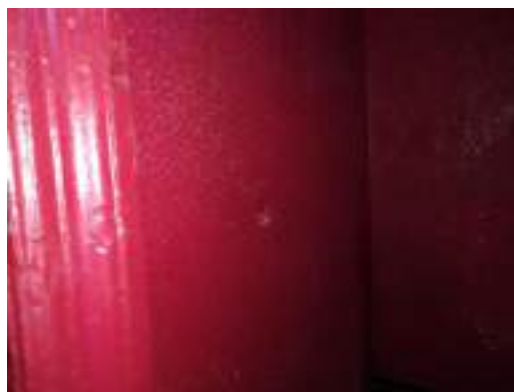
Inspection no:	R258	Type:	Referred Sample
Room/Area	1st Floor. RM.1-09 [042]		
Location/Element	Textured paint to brick walls and concrete ceiling		
Notes			
Product Type	Textured Coating	Score:	1
Damage/Deterioration	Low Damage	Score:	1
Surface Treatment	Sealed	Score:	1
Asbestos Type	Chrysotile	Score:	1
Extent	5 m ²		
Recommended Action	Remove	Total Score	4

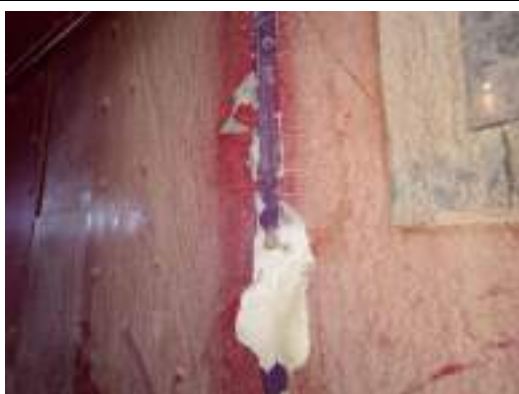
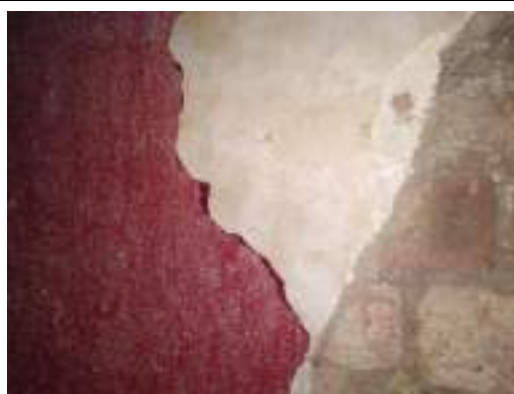
Inspection no:	S270	Type:	Sampled
Room/Area	1st Floor. RM.1-09 [042]		
Location/Element	Paint to walls		
Notes			
Product Type	Textured Coating	Score:	1
Damage/Deterioration	Low Damage	Score:	1
Surface Treatment	Sealed	Score:	1
Asbestos Type	Chrysotile	Score:	1
Extent	20 m ²		
Recommended Action	Remove	Total Score	4

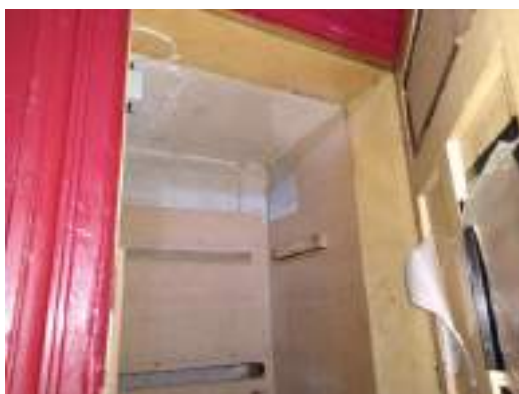
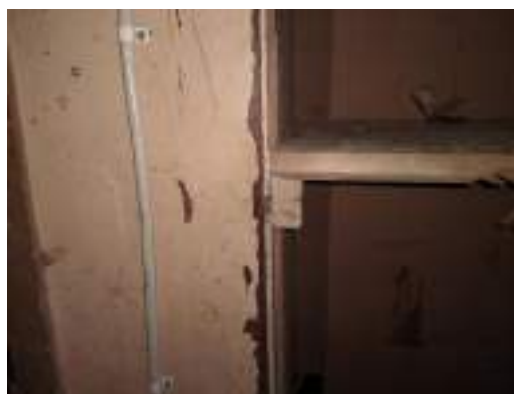
Inspection no:	S030	Type:	Sampled
Room/Area	1st Floor. RM.1-14 [043]		
Location/Element	Ceiling and wall lining to cupboard		
Notes			
Product Type	Insulating Board	Score:	2
Damage/Deterioration	Low Damage	Score:	1
Surface Treatment	Sealed	Score:	1
Asbestos Type	Amosite, Chrysotile	Score:	2
Extent	6 m ²		
Recommended Action	Remove	Total Score	6

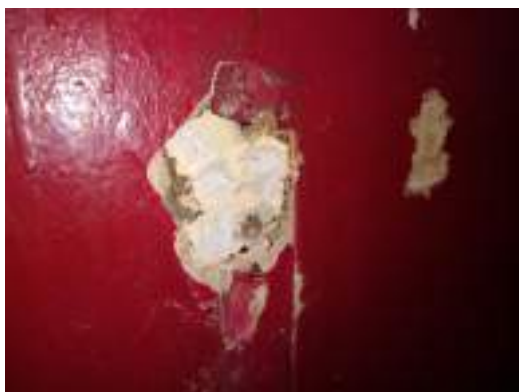
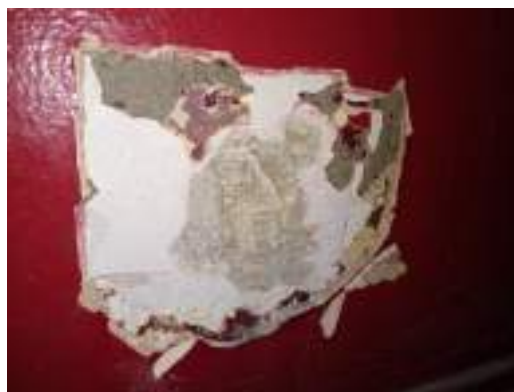
Inspection no:	S257	Type:	Sampled
Room/Area	1st Floor. RM.1-14 [043]		
Location/Element	Paint to walls		
Notes			
Product Type	Textured Coating	Score:	1
Damage/Deterioration	Low Damage	Score:	1
Surface Treatment	Sealed	Score:	1
Asbestos Type	Chrysotile	Score:	1
Extent	50 m ²		
Recommended Action	Remove	Total Score	4

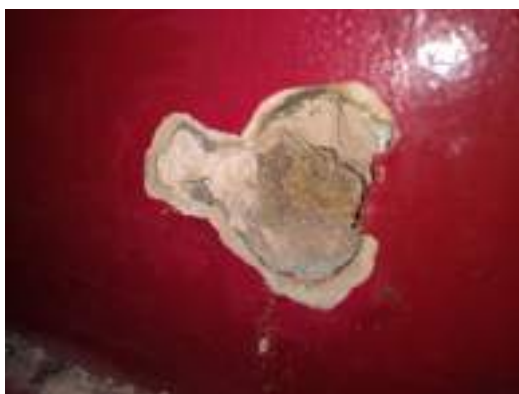
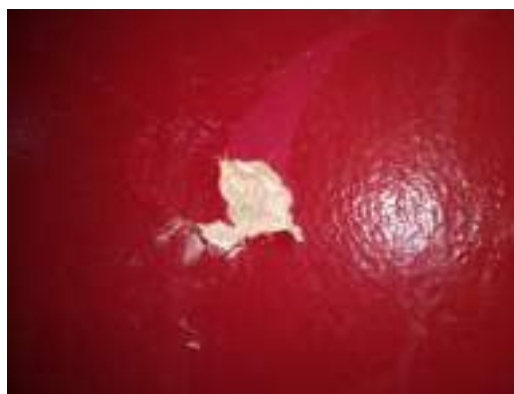
Inspection no:	S259	Type:	Sampled
Room/Area	1st Floor. RM.1-14 [043]		
Location/Element	Paint to walls		
Notes			
Product Type	Textured Coating	Score:	1
Damage/Deterioration	Low Damage	Score:	1
Surface Treatment	Sealed	Score:	1
Asbestos Type	Chrysotile	Score:	1
Extent	50 m ²		
Recommended Action	Remove	Total Score	4

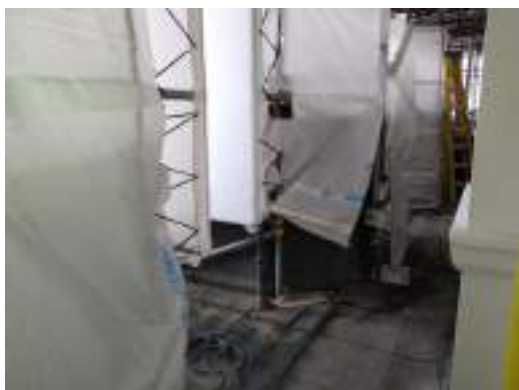
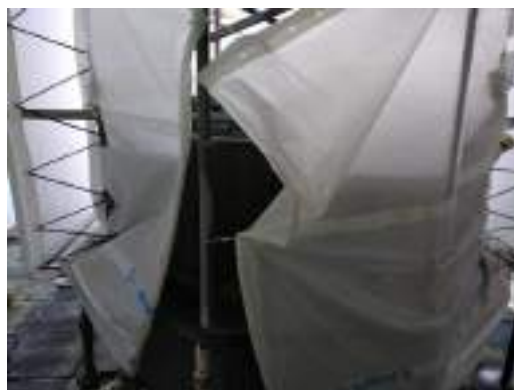
Inspection no:	P005	Type:	Presumed
Room/Area	1st Floor. RM.1-14 - Balcony [044]		
Location/Element	Rope seal to skylights		
Notes	Presumed to contain asbestos as unable to gain access to skylight as has been scaffolded out. Unable to identify presence from internal ground floor.		
Product Type	Rope Seal	Score:	2
Damage/Deterioration	Low Damage	Score:	1
Surface Treatment	Sealed	Score:	1
Asbestos Type	Chrysotile	Score:	1
Extent	3 no		
Recommended Action	Remove	Total Score	5

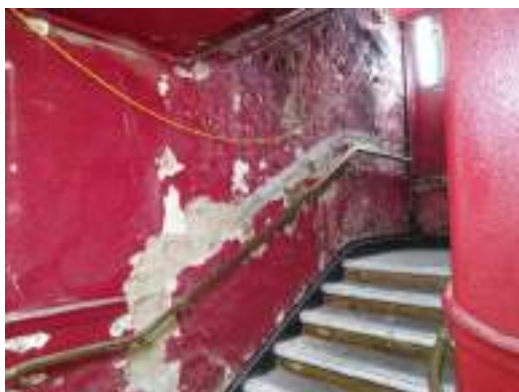
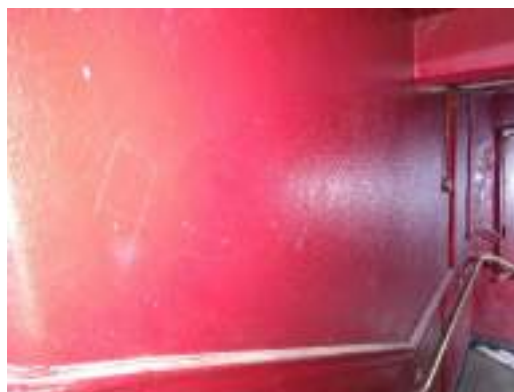
Inspection no:	R258	Type:	Referred Sample
Room/Area	1st Floor. RM.1-15 [045]		
Location/Element	Textured paint to brick walls and concrete ceiling		
Notes			
Product Type	Textured Coating	Score:	1
Damage/Deterioration	Medium Damage	Score:	2
Surface Treatment	Sealed	Score:	1
Asbestos Type	Chrysotile	Score:	1
Extent	40 m ²		
Recommended Action	Remove	Total Score	5

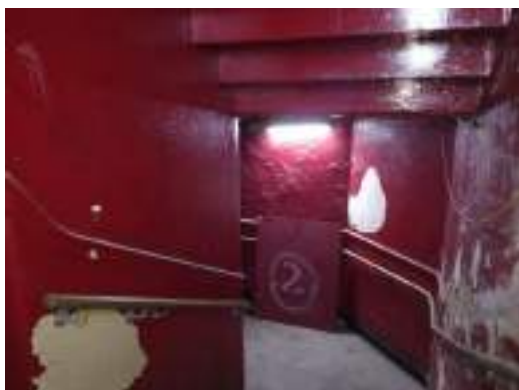
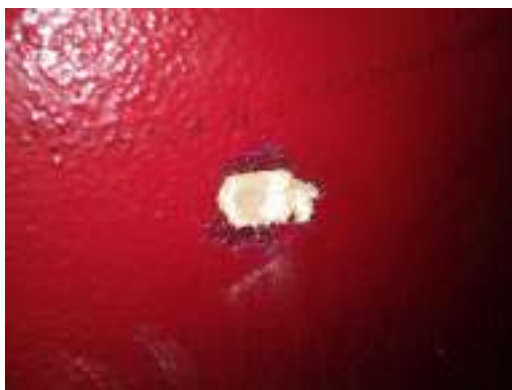
Inspection no:	S254	Type:	Sampled
Room/Area	1st Floor. RM.1-15 [045]		
Location/Element	Paint to walls		
Notes			
Product Type	Paint	Score:	1
Damage/Deterioration	Low Damage	Score:	1
Surface Treatment	Self Sealed	Score:	0
Asbestos Type	Chrysotile	Score:	1
Extent	20 m ²		
Recommended Action	Remove	Total Score	3

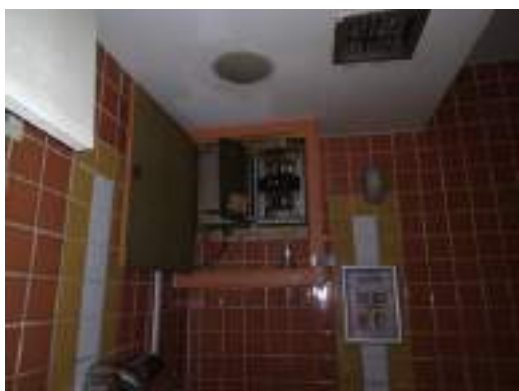
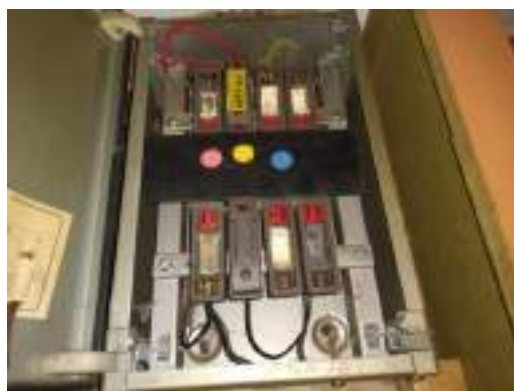
Inspection no:	S031	Type:	Sampled
Room/Area	1st Floor. WC [046]		
Location/Element	Flashguards within electrical units		
Notes			
Product Type	Textile Flash Guard	Score:	2
Damage/Deterioration	Low Damage	Score:	1
Surface Treatment	Partially Unsealed	Score:	2
Asbestos Type	Chrysotile	Score:	1
Extent	2 no		
Recommended Action	Remove	Total Score	6

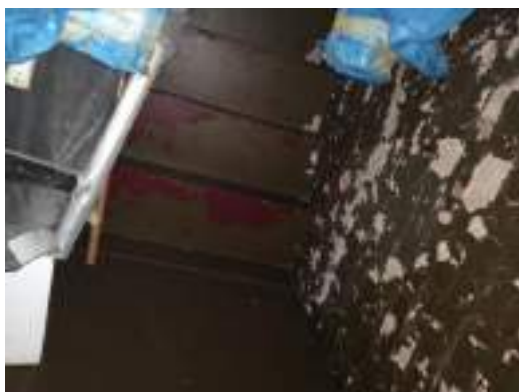
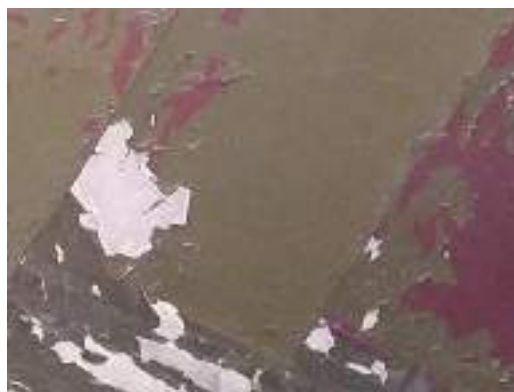
Inspection no:	S171	Type:	Sampled
Room/Area	2nd Floor. RM.2-14 [048]		
Location/Element	Paint to walls		
Notes	Sampled from all walls back to substrate.		
Product Type	N/A	Score:	N/A
Damage/Deterioration	N/A	Score:	N/A
Surface Treatment	N/A	Score:	N/A
Asbestos Type	NAD	Score:	N/A
Extent	60 m ²		
Recommended Action	N/A	Total Score	0

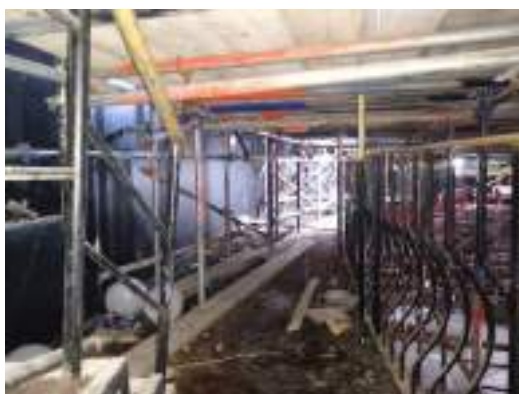
Inspection no:	S172	Type:	Sampled
Room/Area	2nd Floor. RM.2-14 [048]		
Location/Element	Paint to ceiling		
Notes	Sampled back to substrate.		
Product Type	N/A	Score:	N/A
Damage/Deterioration	N/A	Score:	N/A
Surface Treatment	N/A	Score:	N/A
Asbestos Type	NAD	Score:	N/A
Extent	40 m ²		
Recommended Action	N/A	Total Score	0

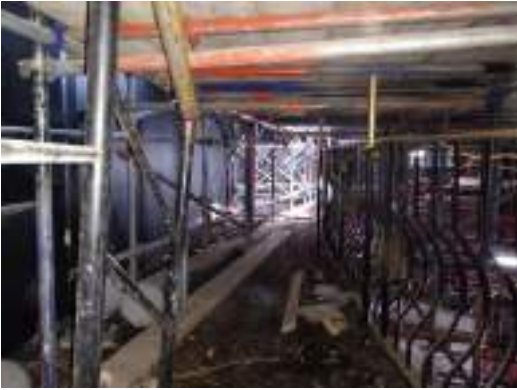
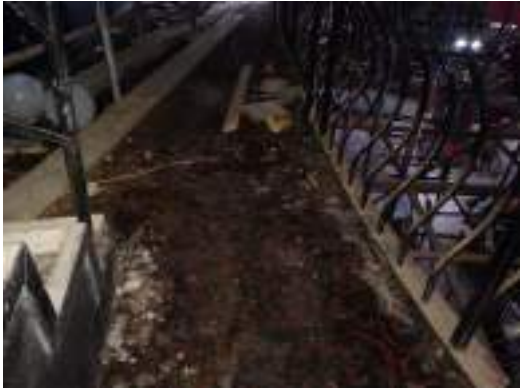
Inspection no:	P006	Type:	Presumed
Room/Area	2nd Floor. RM.2-15 [049]		
Location/Element	Insulating board beneath timber floor		
Notes	Presumed as unable to lift up due to evidence throughout building of AIB nailed directly to timber floor. Debris will be present throughout void.		
Product Type	Insulating Board	Score:	2
Damage/Deterioration	High Damage	Score:	3
Surface Treatment	Partially Unsealed	Score:	2
Asbestos Type	Amosite	Score:	2
Extent	150 m ²		
Recommended Action	Remove	Total Score	9

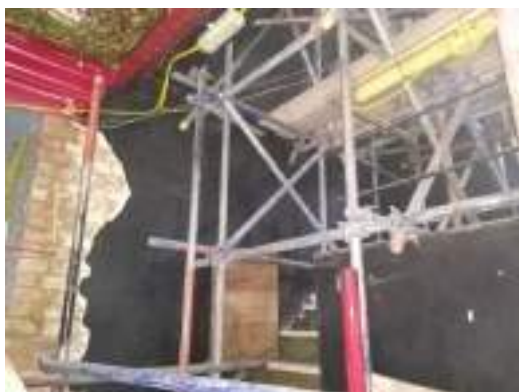
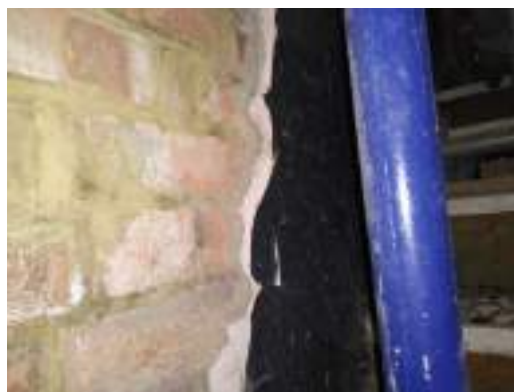
Inspection no:	S173	Type:	Sampled
Room/Area	2nd Floor. RM.2-15 [049]		
Location/Element	Textured paint to walls		
Notes			
Product Type	N/A	Score:	N/A
Damage/Deterioration	N/A	Score:	N/A
Surface Treatment	N/A	Score:	N/A
Asbestos Type	NAD	Score:	N/A
Extent	30 m ²		
Recommended Action	N/A	Total Score	0

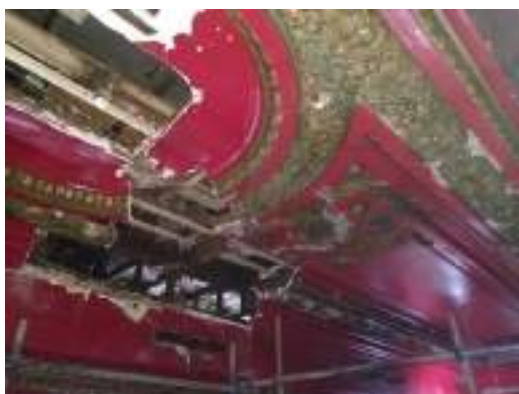
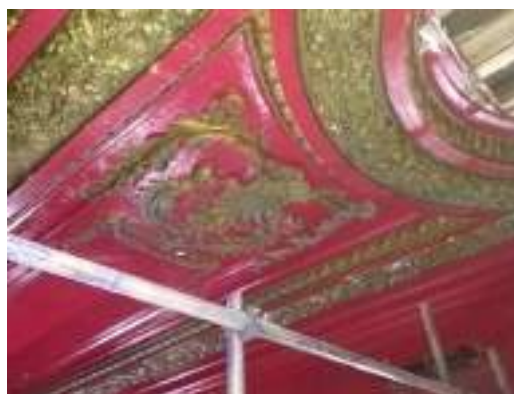
Inspection no:	S174	Type:	Sampled
Room/Area	2nd Floor. RM.2-15 [049]		
Location/Element	Textured paint to walls		
Notes			
Product Type	N/A	Score:	N/A
Damage/Deterioration	N/A	Score:	N/A
Surface Treatment	N/A	Score:	N/A
Asbestos Type	NAD	Score:	N/A
Extent	100+ m ²		
Recommended Action	N/A	Total Score	0

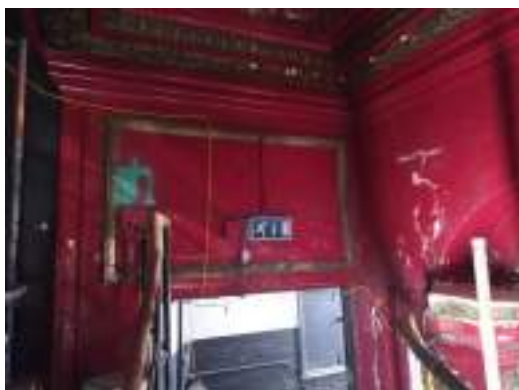
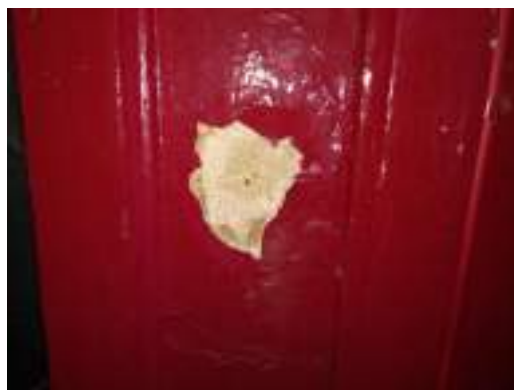
Inspection no:	S175	Type:	Sampled
Room/Area	2nd Floor. RM.2-15 [049]		
Location/Element	Textured paint to ceiling		
Notes			
Product Type	N/A	Score:	N/A
Damage/Deterioration	N/A	Score:	N/A
Surface Treatment	N/A	Score:	N/A
Asbestos Type	NAD	Score:	N/A
Extent	100+ m ²		
Recommended Action	N/A	Total Score	0

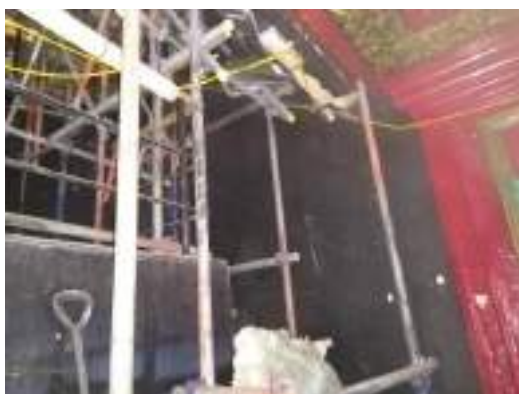
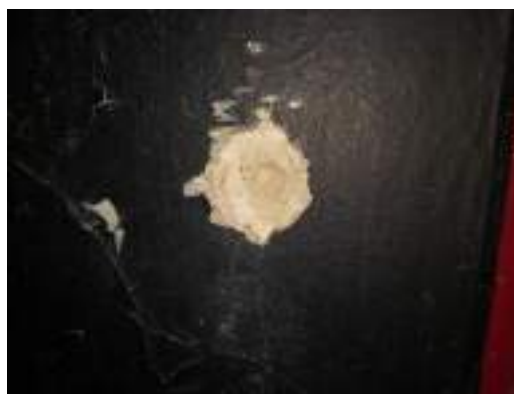
Inspection no:	S176	Type:	Sampled
Room/Area	2nd Floor. RM.2-15 [049]		
Location/Element	Textured paint to walls		
Notes			
Product Type	N/A	Score:	N/A
Damage/Deterioration	N/A	Score:	N/A
Surface Treatment	N/A	Score:	N/A
Asbestos Type	NAD	Score:	N/A
Extent	30 m ²		
Recommended Action	N/A	Total Score	0

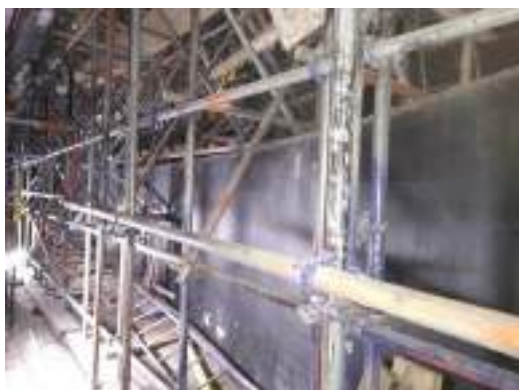
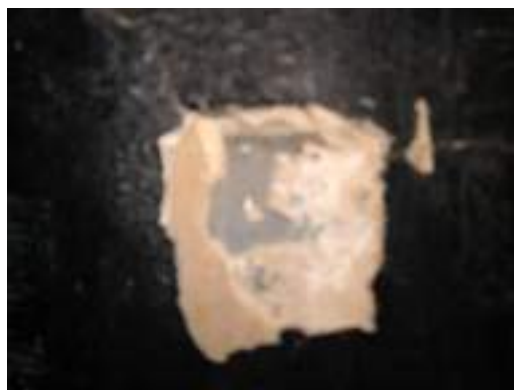
Inspection no:	S177	Type:	Sampled
Room/Area	2nd Floor. RM.2-15 [049]		
Location/Element	Textured paint to walls		
Notes			
Product Type	N/A	Score:	N/A
Damage/Deterioration	N/A	Score:	N/A
Surface Treatment	N/A	Score:	N/A
Asbestos Type	NAD	Score:	N/A
Extent	100+ m ²		
Recommended Action	N/A	Total Score	0

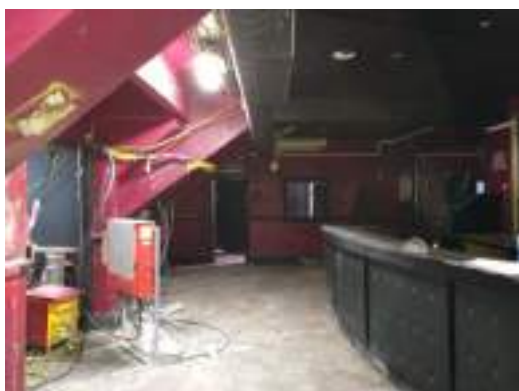
Inspection no:	S178	Type:	Sampled
Room/Area	2nd Floor. RM.2-15 [049]		
Location/Element	Textured paint to walls		
Notes			
Product Type	N/A	Score:	N/A
Damage/Deterioration	N/A	Score:	N/A
Surface Treatment	N/A	Score:	N/A
Asbestos Type	NAD	Score:	N/A
Extent	100+ m ²		
Recommended Action	N/A	Total Score	0

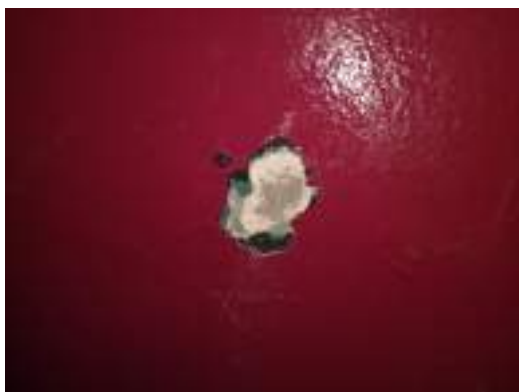
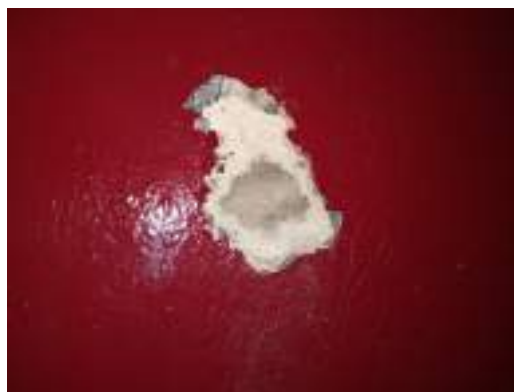
Inspection no:	S249	Type:	Sampled
Room/Area	2nd Floor. RM.2-22 [051]		
Location/Element	Paint to walls		
Notes			
Product Type	N/A	Score:	N/A
Damage/Deterioration	N/A	Score:	N/A
Surface Treatment	N/A	Score:	N/A
Asbestos Type	NAD	Score:	N/A
Extent	20 m ²		
Recommended Action	N/A	Total Score	0

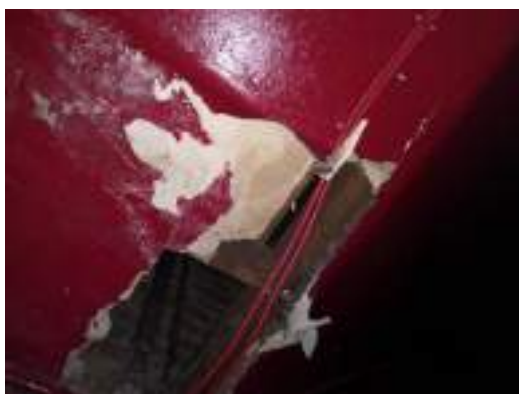
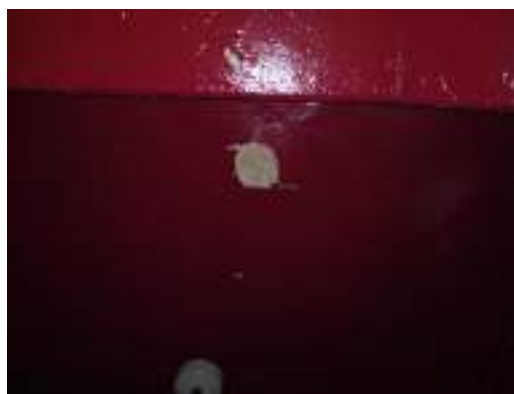
Inspection no:	S250	Type:	Sampled
Room/Area	2nd Floor. RM.2-22 [051]		
Location/Element	Paint to ceiling		
Notes			
Product Type	Textured Coating	Score:	1
Damage/Deterioration	Low Damage	Score:	1
Surface Treatment	Sealed	Score:	1
Asbestos Type	Chrysotile	Score:	1
Extent	10 m ²		
Recommended Action	Remove	Total Score	4

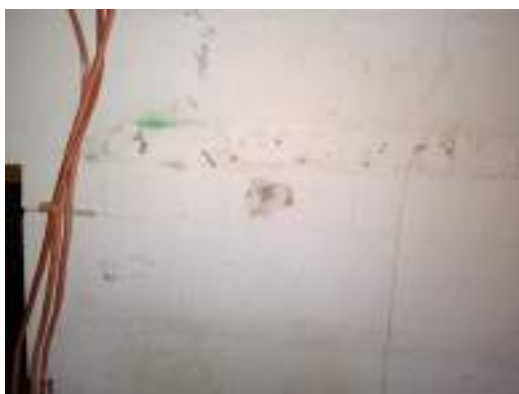
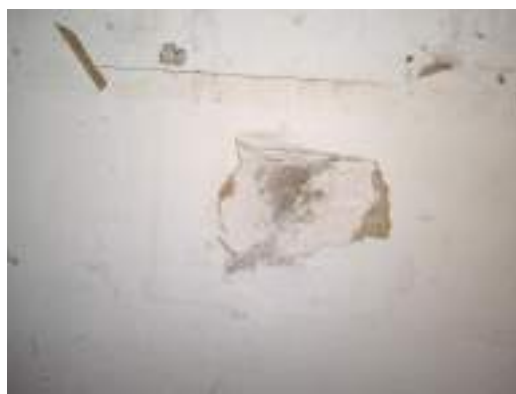
Inspection no:	S032	Type:	Sampled
Room/Area	2nd Floor. RM.2-23 [052]		
Location/Element	Plaster to brick wall		
Notes	Behind plasterboard.		
Product Type	N/A	Score:	N/A
Damage/Deterioration	N/A	Score:	N/A
Surface Treatment	N/A	Score:	N/A
Asbestos Type	NAD	Score:	N/A
Extent	10 m ²		
Recommended Action	N/A	Total Score	0

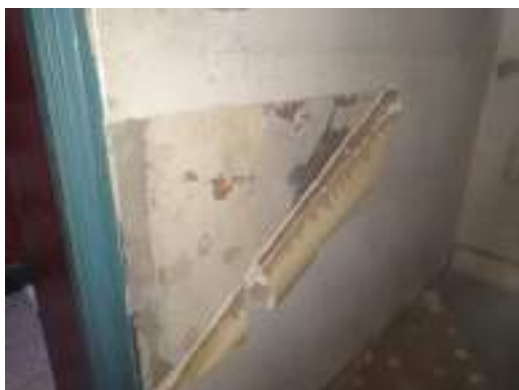
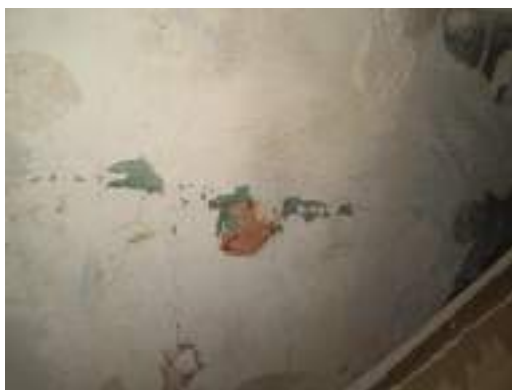
Inspection no:	S247	Type:	Sampled
Room/Area	2nd Floor. RM.2-23 [052]		
Location/Element	Paint to walls		
Notes			
Product Type	N/A	Score:	N/A
Damage/Deterioration	N/A	Score:	N/A
Surface Treatment	N/A	Score:	N/A
Asbestos Type	NAD	Score:	N/A
Extent	10 m ²		
Recommended Action	N/A	Total Score	0

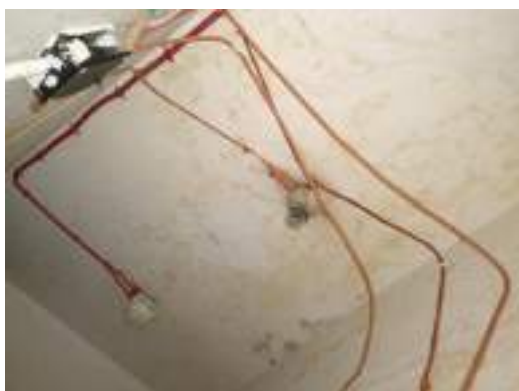
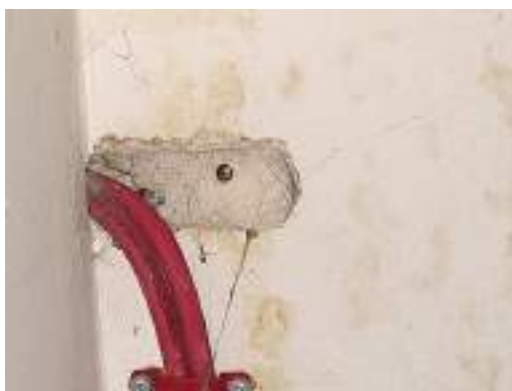
Inspection no:	S248	Type:	Sampled
Room/Area	2nd Floor. RM.2-23 [052]		
Location/Element	Paint to ceiling		
Notes			
Product Type	Textured Coating	Score:	1
Damage/Deterioration	Low Damage	Score:	1
Surface Treatment	Sealed	Score:	1
Asbestos Type	Chrysotile	Score:	1
Extent	4 m ²		
Recommended Action	Remove	Total Score	4

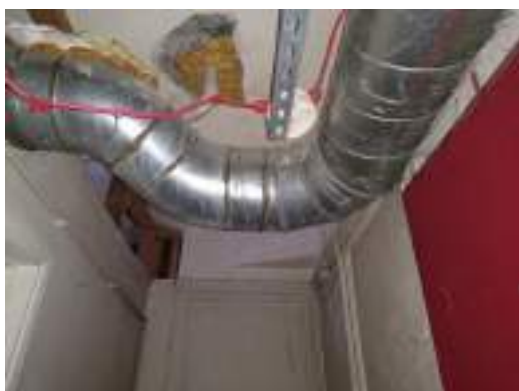
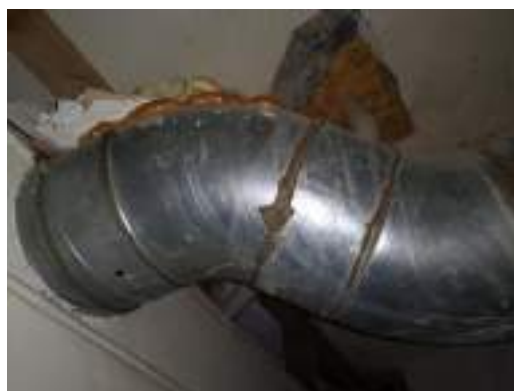
Inspection no:	S033	Type:	Sampled
Room/Area	2nd Floor. RM.2-20 [053]		
Location/Element	Beige mastic to ductwork		
Notes			
Product Type	N/A	Score:	N/A
Damage/Deterioration	N/A	Score:	N/A
Surface Treatment	N/A	Score:	N/A
Asbestos Type	NAD	Score:	N/A
Extent	1 lin m		
Recommended Action	N/A	Total Score	0

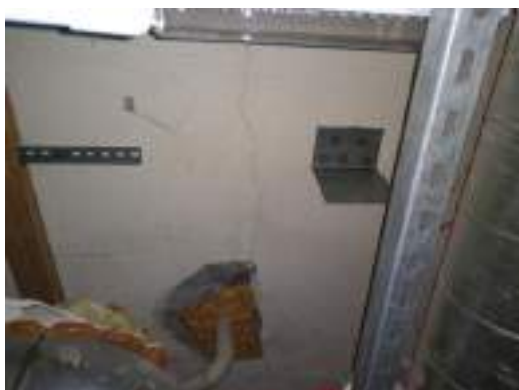
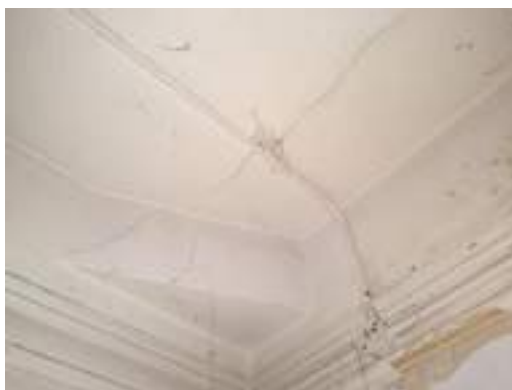
Inspection no:	S034	Type:	Sampled
Room/Area	2nd Floor. RM.2-20 [053]		
Location/Element	Paint to ceiling		
Notes			
Product Type	N/A	Score:	N/A
Damage/Deterioration	N/A	Score:	N/A
Surface Treatment	N/A	Score:	N/A
Asbestos Type	NAD	Score:	N/A
Extent	3 m ²		
Recommended Action	N/A	Total Score	0

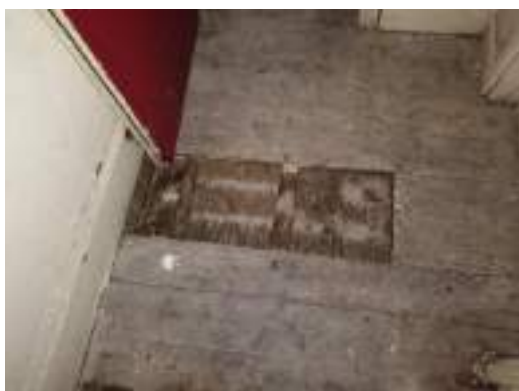
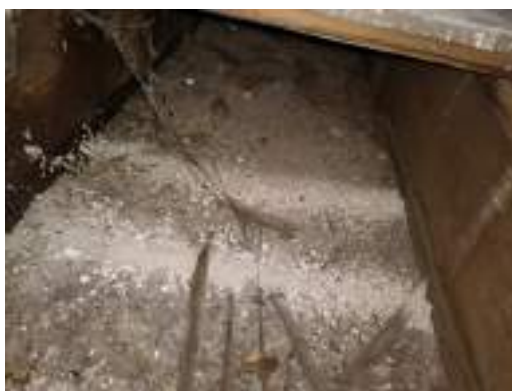
Inspection no:	S035	Type:	Sampled
Room/Area	2nd Floor. RM.2-20 [053]		
Location/Element	Debris within floor void		
Notes			
Product Type	N/A	Score:	N/A
Damage/Deterioration	N/A	Score:	N/A
Surface Treatment	N/A	Score:	N/A
Asbestos Type	NAD	Score:	N/A
Extent	3 m ²		
Recommended Action	N/A	Total Score	0

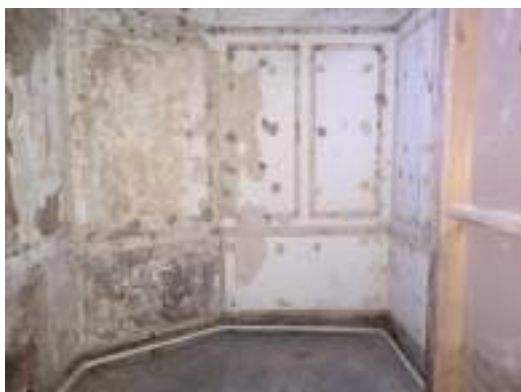
Inspection no:	S244	Type:	Sampled
Room/Area	2nd Floor. RM.2-20 [053]		
Location/Element	Textured coating to ceiling under paint		
Notes			
Product Type	Textured Coating	Score:	1
Damage/Deterioration	Low Damage	Score:	1
Surface Treatment	Sealed	Score:	1
Asbestos Type	Chrysotile	Score:	1
Extent	4 m ²		
Recommended Action	Remove	Total Score	4

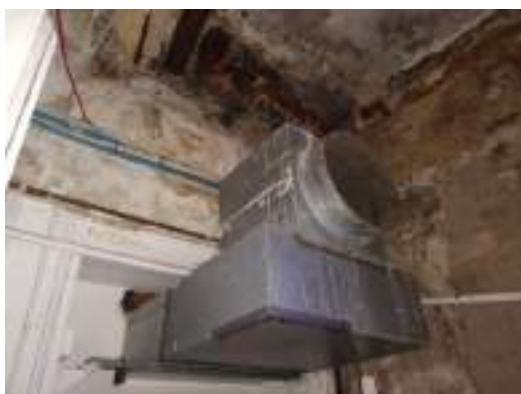
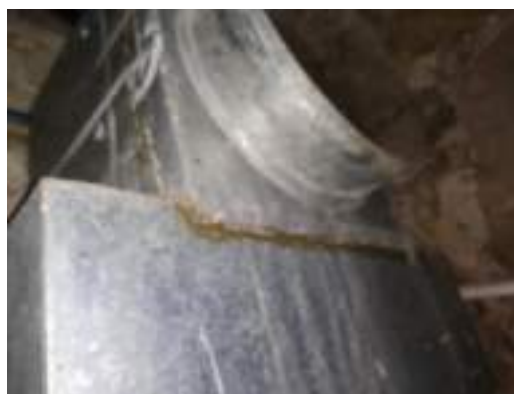
Inspection no:	R033	Type:	Referred Sample
Room/Area	2nd Floor. RM.2-21 [054]		
Location/Element	Beige mastic to ductwork		
Notes			
Product Type	Mastic Sealant	Score:	N/A
Damage/Deterioration	N/A	Score:	N/A
Surface Treatment	N/A	Score:	N/A
Asbestos Type	NAD	Score:	N/A
Extent	1 lin m		
Recommended Action	N/A	Total Score	0

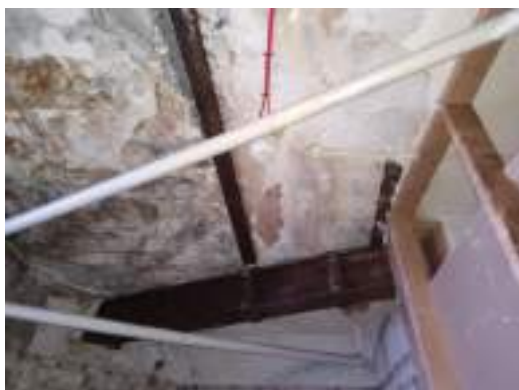
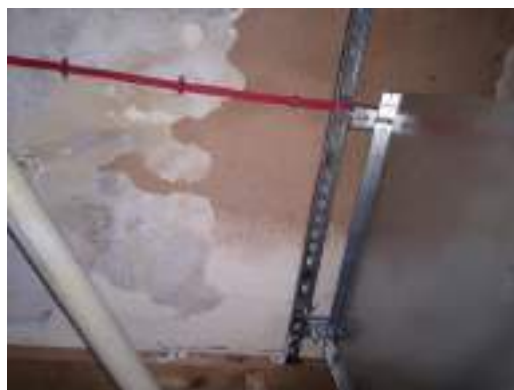
Inspection no:	R244	Type:	Referred Sample
Room/Area	2nd Floor. RM.2-21 [054]		
Location/Element	Textured coating to concrete ceiling		
Notes			
Product Type	Textured Coating	Score:	1
Damage/Deterioration	Medium Damage	Score:	2
Surface Treatment	Sealed	Score:	1
Asbestos Type	Chrysotile	Score:	1
Extent	5 m ²		
Recommended Action	Remove	Total Score	5

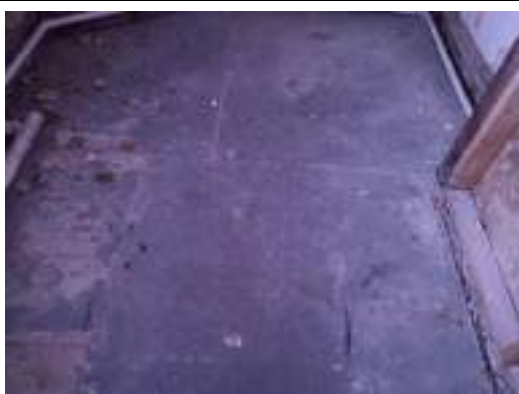
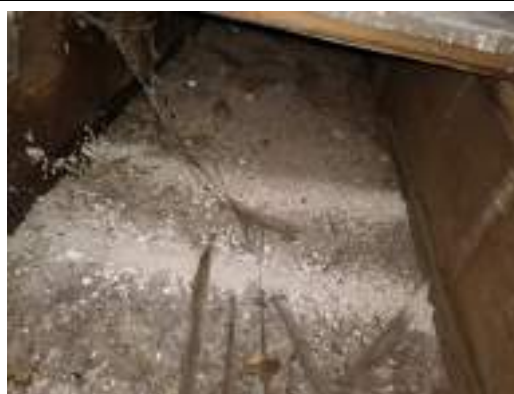
Inspection no:	R035	Type:	Referred Sample
Room/Area	2nd Floor. RM.2-21 [054]		
Location/Element	Debris within floor void		
Notes			
Product Type	Debris	Score:	N/A
Damage/Deterioration	N/A	Score:	N/A
Surface Treatment	N/A	Score:	N/A
Asbestos Type	NAD	Score:	N/A
Extent	5 m ²		
Recommended Action	N/A	Total Score	0

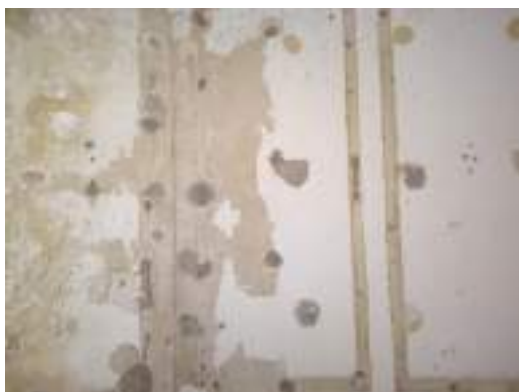
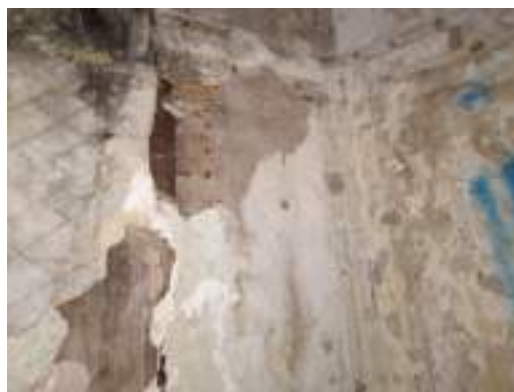
Inspection no:	S245	Type:	Sampled
Room/Area	2nd Floor. RM.2-21 [054]		
Location/Element	Paint to walls		
Notes			
Product Type	N/A	Score:	N/A
Damage/Deterioration	N/A	Score:	N/A
Surface Treatment	N/A	Score:	N/A
Asbestos Type	NAD	Score:	N/A
Extent	15 m ²		
Recommended Action	N/A	Total Score	0

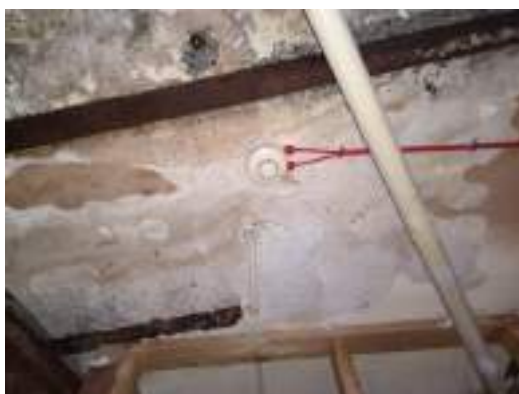
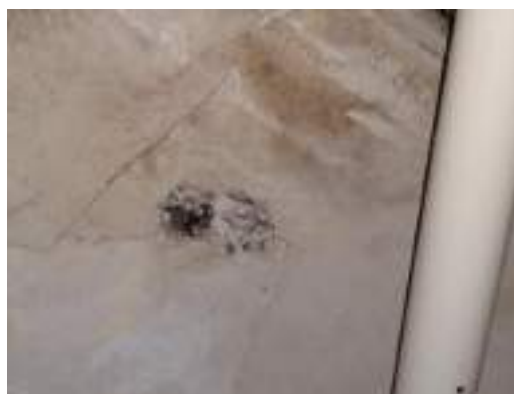
Inspection no:	S246	Type:	Sampled
Room/Area	2nd Floor. RM.2-21 [054]		
Location/Element	Paint to ceiling		
Notes			
Product Type	Textured Coating	Score:	1
Damage/Deterioration	Low Damage	Score:	1
Surface Treatment	Sealed	Score:	1
Asbestos Type	Chrysotile	Score:	1
Extent	4 m ²		
Recommended Action	Remove	Total Score	4

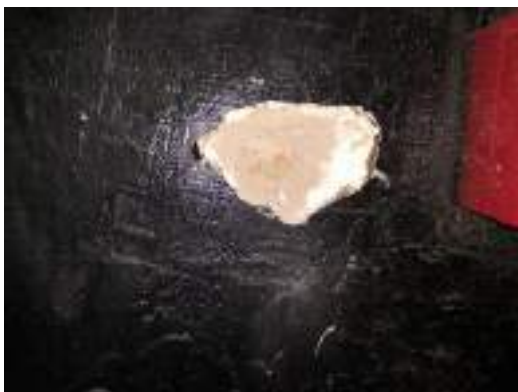
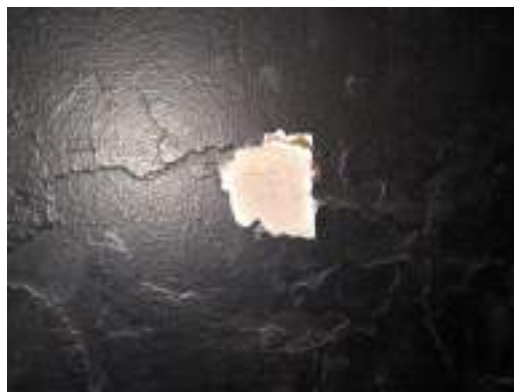
Inspection no:	S184	Type:	Sampled
Room/Area	2nd Floor. RM.2-17 [055]		
Location/Element	Paint to walls		
Notes			
Product Type	N/A	Score:	N/A
Damage/Deterioration	N/A	Score:	N/A
Surface Treatment	N/A	Score:	N/A
Asbestos Type	NAD	Score:	N/A
Extent	40 m ²		
Recommended Action	N/A	Total Score	0

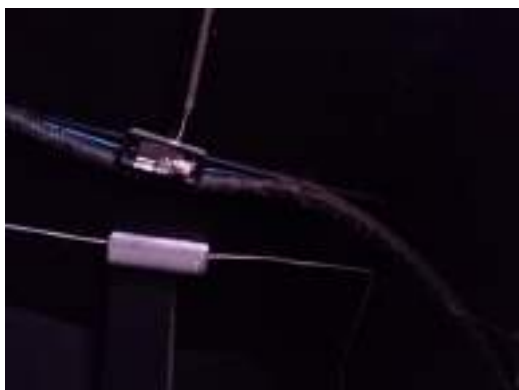
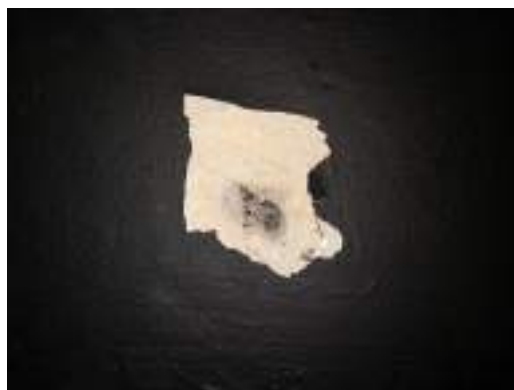
Inspection no:	S185	Type:	Sampled
Room/Area	2nd Floor. RM.2-17 [055]		
Location/Element	Paint to Ceiling		
Notes			
Product Type	N/A	Score:	N/A
Damage/Deterioration	N/A	Score:	N/A
Surface Treatment	N/A	Score:	N/A
Asbestos Type	NAD	Score:	N/A
Extent	10 m ²		
Recommended Action	N/A	Total Score	0

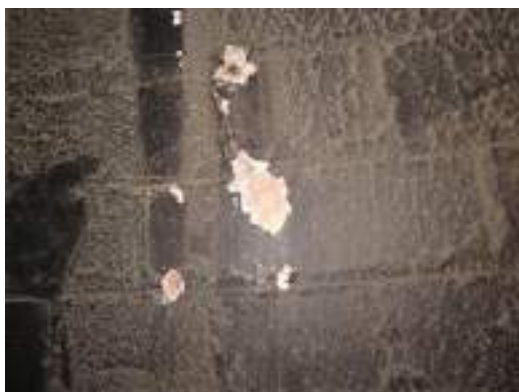
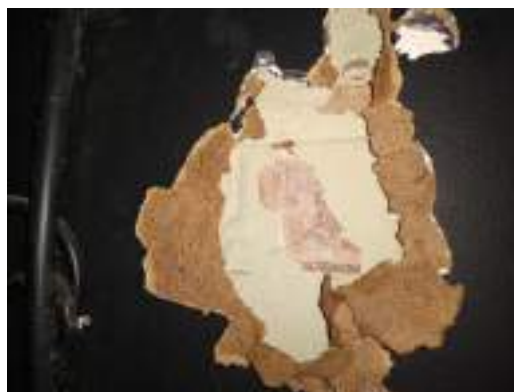
Inspection no:	S241	Type:	Sampled
Room/Area	2nd Floor. RM.2-18 [056]		
Location/Element	Paint to walls		
Notes			
Product Type	N/A	Score:	N/A
Damage/Deterioration	N/A	Score:	N/A
Surface Treatment	N/A	Score:	N/A
Asbestos Type	NAD	Score:	N/A
Extent	15 m ²		
Recommended Action	N/A	Total Score	0

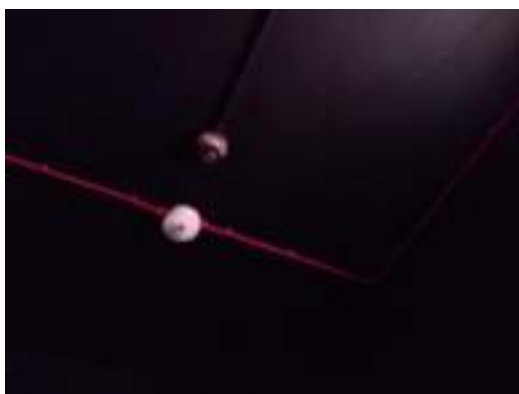
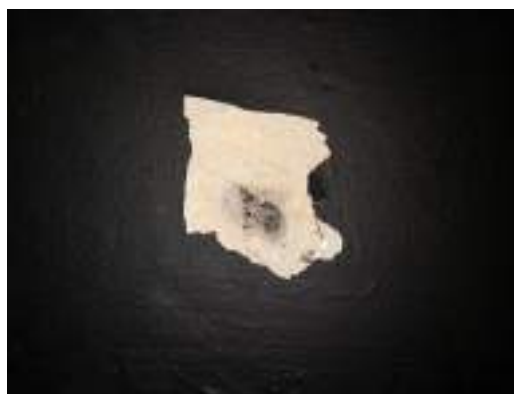
Inspection no:	S242	Type:	Sampled
Room/Area	2nd Floor. RM.2-18 [056]		
Location/Element	Paint to ceiling		
Notes			
Product Type	Textured Coating	Score:	1
Damage/Deterioration	Low Damage	Score:	1
Surface Treatment	Sealed	Score:	1
Asbestos Type	Chrysotile	Score:	1
Extent	5 m ²		
Recommended Action	Remove	Total Score	4

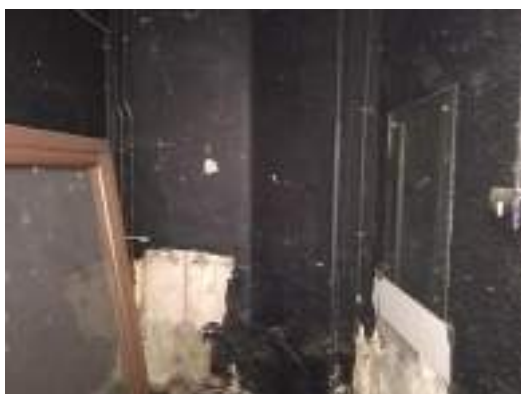
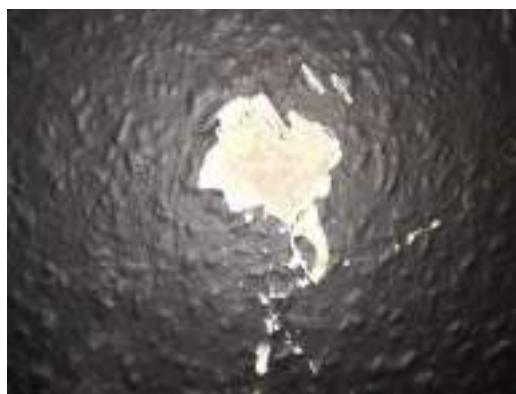
Inspection no:	S186	Type:	Sampled
Room/Area	2nd Floor. RM.2-19 [057]		
Location/Element	Paint to walls		
Notes			
Product Type	N/A	Score:	N/A
Damage/Deterioration	N/A	Score:	N/A
Surface Treatment	N/A	Score:	N/A
Asbestos Type	NAD	Score:	N/A
Extent	10 m ²		
Recommended Action	N/A	Total Score	0

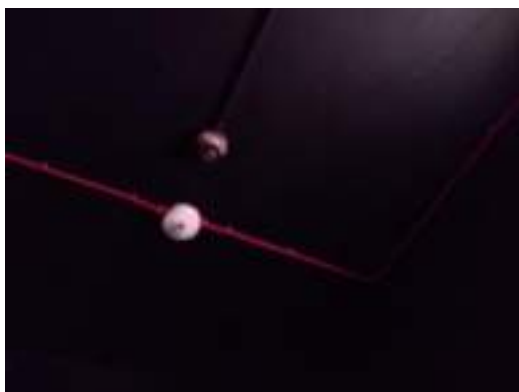
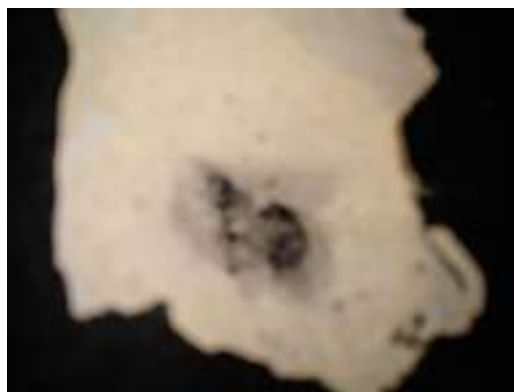
Inspection no:	S187	Type:	Sampled
Room/Area	2nd Floor. RM.2-19 [057]		
Location/Element	Paint to Ceiling		
Notes			
Product Type	N/A	Score:	N/A
Damage/Deterioration	N/A	Score:	N/A
Surface Treatment	N/A	Score:	N/A
Asbestos Type	NAD	Score:	N/A
Extent	5 m ²		
Recommended Action	N/A	Total Score	0

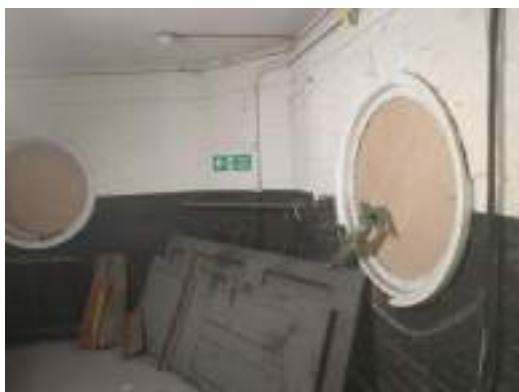
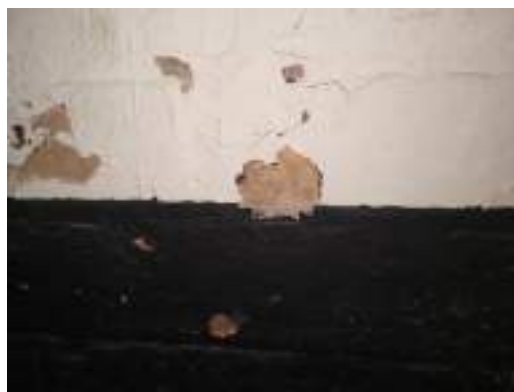
Inspection no:	S102	Type:	Sampled
Room/Area	3rd Floor. RM.3-17 [058]		
Location/Element	Paint to walls		
Notes	Sampled from all walls back to substrate.		
Product Type	N/A	Score:	N/A
Damage/Deterioration	N/A	Score:	N/A
Surface Treatment	N/A	Score:	N/A
Asbestos Type	NAD	Score:	N/A
Extent	40 m ²		
Recommended Action	N/A	Total Score	0

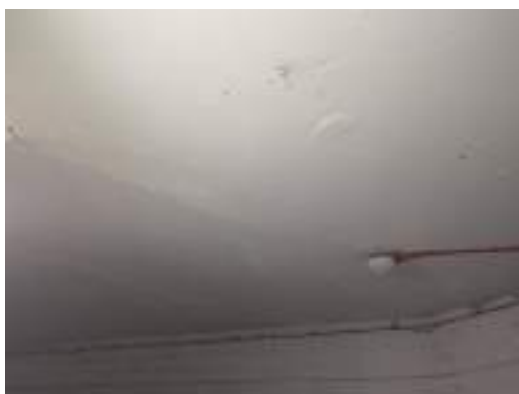
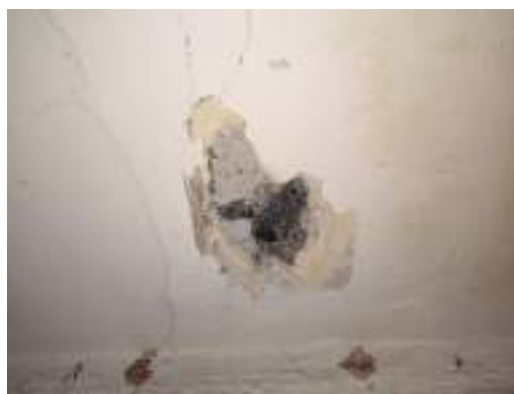
Inspection no:	S103	Type:	Sampled
Room/Area	3rd Floor. RM.3-17 [058]		
Location/Element	Paint to ceiling		
Notes	Sampled back to substrate.		
Product Type	Textured Coating	Score:	1
Damage/Deterioration	High Damage	Score:	3
Surface Treatment	Sealed	Score:	1
Asbestos Type	Chrysotile	Score:	1
Extent	100+ m ²		
Recommended Action	Remove	Total Score	6

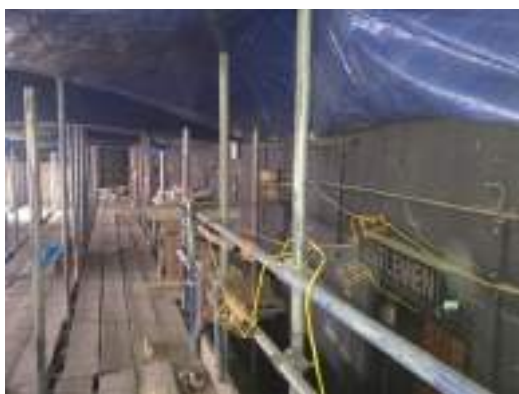
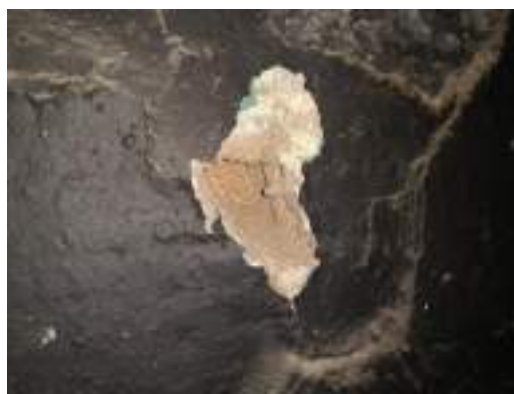
Inspection no:	S100	Type:	Sampled
Room/Area	3rd Floor. RM.3-11 [059]		
Location/Element	Paint to walls		
Notes	Sampled from all walls back to substrate.		
Product Type	N/A	Score:	N/A
Damage/Deterioration	N/A	Score:	N/A
Surface Treatment	N/A	Score:	N/A
Asbestos Type	NAD	Score:	N/A
Extent	100+ m ²		
Recommended Action	N/A	Total Score	0

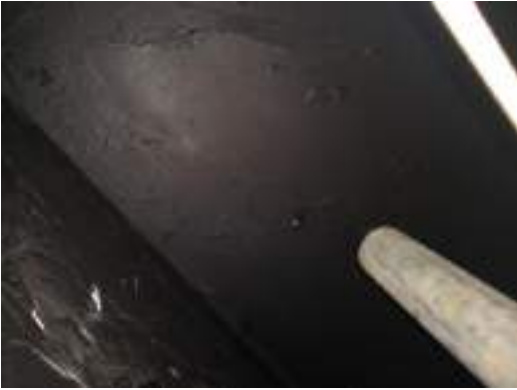
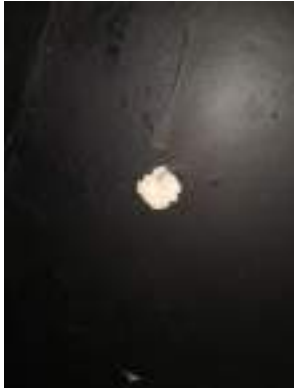
Inspection no:	S101	Type:	Sampled
Room/Area	3rd Floor. RM.3-11 [059]		
Location/Element	Paint to ceiling		
Notes	Sampled back to substrate.		
Product Type	N/A	Score:	N/A
Damage/Deterioration	N/A	Score:	N/A
Surface Treatment	N/A	Score:	N/A
Asbestos Type	NAD	Score:	N/A
Extent	100+ m ²		
Recommended Action	N/A	Total Score	0
