Asbestos Survey Report

ASBESTOS SURVEY
REPORT NO: A-44387 – ISSUE 6

DATE ISSUED: 06/08/2020

Site Address:
KoKo Night Club
Heritage Areas Survey
1A Camden High St
London
NW1 7JE

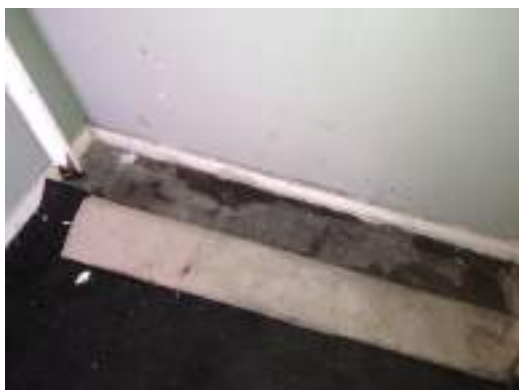
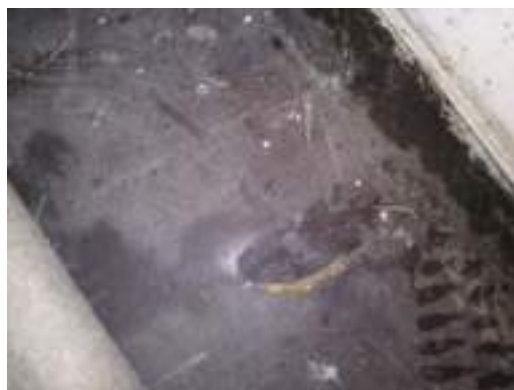
Inspection no:	S036	Type:	Sampled
Room/Area	3rd Floor. RM.3-12 [062]		
Location/Element	Brown floor tiles		
Notes			
Product Type	N/A	Score:	N/A
Damage/Deterioration	N/A	Score:	N/A
Surface Treatment	N/A	Score:	N/A
Asbestos Type	NAD	Score:	N/A
Extent	4 m ²		
Recommended Action	N/A	Total Score	0

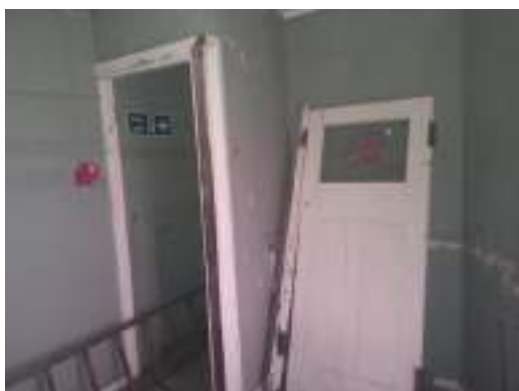
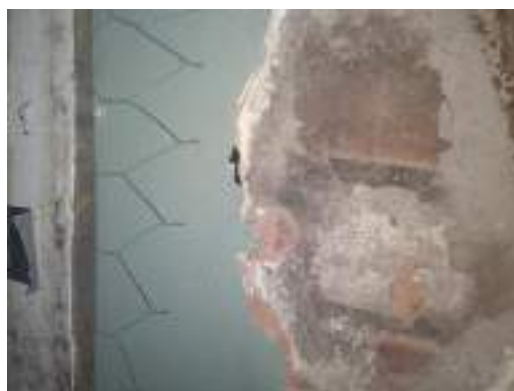
Inspection no:	S098	Type:	Sampled
Room/Area	3rd Floor. RM.3-12 [062]		
Location/Element	Paint to walls		
Notes	Sampled from all walls back to substrate.		
Product Type	N/A	Score:	N/A
Damage/Deterioration	N/A	Score:	N/A
Surface Treatment	N/A	Score:	N/A
Asbestos Type	NAD	Score:	N/A
Extent	20 m ²		
Recommended Action	N/A	Total Score	0

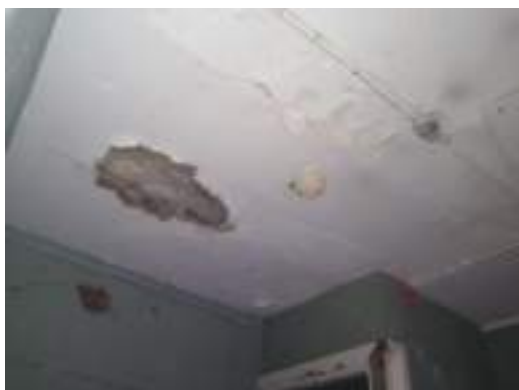
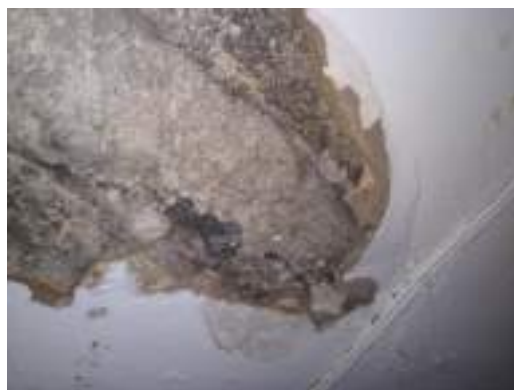
Inspection no:	S099	Type:	Sampled
Room/Area	3rd Floor. RM.3-12 [062]		
Location/Element	Paint to ceiling		
Notes	Sampled back to substrate.		
Product Type	Textured Coating	Score:	1
Damage/Deterioration	High Damage	Score:	3
Surface Treatment	Sealed	Score:	1
Asbestos Type	Chrysotile	Score:	1
Extent	5 m ²		
Recommended Action	Remove	Total Score	6

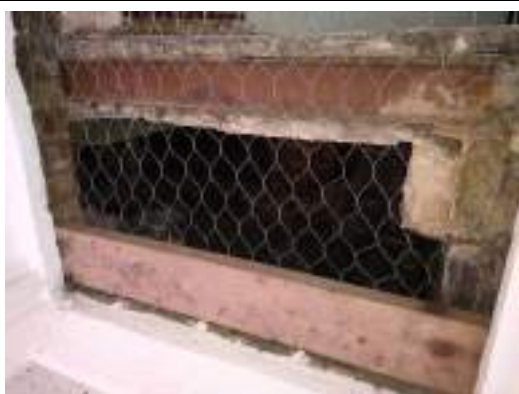
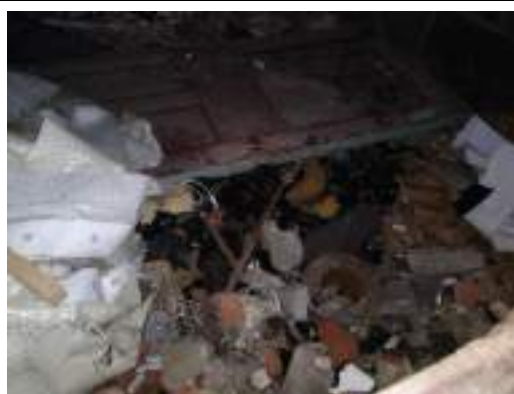
Inspection no:	S037	Type:	Sampled
Room/Area	3rd Floor. RM.3-13 [063]		
Location/Element	Debris within floor void		
Notes			
Product Type	N/A	Score:	N/A
Damage/Deterioration	N/A	Score:	N/A
Surface Treatment	N/A	Score:	N/A
Asbestos Type	NAD	Score:	N/A
Extent	18 m ²		
Recommended Action	N/A	Total Score	0

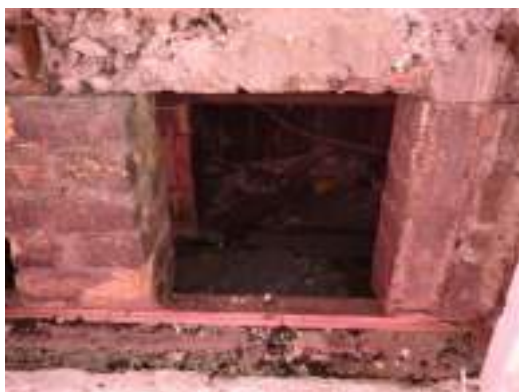
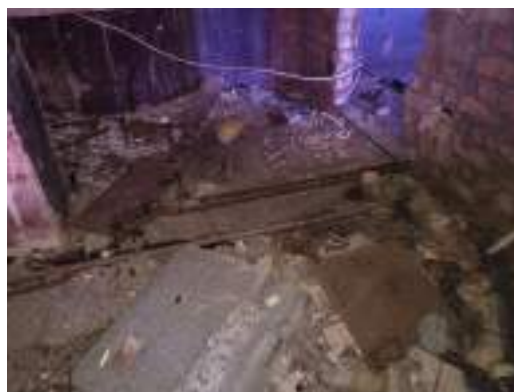
Inspection no:	S038	Type:	Sampled
Room/Area	3rd Floor. RM.3-13 [063]		
Location/Element	Debris within floor void		
Notes			
Product Type	N/A	Score:	N/A
Damage/Deterioration	N/A	Score:	N/A
Surface Treatment	N/A	Score:	N/A
Asbestos Type	NAD	Score:	N/A
Extent	18 m ²		
Recommended Action	N/A	Total Score	0

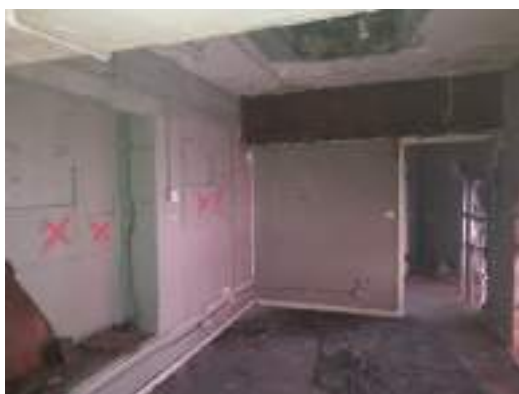
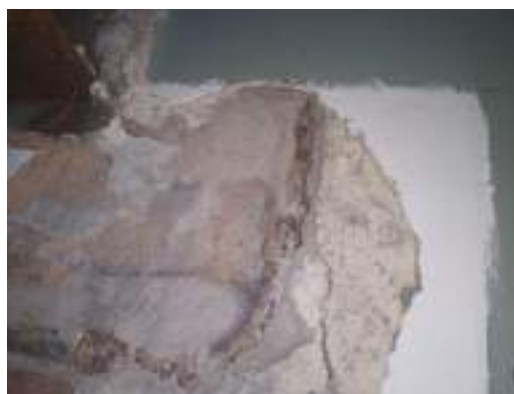
Inspection no:	S096	Type:	Sampled
Room/Area	3rd Floor. RM.3-13 [063]		
Location/Element	Paint to walls		
Notes	Sampled from all walls back to substrate.		
Product Type	N/A	Score:	N/A
Damage/Deterioration	N/A	Score:	N/A
Surface Treatment	N/A	Score:	N/A
Asbestos Type	NAD	Score:	N/A
Extent	40 m ²		
Recommended Action	N/A	Total Score	0

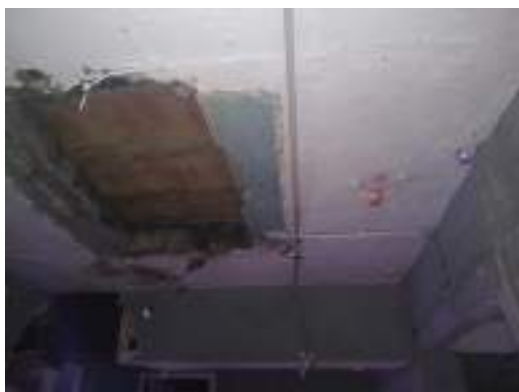
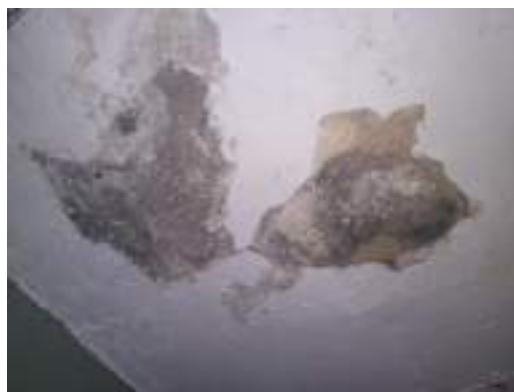
Inspection no:	S097	Type:	Sampled
Room/Area	3rd Floor. RM.3-13 [063]		
Location/Element	Paint to ceiling		
Notes	Sampled back to substrate.		
Product Type	Textured Coating	Score:	1
Damage/Deterioration	High Damage	Score:	3
Surface Treatment	Sealed	Score:	1
Asbestos Type	Chrysotile	Score:	1
Extent	15 m ²		
Recommended Action	Remove	Total Score	6

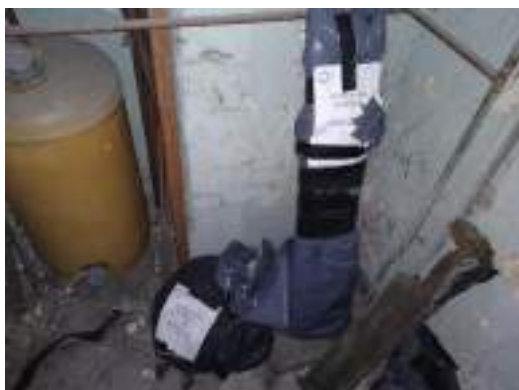
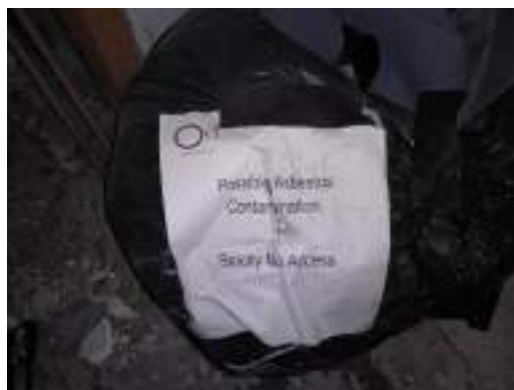
Inspection no:	P007	Type:	Presumed
Room/Area	3rd Floor. RM.3-14 [064]		
Location/Element	Items within bags		
Notes	Presumed as bags have been sealed and signed off.		
Product Type	Insulating Board	Score:	2
Damage/Deterioration	Medium Damage	Score:	2
Surface Treatment	Sealed	Score:	1
Asbestos Type	Amosite	Score:	2
Extent	2 no		
Recommended Action	Remove	Total Score	7

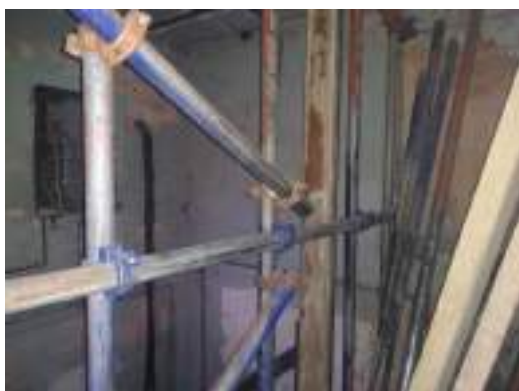
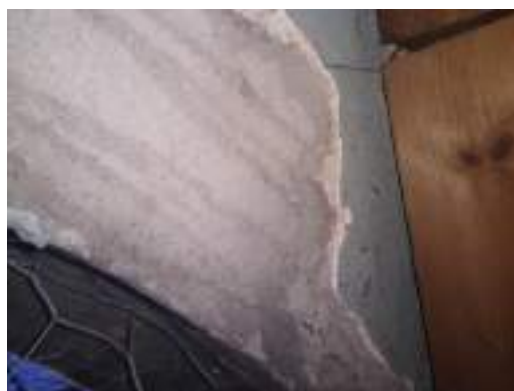
Inspection no:	S094	Type:	Sampled
Room/Area	3rd Floor. RM.3-14 [064]		
Location/Element	Paint to walls		
Notes	Sampled from all walls back to substrate.		
Product Type	N/A	Score:	N/A
Damage/Deterioration	N/A	Score:	N/A
Surface Treatment	N/A	Score:	N/A
Asbestos Type	NAD	Score:	N/A
Extent	20 m ²		
Recommended Action	N/A	Total Score	0

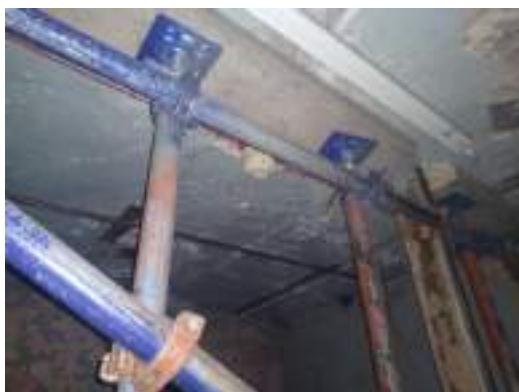
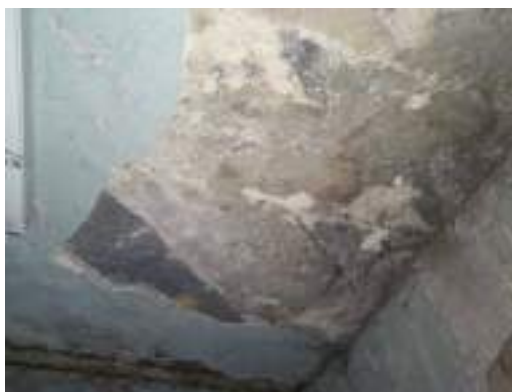
Inspection no:	S095	Type:	Sampled
Room/Area	3rd Floor. RM.3-14 [064]		
Location/Element	Paint to ceiling		
Notes	Sampled back to substrate.		
Product Type	N/A	Score:	N/A
Damage/Deterioration	N/A	Score:	N/A
Surface Treatment	N/A	Score:	N/A
Asbestos Type	NAD	Score:	N/A
Extent	12 m ²		
Recommended Action	N/A	Total Score	0

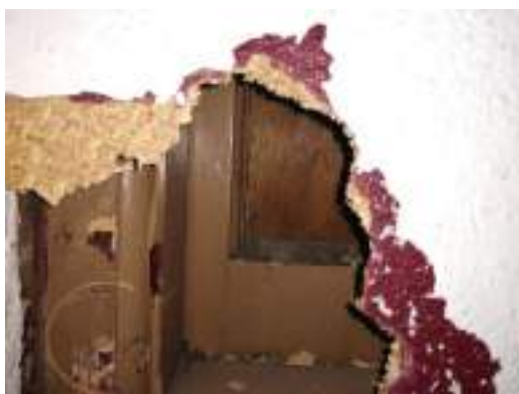
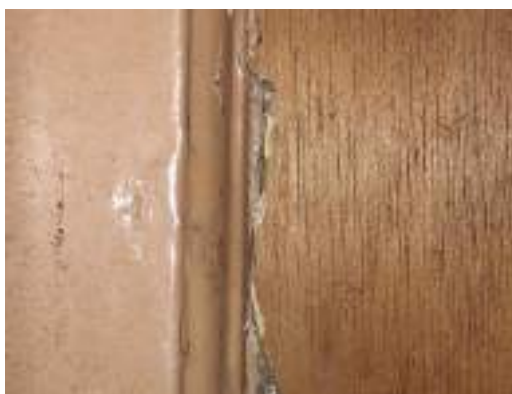
Inspection no:	R039	Type:	Referred Sample
Room/Area	Ground Floor. WG-06 [065]		
Location/Element	Mastic to window		
Notes			
Product Type	Mastic Sealant	Score:	N/A
Damage/Deterioration	N/A	Score:	N/A
Surface Treatment	N/A	Score:	N/A
Asbestos Type	NAD	Score:	N/A
Extent	3 lin m		
Recommended Action	N/A	Total Score	0

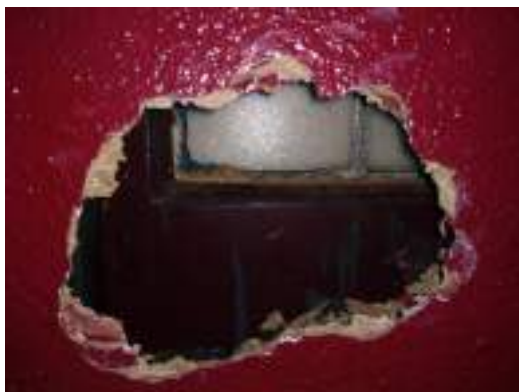
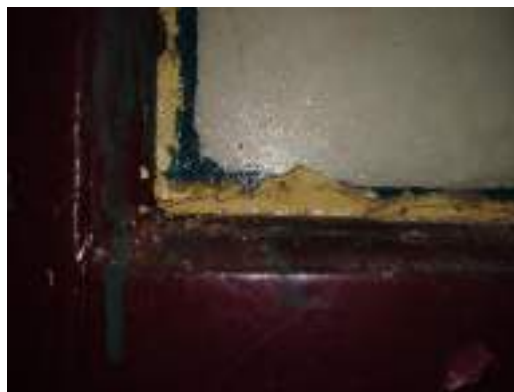
Inspection no:	S039	Type:	Sampled
Room/Area	Ground Floor. WG-07 [066]		
Location/Element	Mastic to window		
Notes			
Product Type	N/A	Score:	N/A
Damage/Deterioration	N/A	Score:	N/A
Surface Treatment	N/A	Score:	N/A
Asbestos Type	NAD	Score:	N/A
Extent	3 lin m		
Recommended Action	N/A	Total Score	0

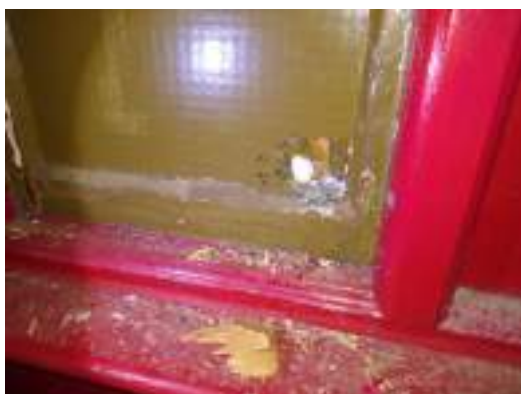
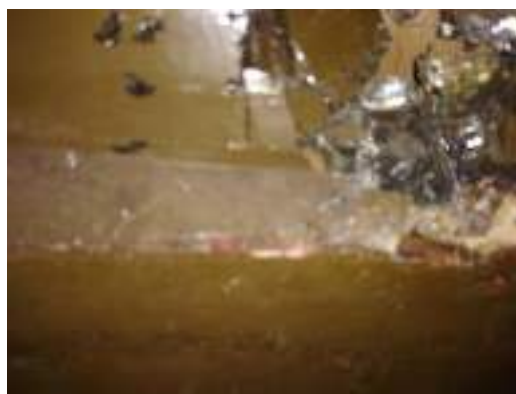
Inspection no:	S040	Type:	Sampled
Room/Area	Ground Floor. WG-08 [067]		
Location/Element	Mastic to window		
Notes			
Product Type	N/A	Score:	N/A
Damage/Deterioration	N/A	Score:	N/A
Surface Treatment	N/A	Score:	N/A
Asbestos Type	NAD	Score:	N/A
Extent	4 m ²		
Recommended Action	N/A	Total Score	0

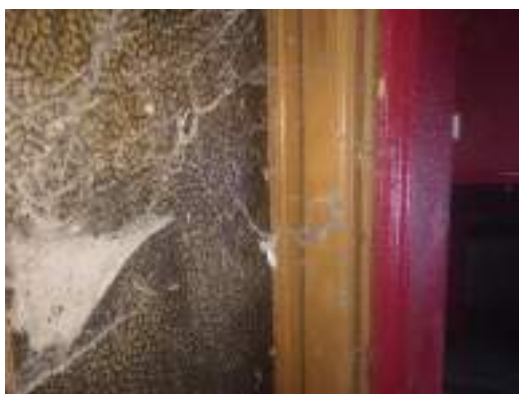
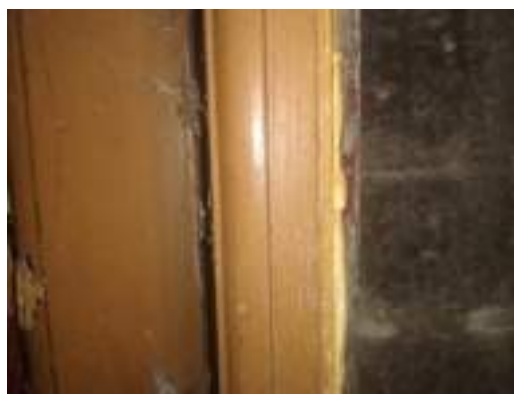
Inspection no:	S044	Type:	Sampled
Room/Area	1st Floor. W1-01A [072]		
Location/Element	Mastic to window		
Notes			
Product Type	N/A	Score:	N/A
Damage/Deterioration	N/A	Score:	N/A
Surface Treatment	N/A	Score:	N/A
Asbestos Type	NAD	Score:	N/A
Extent	4 lin m		
Recommended Action	N/A	Total Score	0

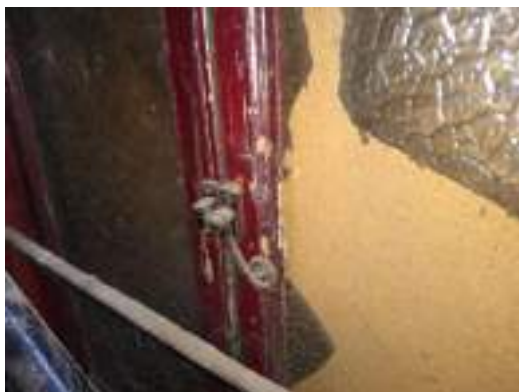
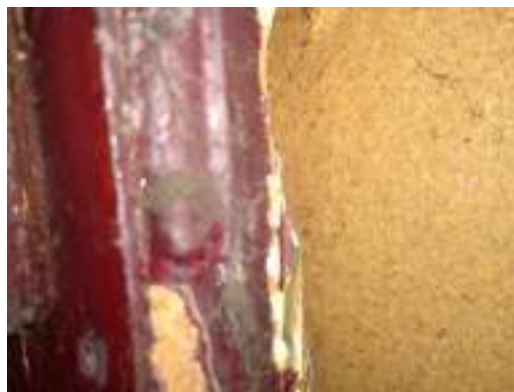
Inspection no:	S041	Type:	Sampled
Room/Area	1st Floor. W1-01D [075]		
Location/Element	Mastic to window		
Notes			
Product Type	N/A	Score:	N/A
Damage/Deterioration	N/A	Score:	N/A
Surface Treatment	N/A	Score:	N/A
Asbestos Type	NAD	Score:	N/A
Extent	1 m ²		
Recommended Action	N/A	Total Score	0

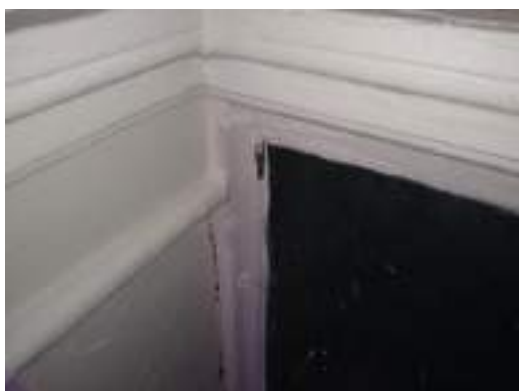
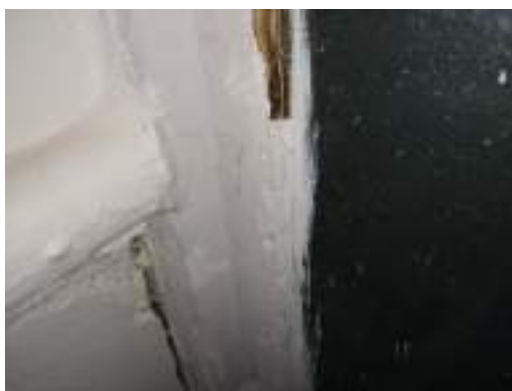
Inspection no:	S043	Type:	Sampled
Room/Area	1st Floor. D1-05 [076]		
Location/Element	Mastic to window		
Notes			
Product Type	N/A	Score:	N/A
Damage/Deterioration	N/A	Score:	N/A
Surface Treatment	N/A	Score:	N/A
Asbestos Type	NAD	Score:	N/A
Extent	4 lin m		
Recommended Action	N/A	Total Score	0

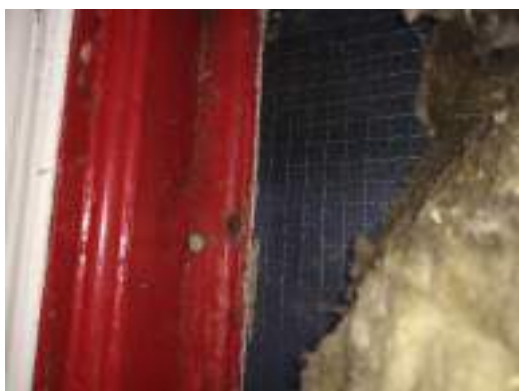
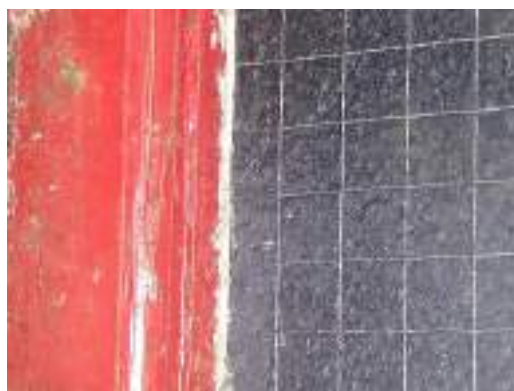
Inspection no:	S042	Type:	Sampled
Room/Area	2nd Floor. W2-08G [079]		
Location/Element	Mastic to window		
Notes			
Product Type	N/A	Score:	N/A
Damage/Deterioration	N/A	Score:	N/A
Surface Treatment	N/A	Score:	N/A
Asbestos Type	NAD	Score:	N/A
Extent	4 lin m		
Recommended Action	N/A	Total Score	0

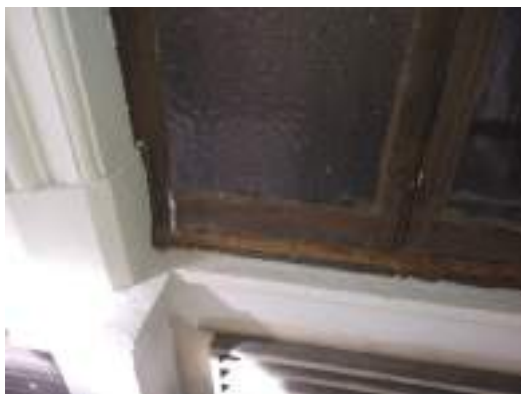
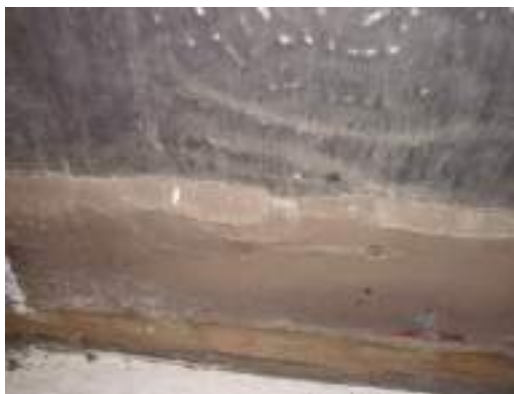
Inspection no:	R045	Type:	Referred Sample
Room/Area	2nd Floor. W2-08F [080]		
Location/Element	Mastic to window		
Notes			
Product Type	Mastic Sealant	Score:	N/A
Damage/Deterioration	N/A	Score:	N/A
Surface Treatment	N/A	Score:	N/A
Asbestos Type	NAD	Score:	N/A
Extent	4 lin m		
Recommended Action	N/A	Total Score	0

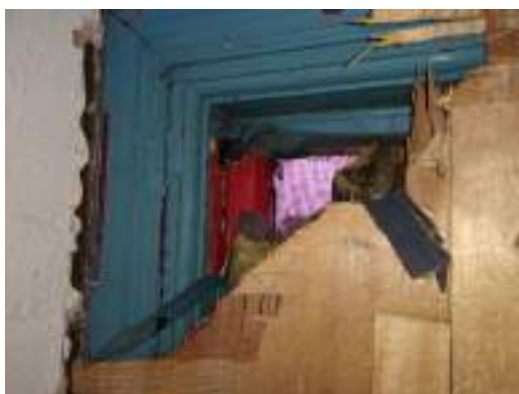
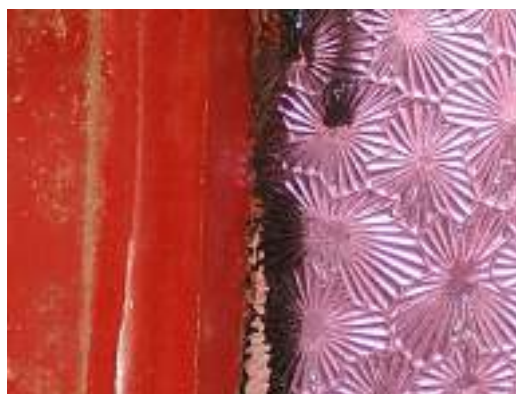
Inspection no:	R042	Type:	Referred Sample
Room/Area	2nd Floor. W2-08E [081]		
Location/Element	Mastic to window		
Notes			
Product Type	Mastic Sealant	Score:	N/A
Damage/Deterioration	N/A	Score:	N/A
Surface Treatment	N/A	Score:	N/A
Asbestos Type	NAD	Score:	N/A
Extent	5 lin m		
Recommended Action	N/A	Total Score	0

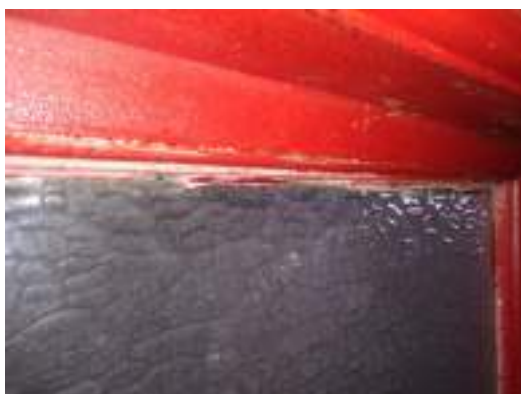
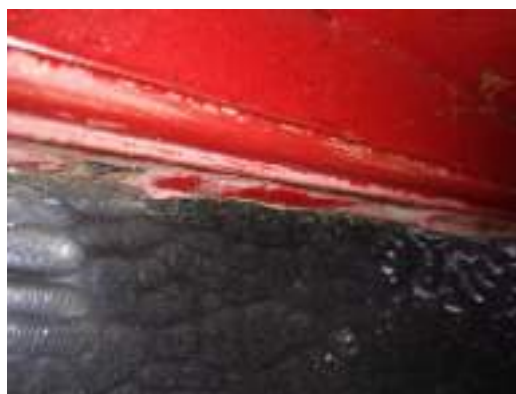
Inspection no:	R042	Type:	Referred Sample
Room/Area	2nd Floor. W2-08D [082]		
Location/Element	Mastic to window		
Notes			
Product Type	Mastic Sealant	Score:	N/A
Damage/Deterioration	N/A	Score:	N/A
Surface Treatment	N/A	Score:	N/A
Asbestos Type	NAD	Score:	N/A
Extent	5 lin m		
Recommended Action	N/A	Total Score	0

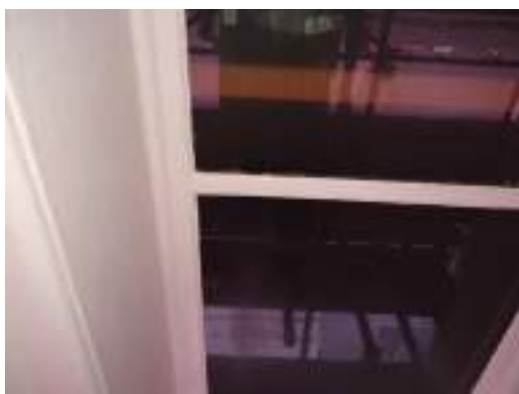
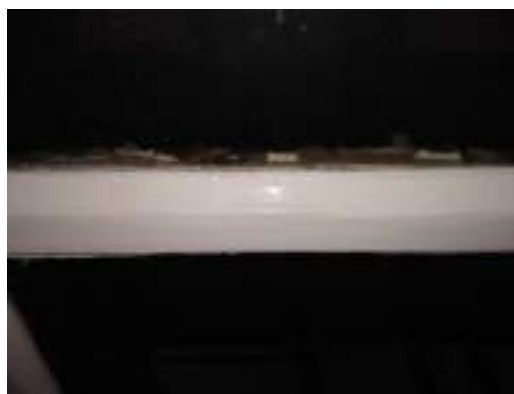
Inspection no:	S046	Type:	Sampled
Room/Area	2nd Floor. W2-02 and W2-03 [083]		
Location/Element	Mastic to windows		
Notes			
Product Type	N/A	Score:	N/A
Damage/Deterioration	N/A	Score:	N/A
Surface Treatment	N/A	Score:	N/A
Asbestos Type	NAD	Score:	N/A
Extent	4 lin m		
Recommended Action	N/A	Total Score	0

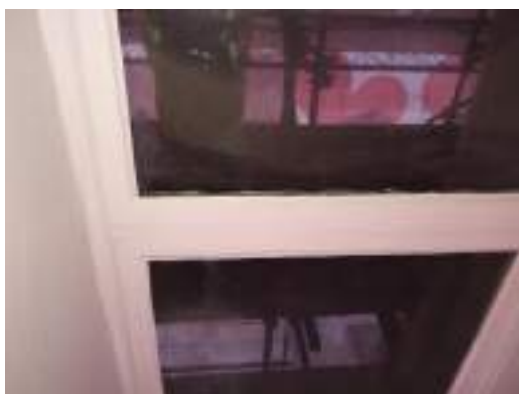
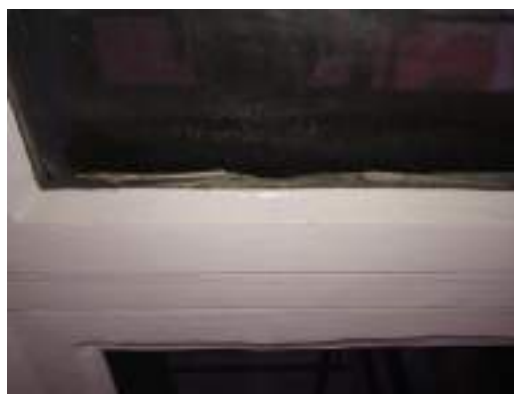
Inspection no:	R046	Type:	Referred Sample
Room/Area	2nd Floor. W2-04 and W2-05 [084]		
Location/Element	Mastic to windows		
Notes			
Product Type	Mastic Sealant	Score:	N/A
Damage/Deterioration	N/A	Score:	N/A
Surface Treatment	N/A	Score:	N/A
Asbestos Type	NAD	Score:	N/A
Extent	4 Lin m		
Recommended Action	N/A	Total Score	0

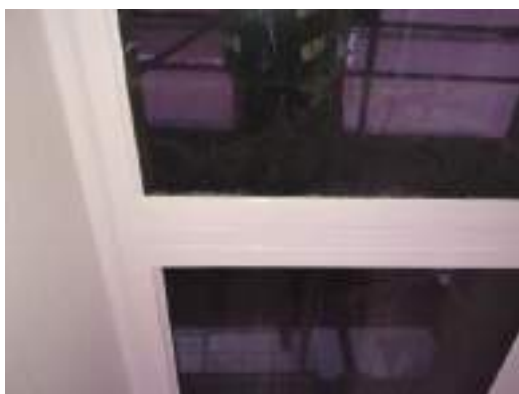
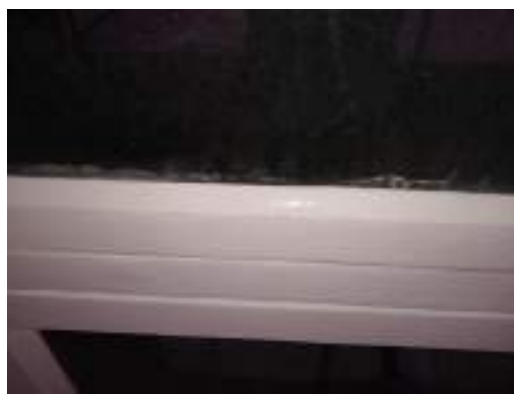
Inspection no:	R046	Type:	Referred Sample
Room/Area	2nd Floor. W2-06 and W2-07 [085]		
Location/Element	Mastic to windows		
Notes			
Product Type	Mastic Sealant	Score:	N/A
Damage/Deterioration	N/A	Score:	N/A
Surface Treatment	N/A	Score:	N/A
Asbestos Type	NAD	Score:	N/A
Extent	4 Lin m		
Recommended Action	N/A	Total Score	0

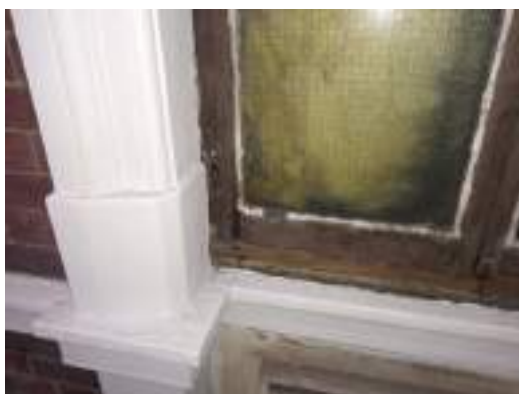
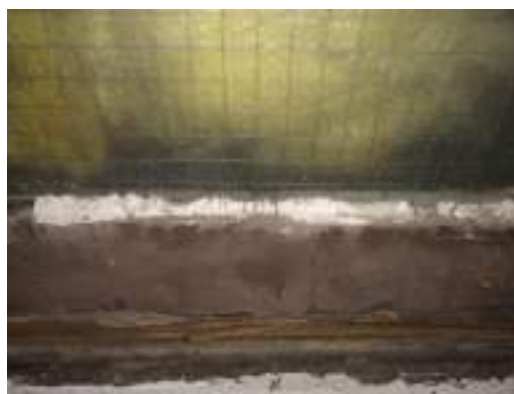
Inspection no:	S045	Type:	Sampled
Room/Area	External. W2-08G - External [086]		
Location/Element	Mastic to window		
Notes			
Product Type	N/A	Score:	N/A
Damage/Deterioration	N/A	Score:	N/A
Surface Treatment	N/A	Score:	N/A
Asbestos Type	NAD	Score:	N/A
Extent	4 lin m		
Recommended Action	N/A	Total Score	0

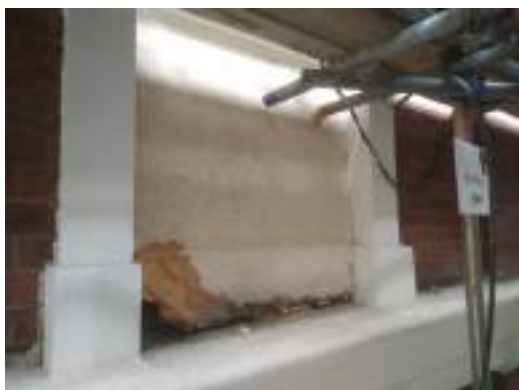
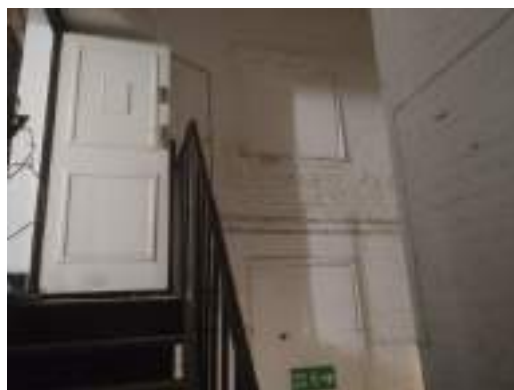
Inspection no:	N/A	Type:	N/A
Room/Area	3rd Floor. W3-08G [089]		
Location/Element	Window		
Notes	Limited access gained. Internal visual inspection, not accessed due to high level and stairs. External inspection, timber panel to timber window, solid walls, modern putty.		
Product Type	N/A	Score:	N/A
Damage/Deterioration	N/A	Score:	N/A
Surface Treatment	N/A	Score:	N/A
Asbestos Type		Score:	N/A
Extent			
Recommended Action	N/A	Total Score	0

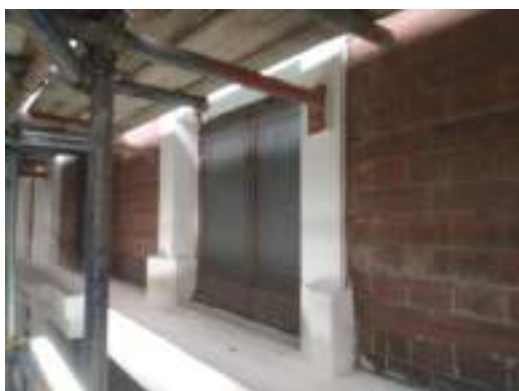
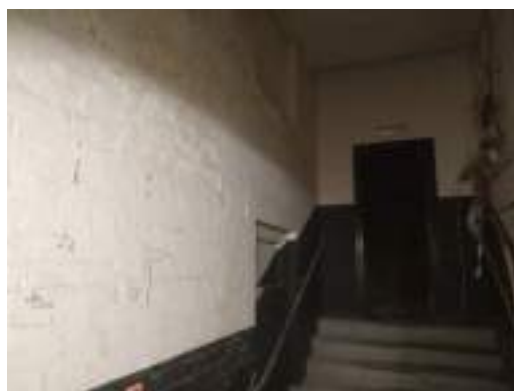
Inspection no:	N/A	Type:	N/A
Room/Area	3rd Floor. W3-08D [092]		
Location/Element	Window		
Notes	Limited access gained. Internal inspection, not accessed due to high level and stairs. External inspection, timber board to window, modern putty. External inspection, timber window to solid walls.		
Product Type	N/A	Score:	N/A
Damage/Deterioration	N/A	Score:	N/A
Surface Treatment	N/A	Score:	N/A
Asbestos Type		Score:	N/A
Extent			
Recommended Action	N/A	Total Score	0

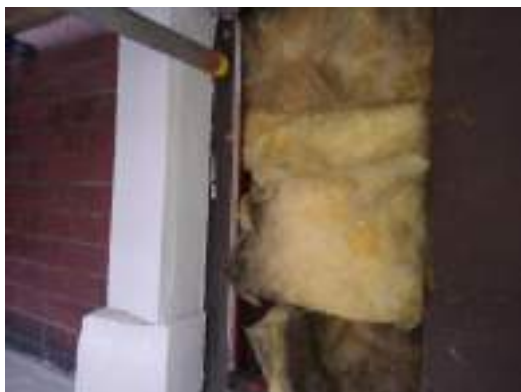
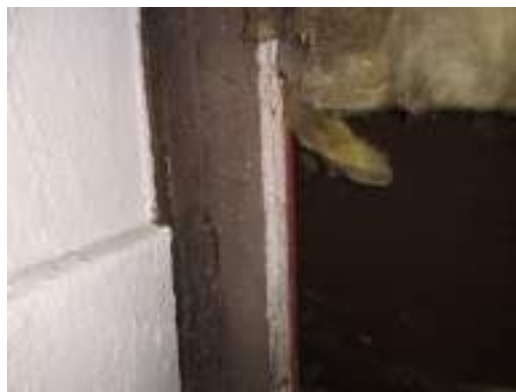
Inspection no:	N/A	Type:	N/A
Room/Area	External. W3-08F - External [093]		
Location/Element	Room Construction		
Notes	Refer to register		
Product Type	N/A	Score:	N/A
Damage/Deterioration	N/A	Score:	N/A
Surface Treatment	N/A	Score:	N/A
Asbestos Type		Score:	N/A
Extent			
Recommended Action	N/A	Total Score

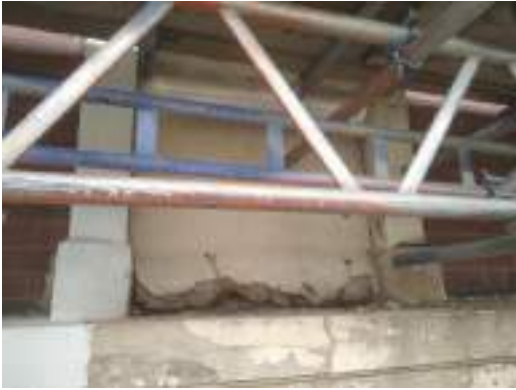
Inspection no:	S047	Type:	Sampled
Room/Area	External. W3-08F - External [093]		
Location/Element	Mastic to window		
Notes			
Product Type	N/A	Score:	N/A
Damage/Deterioration	N/A	Score:	N/A
Surface Treatment	N/A	Score:	N/A
Asbestos Type	NAD	Score:	N/A
Extent	3 lin m		
Recommended Action	N/A	Total Score	0

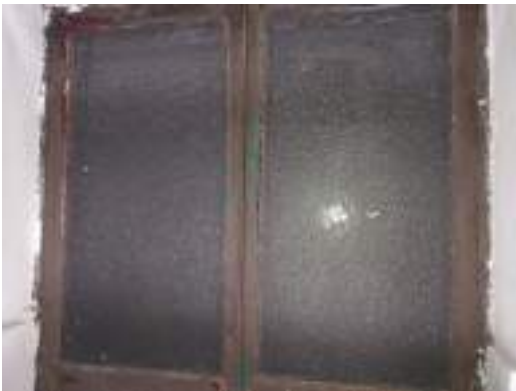
Inspection no:	N/A	Type:	N/A
Room/Area	3rd Floor. W3-08E [094]		
Location/Element	Window		
Notes	Limited access gained. External inspection, timber board, not accessed due to scaffolding. Internal inspection, timber window to solid walls, timber sill, timber boards, MMMF insulation.		
Product Type	N/A	Score:	N/A
Damage/Deterioration	N/A	Score:	N/A
Surface Treatment	N/A	Score:	N/A
Asbestos Type		Score:	N/A
Extent			
Recommended Action	N/A	Total Score

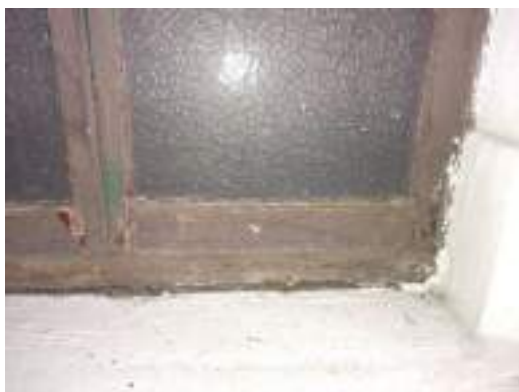
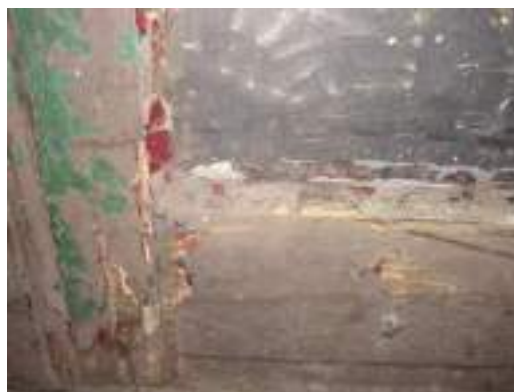
Inspection no:	N/A	Type:	N/A
Room/Area	External. W3-08D - External [095]		
Location/Element	Room Construction		
Notes	Refer to register		
Product Type	N/A	Score:	N/A
Damage/Deterioration	N/A	Score:	N/A
Surface Treatment	N/A	Score:	N/A
Asbestos Type		Score:	N/A
Extent			
Recommended Action	N/A	Total Score

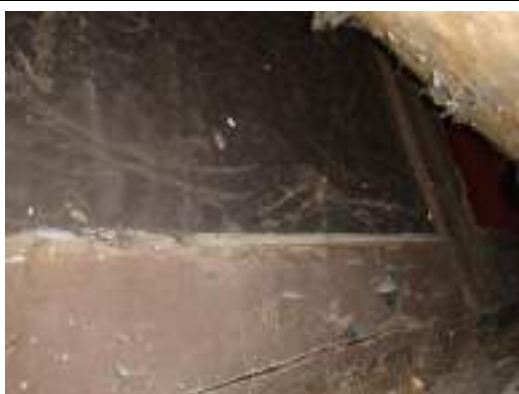
Inspection no:	R047	Type:	Referred Sample
Room/Area	External. W3-08D - External [095]		
Location/Element	Mastic to window		
Notes			
Product Type	Mastic Sealant	Score:	N/A
Damage/Deterioration	N/A	Score:	N/A
Surface Treatment	N/A	Score:	N/A
Asbestos Type	NAD	Score:	N/A
Extent	3 lin m		
Recommended Action	N/A	Total Score	0

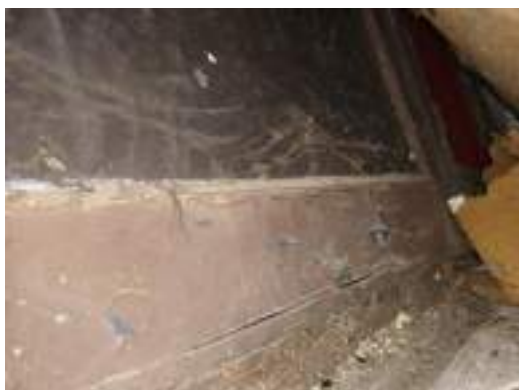
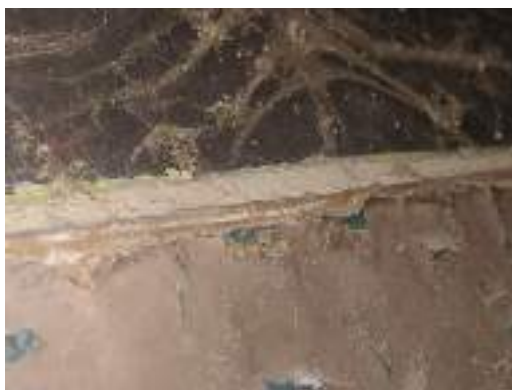
Inspection no:	N/A	Type:	N/A
Room/Area	External. W3-08 - External [096]		
Location/Element	Room Construction		
Notes	Refer to register		
Product Type	N/A	Score:	N/A
Damage/Deterioration	N/A	Score:	N/A
Surface Treatment	N/A	Score:	N/A
Asbestos Type		Score:	N/A
Extent			
Recommended Action	N/A	Total Score

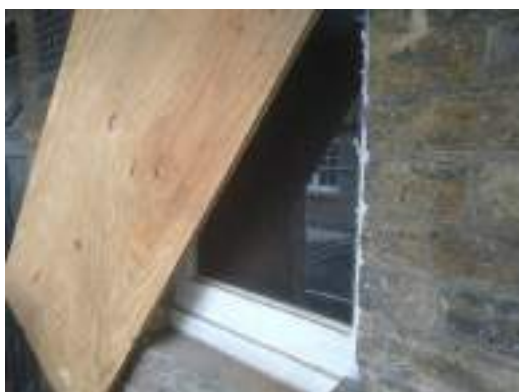
Inspection no:	R047	Type:	Referred Sample
Room/Area	External. W3-08 - External [096]		
Location/Element	Mastic to window		
Notes			
Product Type	Mastic Sealant	Score:	N/A
Damage/Deterioration	N/A	Score:	N/A
Surface Treatment	N/A	Score:	N/A
Asbestos Type	NAD	Score:	N/A
Extent	3 lin m		
Recommended Action	N/A	Total Score	0

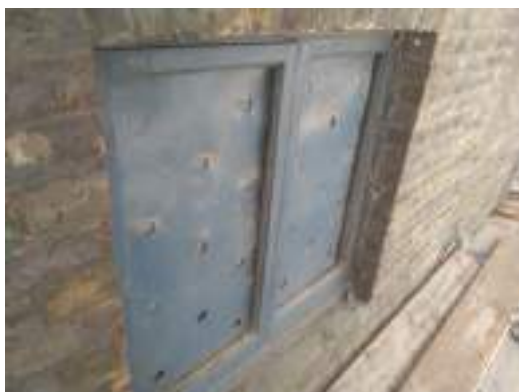
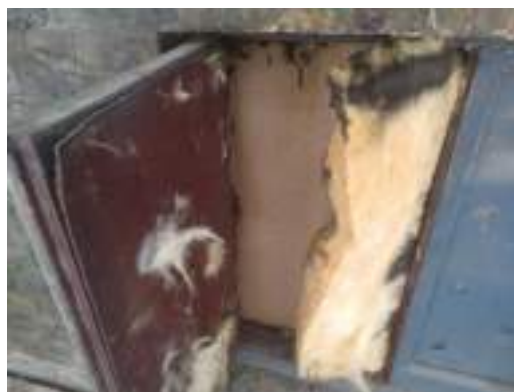
Inspection no:	N/A	Type:	N/A
Room/Area	Ground Floor. WG-01 [097]		
Location/Element	Window		
Notes	Limited access gained. External visual inspection, timber window to solid wall with modern putty, timber board. No access to internal area.		
Product Type	N/A	Score:	N/A
Damage/Deterioration	N/A	Score:	N/A
Surface Treatment	N/A	Score:	N/A
Asbestos Type		Score:	N/A
Extent			
Recommended Action	N/A	Total Score	0

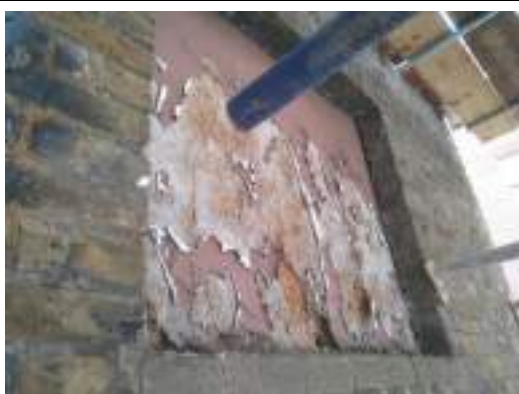
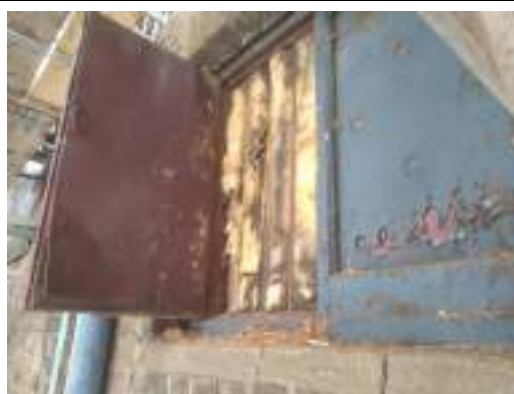
Inspection no:	N/A	Type:	N/A
Room/Area	1st Floor. W1-01E [098]		
Location/Element	Window		
Notes	Limited access gained. Timber window to solid walls, timber panel, MMMF insulation. No access to interior, no access to staircase.		
Product Type	N/A	Score:	N/A
Damage/Deterioration	N/A	Score:	N/A
Surface Treatment	N/A	Score:	N/A
Asbestos Type		Score:	N/A
Extent			
Recommended Action	N/A	Total Score	0

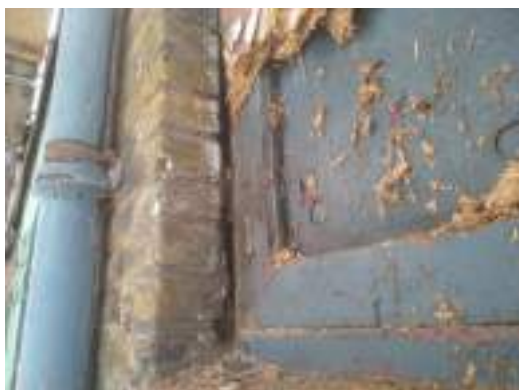
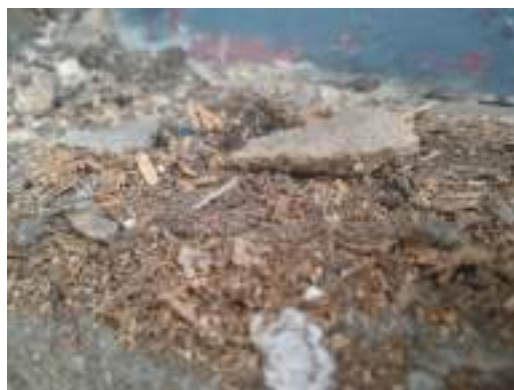
Inspection no:	N/A	Type:	N/A
Room/Area	1st Floor. W1-01F [099]		
Location/Element	Window		
Notes	Limited access gained. Timber window to solid walls, timber panel, fibreboard panel, MMMF insulation. Inspected from the outside only, no access to staircase.		
Product Type	N/A	Score:	N/A
Damage/Deterioration	N/A	Score:	N/A
Surface Treatment	N/A	Score:	N/A
Asbestos Type		Score:	N/A
Extent			
Recommended Action	N/A	Total Score	0

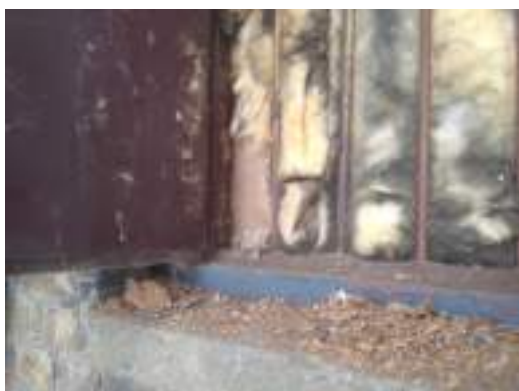
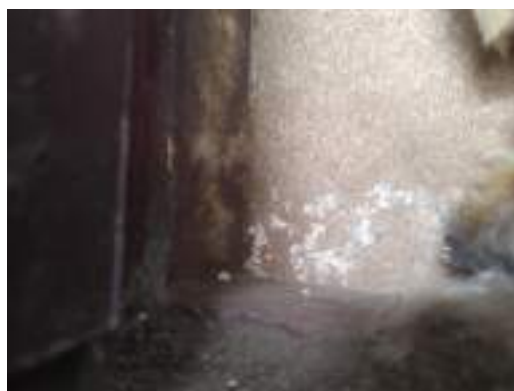
Inspection no:	S048	Type:	Sampled
Room/Area	1st Floor. W1-01F [099]		
Location/Element	Window Frame		
Notes			
Product Type	N/A	Score:	N/A
Damage/Deterioration	N/A	Score:	N/A
Surface Treatment	N/A	Score:	N/A
Asbestos Type	NAD	Score:	N/A
Extent	0.1 lin m		
Recommended Action	N/A	Total Score	0

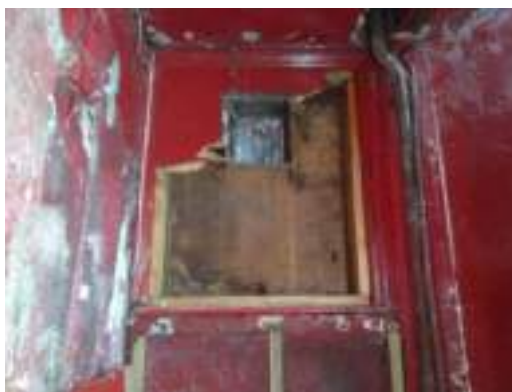
Inspection no:	S049	Type:	Sampled
Room/Area	1st Floor. W1-01F [099]		
Location/Element	Window Panel		
Notes			
Product Type	N/A	Score:	N/A
Damage/Deterioration	N/A	Score:	N/A
Surface Treatment	N/A	Score:	N/A
Asbestos Type	NAD	Score:	N/A
Extent	0.1 m ²		
Recommended Action	N/A	Total Score	0

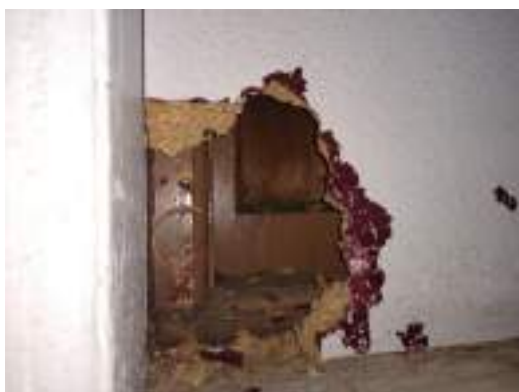
Inspection no:	N/A	Type:	N/A
Room/Area	2nd Floor. LW2-01 [100]		
Location/Element	Window		
Notes	Limited access gained. Internal visual inspection, timber window to solid walls, timber sill, timber boards, plastic air vent. No access to the external area.		
Product Type	N/A	Score:	N/A
Damage/Deterioration	N/A	Score:	N/A
Surface Treatment	N/A	Score:	N/A
Asbestos Type		Score:	N/A
Extent			
Recommended Action	N/A	Total Score	0

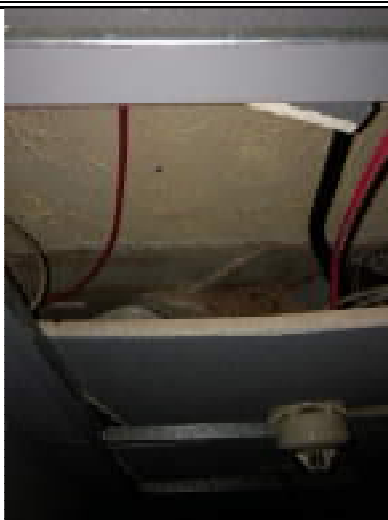
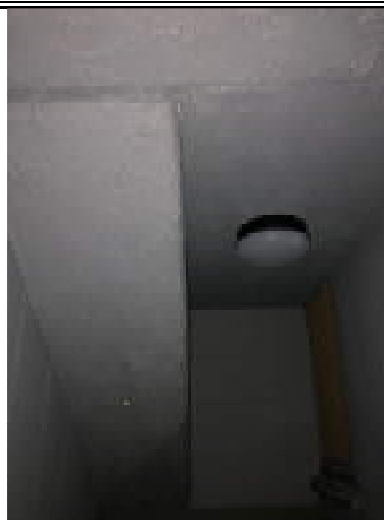
Inspection no:	S051	Type:	Sampled
Room/Area	1st Floor. Toilet 1-08 [105]		
Location/Element	Textured finish to soffit and beam		
Notes			
Product Type	N/A	Score:	N/A
Damage/Deterioration	N/A	Score:	N/A
Surface Treatment	N/A	Score:	N/A
Asbestos Type	NAD	Score:	N/A
Extent	3 m ²		
Recommended Action	N/A	Total Score	0

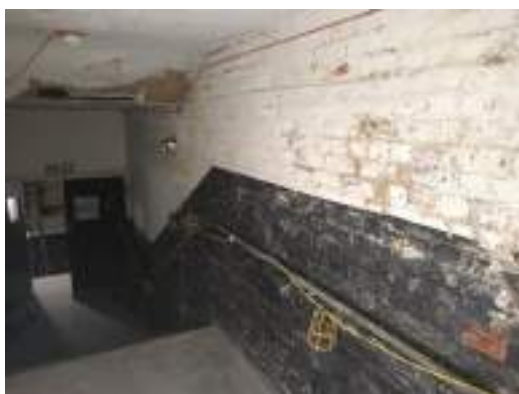
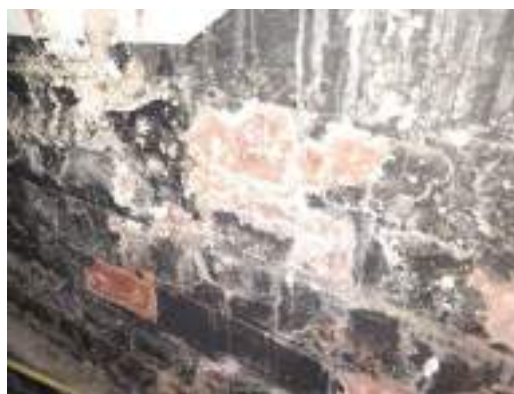
Inspection no:	S104	Type:	Sampled
Room/Area	3rd Floor. RM.3-08 and RM.3-10 - Corridor Stairwell [106]		
Location/Element	Paint to walls		
Notes	Sampled from all walls back to substrate.		
Product Type	N/A	Score:	N/A
Damage/Deterioration	N/A	Score:	N/A
Surface Treatment	N/A	Score:	N/A
Asbestos Type	NAD	Score:	N/A
Extent	50 m ²		
Recommended Action	N/A	Total Score	0

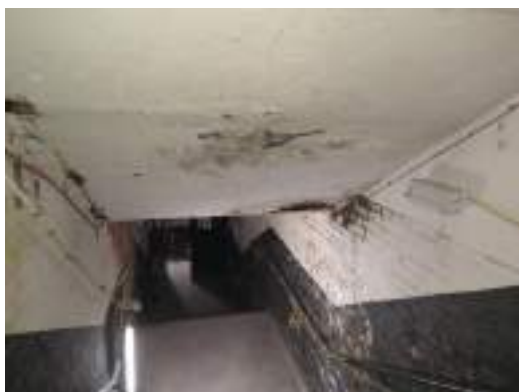
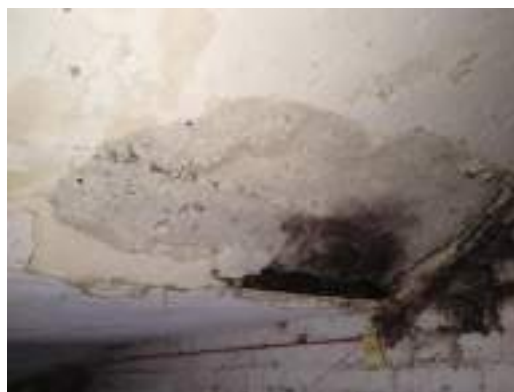
Inspection no:	S105	Type:	Sampled
Room/Area	3rd Floor. RM.3-08 and RM.3-10 - Corridor Stairwell [106]		
Location/Element	Paint to ceiling		
Notes	Sampled back to substrate.		
Product Type	Textured Coating	Score:	1
Damage/Deterioration	High Damage	Score:	3
Surface Treatment	Sealed	Score:	1
Asbestos Type	Chrysotile	Score:	1
Extent	25 m ²		
Recommended Action	Remove	Total Score	6

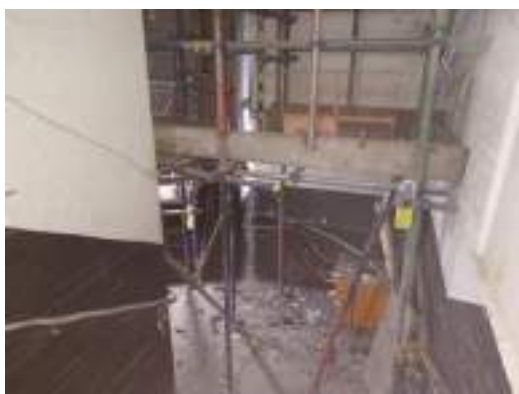
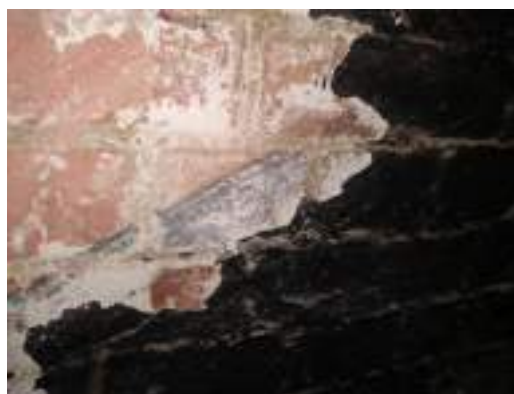
Inspection no:	S106	Type:	Sampled
Room/Area	3rd Floor. RM.3-08 and RM.3-10 - Corridor Stairwell [106]		
Location/Element	Paint to walls		
Notes	Sampled from all walls back to substrate.		
Product Type	N/A	Score:	N/A
Damage/Deterioration	N/A	Score:	N/A
Surface Treatment	N/A	Score:	N/A
Asbestos Type	NAD	Score:	N/A
Extent	60 m ²		
Recommended Action	N/A	Total Score	0

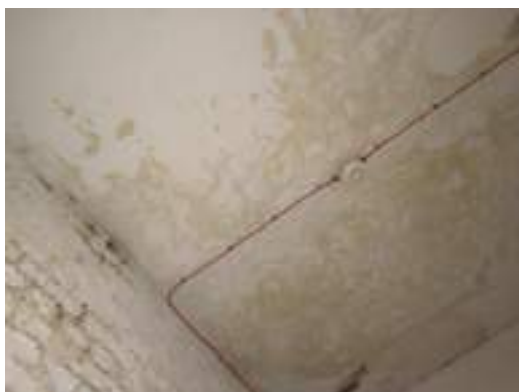
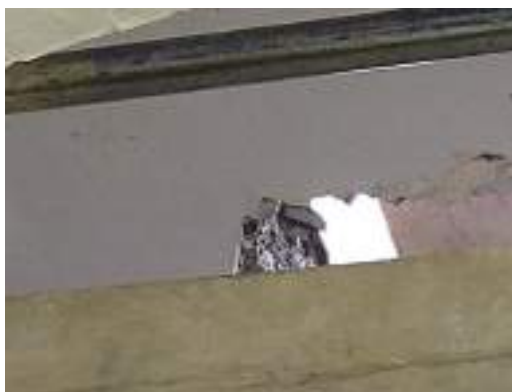
Inspection no:	S107	Type:	Sampled
Room/Area	3rd Floor. RM.3-08 and RM.3-10 - Corridor Stairwell [106]		
Location/Element	Paint to Ceiling		
Notes	Sampled back to substrate.		
Product Type	N/A	Score:	N/A
Damage/Deterioration	N/A	Score:	N/A
Surface Treatment	N/A	Score:	N/A
Asbestos Type	NAD	Score:	N/A
Extent	30 m ²		
Recommended Action	N/A	Total Score	0

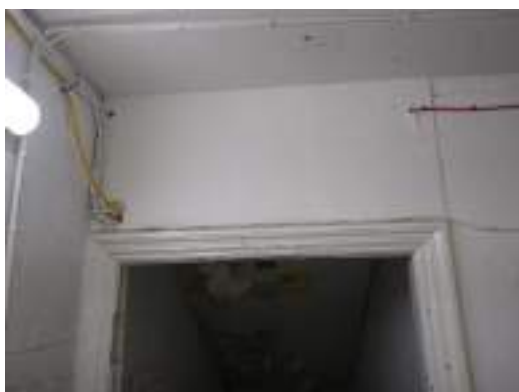
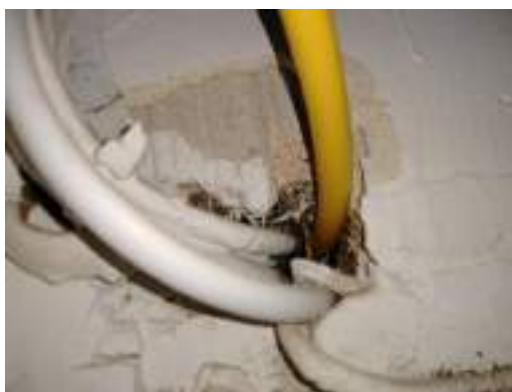
Inspection no:	S052	Type:	Sampled
Room/Area	2nd Floor. RM.2-13 and RM.2-12 - Corridor Stairwell [107]		
Location/Element	Header panel		
Notes			
Product Type	N/A	Score:	N/A
Damage/Deterioration	N/A	Score:	N/A
Surface Treatment	N/A	Score:	N/A
Asbestos Type	NAD	Score:	N/A
Extent	1 m ²		
Recommended Action	N/A	Total Score	0

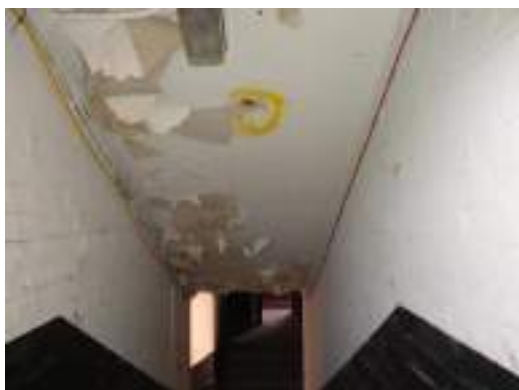
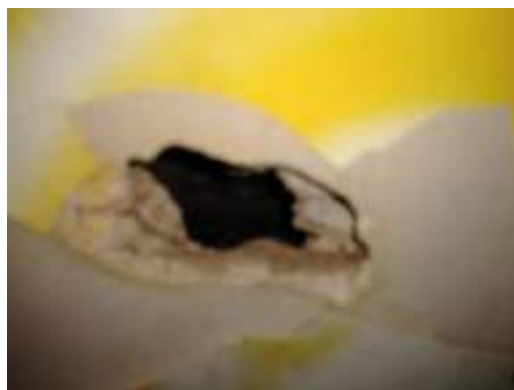
Inspection no:	S053	Type:	Sampled
Room/Area	2nd Floor. RM.2-13 and RM.2-12 - Corridor Stairwell [107]		
Location/Element	Ceiling panel to stairs		
Notes			
Product Type	N/A	Score:	N/A
Damage/Deterioration	N/A	Score:	N/A
Surface Treatment	N/A	Score:	N/A
Asbestos Type	NAD	Score:	N/A
Extent	5 m ²		
Recommended Action	N/A	Total Score	0

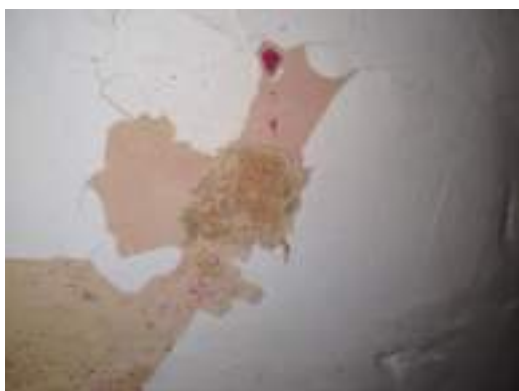
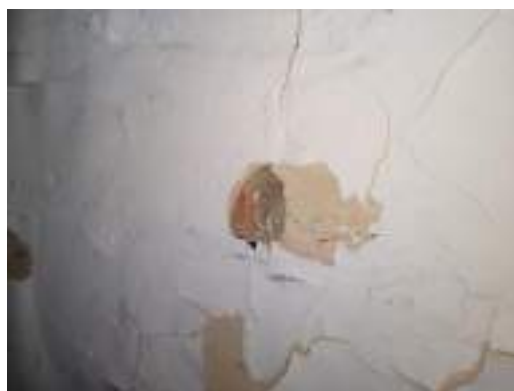
Inspection no:	S167	Type:	Sampled
Room/Area	2nd Floor. RM.2-13 and RM.2-12 - Corridor Stairwell [107]		
Location/Element	Paint to walls		
Notes	Sampled from all walls back to substrate.		
Product Type	N/A	Score:	N/A
Damage/Deterioration	N/A	Score:	N/A
Surface Treatment	N/A	Score:	N/A
Asbestos Type	NAD	Score:	N/A
Extent	60 m ²		
Recommended Action	N/A	Total Score	0

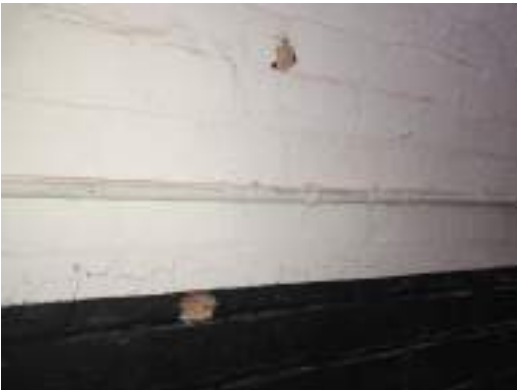
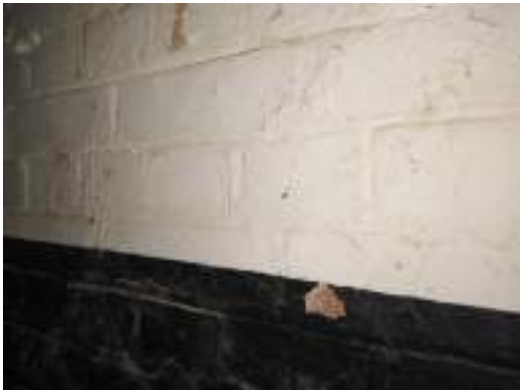
Inspection no:	S168	Type:	Sampled
Room/Area	2nd Floor. RM.2-13 and RM.2-12 - Corridor Stairwell [107]		
Location/Element	Paint to Ceiling		
Notes	Sampled back to substrate.		
Product Type	N/A	Score:	N/A
Damage/Deterioration	N/A	Score:	N/A
Surface Treatment	N/A	Score:	N/A
Asbestos Type	NAD	Score:	N/A
Extent	40 m ²		
Recommended Action	N/A	Total Score	0
