Asbestos Survey Report

ASBESTOS SURVEY
REPORT NO: A-44387 – ISSUE 6

DATE ISSUED: 06/08/2020

Site Address:
KoKo Night Club
Heritage Areas Survey
1A Camden High St
London
NW1 7JE

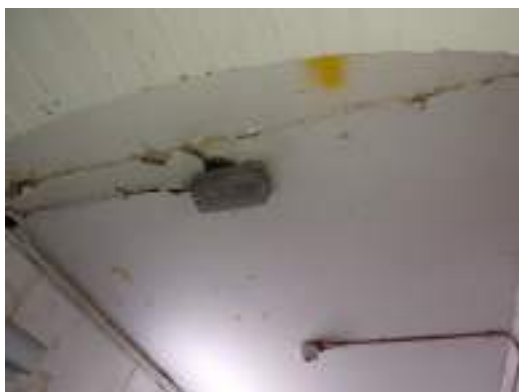
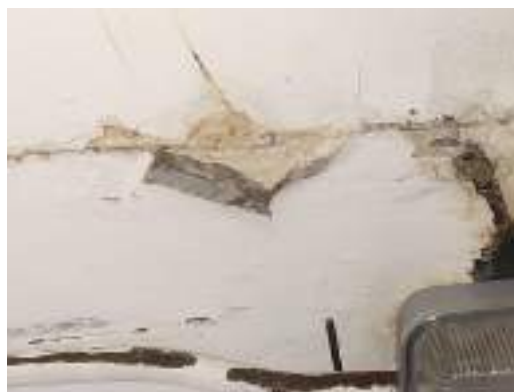
Inspection no:	S169	Type:	Sampled
Room/Area	2nd Floor. RM.2-13 and RM.2-12 - Corridor Stairwell [107]		
Location/Element	Paint to walls		
Notes	Sampled from all walls back to substrate.		
Product Type	N/A	Score:	N/A
Damage/Deterioration	N/A	Score:	N/A
Surface Treatment	N/A	Score:	N/A
Asbestos Type	NAD	Score:	N/A
Extent	60 m ²		
Recommended Action	N/A	Total Score	0

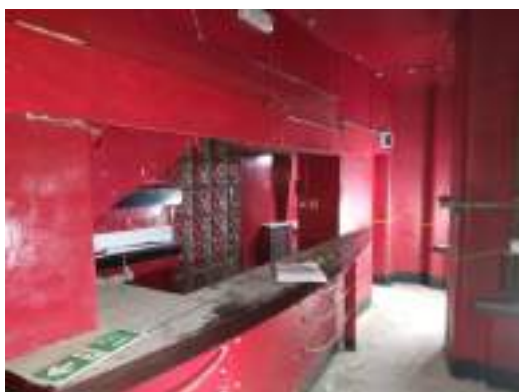
Inspection no:	S170	Type:	Sampled
Room/Area	2nd Floor. RM.2-13 and RM.2-12 - Corridor Stairwell [107]		
Location/Element	Paint to Ceiling		
Notes	Sampled back to substrate.		
Product Type	N/A	Score:	N/A
Damage/Deterioration	N/A	Score:	N/A
Surface Treatment	N/A	Score:	N/A
Asbestos Type	NAD	Score:	N/A
Extent	40 m ²		
Recommended Action	N/A	Total Score	0

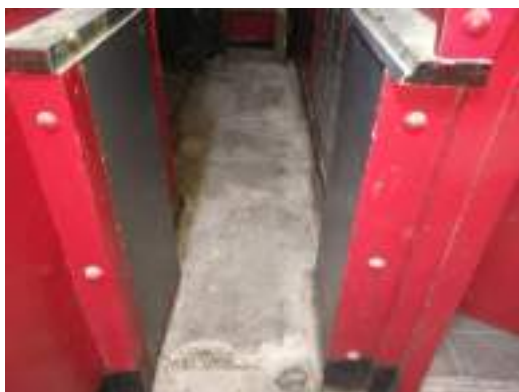
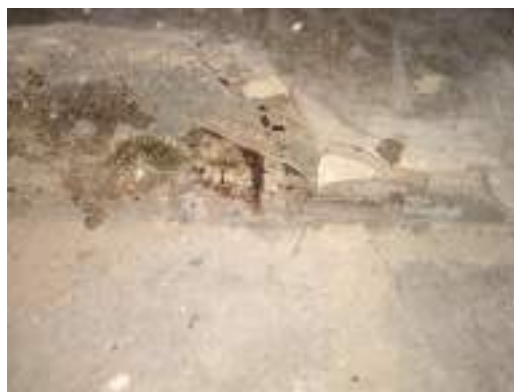
Inspection no:	S055	Type:	Sampled
Room/Area	1st Floor. RM.1-07 - Bar Area [108]		
Location/Element	Floor tiles and bitumen		
Notes			
Product Type	Thermoplastic and bitumen	Score:	1
Damage/Deterioration	Low Damage	Score:	1
Surface Treatment	Self Sealed	Score:	0
Asbestos Type	Chrysotile	Score:	1
Extent	6 m ²		
Recommended Action	Remove	Total Score	3

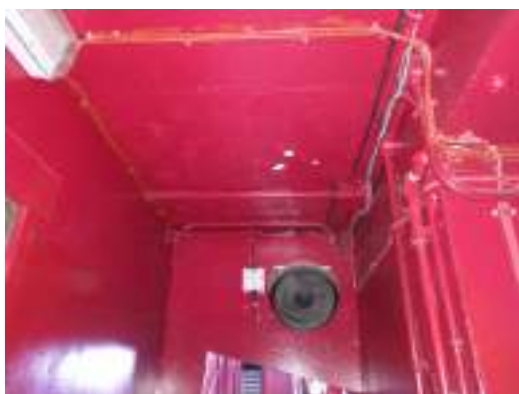
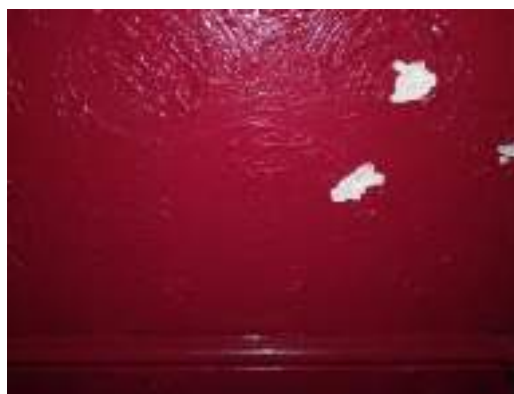
Inspection no:	S056	Type:	Sampled
Room/Area	1st Floor. RM.1-07 - Bar Area [108]		
Location/Element	Textured coating to ceiling		
Notes			
Product Type	N/A	Score:	N/A
Damage/Deterioration	N/A	Score:	N/A
Surface Treatment	N/A	Score:	N/A
Asbestos Type	NAD	Score:	N/A
Extent	1 m ²		
Recommended Action	N/A	Total Score	0

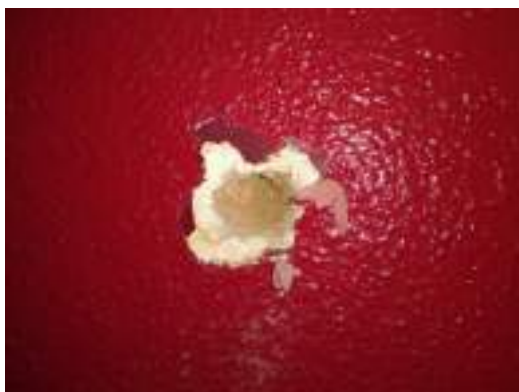
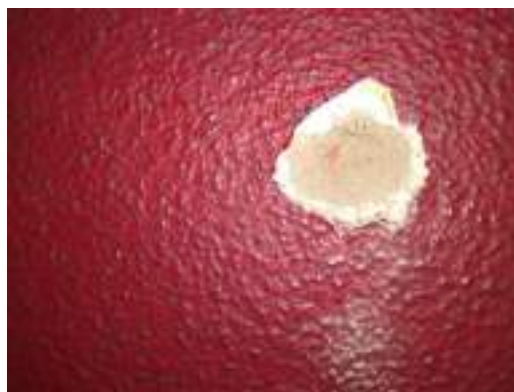
Inspection no:	S274	Type:	Sampled
Room/Area	1st Floor. RM.1-07 - Bar Area [108]		
Location/Element	Paint to walls		
Notes			
Product Type	Textured Coating	Score:	1
Damage/Deterioration	Low Damage	Score:	1
Surface Treatment	Sealed	Score:	1
Asbestos Type	Chrysotile	Score:	1
Extent	15 m ²		
Recommended Action	Remove	Total Score	4

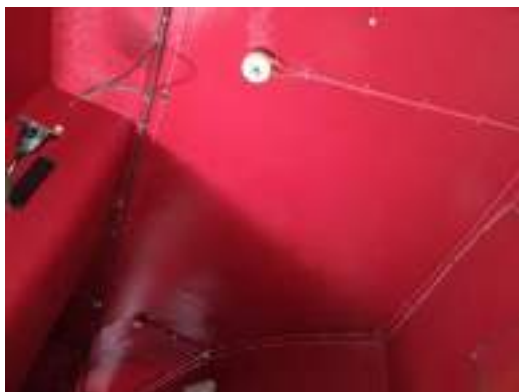
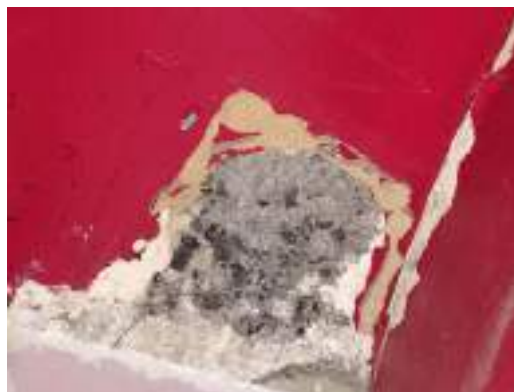
Inspection no:	S275	Type:	Sampled
Room/Area	1st Floor. RM.1-07 - Bar Area [108]		
Location/Element	Paint to ceiling		
Notes			
Product Type	N/A	Score:	N/A
Damage/Deterioration	N/A	Score:	N/A
Surface Treatment	N/A	Score:	N/A
Asbestos Type	NAD	Score:	N/A
Extent	10 m ²		
Recommended Action	N/A	Total Score	0

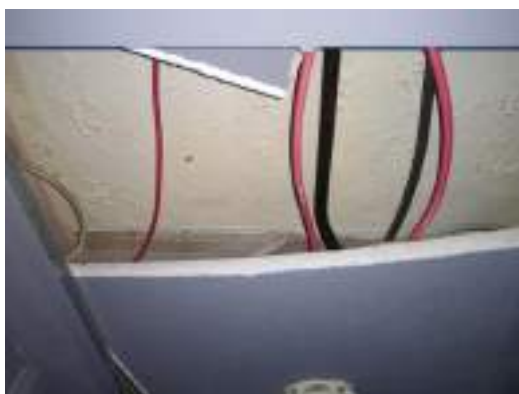
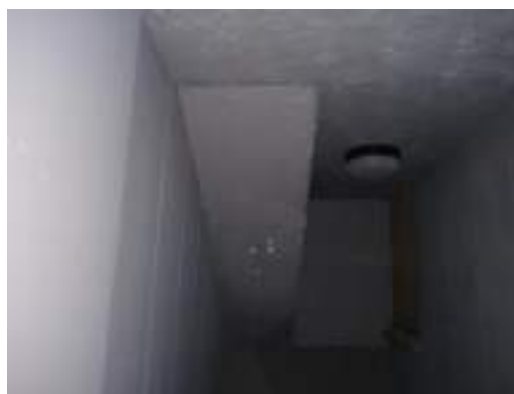
Inspection no:	S057	Type:	Sampled
Room/Area	1st Floor. RM.1-08 - Toilet [109]		
Location/Element	Textured coating to ceiling and walls		
Notes			
Product Type	N/A	Score:	N/A
Damage/Deterioration	N/A	Score:	N/A
Surface Treatment	N/A	Score:	N/A
Asbestos Type	NAD	Score:	N/A
Extent	10 m ²		
Recommended Action	N/A	Total Score	0

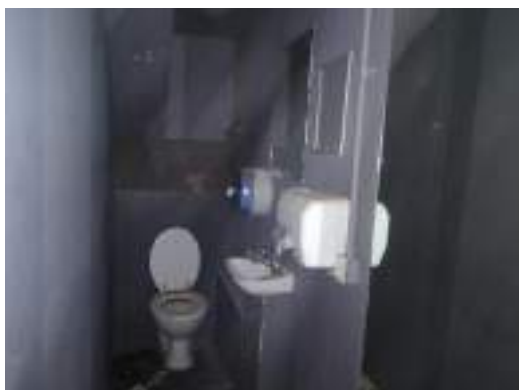
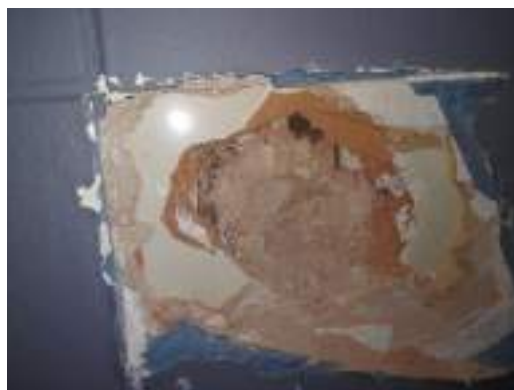
Inspection no:	S272	Type:	Sampled
Room/Area	1st Floor. RM.1-08 - Toilet [109]		
Location/Element	Paint to walls		
Notes			
Product Type	N/A	Score:	N/A
Damage/Deterioration	N/A	Score:	N/A
Surface Treatment	N/A	Score:	N/A
Asbestos Type	NAD	Score:	N/A
Extent	10 m ²		
Recommended Action	N/A	Total Score	0

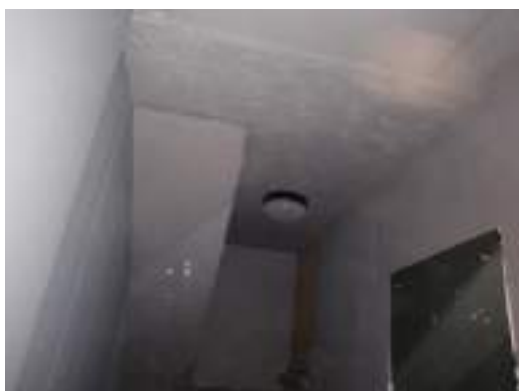
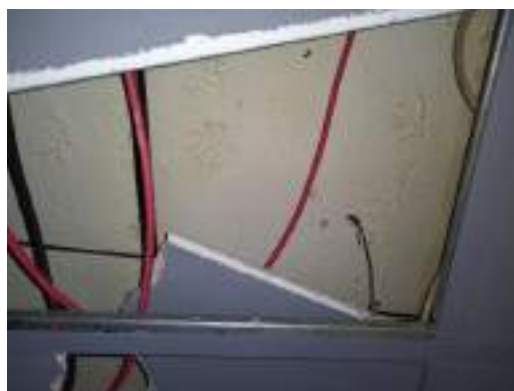
Inspection no:	S273	Type:	Sampled
Room/Area	1st Floor. RM.1-08 - Toilet [109]		
Location/Element	Paint to ceiling		
Notes			
Product Type	N/A	Score:	N/A
Damage/Deterioration	N/A	Score:	N/A
Surface Treatment	N/A	Score:	N/A
Asbestos Type	NAD	Score:	N/A
Extent	10 m ²		
Recommended Action	N/A	Total Score	0

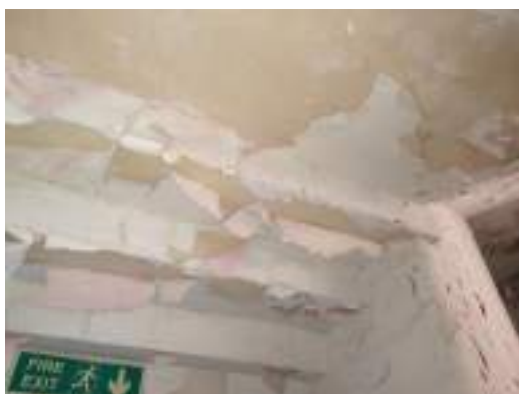
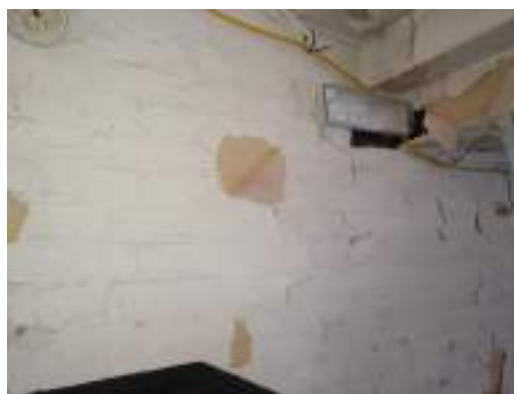
Inspection no:	S058	Type:	Sampled
Room/Area	1st Floor. RM.1-06 [110]		
Location/Element	Paint to walls		
Notes			
Product Type	N/A	Score:	N/A
Damage/Deterioration	N/A	Score:	N/A
Surface Treatment	N/A	Score:	N/A
Asbestos Type	NAD	Score:	N/A
Extent	60 m ²		
Recommended Action	N/A	Total Score	0

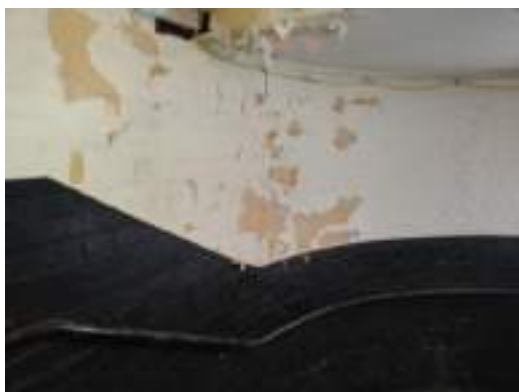
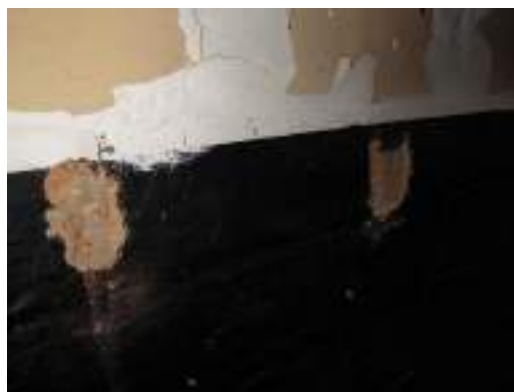
Inspection no:	S276	Type:	Sampled
Room/Area	1st Floor. RM.1-06 [110]		
Location/Element	Textured coating to walls under paint		
Notes			
Product Type	Textured Coating	Score:	1
Damage/Deterioration	Low Damage	Score:	1
Surface Treatment	Sealed	Score:	1
Asbestos Type	Chrysotile	Score:	1
Extent	20 m ²		
Recommended Action	Remove	Total Score	4

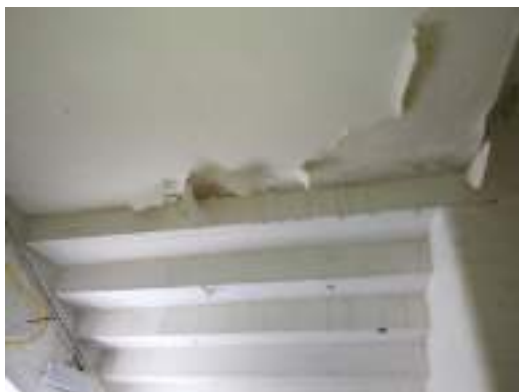
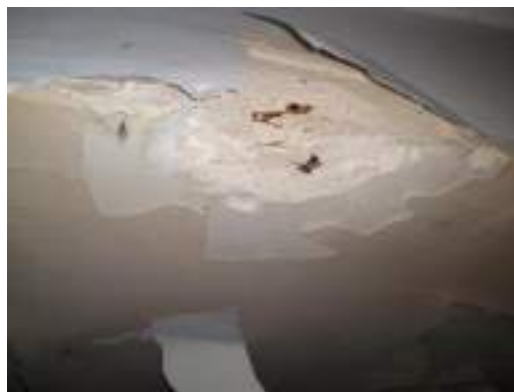
Inspection no:	S277	Type:	Sampled
Room/Area	1st Floor. RM.1-06 [110]		
Location/Element	Paint to ceiling		
Notes			
Product Type	N/A	Score:	N/A
Damage/Deterioration	N/A	Score:	N/A
Surface Treatment	N/A	Score:	N/A
Asbestos Type	NAD	Score:	N/A
Extent	10 m ²		
Recommended Action	N/A	Total Score	0

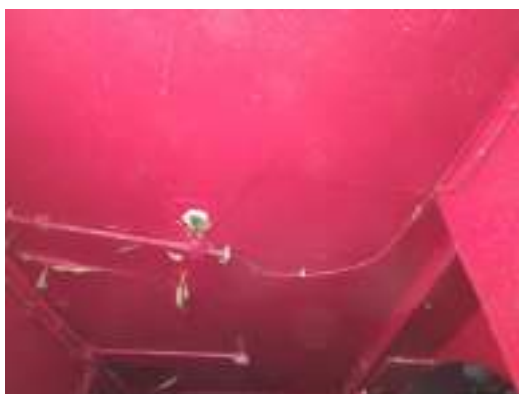
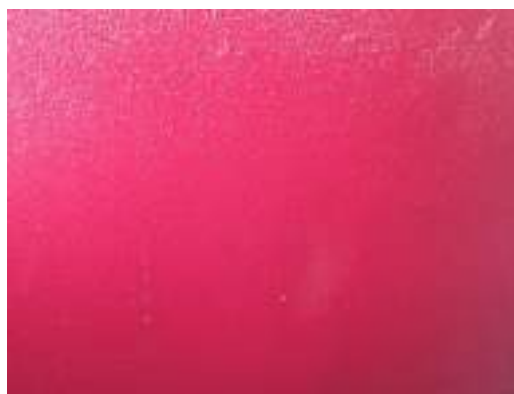
Inspection no:	S059	Type:	Sampled
Room/Area	Ground Floor. RM.G-10 - Landing [111]		
Location/Element	Textured paint to ceiling		
Notes			
Product Type	N/A	Score:	N/A
Damage/Deterioration	N/A	Score:	N/A
Surface Treatment	N/A	Score:	N/A
Asbestos Type	NAD	Score:	N/A
Extent	10 m ²		
Recommended Action	N/A	Total Score	0

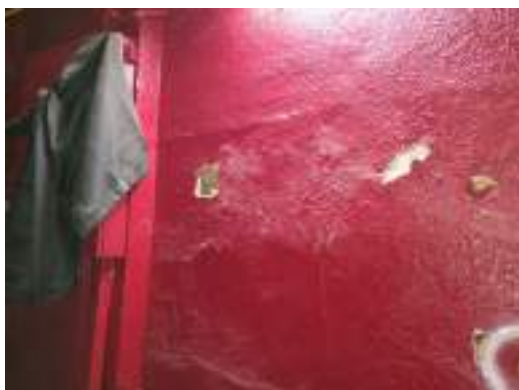
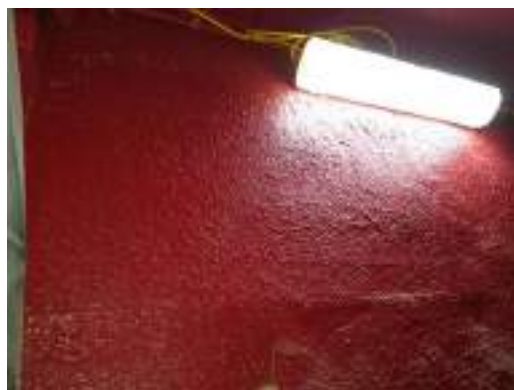
Inspection no:	S060	Type:	Sampled
Room/Area	Ground Floor. RM.G-10 - Landing [111]		
Location/Element	Paint to walls		
Notes			
Product Type	N/A	Score:	N/A
Damage/Deterioration	N/A	Score:	N/A
Surface Treatment	N/A	Score:	N/A
Asbestos Type	NAD	Score:	N/A
Extent	20 m ²		
Recommended Action	N/A	Total Score	0

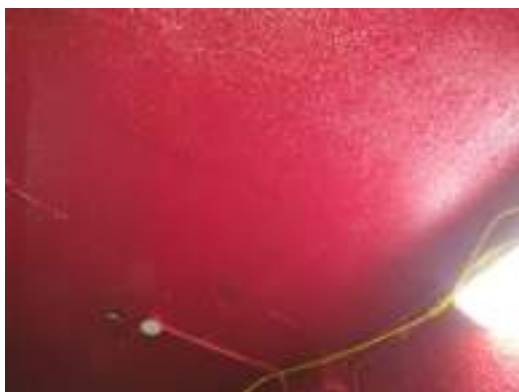
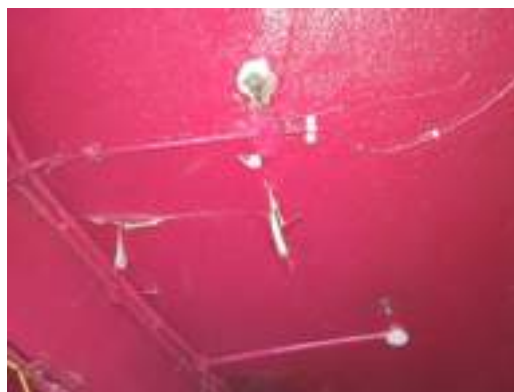
Inspection no:	S062	Type:	Sampled
Room/Area	Ground Floor. RM.G-10 - Landing [111]		
Location/Element	Panels beneath floor		
Notes	Used as lining to timber floor, packers between joists, and damaged loose sheets and debris throughout void.		
Product Type	Insulating Board	Score:	2
Damage/Deterioration	High Damage	Score:	3
Surface Treatment	Partially Unsealed	Score:	2
Asbestos Type	Amosite	Score:	2
Extent	5 m ²		
Recommended Action	Remove	Total Score	9

Inspection no:	S337	Type:	Sampled
Room/Area	Ground Floor. RM.G-10 - Landing [111]		
Location/Element	Textured coating to walls under paint		
Notes			
Product Type	Textured Coating	Score:	1
Damage/Deterioration	Low Damage	Score:	1
Surface Treatment	Sealed	Score:	1
Asbestos Type	Chrysotile	Score:	1
Extent	20 m ²		
Recommended Action	Remove	Total Score	4

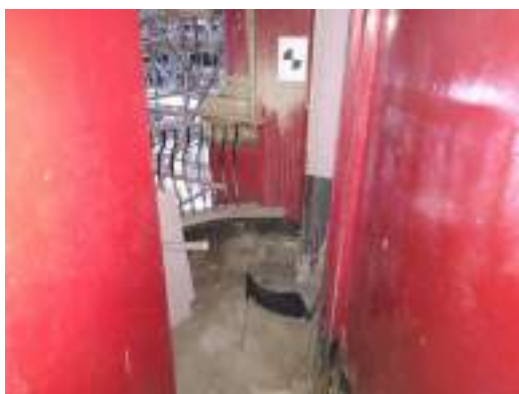
Inspection no:	S338	Type:	Sampled
Room/Area	Ground Floor. RM.G-10 - Landing [111]		
Location/Element	Paint to ceiling		
Notes			
Product Type	N/A	Score:	N/A
Damage/Deterioration	N/A	Score:	N/A
Surface Treatment	N/A	Score:	N/A
Asbestos Type	NAD	Score:	N/A
Extent	10 m ²		
Recommended Action	N/A	Total Score	0

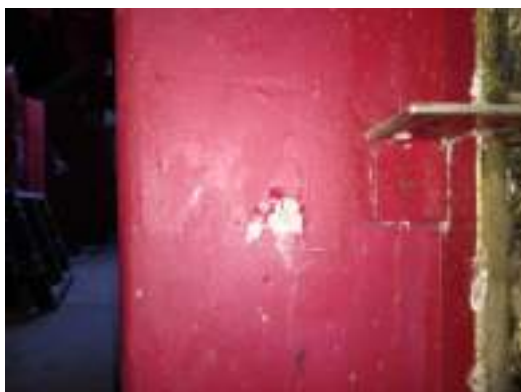
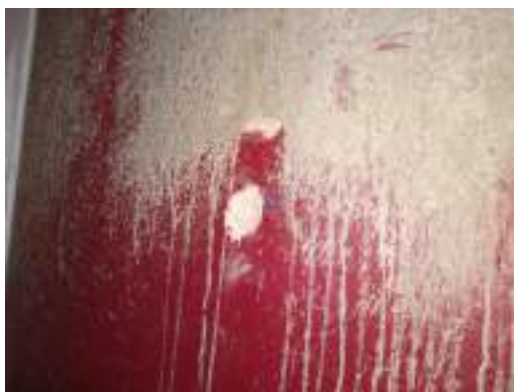
Inspection no:	S339	Type:	Sampled
Room/Area	Ground Floor. RM.G-10 - Balcony [112]		
Location/Element	Paint to walls		
Notes			
Product Type	N/A	Score:	N/A
Damage/Deterioration	N/A	Score:	N/A
Surface Treatment	N/A	Score:	N/A
Asbestos Type	NAD	Score:	N/A
Extent	10 m ²		
Recommended Action	N/A	Total Score	0

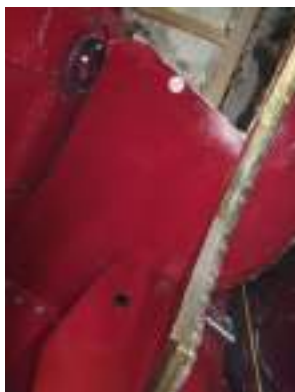
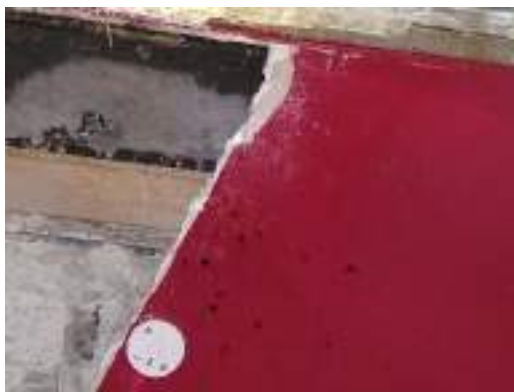
Inspection no:	S340	Type:	Sampled
Room/Area	Ground Floor. RM.G-10 - Balcony [112]		
Location/Element	Paint to ceiling		
Notes			
Product Type	N/A	Score:	N/A
Damage/Deterioration	N/A	Score:	N/A
Surface Treatment	N/A	Score:	N/A
Asbestos Type	NAD	Score:	N/A
Extent	5 m ²		
Recommended Action	N/A	Total Score	0

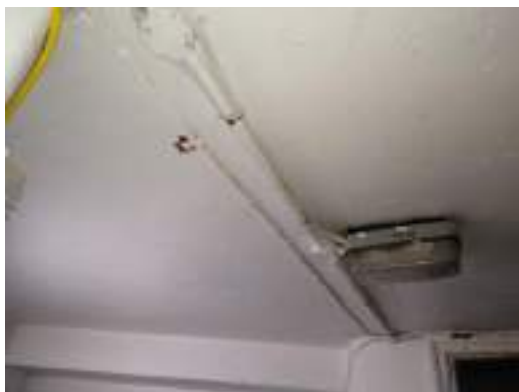
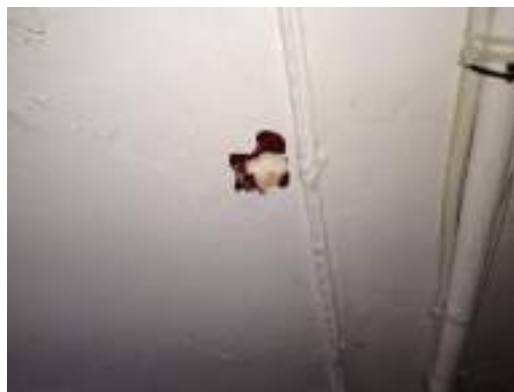
Inspection no:	S063	Type:	Sampled
Room/Area	Ground Floor. RM.G-07 [113]		
Location/Element	Paint and plaster to ceiling		
Notes			
Product Type	N/A	Score:	N/A
Damage/Deterioration	N/A	Score:	N/A
Surface Treatment	N/A	Score:	N/A
Asbestos Type	NAD	Score:	N/A
Extent	20 m ²		
Recommended Action	N/A	Total Score	0

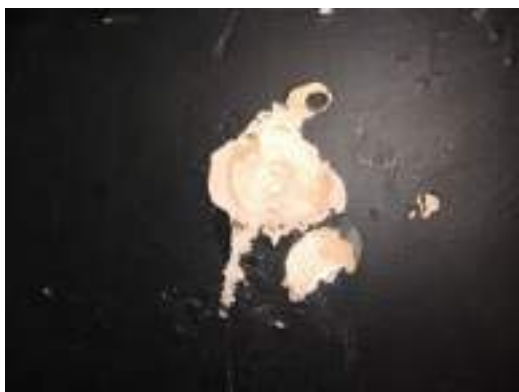
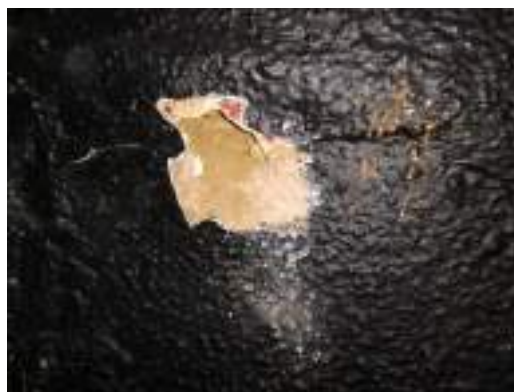
Inspection no:	S341	Type:	Sampled
Room/Area	Ground Floor. RM.G-07 [113]		
Location/Element	Textured coating to walls under paint		
Notes			
Product Type	Textured Coating	Score:	1
Damage/Deterioration	Low Damage	Score:	1
Surface Treatment	Sealed	Score:	1
Asbestos Type	Chrysotile	Score:	1
Extent	40 m ²		
Recommended Action	Remove	Total Score	4

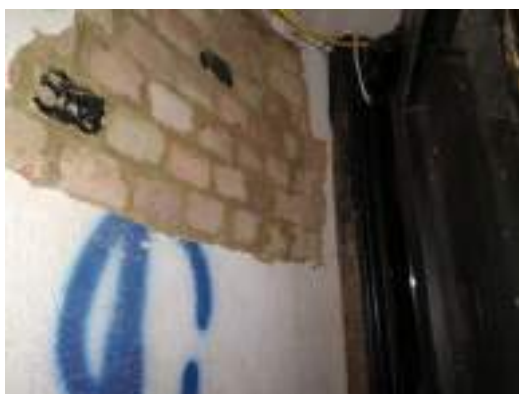
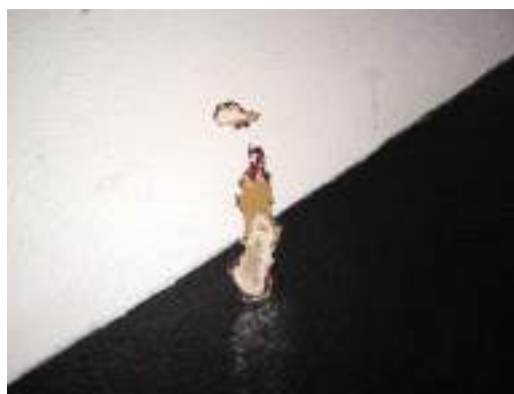
Inspection no:	S342	Type:	Sampled
Room/Area	Ground Floor. RM.G-07 [113]		
Location/Element	Textured coating to walls under paint		
Notes			
Product Type	Textured Coating	Score:	1
Damage/Deterioration	Low Damage	Score:	1
Surface Treatment	Sealed	Score:	1
Asbestos Type	Chrysotile	Score:	1
Extent	40 m ²		
Recommended Action	Remove	Total Score	4

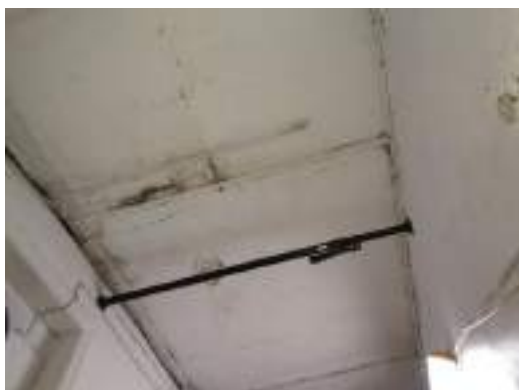
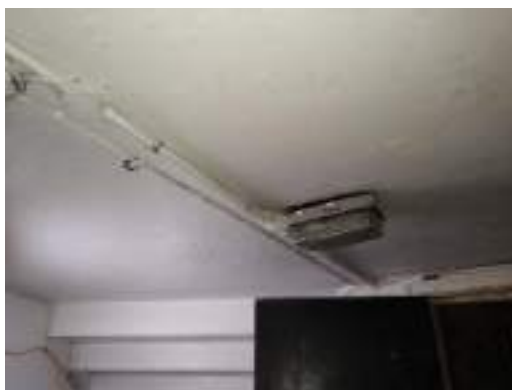
Inspection no:	S343	Type:	Sampled
Room/Area	Ground Floor. RM.G-07 [113]		
Location/Element	Textured coating to ceiling under paint		
Notes			
Product Type	Textured Coating	Score:	1
Damage/Deterioration	Low Damage	Score:	1
Surface Treatment	Sealed	Score:	1
Asbestos Type	Chrysotile	Score:	1
Extent	20 m ²		
Recommended Action	Remove	Total Score	4

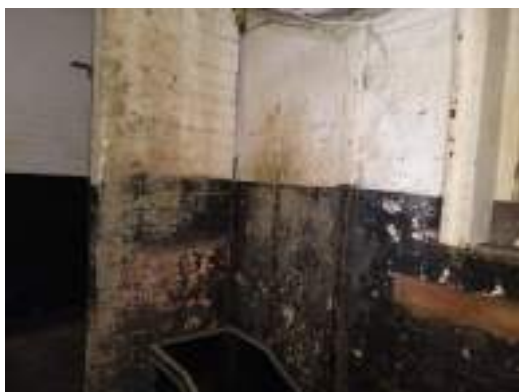
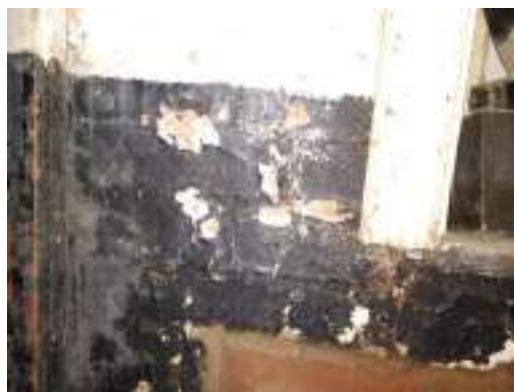
Inspection no:	S344	Type:	Sampled
Room/Area	Ground Floor. RM.G-07 - Store [114]		
Location/Element	Paint to walls		
Notes			
Product Type	N/A	Score:	N/A
Damage/Deterioration	N/A	Score:	N/A
Surface Treatment	N/A	Score:	N/A
Asbestos Type	NAD	Score:	N/A
Extent	12 m ²		
Recommended Action	N/A	Total Score	0

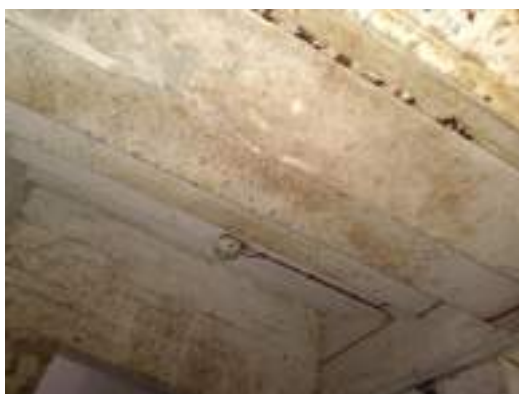
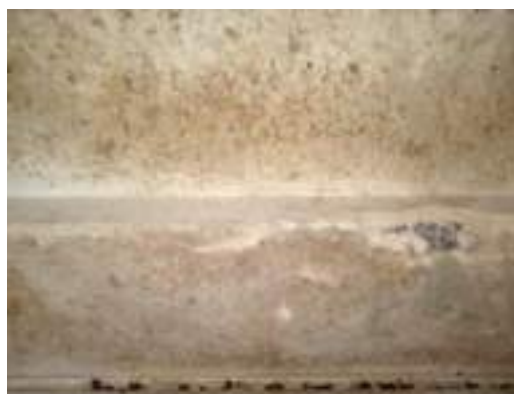
Inspection no:	S345	Type:	Sampled
Room/Area	Ground Floor. RM.G-07 - Store [114]		
Location/Element	Paint to ceiling		
Notes			
Product Type	N/A	Score:	N/A
Damage/Deterioration	N/A	Score:	N/A
Surface Treatment	N/A	Score:	N/A
Asbestos Type	NAD	Score:	N/A
Extent	4 m ²		
Recommended Action	N/A	Total Score	0

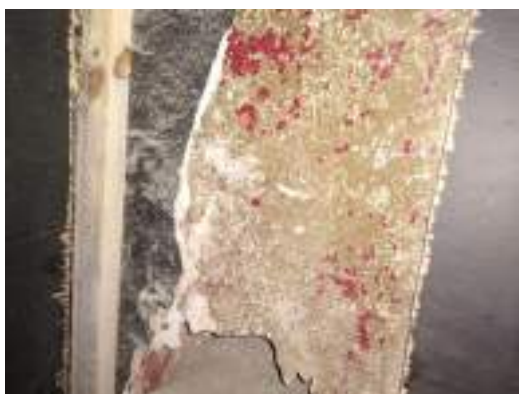
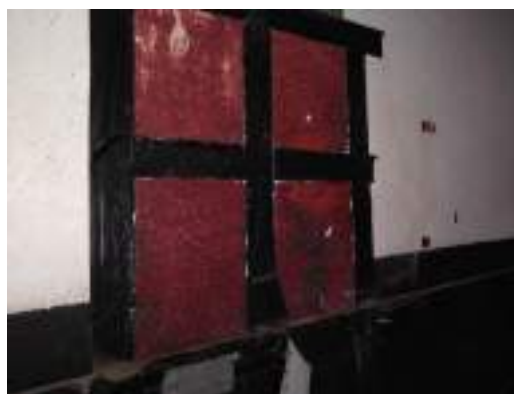
Inspection no:	S235	Type:	Sampled
Room/Area	Basement. RM.B-18 - Stairs [115]		
Location/Element	Paint to walls		
Notes			
Product Type	N/A	Score:	N/A
Damage/Deterioration	N/A	Score:	N/A
Surface Treatment	N/A	Score:	N/A
Asbestos Type	NAD	Score:	N/A
Extent	30 m ²		
Recommended Action	N/A	Total Score	0

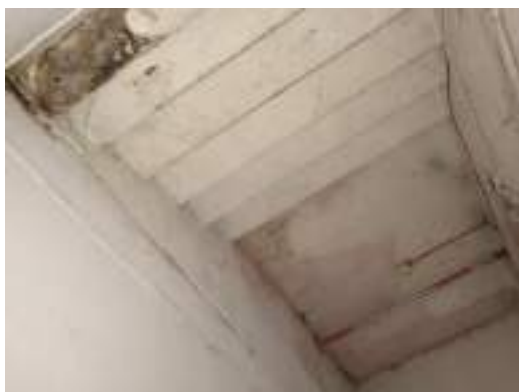
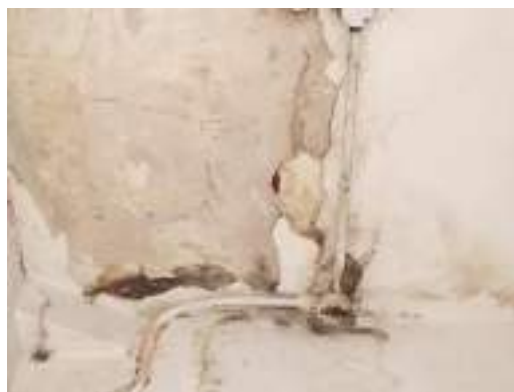
Inspection no:	S236	Type:	Sampled
Room/Area	Basement. RM.B-18 - Stairs [115]		
Location/Element	Paint to ceiling		
Notes			
Product Type	Textured Coating	Score:	1
Damage/Deterioration	Low Damage	Score:	1
Surface Treatment	Sealed	Score:	1
Asbestos Type	Chrysotile	Score:	1
Extent	15 m ²		
Recommended Action	Remove	Total Score	4

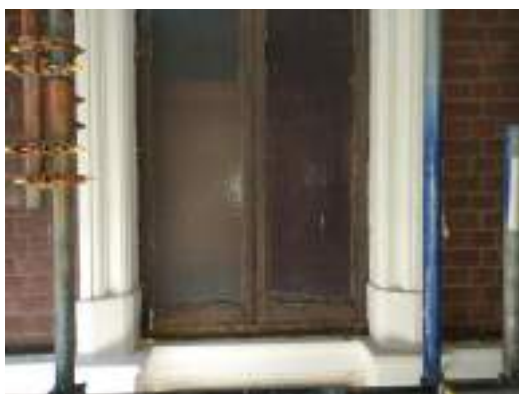
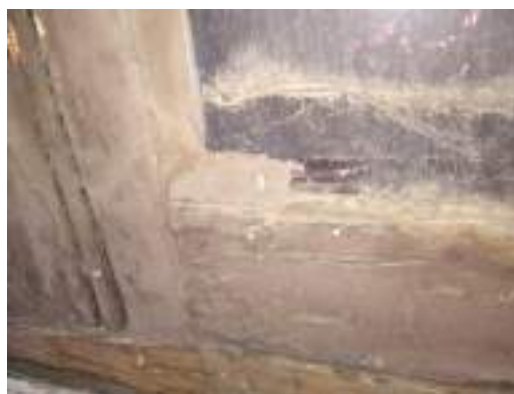
Inspection no:	S064	Type:	Sampled
Room/Area	2nd Floor. RM.2-12 - External [119]		
Location/Element	Window putty		
Notes			
Product Type	N/A	Score:	N/A
Damage/Deterioration	N/A	Score:	N/A
Surface Treatment	N/A	Score:	N/A
Asbestos Type	NAD	Score:	N/A
Extent	3 no		
Recommended Action	N/A	Total Score	0

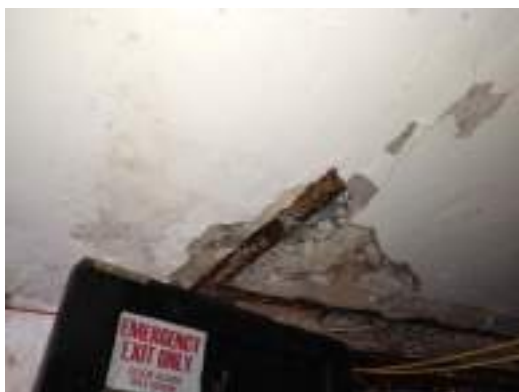
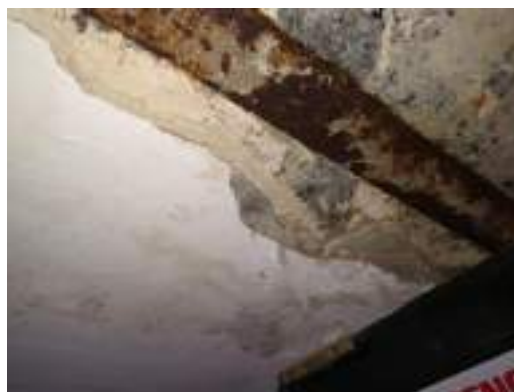
Inspection no:	S065	Type:	Sampled
Room/Area	2nd Floor. RM.2-24 [121]		
Location/Element	Paint and plaster to ceiling		
Notes			
Product Type	N/A	Score:	N/A
Damage/Deterioration	N/A	Score:	N/A
Surface Treatment	N/A	Score:	N/A
Asbestos Type	NAD	Score:	N/A
Extent	15 m ²		
Recommended Action	N/A	Total Score	0

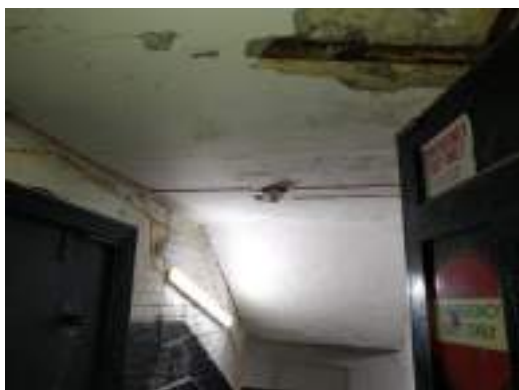
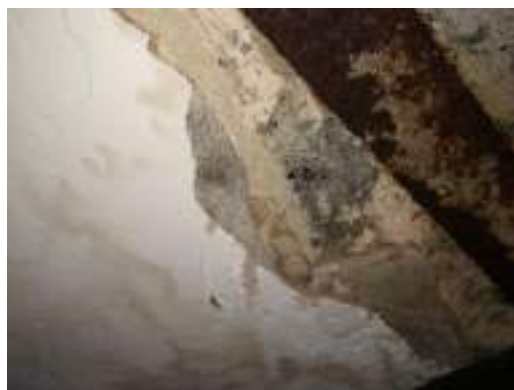
Inspection no:	S179	Type:	Sampled
Room/Area	2nd Floor. RM.2-24 [121]		
Location/Element	Textured paint to walls		
Notes			
Product Type	N/A	Score:	N/A
Damage/Deterioration	N/A	Score:	N/A
Surface Treatment	N/A	Score:	N/A
Asbestos Type	NAD	Score:	N/A
Extent	40 m ²		
Recommended Action	N/A	Total Score	0

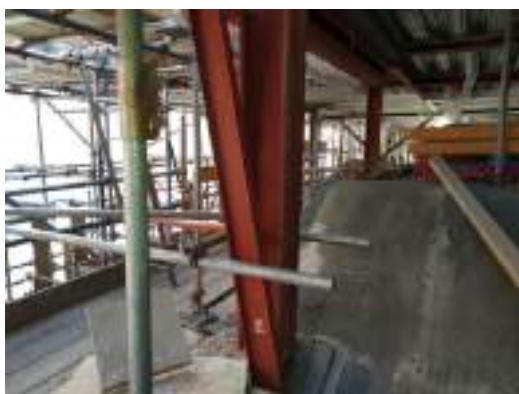
Inspection no:	S180	Type:	Sampled
Room/Area	2nd Floor. RM.2-24 [121]		
Location/Element	Textured paint to walls		
Notes			
Product Type	N/A	Score:	N/A
Damage/Deterioration	N/A	Score:	N/A
Surface Treatment	N/A	Score:	N/A
Asbestos Type	NAD	Score:	N/A
Extent	20 m ²		
Recommended Action	N/A	Total Score	0

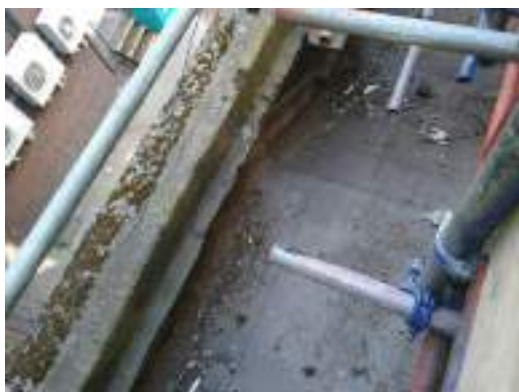
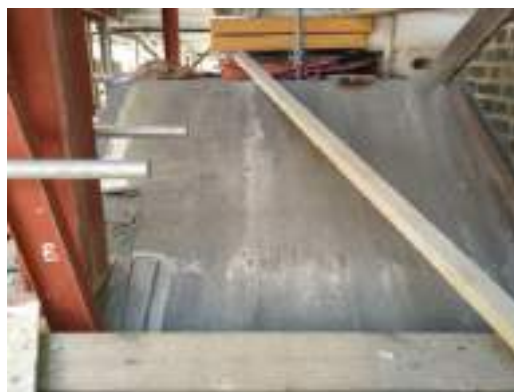
Inspection no:	N/A	Type:	N/A
Room/Area	2nd Floor. RM.2-24 - External [122]		
Location/Element	Room Construction		
Notes	Refer to register		
Product Type	N/A	Score:	N/A
Damage/Deterioration	N/A	Score:	N/A
Surface Treatment	N/A	Score:	N/A
Asbestos Type		Score:	N/A
Extent			
Recommended Action	N/A	Total Score

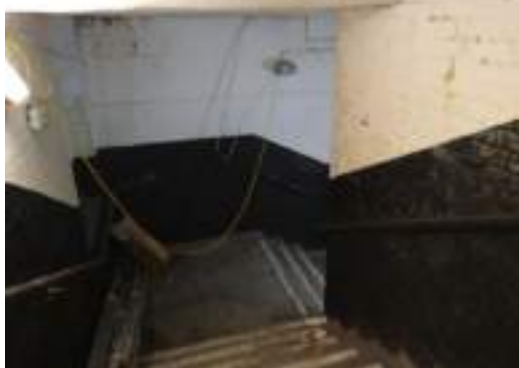
Inspection no:	S066	Type:	Sampled
Room/Area	2nd Floor. RM.2-24 - External [122]		
Location/Element	Roof Felt		
Notes			
Product Type	N/A	Score:	N/A
Damage/Deterioration	N/A	Score:	N/A
Surface Treatment	N/A	Score:	N/A
Asbestos Type	NAD	Score:	N/A
Extent	20 m ²		
Recommended Action	N/A	Total Score	0

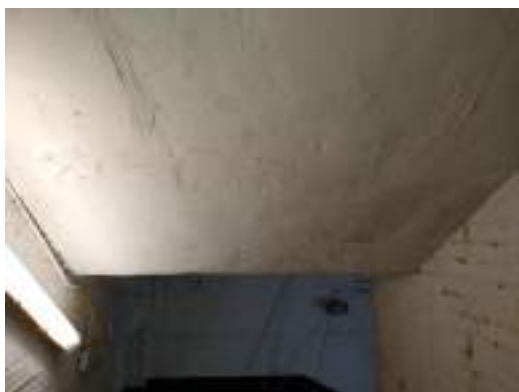
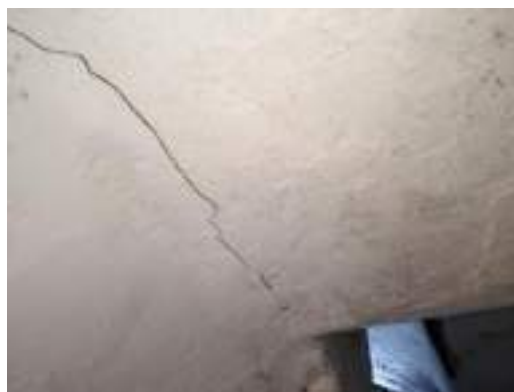
Inspection no:	N/A	Type:	N/A
Room/Area	1st Floor. Stairs [123]		
Location/Element	Room Construction		
Notes	Refer to register		
Product Type	N/A	Score:	N/A
Damage/Deterioration	N/A	Score:	N/A
Surface Treatment	N/A	Score:	N/A
Asbestos Type		Score:	N/A
Extent			
Recommended Action	N/A	Total Score

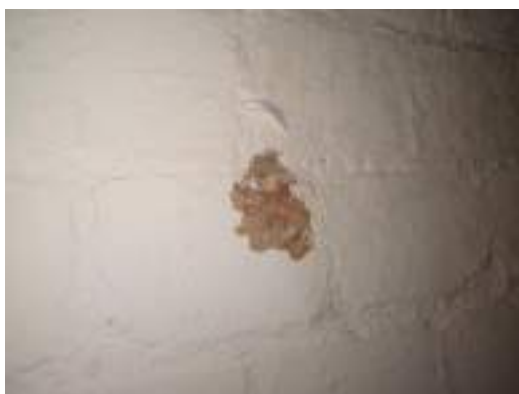
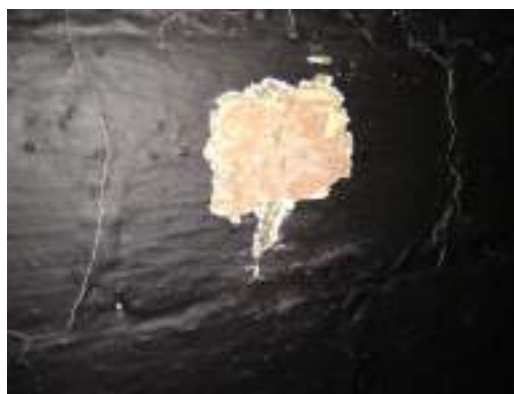
Inspection no:	S067	Type:	Sampled
Room/Area	1st Floor. Stairs [123]		
Location/Element	Paint and plaster to ceiling		
Notes			
Product Type	N/A	Score:	N/A
Damage/Deterioration	N/A	Score:	N/A
Surface Treatment	N/A	Score:	N/A
Asbestos Type	NAD	Score:	N/A
Extent	15 m ²		
Recommended Action	N/A	Total Score	0
