### CampbellReith consulting engineers

### 26 Netherhall Gardens

Basement Impact Assessment

Audit

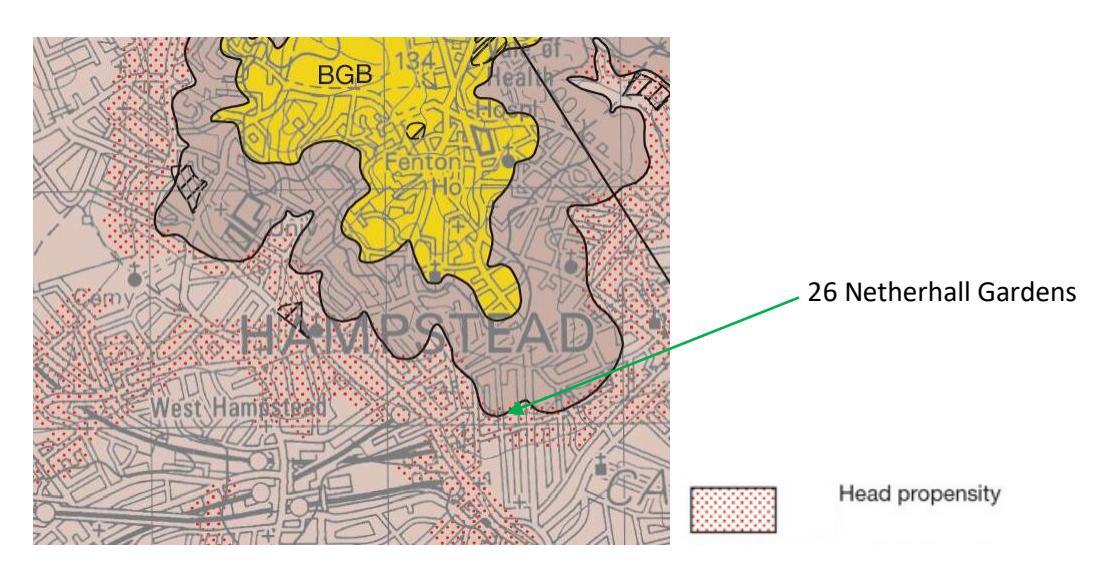
In fact, this whole area is overlain by superficial deposits of 'Head': a solifluction deposited at the end of the last Ice Age and clearly marked on the very map they report to have used which can be found at http://www.largeimages.bgs.ac.uk/iip/mapsportal.html?id=1001750 :
