Tree Assessment Report

HAVERSTOCK HILL

TREE CONSTRAINTS ASSESSMENT

Project Name and Address
5-17 Haverstock Hill
LB Camden

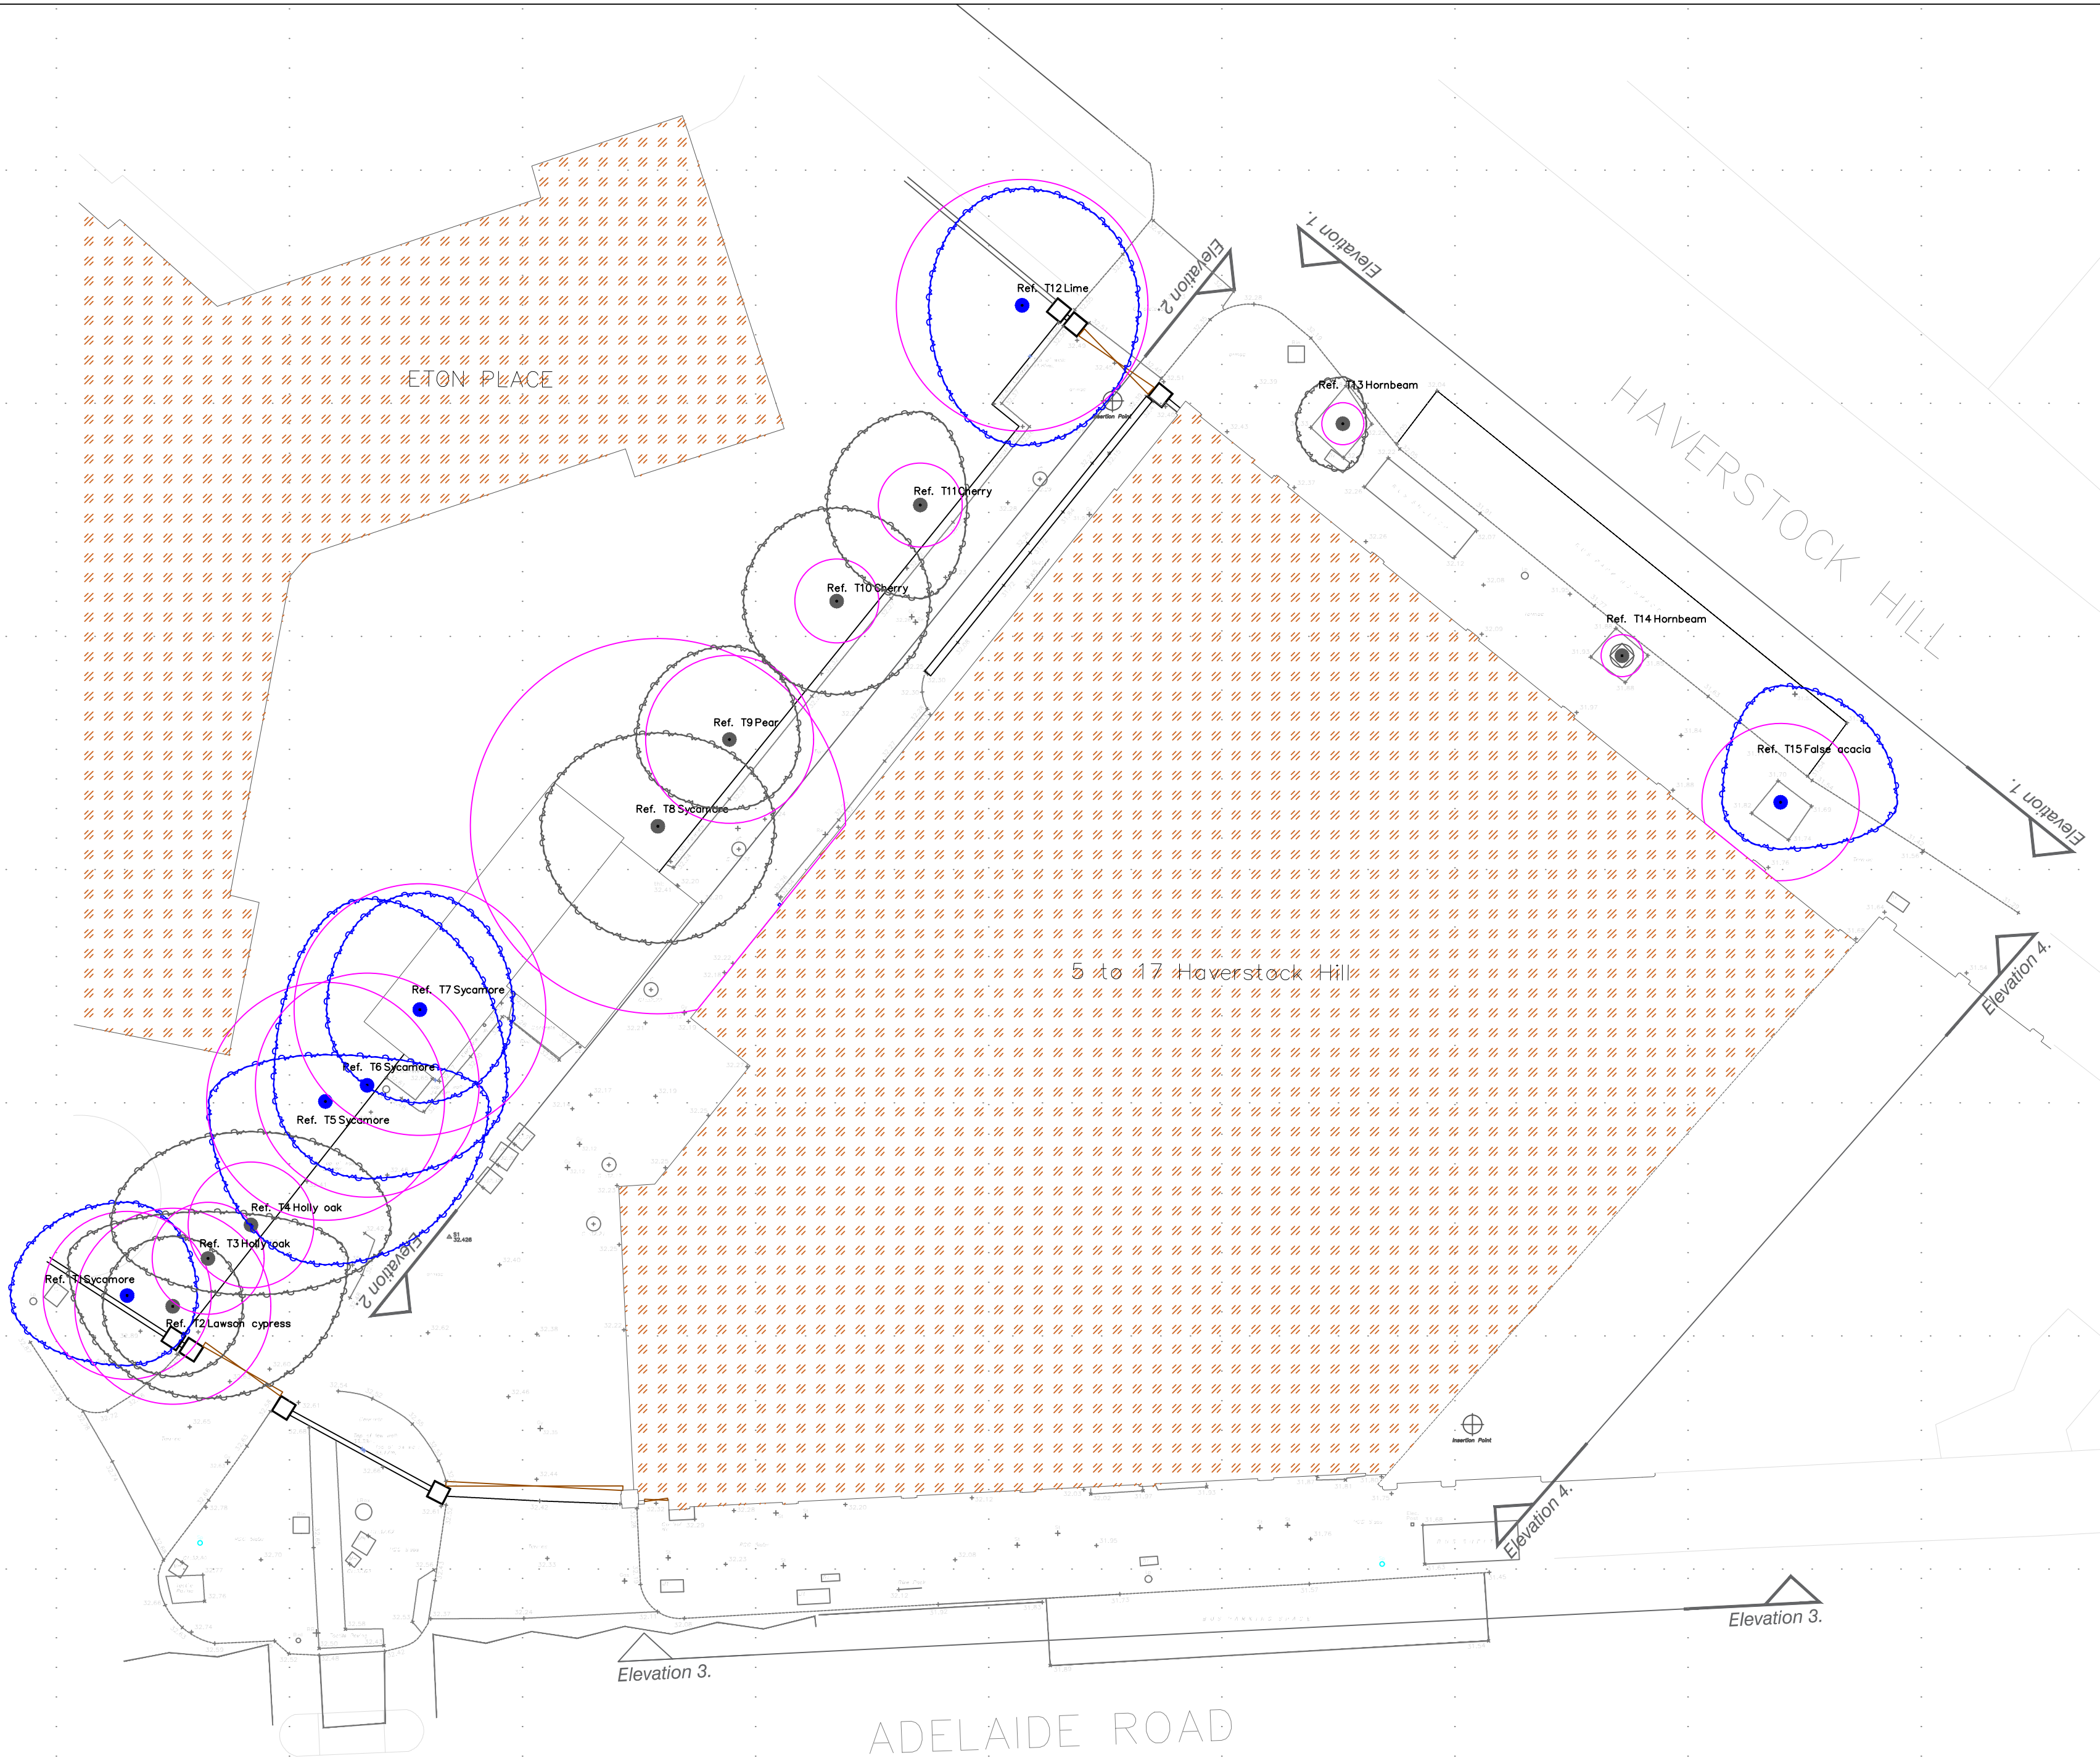
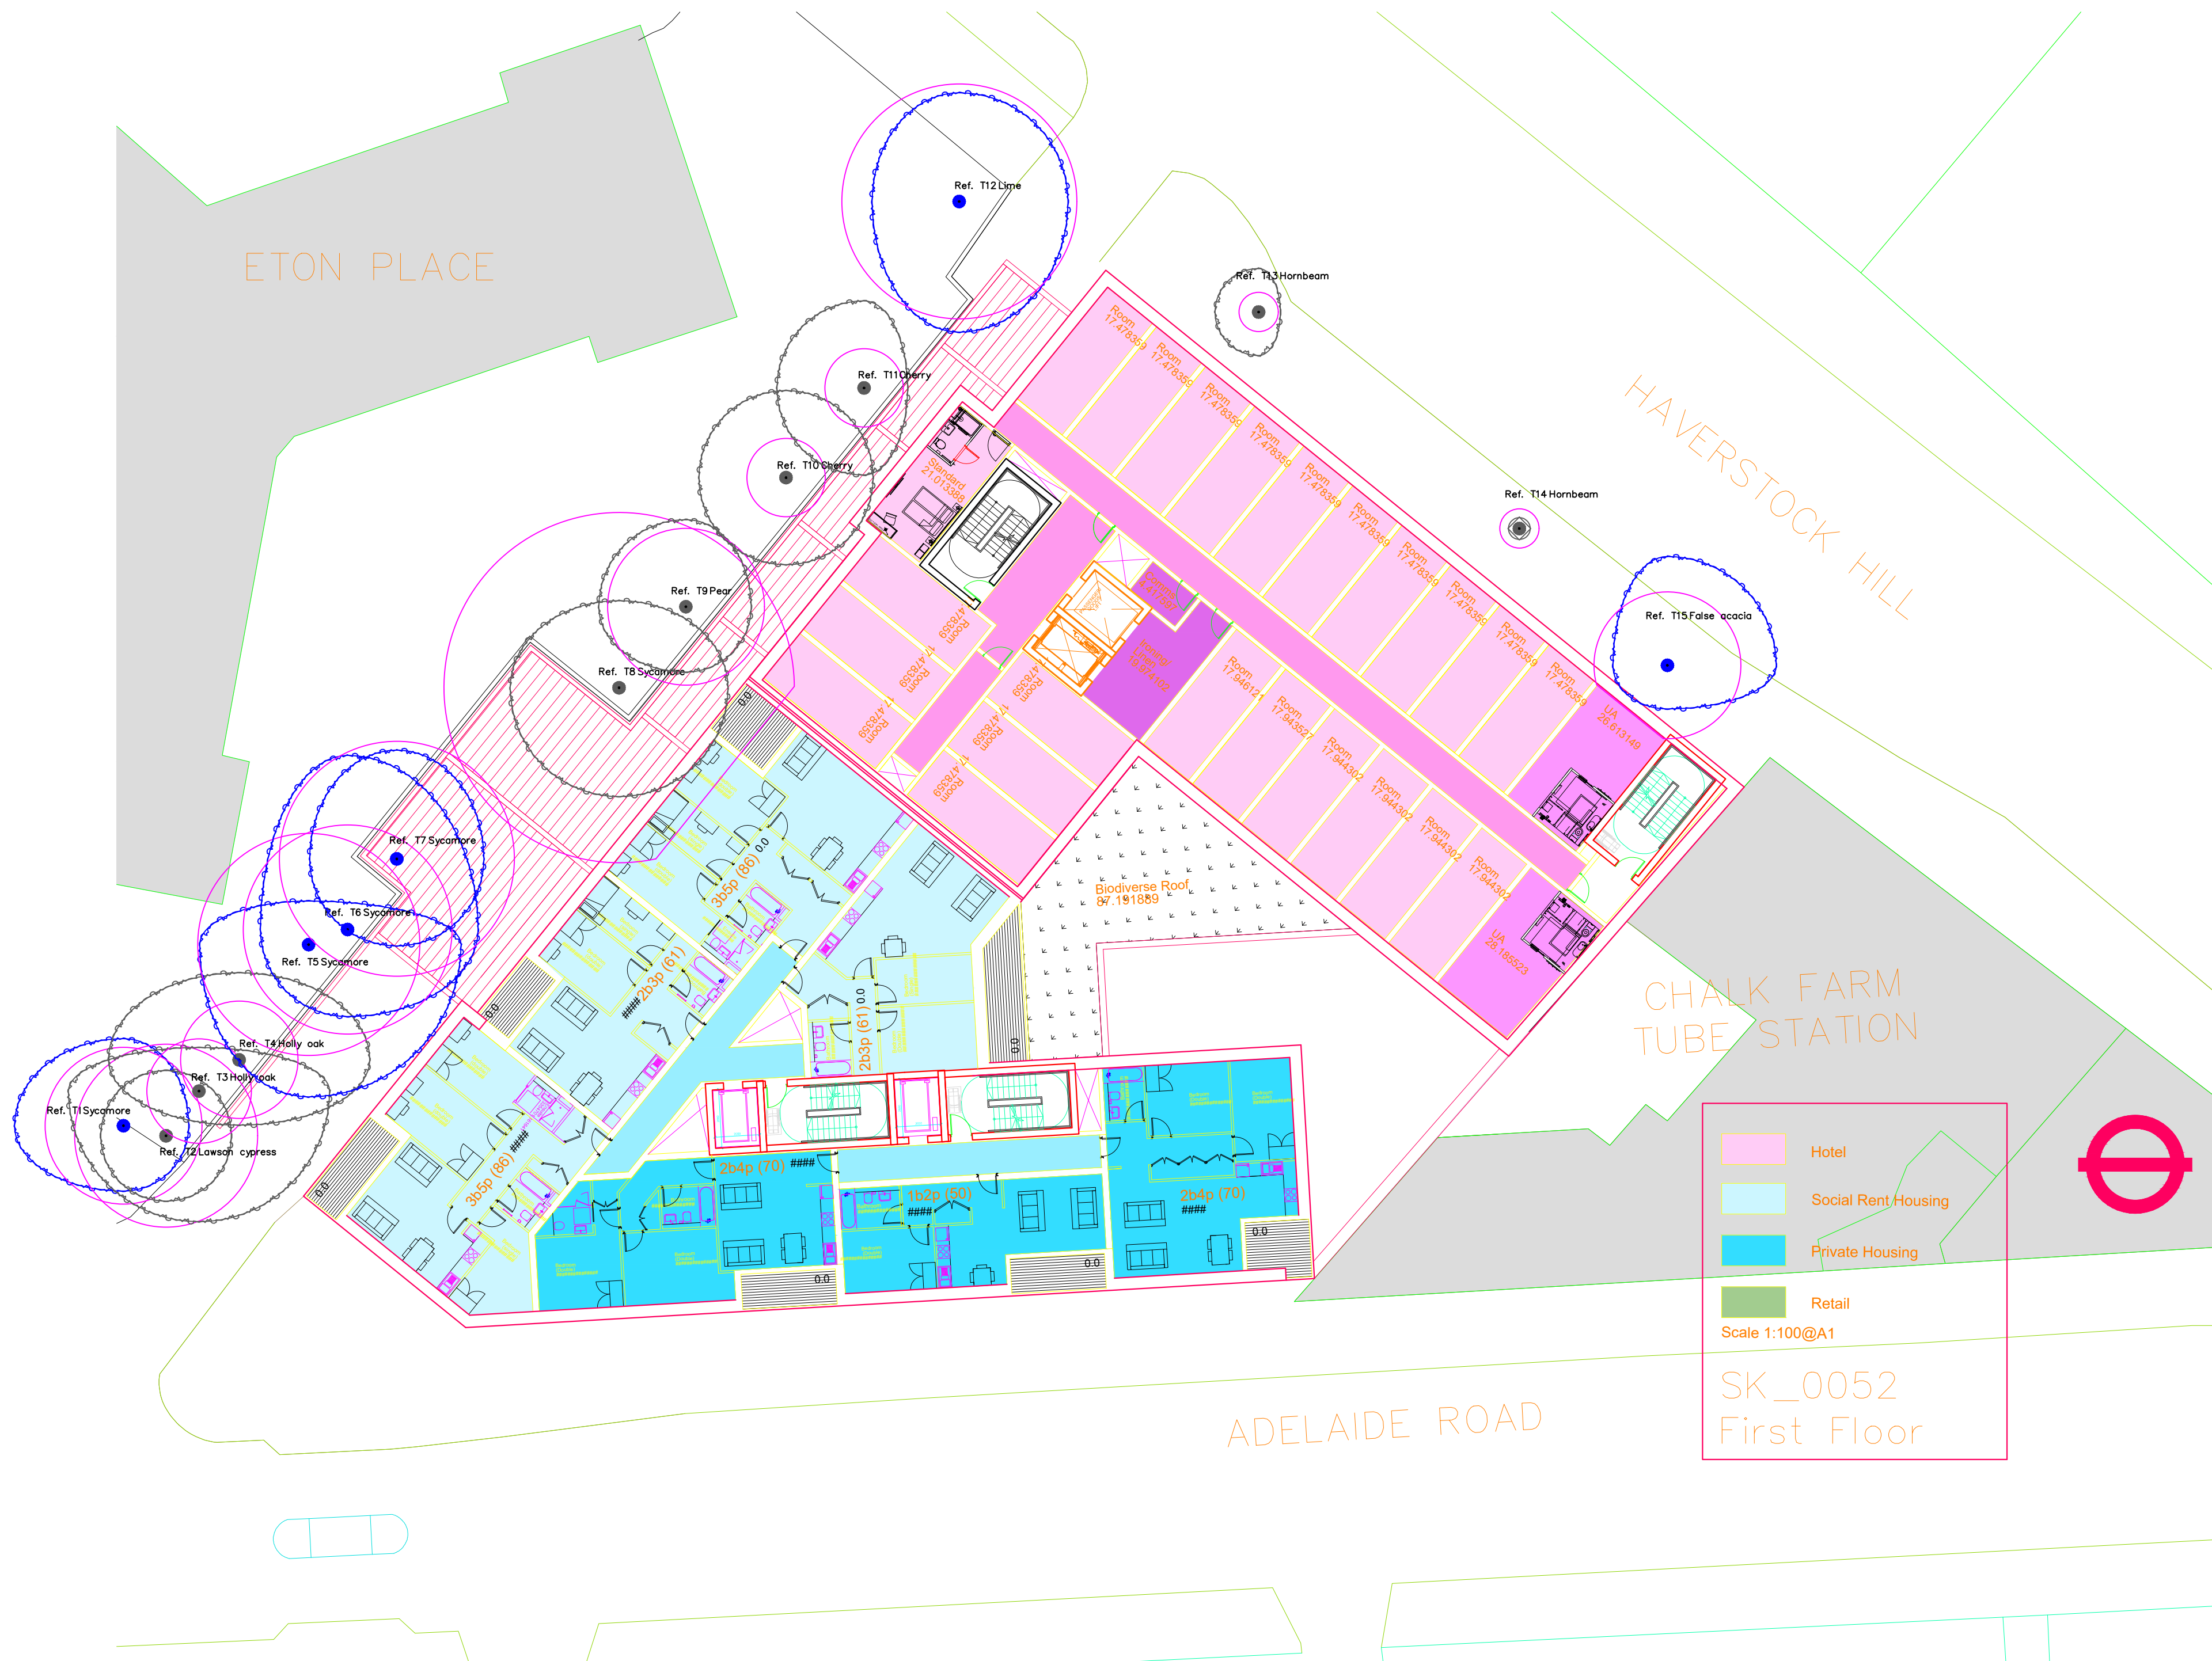
Tree Constraints
Plan showing
proposed layout
against
BS5837:2012 tree
categories & Root
Protection Areas

As shown on the Tree Constraints Plan at Appendix 2.0, the majority of trees included in the survey are located just beyond the western perimeter retaining wall and single story garage building, which are both now forming large cracks presumably as a result of tree root growth pressure from the surveyed trees in these locations. The largest area of damage was shown to be adjacent to T8, (Figures 1 and 2) which is very close to both structures.
