Haverstock Place. BS5837 Tree Survey & Arboricultural Impact Assessment

Issue/Revision:	Draft V1	Final V2
Date:	October 2020	October 2020
Comments:		
Prepared by:	James Rawlinson	James Rawlinson
Signature:

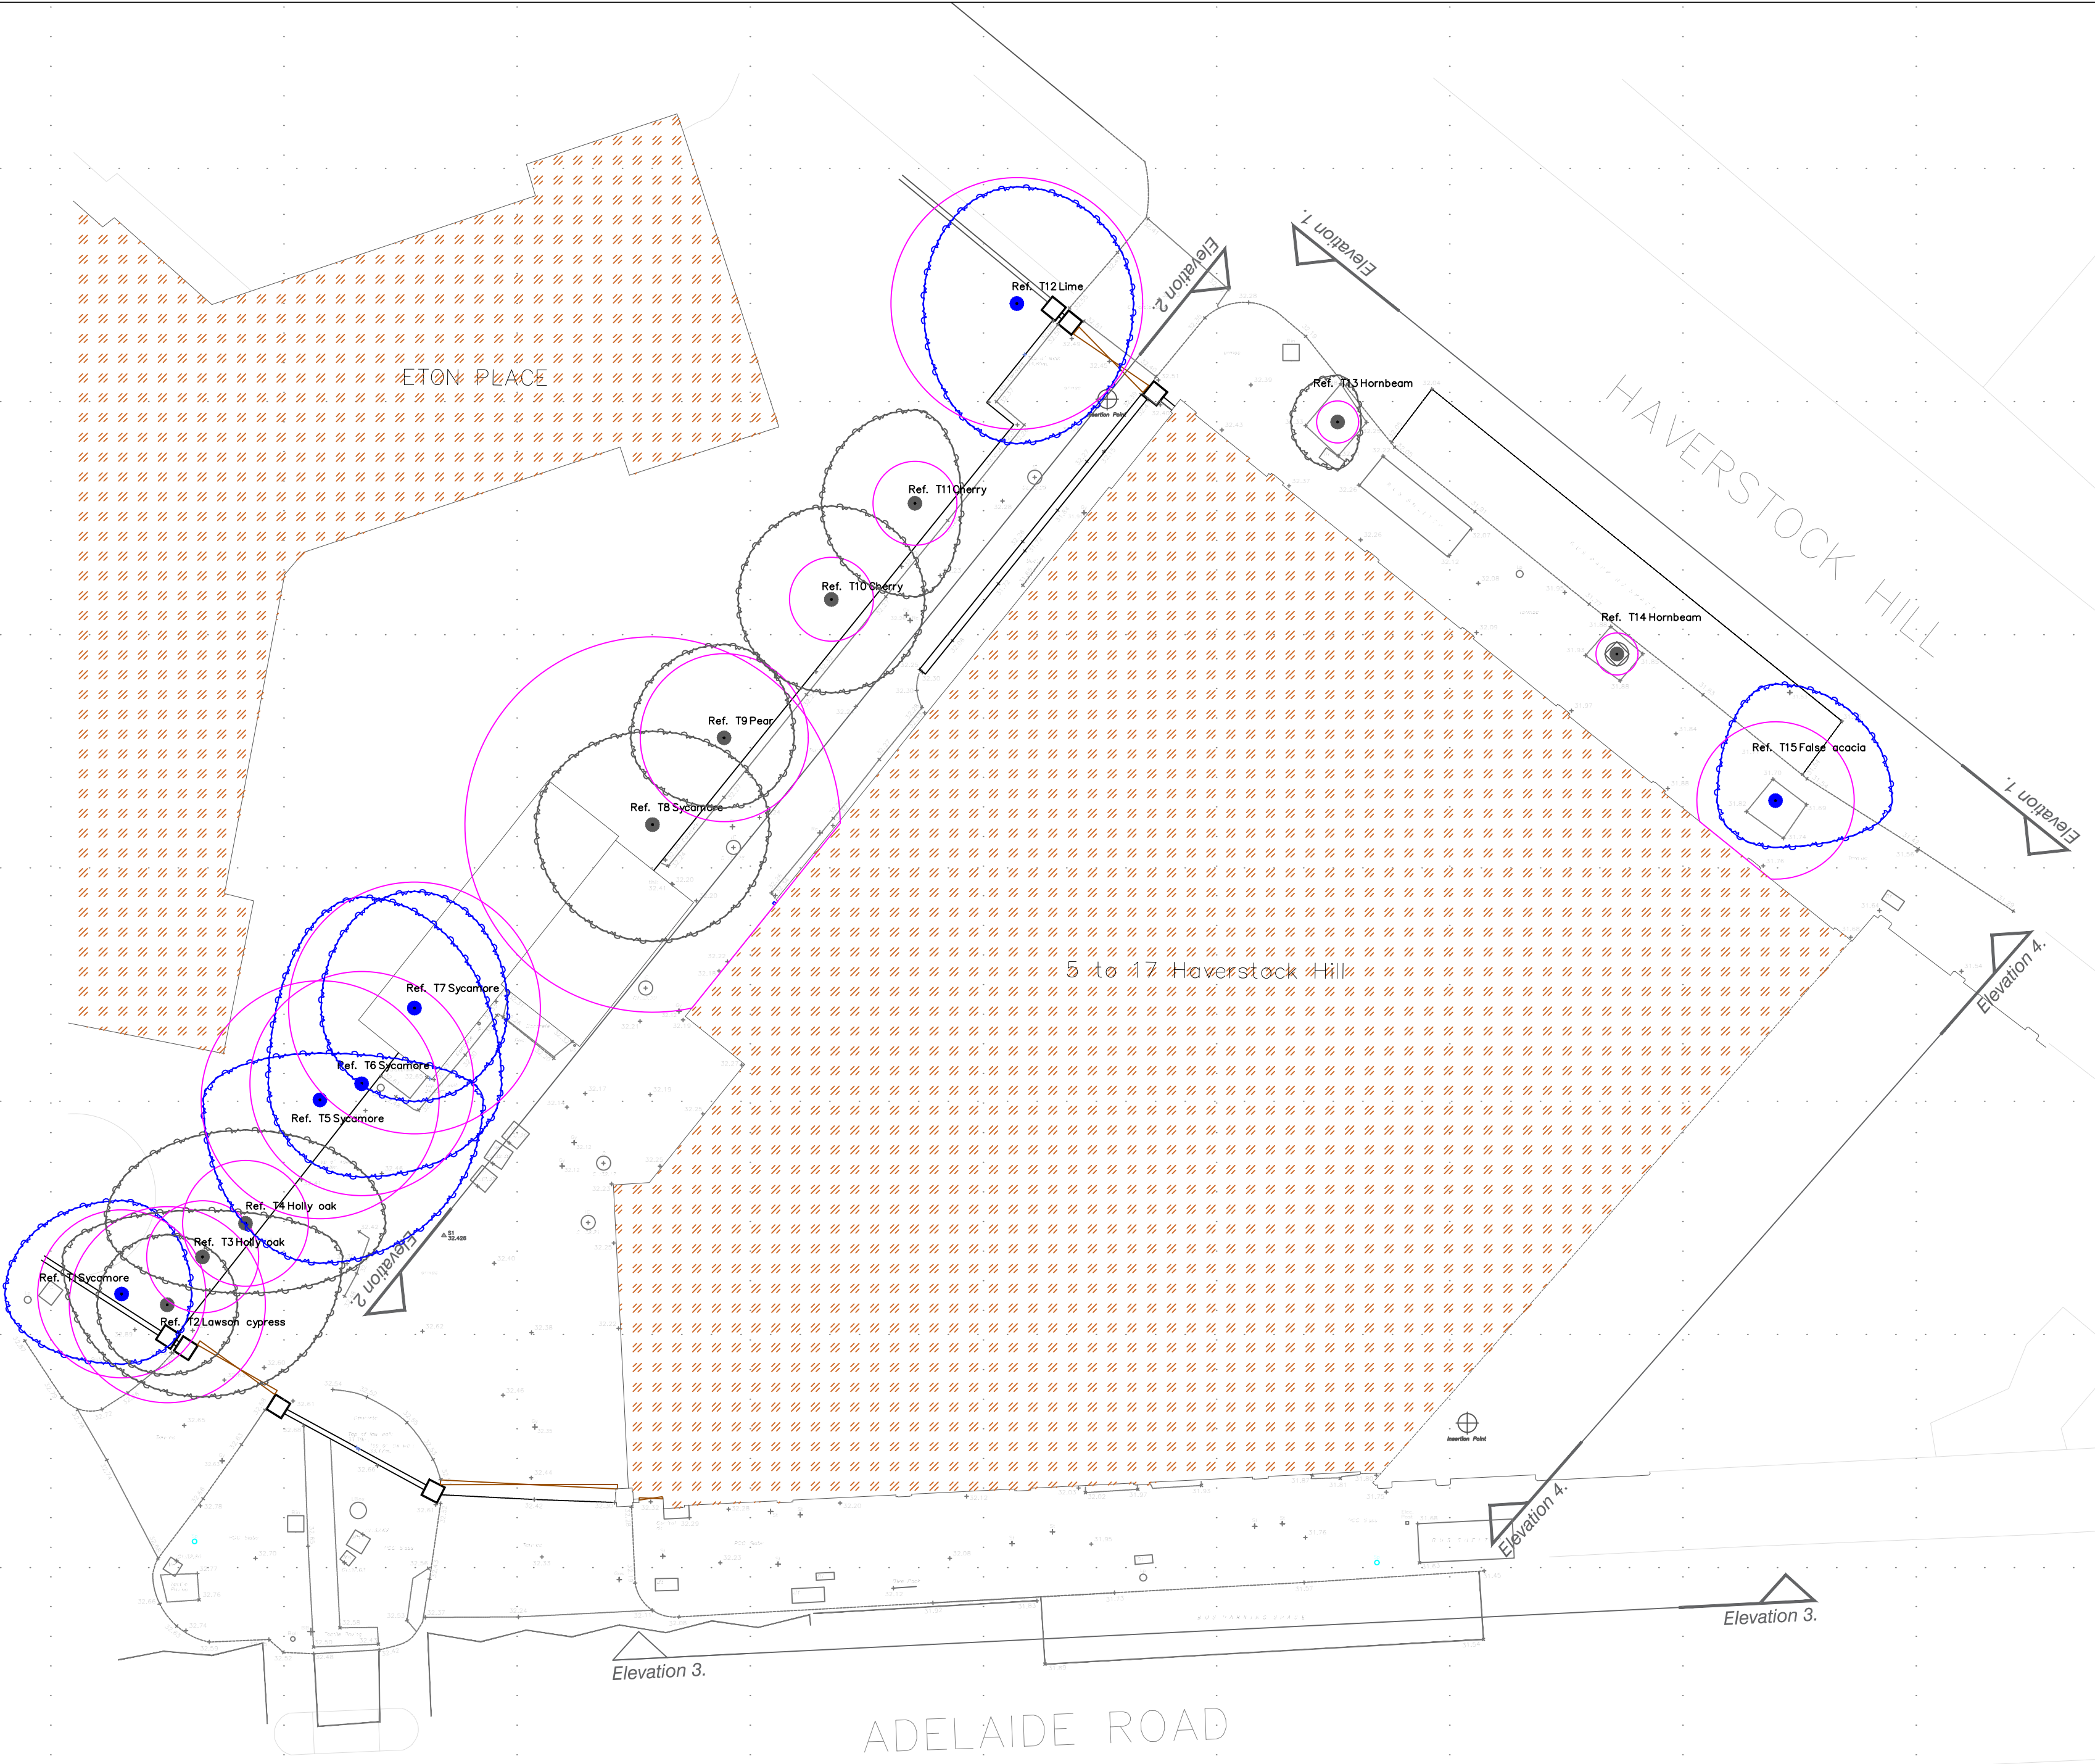
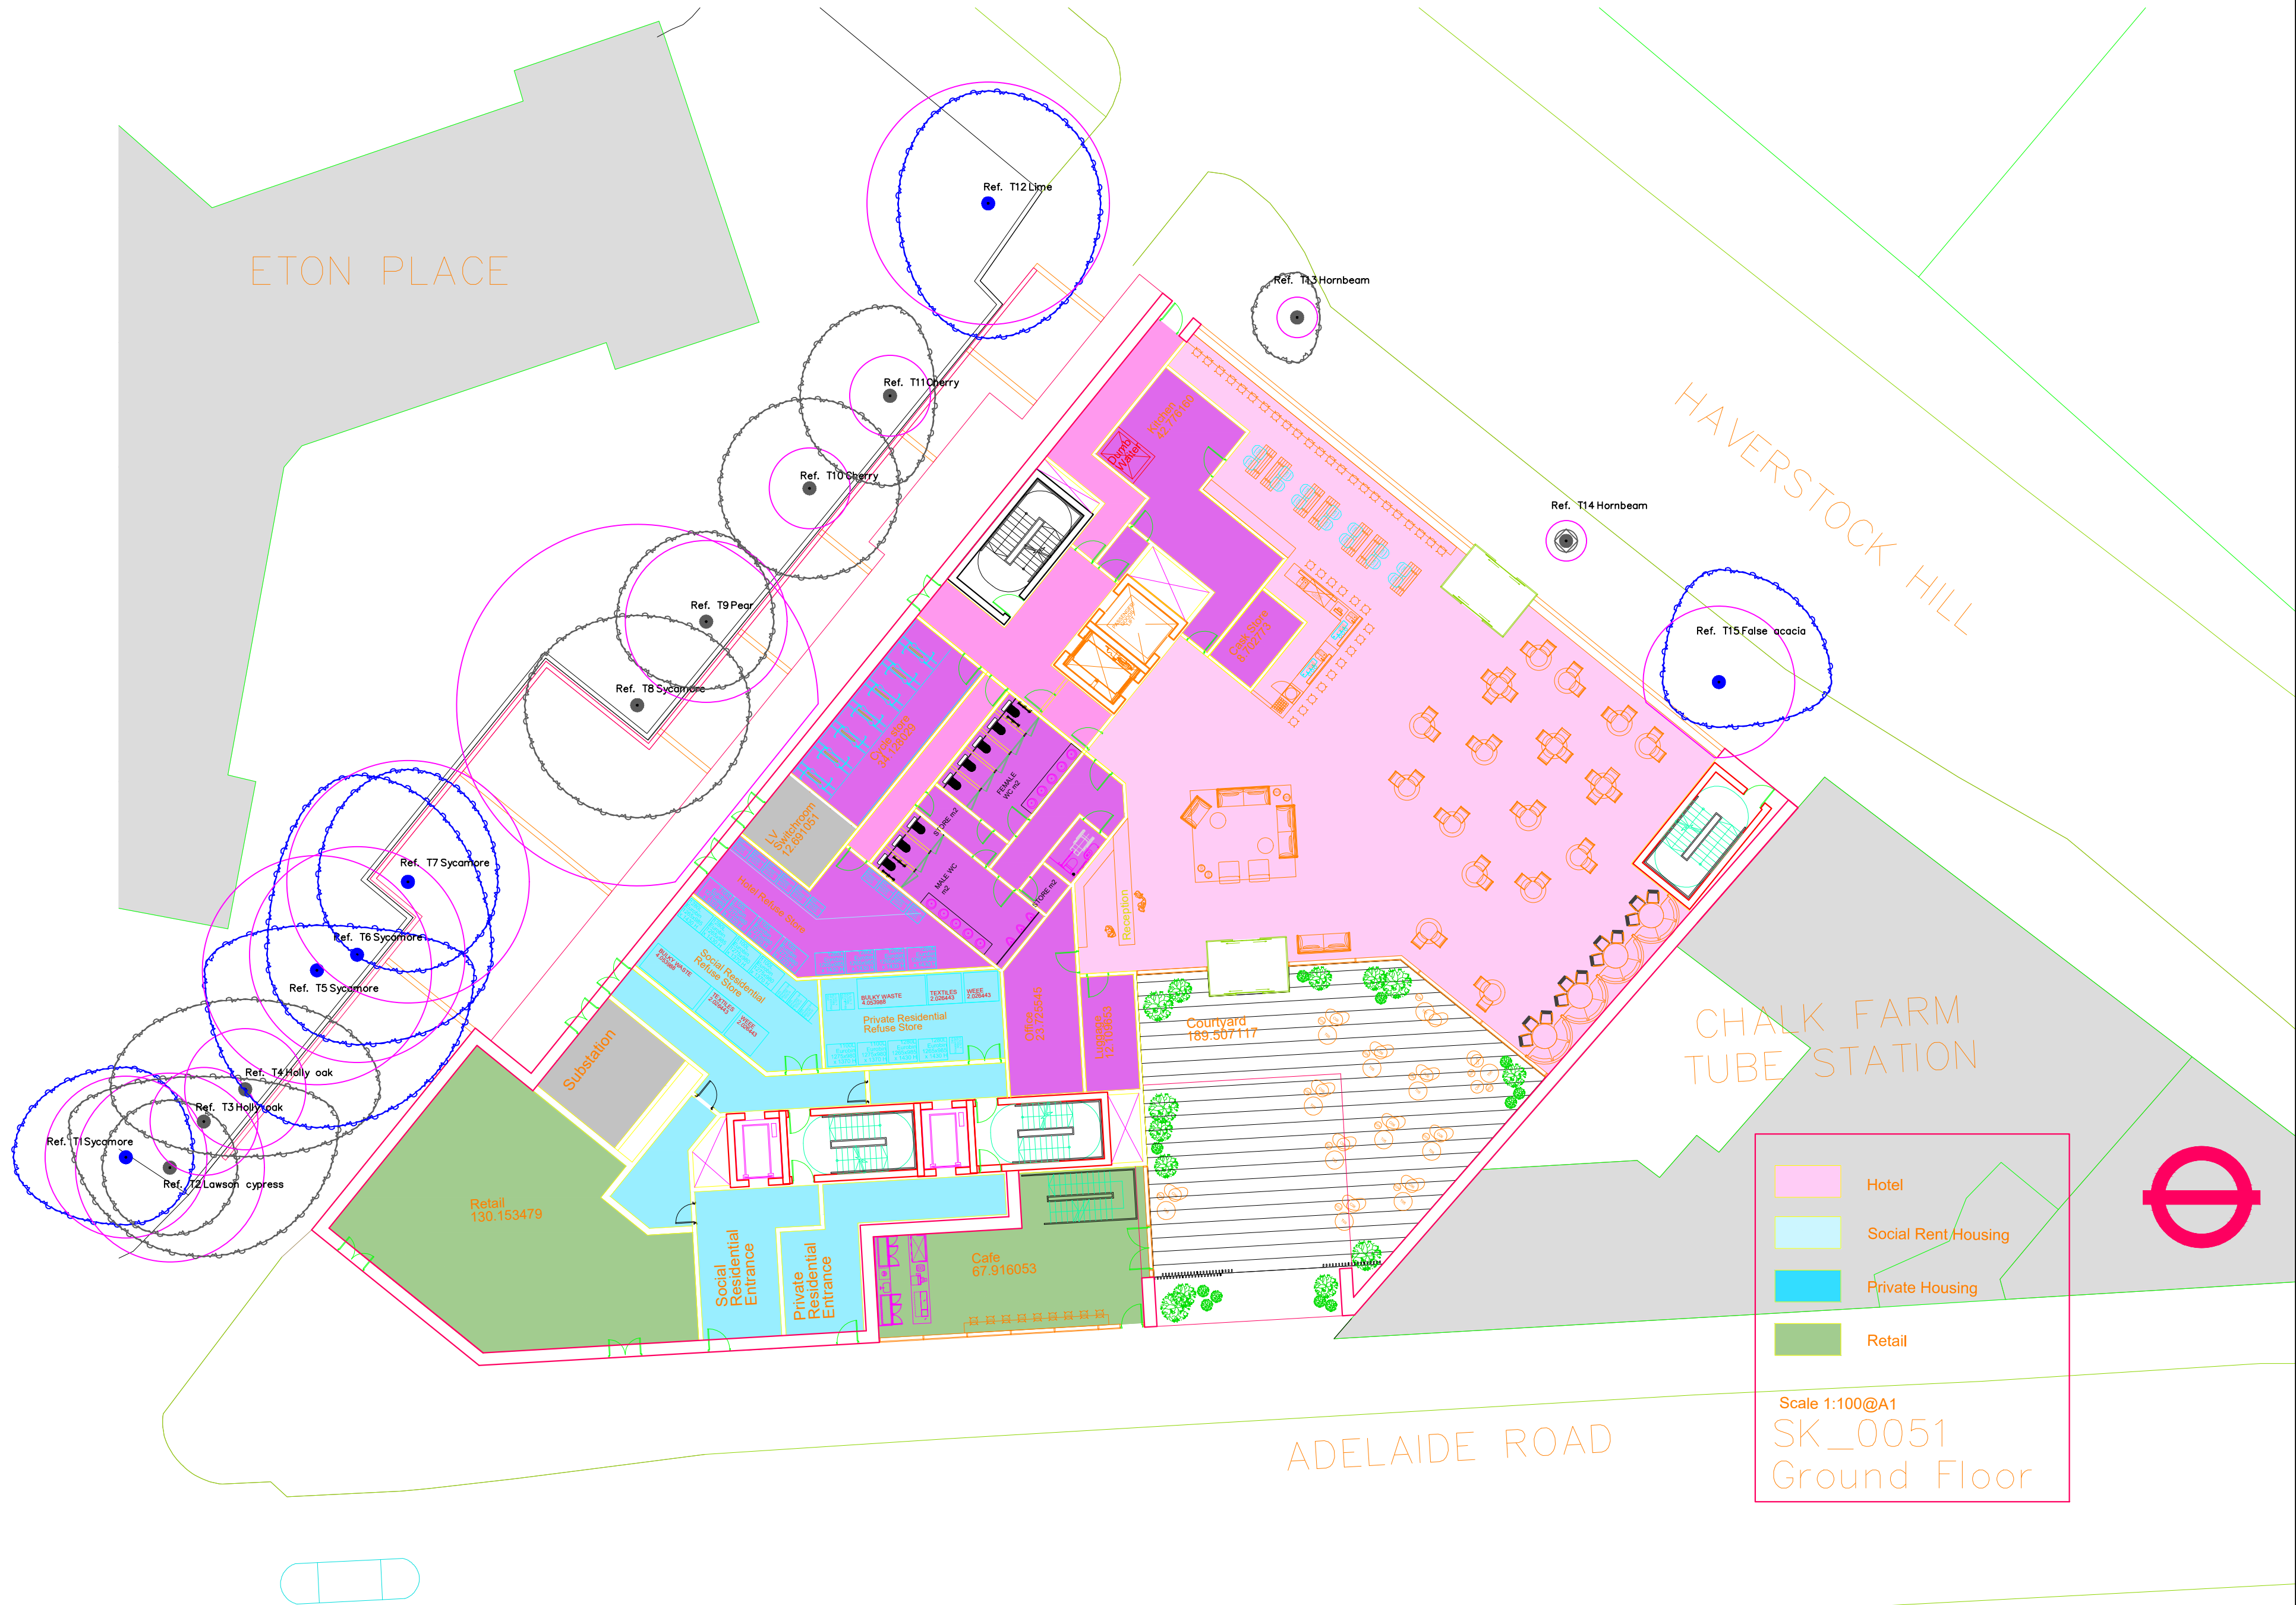
Tree Constraints
Plan showing
proposed layout
against
BS5837:2012 tree
categories & Root
Protection Areas

- 5.8 The provisional root protection areas for all site trees have been calculated via the methodology set out in BS5837 and are shown in the Tree Constraints Plan (Appendix 2.0).
- 5.9 In terms of providing constraints information for any future development, providing accurate root zone information is of great significance, as this defines the area that cannot be generally constructed over or disturbed without bespoke foundation and site design considerations.
- 5.10 With the development plans showing the proposed building to be essentially within the footprint of the existing building (including the new foundations), development within

RPA's has been avoided as any root spread from the surveyed trees onto the site is not anticipated to have grown beneath the existing building foundations.

- 5.14 Whilst there are a number of areas that show overlaps within the RPA's of retained trees, where possible these will be resolved through selective root pruning, in line with BS5837. This then allowing for anything smaller than 25 mm diameter to be pruned back by making a clean cut with a suitable sharp tool (secateurs or pruning saw), except where they occur in clumps. All such works should be done under arboricultural supervision. Where this is not possible the mitigated foundation design will instead be constructed.

- 5.18 Given the locations of the trees are behind the retaining wall and off site, the need for any tree protection fencing has not been identified. Furthermore, as the calculated onsite RPA's of all surveyed trees are to remain beneath the existing hard surface area (albeit with a reconstructed top layer), the need for additional tree root ground protection has been avoided.
- 5.19 However, for completeness, construction site good practice and guidance for how site works should be carried out near trees to avoid accidental damage is set out in Appendix 4.
- 5.20 Subsequent to this it is anticipated that the Local Authority will secure by planning condition a formal Arboricultural Method Statement (AMS) that will be drawn up in unison with the Construction Management Plan, to ensure all tree related construction constraints are fully understood.

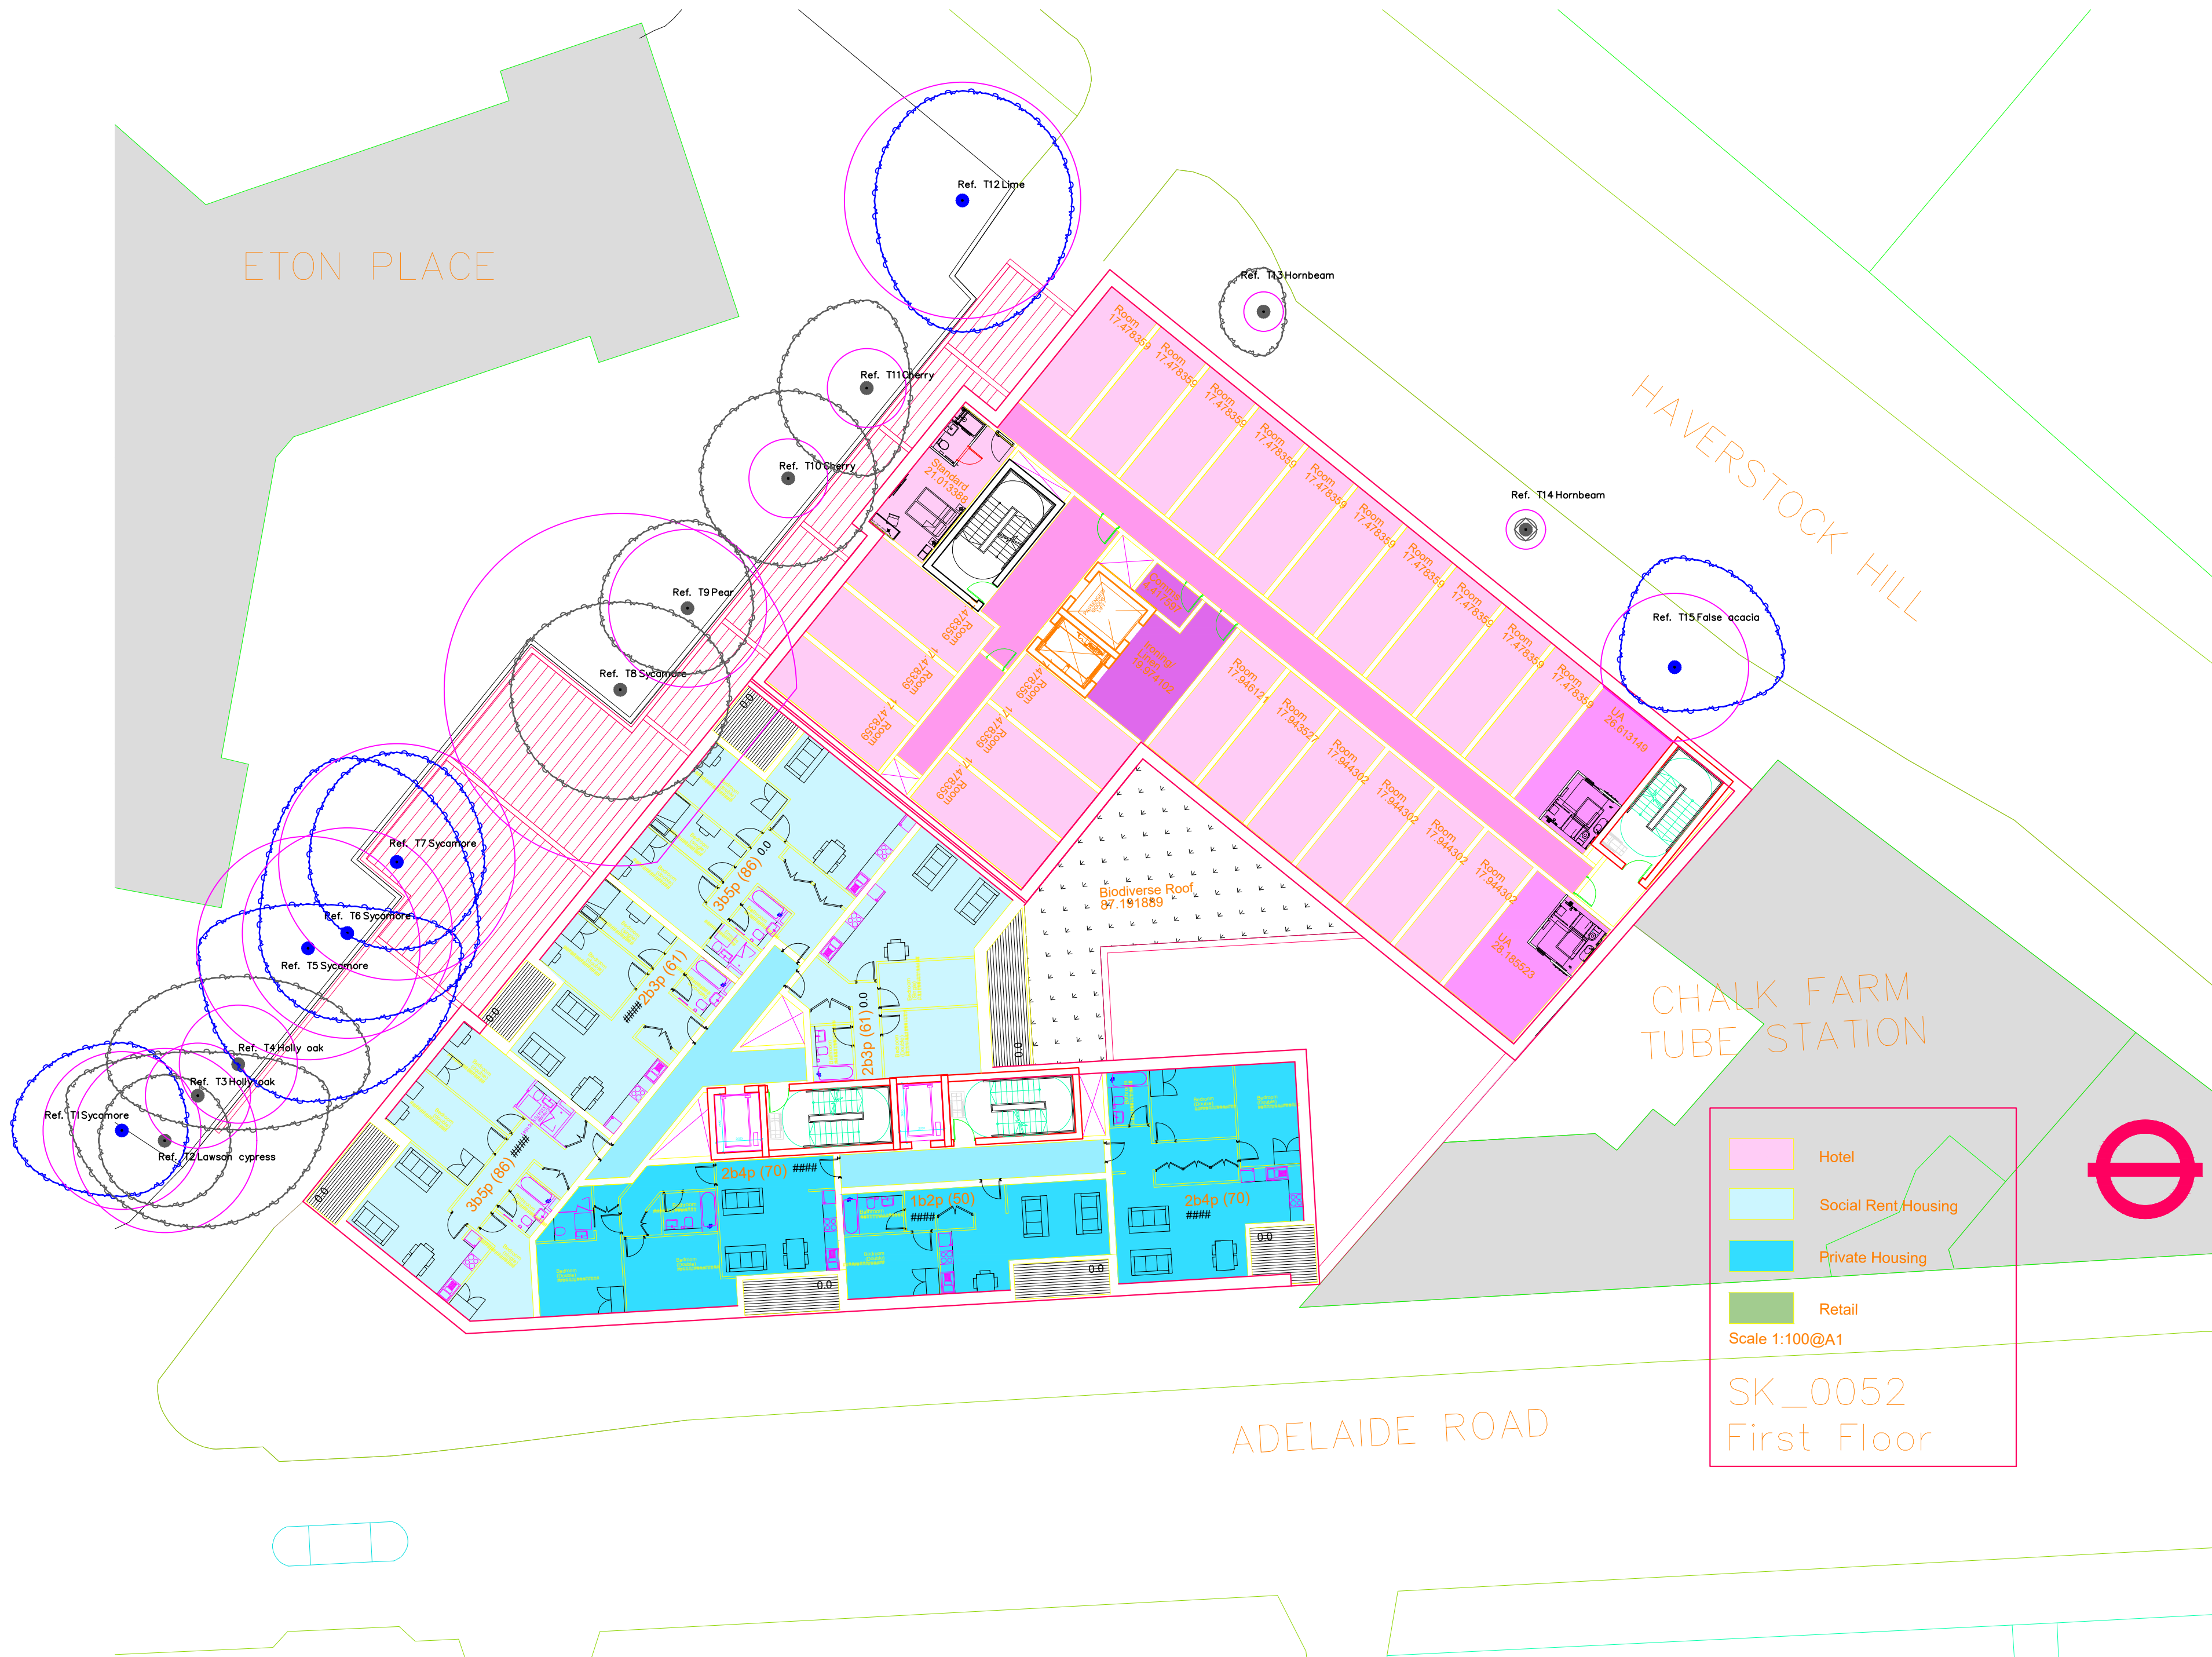
Tree Constraints

Plan showing proposed layout against BS5837:2012 tree categories & Root Protection Areas
