3 LYNDHURST TERRACE, HAMPSTEAD, LONDON  
HISTORIC INTERIORS RESEARCH AND ANALYSIS REPORT

PROJECT CONTACT: : MAX CURTIS-DONNELLY, tmd BUILDING CONSULTANTS

5<sup>th</sup> SEPTEMBER 2020

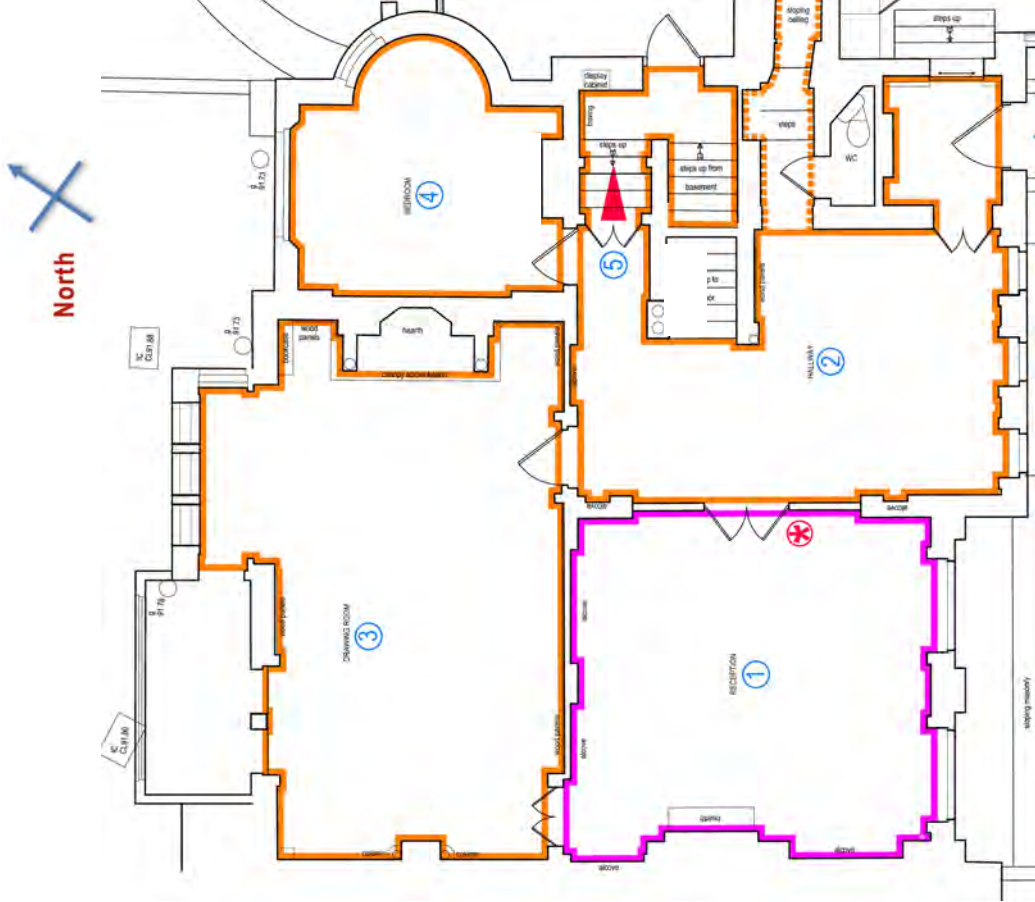
Figure 2: Floor plan showing location of the interiors affected by fire  
Red 'Star' identifies the location of the fire

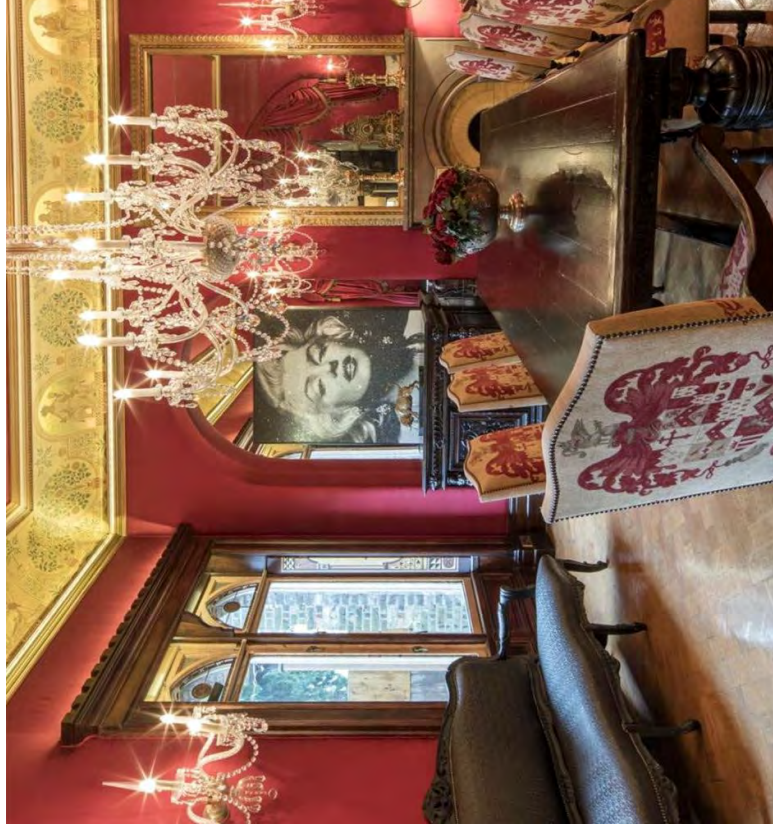
Figure 3: Room 1, Reception photograph from before the fire

The property owner confirmed that this scheme is approximately 10 years old and included the installation of reclaimed items, such as a pair of double doors fitted to the main arch.

The interior was also lined with modern silk damask hangings on all original wall surfaces and across the arch, which appears to have been keyed in order to take a supporting partition structure.

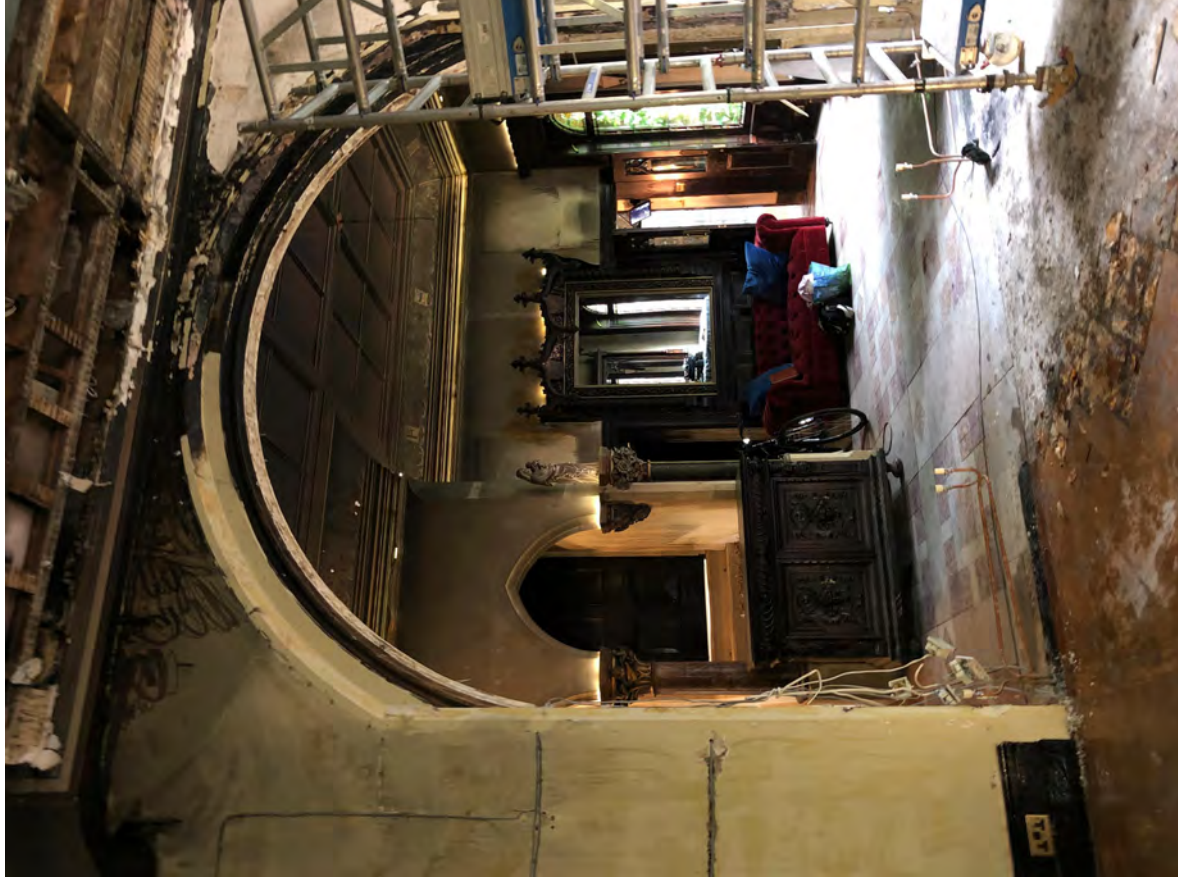
Figure 6 shows the interior after the fire, but also records alterations to detailing, for example, the bookcase adornments, overpainted stencil work and general streamlining of the features., which makes a dramatic movement away from the original architectural intentions.

Figure 6: The same view after the fire

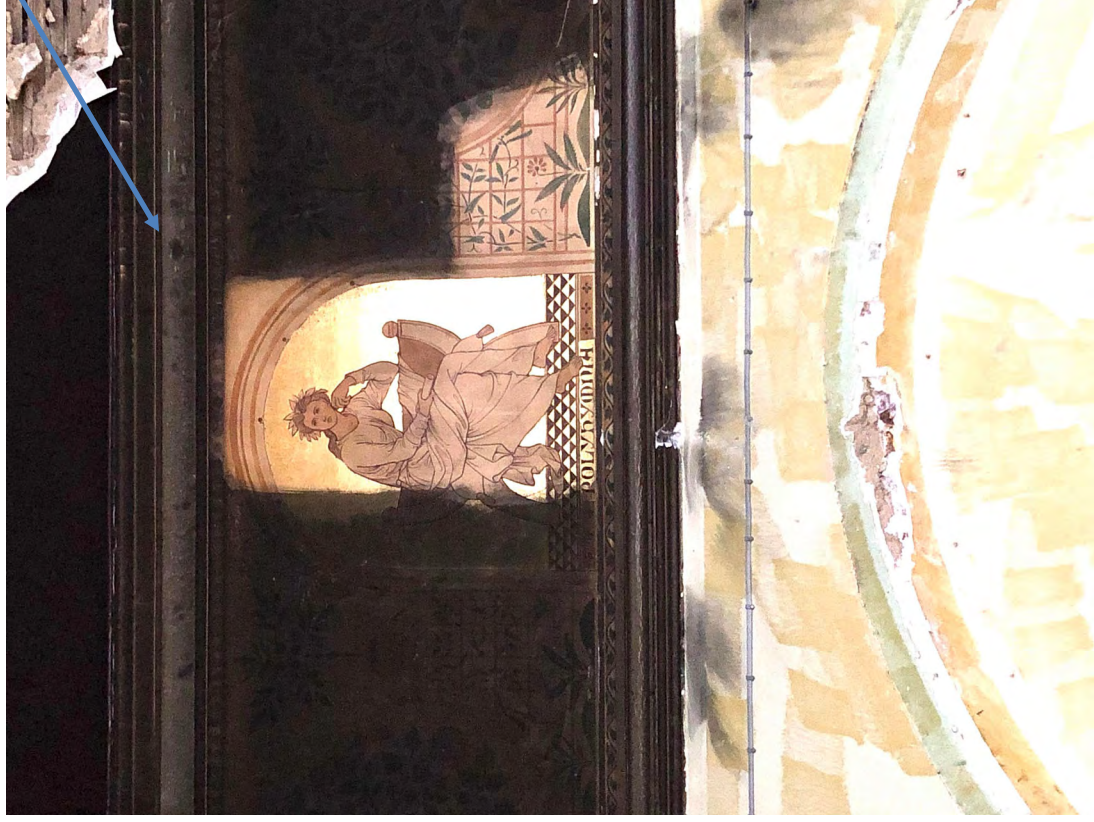
Figure 11: Room 1 Ceiling Cove

With decorative frieze of Musical Muses

The frieze has an original varnish coat which has assisted its survival and large areas will clean readily. Unfortunately, areas directly above the site of the fire require more detailed and careful conservation and reinstatement. (covered in detail later in this report).

1. Record photograph of each area to record current condition
2. Light brushing to remove loose surface deposits (on larger areas thus should be accompanied by vacuuming)
3. Gentle rubbing with 'Smoke Sponges' to lift if more tenacious surface dirt.

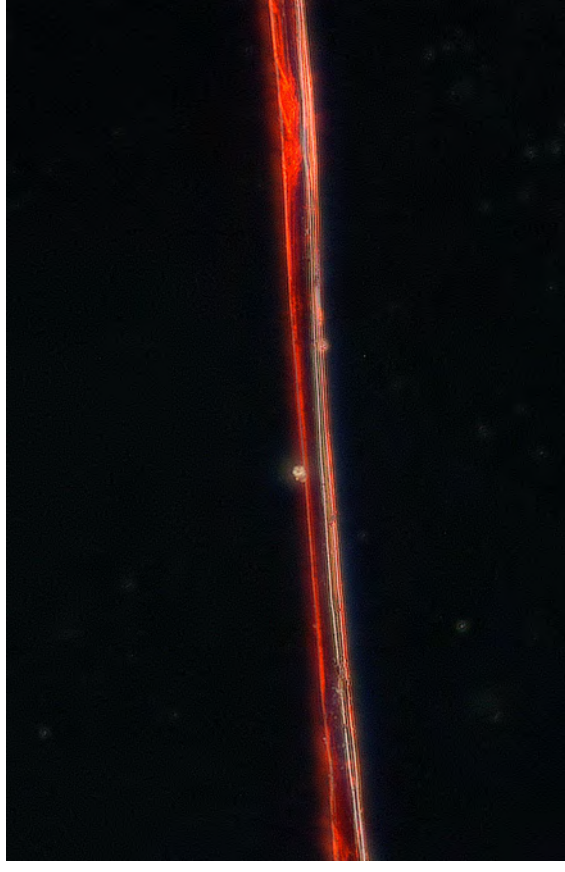
Figure 20: 2.6 Room 1 Red Silk Damask Hangings

The analysis has identified the fabric as a modern silk damask; confirming the statement from the property owner that this was part of a major remodelling and restyling of the interior at that time. It is only 10 years old.

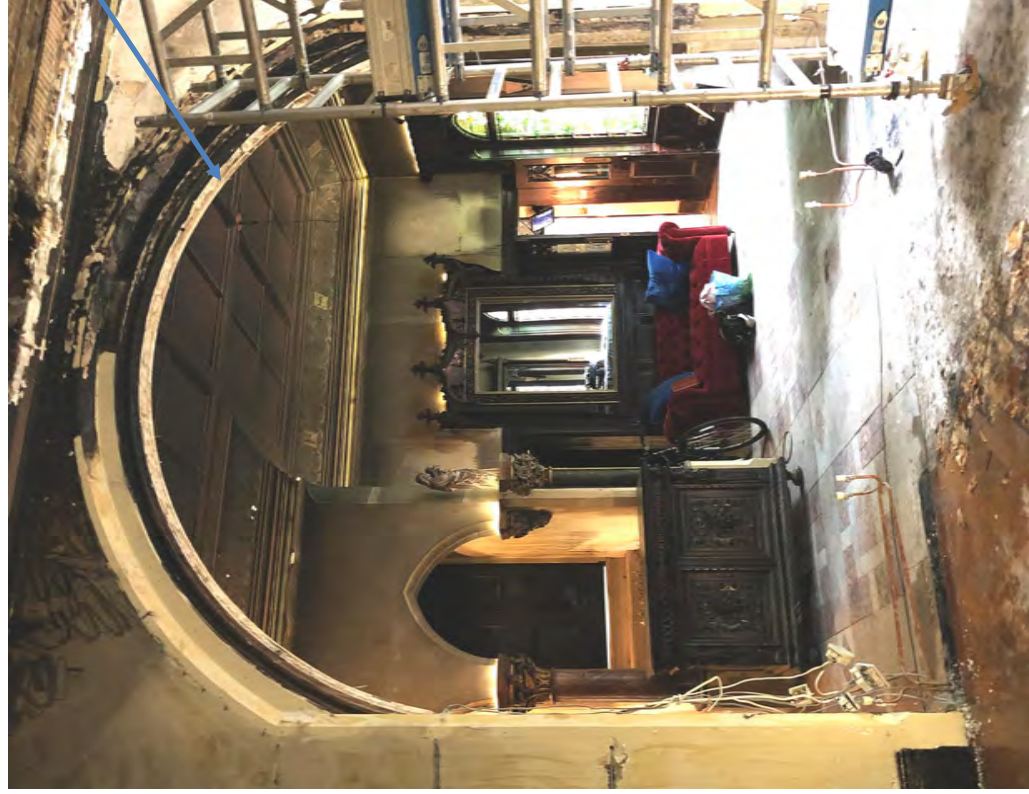
Figure 21: Room 1 Large Arch to Hallway,

On-site inspection of the arch reveals a damage surface, much of which can be attributed to the fire starting in that location. Fortunately, much of the profiling and style of the arch survives in reality and record, the earlier and the original stencil designs can be seen with their polychromatic treatment.

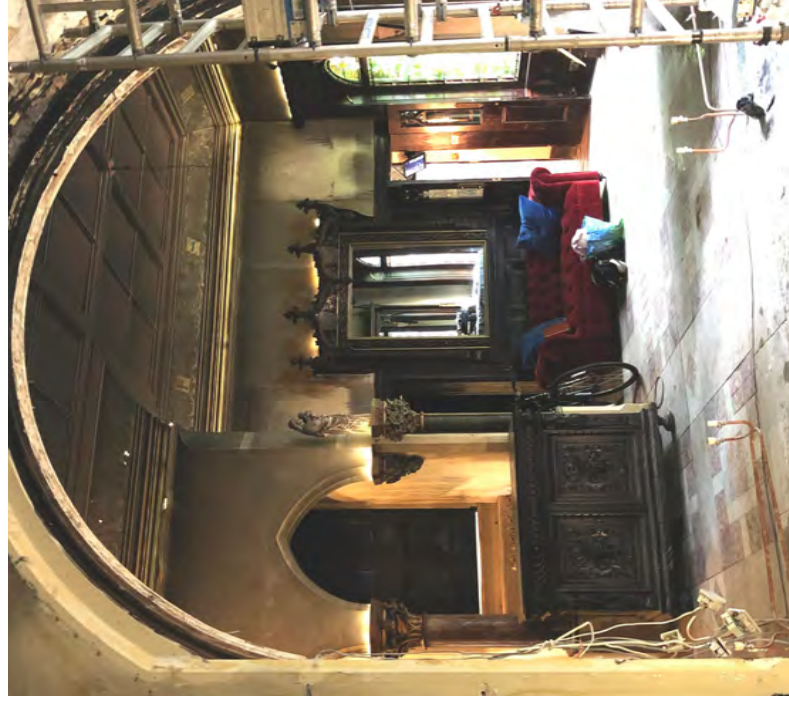
Figure 37: Room 2. Entrance Hall after the fire

These three images confirm the development of this interior in with Room 1, the Reception Room, over time. The scheme chart again documenting the move away from the original intention. There is a close link between these two interiors that continued up to the scheme applied prior to the fire. The design of the silk hanging scheme was the first point at which the areas were separated and defined as two spaces, not a single space.

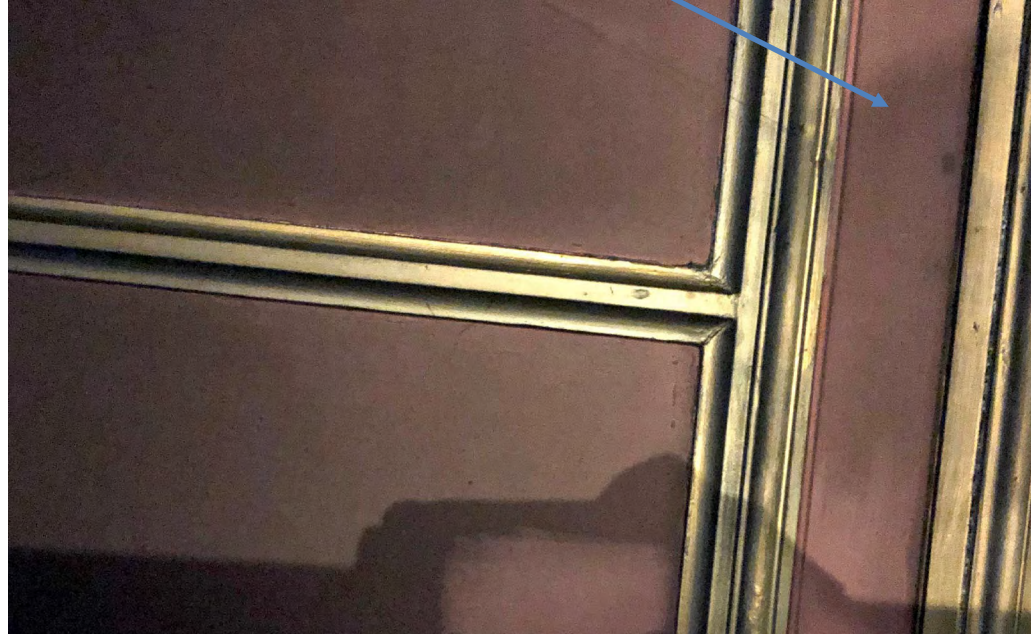
Figure 38: Room 2. Detail of ceiling panels, frames and mouldings

The above cross-section and the 1880 photograph in figure 36, both identify that originally the ceiling of the Entrance Hall was a much paler, mid stone colour, than the later red decoration. However, this change to a darker shade was first made at an early date, possibly prior to the separation of the two properties in 1895. The current red scheme is in a mid-twentieth century lead paint system.

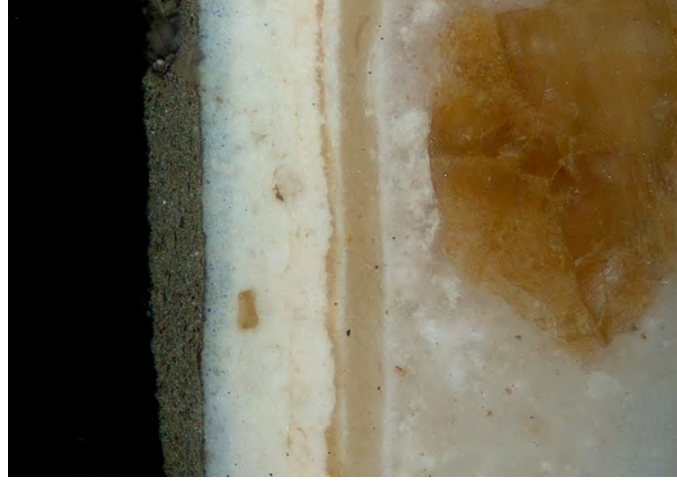
This image shows test cleans on site and areas of damage, possibly caused by heat expansion caused by the fire. However, cracks in room 3 to the rear of this location, appear to be of some age and have indeed been filled, repaired and repainted. It must be assumed that the two are a result of the same historical cause.

Figure 43: Room 2. Sample 5.23 Large decorative cove

- Surface soot, dirt and oily residues
- Localise retouching over original Music design
- Scheme 1, original Music themed scheme of polychromatic lead oil paint, with later retouching and additions
- Distemper builder's finish
- Lime plaster substrate,

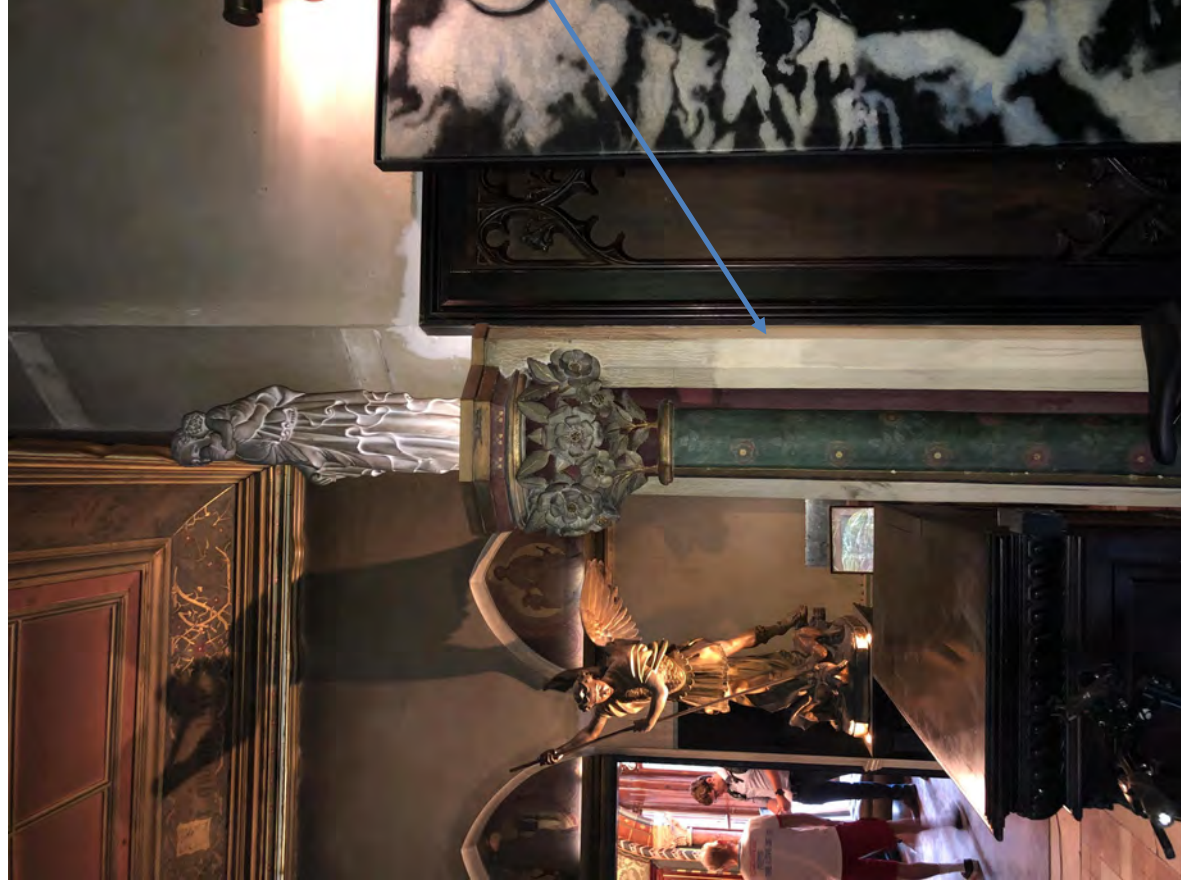
Figure 49: Room 2. Architectural Gothic detailing of columns and capitals

The column within the interior were not sampled as they appeared to retain original historic finishes in good condition. Instead the research focused on following the same cleaning processes as detailed in room 1 and as seen here proved very effective.

1. Record photograph of each area to record current condition
2. Light brushing to remove loose surface deposits (on larger areas thus should be accompanied by vacuuming)
3. Gentle rubbing with 'Smoke Sponges' to lift if more tenacious surface dirt.
4. Gentle cleaning with lint free cotton cloths, using a dilute Synperonic detergent solution in deionised water.
5. Repeat stage 4 using an alkaline soap solution at low percentage strength (5-10%) in deionised water.
6. Cleaning down with pure deionised water to remove and neutralise any surface cleaning product in the surface

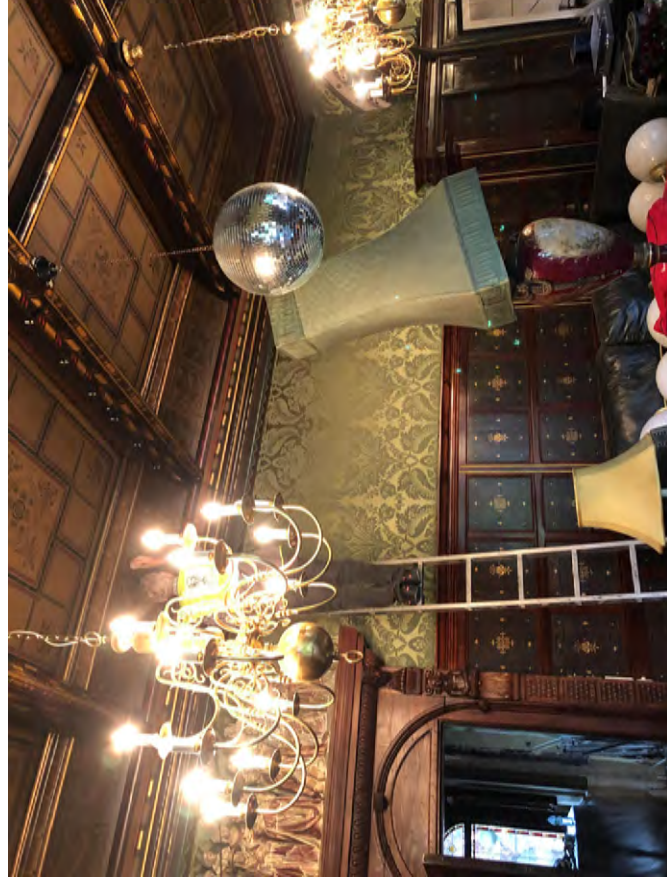
Room 3, the Drawing Room has fewer complex issues than the previous two interiors. There was no evidence for direct fire damage, heaving or cracking, as where these had occurred they had been repaired and the repairs appeared to be of some age.

Figure 52: Room 3. Drawing Room, as it appears now

1. Record photograph of each area to record current condition
2. Light brushing to remove loose surface deposits (on larger areas thus should be accompanied by vacuuming)
3. Gentle rubbing with 'Smoke Sponges' to lift if more tenacious surface dirt.
4. Gentle cleaning with lint free cotton cloths, using a dilute Synperonic detergent solution in deionised water.
5. Repeat stage 4 using an alkaline soap solution at low percentage strength (5-10%) in deionised water.
6. Cleaning down with pure deionised water to remove and neutralise any surface cleaning product in the surface

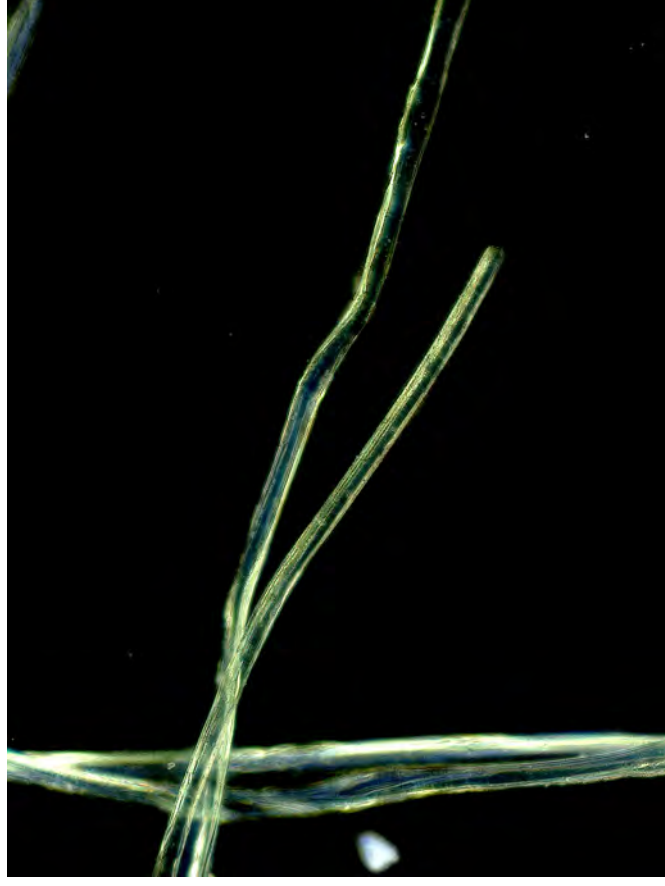
Figure 54: 7.7 Room 3 Green Silk Damask Hangings

The analysis has identified the fabric as a modern silk damask; confirming the statement from the property owner that this was part of a major remodelling and restyling of the properties interior at that time. It is only 10 years old.

While surveying the interior it was noted that the edges of the silk hangings would benefit from a more secure fixing method, that would cause less stress to the fabric by applying even support throughout the material. In particular fixing to the edges has excess material tucked away from behind the adjacent panels and architraves. The removal of this unnecessary excess would assist airflow and benefit both the fabric and the adjacent joinery. It would also make more regular housekeeping an easier process.

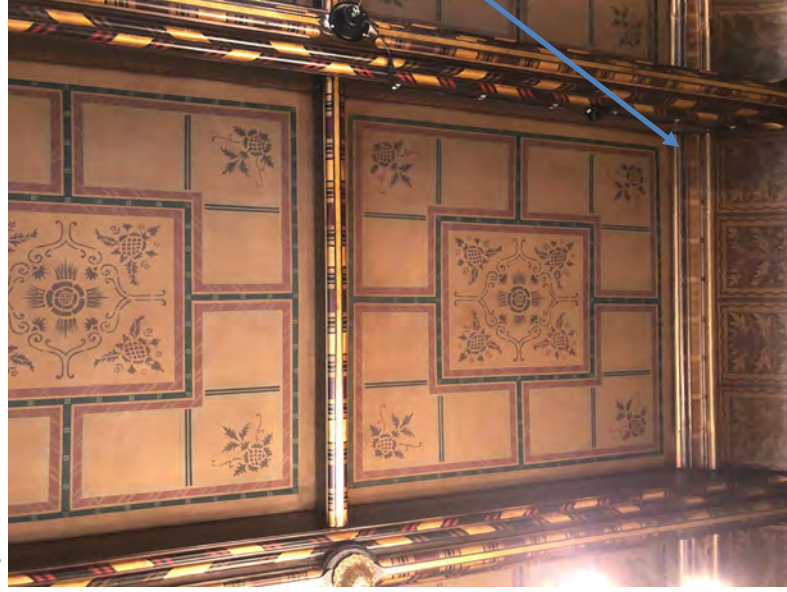
Figure 57:

There is evidence for repair and retouching to the second scheme, where historic settlement has occurred. There are also more recent fitted joinery introductions

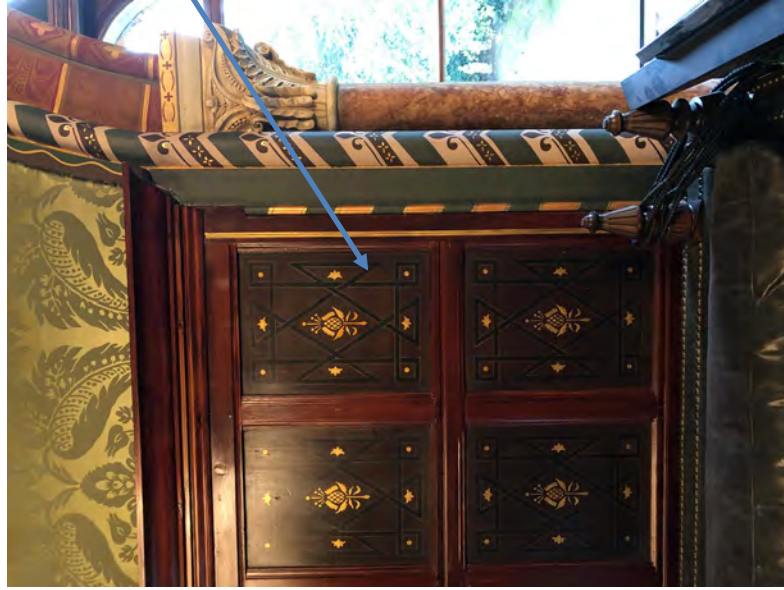
Figure 59:

There is evidence for repair and retouching to the second scheme, where historic losses has occurred. There are also more recent fitted joinery introductions
