Regent's Canal Wall Survey

Revision A 2/12/2020

1 St Mark's Crescent London NW1 7TS

October 2020 Jonathan Freegard Architects

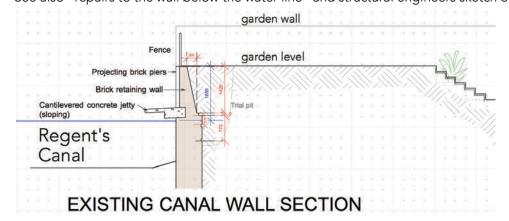
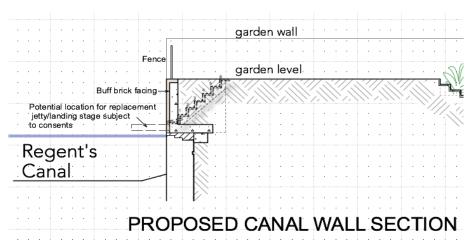
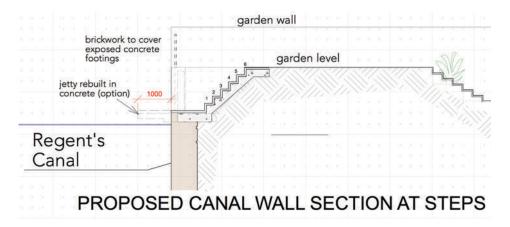
The canal wall is a 225mm – 750mm thick battered retaining brick wall. The width reaches 750mm thick at a depth of 1650mm with a three piers on the Canal side 340mm wide and projecting 110mm from the point just above water level where the wall steps. A trial pit carried out on 4/12/2019 showed the profile of the wall and is recorded with photos and an excavation log at the end of this survey report. There is a projecting 150mm thick concrete slab 300mm above water level forming a jetty. This slab was built pre-WWII and has rotated slightly over the last 80 years or so under its own weight. The jetty it forms matches the width of those at the properties on either side that are constructed of timber. The brickwork below the water line is firm and undisturbed by the slight rotation of the wall above.

It is proposed first to strengthen the wall from the rear garden side with a 250mm thick concrete retaining wall behind it, all hidden below ground level. This retaining wall will be secured from rotation by a 1m toe projecting beneath the garden and also by two transverse concrete walls containing in-set steps. This will spread the load over a greater width than at present thus reducing any load on the old brickwork beneath. The cantilevered slab (jetty) will then, subject to any necessary consents by The Canal and River Trust, be re-formed anchored to the concrete retaining wall and the facing brickwork towards the Canal rebuilt in the existing or matching reclaimed buff-coloured London stock bricks with the central pier retained as a feature. The slab and steps will be faced with yorkstone paving stones on the both the landing treads and step risers.

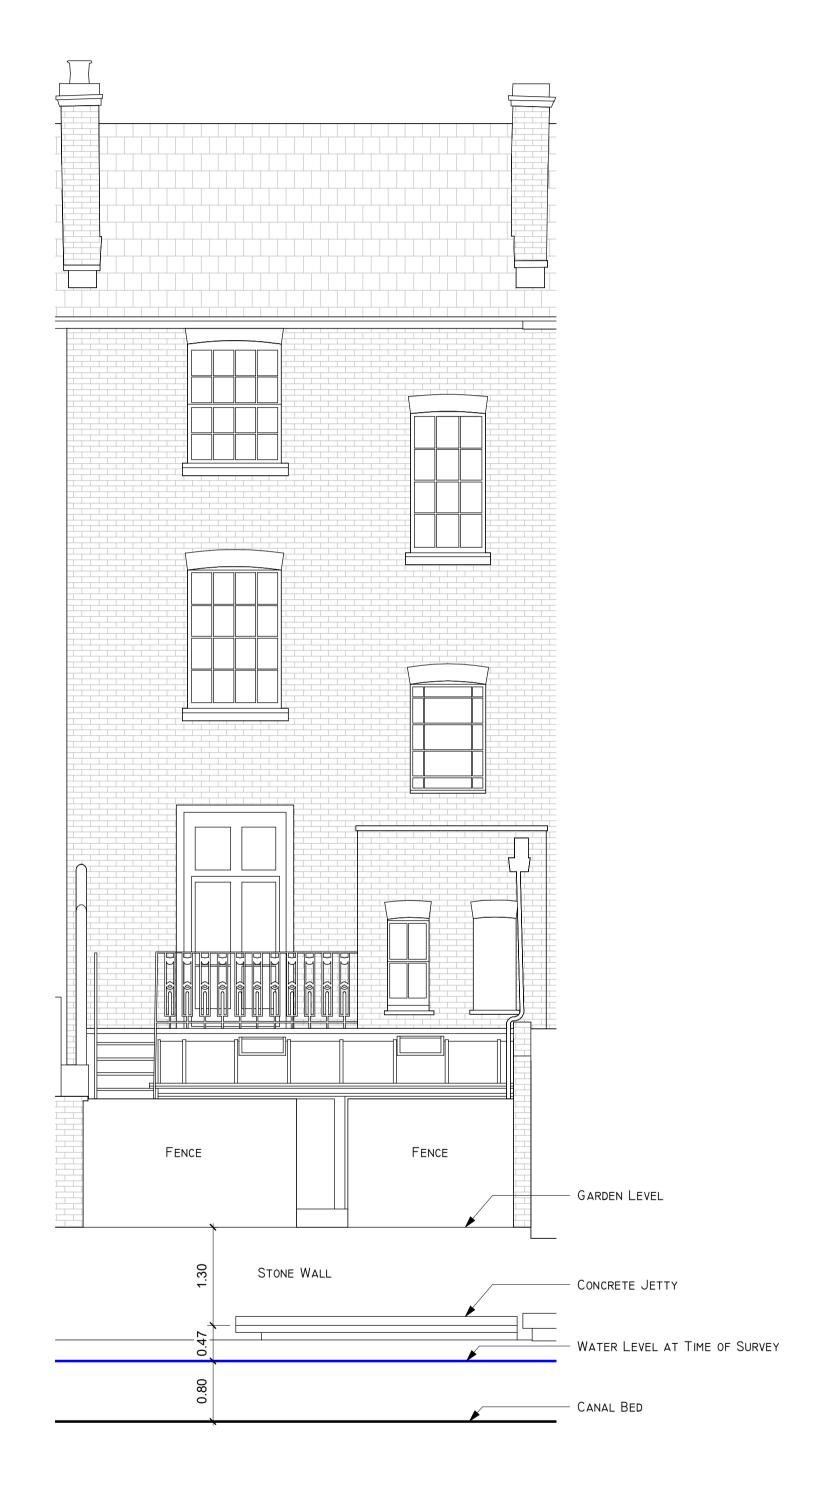
REAR ELEVATION

Anomaly 1 was located approximately 1.4 meters to the left of the outer edge of the jetty, this was a vertical crack approximately 5 to 10mm wide.

Anomaly 2 was the worst of the 3 anomalies, this was located approximately 1 meter to the left of the outer edge of the jetty, this crack has migrated across as seen in the diagram. The crack at its widest was at approximately 30mm.

Anomaly 3 was located approximately 875mm from the centre of the jetty, this was vertical and was approximately 20mm wide at is widest, this appears to be mortar that has come away from in between the brickwork.

It was noticed that the stone block ended level with the start of the concrete jetty

No scour noted.

Repairs to the limited cracks found in the canal wall below the water line will be carried out by a specialist firm using Rockbond Underwater Super Accelerated Mortar (RB UWSAM) powder. This is a blend of special cement powders, high quality graded sands, water soluble polymers and an unique combination of accelerating agents. The powder, when mixed with water, produces a rapid early strength mortar for underwater void filling and concrete repairs at freezing temperatures, and to fast stop the flow of water through cementitious surfaces, masonry, brick and stone.

After filling and sealing any leaking joints, cracks and channels, the mortar will be built up to the profile of the surrounding stonework and form a bridge of mortar over the joint.
