INITIAL TECHNICAL REPORT
Retained

DATE OF ISSUE:	20 th March 2020
OUR REFERENCE NO:	
YOUR REFERENCE NO:	
JR Clare MS Amlin Davies Group Ltd (Stoke) 2nd Floor, East Court Riverside Park Stoke-on-Trent Staffordshire ST4 4EY	Contover Trading Co Ltd 73 Aberdare Gardens London NW6 3AN

General view of property

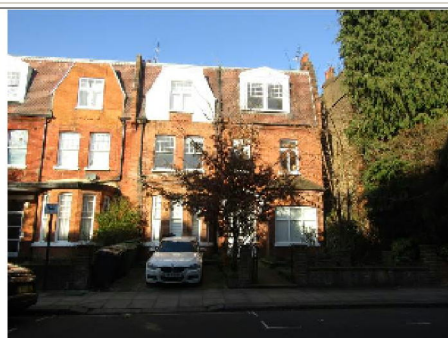
Photograph 1 front

Diagonal and vertical tapering crack damage is evident within the face brickwork to the right and left front bay windows measuring up to 3mm in width.

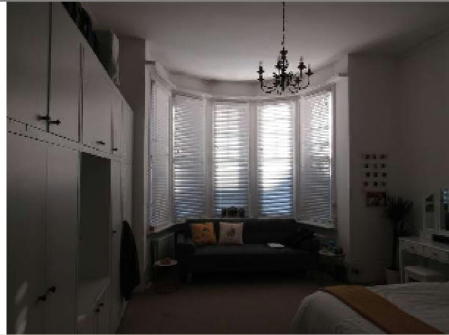
Photograph 12 Front LHS bedroom

Internally crack damage measuring up to 3mm in width is located within the ground floor front bedrooms to either side of the left hand bedroom bay and to the return within the right hand bedroom.
