Photographic Audit with Heritage Survey of 37 Doughty Street

January 2021

This Report is to support the Heritage Statement and the Planning Application and Listed Building Application for the proposed internal and external alterations to 37 Doughty Street.

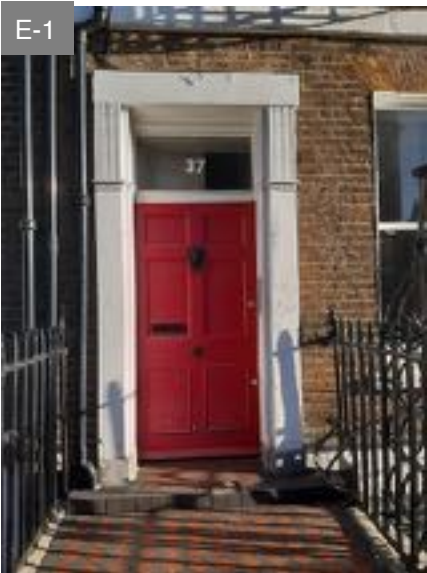
Arriving at no. 37 the 6-panel entrance door and decorative knocker matches the neighbouring properties and is presumed to be original (E-1). Visual comparison with no. 36 suggests the door surround is missing some features; the side pilasters are missing the framing detail, the reeding is present but the decorative entablature above is missing (E-5). The glazed radial fanlight is also missing.

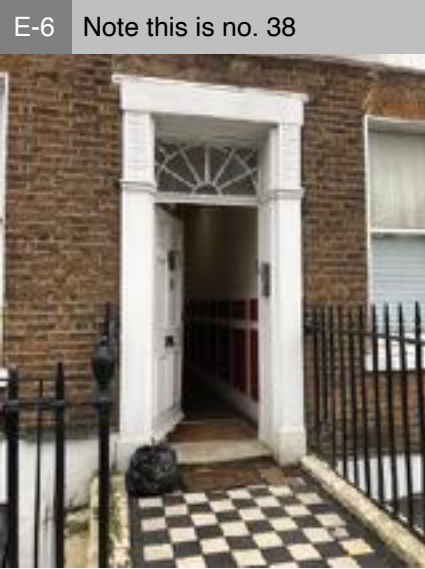
E-6 Note this is no. 38

Two external steps and landing at pavement level have tiles missing (E-3). The arrangement is a diagonal red and grey pattern in modern tiles while other neighbouring properties have a black and white orthogonal arrangement (E-6).

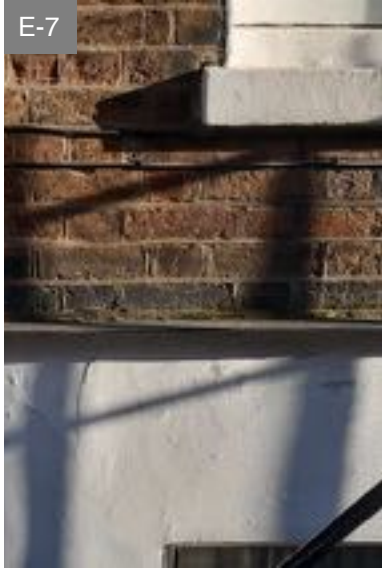
E-7

The brickwork to the front of the property looks in poor condition with patches of spalling (E-5). On close inspection the mortar is very rigid and pronounced and presumed to be cement based (E-7).

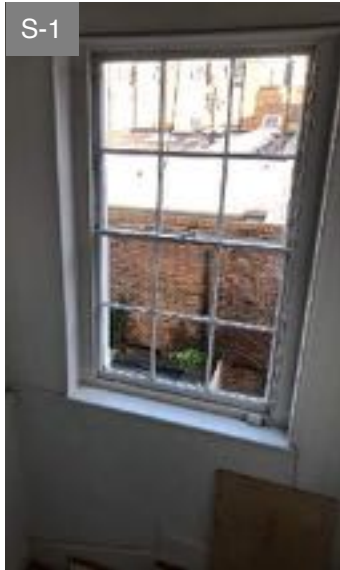
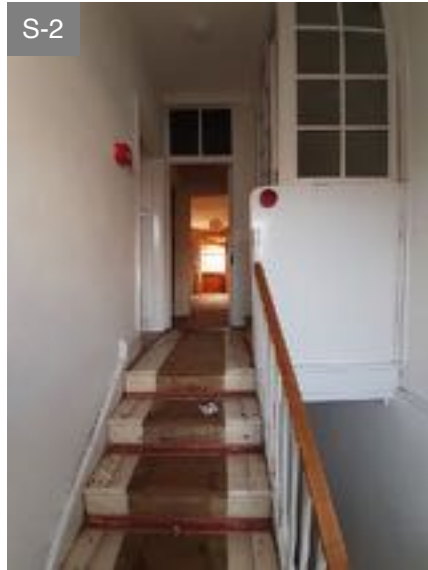
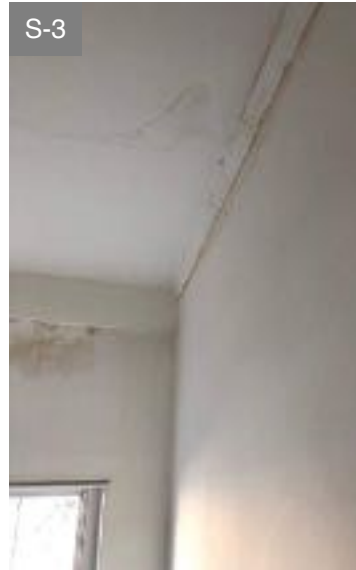
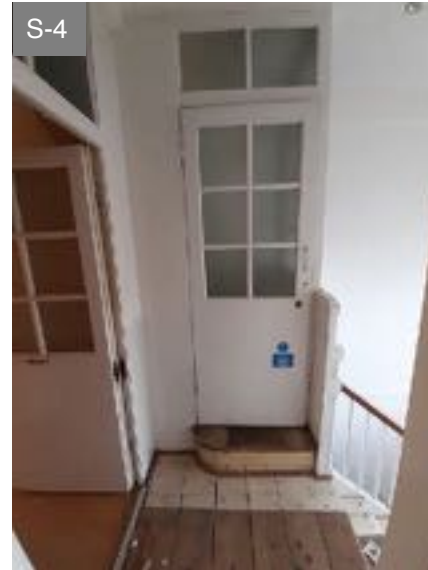
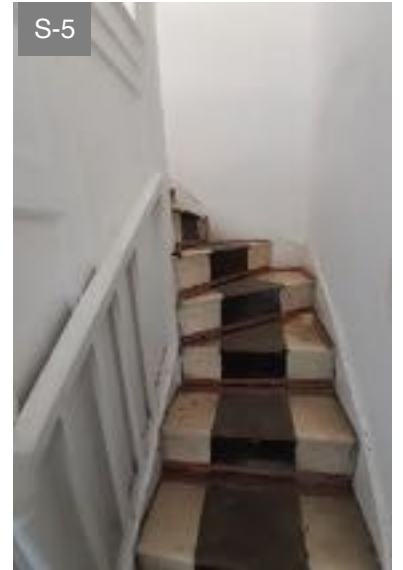
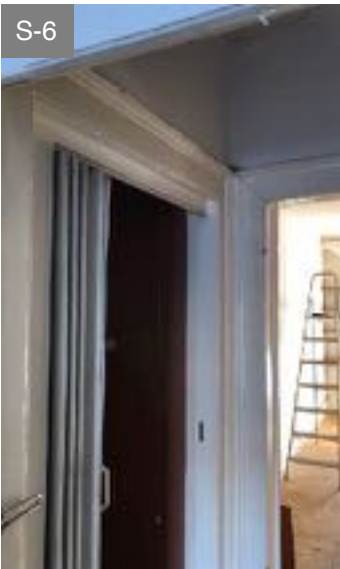
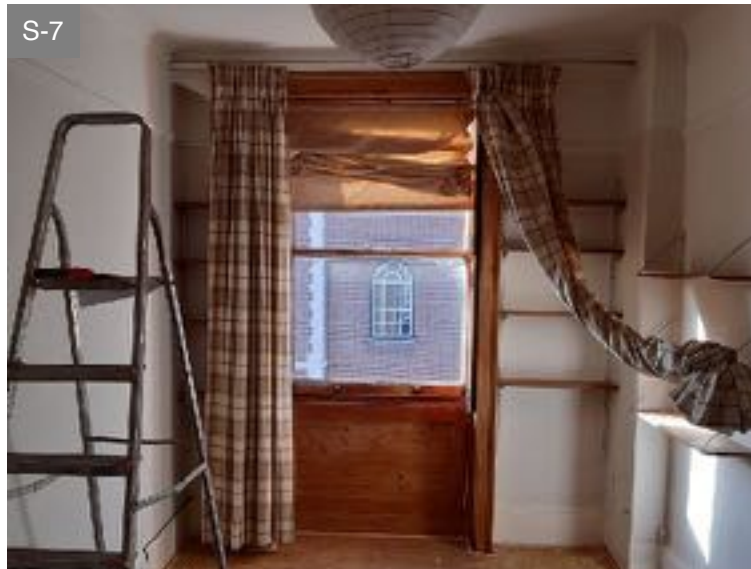
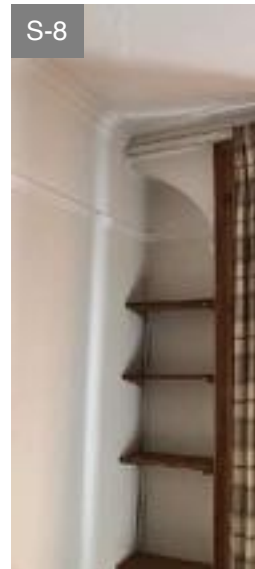
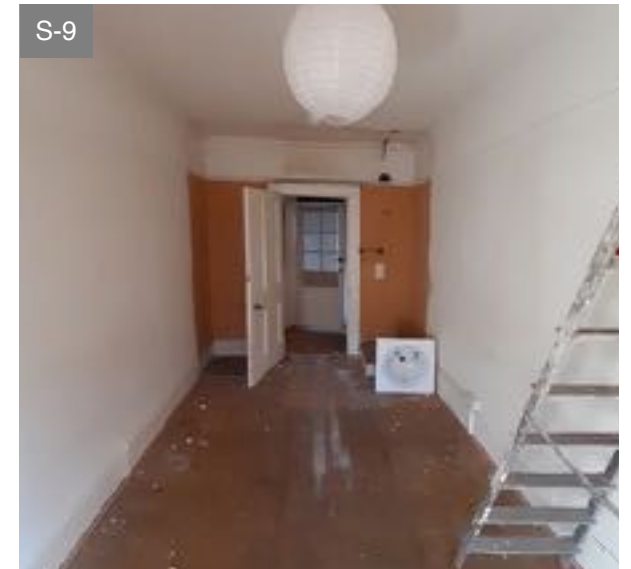
Appendix A: Second Floor

The window to the stair as you rise up to the second floor appears to be original (S-1). Above it is noticeable that the ceiling has been badly water damaged and only part of the simple style cornice remains, other parts have been boxed out (S-3).

There are 3 doorways at the head of the stair (S-2). The access to the third floor is to the right at the head of the stairs. This is adjacent to the top landing guarding which has been replaced by a modern panel. The stair to the third floor is boxed off with a timber structure with fixed steel framed windows. The door entry to the third floor stair is a step up and has been overboarded, presumably for fire reasons giving it a plain appearance (S-4). The boxed structure looks to have been a 20th century intervention. The doorway directly opposite the stair head seems to also date from 20th century and incorporates similarly glazed panels. This leads to the bedsit adjacent to no 36. The door to the left at the head of the stair is a 20th century intervention and has no door leaf. The opening leads to the other bedsit, adjacent to no. 38.
