# Design and Access Statement St Benet's Church, Lupton Street, Kentish Town

Project: Roof Drainage

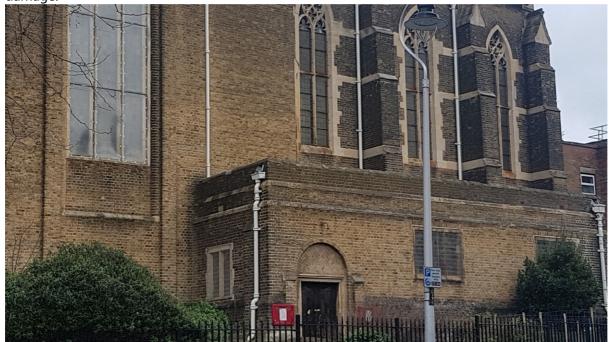
Hare preferred to hide the means of drainage. Pipes appear through the wall and drop down to hidden gutters and sometimes they reappear above ground level and secretive outlets. The open gutter areas are also frequently inaccessible and the areas where pipes are internalised makes it impossible to keep them clear and sometimes the cast iron corrodes and leaks cause further damage.
