Shaldon Mansions Lightwell - Context photos

Introduction

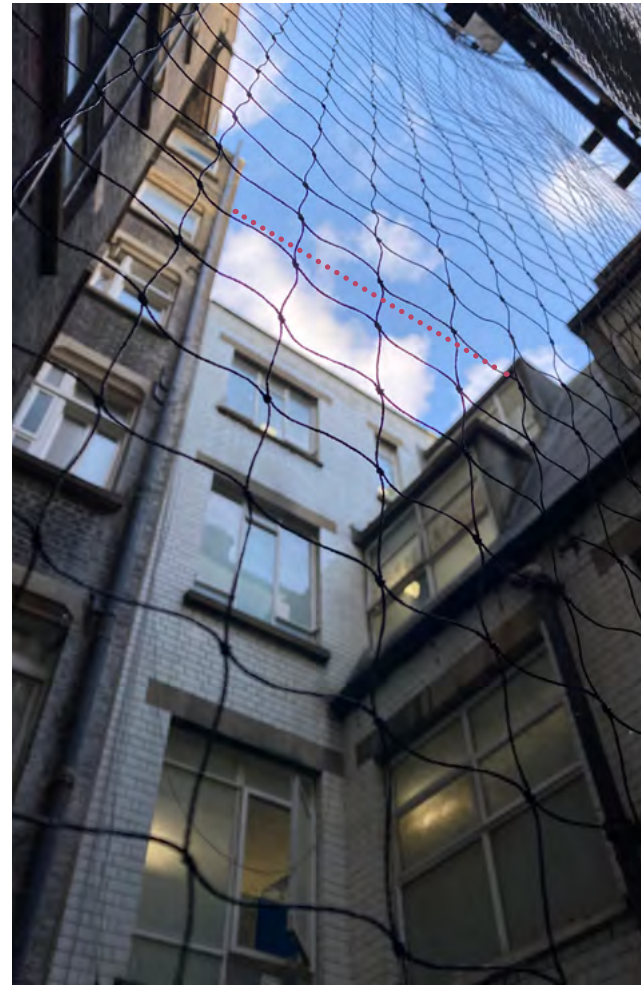
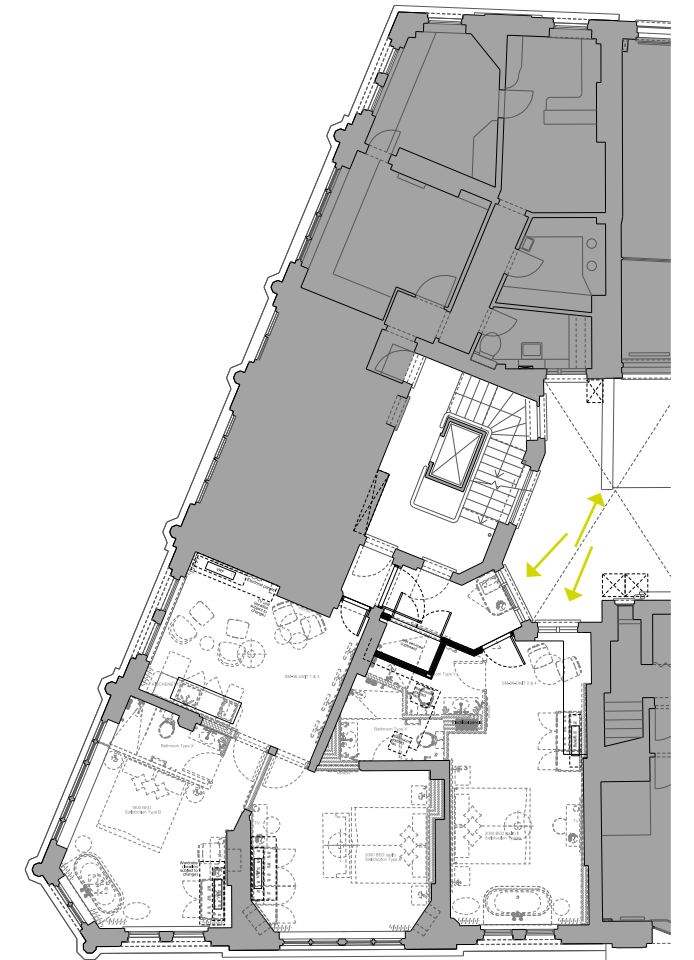
1st floor windows.
Left hand window is fully obscured.
Right hand window partially frosted at low level.

Both form part of new double aspect apartment currently being reconfigured. Windows are replaced as part of the recent planning consent. Daylighting into the spaces is improved considerably.

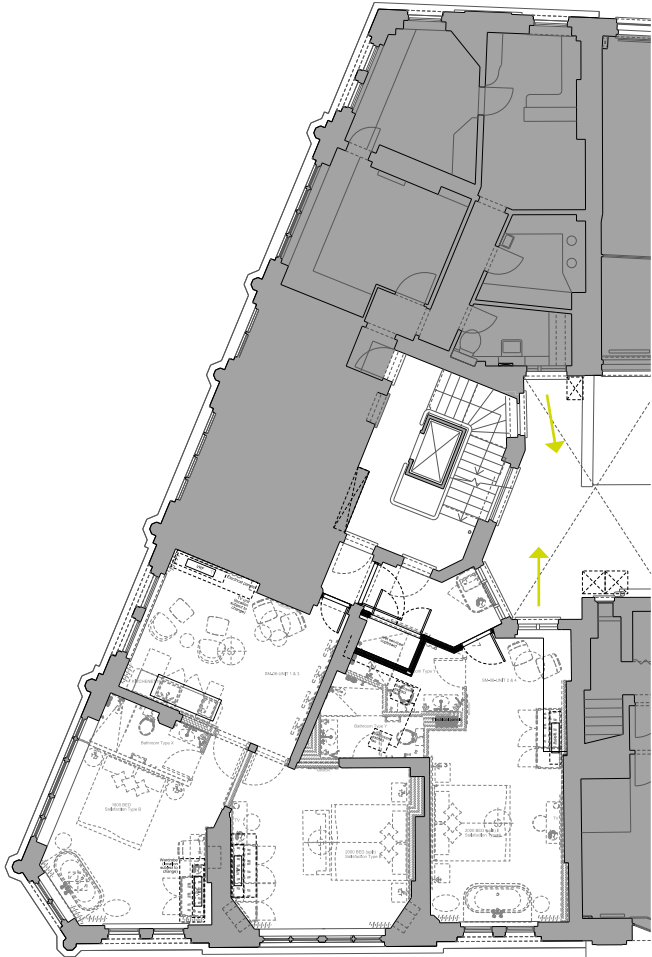
View from 1st floor looking south (2nd floor window is higher than this so view would be 'improved').

All windows are replaced as part of the recent planning consent. Daylighting into the spaces is improved considerably.

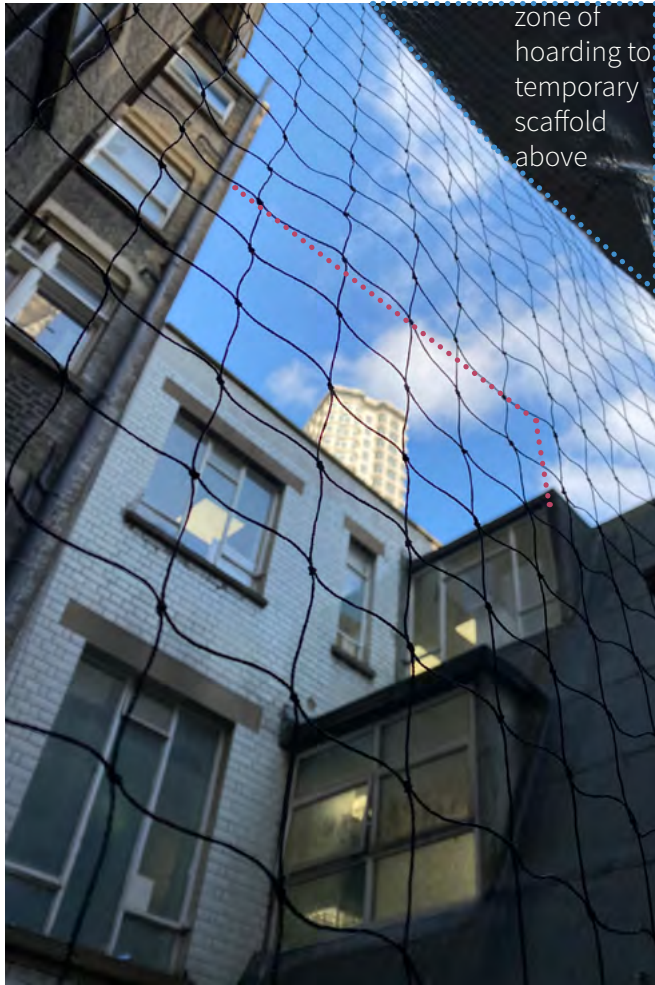
2nd floor window (currently a toilet)

Both windows form part of new double aspect apartment currently being reconfigured. Windows are replaced as part of the recent planning consent. Daylighting into the spaces is improved considerably.

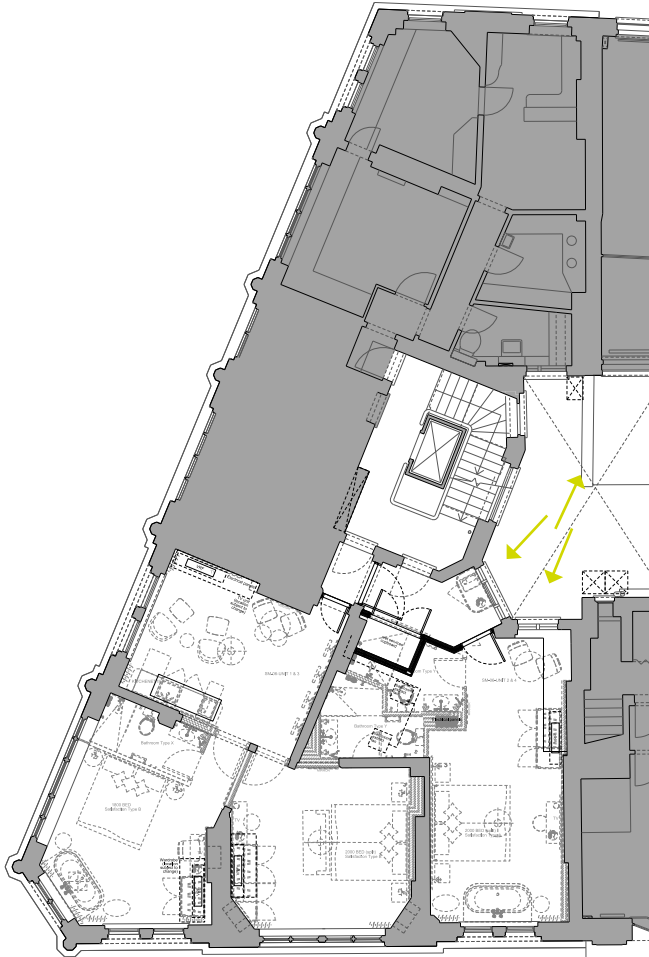
2nd floor toilet window (currently a site office reception)

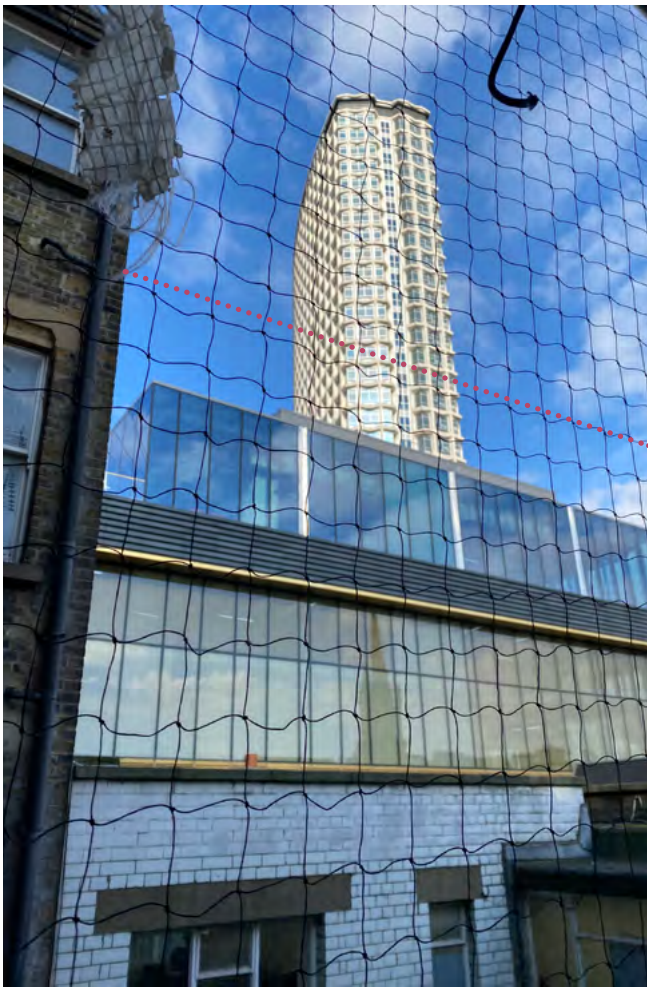
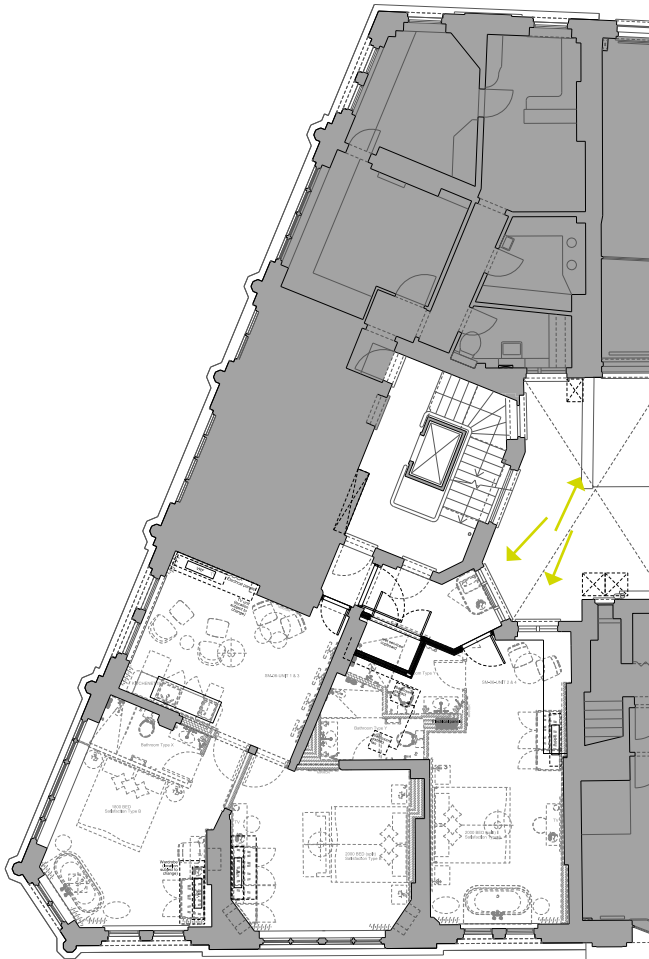
3rd floor south side former kitchen. Unused.

Both form part of new double aspect apartment currently being reconfigured. Windows are replaced as part of the recent planning consent. Daylighting into the spaces is improved considerably.
